# 530 JACKSON STREET FOCUSED HISTORIC STRUCTURE REPORT

SAN FRANCISCO, CALIFORNIA  
[24394]

PREPARED FOR  
Brick & Timber

May 1, 2025  
(Revised September 17, 2025)

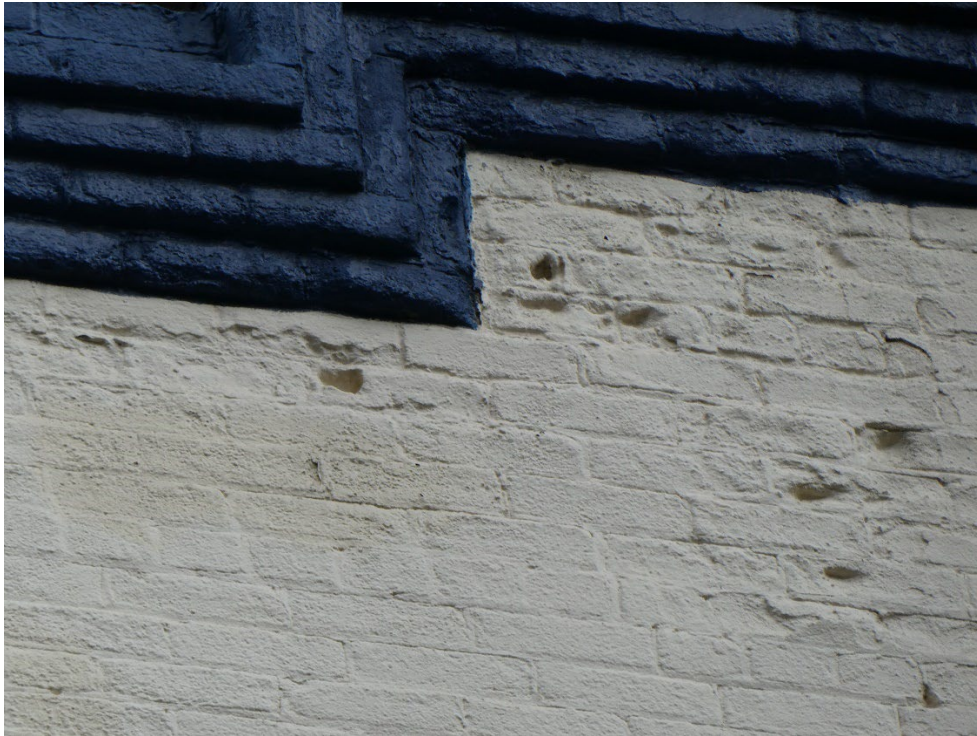
The brick masonry on the primary façade is painted and appears to be in good overall condition. Generally, there are some locations with mortar loss, and there are areas of mortar loss and brick erosion/spalling at the parapet below the stepped, crenellated cornice that have been painted over (**Figure 21**). The erosion and rough texture through the paint may indicate that the wall had been previously sandblasted. Similar areas of erosion occur at various locations across the façade, but are less concentrated than at the parapet. The paint is in good condition. There are two climbing vines flanking the facade at the southwest and southeast corners, which appear to be bougainvillea and jasmine. The plant at the southeast corner appears to be supported by and climbing up a cable rather than the brick itself, and the vines do not appear to be causing damage to the masonry at this time. It is unknown if they hold any moisture in the masonry during the rainy season. The wood mid-band cornice across the top of the storefront between the first and second floors is in good condition. There is an area of missing paint, exposing bare wood where a former tenant sign once was located (**Figure 22**). The metal flashing on the mid-band cornice is in fair condition. The metal fire escape, which is original to construction, also appears to be in good condition. Minor surface corrosion and paint loss at the fire escape was noted. The connection points between the fire escape and the masonry appear to be in generally good condition except at the third floor, where one connection point exhibits some mortar, and paint loss (**Figure 23**). Behind the parapet, the fire escape is no longer anchored to the roof (**Figure 24**).

Figure 21: Brick and mortar deterioration at the parapet, Jackson Street (south) façade.

| <p>Description of work:</p> <p>Inspect and repair masonry. Repoint mortar where missing, deteriorated, or loose. Use an appropriate mortar mix that is compatible with historic masonry and matches the texture, color, and visual characteristics of existing. Repoint and repair the parge coat on the masonry window sills. Patch bricks with material loss with an appropriate masonry patching compound that matches the color, texture, and visual characteristics of the original brick. Once the brick is repointed and patched, prepare, prime, and paint the masonry with a breathable masonry paint.</p> | |

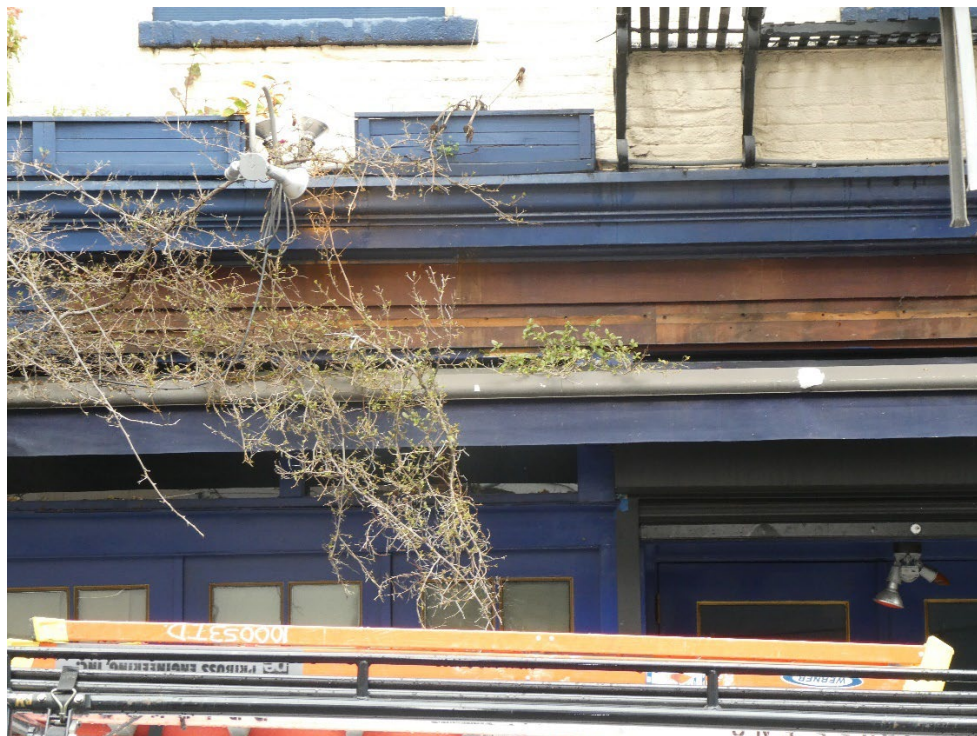
Figure 22: Unpainted area of wood at the mid-band cornice, south façade.

| <p>Description of work:</p> <p>Repair and paint historic mid-band cornice. Properly prepare, prime, and paint the cornice with an appropriate wood paint at wood elements and rust-inhibitive paint at metal elements, including flashings.</p> | |

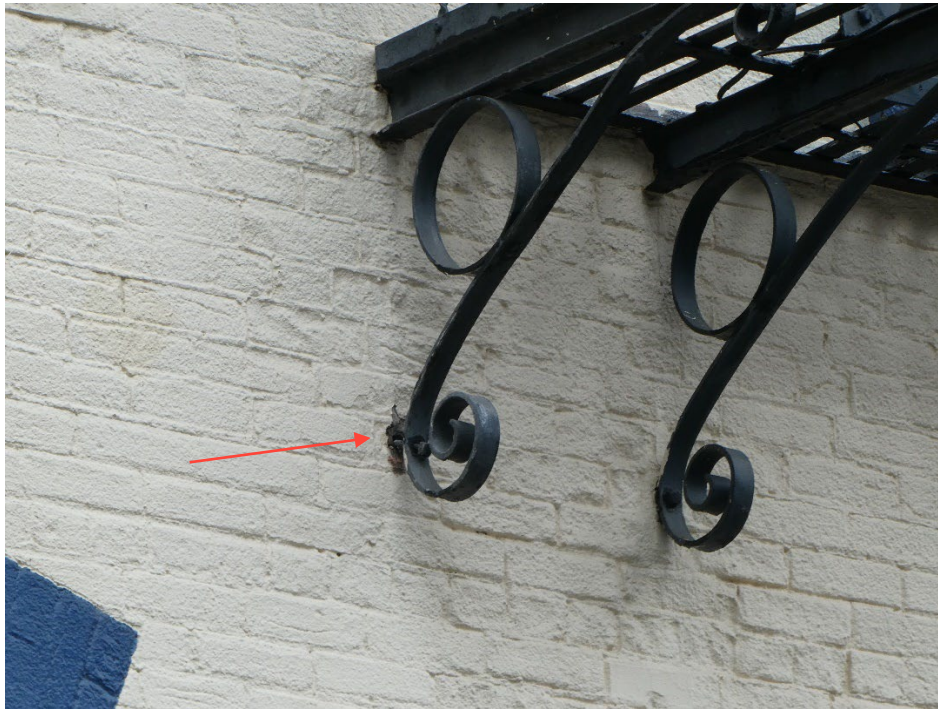
Figure 23: Loose anchor and masonry loss at the connection point between the masonry and the fire escape, above the second floor, south façade.

| <p>Description of work:</p> <p>Engage with a structural engineer to inspect the connections between the fire escape and the masonry, connections between wrought iron members, and for compliance with fire escape codes and standards as needed. With the guidance of a structural engineer, create a repair plan to tie the fire escape to the roof structure, where the connection has been removed. Secure anchorage points as needed and repair the masonry around connection points where there is material loss and deterioration. Spot treat surface corrosion and areas of anchorage. Repair, and properly prepare, prime, and paint using a rust-inhibitive paint where needed.</p> | |

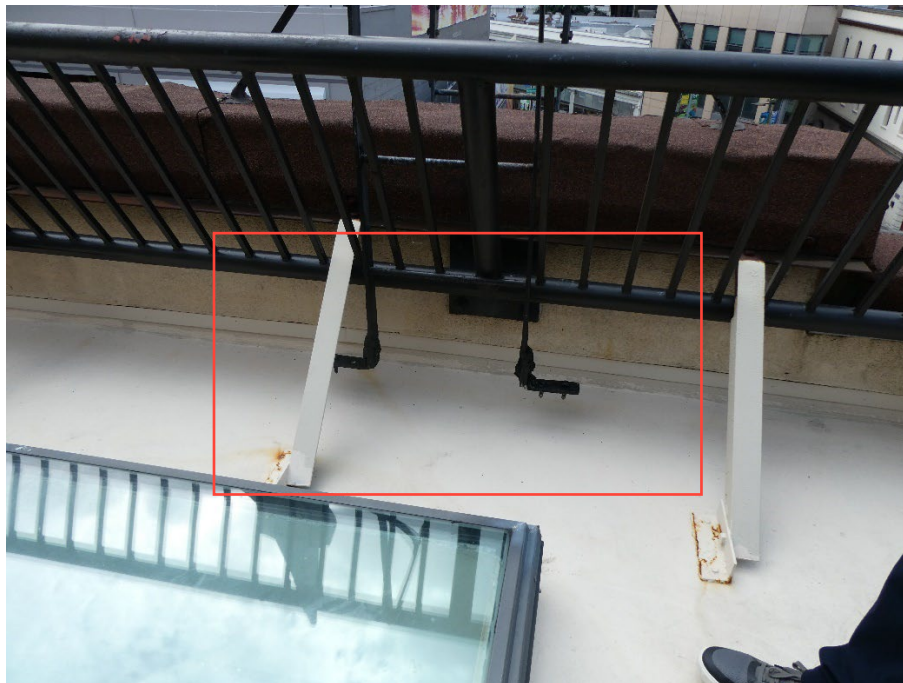
Figure 24: Fire escape is no longer anchored to the roof, fifth floor balcony.

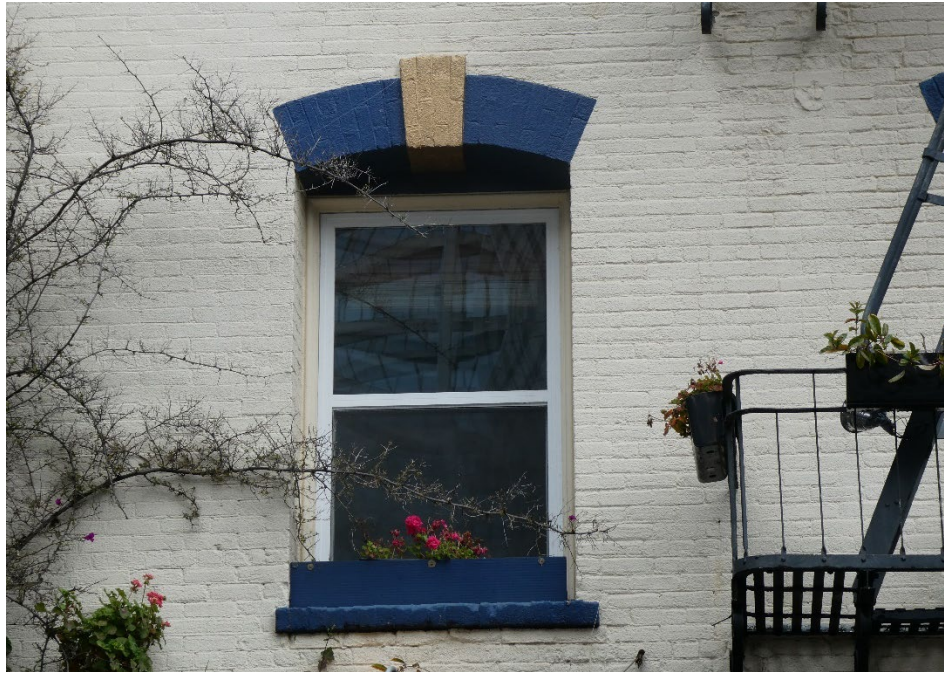
Figure 25: Second floor window with historically incompatible vinyl windows inserted into the historic wood frame, south façade.

| <p>Description of work:</p> <p>Replace historically incompatible vinyl and aluminum windows at the second and third floors, and replace non-historic wood windows inserted into original wood frames at the fourth floor with compatible double-hung wood sash windows. Retain and repair the existing historic wood frames and sills, where possible. Repair wood frames and sills by patching wood checking and deterioration with an appropriate wood patching compound. Prepare, prime, and paint.</p> | |

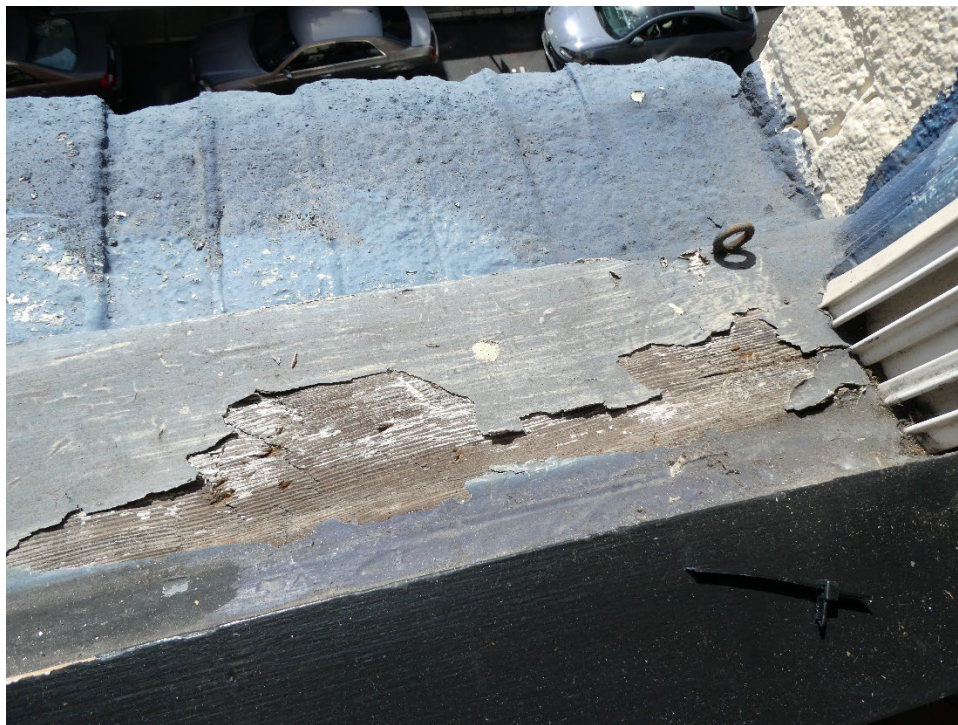
Figure 26: Paint loss exposing weathered wood with checking, UV damage, and raised grain at historic wood window sill, fourth floor, south façade.

| <p>Description of work:</p> <p>Retain and repair historic wood window sashes and frames. Inspect and repair as needed. Repair wood by patching wood checking and deterioration on the frame, sash, and window sills. Replace glazing putty as needed. Properly prepare, prime, and paint the frame, sash, and sill. Restore operability of the sash and latches. Paint exterior security grilles on the first floor with rust inhibitive paint. There is an approved permit for replacement of three exterior windows with new rated windows.</p> <p>At the masonry portion, replace historically incompatible vinyl and aluminum windows at the second and third floors, and replace with historically compatible double-hung wood sash windows. Retain and repair the existing historic wood frames and sills, where extant. Repair wood frames and sills by patching wood checking and deterioration with an appropriate wood patching compound. Prepare, prime, and paint. There is an approved permit for replacement of three exterior windows with new rated windows.</p> | |

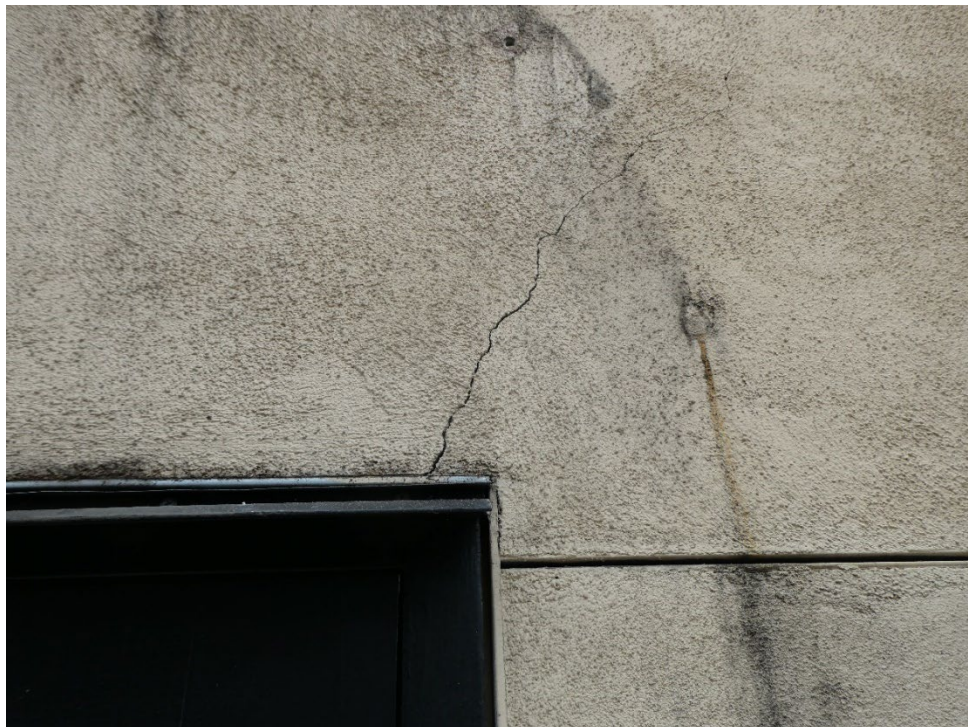
The stucco on the south façade of the set-back vertical addition is in good condition. There is one diagonal crack in the stucco originating from the corner of the east door (**Figure 28**). There is atmospheric staining around the two doors where awnings were once extant. The glazed doors exhibit paint loss and wood checking at the bottom rail, and the hinges and hardware have surface corrosion. (**Figure 29**). An open gap between the perimeter of the door frame and the adjacent stucco could allow water intrusion (**Figure 30**).

Figure 28: Diagonal crack originating from the corner of the door, south façade.

At the balcony wall, clean the atmospheric staining from the stucco as needed for painting. Then prepare, prime, and repaint the stucco. The diagonal crack located at the upper corner of the door

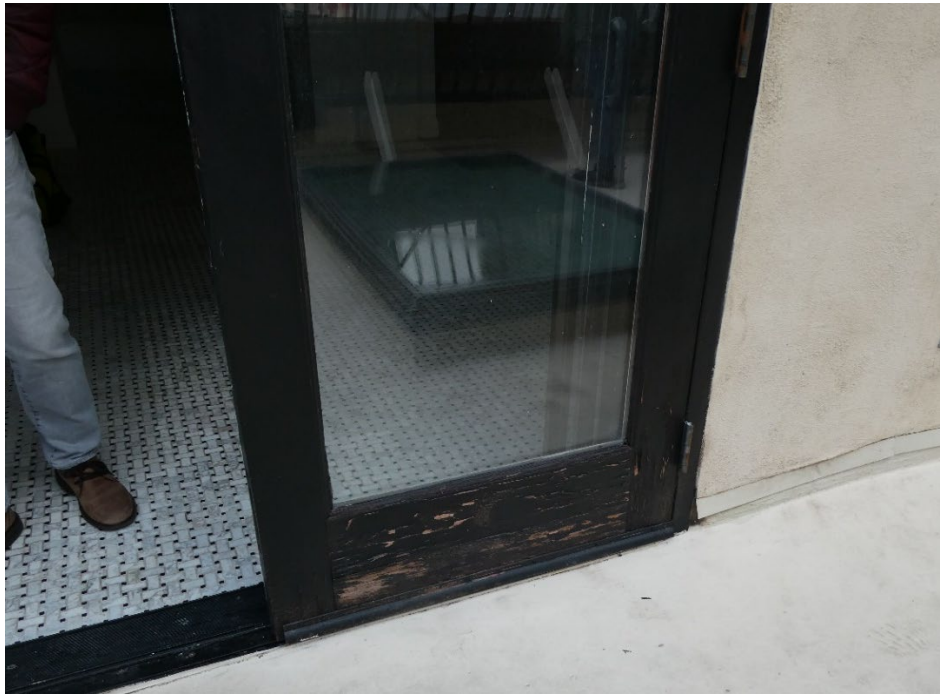
Figure 29: Deterioration of the bottom rail of the glazed doors, south façade.

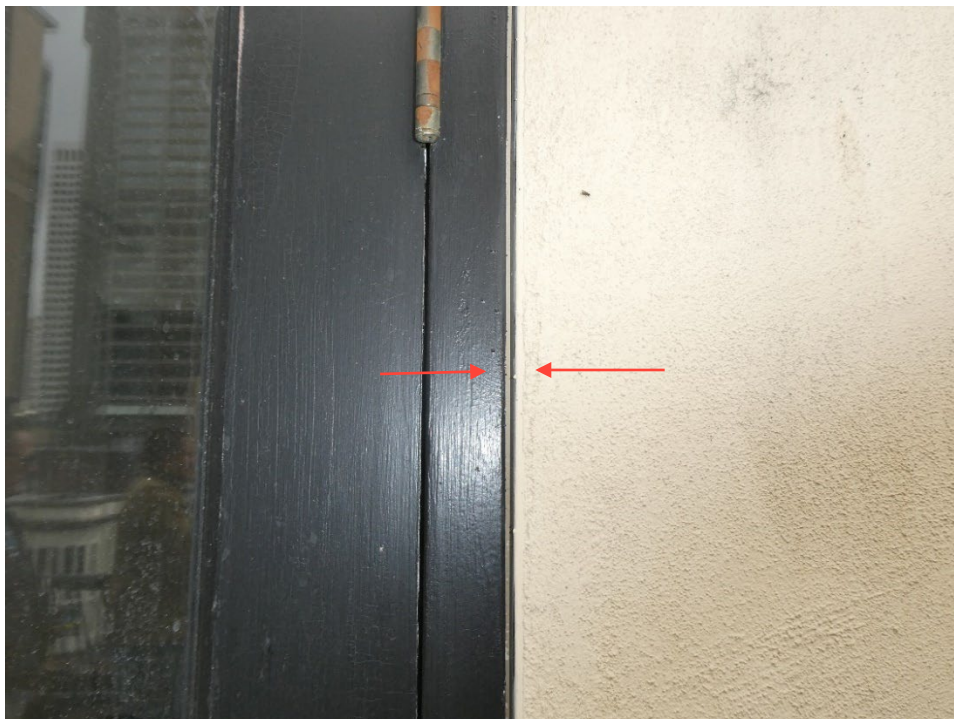
Figure 30: Open gap between the door frame and stucco, south façade.

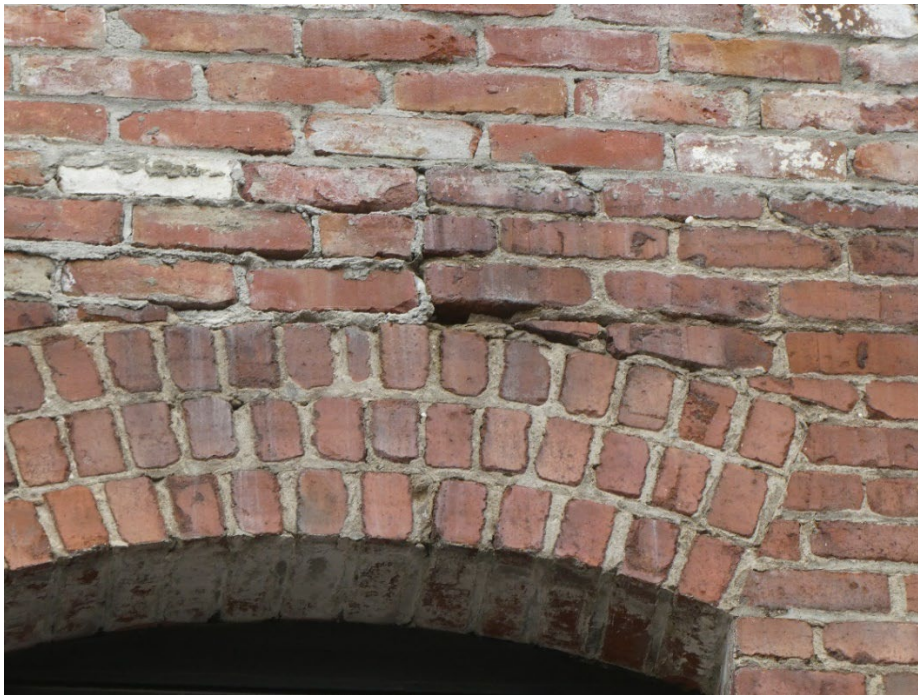
Figure 32: Mortar deterioration and loss at segmental arch, third floor, west façade.

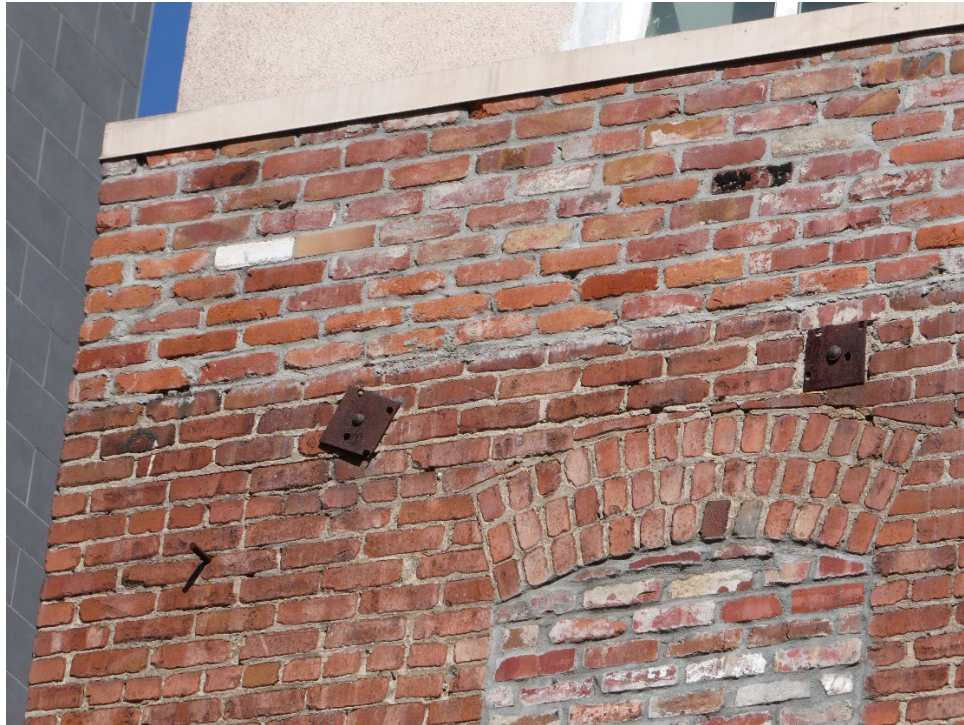
Figure 33: Tie rods with surface corrosion, west façade.

| <p>Description of work:</p> <p>Clean masonry of soiling, spills, and biological growth with a warm water wash and chemical cleaner. If determined feasible without causing damage, remove the parge skim coat at the base of the wall. Use mockups to test removal approaches. If the removal of the parge skim coat is deemed too damaging to the brick, cut joints, and repoint 100% of the parged area. Repainting of the parged area with a breathable paint may be needed if the parge cannot be removed. Remove paint from the masonry using a pH neutral masonry paint stripper. Mockups should be used to test strippers before full removal takes place. Repoint areas of deteriorated, missing, and inappropriate mortar at these façades. Repoint joints at the window sills as needed, and re-parge the horizontal sill surface. The mortar and parge should match the original visually. Patch cracked, eroded, and deteriorated bricks with an appropriate masonry patching compound to match the existing color and texture. Remove the corrosion from the metal tie rods and plates, and prepare, prime, and paint with rust inhibitive paint.</p> | |

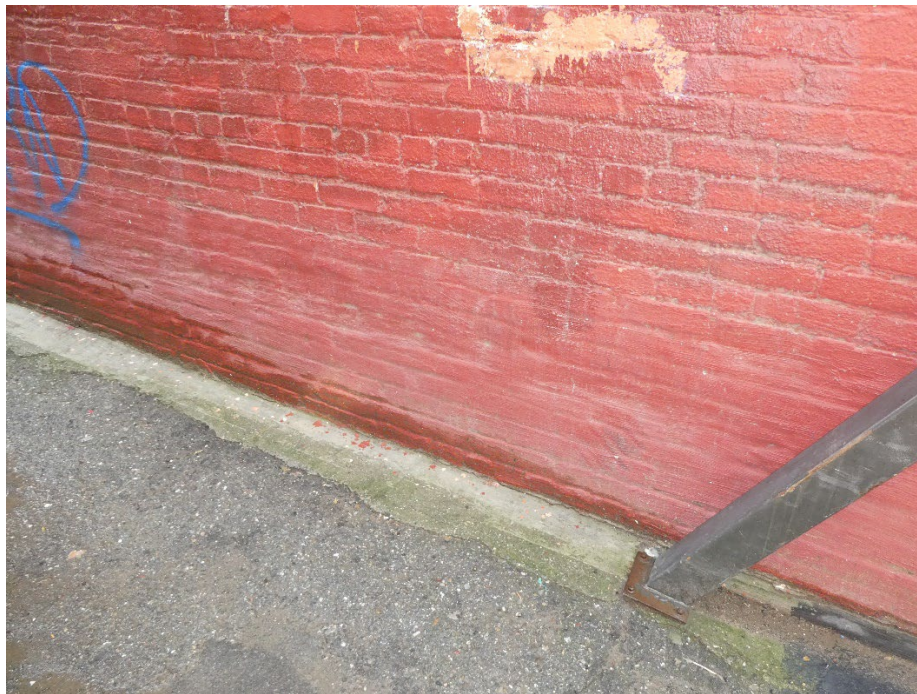
Figure 34: Parge coat and paint layer at the base of the masonry wall, west façade.

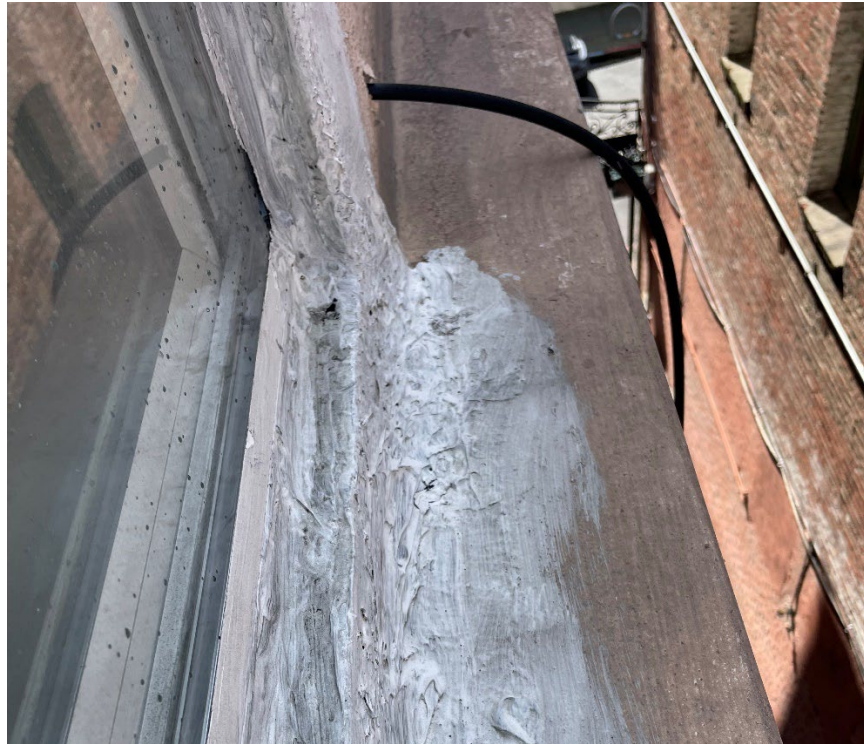
floor, except they have been modified with the insertion of a vinyl slider window that replaces the fixed lower pane of the steel window. These windows are in poor condition. The slider windows were installed poorly and have a large build-up of sealant, including where they meet the exterior metal coping flashing (see coping description above). Perimeter sealants and waterproofing between the windows and the stucco have also failed, and water intrusion was noted around the interiors at several of these windows (**Figure 35**).

Figure 35: Deteriorated metal coping and large build-up of sealant around windows, fourth floor, west façade.

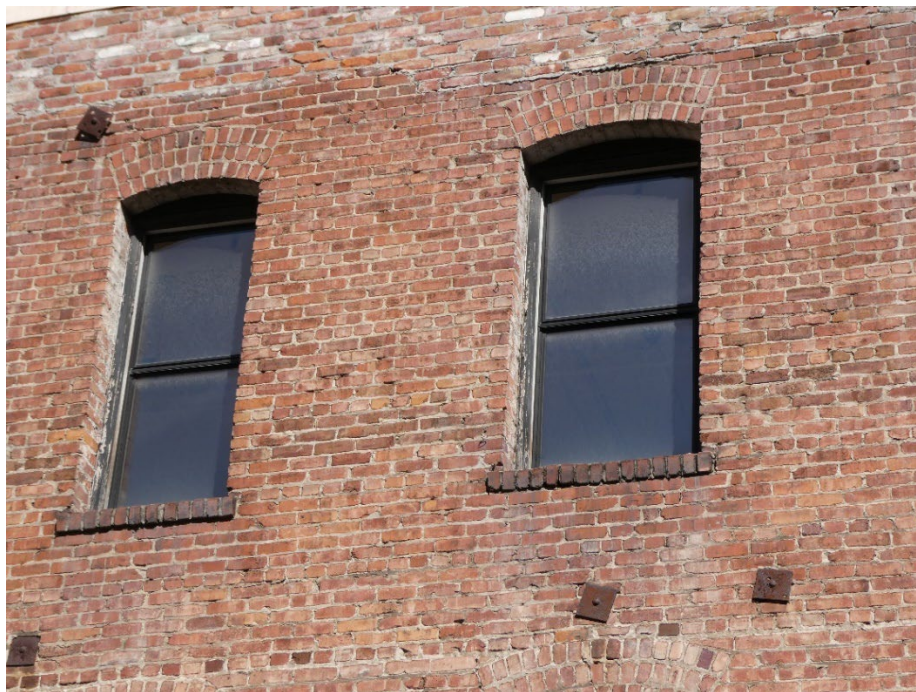
Figure 36: Third floor windows with historically incompatible aluminum frames and historic wood frames, west façade.

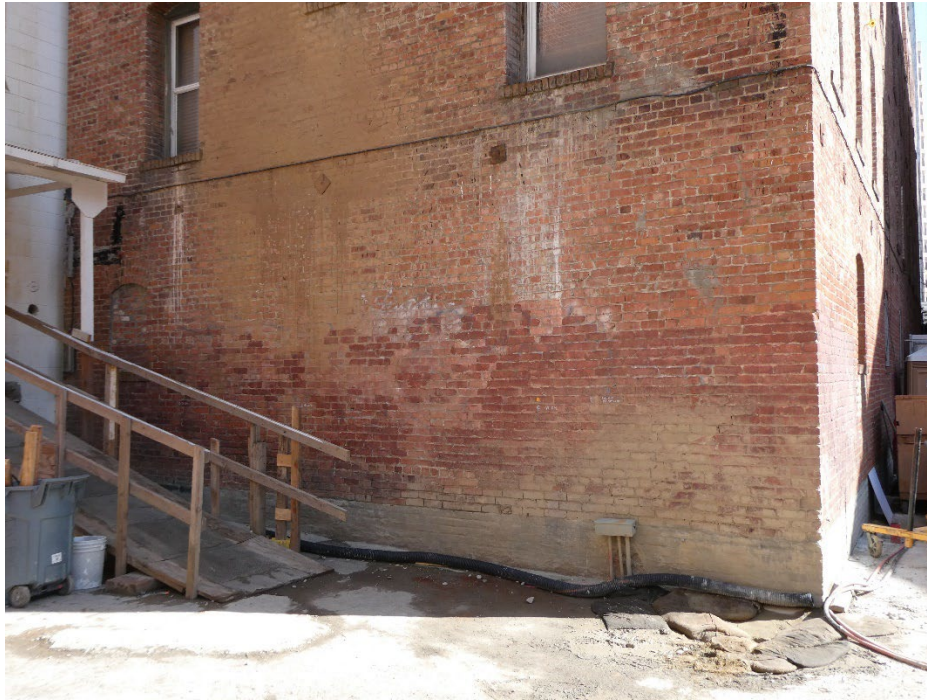
Figure 38: Water pooling at the base of the wall, mortar loss and extraneous paint and soiling on the masonry, north façade.

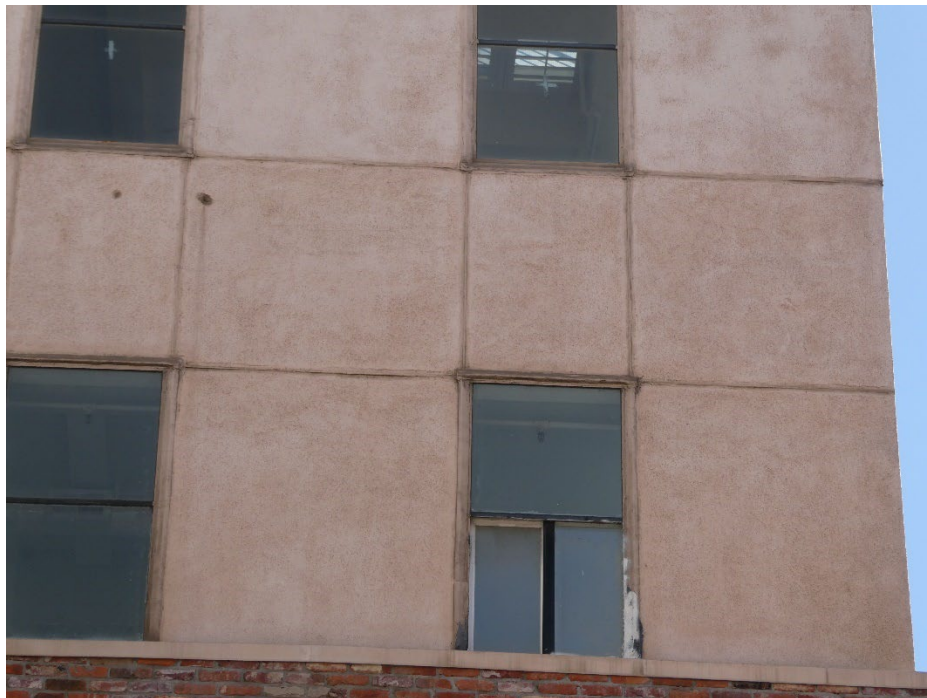
The windows at this façade include vinyl, wood, and steel. One window at the second floor of the lower brick masonry portion has an original wood frame with its original wood double hung sash. This window appears to be in fair condition with some paint loss, minor wood checking at the bottom rail of the sash, and glazing putty loss (**Figure 39**). The remaining windows at the second and third floors appear to have original wood frames with replacement vinyl and aluminum windows inserted into the original frames. The wood frames are in fair condition with some paint loss and wood checking. The non-historic insert windows are generally in fair condition but are incompatible with the historic character of the building. All the windows at the fifth floor are fixed steel sash windows with wire glass; some exhibit cracked glass at the steel frame and/or due to the embedded wire. The windows at the fourth floor are similar to those at the fifth floor, except they have been modified with the insertion of a vinyl slider window that replaces the fixed lower pane of the steel window. These windows are in poor condition. The slider windows were installed poorly and have a large build-up of sealant, including where they meet the exterior metal coping flashing (see coping description above). Perimeter sealants and waterproofing between the windows and the stucco have also failed, and water intrusion was noted around the interiors at some of these windows (**Figure 40**).

Figure 39: Deteriorated and poorly installed windows at the fourth and fifth floors, north façade. Note failed joints at the stucco.

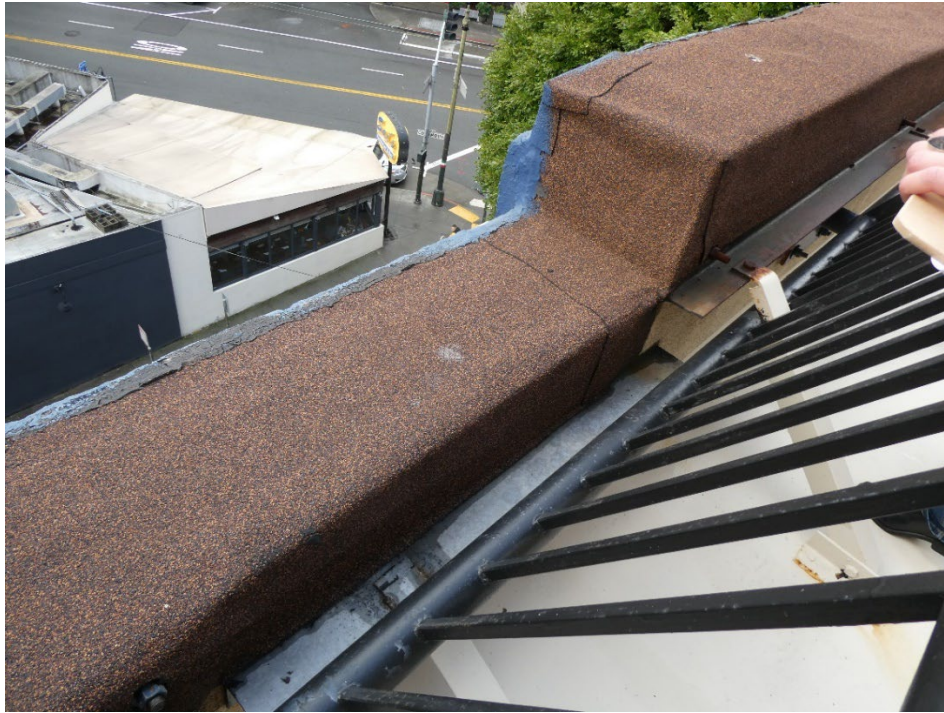
The fifth floor balcony on the south end of the building is in fair overall condition. At the south and west parapet walls, the asphalt sheet flashing exhibits puckered areas at a couple lap seams and may begin to allow water intrusion through to the masonry below (**Figure 42**). At the east parapet wall, the seismic expansion joint cover and associated metal flashing has surface corrosion and some denting (**Figure 43**). No issues were visually noted at the flexible rubber bumper. The steel parapet bracing and railing have minor surface corrosion and paint loss. The roof membrane on the balcony is in fair condition, as it exhibits a few cracks in the membrane (**Figure 44**). Build-up and debris were noted at the roof drains, and no drain covers were noted. There is no guard rail surrounding the skylight, which is a falling hazard (**Figure 45**).

Figure 42: Some deterioration of the seams at the asphaltic coping at the south parapet wall, fifth floor balcony.

| <p>Description of work:</p> <p>Inspect the balcony roofing and ensure there is no water intrusion into the interior. Recoat and patch the membrane roofing at the balcony. Remove the asphaltic coping at the south and west parapet walls and replace with G90 heavy galvanized or non-corroding metal coping and paint with a rust inhibitive paint. Install drain covers at the two roof drains at the north corners. Remove the corrosion from the seismic parapet bracing and metal parapet coping at the expansion joint cover (the expansion joint cover extends along the full east wall at the fifth floor balcony and the upper roof). Paint both with a rust-inhibitive paint to protect from future corrosion.</p> | |

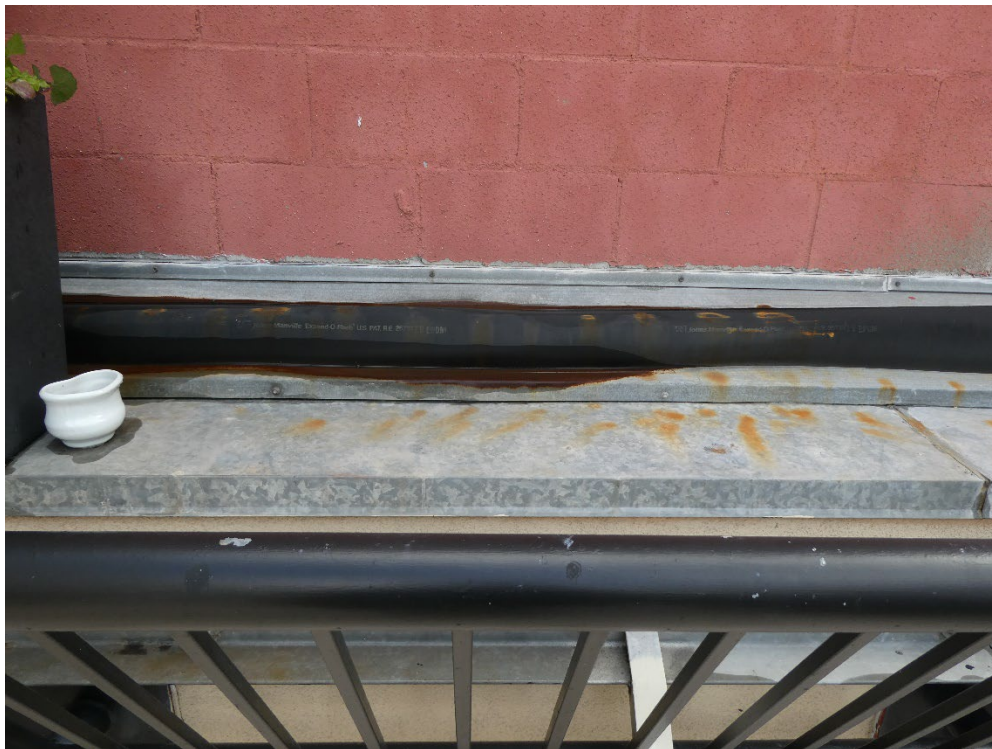
Figure 43: Surface corrosion at the metal coping/seismic expansion joint, fifth floor balcony.

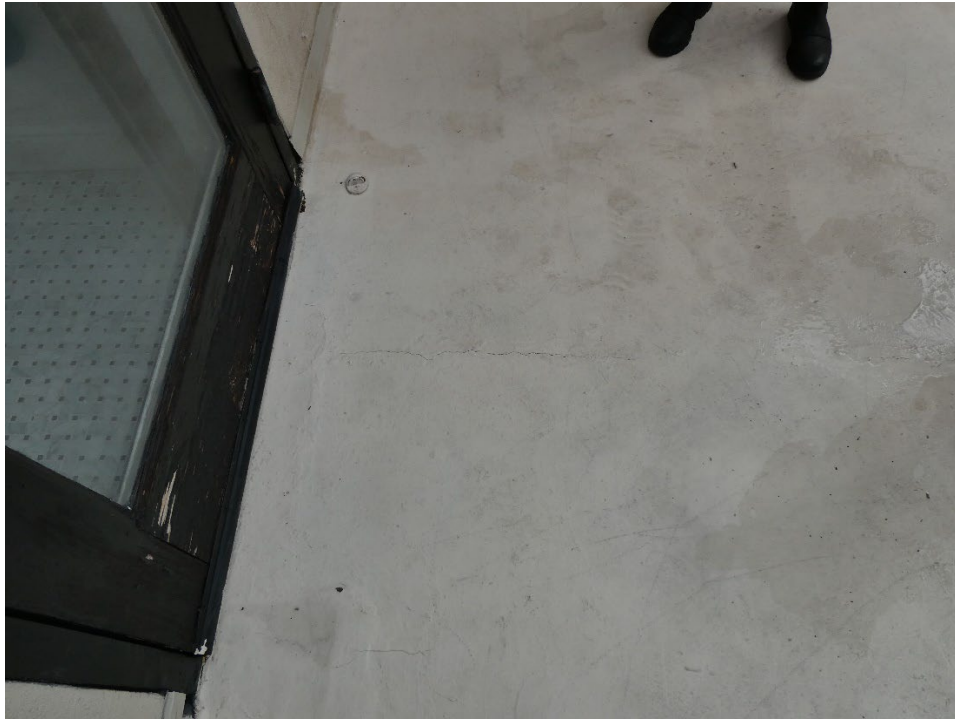
Figure 44: Cracking at the roof membrane, fifth floor balcony.

| <p>Description of work:</p> <p>Replace roofing membrane at the balcony roof with new roofing that is appropriate for a low-slope roof. During roof work, ensure adjacent historic materials are protected in place and care is taken to minimize damage.</p> | |

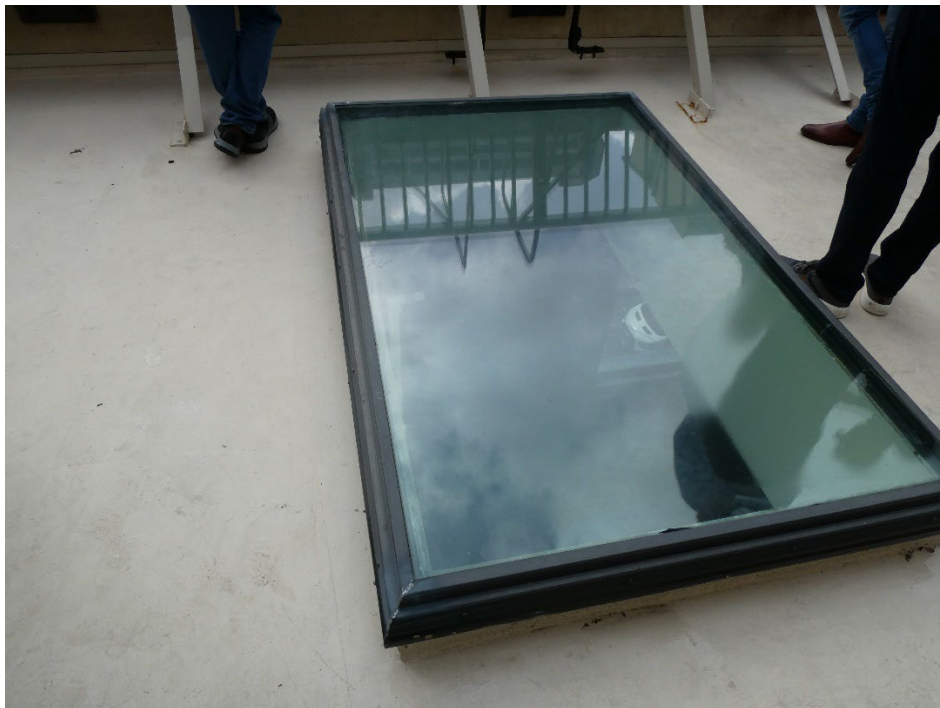
Figure 45: Skylight with no guard rail, fifth floor balcony.

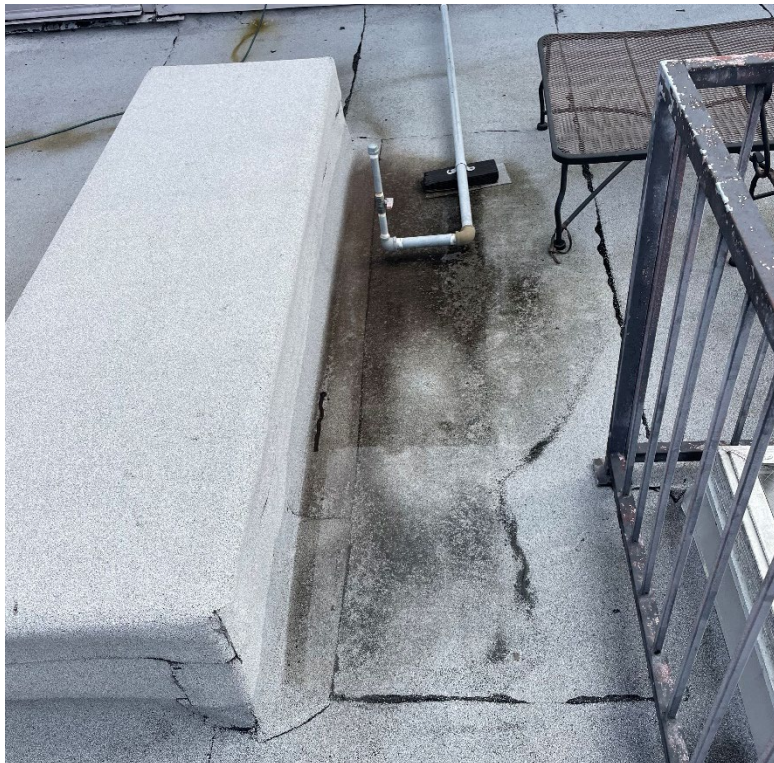
Figure 47: Active ponding on the main roof.

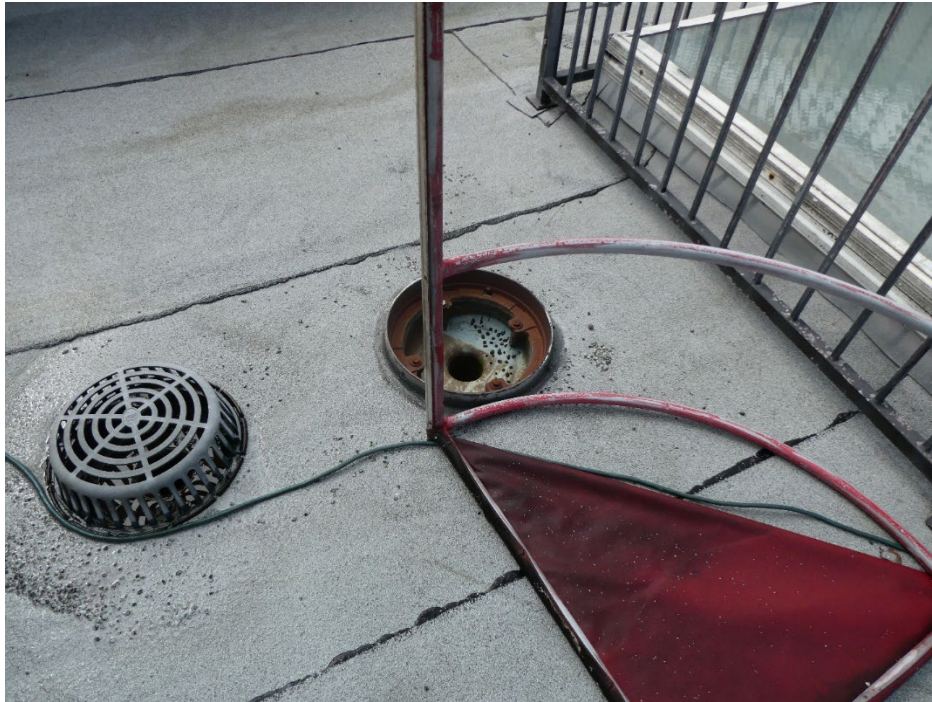
Figure 48: Missing drain cover, main roof.

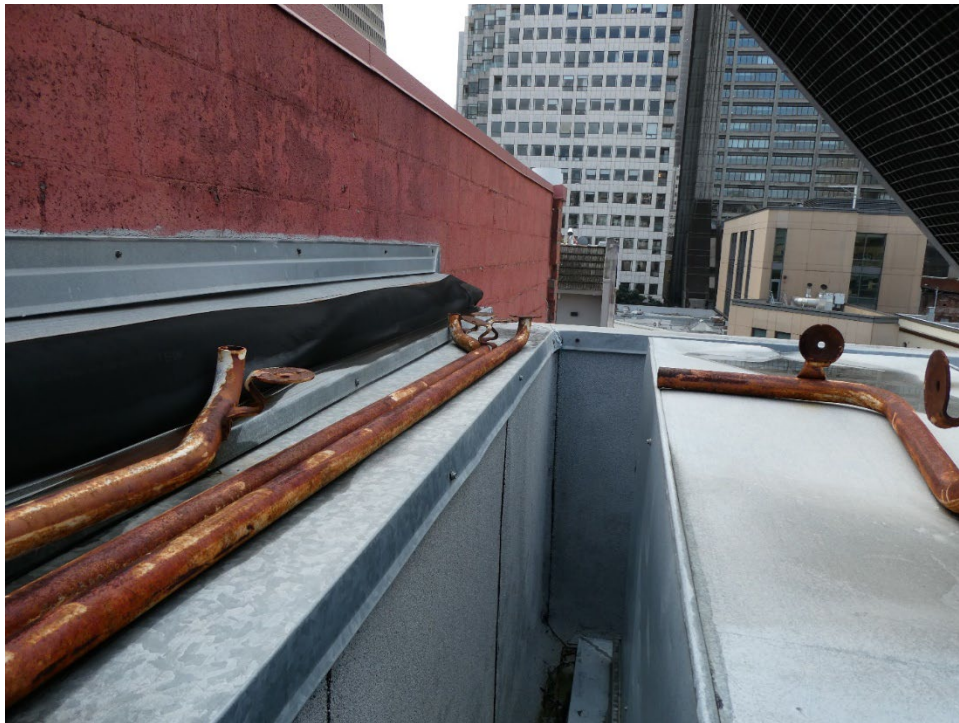
Figure 49: Miscellaneous rusting pipes on the expansion joint, main roof.

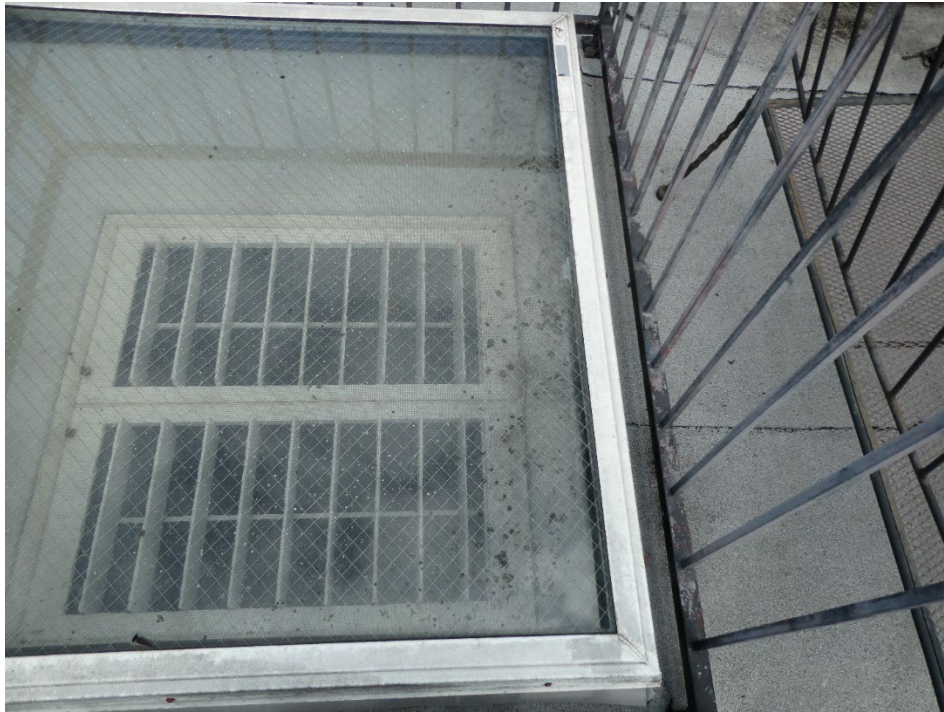
Figure 50: Ponding on top of the skylight and potential mold or mildew growth on the interior, main roof.

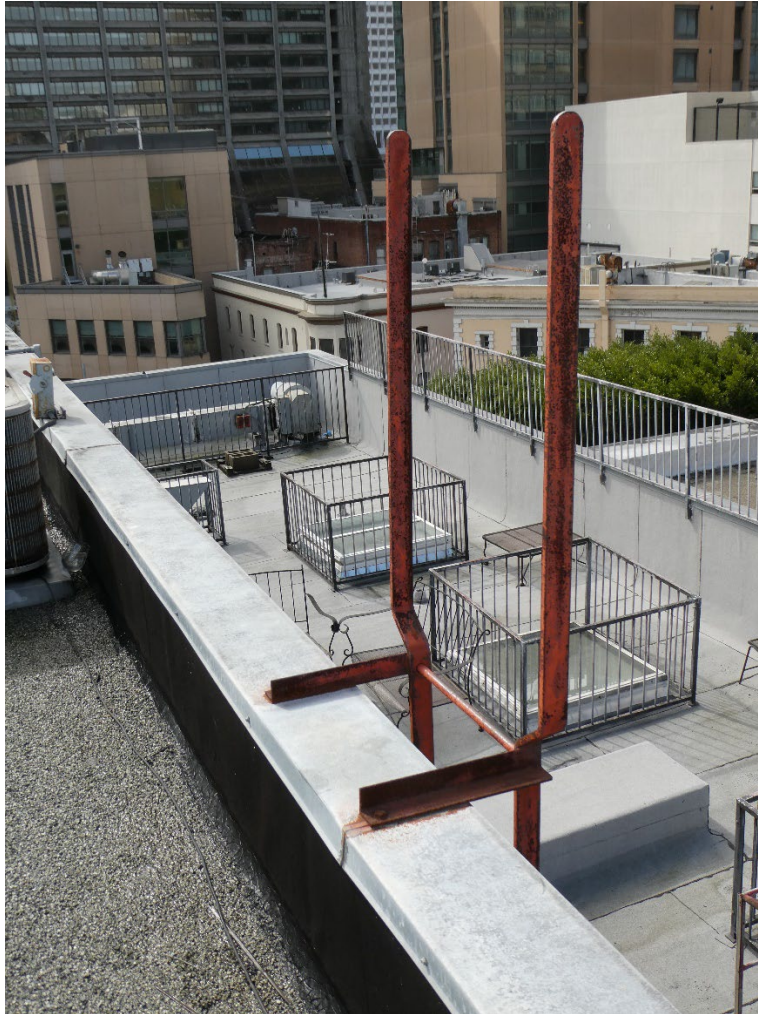
Figure 51: Rusted fasteners at the connection point between the ladder and parapet coping, penthouse roof.

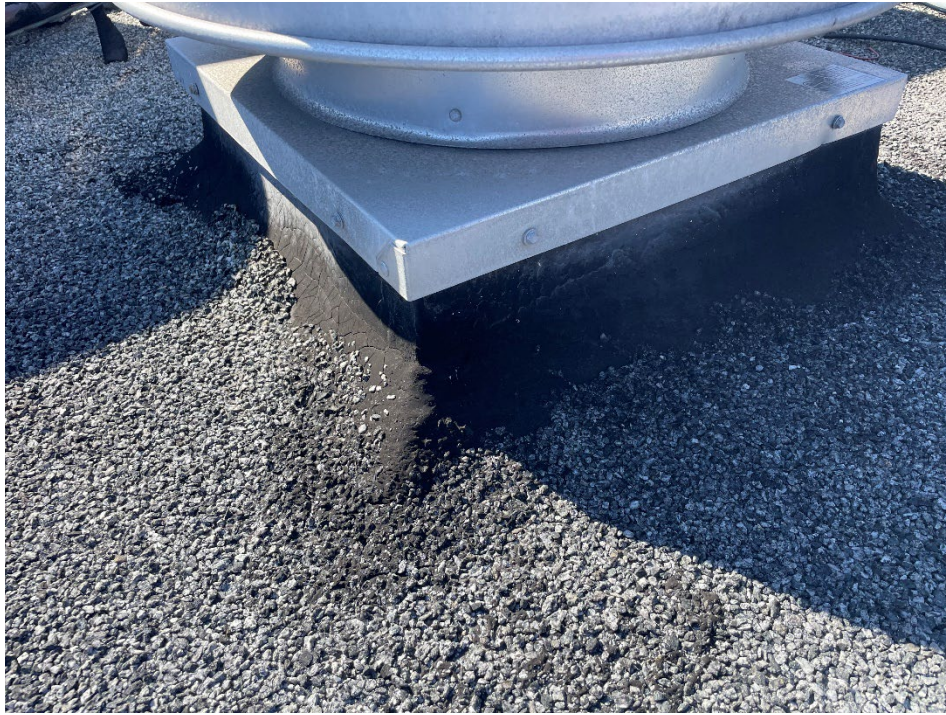
Figure 52: Alligatoring of the asphaltic roof coating, penthouse roof.

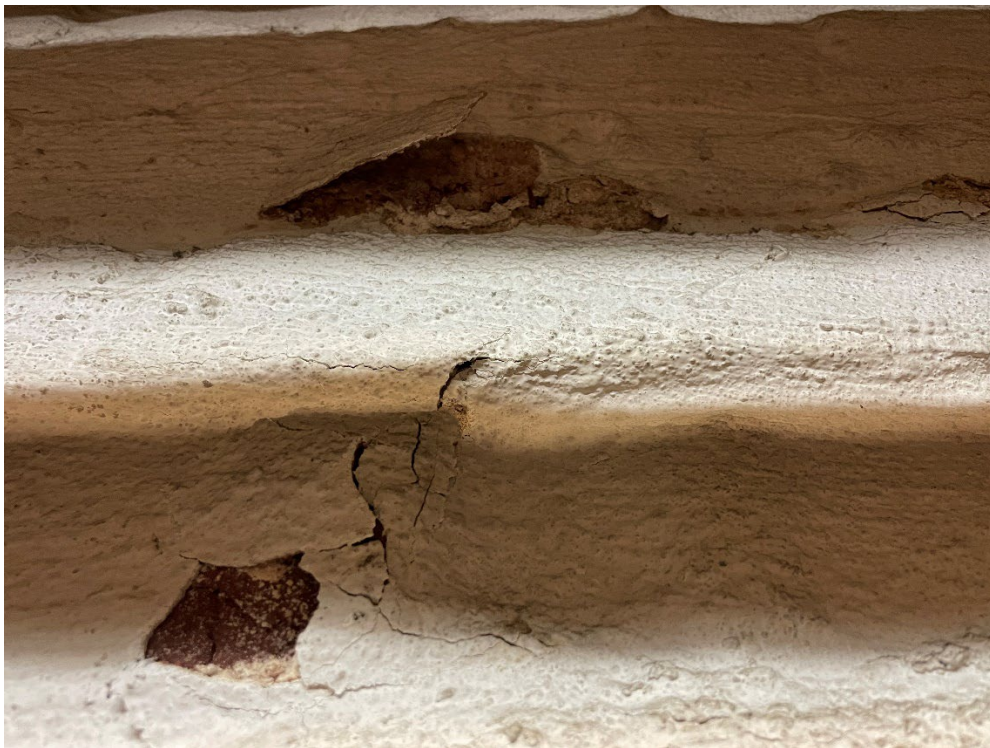
Figure 55: Paint loss at efflorescence, north wall, basement.

| <p>Description of work:</p> <p>Create a waterproofing scheme that is sympathetic to the historic character of the building. Once the water intrusion issues have been addressed, clean the unpainted masonry walls with warm water, a mild detergent, and a soft bristle brush. Remove the failing paint layers from the masonry walls with a pH neutral paint stripper as needed. Repoint masonry walls where the mortar has deteriorated, as needed. Use an appropriate mortar mix compatible with historic masonry. Treat corrosion at the cast iron columns, and prepare, prime, and paint with a rust-inhibitive paint to protect from further deterioration.</p> | |

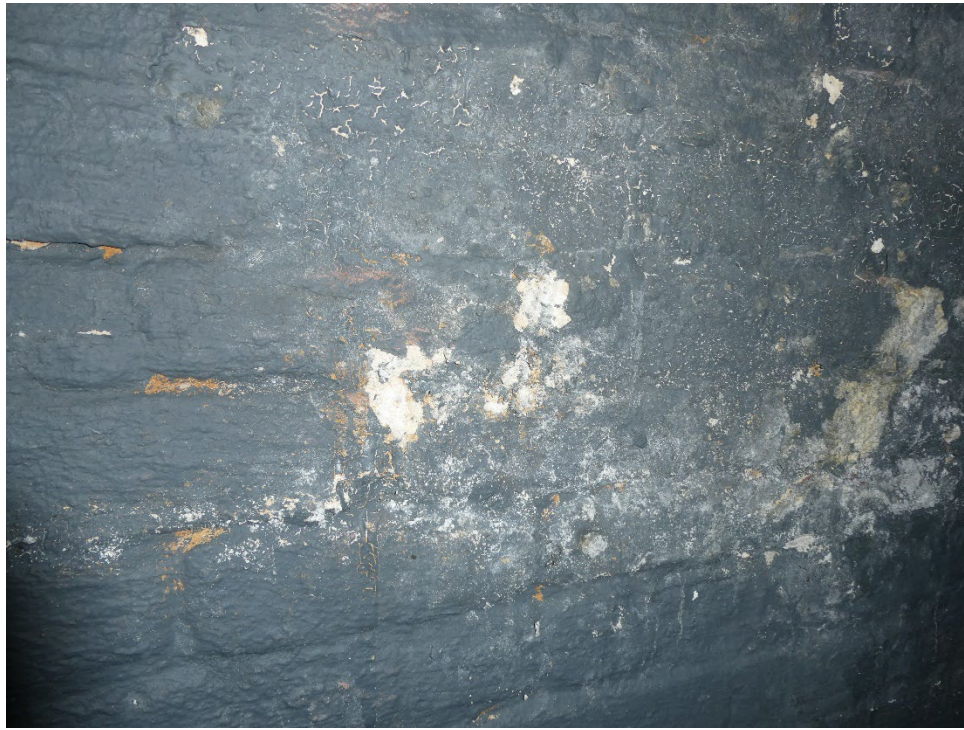
Figure 56: Efflorescence and paint loss on masonry west wall, basement.
