# 530 JACKSON STREET FOCUSED HISTORIC STRUCTURE REPORT

SAN FRANCISCO, CALIFORNIA  
[24394]

PREPARED FOR  
Brick & Timber

May 1, 2025  
(Revised September 17, 2025)

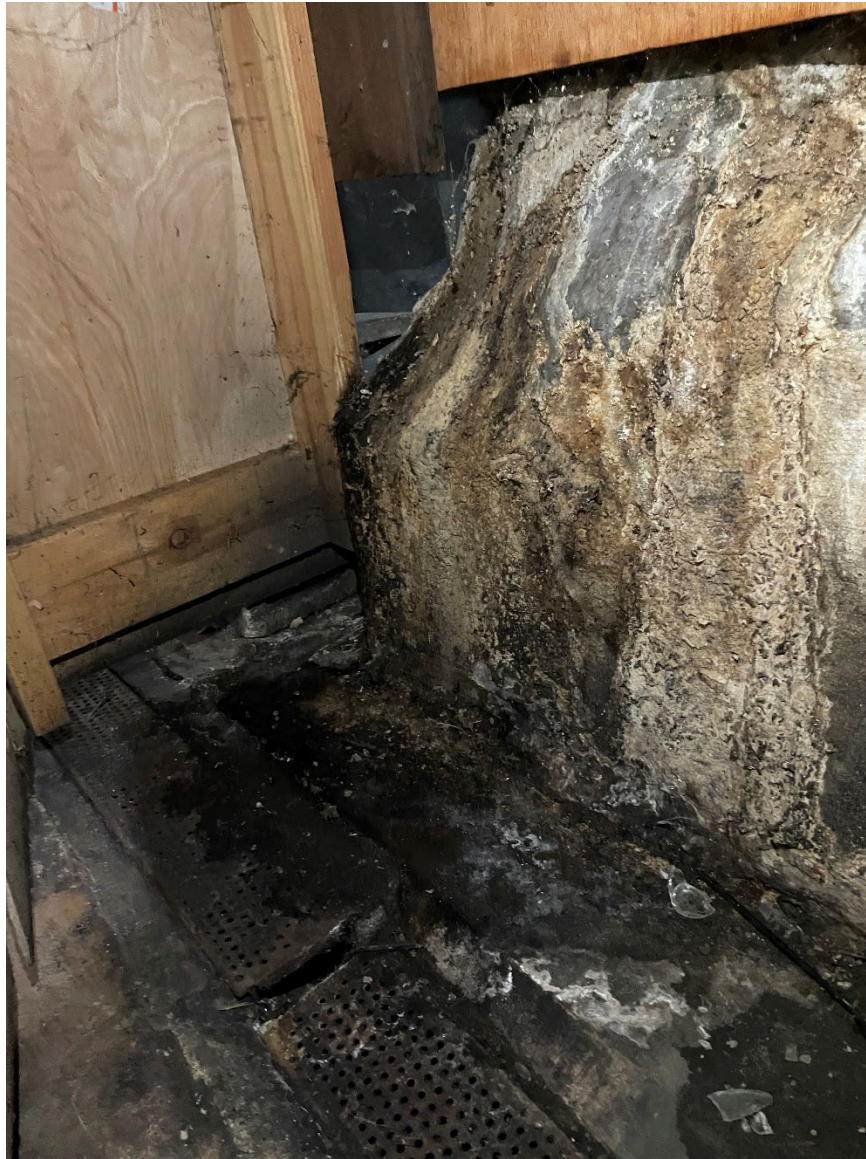
Figure 57: Active water infiltration and efflorescence, west wall, basement.

| <p>Description of work:</p> <p>Create a waterproofing scheme that is sympathetic to the historic character of the building. Once the water intrusion issues have been addressed, clean the unpainted masonry walls with warm water, a mild detergent, and a soft bristle brush. Remove the failing paint layers from the masonry walls with a pH neutral paint stripper as needed. Repoint masonry walls where the mortar has deteriorated, as needed. Use an appropriate mortar mix compatible with historic masonry. Treat corrosion at the cast iron columns, and prepare, prime, and paint with a rust-inhibitive paint to protect from further deterioration.</p> | |

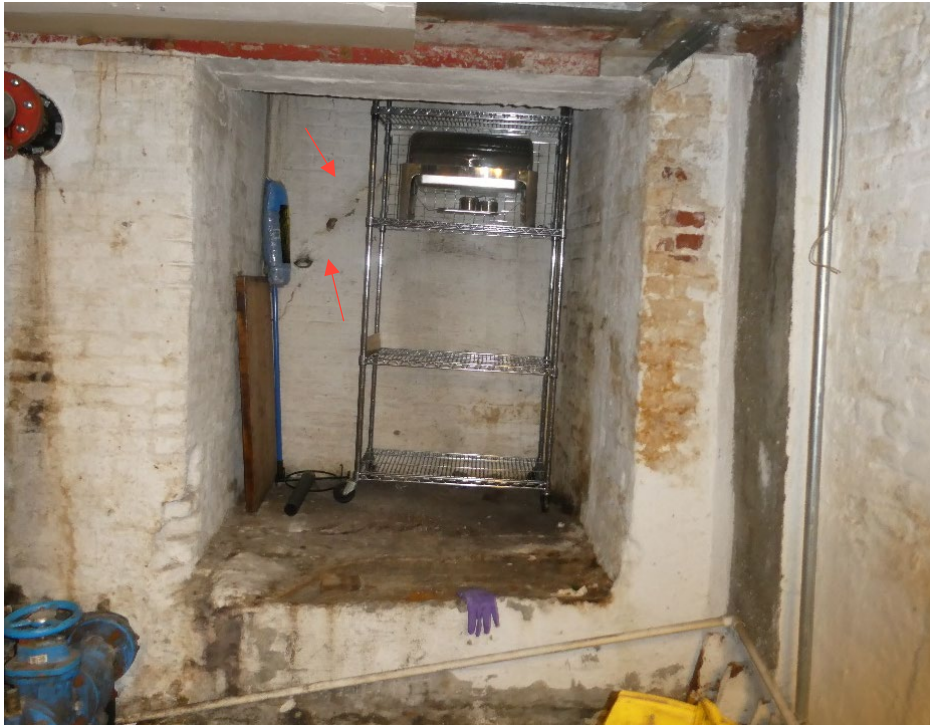
Figure 58: Diagonal crack in the south basement wall under the sidewalk hatch.

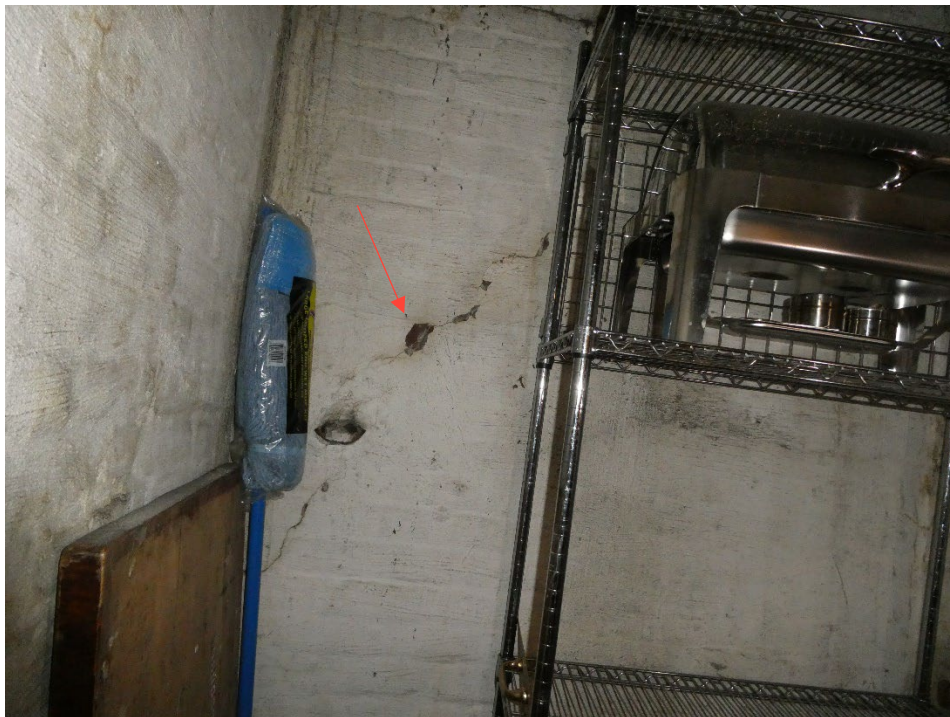
Figure 59: Detail view of the diagonal crack, south basement wall.

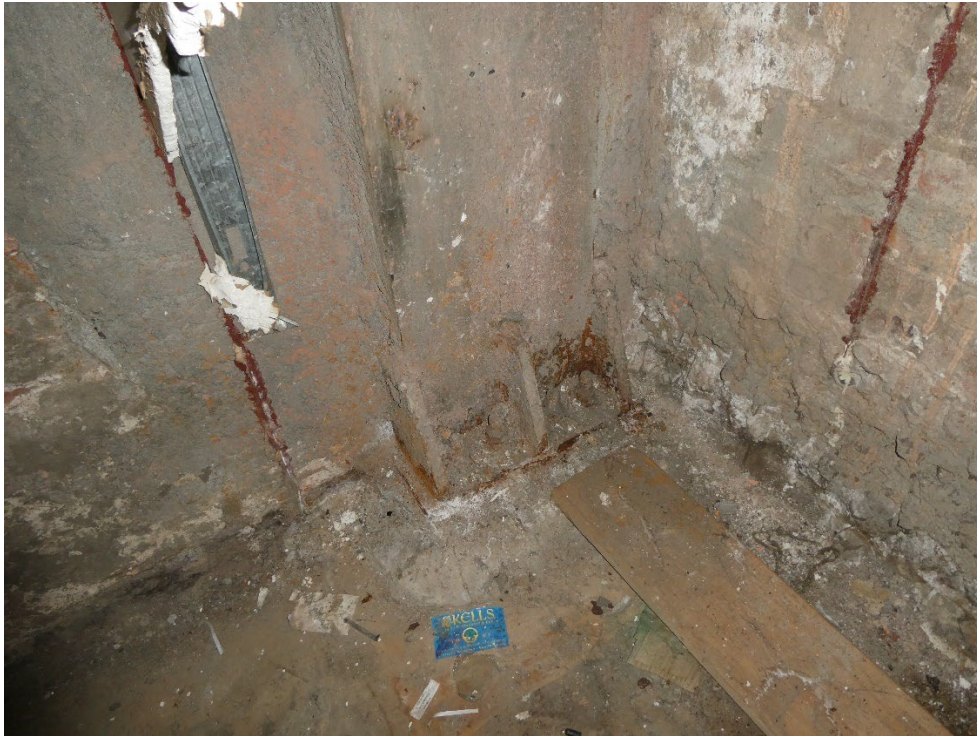
Figure 60: Corroded iron column base, basement.

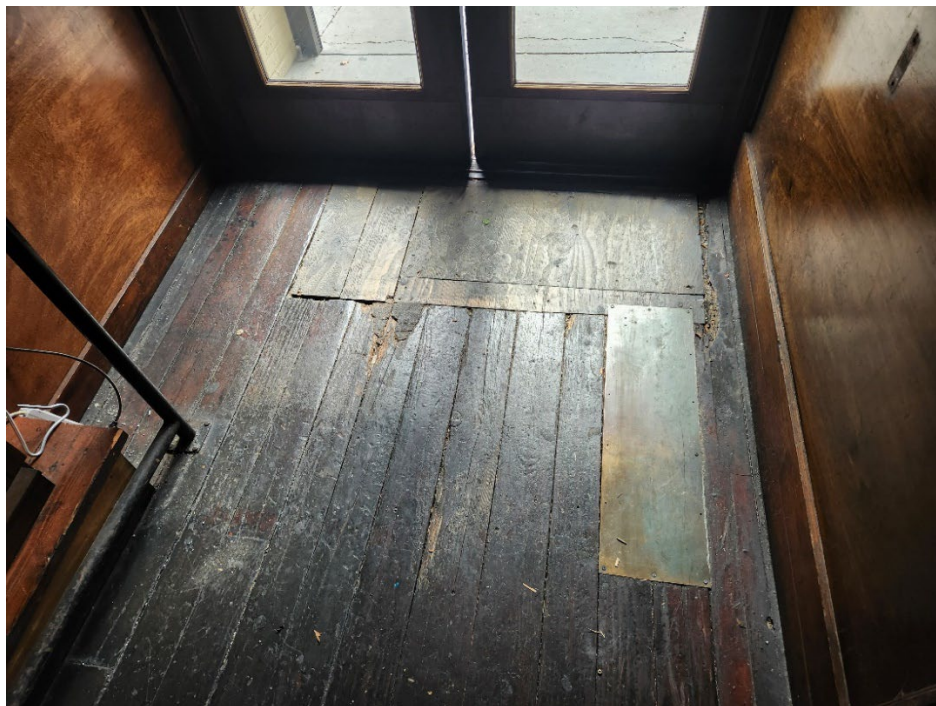
Figure 61: Damaged flooring at the south ramped (main entrance), first floor.

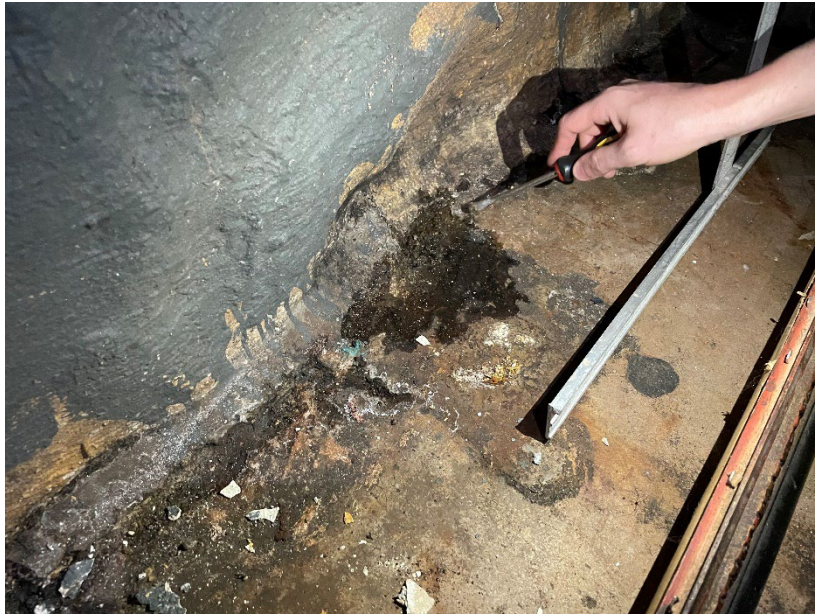
Image 27: View of typical area of water intrusion at west foundation wall, basement floor. (Photo taken by P&T 03/14/2025)

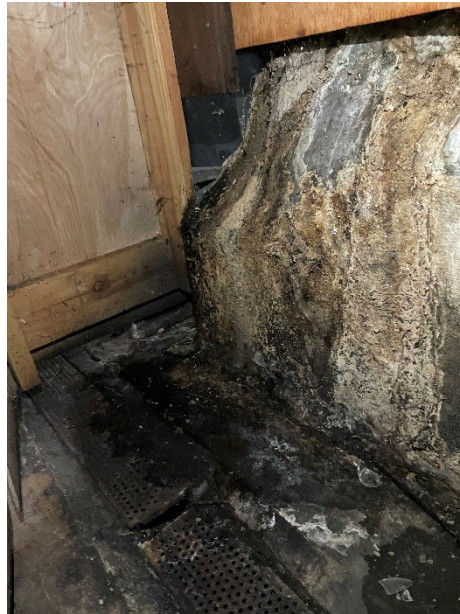
Image 28: View of typical area of water intrusion at west foundation wall, basement floor. (Photo taken by P&T 03/14/2025)

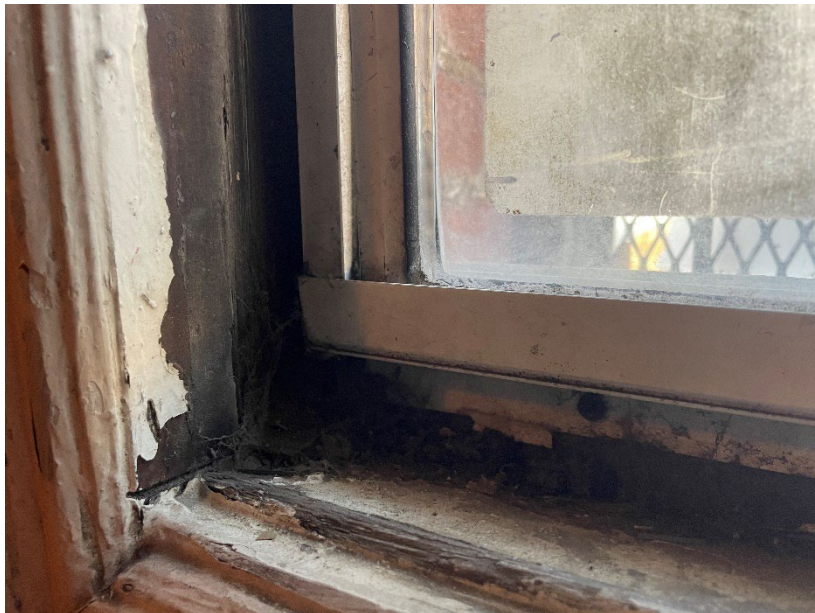
Image 34: View of wood frame deterioration at first floor, west wall. (Photo taken by P&T 03/14/2025)

| <p>Description of work:</p> <p>Retain and repair historic wood window sashes and frames at the first floor. Inspect and repair as needed. Repair wood by patching wood checking and deterioration on the frame, sash, and window sills. Replace glazing putty as needed. Properly prepare, prime, and paint the frame, sash, and sill. Restore operability of the sash and latches. Paint exterior security grilles on the first floor with rust inhibitive paint. There is an approved permit for replacement of three exterior windows with new rated windows.</p> <p>At the masonry portion, replace historically incompatible vinyl and aluminum windows at the first, second, and third floors; replace with historically compatible double-hung wood sash windows at the first and second floors and with window sash that match the original sash at the first floor. Replace non-historic wood windows inserted into original wood frames at the fourth floor with compatible double-hung wood sash windows. Retain and repair the existing historic wood frames and sills, where extant. Repair wood frames and sills by patching wood checking and deterioration with an appropriate wood patching compound. Prepare, prime, and paint. There is an approved permit for replacement of three exterior windows with new rated windows.</p> | |
