530 JACKSON STREET FOCUSED HISTORIC STRUCTURE REPORT

SAN FRANCISCO, CALIFORNIA [24394]

PREPARED FOR Brick & Timber

May 1, 2025 (Revised September 17, 2025)

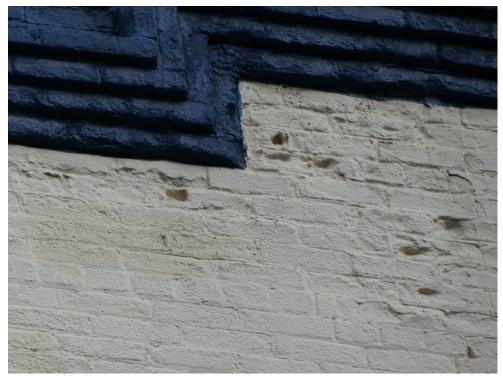
The brick masonry on the primary façade is painted and appears to be in good overall condition. Generally, there are some locations with mortar loss, and there are areas of mortar loss and brick erosion/spalling at the parapet below the stepped, crenellated cornice that have been painted over (Figure 21). The erosion and rough texture through the paint may indicate that the wall had been previously sandblasted. Similar areas of erosion occur at various locations across the façade, but are less concentrated than at the parapet. The paint is in good condition. There are two climbing vines flanking the facade at the southwest and southeast corners, which appear to be bougainvillea and jasmine. The plant at the southeast corner appears to be supported by and climbing up a cable rather than the brick itself, and the vines do not appear to be causing damage to the masonry at this time. It is unknown if they hold any moisture in the masonry during the rainy season. The wood midband cornice across the top of the storefront between the first and second floors is in good condition. There is an area of missing paint, exposing bare wood where a former tenant sign once was located (Figure 22). The metal flashing on the mid-band cornice is in fair condition. The metal fire escape, which is original to construction, also appears to be in good condition. Minor surface corrosion and paint loss at the fire escape was noted. The connection points between the fire escape and the masonry appear to be in generally good condition except at the third floor, where one connection point exhibits some mortar, and paint loss (Figure 23). Behind the parapet, the fire escape is no longer anchored to the roof (Figure 24).

Figure 21: Brick and mortar deterioration at the parapet, Jackson Street (south) façade.

In areas with brick deterioration and erosion, patch bricks with an appropriate masonry patching compound that matches the color, texture, and visual characteristics of the original brick. Selective replacement with matching brick may be considered or necessary, but the repair method should be informed by more thorough understanding of the brick condition and cause once exposed. Repoint mortar where missing, deteriorated, or loose. Use an appropriate mortar mix that is compatible with historic masonry and matches the texture, color, and visual characteristics of existing. At the window sills, repoint and repair the parge coat. Selective paint will likely be needed at areas of repair and should be undertaken with gentle means (likely a pH neutral paint stripper, soft bristle brushes, and cold water). Full scale paint removal may also be considered at the masonry. Once the brick is repointed, and patched, the brick may be prepared, primed, and painted with a breathable masonry paint.

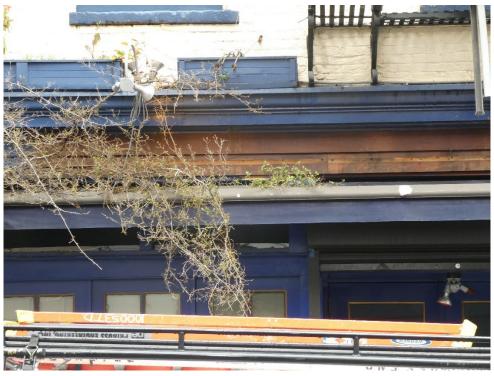
Figure 22: Unpainted area of wood at the mid-band cornice, south façade.

The mid-band cornice located between the first and second floor has some paint loss and an area which is unpainted. Properly prepare, prime, and paint with an appropriate wood paint. At the flashing and other metal elements, prepare, prime, and paint with a rust-inhibitive metal paint.

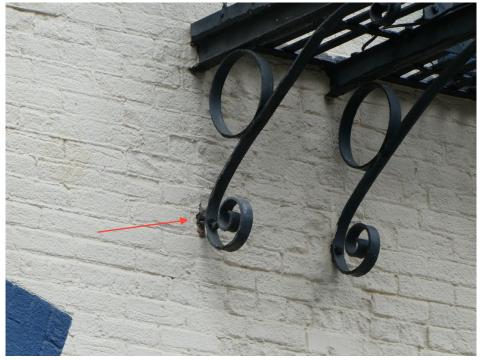
Figure 23: Loose anchor and masonry loss at the connection point between the masonry and the fire escape, above the second floor, south façade.

To ensure the safety and structural integrity of the fire escape, engage with a structural engineer to inspect the connections between the fire escape and the masonry, connections between wrought iron members, and for compliance with fire escape codes and standards as needed. With the guidance of a structural engineer, create a repair plan to tie the fire escape to the roof structure, where it is no longer connected. Secure anchorage points as needed and repair the masonry around connection points where there is material loss and deterioration. Treat surface corrosion and areas of anchorage as recommended by the structural engineer. The fire escape should then be properly prepared, primed, and painted using a rust-inhibitive paint.

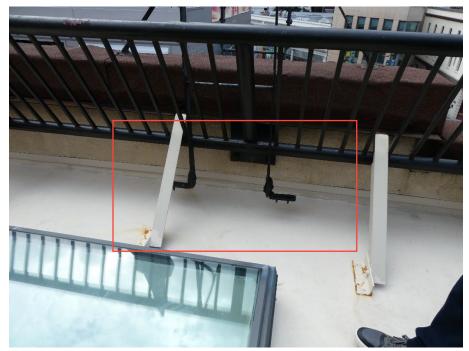
Figure 24: Fire escape is no longer anchored to the roof, fifth floor balcony.

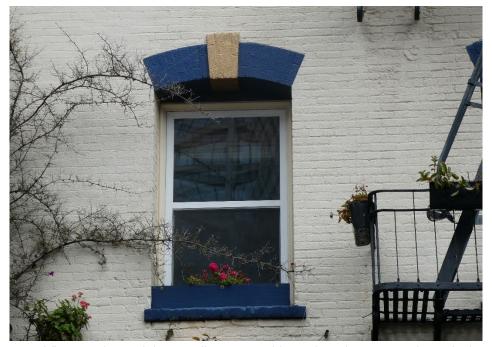
Figure 25: Second floor window with historically incompatible vinyl windows inserted into the historic wood frame, south façade.

The windows at the south façade consist of various types of non-historic windows inserted into historic wood frames. Retain and repair the original wood frames by patching wood checking and deterioration with an appropriate wood patching compound. Then prepare, prime, and paint the frames. The historically incompatible windows should be replaced with compatible double-hung wood sash windows. The non-historic wood sashes on the fourth floor should also be replaced at the same time for a cohesive appearance and installation.

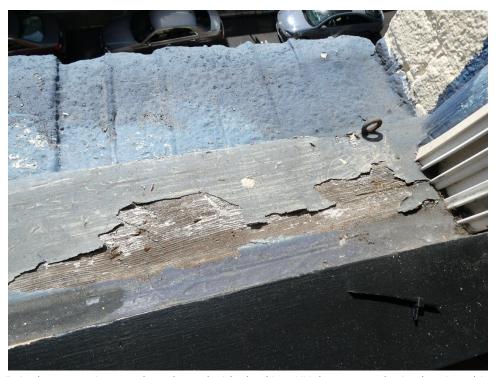
Figure 26: Paint loss exposing weathered wood with checking, UV damage, and raised grain at historic wood window sill, fourth floor, south façade.

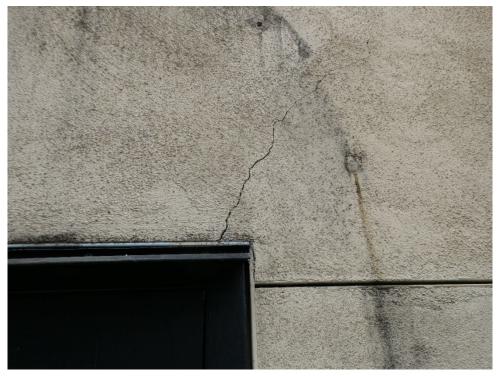
The stucco on the south façade of the set-back vertical addition is in good condition. There is one diagonal crack in the stucco originating from the corner of the east door (Figure 28). There is atmospheric staining around the two doors where awnings were once extant. The glazed doors exhibit paint loss and wood checking at the bottom rail, and the hinges and hardware have surface corrosion. (Figure 29). An open gap between the perimeter of the door frame and the adjacent stucco could allow water intrusion (Figure 30).

Figure 28: Diagonal crack originating from the corner of the door, south façade.

At the balcony wall, clean the atmospheric staining from the stucco as needed for painting. Then prepare, prime, and repaint the stucco. The diagonal crack located at the upper corner of the door should be routed and patched with appropriate stucco material. The two non-historic glazed doors are in fair condition. Repair or replacement are both acceptable, as replacement may be more cost effective than repair. To repair, patch the wood checking at the deteriorated bottom rail. Then prepare, prime, and paint with appropriate wood paint. Fill the gaps between the door frame and the stucco transition with a proper sealant joint to prevent water intrusion.

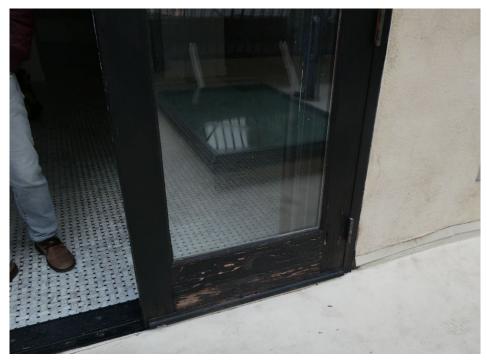
Figure 29: Deterioration of the bottom rail of the glazed doors, south façade.

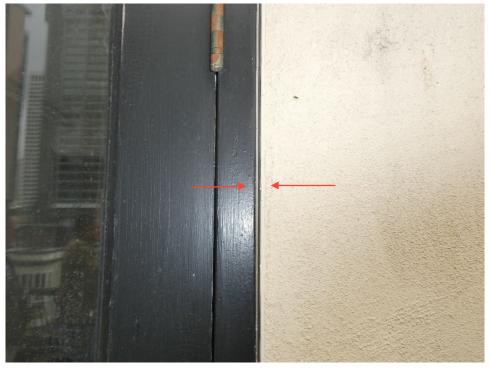
Figure 30: Open gap between the door frame and stucco, south façade.

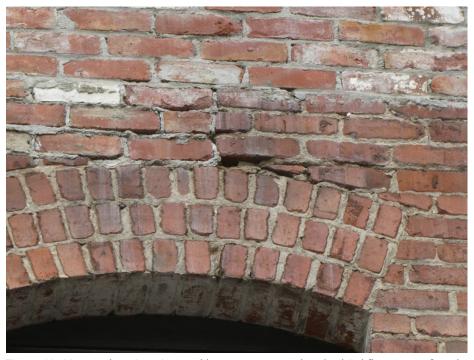
Figure 32: Mortar deterioration and loss at segmental arch, third floor, west façade.

At the masonry portion of the west and north façades, clean the masonry of soiling, spills, and biological growth with a warm water wash and mild chemical cleaner. At the base of the north wall, water ponding was observed. Determine the source of the drainage problem and correct the drainage issues. At the base of both masonry walls, determine, in conjunction with a qualified historic preservation consultant and historic masonry restoration contractor, if it feasible to remove the parge skim coat from the masonry. If the removal of the parge skim coat is deemed too damaging to the masonry, cut the joints and repoint 100% of the parged area. Then repaint the parge coat with a breathable paint. If the parge can be safely removed, remove it and repoint the joints 100% in the parged area. In non-parged areas, remove paint from the masonry using a pH neutral masonry paint stripper, soft bristle brushes, and cold water. Mockups should be used to test paint removal process before a full removal campaign takes place. Care should be taken, particularly at the south end of the west wall ground floor, as this area may have been sandblasted in the past. Repoint areas having missing, deteriorated, and inappropriate mortar, including at window sills prior to re-parging with an appropriate repair parge matching the color, texture, and appearance of the original. The mortar should match the visual characteristics, texture, and color of the existing joints and should be an appropriate mortar for the historic masonry. Where bricks are cracked, eroded, or deteriorated, patch with an appropriate masonry patching compound. The patches should match the characteristics of the original bricks and be virtually indistinguishable from the original material. Selective replacement with matching brick may be considered or necessary, but the repair method should be informed by a case by case understanding of the brick condition and causes of deterioration. Remove the corrosion from the metal tie rods and plates, and prepare, prime, and paint with rust inhibitive paint.

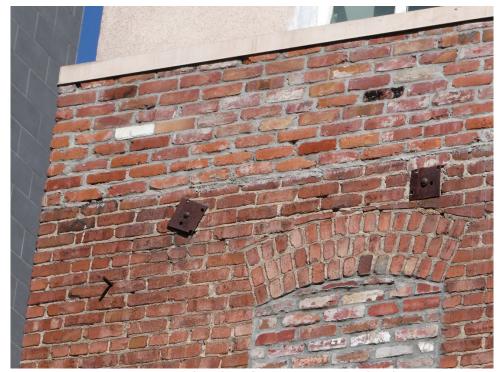
Figure 33: Tie rods with surface corrosion, west façade.

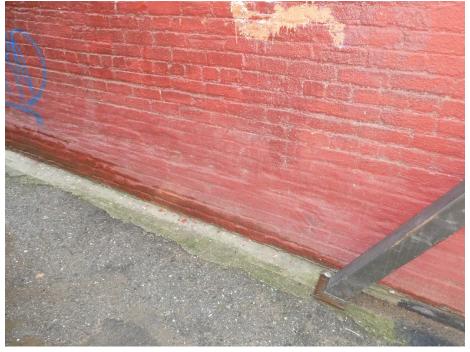
Figure 34: Parge coat and paint layer at the base of the masonry wall, west façade.

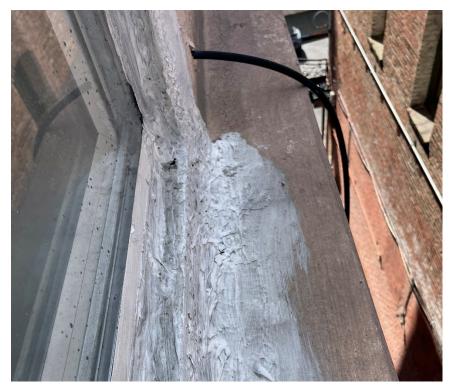
floor, except they have been modified with the insertion of a vinyl slider window that replaces the fixed lower pane of the steel window. These windows are in poor condition. The slider windows were installed poorly and have a large build-up of sealant, including where they meet the exterior metal coping flashing (see coping description above). Perimeter sealants and waterproofing between the windows and the stucco have also failed, and water intrusion was noted around the interiors at several of these windows (**Figure 35**).

Figure 35: Deteriorated metal coping and large build-up of sealant around windows, fourth floor, west façade.

At the masonry to stucco transition at the vertical addition, remove and replace the flashing with a G90 heavy galvanized or non-corroding metal flashing. Prepare, prime, and paint the flashing with a rust-inhibitive paint. The windows in the stucco addition at the fourth and fifth floors are in poor condition and should be replaced with new operable windows. Replace all sealants at the stucco joints and between the new windows and existing stucco. Repair the stucco as needed, and prepare, prime, and paint the stucco portion of the façade.

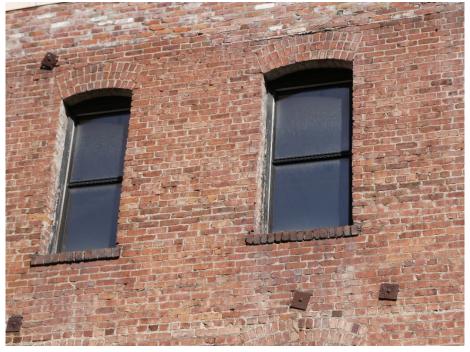
Figure 36: Third floor windows with historically incompatible aluminum frames and historic wood frames, west façade.

At the lower masonry portion, retain and repair the original wood windows located at the first floor of the west wall and at the second floor of the north wall, including the original wood frames and the original sash, where extant. Repair minor wood deterioration, such as checking, by patching with an appropriate wood patching compound, and reglaze as needed. Properly prepare, prime, and paint the windows. If the metal security grilles at the first floor are to be retained, prepare, prime, and paint with a rust-inhibitive paint. Rehabilitate the other windows at the second and third floors and at the masonry portion of the west wall's fourth floor by retaining and repairing the original wood frames and replacing the non-historic inserted windows with compatible wood double-hung

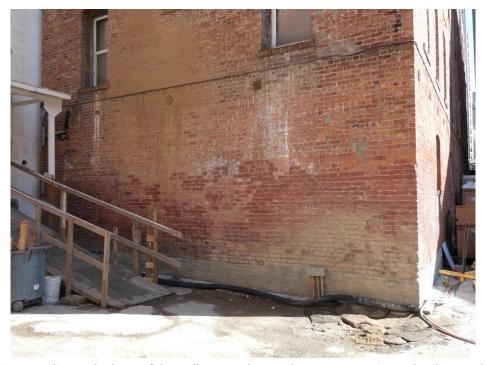
Figure 38: Water pooling at the base of the wall, mortar loss and extraneous paint and soiling on the masonry, north façade.

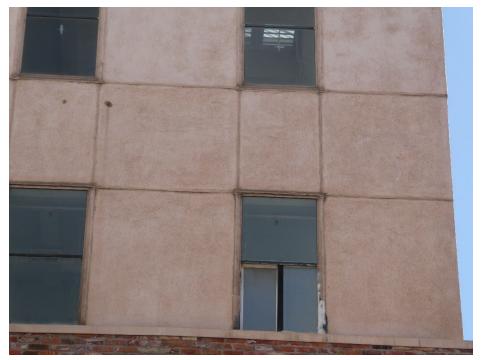
Figure 39: Deteriorated and poorly installed windows at the fourth and fifth floors, north façade. Note failed joints at the stucco.

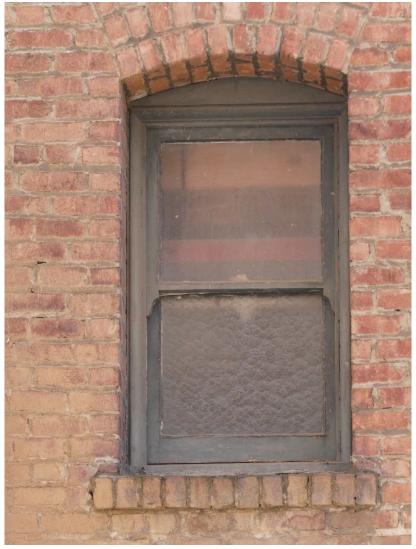
The windows at this façade include vinyl, wood, and steel. One window at the second floor of the lower brick masonry portion has an original wood frame with its original wood double hung sash. This window appears to be in fair condition with some paint loss, minor wood checking at the bottom rail of the sash, and glazing putty loss (Figure 39). The remaining windows at the second and third floors appear to have original wood frames with replacement vinyl and aluminum windows inserted into the original frames. The wood frames are in fair condition with some paint loss and wood checking. The non-historic insert windows are generally in fair condition but are incompatible with the historic character of the building. All the windows at the fifth floor are fixed steel sash windows with wire glass; some exhibit cracked glass at the steel frame and/or due to the embedded wire. The windows at the fourth floor are similar to those at the fifth floor, except they have been modified with the insertion of a vinyl slider window that replaces the fixed lower pane of the steel window. These windows are in poor condition. The slider windows were installed poorly and have a large build-up of sealant, including where they meet the exterior metal coping flashing (see coping description above). Perimeter sealants and waterproofing between the windows and the stucco have also failed, and water intrusion was noted around the interiors at some of these windows (Figure 40).

Figure 40: Original double-hung wood sash window at the second floor, north façade.

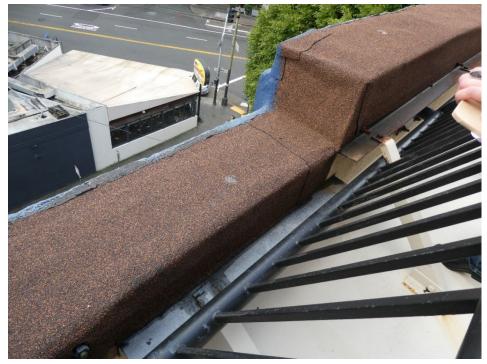
Figure 42: Some deterioration of the seams at the asphaltic coping at the south parapet wall, fifth floor balcony.

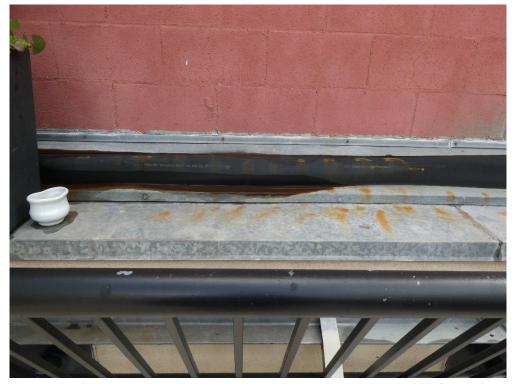
Figure 43: Surface corrosion at the metal coping/seismic expansion joint, fifth floor balcony.

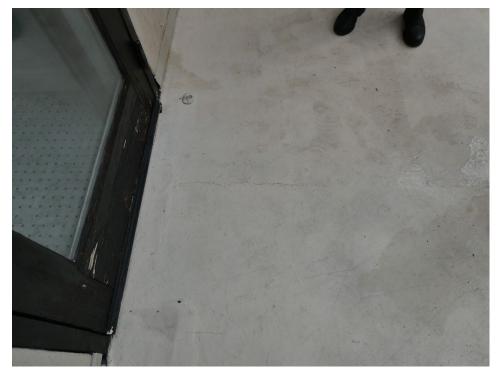
Figure 44: Cracking at the roof membrane, fifth floor balcony.

Inspect the balcony roof for deterioration and for water intrusion into the interior. The roofing membrane exhibits some cracking. Recoat and patch the membrane as needed. Within the next 10 years, replace the roofing with a compatible roofing material suitable for a low-slope occupiable roof deck. Remove asphaltic coping at the south and west parapets and install a new G90 heavy galvanized or non-corroding metal flashing. Install a guardrail around the skylight. Remove the corrosion from the seismic parapet bracing and metal parapet coping at the expansion joint cover. Prepare, prime, and paint metal, including the parapet coping, guardrail, seismic joint cover, and parapet bracing with a rust-inhibitive paint to protect from future corrosion. Install drain covers at the floor drains in the north corners. Regularly inspect and clean roof drains of debris.

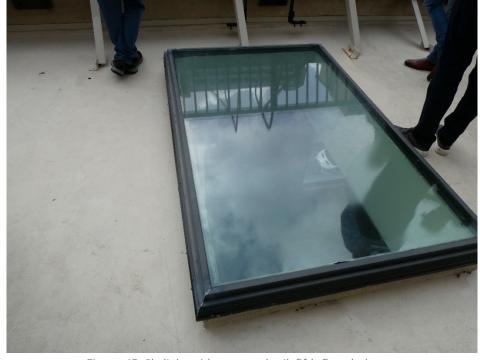
The fifth floor balcony on the south end of the building is in fair overall condition. At the south and west parapet walls, the asphalt sheet flashing exhibits puckered areas at a couple lap seams and may begin to allow water intrusion through to the masonry below (**Figure 42**). At the east parapet wall, the seismic expansion joint cover and associated metal flashing has surface corrosion and some denting (**Figure 43**). No issues were visually noted at the flexible rubber bumper. The steel parapet bracing and railing have minor surface corrosion and paint loss. The roof membrane on the balcony is in fair condition, as it exhibits a few cracks in the membrane (**Figure 44**). Build-up and debris were noted at the roof drains, and no drain covers were noted. There is no guard rail surrounding the skylight, which is a falling hazard (**Figure 45**).

Figure 45: Skylight with no guard rail, fifth floor balcony.

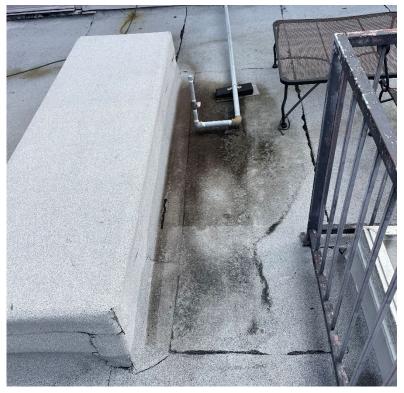
Figure 47: Active ponding on the main roof.

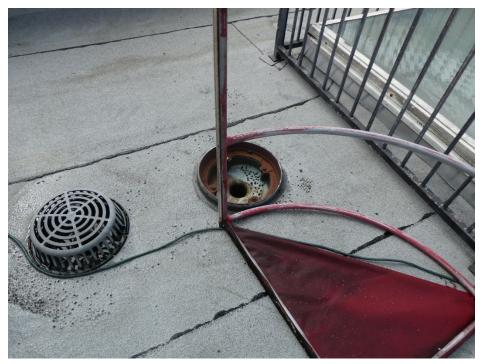
Figure 48: Missing drain cover, main roof.

Inspect asphaltic sheet roofing and skylights for deterioration and to ensure there is no water intrusion into the interior of the building. Install new roof drain covers where missing. Remove corrosion from the metal parapet coping at the expansion joint cover. Paint the metal with a rust-inhibitive paint to prevent future corrosion. Remove the miscellaneous rusting metal objects place on top of the coping. Inspect skylights for deterioration and for water intrusion and ensure sealants and seals are in good condition. Paint skylights as needed. Regularly inspect and clean roof drains of debris.

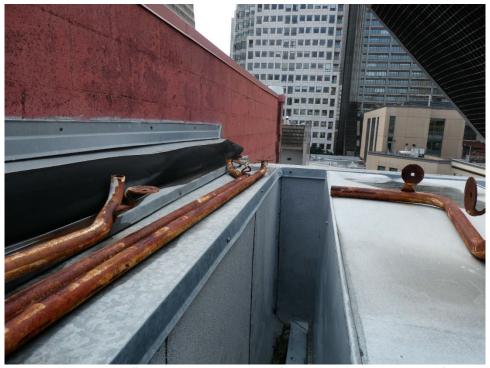
No major deficiencies were noted at the rolled asphalt sheet roofing at the main roof. From the interior of the fifth floor below, there is no visible evidence of water intrusion. The low-slope roof has several areas of negative slope, causing an uneven surface and water ponding after rainfall. Ponding was observed in several different areas (Figure 47). The mechanical equipment and penetrations on the roof have some surface corrosion, but these areas do not appear to be causing water infiltration. The drains on the roof have minor surface corrosion but were observed to be in relatively good condition. However, one drain on the main roof section is missing a drain cover (Figure 48). The guardrails and metal coping at the west, north, and south parapets are in good condition but exhibit minor surface corrosion and paint loss. At the east parapet expansion joint cover, standing water was noted to be causing some corrosion. At the south end of the joint cover, miscellaneous rusted metal pipes are sitting on the expansion joint and are contributing to corrosion staining (Figure 49). No signs of deterioration of the flexible rubber bumper were observed.

Figure 49: Miscellaneous rusting pipes on the expansion joint, main roof.

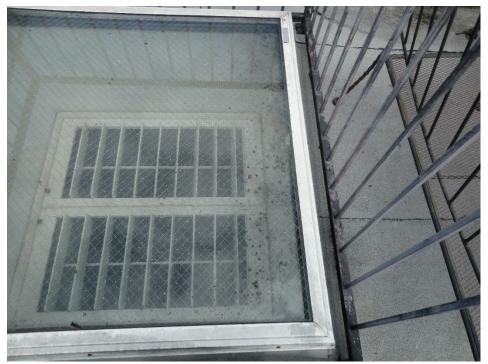
The skylights are generally in good condition. The flashing around the skylights appears to be fairly recent or well-maintained. The skylights have very little slope, causing ponding on the glass. Although there were no indications of active water intrusion, the ponding should be closely monitored. Mold or mildew growth on the interior of the glass was noted at one skylight. Further observation should seek to understand if there is moisture infiltration at this location or if it may stem from a condensation, ventilation, and/or humidity issue at the interior (Figure 50).

Figure 50: Ponding on top of the skylight and potential mold or mildew growth on the interior, main roof.

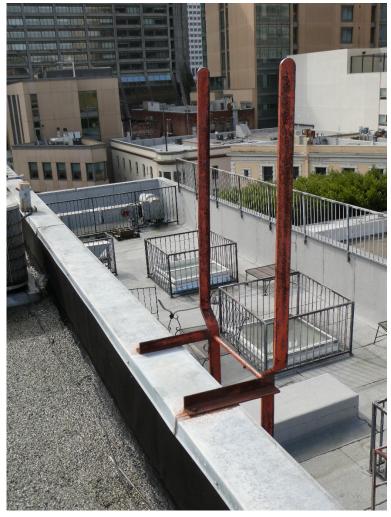
Figure 51: Rusted fasteners at the connection point between the ladder and parapet coping, penthouse roof.

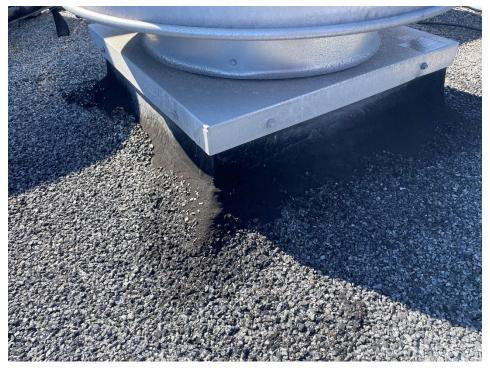
Figure 52: Alligatoring of the asphaltic roof coating, penthouse roof.

downspouts of debris. The liquid applied asphaltic roofing may be nearing the end of its useful life. It is assumed that replacement will be needed within the next 10 years.

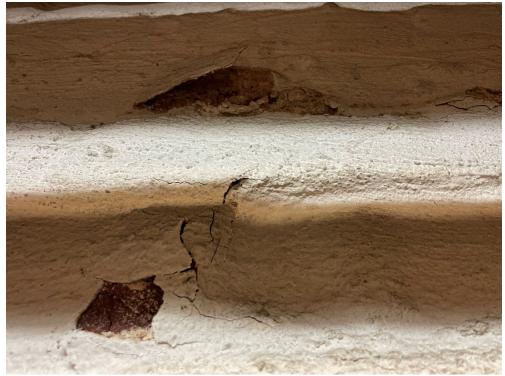
Figure 55: Paint loss at efflorescence, north wall, basement.

Engage a waterproofing consultant to create a waterproofing scheme that is appropriate for the historic materials and sympathetic to the historic character of the building. Remove efflorescence regularly and as needed by dry brushing and/or vacuuming. Once the water intrusion issues have been addressed, areas of masonry requiring repair will likely need the paint removed. Unsound and flaky paint at the walls should also be carefully removed. If desired or recommended, full removal of the paint can occur, or the walls can be repainted following repair work. Remove the failing paint from the masonry walls with a pH neutral paint stripper as needed. Clean the unpainted masonry walls with warm water, a mild cleaner, and a soft bristle brush. Repoint masonry walls where the mortar has deteriorated, as needed. Use an appropriate mortar mix compatible with historic masonry. Treat corrosion at the cast iron columns, and prepare, prime, and paint with a rust-inhibitive paint to protect from further deterioration. If repainting the masonry walls, prepare, prime, and paint with an appropriate breathable masonry paint.

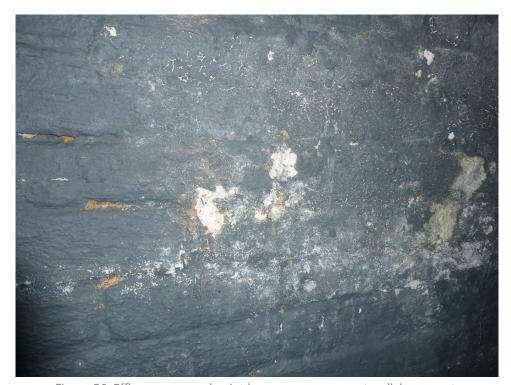
Figure 56: Efflorescence and paint loss on masonry west wall, basement.

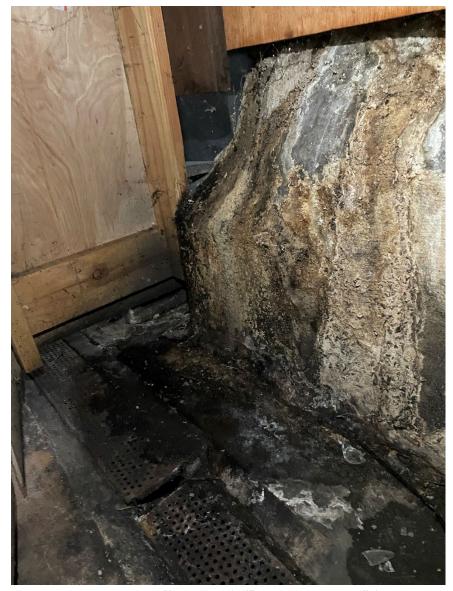
Active water intrusion was noted at various areas of the basement but was primarily noted at the west masonry wall. The water appears to be entering the basement at several locations near the base of the wall, where a concrete curb has been poured, and was observed to be seeping and pooling. The cast iron columns and base plates also have moderate to heavy surface corrosion and soiling (Figure 60). The presence of some trough drains along the west wall indicate that this is not a new issue. Active efflorescence build up, soiling, paint loss, and mortar loss throughout the west wall was noted (Figure 55, Figure 56, Figure 57). Generally, there is mortar loss, paint failure, and heavy soiling build-up on the masonry walls of the basement. An approximately 8 foot long diagonal crack was observed in the south masonry wall located at the sidewalk access hatch (Figure 58, Figure 59).

Figure 57: Active water infiltration and efflorescence, west wall, basement.

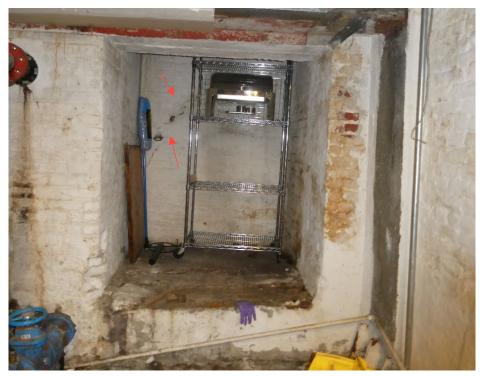
Figure 58: Diagonal crack in the south basement wall under the sidewalk hatch.

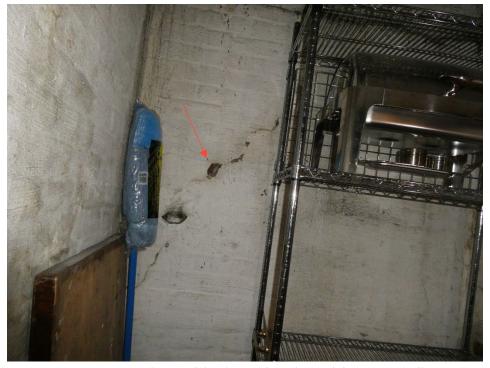
Figure 59: Detail view of the diagonal crack, south basement wall.

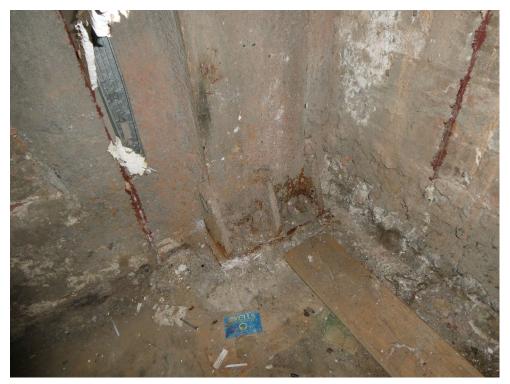
Figure 60: Corroded iron column base, basement.

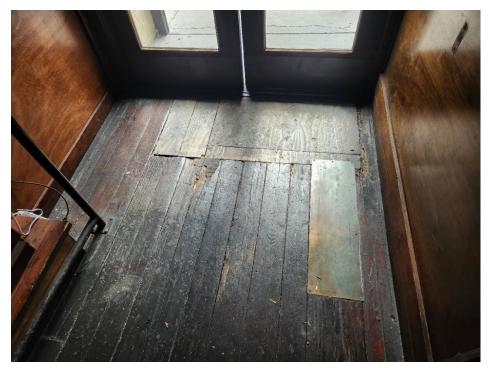
The wood flooring is not original and dates to a 1997 renovation. The flooring is generally in fair condition with some gouges, splitting, gaps, and dirt build up. A few areas appear to have patches or replacement wood. The original columns on the first floor are concealed by various types of cladding depending on the location, and the condition of the concealed columns was not accessible for observation (Figure 61). The windows appear to retain their original wood trim and frames (Figure 62).

Figure 61: Damaged flooring at the south ramped (main entrance), first floor.

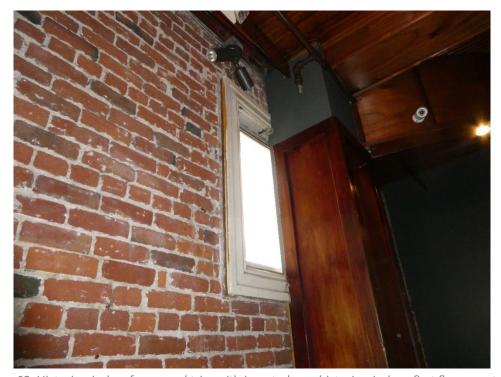
Figure 62: Historic window frame and trim with inserted non-historic window, first floor, west wall.

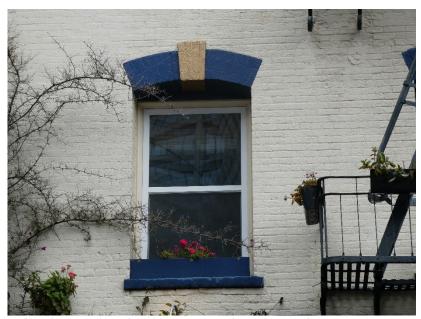
Image 12: Primary façade, typical vinyl replacement window in original masonry opening. (Photo taken by P&T 03/14/2025)

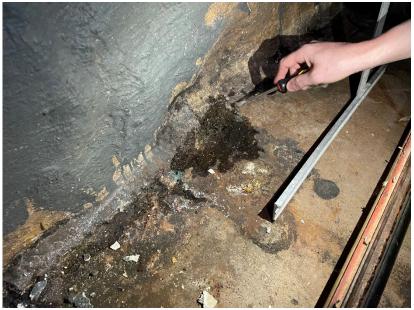
Image 27: View of typical area of water intrusion at west foundation wall, basement floor. (Photo taken by P&T 03/14/2025)

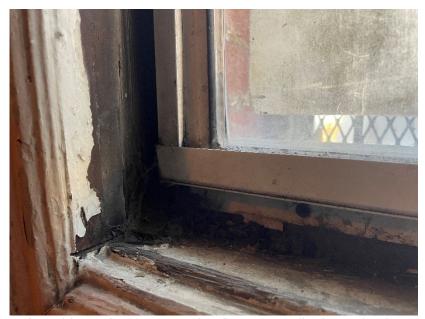
Image 34: View of wood frame deterioration at first floor, west wall. (Photo taken by P&T 03/14/2025)
