**SF X (Mission)  
Substation Outage Event  
December 20, 2025**

**Direct Cause Evaluation**

*Prepared for:*

Pacific Gas and Electric Company  
300 Lakeside Drive  
Oakland, California 94612

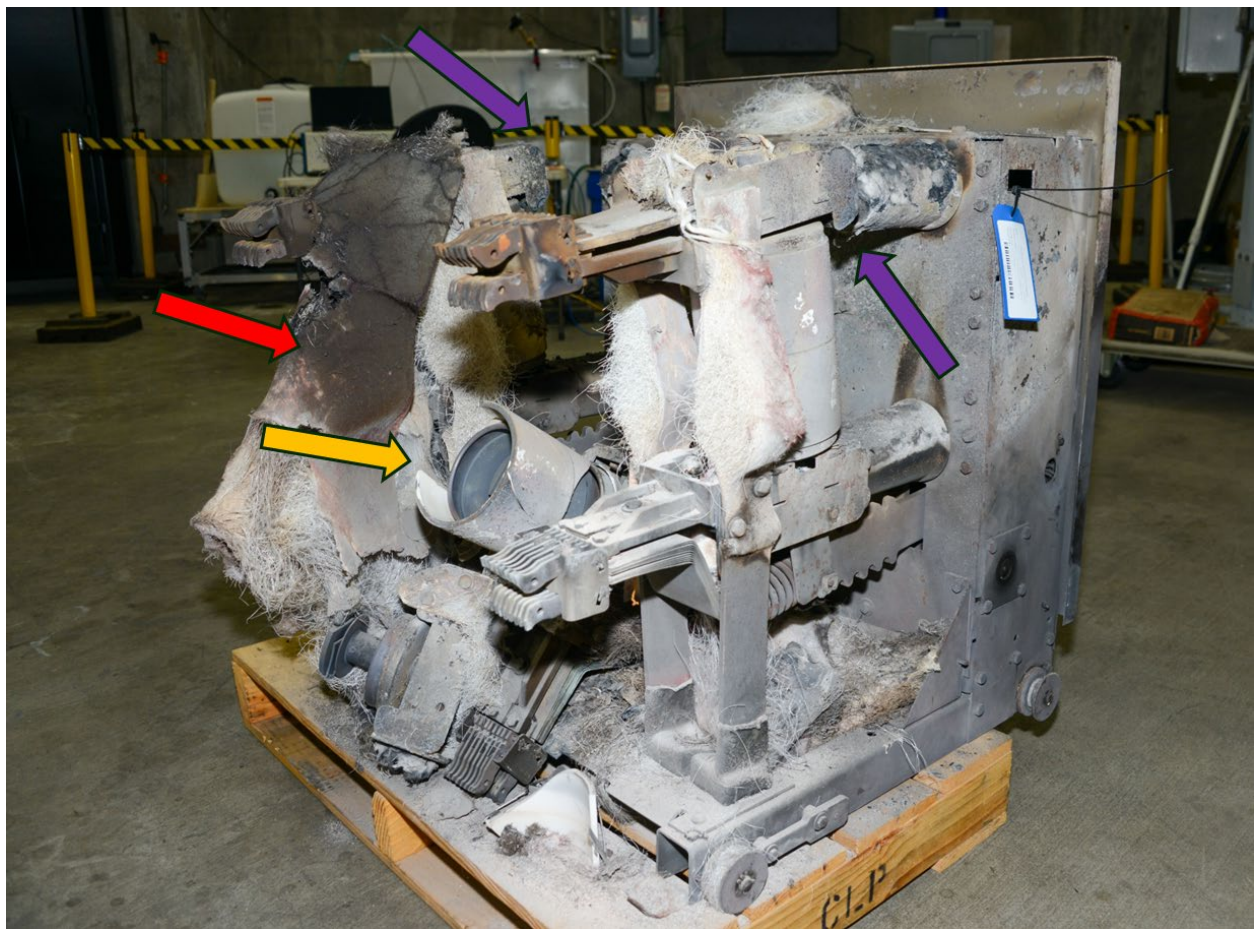
The vacuum bottle on the B-phase was entirely detached from the insulators. The ceramic exterior of the B-phase vacuum bottle was damaged with a large crack on the bottom half that separated part of the exterior. A crack was also visible on the top half of the B-phase vacuum bottle that separated part of the ceramic exterior. The contacts were visible on this cracked vacuum bottle and did not appear damaged by arcing. The A and C phase vacuum bottles were detached at the top insulator but appeared loosely connected at the bottom. The C-phase vacuum bottle had a crack on the lower half of the ceramic exterior. The A, B, and C phase vacuum bottles had clear damage patterns on the front-facing side of the ceramic exterior (see Figure 14).

Figure 14. Incident Breaker No. 52 showing detached insulators (purple arrows), damage to the B-phase vacuum bottle (yellow arrow), and burned Incident Insulating Board (red arrow).
