# Appeal of Determination of Exemption from Environmental Review Embarcadero Fountain by Armand Vaillancourt (Vaillancourt Fountain)

January 13, 2026

San Francisco Arts Commission

San Francisco Recreation & Park Department

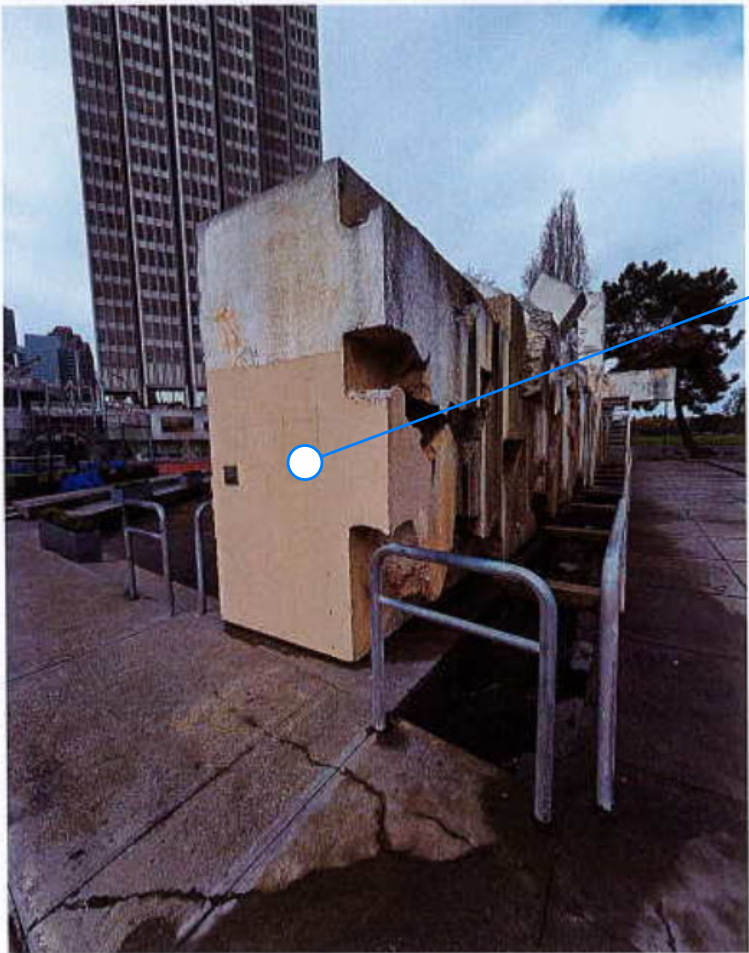
Rear wall - no reinforcing was found.

Photo 4. Rear wall – no reinforcing steel was found.

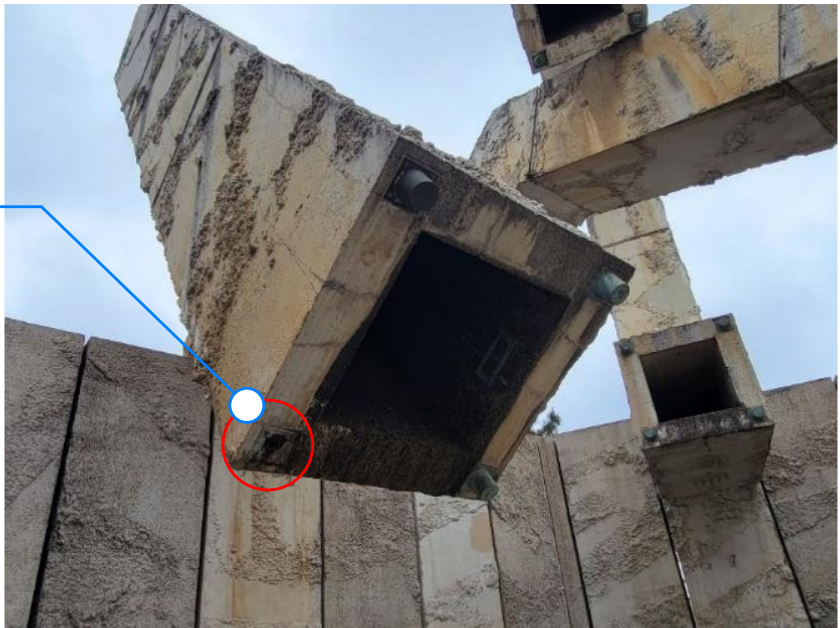
Absence of thru rod.

Figure 11: Vaillancourt Fountain – Showing Corroded End Plate and Absence of Thru Rod and Spalled Concrete Surface

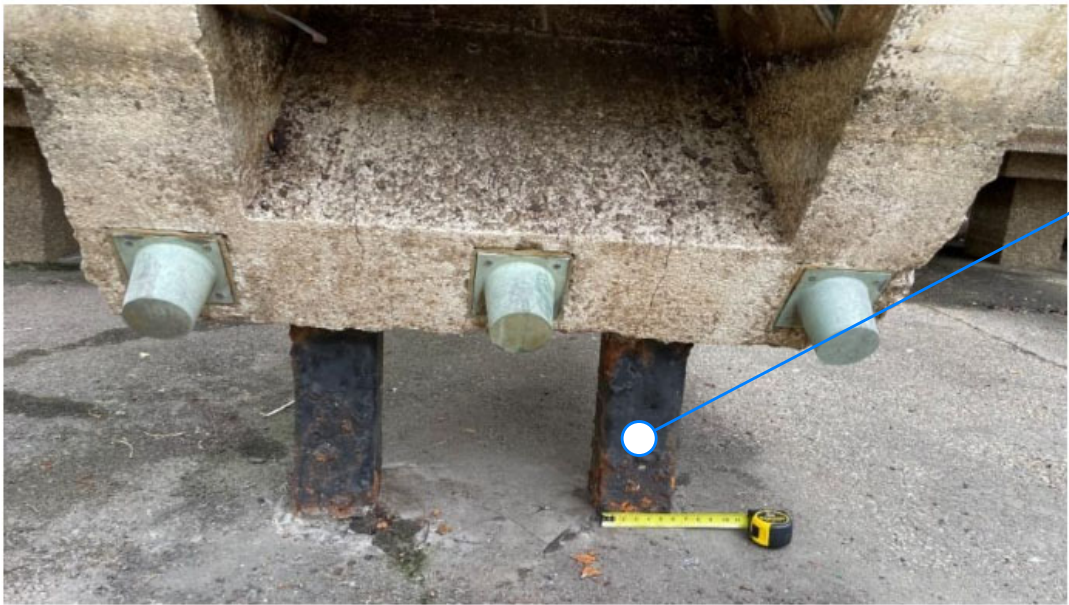
Corroded steel tubes.

Figure 8: Vaillancourt Fountain - Corroded Steel Tubes and Spalled and Cracked Concrete

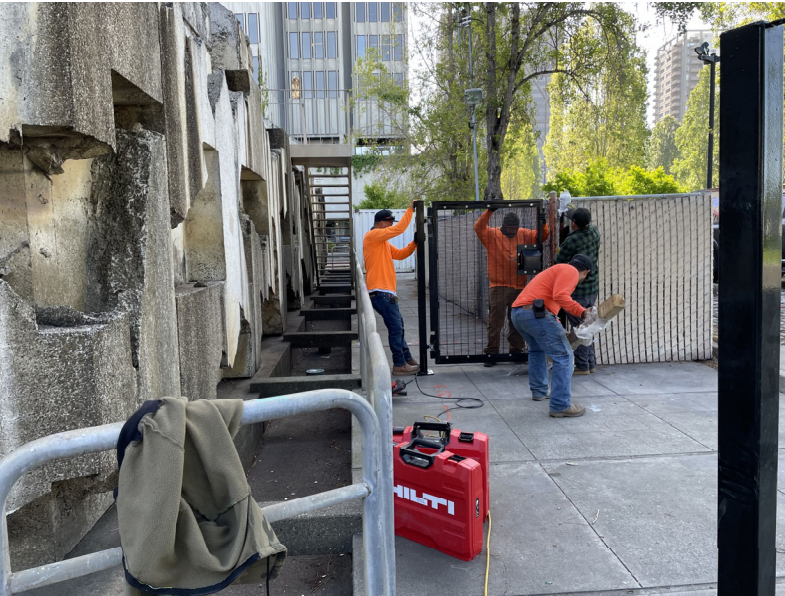
Breaching of mesh

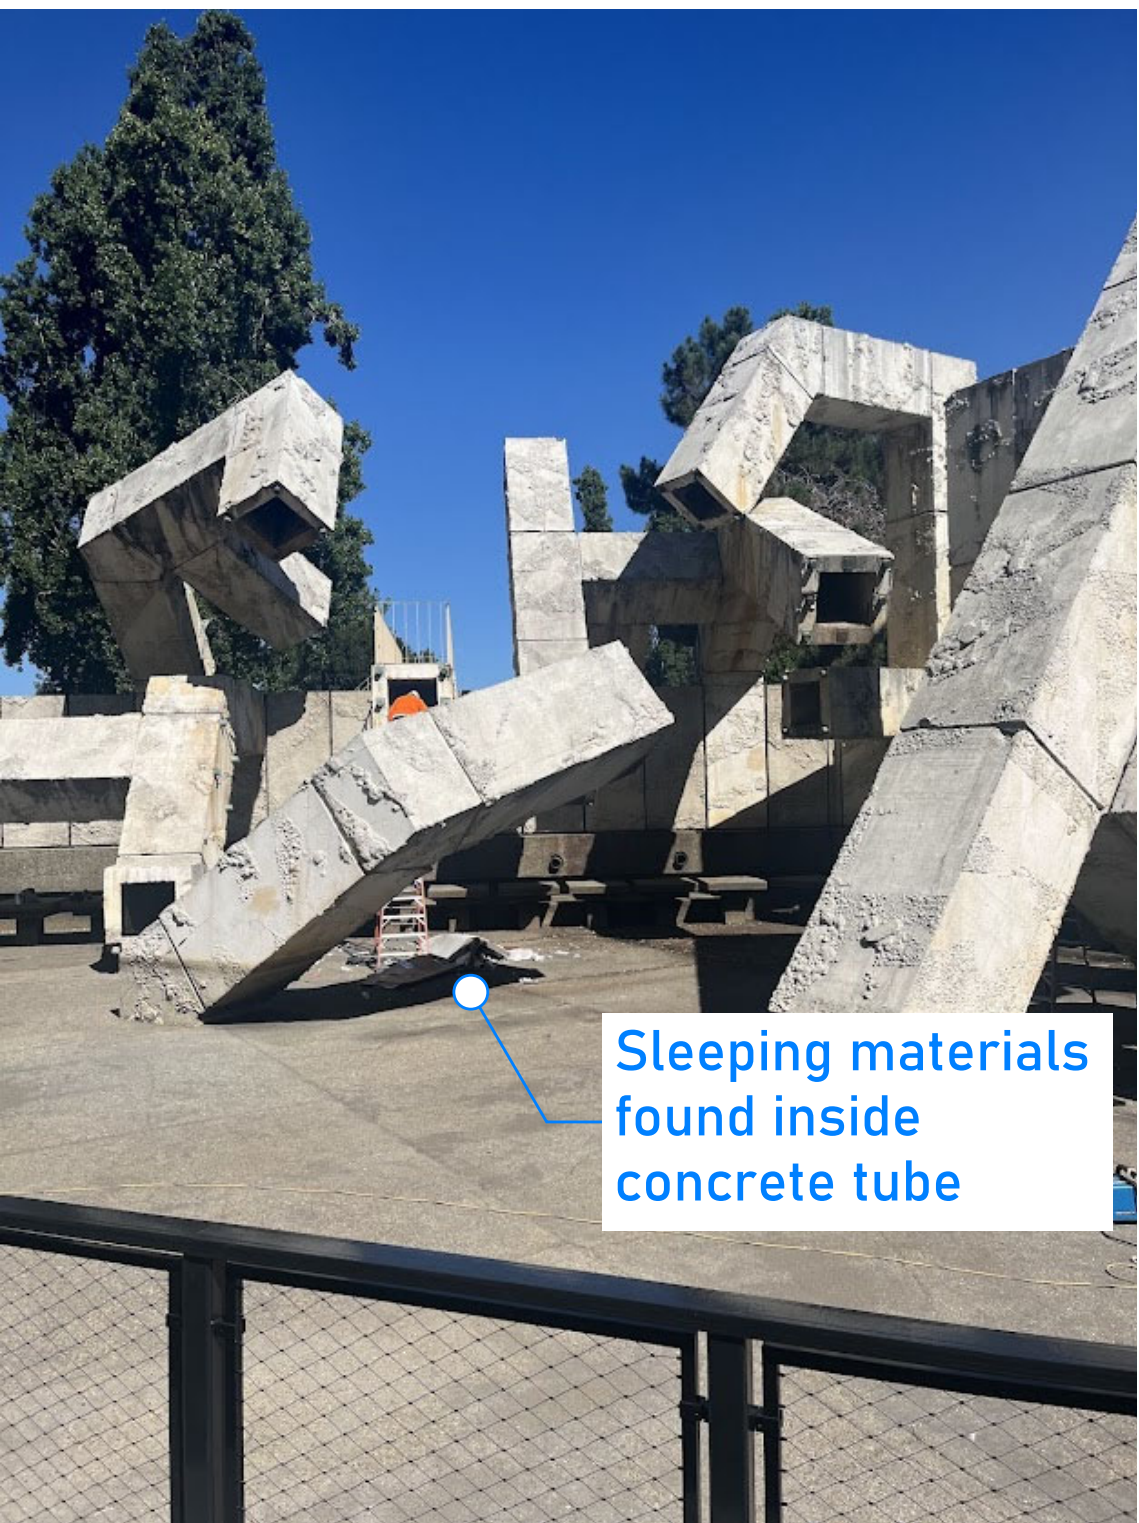
Sleeping materials found inside concrete tube
