SAN FRANCISCO PLANNING DEPARTMENT

PRE-APPROVAL INSPECTION REPORT

Report Date: May 24, 2019
Inspection Date: May 22, 2019; 11:00am
Filing Date: May 1, 2018
Case No.: 2019-006384MLS
Project Address: 1401 Howard Street
Block/Lot: 3517/035
Eligibility Article 10 Landmark No. 120: Saint Joseph's Church
National Register listed property
Zoning: RCD – Regional Commercial District
Height & Bulk: 40-X
Supervisor District: District 6 (Matt Haney)
Project Sponsor: Christopher Foley of 1401 Howard LLC
Address: 1401 Howard Street
San Francisco, CA 94103
415-305-4600
cfoley@groundmatrix.com
Staff Contact: Michelle Taylor – (415) 575-9197
michelle.taylor@sfgov.org
Reviewed By: Tim Frye – (415) 575-6822
tim.frye@sfgov.org

**MILLS ACT APPLICATION
1401 HOWARD STREET
SAN FRANCISCO, CALIFORNIA**

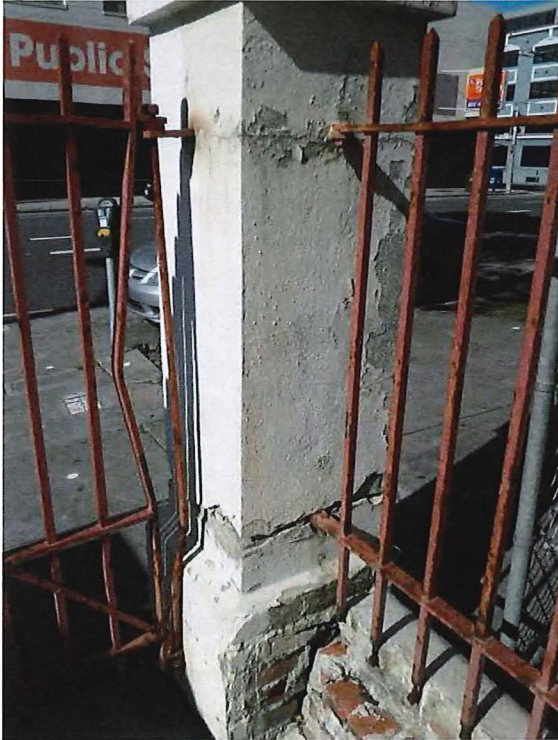
Figure 32a. Pier near west tower, showing large cracks and displaced areas of brick (arrow) and corroded metal fence.

Scope: # 1			
Building Feature: Exterior Gates, Curbs, Fence, Piers, Granite Steps			
Rehab/Restoration	<input checked="" type="checkbox"/>	Maintenance	Completed <input checked="" type="checkbox"/> Proposed
Contract year work completion: 2018			
Total Cost: \$25,000.00 Source SOV #2920			
Description of work: Restoration and Repair of Exterior Gates, Curbs, Fences, Piers and Granite Steps			
<ul style="list-style-type: none"> ▪ The direction of the swing of all gates was reversed in the direction of egress. The gates were prepared, primed, and painted, and latch and lock sets were provided. At the two existing double gateways, the existing gates were reinstalled on new freestanding supports similar to the existing. The original hinges were retained at the original piers. The displaced sections of the piers were reset in the original locations and grouted. The cement plaster parge was repaired as required to match the original. ▪ The iron fence was prepared, primed, and painted. The gaps and voids were filled with mortar at the base and pier attachments. Where the fence is set into the curb and is corroded, the metal was repaired, painted, and set into lead or sealant as required to prevent future damage to the fence or curb. ▪ The cement plaster parge on the piers was cleaned and graffiti was removed or painted over. The cement plaster parge was repaired to match the existing adjacent color and texture as required. ▪ Existing joints were raked out and the granite steps were cleared of debris. Joints were repaired with mortar. Algae, moss, and other biological growth was removed. Soil and paint spatters were removed. New code-required bronze handrails were installed.

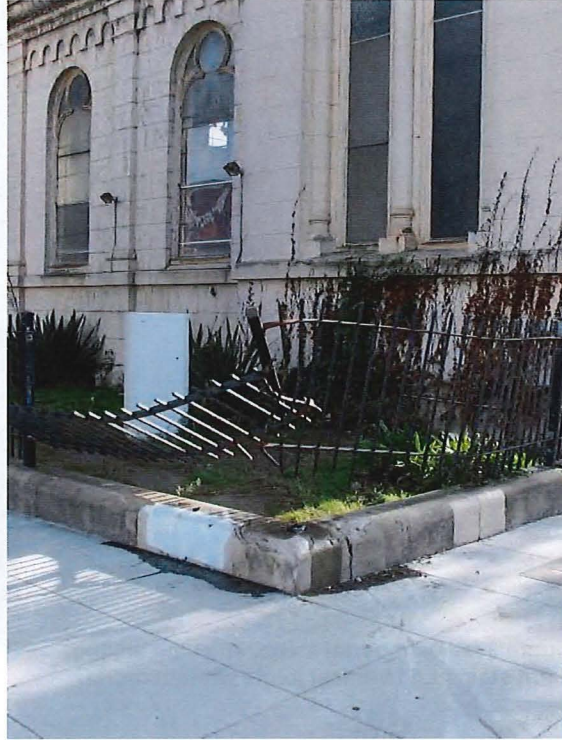
Figure 32b. Damage to metal fence at northeast corner of property.

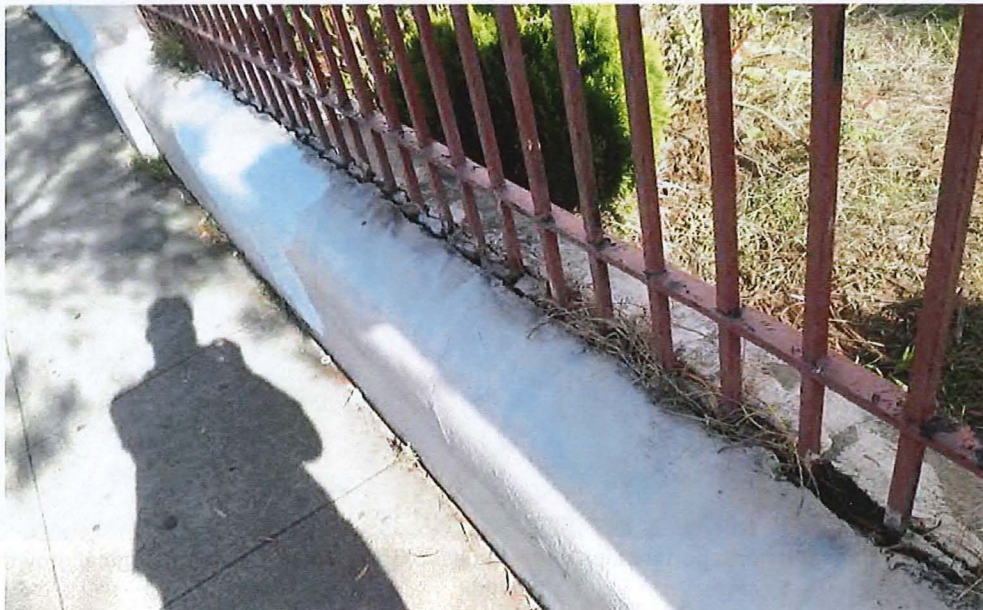
Figure 32c. Low brick wall along Howard Street, showing gaps and voids, corroded metal fence, and graffiti (painted over with mismatched paint).

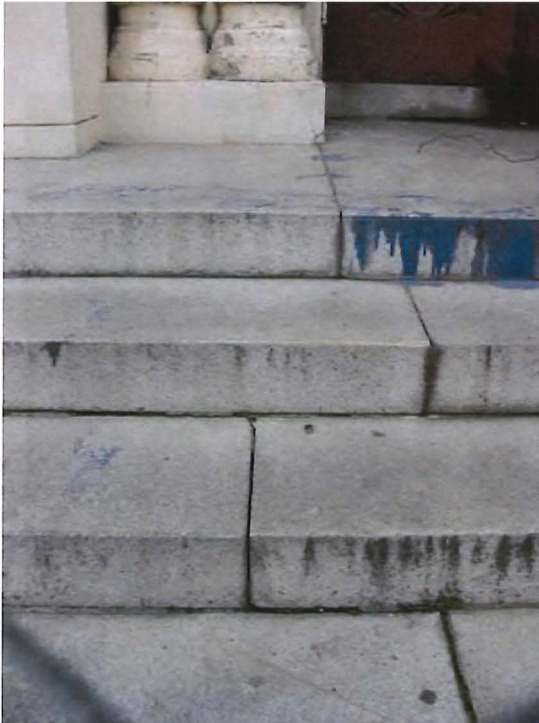
Figure 33a. Main portal steps, showing soiling, paint stains and vertical joints without mortar.

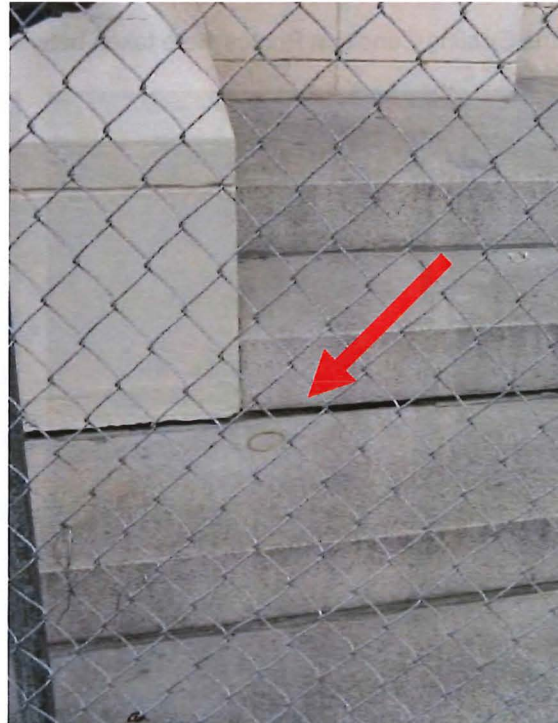
Figure 33b. Detail, east side of main portal steps, showing gap between blocks (arrow) due to uneven settling.

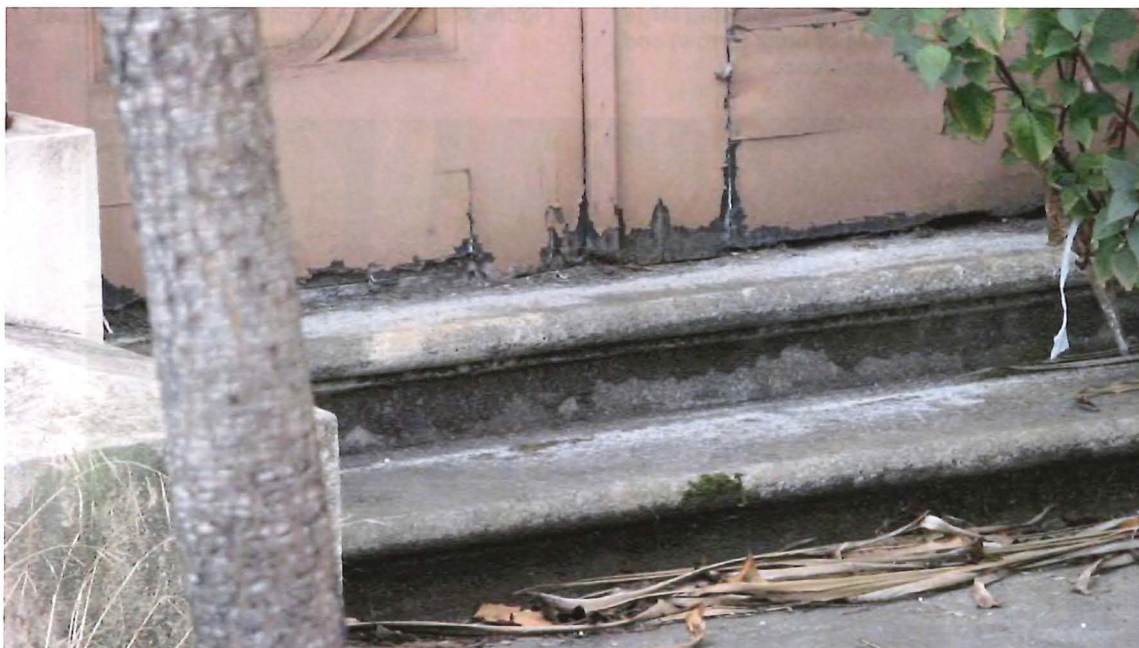
Figure 33c. East transept, north portal steps, showing decorative bull nose with biological growth and soiling.

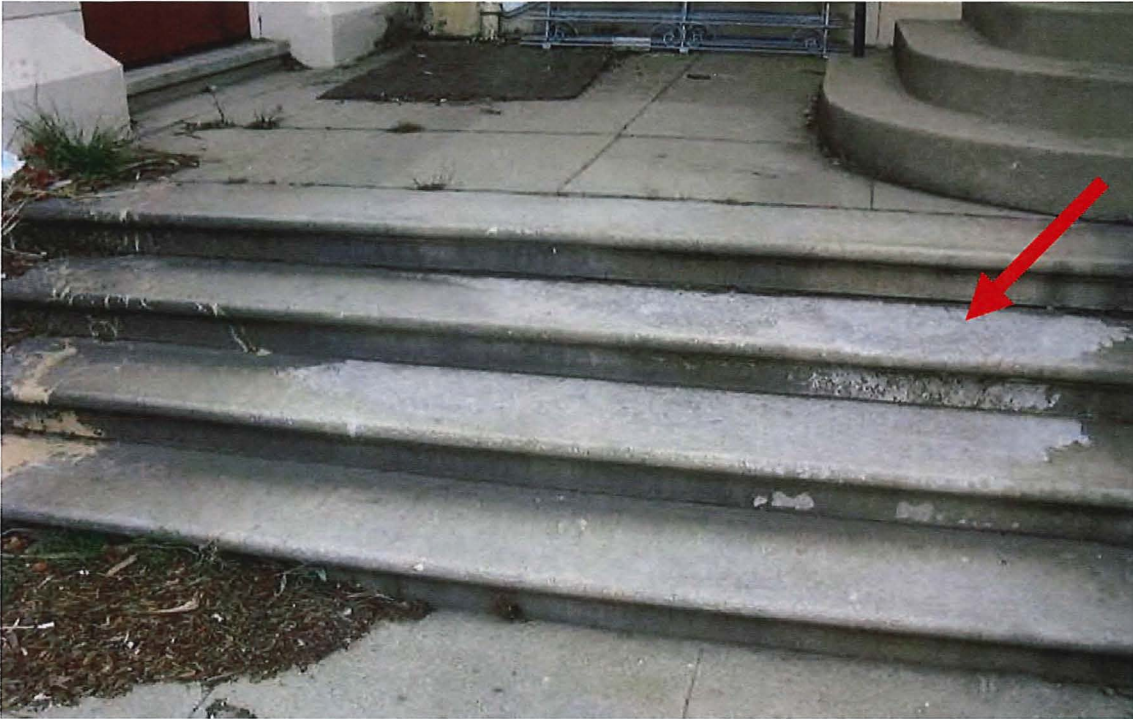
Figure 33d. West transept, south portal steps, showing paint stains (left), soiling and spalling surface (arrow).

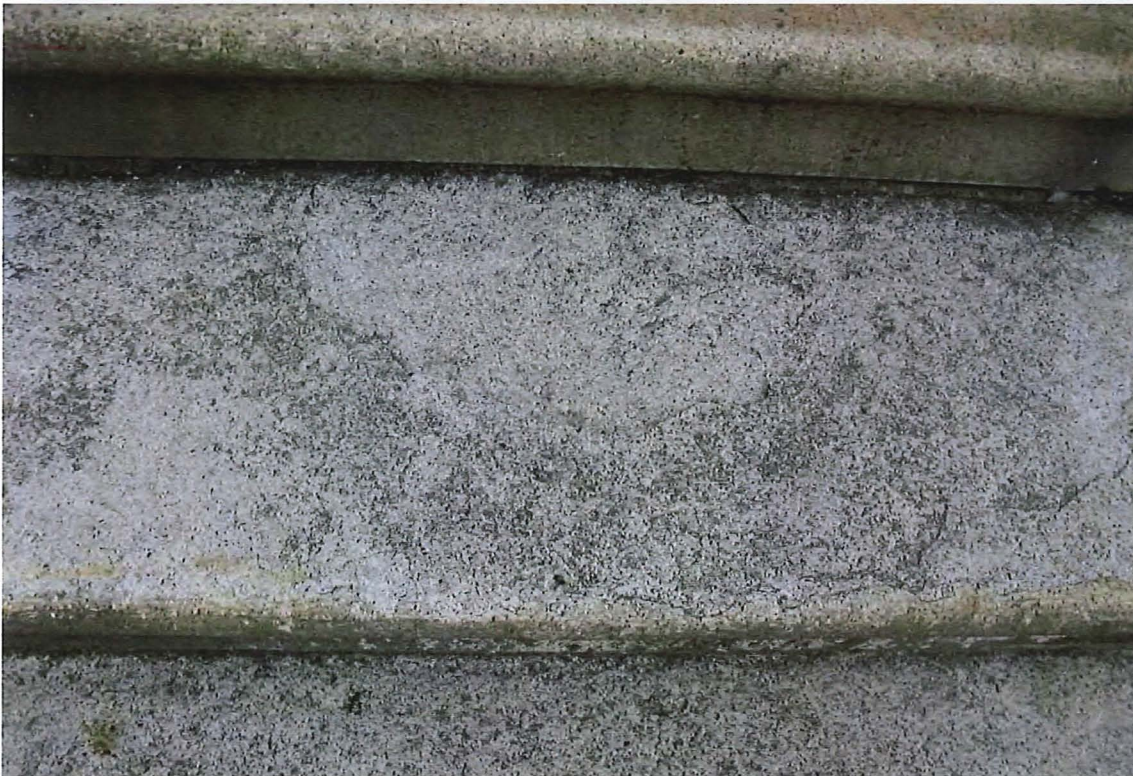
Figure 33e. Detail, south portal steps, spalled surface of granite tread.

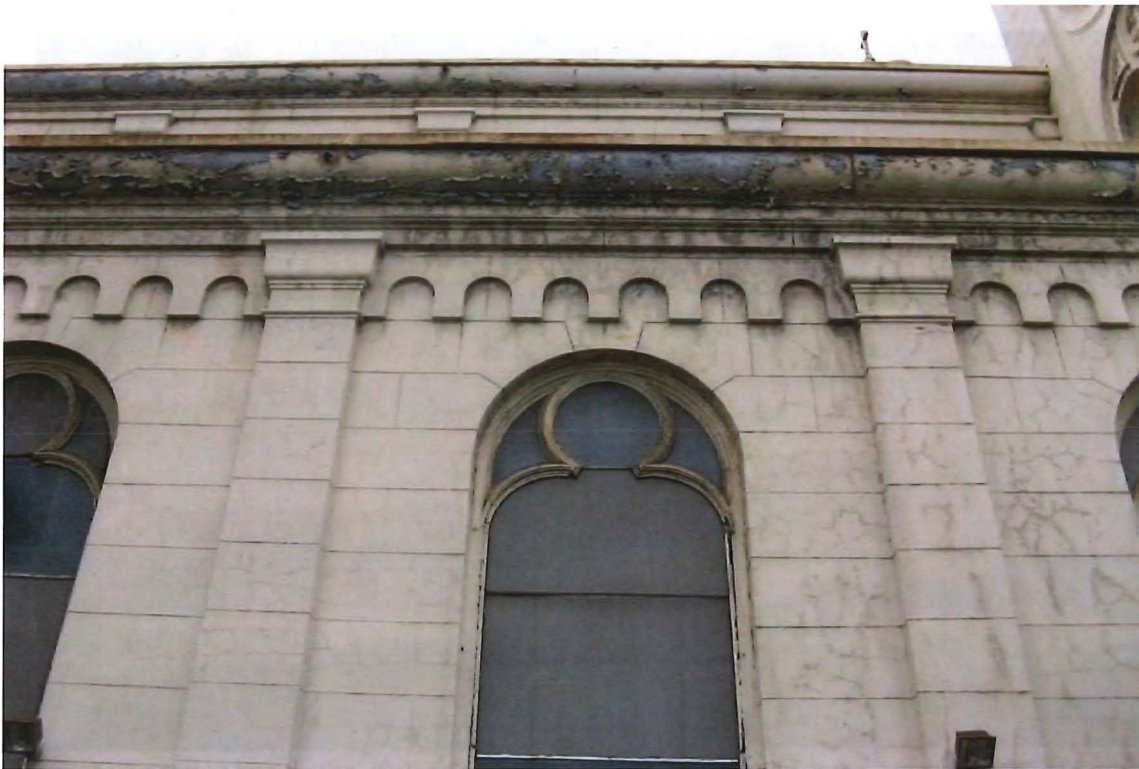
Figure 34a. East nave façade, showing soiling, water staining and hairline cracking of stucco.

Scope: # 2			
Building Feature: Exterior Paint and Stucco Repair			
Rehab/Restoration	<input checked="" type="checkbox"/>	Maintenance	Completed <input checked="" type="checkbox"/> Proposed
Contract year work completion: 2018 Phase 1, Phase 2 scheduled for 2026			
Total Cost: \$146,950. Source SOV #9900 (half), \$293850/2=\$146,950.			
Description of work: Façade Restoration and Full Repainting			
<ul style="list-style-type: none"> ▪ The existing stucco was analyzed to determine if it was lime or Portland cement-based. These tests were performed by an architectural conservator. ▪ Staining and soiling was removed by the gentlest means possible, this included light brushing and water washing, and cleaning with a commercial agent. ▪ Areas of significant hairline cracking were repaired based on analysis to determine the root cause of the condition. Investigation included testing for underlying detachment of the stucco layer, moisture intrusion, structural movement, or other causes. ▪ Climbing vegetation such as ivy was removed. ▪ Spalls and cracks through cement plaster were repaired. The cracks were routed and patched to match the existing adjacent texture, profile, and appearance. ▪ The existing deteriorated or detached cement plaster was removed. Graffiti and stains were removed. ▪ Unsound paint was removed and coated with a new breathable paint coating.

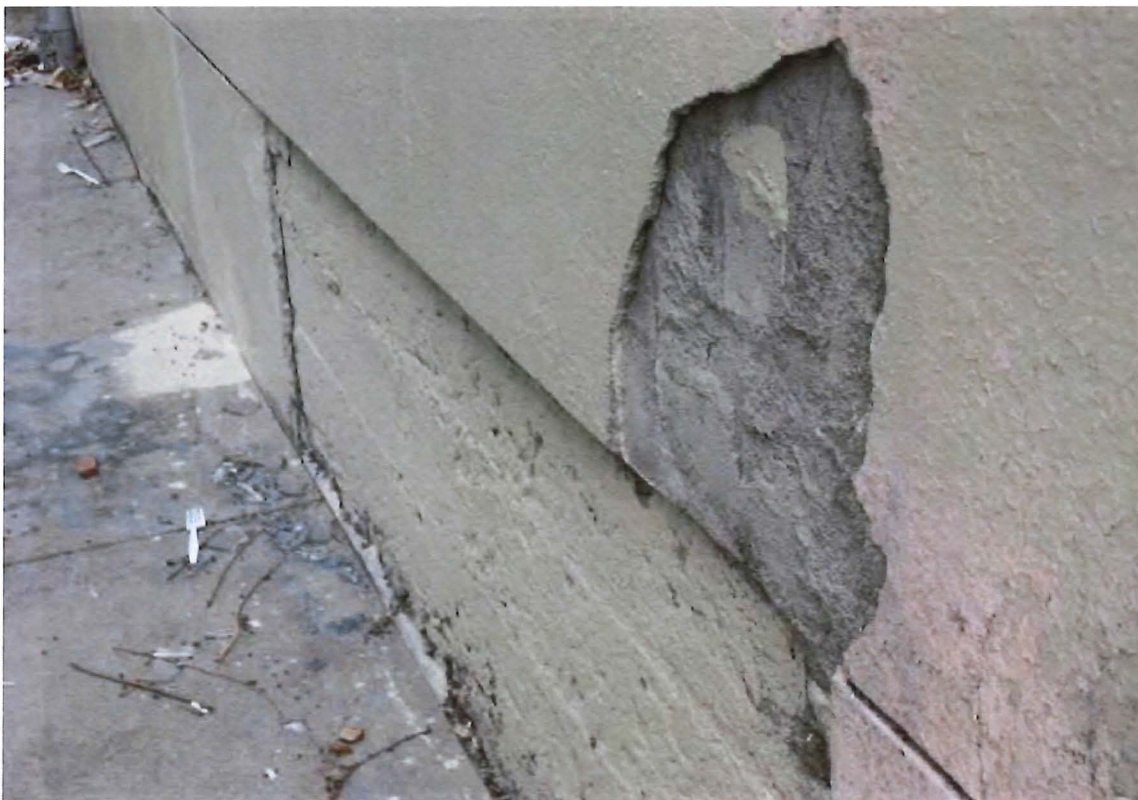
Figure 34b. East tower, north façade, showing loss of stucco at ground level.

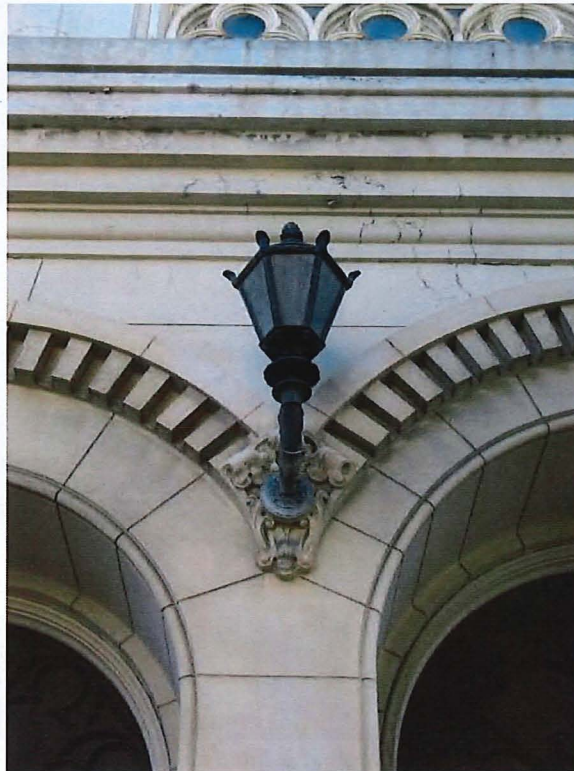
Figure 35a. Light fixtures (now missing) at main entry on north façade in 2007.

Total Cost: \$92,625.00 Source SOV #16080
Description of work: <ul style="list-style-type: none"> ▪ The missing original fixtures on the main entry façade were replicated based on historic documentation. ▪ Building façade lighting was replaced with LED fixtures to save energy.

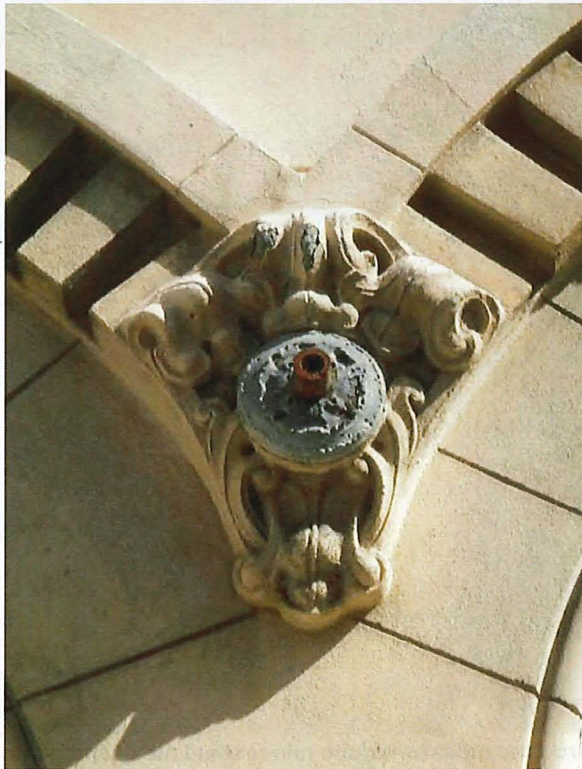
Figure 35b. Detail, original mounting hardware is all that remains in place.

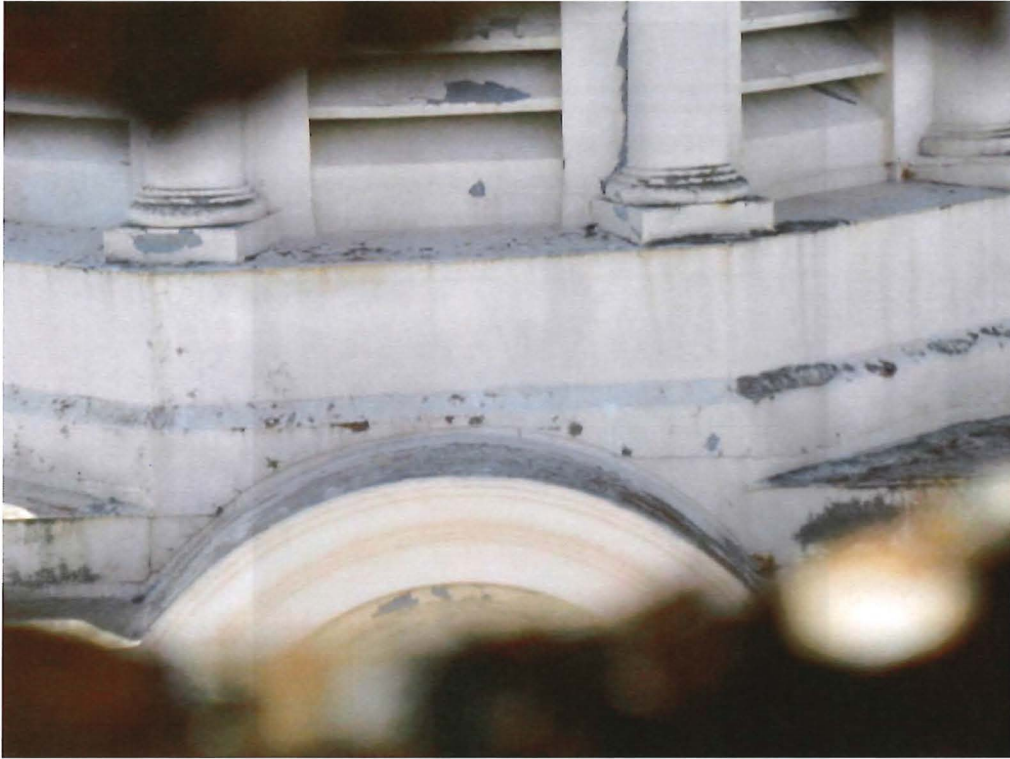
Figure 36a. Detail, rust-through at painted sheet metal cupolas.

Scope: # 3			
Building Feature: Exterior _ Sheet Metal Elements, including domes on towers, column capitals, decorative moldings, gutters and down spouts.			
Rehab/Restoration	<input checked="" type="checkbox"/>	Maintenance	Completed <input checked="" type="checkbox"/> Proposed
Contract year work completion: 2018			
Total Cost: \$424,323. Source SOV #7600 = \$434,323			
Description of work: Repair and Restoration of Exterior Sheet Metal Elements			
<ul style="list-style-type: none"> ▪ Peeling or blistering paint was scraped or sanded. ▪ Corrosion was removed with hand scrapers or a wire brush. ▪ For panels with heavy corrosion and resulting perforation of the sheet metal unit, there were three options, dependent on severity and size: <ol style="list-style-type: none"> 1. Corroded panels were removed and the unit was replaced with a new piece of sheet metal cut to the appropriate dimension and profile, 2. The corroded area was cut out of existing sheet metal, a new piece was braze-welded and the joint was ground flat; or 3. The corroded area was cut out of existing sheet metal and steel-filled epoxy compound was installed to patch small holes. ▪ All exposed metal was painted with a rust-inhibiting primer and two coats of color-appropriate outdoor paint. ▪ Missing elements were replaced to maintain visual consistency.

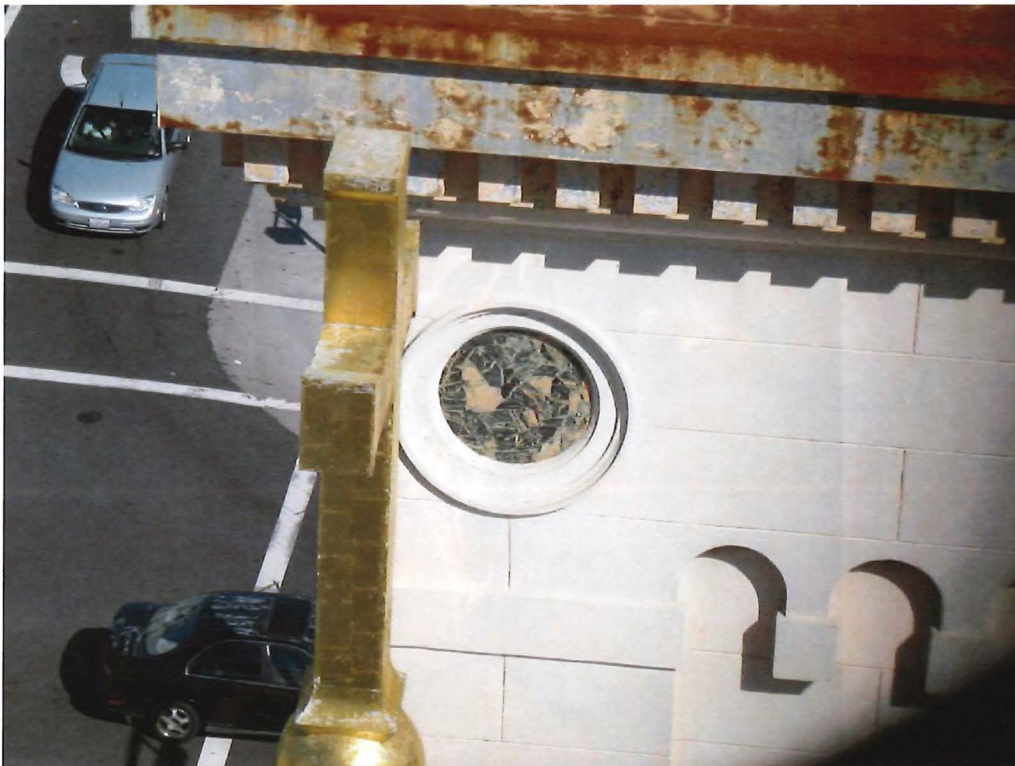
Figure 36b. The rooftop crosses require minor sheet metal and gilding repair.

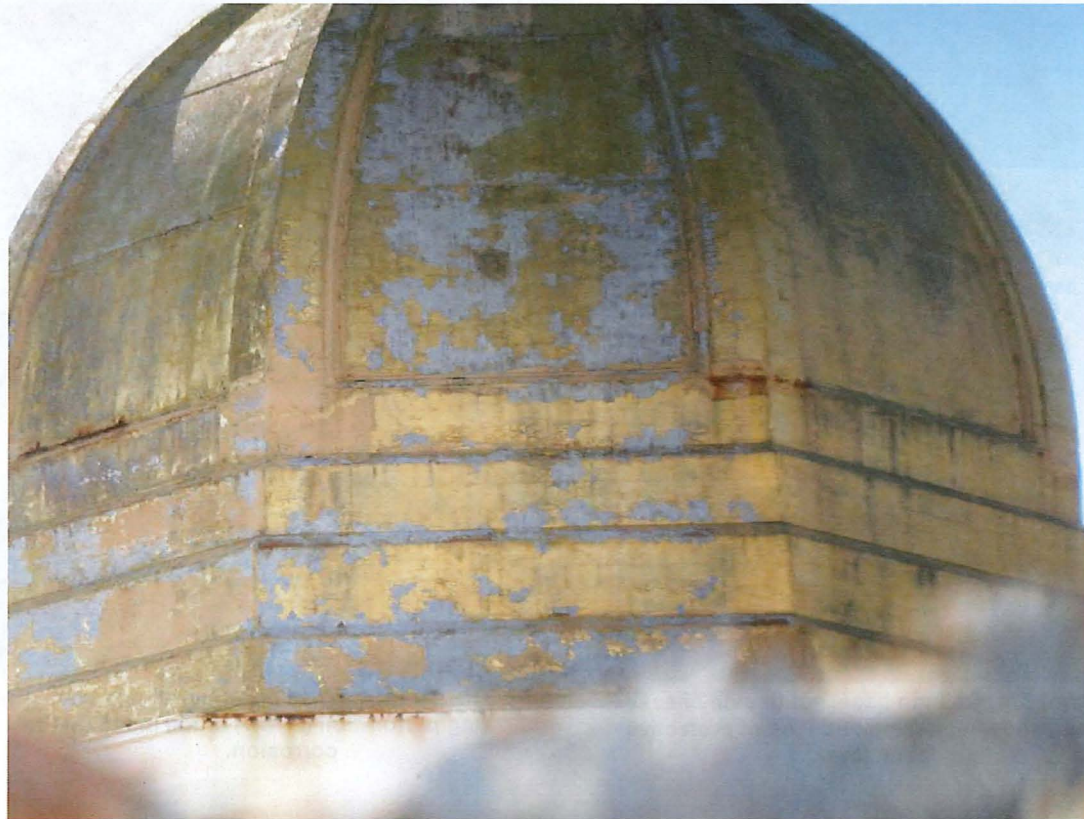
Figure 36c. Detail, corrosion and loss of paint and gilding at domes.

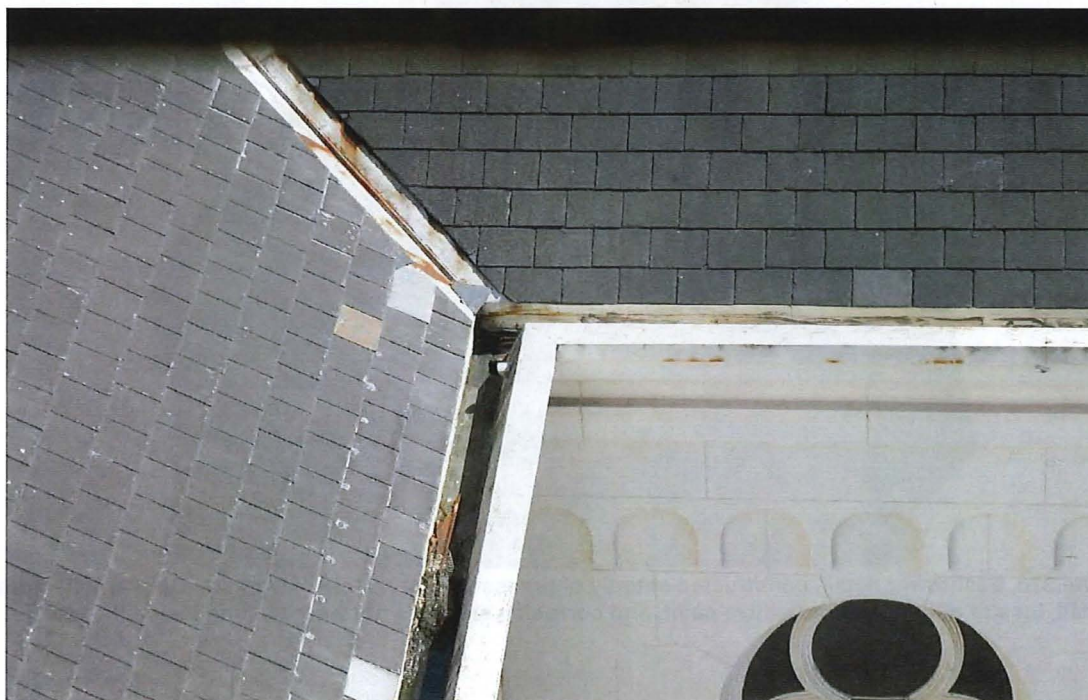
Figure 36d. Broken, loose, and missing slate tiles at main roof.

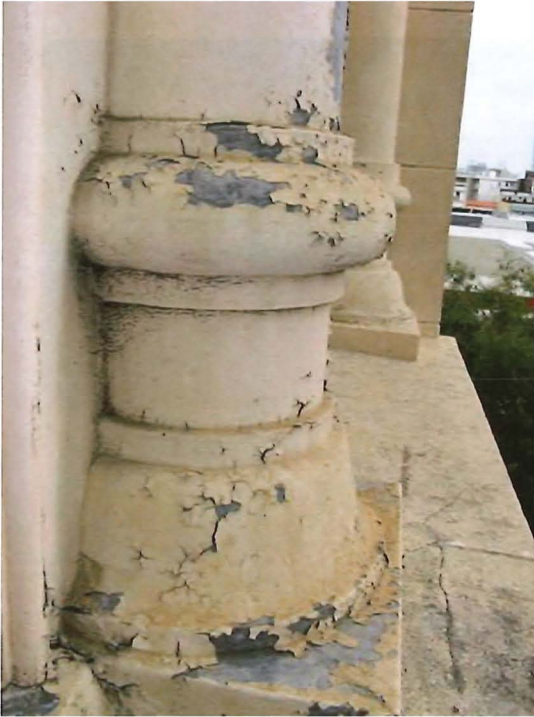
Figure 37a. Column base, south side of east tower, showing flaking and loss of protective paint layer.

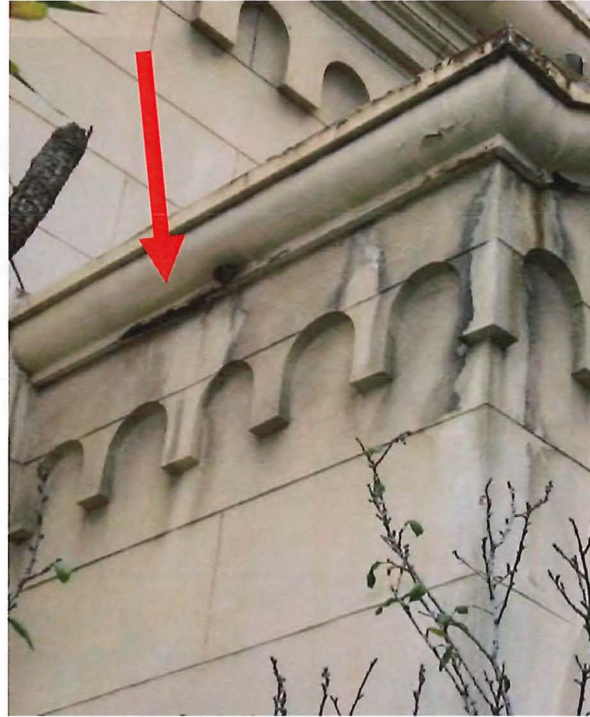
Figure 37b. Cornice above north portal, east transept, showing perforation (arrow) of the metal due to corrosion.

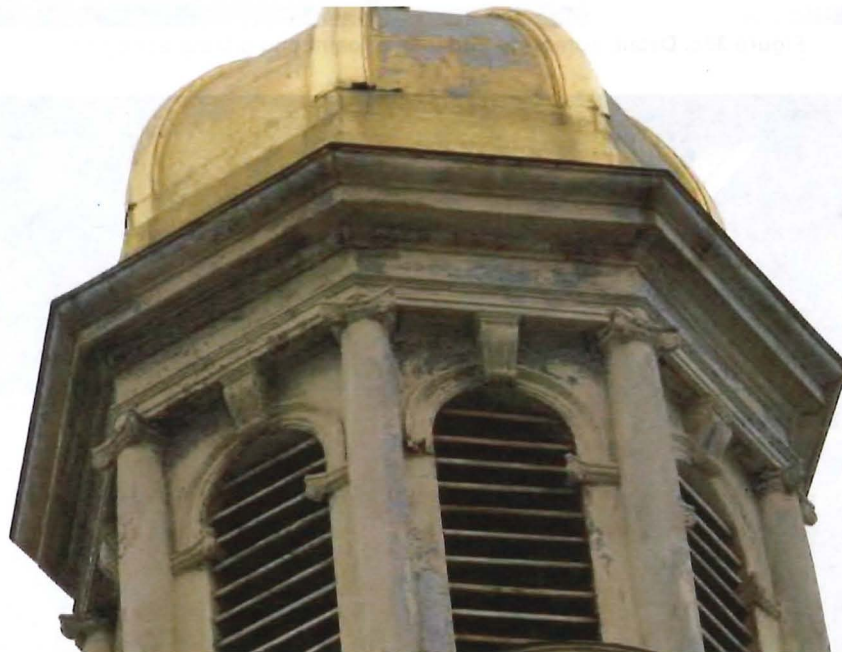
Figure 37c. East tower detail, constructed entirely of pressed sheet metal, showing missing architectural detail, loss of gilding and protective paint, and corrosion stains. Birds were nesting inside the towers.

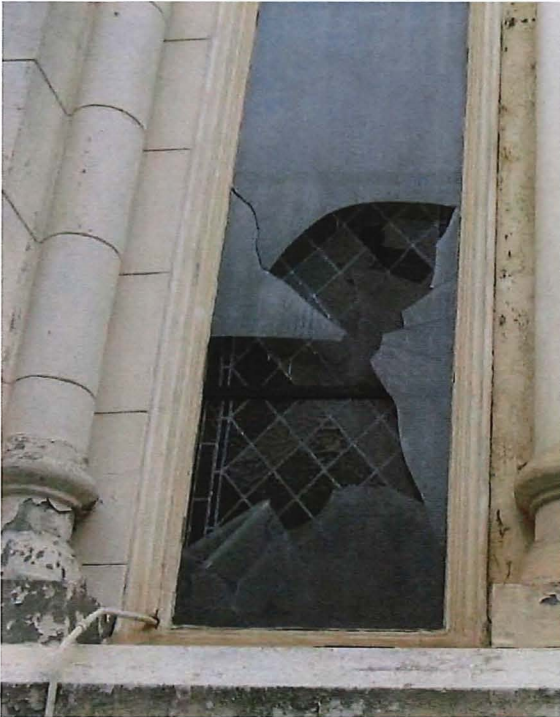
Figure 38a. West tower, north window, showing broken protective glazing.

Scope: # 4			
Building Feature: Exterior _ Wood-sash Windows and Steel Tracery			
Rehab/Restoration	<input checked="" type="checkbox"/>	Maintenance	Completed <input checked="" type="checkbox"/> Proposed
Contract year work completion: 2018			
Total Cost: \$366,443. Source SOV #6150 and # 8050 for \$96,867 and \$269,576 = 366,443			
Description of Work: Repair, Restoration and Replacement of Windows			
<ul style="list-style-type: none"> ▪ A detailed conditions assessment of windows at St. Joseph's Church was conducted to determine the extent of deterioration and appropriate treatments at each window. This included careful inspection and documentation of each window frame and its conditions, and other non-invasive diagnostic tests. ▪ Repair of the window frames attempted to retain as much original material as possible, while providing adequate moisture protection for the building, and included paint removal, splicing of new wood elements in areas of severe deterioration, and replacement of all glazing compound. ▪ The wood frames were prepared and painted, all the existing ribbed glass that could be preserved was reused. Ribbed glass that matched the original was installed in selected locations.

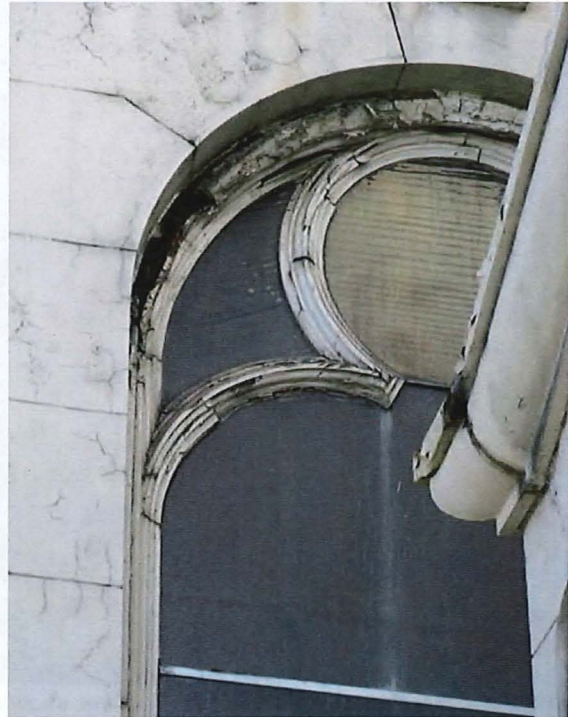
Figure 38b. East façade, transept window, showing soiling, paint loss and rotting/loss of tracery elements.

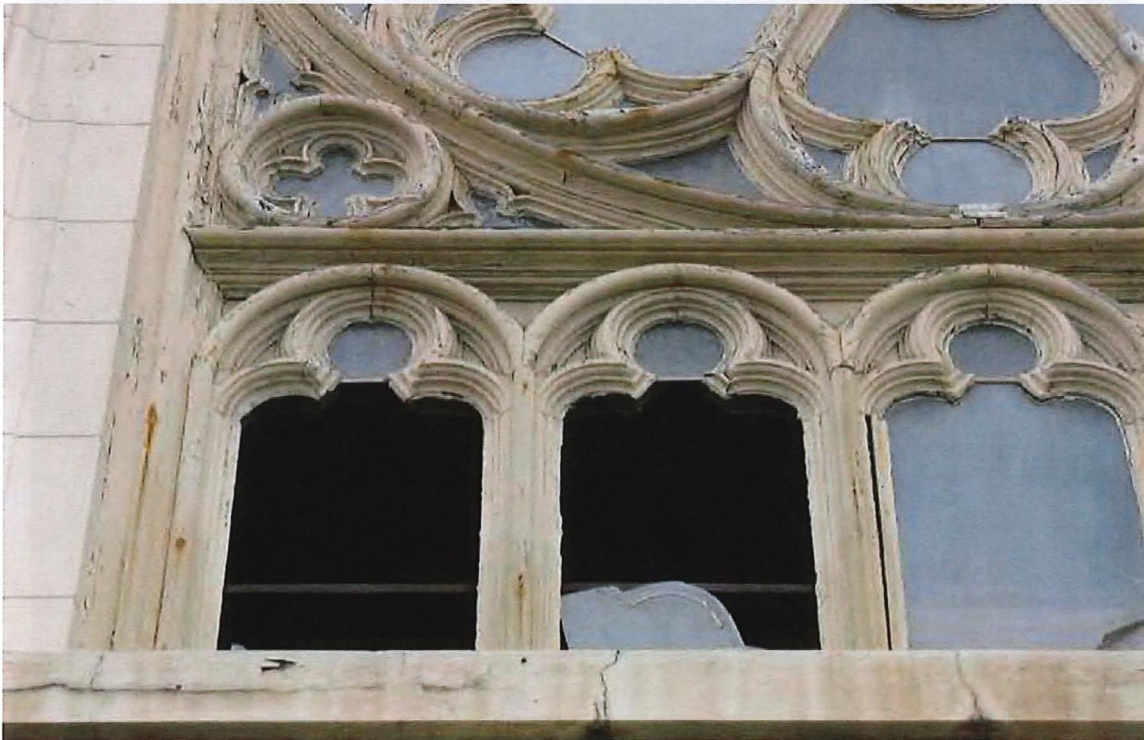
Figure 38c. West transept rose window, showing paint loss and missing glazing.

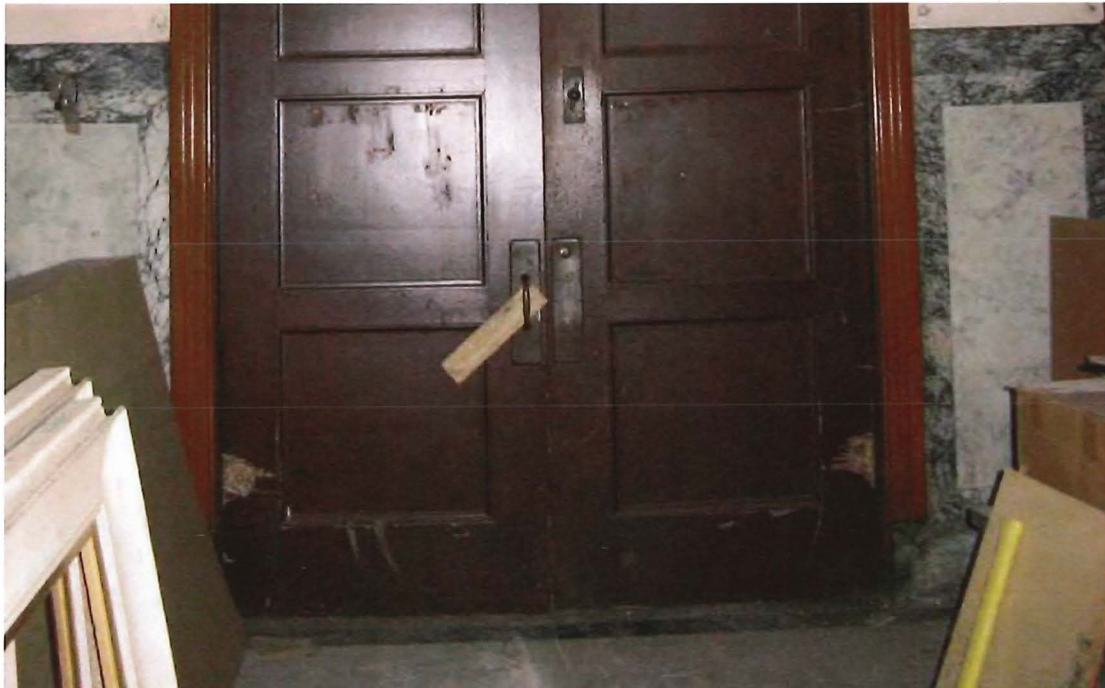
Figure 39a. Marble wainscoting of the narthex, showing soiling of the baseboard, wear of polished surface, and adhered tape. Original marble floor was covered with vinyl tile.

Scope: # 10			
Building Feature: Interior Marble Wainscoting and Tiles			
Rehab/Restoration	<input checked="" type="checkbox"/>	Maintenance	Completed <input checked="" type="checkbox"/> Proposed
Contract year work completion: 2018			
Total Cost: \$5,000.00 Source From KFI (3/28/19 email)			
Description of work: Restoration of Interior Marble			
<ul style="list-style-type: none"> ▪ Tape residue and soiling was removed with a gentle stone cleaner. Mock-ups were conducted to determine the most effective product. ▪ Vinyl tiles and mastic were removed in the vestibule without causing damage to underlying marble, which was cleaned with a gentle stone cleaner to remove staining and adhesive. Mockups were conducted to determine the most effective product. ▪ Vinyl tiles and mastic were removed from the vestibule floor and cleaned using the gentlest means possible. ▪ The marble floors were polished to restore luster

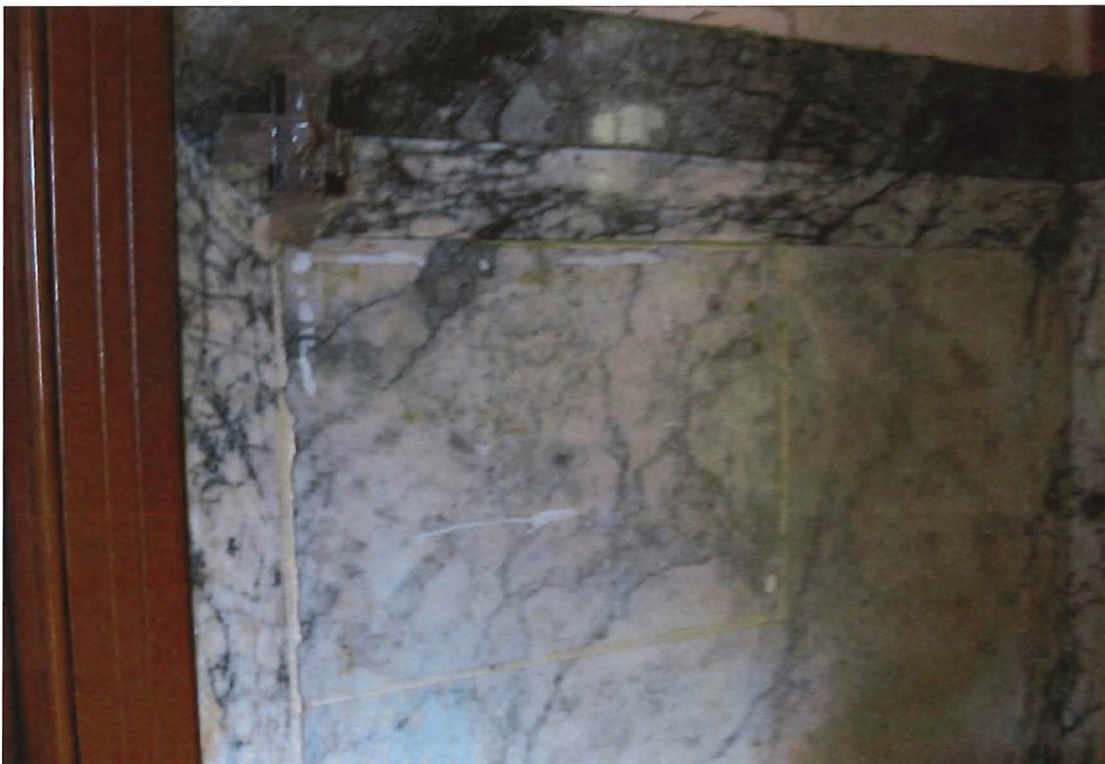
Figure 39b. Detail, showing tape and adhesive residue.

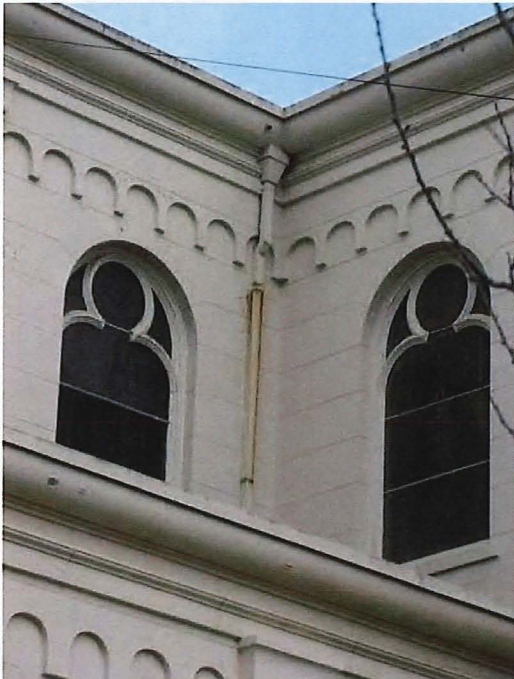
Figure 40a. West façade, showing blocked or perforated drainage which is causing damage to interior plaster.

Scope: # 8			
Building Feature: Interior Decorative Plaster			
Rehab/Restoration	<input checked="" type="checkbox"/>	Maintenance	Completed <input checked="" type="checkbox"/> Proposed
Contract year work completion: 2018			
Total Cost: \$1,350,577.00 Source SOV #9050 , \$1,350,577			
Description of work: Repair and Restoration of Interior Decorative Plaster			
<ul style="list-style-type: none"> ▪ Detached or cracked plaster elements were repaired, if in otherwise sound condition, with an injected epoxy or gypsum-based grout. Testing was conducted to determine the most effective adhesive. ▪ Non-historic wood veneer was removed so that plaster at the base of the wall could be restored and painted. ▪ Further testing of the plaster was conducted to determine the extent of deterioration. This determined the treatment method: patching and reshaping damaged elements when possible, or replacement in kind.

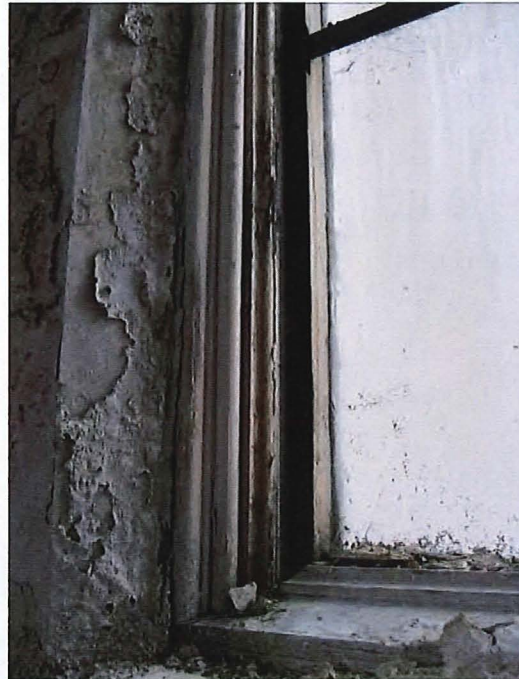
Figure 40b. Deterioration of plaster caused by moisture from poorly sealed window.

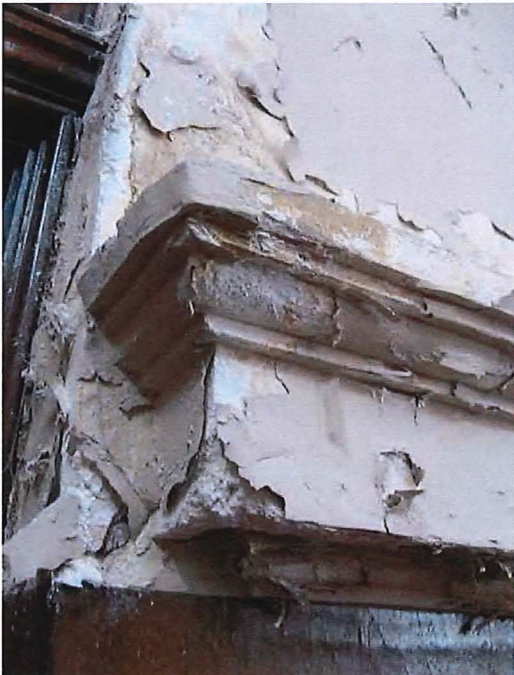
Figure 40c. Softening and deterioration of decorative plaster elements caused by moisture from faulty roofing.

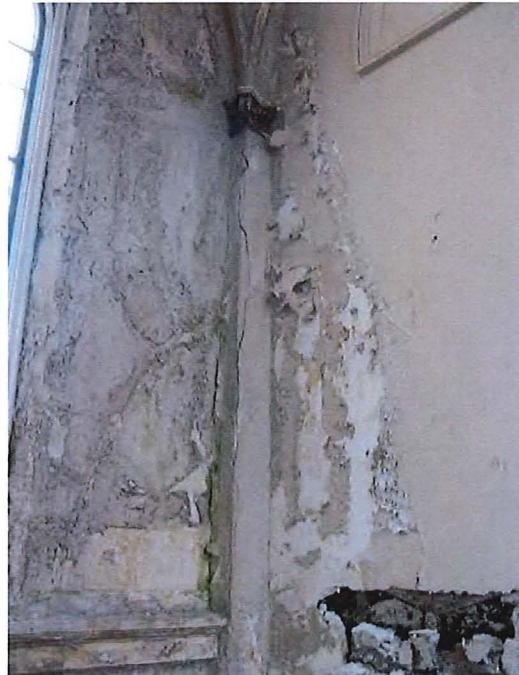
Figure 40d. Structural cracking and separation of plaster details from masonry substrate caused by moisture from blocked drains.

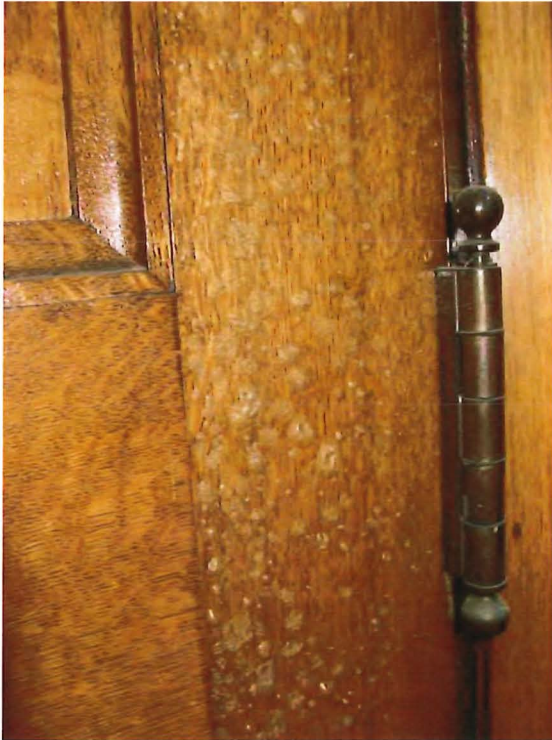
Figure 41a. Blistering of varnish on an oak door caused by moisture penetration.

- Wood was replaced where missing to match the original.
- At exterior doors, deteriorated wood was repaired with wood Dutchman and matched the original species, grade, grain, and profile. The exterior surface was prepped and painted. The interior was cleaned and touched up or refinished to match the original stain or clear coat.
- Door hardware was replaced or repaired to match existing and to meet current code.

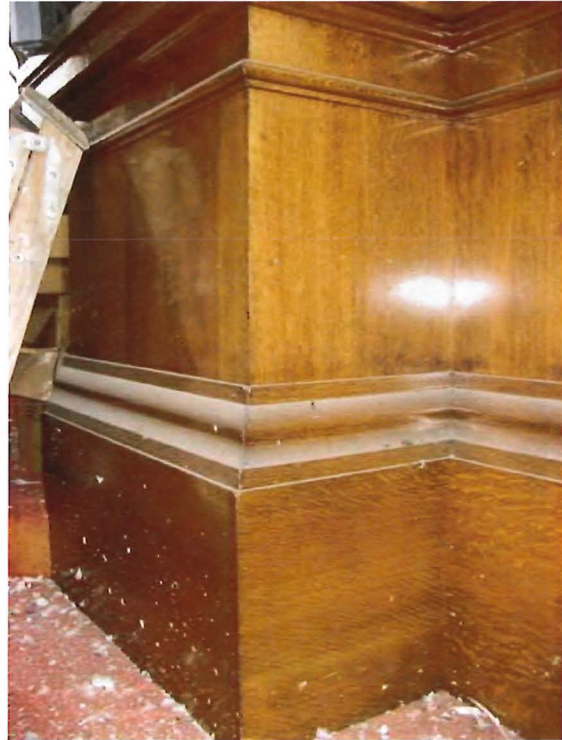
Figure 41b. Dust (on molding) and paint/guano spatters can cause permanent damage to wood finish.

Scope: # 9			
Building Feature: Interior Woodwork, Doors and Finish Hardware			
Rehab/Restoration	<input checked="" type="checkbox"/>	Maintenance	Completed <input checked="" type="checkbox"/> Proposed
Contract year work completion: 2018			
Total Cost: \$269,000.00 Source SOV #8200			
Description of work: Repair and Restoration of Interior Woodwork, Doors and Finish Hardware			
<ul style="list-style-type: none"> ▪ Soiling was cleaned with the gentlest means possible, using a soft bristle brush to remove loose dust and a damp cloth for tenacious soiling. ▪ Blistered varnish was treated with the gentlest means possible in order to preserve the existing finish. Treatments included lightly scraping blistered areas of varnish and spot-treating with fine steel wool or cotton, alcohol and a compatible varnish or shellac. ▪ White stains were tested to determine the cause Paint and guano were removed mechanically with a scraper so as not to damage the existing wood finish. ▪ Where required by the level of damage, select areas of woodwork were refinished to match the original.

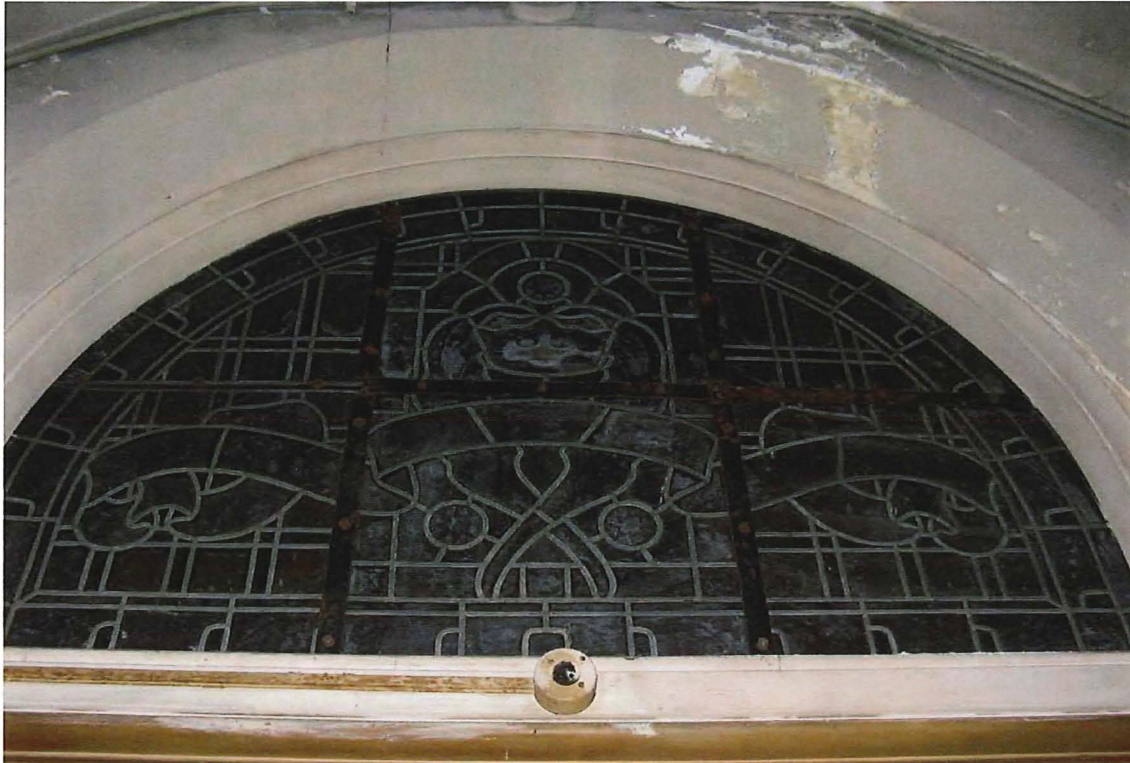
Figure 42a. North-east transept portal, showing blocked figurative stained glass window with heavy soiling and corrosion of steel frame

Scope: # 5			
Building Feature: Exterior _ Stained Glass Windows			
Rehab/Restoration	<input checked="" type="checkbox"/>	Maintenance	Completed <input checked="" type="checkbox"/> Proposed
Contract year work completion: 2018			
Total Cost: \$81,260.00 Source SOV #8070			
Description of work: Repair and Restoration of Stained Glass Windows			
<ul style="list-style-type: none"> ▪ Documentation and restoration of the windows was performed by a professional conservator. Restoration included removal, transport, restoration, and reinstallation of the stained glass. ▪ The wood and steel armatures remaining from the previous stained glass window installation were prepared and painted. ▪ The remaining stained glass in the south wall of the kitchen was removed, salvaged, and reinstalled in the office on the first floor.

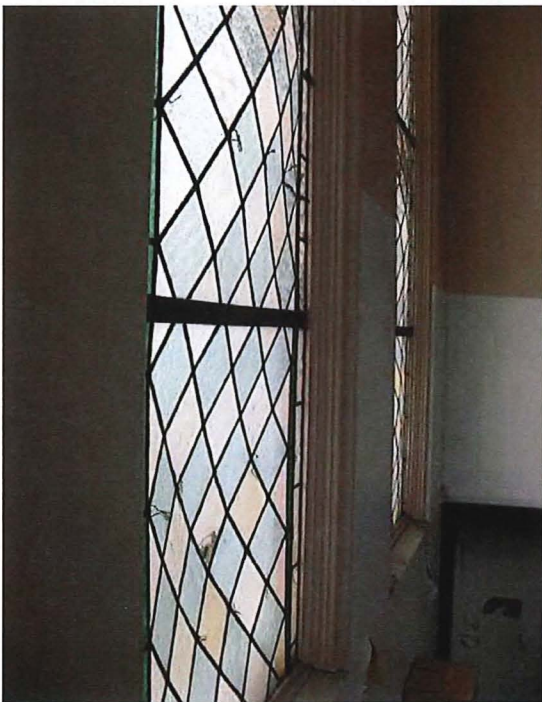
Figure 42 b. East tower, east windows, showing bowing of windows due to sagging lead comes or detachment from saddle bars.
