SAN FRANCISCO PLANNING DEPARTMENT

PRE-APPROVAL INSPECTION REPORT

Report Date: May 24, 2019
Inspection Date: May 22, 2019; 11:00am
Filing Date: May 1, 2018
Case No.: 2019-006384MLS
Project Address: 1401 Howard Street
Block/Lot: 3517/035
Eligibility Article 10 Landmark No. 120: Saint Joseph's Church
National Register listed property
Zoning: RCD – Regional Commercial District
Height & Bulk: 40-X
Supervisor District: District 6 (Matt Haney)
Project Sponsor: Christopher Foley of 1401 Howard LLC
Address: 1401 Howard Street
San Francisco, CA 94103
415-305-4600
cfoley@groundmatrix.com
Staff Contact: Michelle Taylor – (415) 575-9197
michelle.taylor@sfgov.org
Reviewed By: Tim Frye – (415) 575-6822
tim.frye@sfgov.org

**MILLS ACT APPLICATION
1401 HOWARD STREET
SAN FRANCISCO, CALIFORNIA**

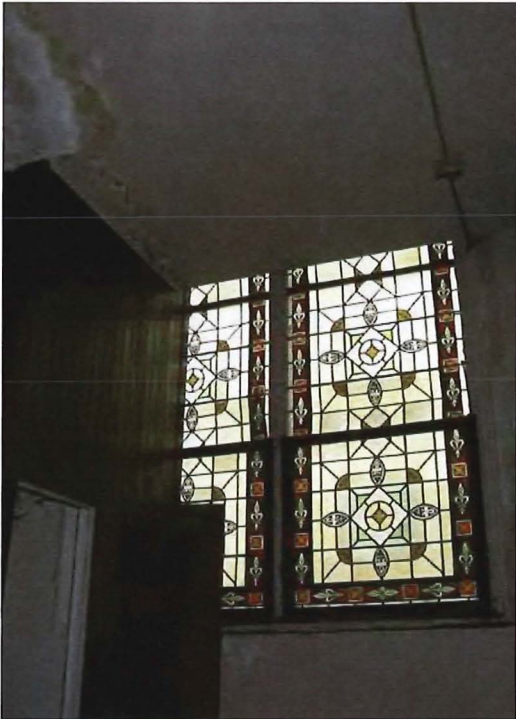
Figure 42d. Kitchen window, showing partition partially covering painted stained glass.

Scope: # 5			
Building Feature: Exterior _ Stained Glass Windows			
Rehab/Restoration	<input checked="" type="checkbox"/>	Maintenance	Completed <input checked="" type="checkbox"/> Proposed
Contract year work completion: 2018			
Total Cost: \$81,260.00 Source SOV #8070			
Description of work: Repair and Restoration of Stained Glass Windows			
<ul style="list-style-type: none"> ▪ Documentation and restoration of the windows was performed by a professional conservator. Restoration included removal, transport, restoration, and reinstallation of the stained glass. ▪ The wood and steel armatures remaining from the previous stained glass window installation were prepared and painted. ▪ The remaining stained glass in the south wall of the kitchen was removed, salvaged, and reinstalled in the office on the first floor.

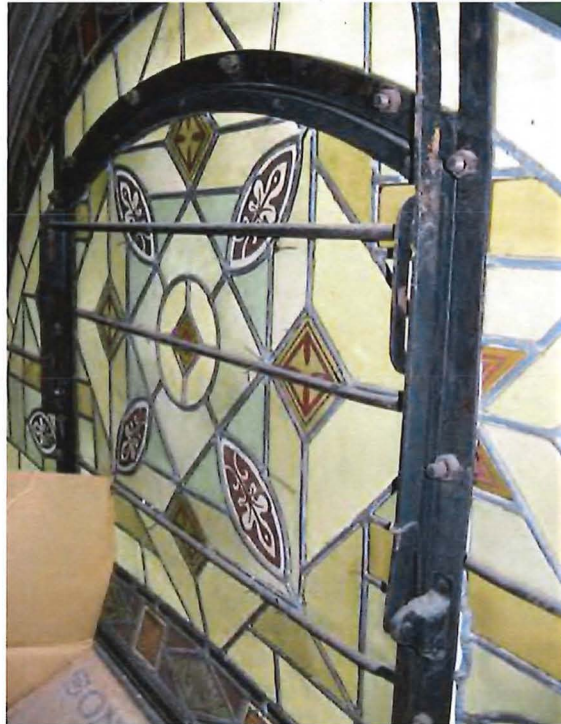
Figure 42 e. Upper portion of window showing corroded hopper-type opening assembly.
