## FIRST AMENDMENT TO LEASE NO. L-16274

# RAPID STRUCTURAL ASSESSMENT REPORT

We are pleased to submit this report summarizing the findings and recommendations of our Rapid Structural Assessment of Pier 33 in San Francisco, California.

Subject: Permit No. B 2018-0121  
Pier 31.5 Substructure Repair, San Francisco

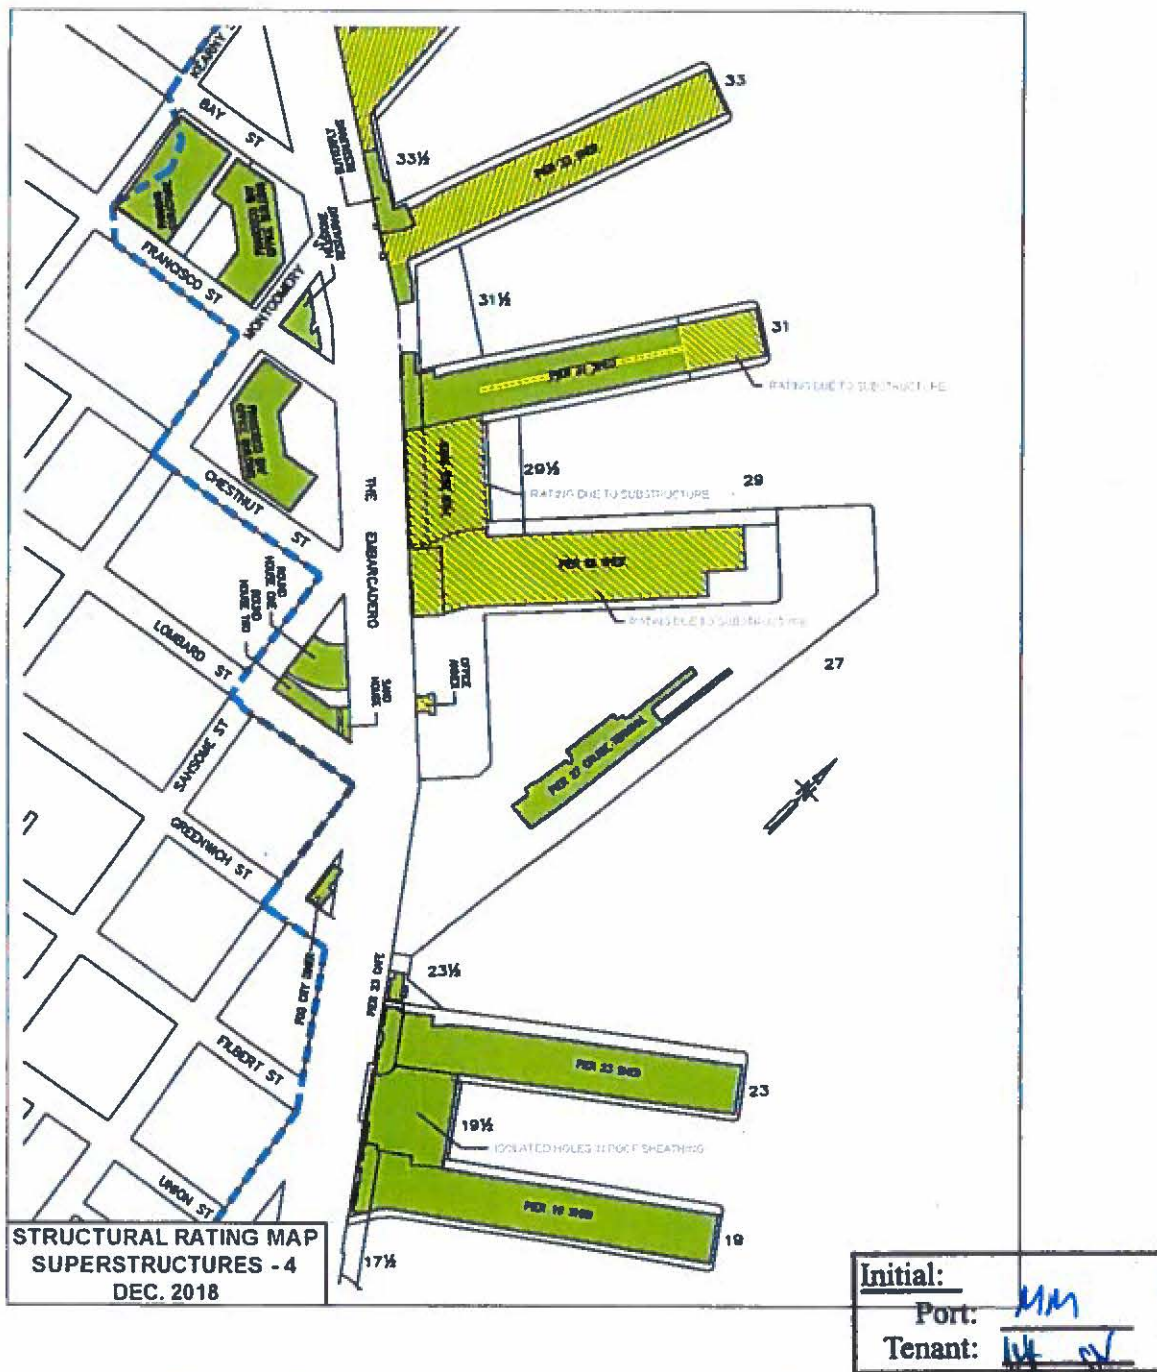
Photo 1. Superstructure rating map updated for Pier 33

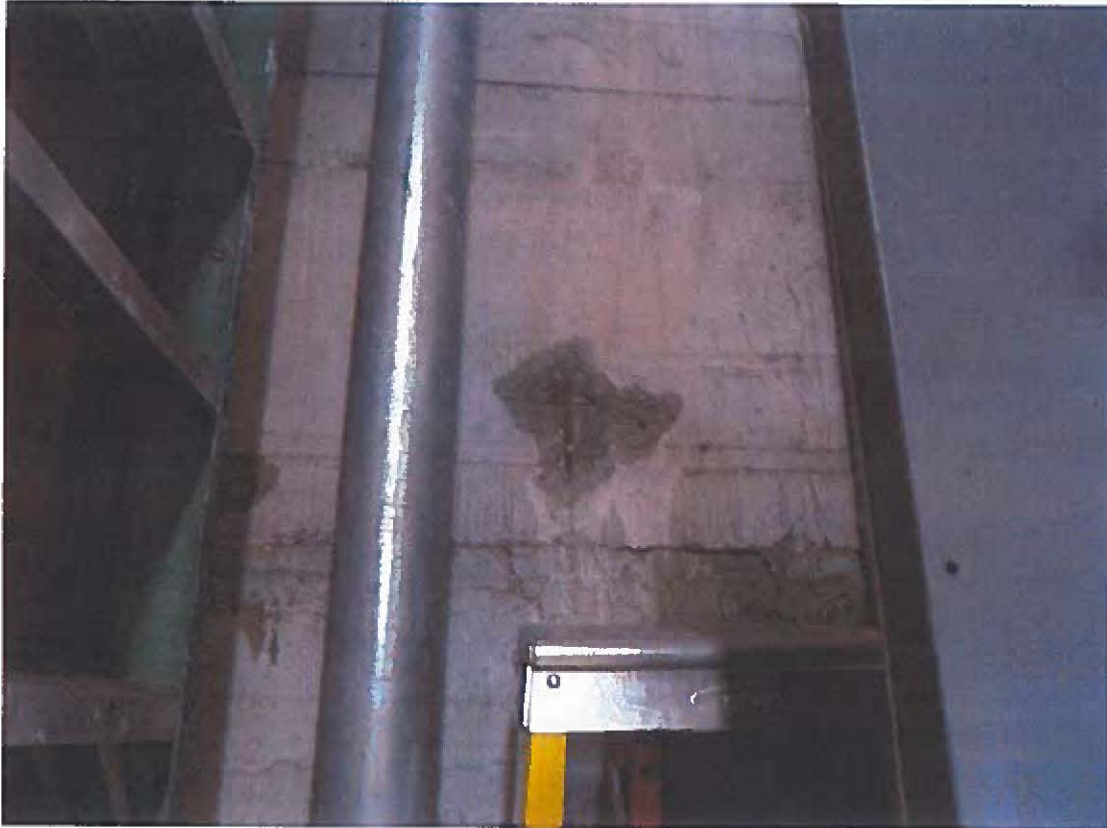
Figure 14 - Spalling at interior face of concrete wall

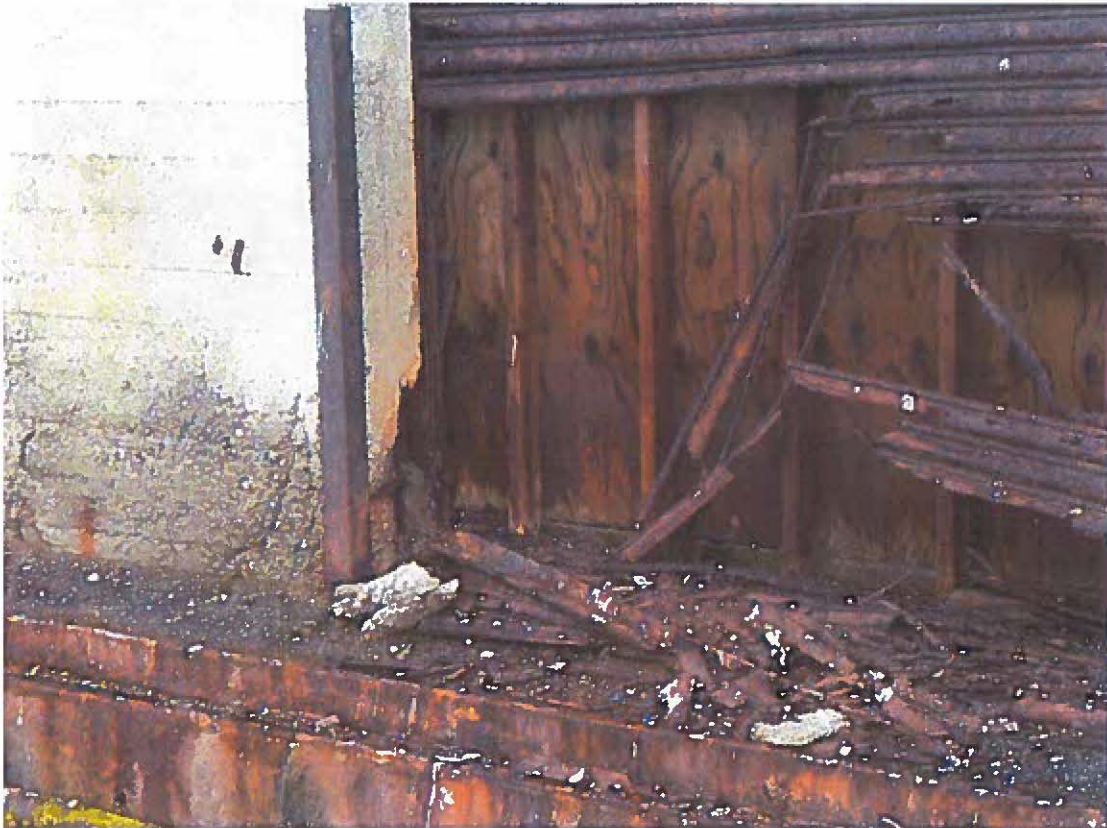
Figure 20 - Corrosion, spalling, and water intrusion at bay door along north apron.

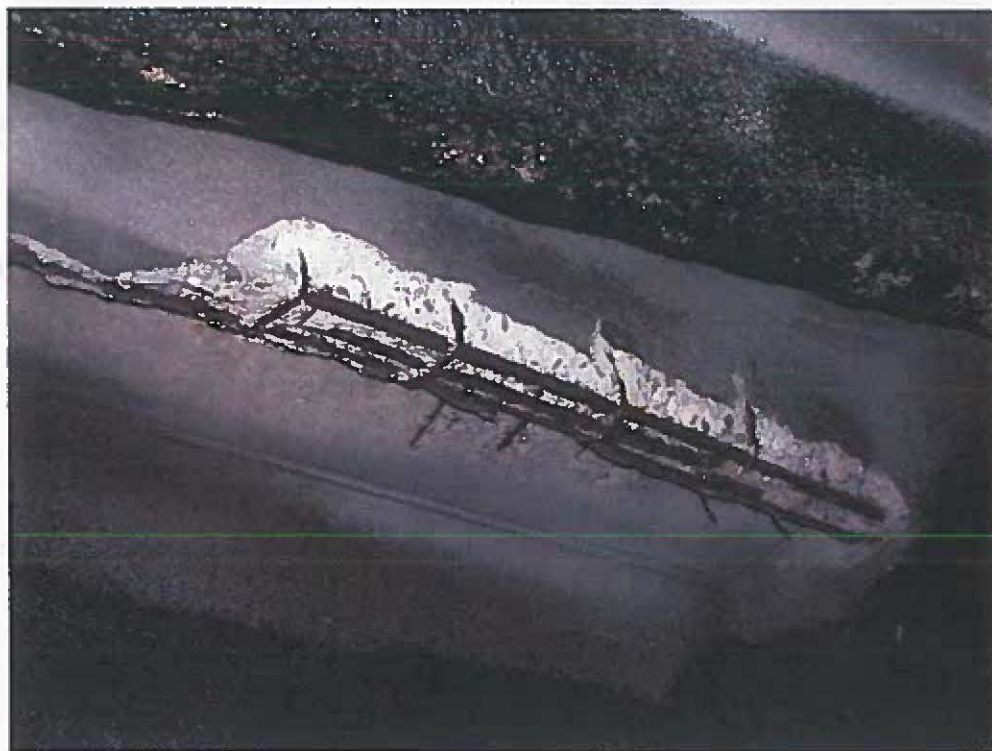
During the inspection it was noticed that a single beam has a severe spall between Bents 7-8, Row B. The beam was not marked to be repaired in the design drawings and no change order request were issued to repair the beam. It is unlikely that this extent of damage was missed during the inspection and construction. Thus, it is possible that the spall is new. See Figure 1 and 2 for photo of unrepaired concrete beam and the location of the beam.

The beam is an intermediate redundant old railway support beam. The railway support beams are typically spaced at 2-4ft on center. Without the railway loads, the slab can span a typical slab width of at least 8ft as shown by previous truck load calculations. Thus, the slab can span over the intermediate railway support beam and the beam is deemed redundant. It is recommended that the beam be repaired with a patch repair to prevent further deterioration but the need to replace rebar is not required. This is consistent with repair recommendation shown on S2 with note NRR (no rebar repair required) for railway support beams. Other repair methods are likely to be very expensive as there is no longer scaffolding or easy access to this area.

Figure 1 - Picture of Unrepaired Concrete Beam (Taken 5/14/19)

There is a single beam that has severe spalling. It is plausible that the damage occurred after that section of pier was repaired. See Section 3.2.1 for additional information. It is recommended that the beam be repaired with a patch repair.

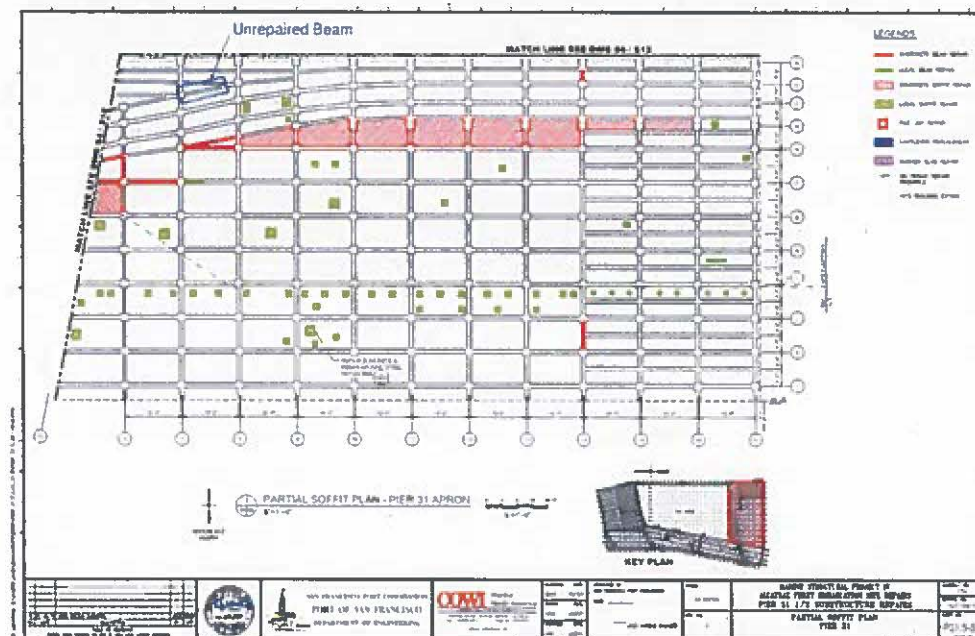
Figure 2 - Location of Unrepaired Beam, Pier 31 Bent 7-8, Row B.

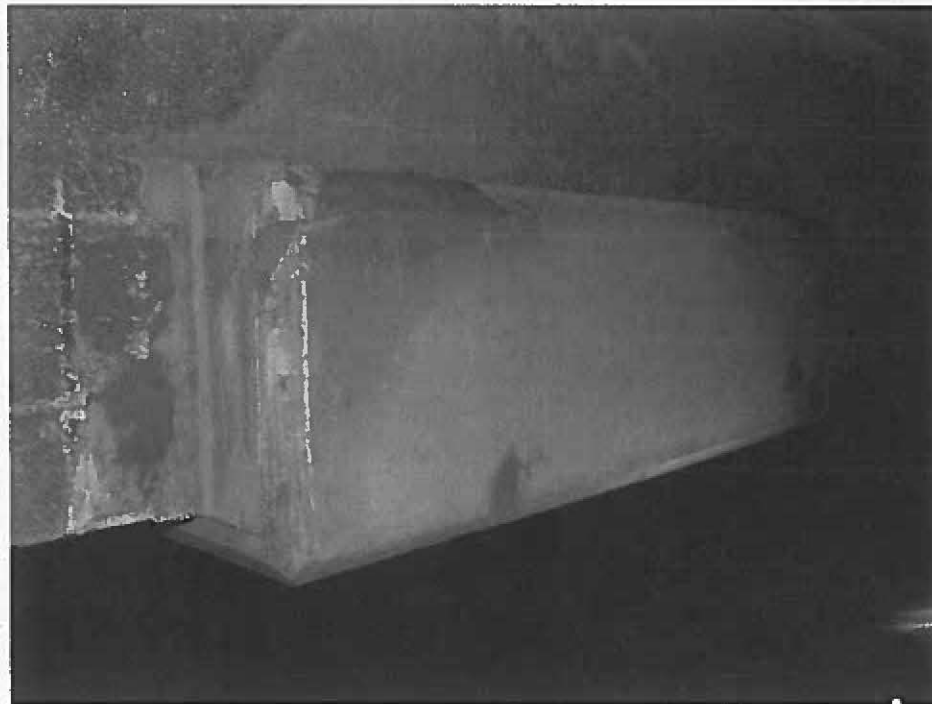
- ✓ Chamfered edges as noted in general notes
- ✓ Approximate adequate cover
- ✓ No noticed damage, rust straining, or cracks
- ✓ General conformance with design details

Figure 6 - Typical Cast in Place Beam Repair (5/14/2019)

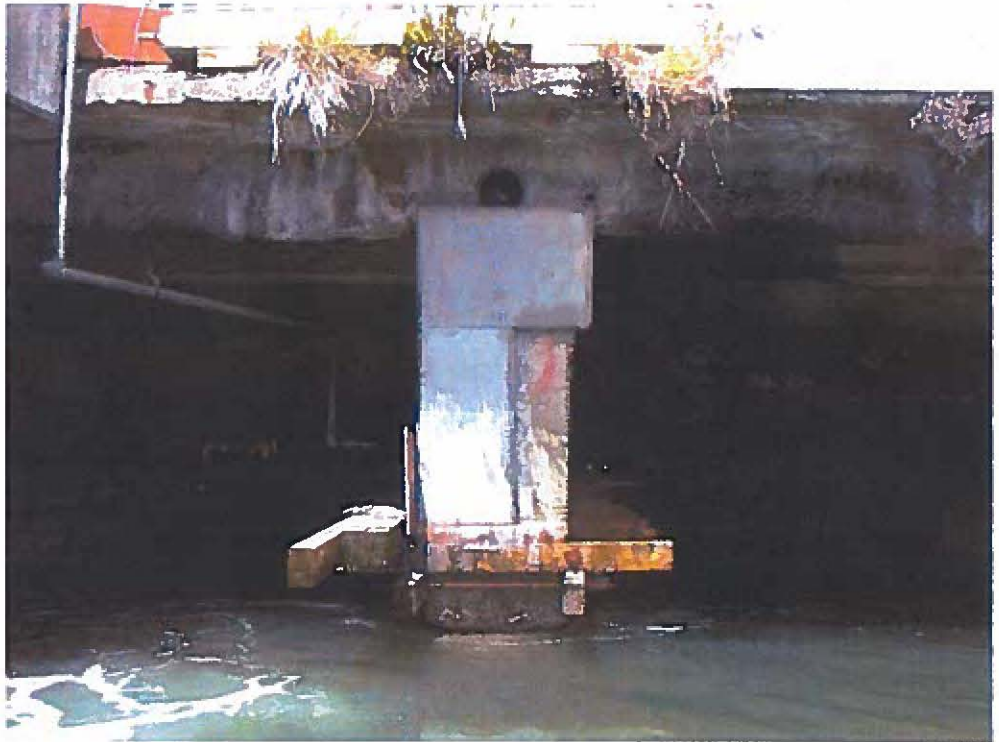
The contractor chose the alternative option to form and pour the pile cap repairs. The form and pour details are outlined in the details in Figure 13 and Figure 14. Photos of repairs are shown in Figure 15 and Figure 16. The drawing shows shotcrete repair; the form and pour repair method was not drawn but outlined in notes. The pile cap repair is in accordance with design drawings.

- ✓ Chamfered Edges
- ✗ Cover looks to be adequate
- ✗ General conformance with design drawings
- ✓ No damage or rust staining

Figure 16 - Large Pile Cap Repair

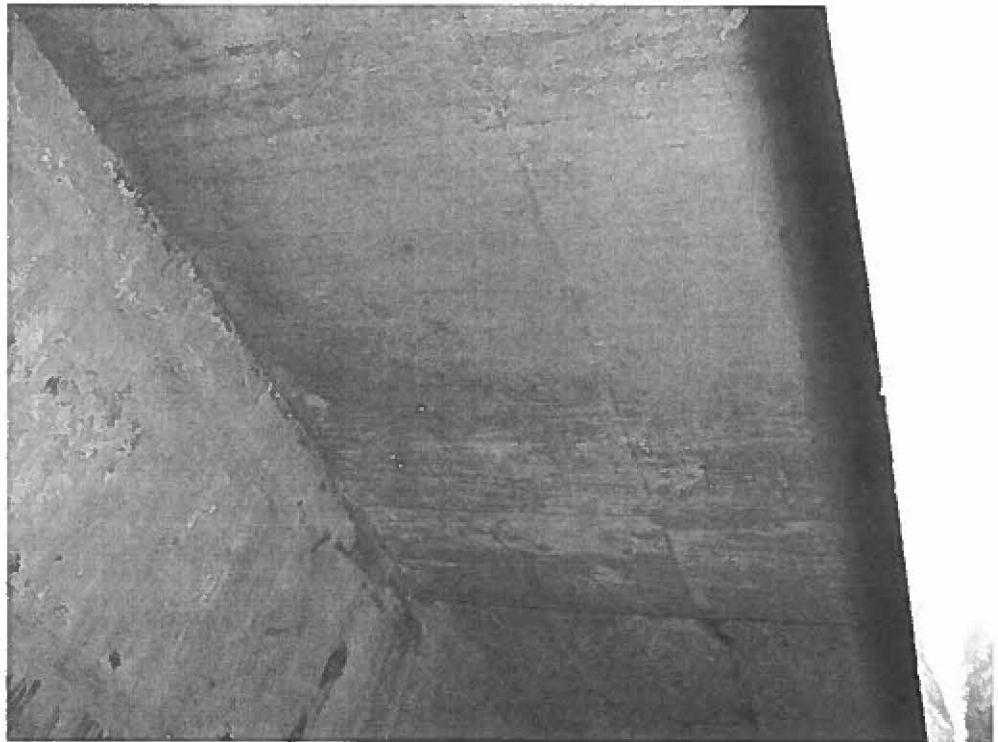
The access hole replacement slab and the top sunken slab replacement were in conformance with the design details. See detail and photos in Figure 17, Figure 18, and Figure 19.

*Figure 19 - Sunken Slab Opening Replacement Slab*

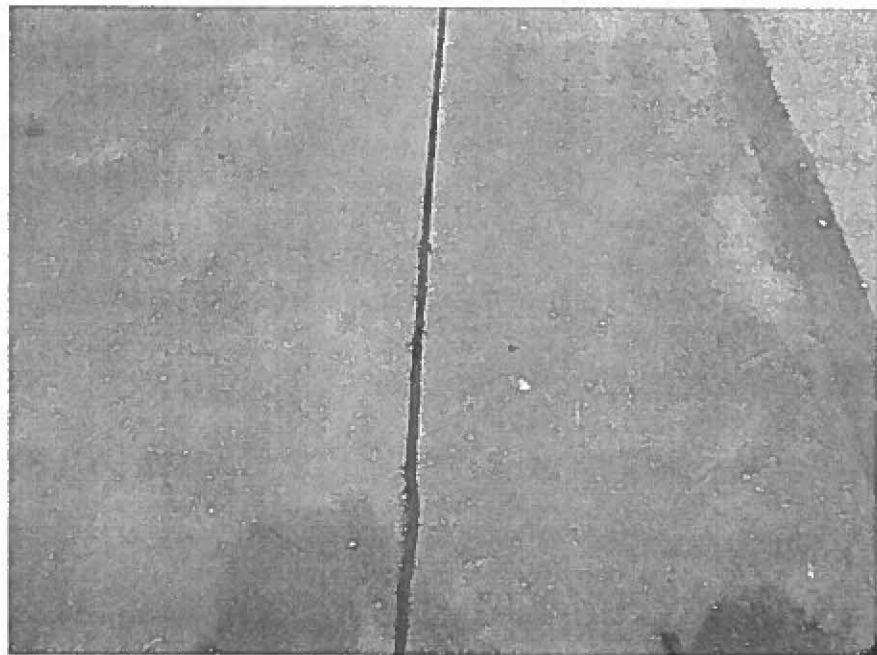
The Asphalt and expansion joint look to be in accordance with design drawings. The detail and typical repair photo is shown in Figure 20 and Figure 21.

- ✓ Elastomeric Sealant
- ✓ Asphalt graded to match existing
- ✓ No tripping hazards

Figure 21 - Cantilever Repair and Asphalt Replacement (5/14/19)

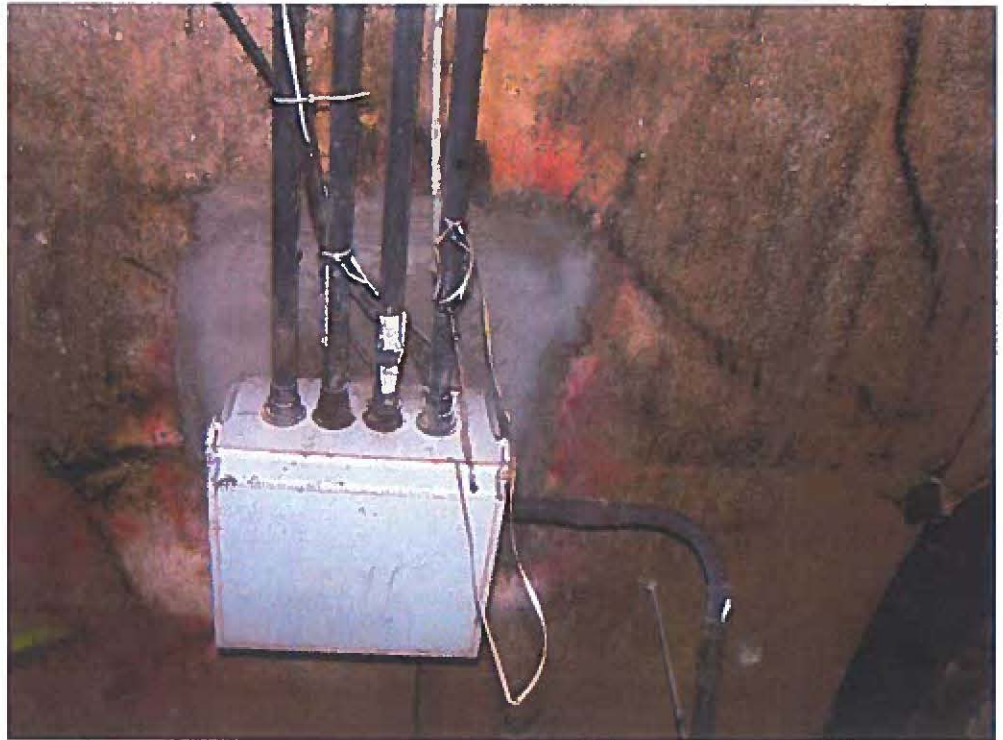
The electrical box repair is in conformance with the design drawings/notes as shown in Figure 24 and Figure 25.

- ✓ Patch around equipment
- ✓ Equipment looks undamaged
- ✓ Patch follows general requirements of patch repair
- ✓ No rust staining, damage, or significant cracking

Figure 25 - Electrical Box Repair Photo (5/14/19)

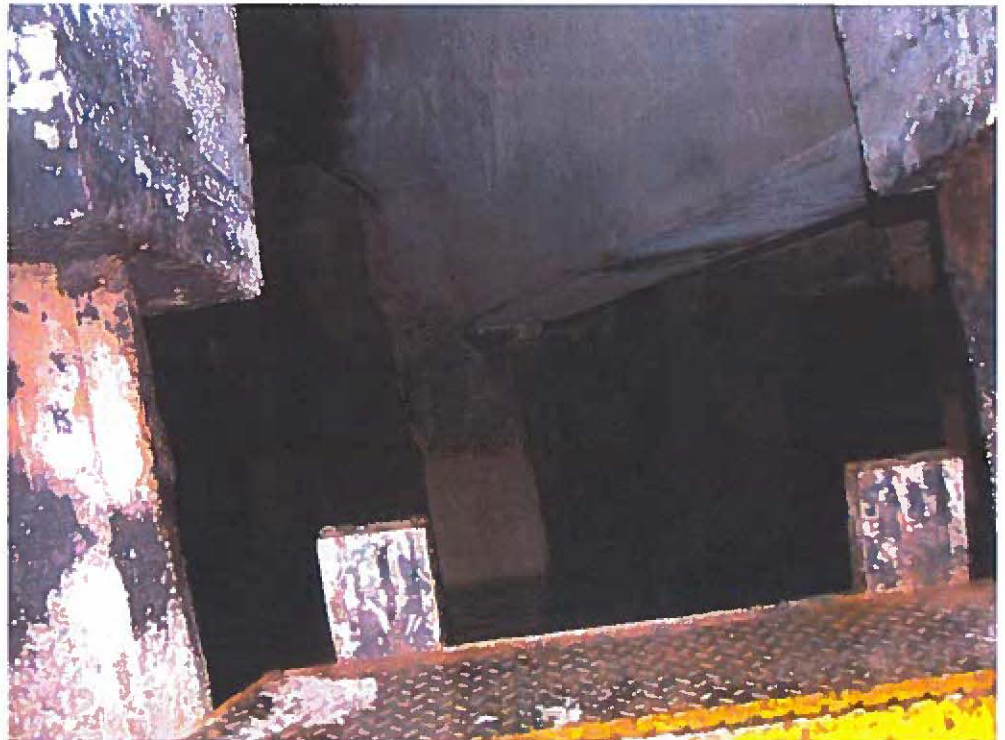
The sunken slab repair is in conformance with the design drawings. The detail and photos are shown in Figure 26, Figure 27, and Figure 28.

- ✓ Form lower section and shotcrete upper section
- ✓ Chamfer Corners
- ✓ No visible rust staining or significant cracking

Figure 27 - Sunken Slab on Pier 31.5 (5/15/19)
