APPLICATION FOR Mills Act Historical Property Contract

Photos: 627 Waller Street

627 WALLER STREET
FOCUSED HSR FOR MILLS ACT APPLICATION

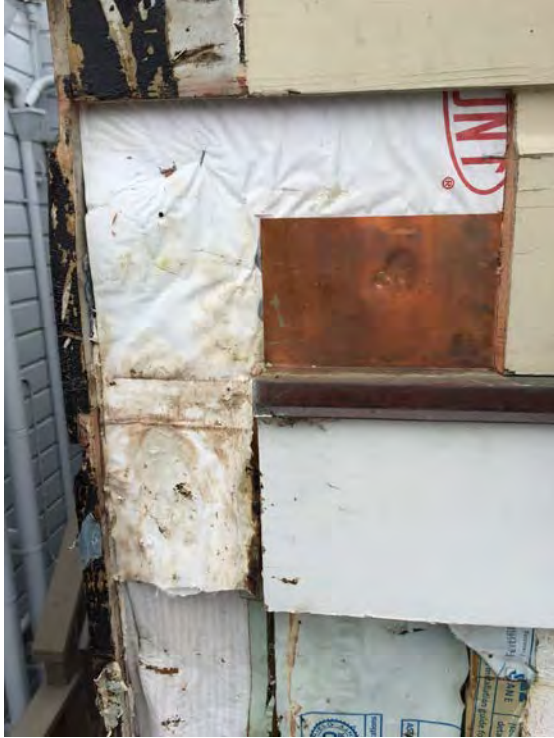
Scope 1: Rear of house

Photo A: Prior condition. Deteriorated sealing.

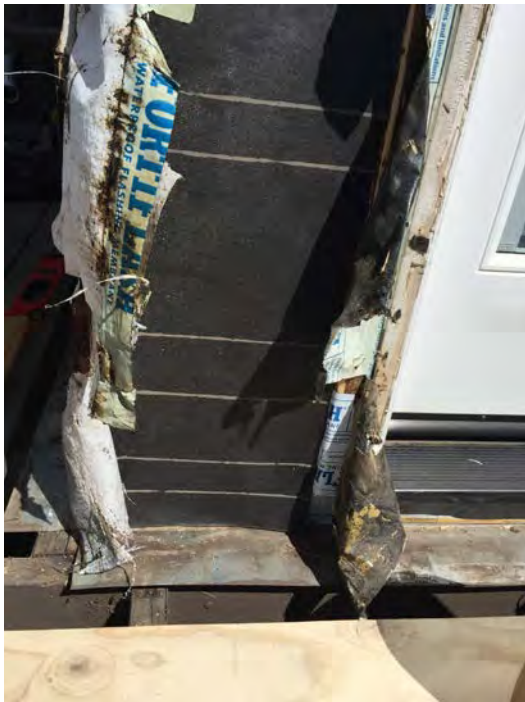
Photo B: New tar paper

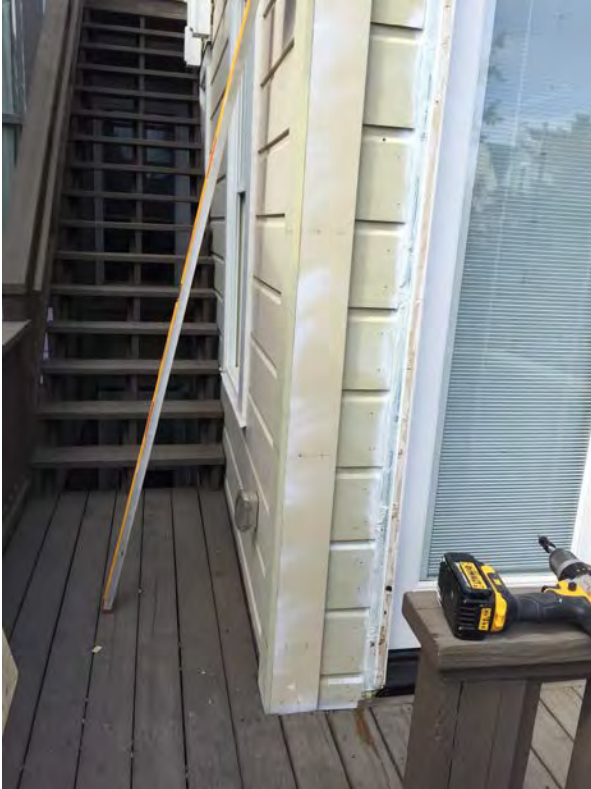
Photo C: Replaced siding, prior to painting

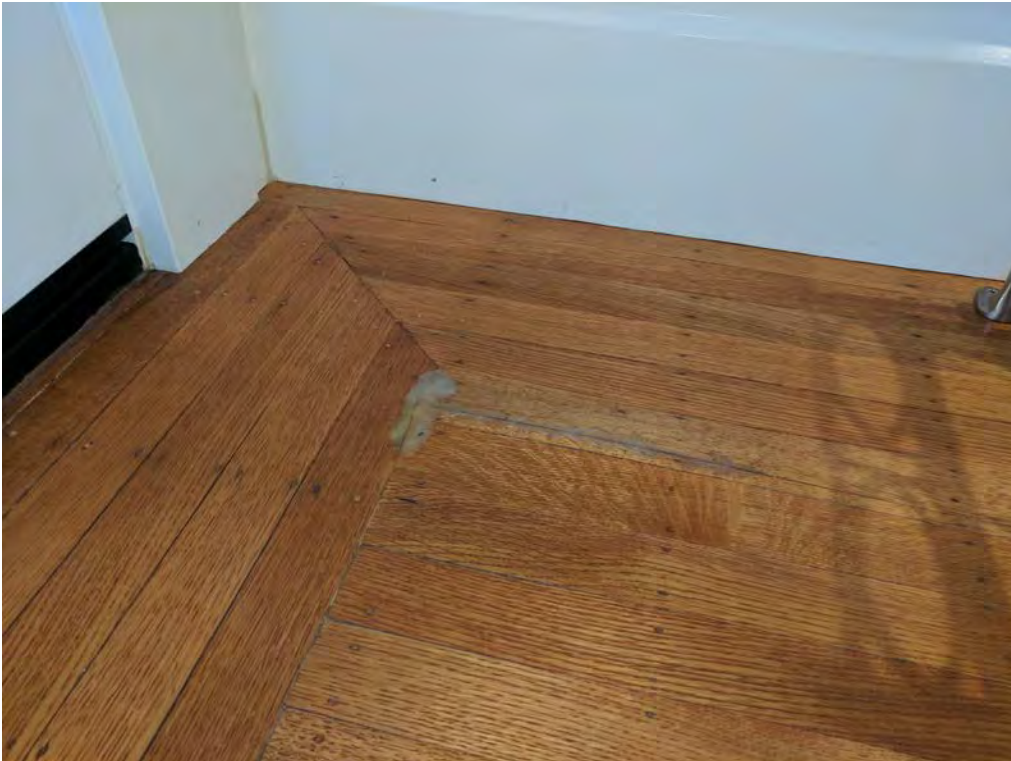
Scope 2: Rear of House

Photo A: Bedroom floor warping (sealed with wax)

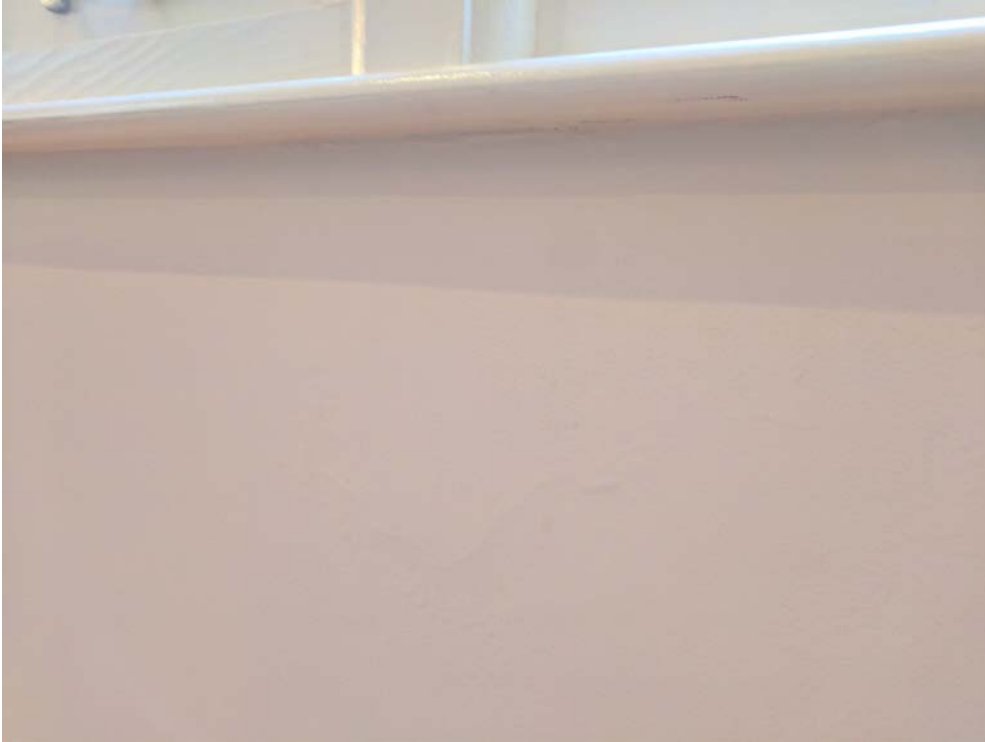
Photo B: Water damage adjacent to 2F kitchen

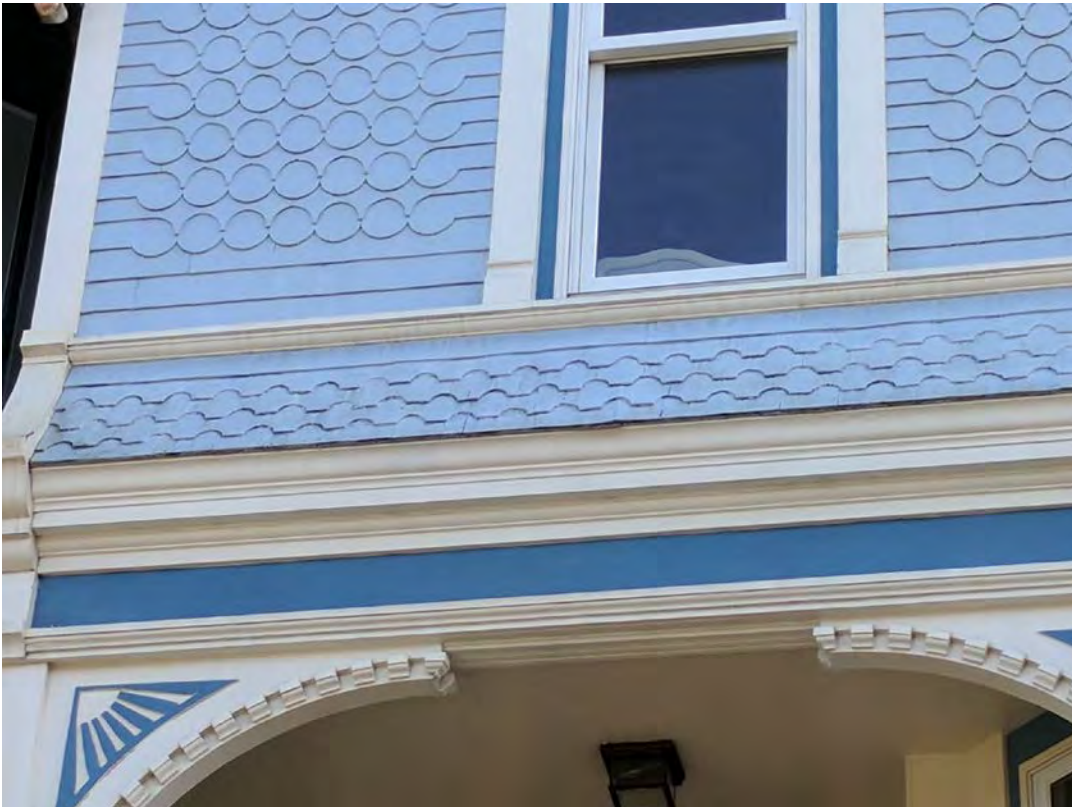
Scope 7: Repainting front façade, side and rear elevations

Cracked shingles to left of window near circular details:

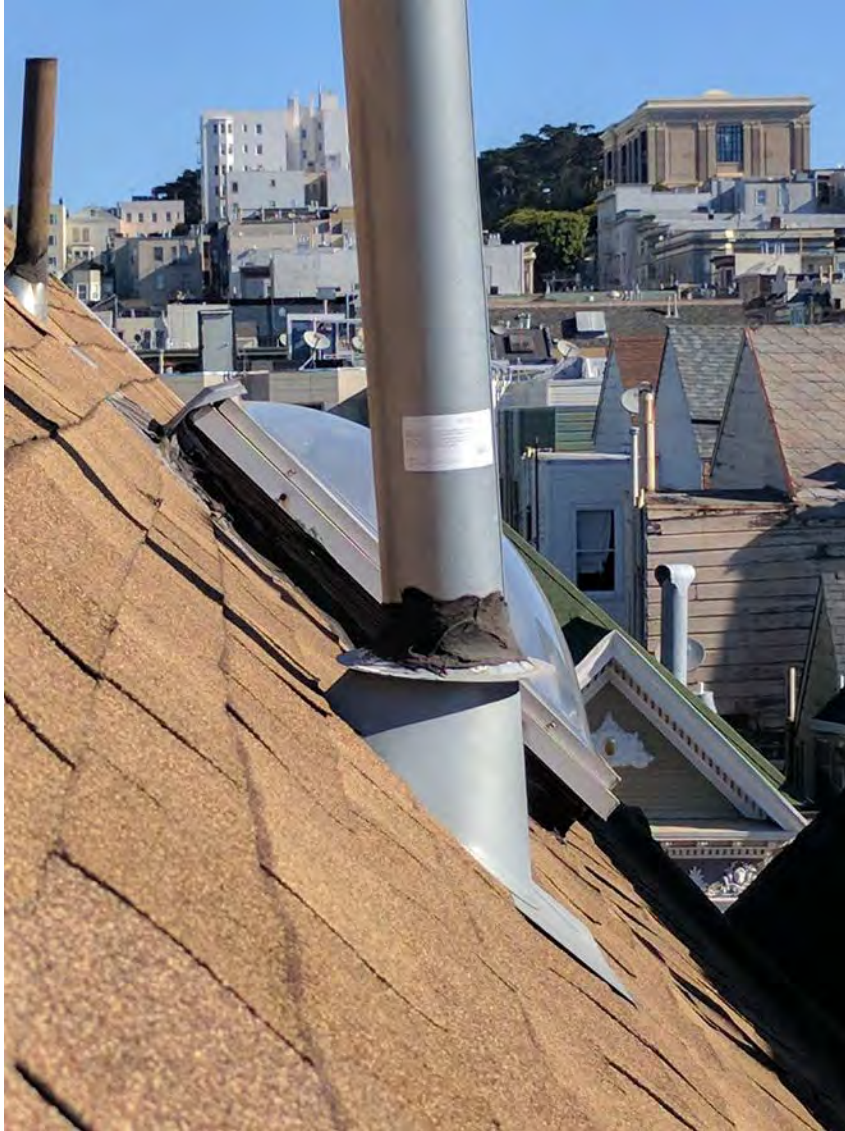
Scope 4: Replace skylight

Skylight Condition: Fair/Poor. The east acrylic lite is cracked. The wood trim at the curb is weathered, checked with raised grain. Mastic waterproofing is applied at the curb to roof interface.

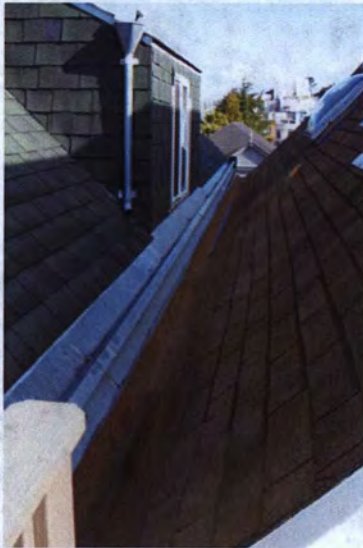
Gutter Condition: Good. Some minor ponding of water due to lack of slope is present at the west gutter (**Figure 13**). The east gutter profile is undersized, likely resulting in water overflowing the gutter edge during a heavy rain storm. Water that overflows will spill onto the adjacent property roof where the gutter and downspout may not be capable of handling the increased runoff (**Figure 14**). Leader heads at both east and west downspouts are missing a debris strainer.

Figure 13: West roof gutter. Note water ponding locations

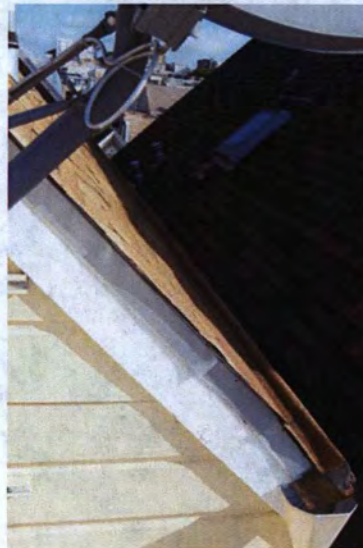
Figure 14: East roof gutter.

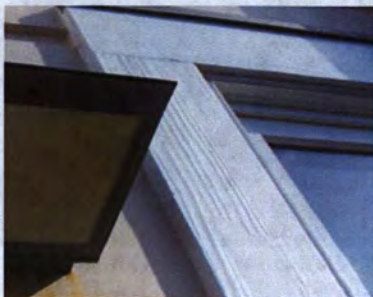
Wood Trim and Sill Condition: Good to Fair. Some raised grain and paint failure is present (**Figure 19**). Organic growth was observed at one rear west façade window (**Figure 20**).

Figure 19: Raised grain at trim

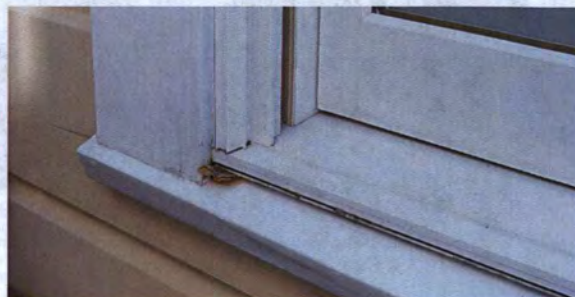
Figure 20: Fungi growing at sill
