MILLS ACT HISTORICAL PROPERTY CONTRACT

1035 Howard Street

Re: Update to 1035 Howard Street Maintenance Plan Update [24256]

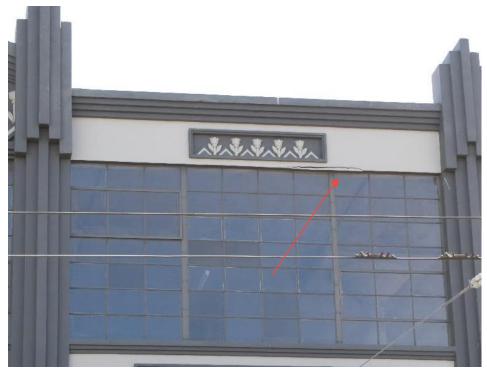
Location	Condition in 2018	Condition in 2024
Exterior North Facade	Not extant in report.	Incipient spall at the window head at the fourth bay from the east end on the third floor (Figure 1).
	Not extant in report.	Horizontal crack below the second-floor window at the fourth bay from the east end (Figure 2).
	"Figure 16. Chip on the tile column base at north façade." (page 11)	Chip no longer visible and has been painted over (Figure 3).
Exterior West Elevation, Decorative First Five Bays	"Figure 19. Holes in the base tile at Russ Street Façade" (page 13)	These tiles below the windows at the base have been removed from the west façade on the first and second bays from the north end. This area has been infilled with concrete (Figure 4).
	"Figure 21. Tile column base that has been replaced by stucco in the same shape." (page 14)	The stucco at this column base has delaminated and detached (Figure 5).

Figure 1: Incipient spall at the window head at the fourth bay from the east on the third floor. (Page & Turnbull, 2024)

At the Howard Street (north) façade, repair the incipient spall at the third floor window head in the fourth bay from the east end (**Figure 1**). In the photos from the 2018 report, this spall nor a crack were extant. This is a potential fall hazard and should be addressed promptly.

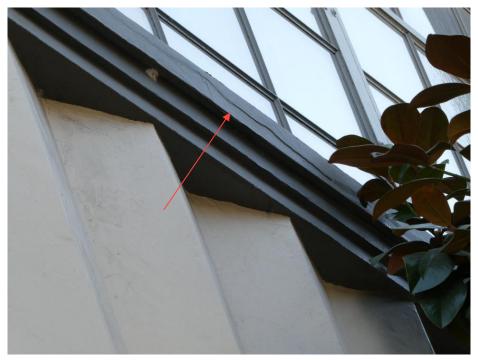
Figure 2: Horizontal crack below the second-floor window at the fourth bay from the east, has since been painted over. (Page & Turnbull, 2024)

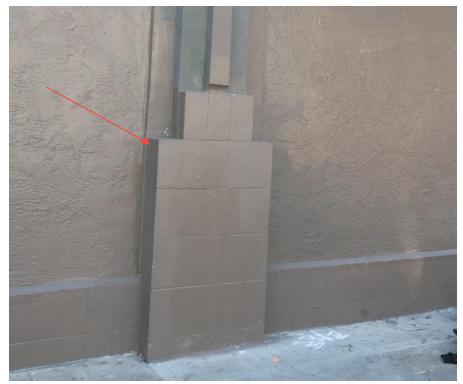
Figure 3: Chip no longer visible and has been painted over. (Page & Turnbull, 2024)

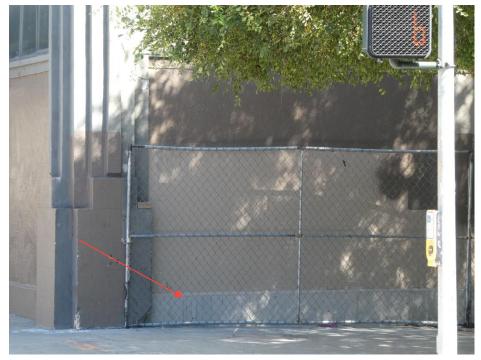
The terra cotta tiles that were located between the piers at the base of the infilled stucco walls have been removed from the first and second bays from the north end since 2018 (**Figure 4**). The areas where the tiles are no longer extant have been infilled with new concrete. It is recommended that inkind replacement tiles be installed where the historic terra cotta tiles were removed.

Figure 4: These tiles at the base have been removed from the west façade on the first and second bays from the north. These two areas have been infilled with concrete. (Page & Turnbull, 2024)

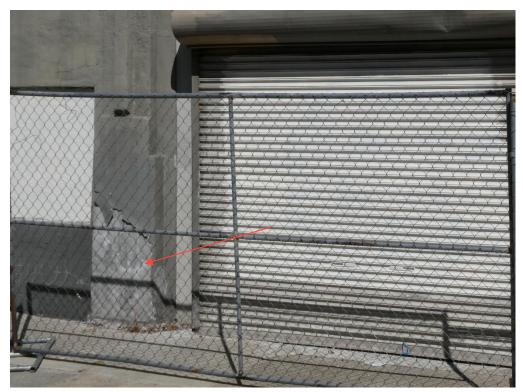
Figure 5: The stucco at this column base has delaminated and detached. (Page & Turnbull, 2024)

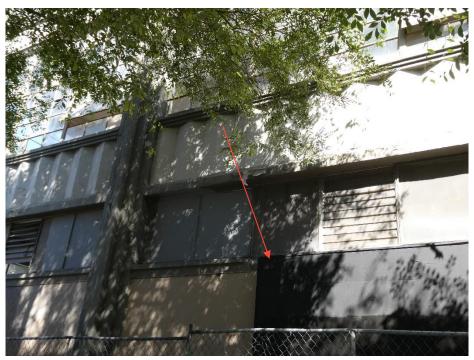
"Figure 24. The transoms at the second bay from the north end of the west façade has a large spall at its sill." (page 15)	The condition of this sill could not be confirmed as it is blocked by plywood (Figure 6).
	"25% of the lights are painted, opaque, missing, or fiberglass." (page 19)	It appears that there are more broken, cracked, or missing glass panes than demonstrated in the 2018 report (Figure 7 & Figure 8).
	"Figure 36. The head of the door at the north end of the western façade" (page 19)	This door is covered with plywood panel, condition could not be confirmed (Figure 9).
Exterior South Facade	"Figure 47. The distribution of cracks and spalls" (page 24)	The mechanical object attached to the window in this photo is no longer extant (Figure 10).
	"Figure 48. Extensive cracks at the upper west corner"	The pipes and wires in this photo are no longer extant (Figure 11).
	"Figure 50. The extensive spall at the bottom" (page 25)	Vent shown in photo is not extant (Figure 12).

Figure 6: The condition of this sill could not be confirmed as it is blocked by plywood. (Page & Turnbull, 2024)

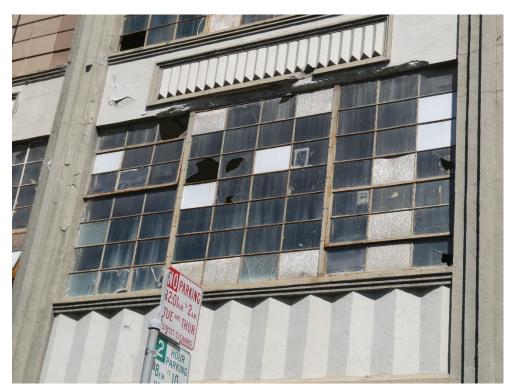
Figure 7: Additional broken and cracked panes at west façade. (Page & Turnbull, 2024)

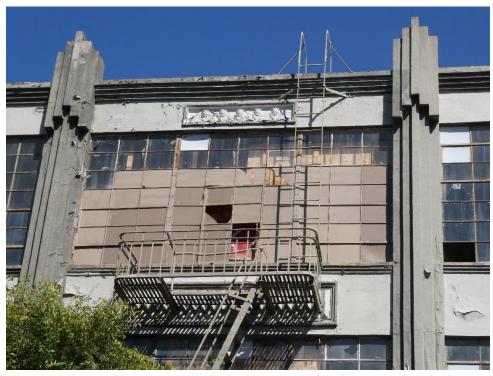
Figure 8: Additional broken and cracked panes at west façade. (Page & Turnbull, 2024)

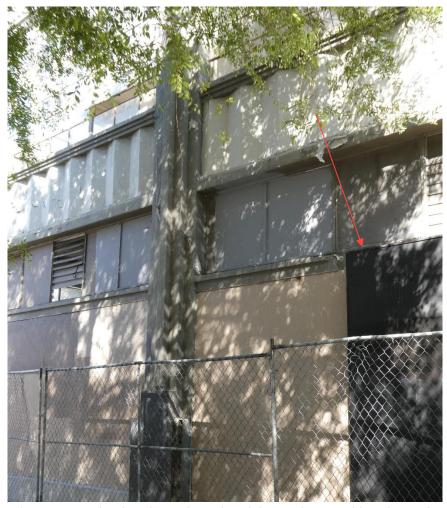
Figure 9: This door is covered with a plywood panel, and the condition could not be confirmed. (Page & Turnbull, 2024)

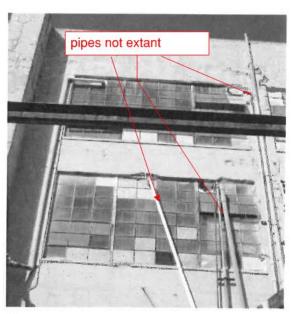
"Figure 51. The second and third floor windows" (page 26)	Pipes shown in photo are not extant (Figure 13).
	"Figure 52. The first and second floor windows" (page 26)	The structure shown in the photo is not extant (Figure 14).
	Not extant in report.	In the areas where the pipes were removed, the concrete substrate was not properly patched and repaired, leading to cracks and spalls in the concrete and exposing some rebar (Figure 15).

Figure 51. The second and third floor windows in the fourth window bay from the west. Knapp Architects photo, 2019.

Figure 13: Pipes shown in photo are not extant. (Knapp Architects, 2018. Edited by Page & Turnbull)

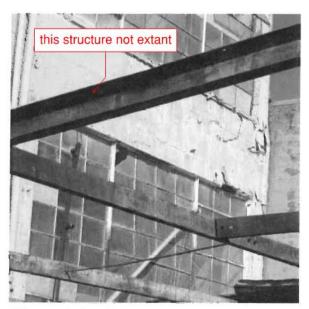
Figure 52. The first and second floor windows in the easternmost bay. Knapp Architects photo, 2019.

Figure 14: The structure shown in the photo is not extant. (Knapp Architects, 2018. Edited by Page & Turnbull)

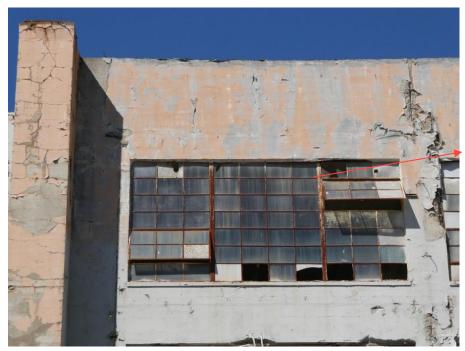
It appears that since 2018, some extraneous pipes and equipment have been removed from the south façade (**Figure 11**, **Figure 12**, & Figure 15: In the areas where the pipes were removed, the substrate was not properly patched and repaired, leading to cracks and spalls in the concrete and some exposed rebar. **Figure 15**). The concrete substrate at these areas were not repaired or patched when the equipment was removed. This has led to additional deterioration, spalling, cracking, rust jacking, and paint failure. It is recommended that these areas be patched and repaired to prevent further deterioration.

Figure 15: In the areas where the pipes were removed, the substrate was not properly patched and repaired, leading to cracks and spalls in the concrete and some exposed rebar. (Page & Turnbull, 2024)

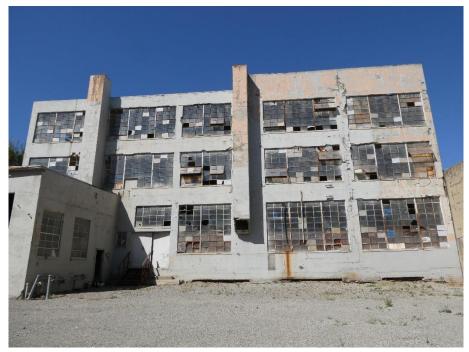
"Parts of two windows are not completely	All windows are now visible as the structure
	visible from grade" (page 27)	abutting the south façade has since been
		demolished (Figure 16).
	"The windows of this façade are in	It appears that there are more broken, cracked,
	generally good condition." (page 27)	and missing window panes than is demonstrated
		in the 2018 report (Figure 17).
Roof	"Figure 60. Typical view of roofing	This area of flashing has now detached from the
	terminated by counter-flashing at the	parapet (Figure 18).
	bottom of the parapet." (page 29)	
	Not extant in report.	The drains appear to be partially or completely
		blocked with debris. It is unclear if any of the
		drains are functioning properly (Figure 19).
Interior, First Floor	"Figure 73. Visible leak damage and spalling	This leak and associated damage at the transom
	at concrete window sill of 1st floor front	have been partially repaired and/or repainted.

Figure 16: All windows are now visible, as the structure abutting the south façade has since been demolished.

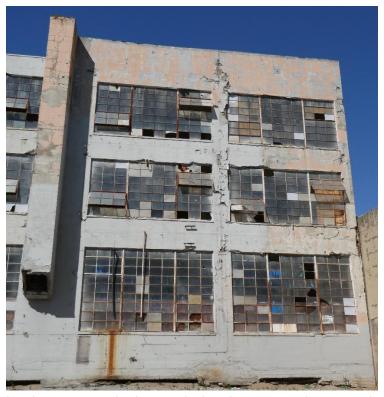
Figure 17: It appears that there are more broken, cracked, and missing window panes than is demonstrated in the 2018 report. (Page & Turnbull, 2024)

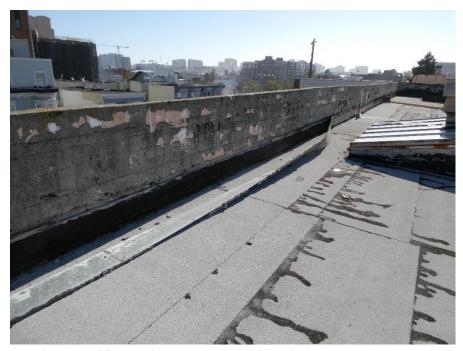
Figure 18: This area of flashing has now detached from the parapet. (Page & Turnbull, 2024)

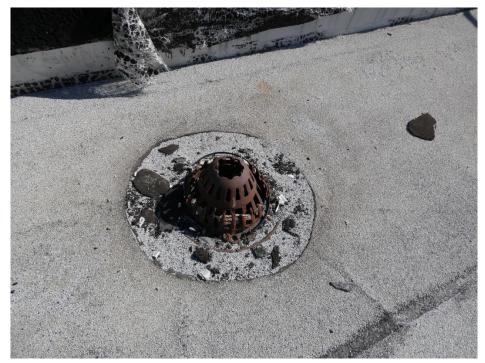
Figure 19: The drains appear to be partially or completely blocked with debris. It is unclear if any of the drains are functioning properly. (Page & Turnbull, 2024)

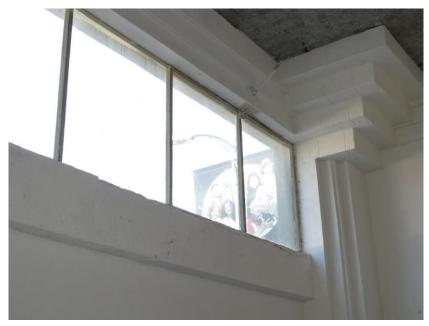
It appears that the leakage at the interior of the transom windows on the east end of the north façade and has been partially completed(Figure 20). This area still exhibits some damage that has been painted over. There are also areas of new paint failure. It is unclear if the source of the water intrusion has been fixed. It is recommended that this area be investigated further to ensure that there is no active water intrusion. Once it is confirmed there are no active leaks, the substrate should be properly prepped, primed, and painted to match the surrounding area.

Figure 20: This leak and associated damage at the transom have been partially repaired and/or repainted. The area still exhibits damage and has areas of new paint failure. It is unclear if the source of the water intrusion has been fixed. (Page & Turnbull, 2024)

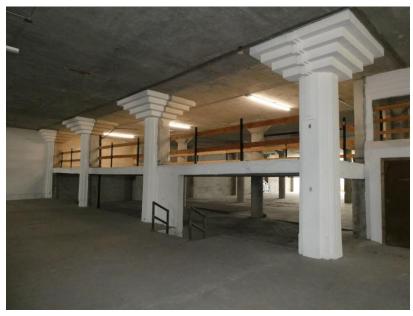
The interior windows in the office area have been removed and salvaged when the interior partition walls were demolished (since the 2018 report). The salvaged windows are stored against the east wall on the first floor (**Figure 21** & **Figure 22**).

Figure 21: Partition walls, interior windows, and furnishings have been demolished or removed. (Page & Turnbull, 2024)

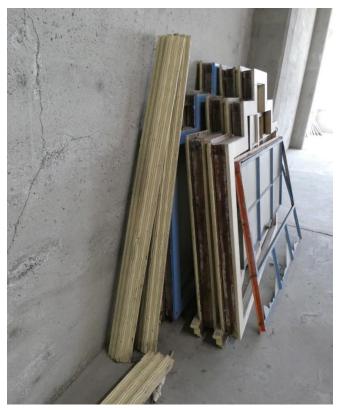
Figure 22: Salvaged wooden window sashes/frames, one metal window, and decorative wavy trim leaning against the east wall first floor. (Page & Turnbull, 2024)
