# MILLS ACT HISTORICAL PROPERTY CONTRACT

## SUPPLEMENTAL APPLICATION

Project Address: 1035 Howard Street

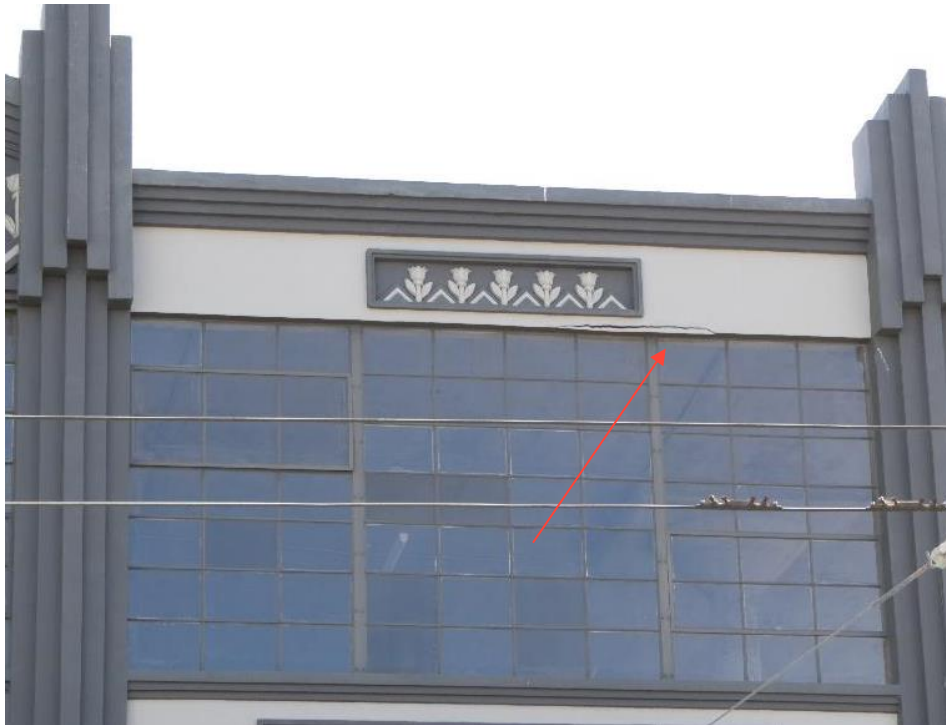
| Location | Condition in 2018 | Condition in 2024 |
|---|---|---|
| <i>Exterior North Facade</i> | Not extant in report. | Incipient spall at the window head at the fourth bay from the east end on the third floor ( <b>Figure 1</b> ). |

Figure 1: Incipient spall at the window head at the fourth bay from the east on the third floor. (Page & Turnbull, 2024)

At the Howard Street (north) façade, repair the incipient spall at the third floor window head in the fourth bay from the east end (**Figure 1**). In the photos from the 2018 report, this spall nor a crack were extant. This is a potential fall hazard and should be addressed promptly.

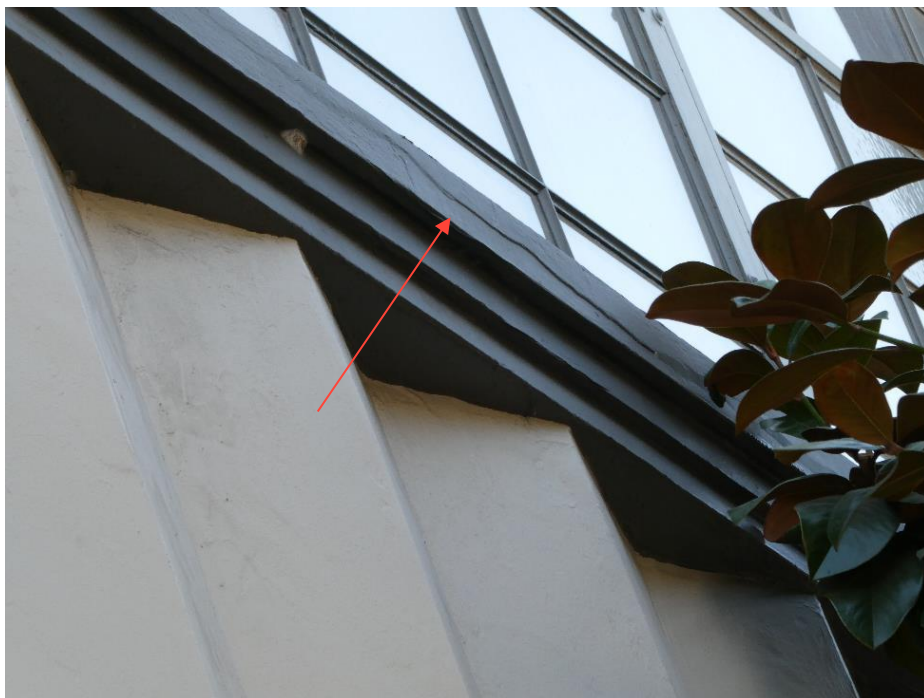
| Location | Condition in 2018 | Condition in 2024 |
|---|---|---|
| | Not extant in report. | Horizontal crack below the second-floor window at the fourth bay from the east end ( <b>Figure 2</b> ). |

Figure 2: Horizontal crack below the second-floor window at the fourth bay from the east, has since been painted over. (Page & Turnbull, 2024)

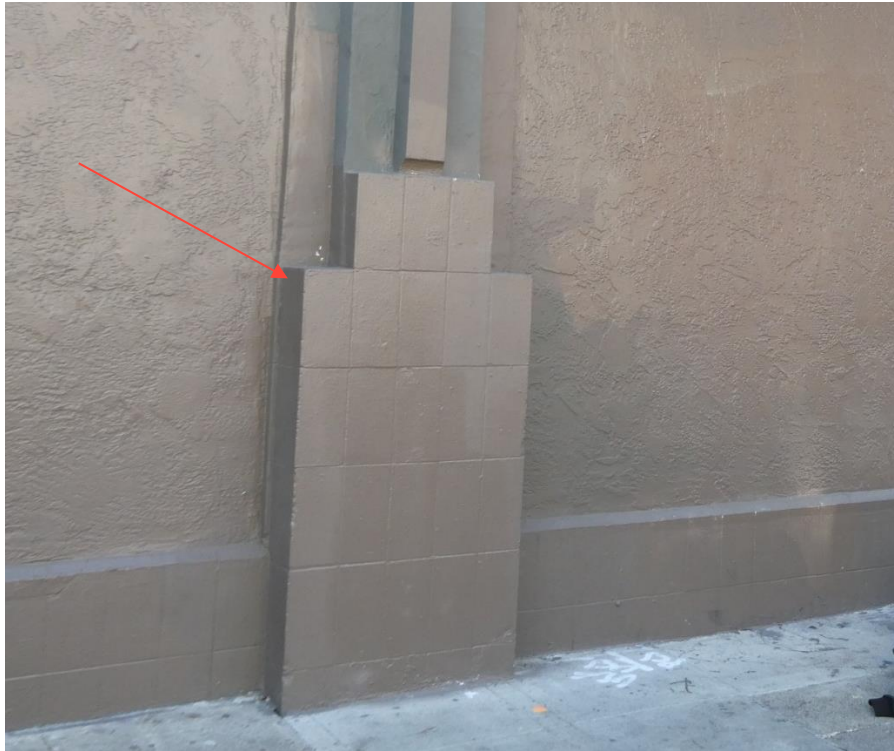
Figure 3: Chip no longer visible and has been painted over. (Page & Turnbull, 2024)

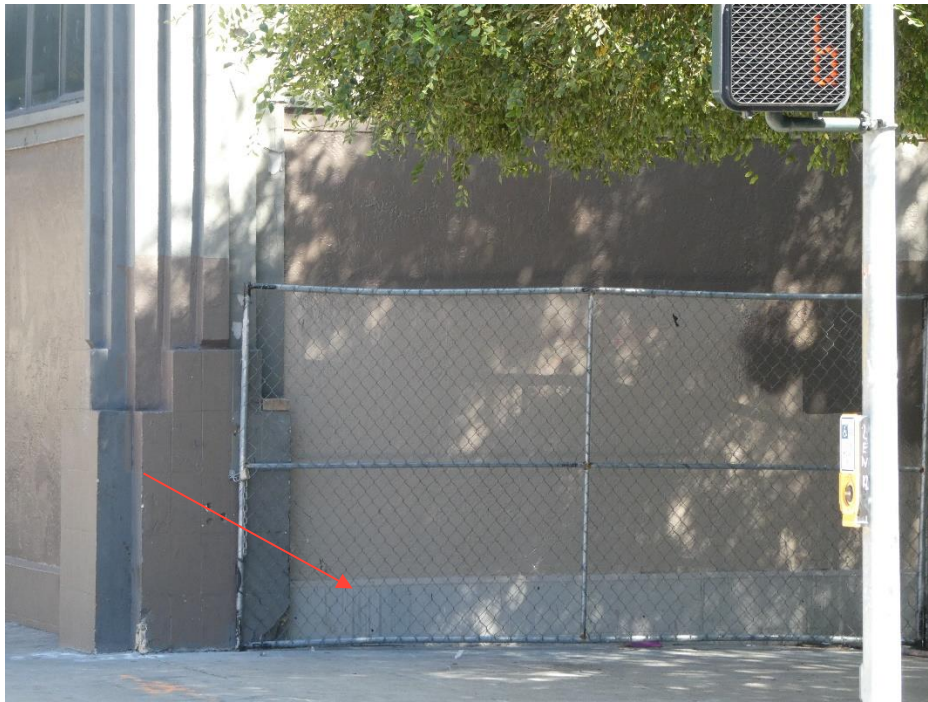
Figure 4: These tiles at the base have been removed from the west façade on the first and second bays from the north. These two areas have been infilled with concrete. (Page & Turnbull, 2024)

The terra cotta tiles that were located between the piers at the base of the infilled stucco walls have been removed from the first and second bays from the north end since 2018 (**Figure 4**). The areas where the tiles are no longer extant have been infilled with new concrete. It is recommended that in-kind replacement tiles be installed where the historic terra cotta tiles were removed.

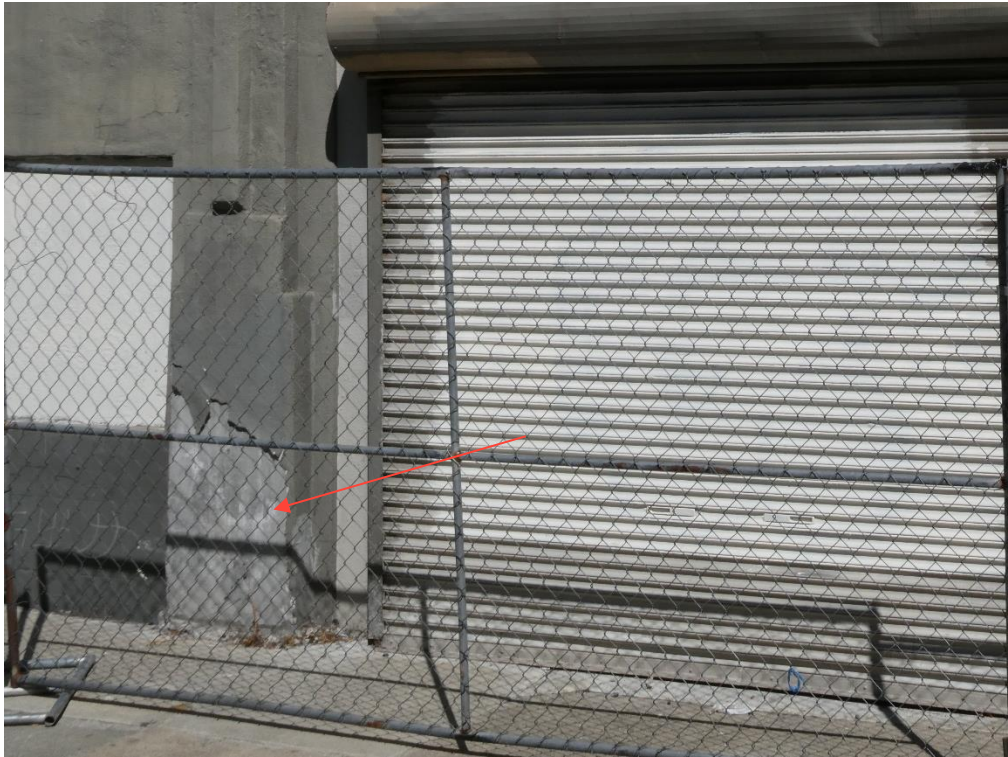
| Location | Condition in 2018 | Condition in 2024 |
|---|---|---|
| | "Figure 21. Tile column base that has been replaced by stucco in the same shape." (page 14) | The stucco at this column base has delaminated and detached ( <b>Figure 5</b> ). |

Figure 5: The stucco at this column base has delaminated and detached. (Page & Turnbull, 2024)

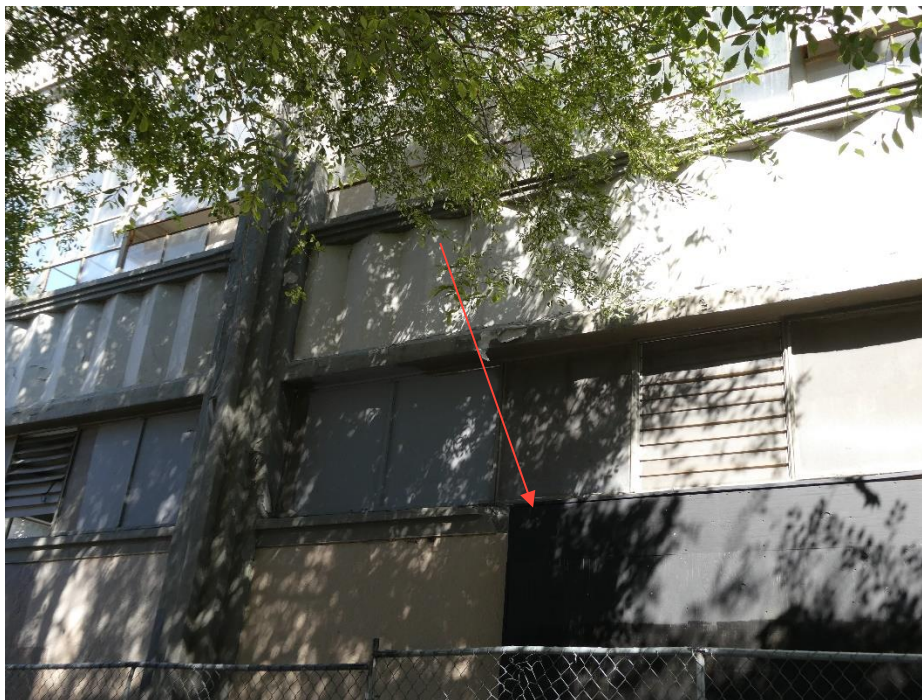
| Location | Condition in 2018 | Condition in 2024 |
|---|---|---|
| | "Figure 24. The transoms at the second bay from the north end of the west façade has a large spall at its sill." (page 15) | The condition of this sill could not be confirmed as it is blocked by plywood ( <b>Figure 6</b> ). |

Figure 6: The condition of this sill could not be confirmed as it is blocked by plywood. (Page & Turnbull, 2024)

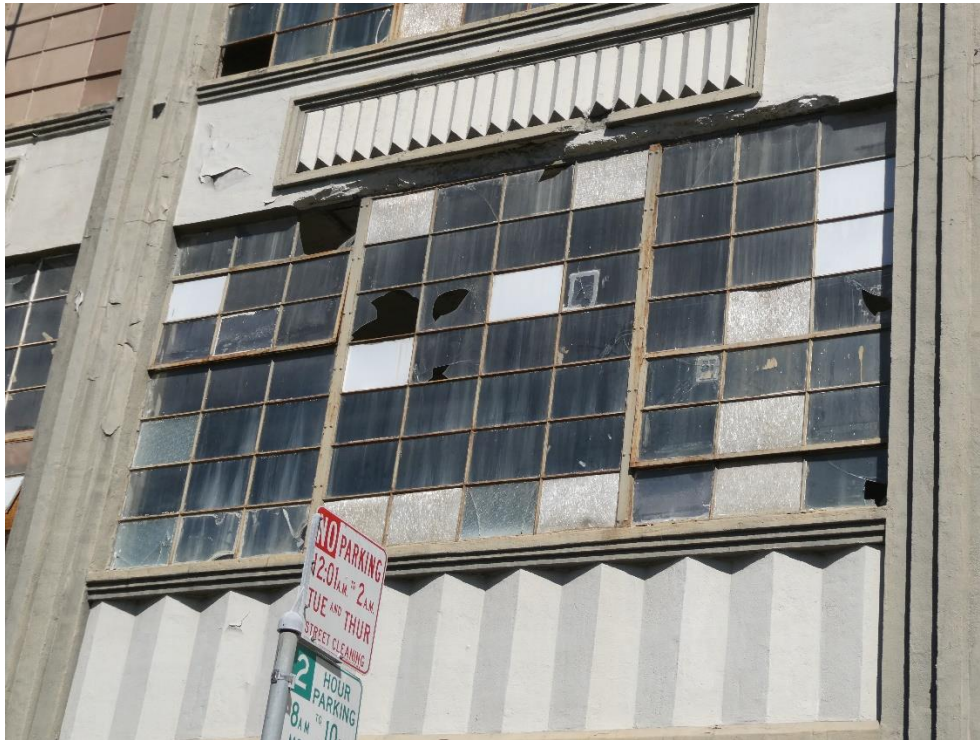
| Location | Condition in 2018 | Condition in 2024 |
|---|---|---|
| | "25% of the lights are painted, opaque, missing, or fiberglass." (page 19) | It appears that there are more broken, cracked, or missing glass panes than demonstrated in the 2018 report ( <b>Figure 7 &amp; Figure 8</b> ). |

Figure 7: Additional broken and cracked panes at west façade. (Page & Turnbull, 2024)

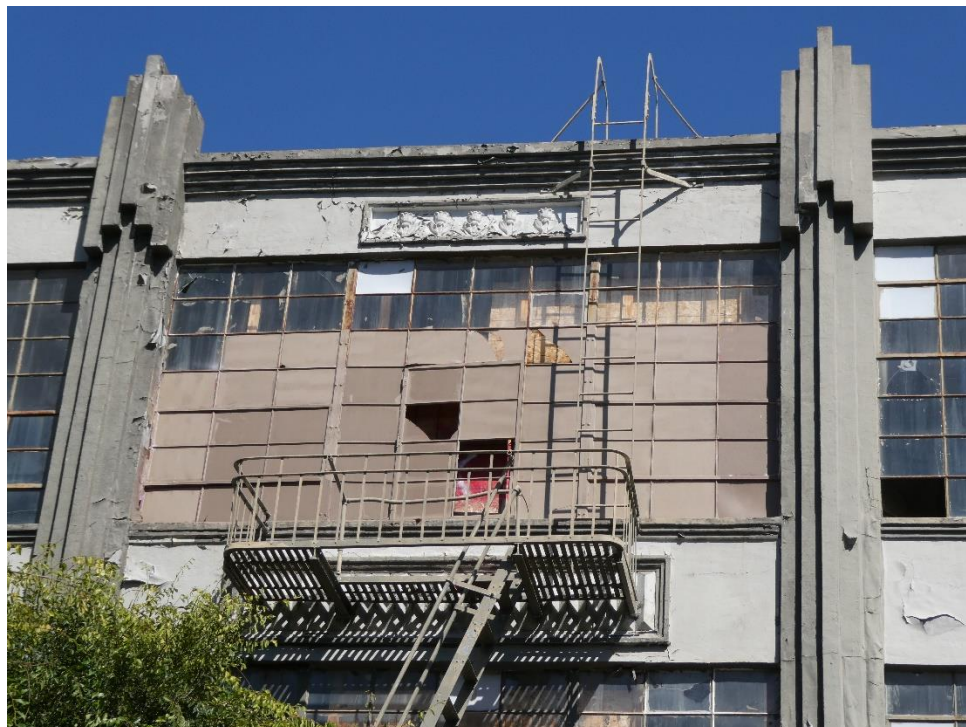
Figure 8: Additional broken and cracked panes at west façade. (Page & Turnbull, 2024)

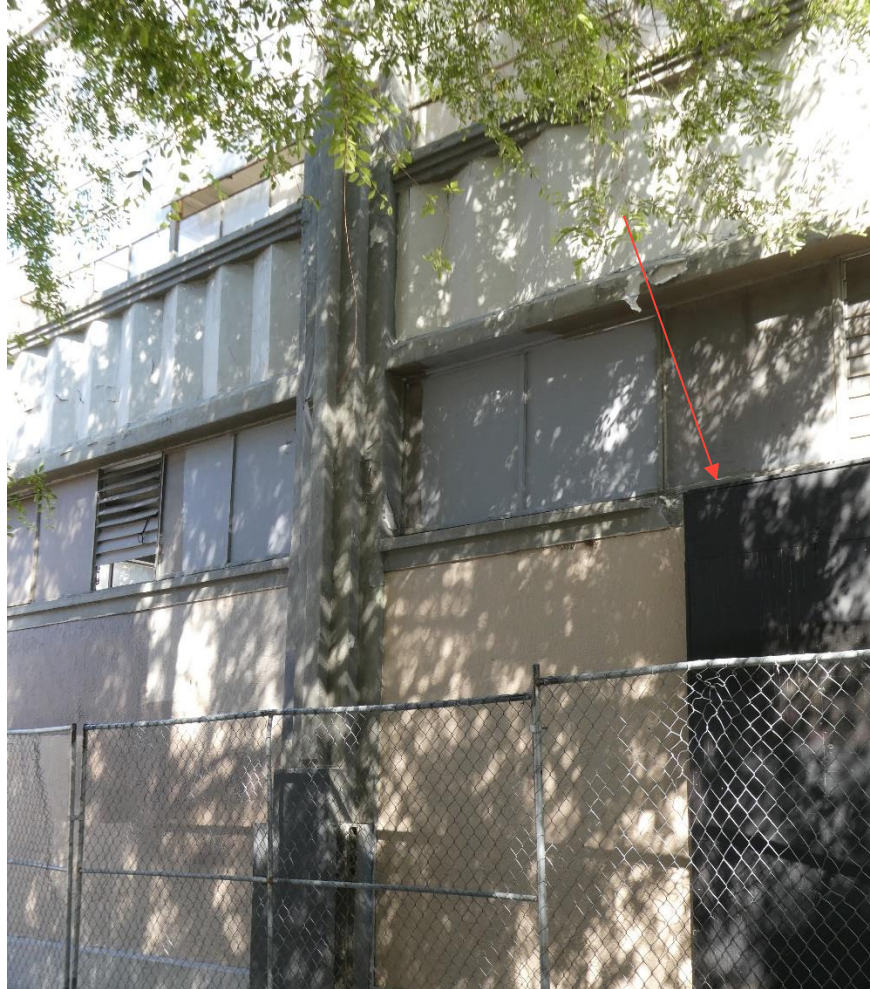
| Location | Condition in 2018 | Condition in 2024 |
|---|---|---|
| | "Figure 36. The head of the door at the north end of the western façade..." (page 19) | This door is covered with plywood panel, condition could not be confirmed ( <b>Figure 9</b> ). |

Figure 9: This door is covered with a plywood panel, and the condition could not be confirmed. (Page & Turnbull, 2024)

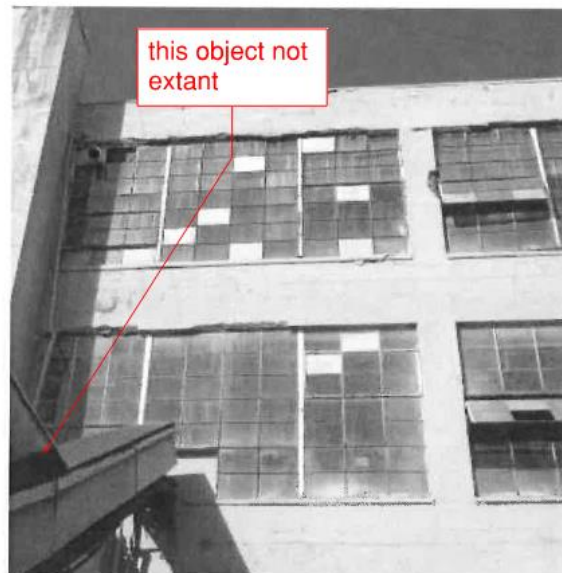
| Location | Condition in 2018 | Condition in 2024 |
|---|---|---|
| <i>Exterior South Facade</i> | "Figure 47. The distribution of cracks and spalls..." (page 24) | The mechanical object attached to the window in this photo is no longer extant ( <b>Figure 10</b> ). |

**Figure 47. The distribution of cracks and spalls on the southern façade, at the second bay from the west. Knapp Architects photo, 2019.**

Figure 10: The mechanical object attached to the window in this photo is no longer extant. (Knapp Architects, 2018. Edited by Page & Turnbull)

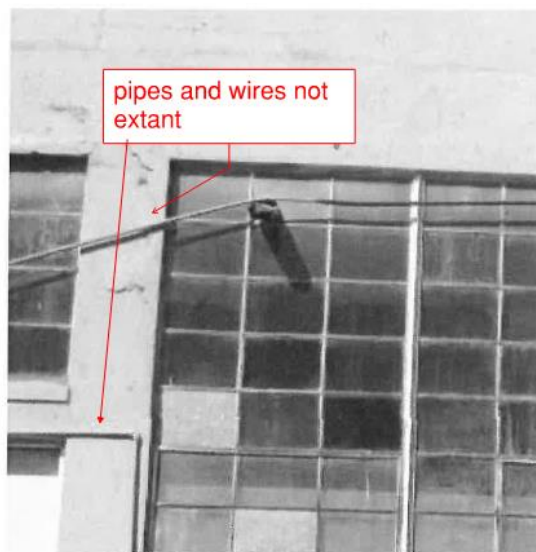
| Location | Condition in 2018 | Condition in 2024 |
|---|---|---|
| | "Figure 48. Extensive cracks at the upper west corner..." | The pipes and wires in this photo are no longer extant ( <b>Figure 11</b> ). |

**Figure 48. Extensive cracks at the upper west corner of the first floor window in the third bay from the west. Knapp Architects photo, 2019.**

Figure 11: The pipes and wires in this photo are no longer extant. (Knapp Architects, 2018. Edited by Page & Turnbull)

It appears that since 2018, some extraneous pipes and equipment have been removed from the south façade (**Figure 11, Figure 12, & Figure 15**: In the areas where the pipes were removed, the substrate was not properly patched and repaired, leading to cracks and spalls in the concrete and some exposed rebar.**Figure 15**). The concrete substrate at these areas were not repaired or patched when the equipment was removed. This has led to additional deterioration, spalling, cracking, rust jacking, and paint failure. It is recommended that these areas be patched and repaired to prevent further deterioration.

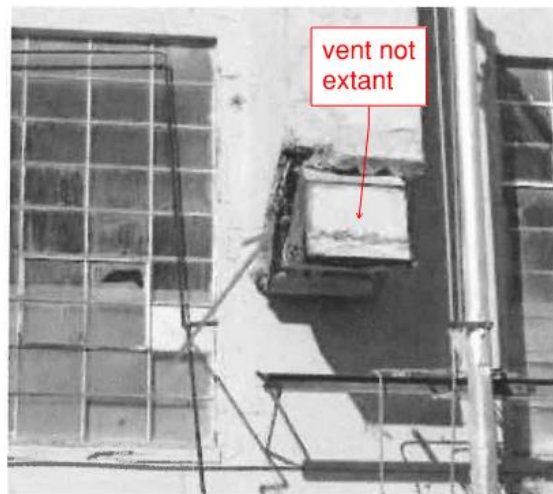
| Location | Condition in 2018 | Condition in 2024 |
|---|---|---|
| | "Figure 50. The extensive spall at the bottom..." (page 25) | Vent shown in photo is not extant ( <b>Figure 12</b> ). |

**Figure 50. The extensive spall at the bottom of the incinerator smokestack (red arrow).  
Knapp Architects photo, 2019.**

Figure 12: Vent shown in photo is not extant. (Knapp Architects, 2018. Edited by Page & Turnbull)

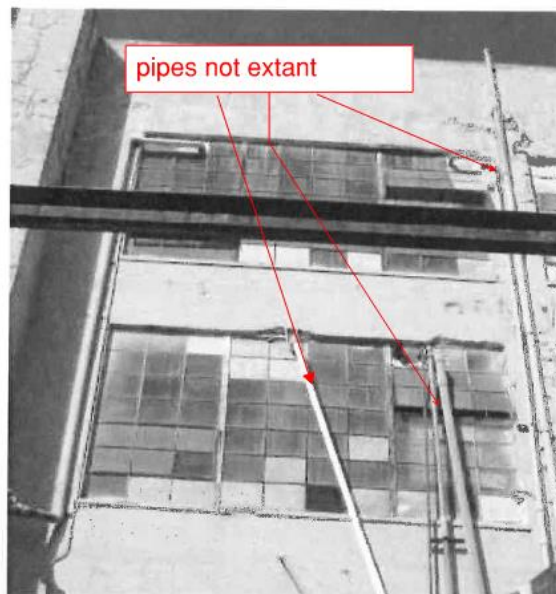
**Figure 51. The second and third floor windows in the fourth window bay from the west. Knapp Architects photo, 2019.**

Figure 13: Pipes shown in photo are not extant. (Knapp Architects, 2018. Edited by Page & Turnbull)

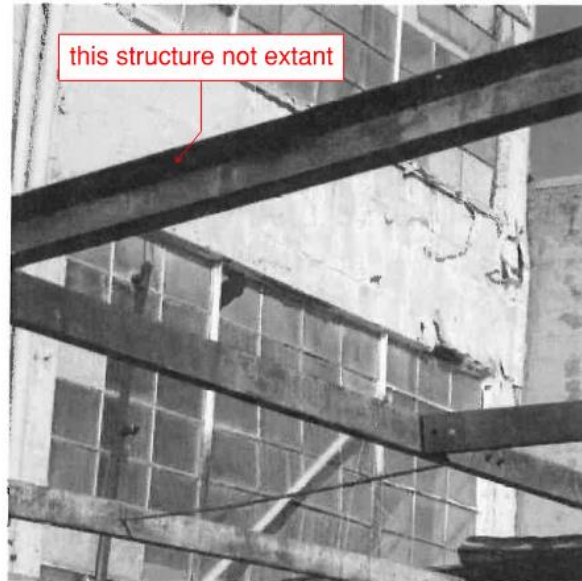
*Figure 52. The first and second floor windows in the easternmost bay. Knapp Architects photo, 2019.*

Figure 14: The structure shown in the photo is not extant. (Knapp Architects, 2018. Edited by Page & Turnbull)

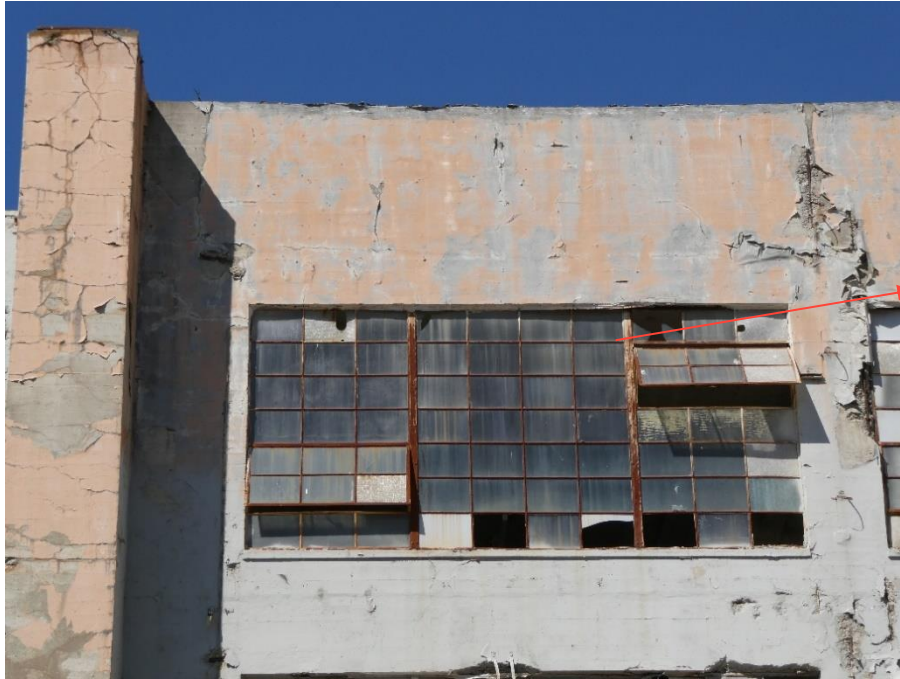
| Location | Condition in 2018 | Condition in 2024 |
|---|---|---|
| | Not extant in report. | In the areas where the pipes were removed, the concrete substrate was not properly patched and repaired, leading to cracks and spalls in the concrete and exposing some rebar ( <b>Figure 15</b> ). |

Figure 15: In the areas where the pipes were removed, the substrate was not properly patched and repaired, leading to cracks and spalls in the concrete and some exposed rebar. (Page & Turnbull, 2024)

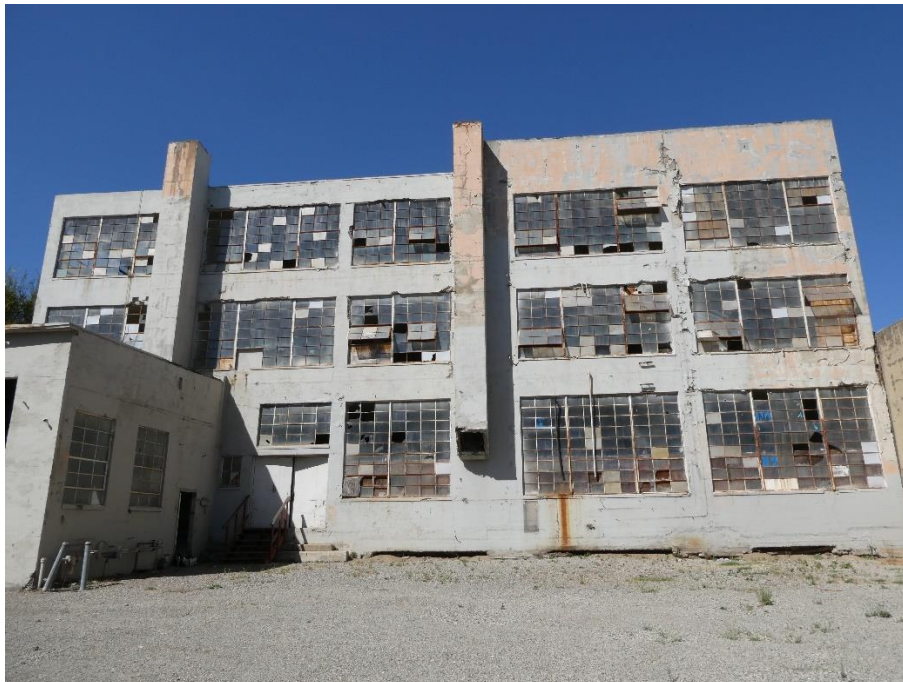
Figure 16: All windows are now visible, as the structure abutting the south façade has since been demolished.

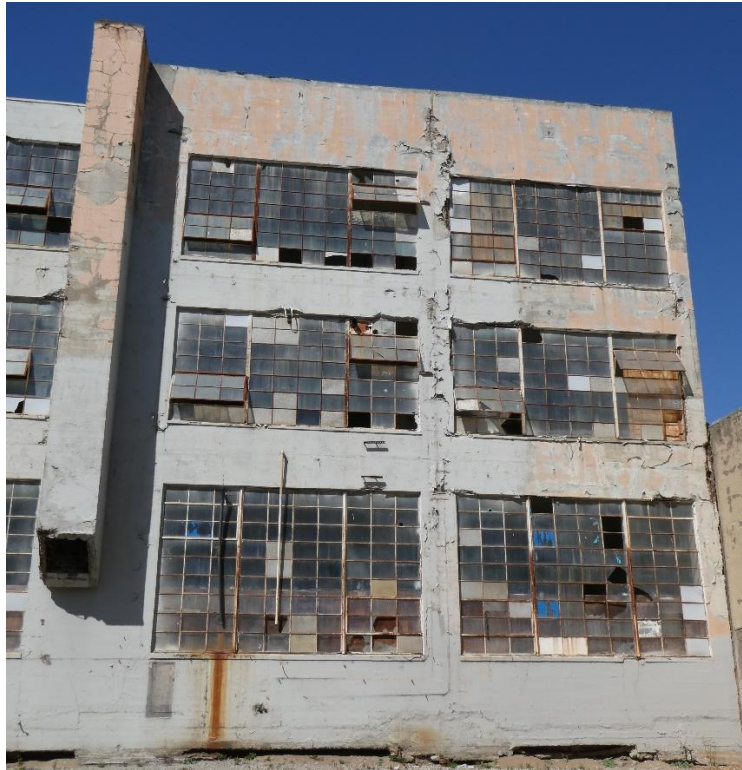
| | "The windows of this façade are in generally good condition." (page 27) | It appears that there are more broken, cracked, and missing window panes than is demonstrated in the 2018 report ( <b>Figure 17</b> ). |

Figure 17: It appears that there are more broken, cracked, and missing window panes than is demonstrated in the 2018 report. (Page & Turnbull, 2024)

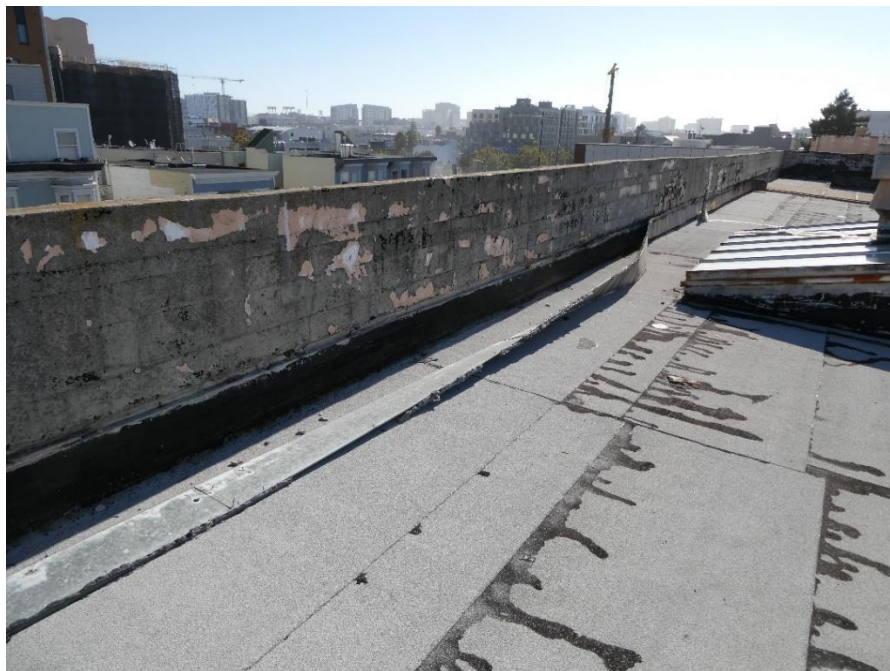
Figure 18: This area of flashing has now detached from the parapet. (Page & Turnbull, 2024)

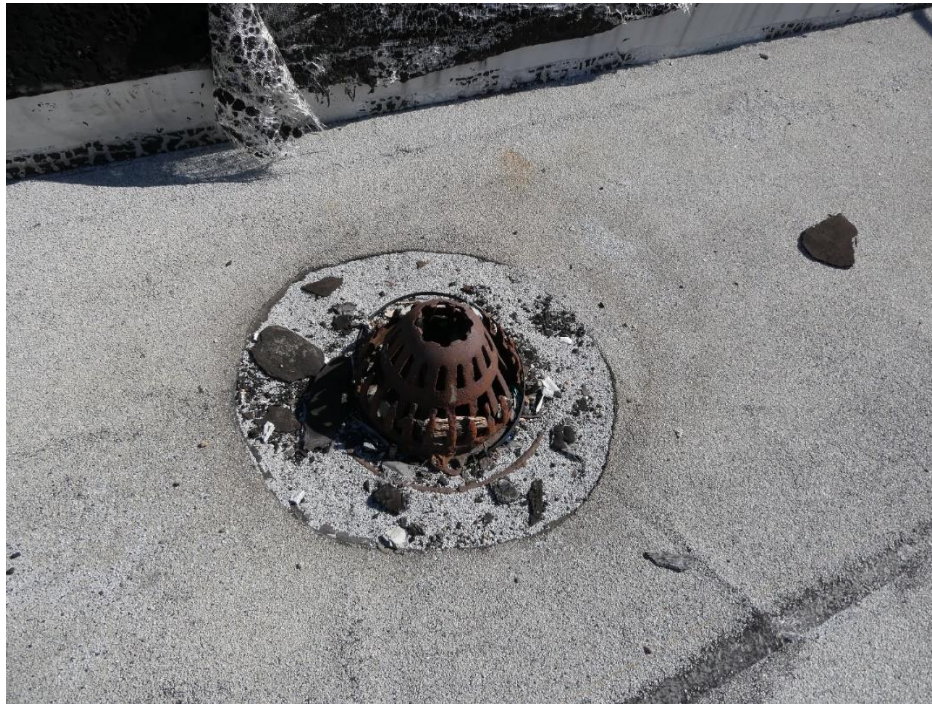
Figure 19: The drains appear to be partially or completely blocked with debris. It is unclear if any of the drains are functioning properly. (Page & Turnbull, 2024)

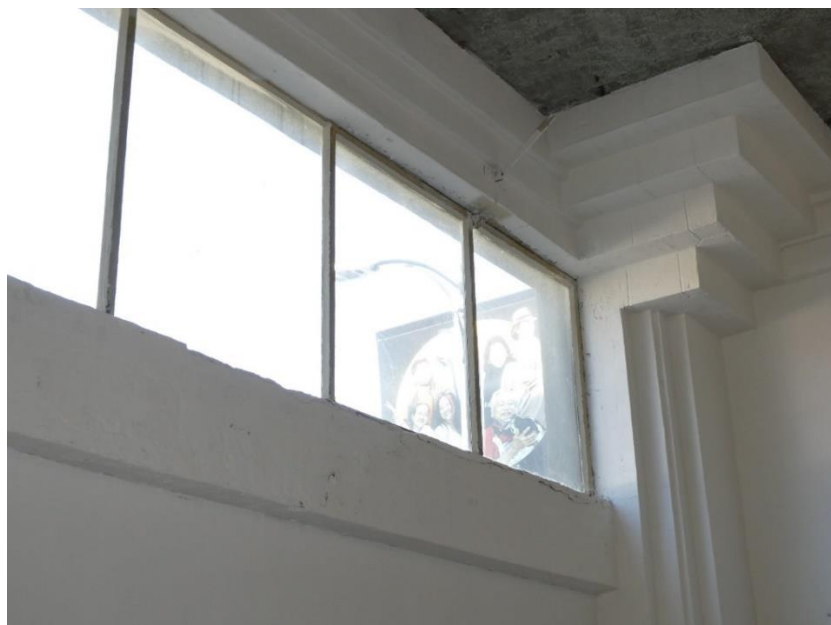
| <i>Interior, First Floor</i> | "Figure 73. Visible leak damage and spalling at concrete window sill of 1 <sup>st</sup> floor front transom." (page 34) | This leak and associated damage at the transom have been partially repaired and/or repainted. The area still exhibits some damage and has some areas of new paint failure. It is unclear if the source of the water intrusion has been fixed ( <b>Figure 20</b> ). |

Figure 20: This leak and associated damage at the transom have been partially repaired and/or repainted. The area still exhibits damage and has areas of new paint failure. It is unclear if the source of the water intrusion has been fixed. (Page & Turnbull, 2024)

It appears that the leakage at the interior of the transom windows on the east end of the north façade and has been partially completed(Figure 20). This area still exhibits some damage that has been painted over. There are also areas of new paint failure. It is unclear if the source of the water intrusion has been fixed. It is recommended that this area be investigated further to ensure that there is no active water intrusion. Once it is confirmed there are no active leaks, the substrate should be properly prepped, primed, and painted to match the surrounding area.

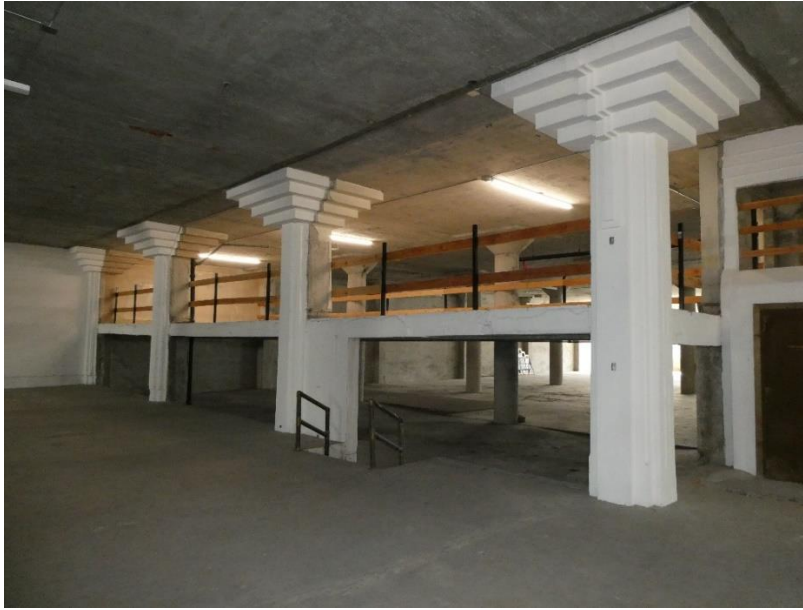
Figure 21: Partition walls, interior windows, and furnishings have been demolished or removed. (Page & Turnbull, 2024)

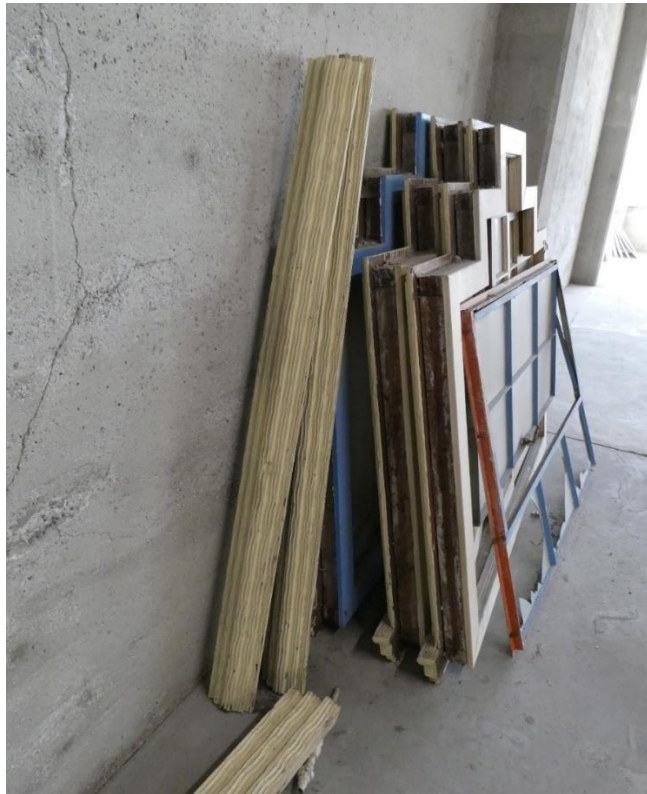
Figure 22: Salvaged wooden window sashes/frames, one metal window, and decorative wavy trim leaning against the east wall first floor. (Page & Turnbull, 2024)
