File No. 260035

Hearing to discuss the cause(s), escalation, response, and impacts of the widespread power outages that began on December 20, 2025, and which have disproportionately affected residents and small businesses in the Richmond, Sunset, Presidio, Civic Center, South of Market (SOMA), and other San Francisco neighborhoods, to understand how a localized substation incident escalated to affect nearly one-third of the City; to assess communication failures and gaps in emergency response protocols; to evaluate economic impacts on small businesses and hardships faced by seniors, persons with disabilities, and other vulnerable residents; to discuss and understand the remedies, claims processes and support being provided to affected residents and businesses; and requesting the Pacific Gas and Electric Company (PG&E) to report.

Direct Cause Evaluation

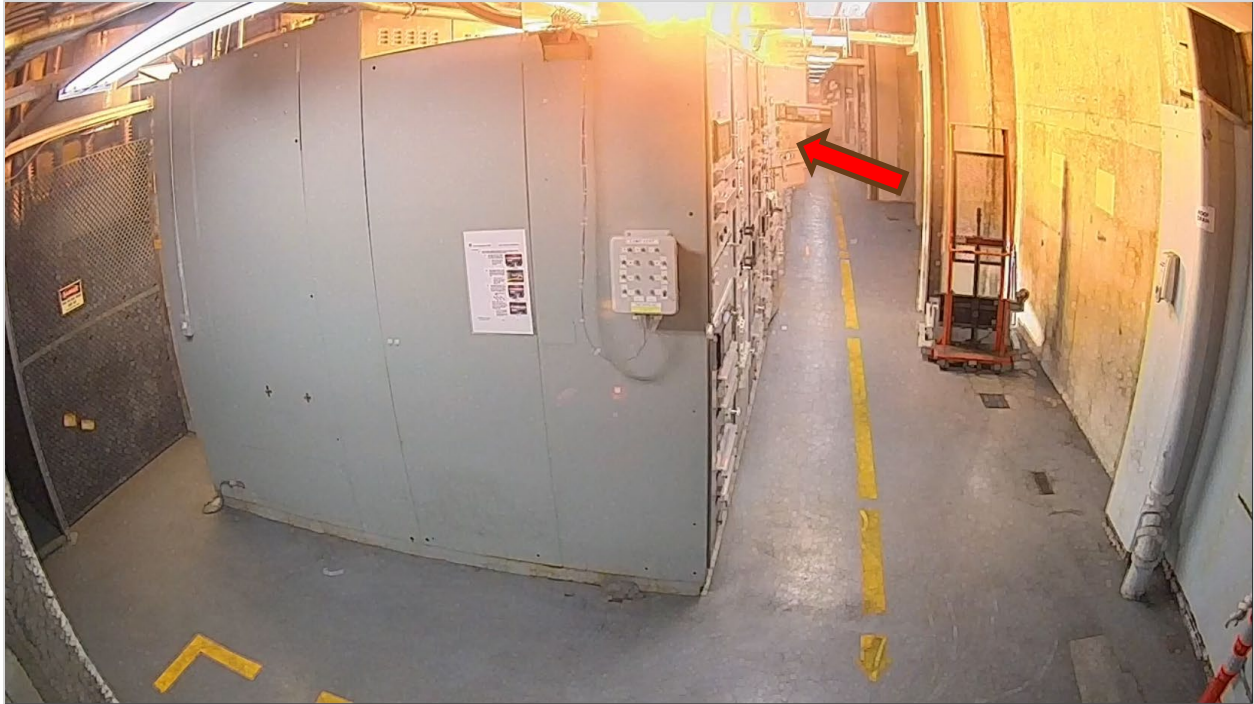
Figure 4. Ignition following arc-flash event in Cell No. 5 (red arrow).

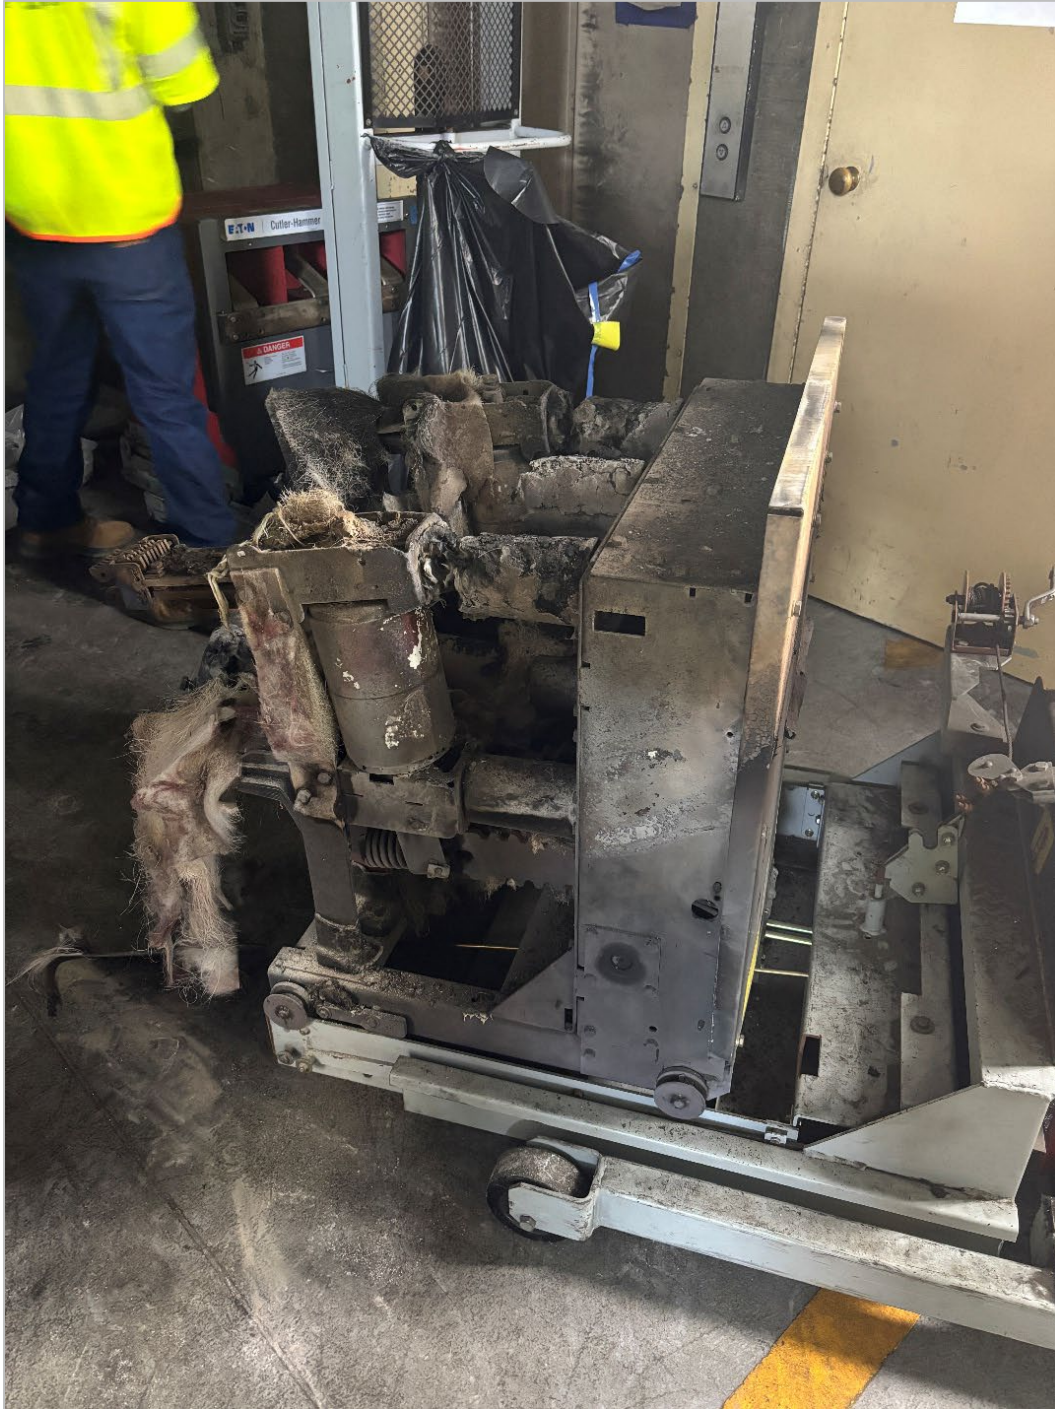
control wiring above the cell. A photograph of the damaged Incident Breaker No. 52 is shown in Figure 5. The damaged Incident Breaker No. 52 was manufactured by Eaton Cutler Hammer (Model No. 150VCPW50C), and the switchgear was designed and built by PowerCon Corporation.

Figure 5. Damaged Circuit Breaker from Cell No. 5 (Incident Breaker No. 52).²³

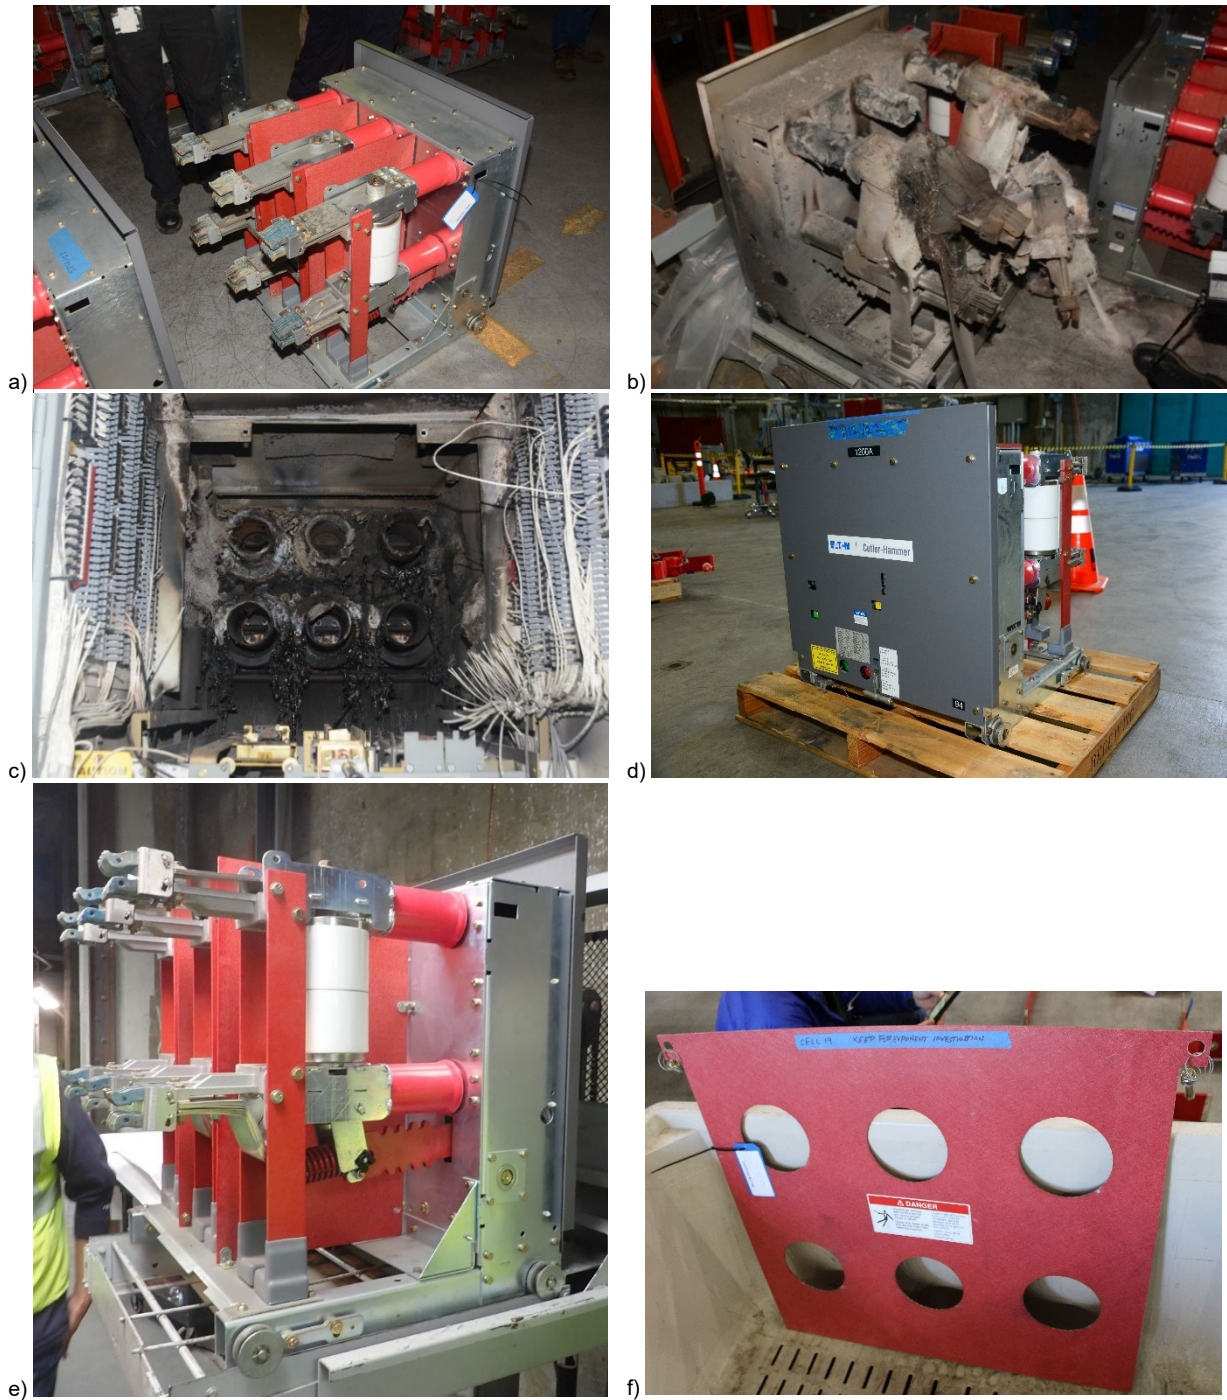
Exponent inspected the evidence at the PG&E ATS facility, including the Incident Breaker No. 52 and Cell No. 5, which contains two cubicles, including the upper 1112/12 breaker cubicle (the Incident Cubicle). Additional evidence included the circuit breaker from the lower cubicle of Cell No. 5 (Circuit Breaker No. 94) and a breaker that had been removed from the top of Cell No. 5 approximately one month before the arc-flash event (Circuit Breaker No. 56). Other collected items included the circuit breaker in Cell No. 19 associated with the station service transformer (Circuit Breaker No. 79), barrier insulating board from the bottom of Cell No. 19, collected bus work, damaged control cables, protective relays, and one of the heaters from Cell No. 5. Additionally, Exponent received barrier insulating boards from selected breaker cells at the 12 kV bus section D of the Mission Substation (“Additional Insulating Boards”). All Additional Insulating Boards were visually inspected, and a selected number of them were destructively examined in laboratory conditions. Photographs of some of the items inspected by Exponent are shown in Figure 11.

Figure 11. Examples of evidence collected by PG&E: a) Circuit Breaker No. 56 - Replaced from Top of Cell No. 5 prior to Incident; b) Circuit Breaker No. 52 from Top of Cell No. 5 (Incident Breaker No. 52); c) Cell No. 5 top cubicle (Incident Cubicle); d) Circuit Breaker No. 94 from the lower cubicle of Cell No. 5; e) Circuit Breaker No. 79 from Bottom of Cell No. 19; and f) Barrier insulating board from Bottom of Cell No. 19.

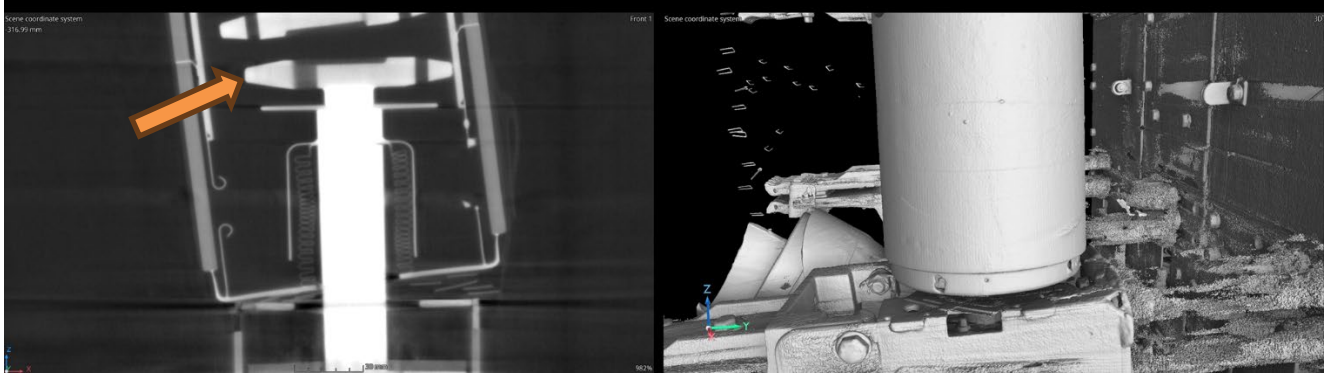
Figure 12. CT Scan imaging of the Incident Breaker No. 52's Vacuum bottle showing the condition of the breaker contacts (orange arrow).

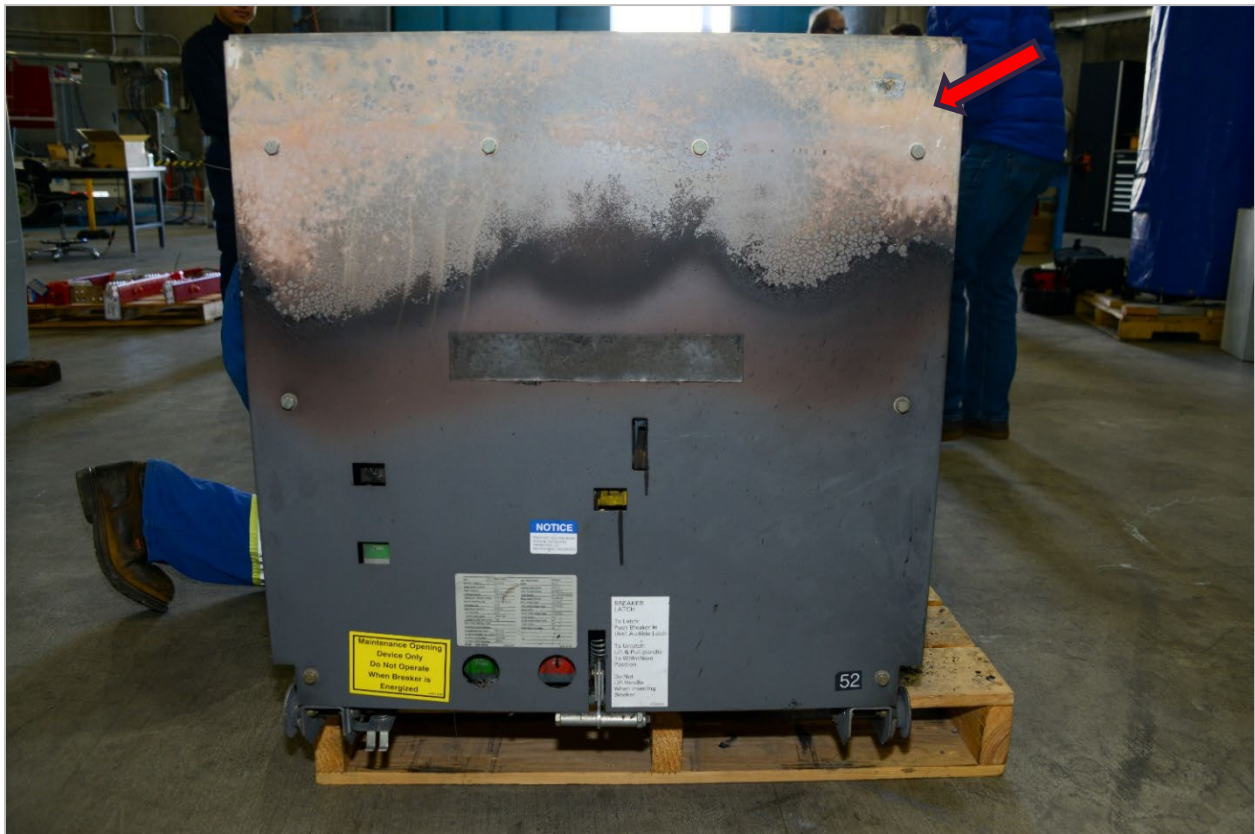
Incident Breaker No. 52 suffered significant thermal damage. On the front face, there is smoke deposition just above the midplane of the breaker. Discoloration and clean burn patterns can be observed on the top third of the front face (see Figure 13).

Figure 13. Discoloration and clean burn patterns on the top third of the front face on Incident Breaker No. 52 (red arrow).

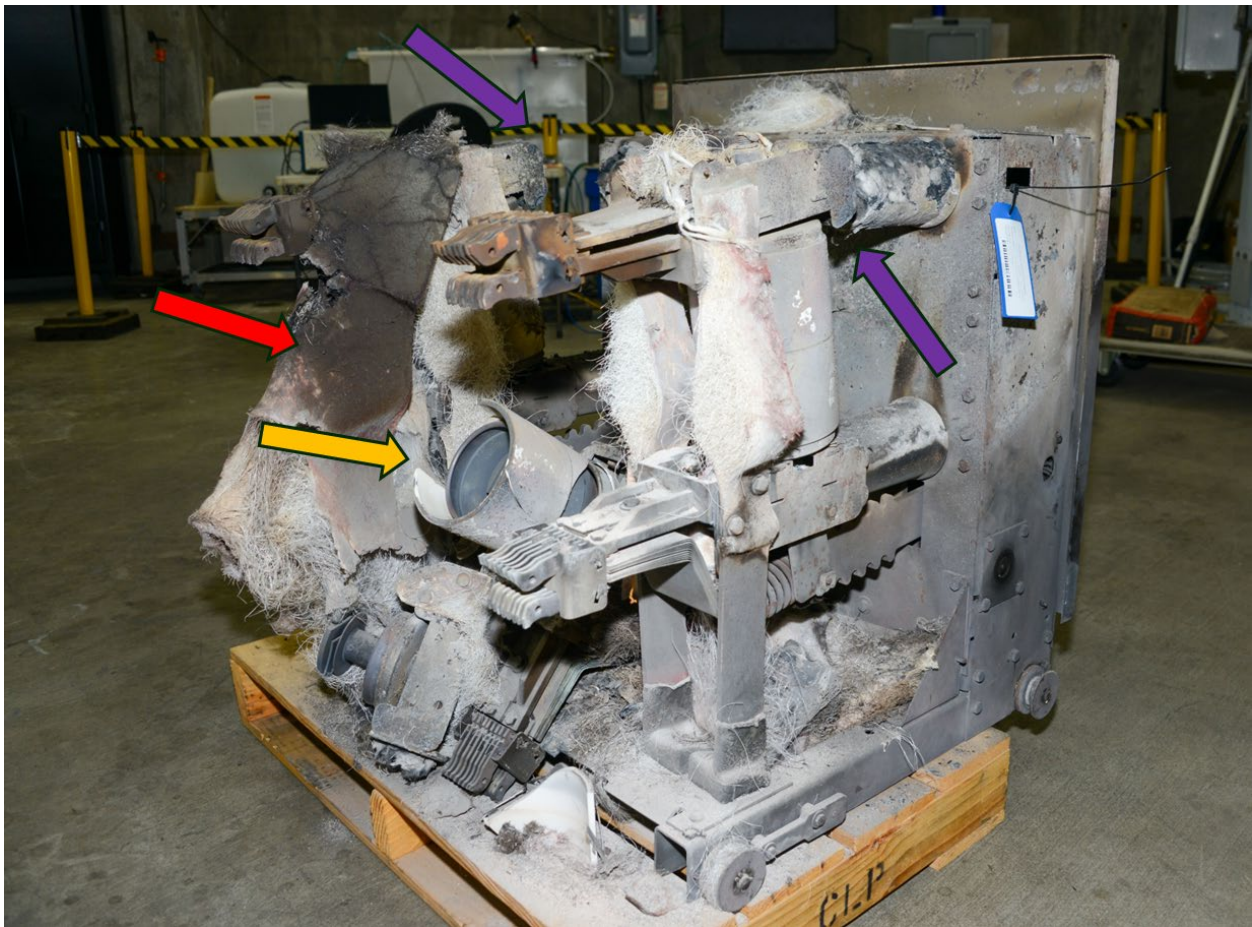
The vacuum bottle on the B-phase was entirely detached from the insulators. The ceramic exterior of the B-phase vacuum bottle was damaged with a large crack on the bottom half that separated part of the exterior. A crack was also visible on the top half of the B-phase vacuum bottle that separated part of the ceramic exterior. The contacts were visible on this cracked vacuum bottle and did not appear damaged by arcing. The A and C phase vacuum bottles were detached at the top insulator but appeared loosely connected at the bottom. The C-phase vacuum bottle had a crack on the lower half of the ceramic exterior. The A, B, and C phase vacuum bottles had clear damage patterns on the front-facing side of the ceramic exterior (see Figure 14).

Figure 14. Incident Breaker No. 52 showing detached insulators (purple arrows), damage to the B-phase vacuum bottle (yellow arrow), and burned Incident Insulating Board (red arrow).

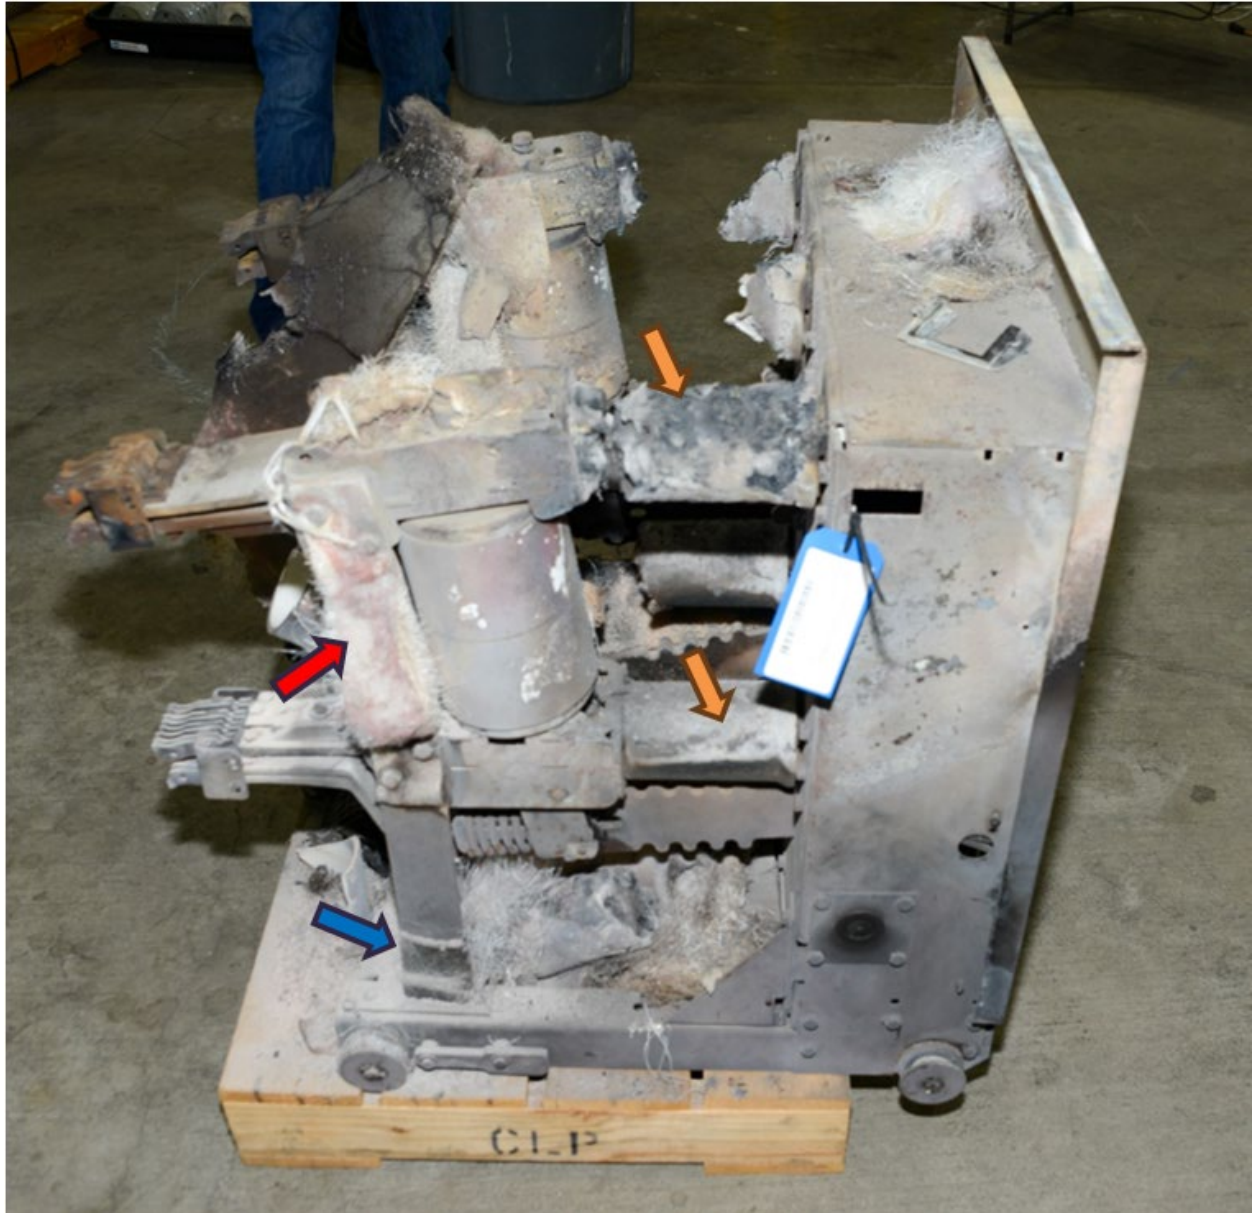
significantly damaged on the top half of the A and C phase sides, while the B-phase bars were consumed by fire. Rubber insulators at the bottom had minor melt damage on the front and upward-facing side (Figure 15). Melted aluminum was found in various locations throughout the breaker.

Figure 15. Thermally damaged electrical insulators for electrically isolating the vacuum bottles (orange arrows), damaged vertical insulating bars at each phase (red arrow), and rubber insulators at the bottom (blue arrow).

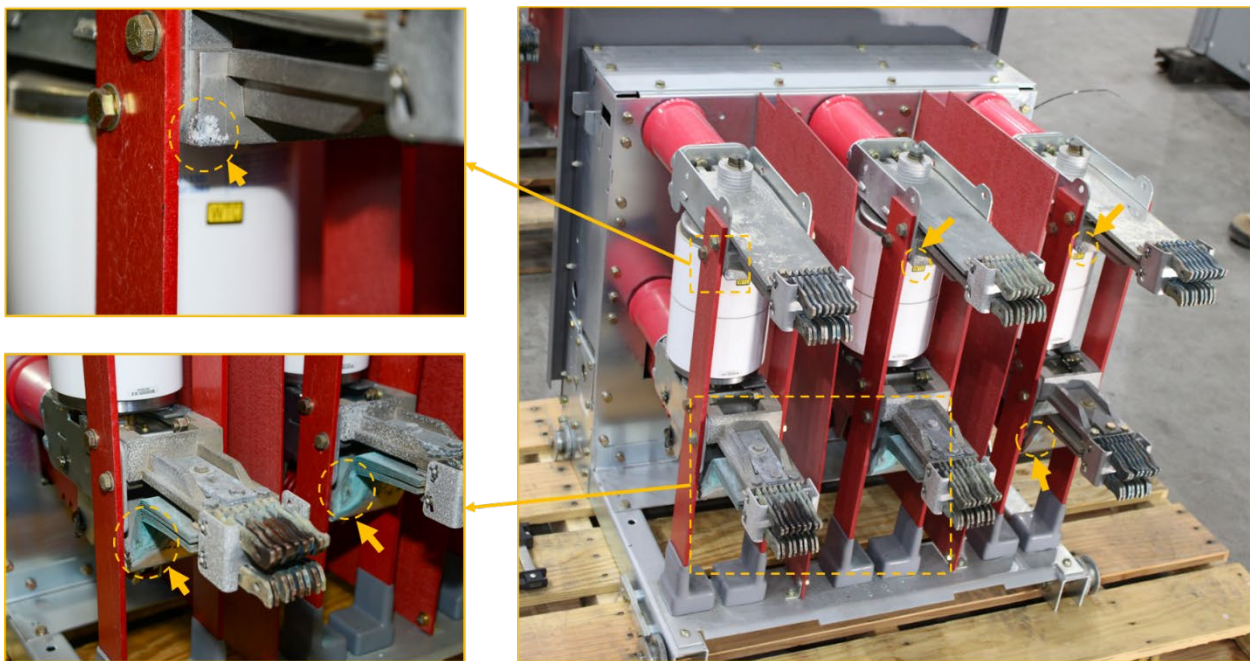
Circuit Breaker No. 56 had been installed in the Incident Cubicle until approximately one month before the event. It was removed on November 2, 2025, and upon inspection, it showed metal erosion and discoloration on the connecting arms above and below the vacuum bottles. The bottom of the phase B and C connecting arms showed evidence of metal loss and discoloration, consistent with copper corrosion. The top of phases A, B, and C connecting arms each had discoloration and metal loss spots on the underside near the vacuum bottles. Circuit Breaker No. 56 was subsequently replaced by Incident Breaker No. 52 in November 2025 (see Figure 18). Circuit Breaker No. 56 was taken out of service after the observed damages and reported as “water damage” (see section 5.2.1 of this report for more details). However, Exponent’s evidence examination after the arc-flash event indicated that the damage and metal loss at the breaker arms were likely due to arcing at the contact points with the Incident Insulating Board and not water intrusion.

Figure 18. Metal erosion and damage at the top and lower breaker arms of Circuit Breaker No. 56 (previously racked in the Incident Cubicle).

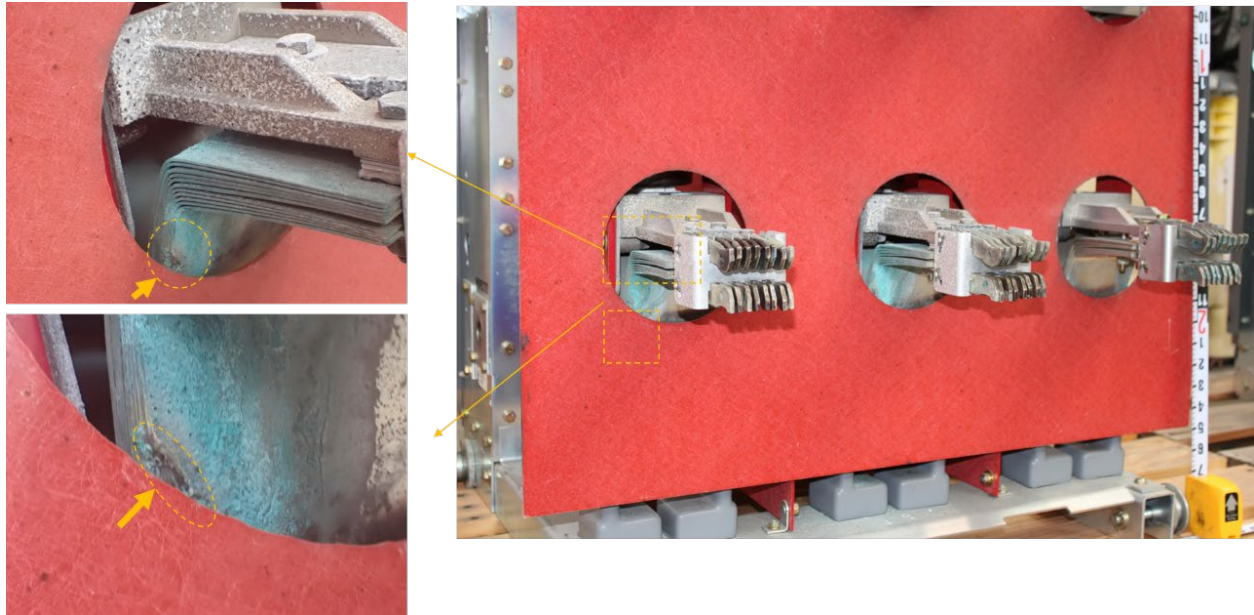
Incident Insulating Board and the Incident Breaker No. 52. Contact between the edge of the through-holes and the breaker arms is further supported by similar damage patterns on other barrier insulating boards recovered from the switchgear (see Figure 20).

Figure 19. Sides of the through-holes align with points of contact on the breaker arms where metal erosion and damage observed on the arms of Circuit Breaker No. 56.

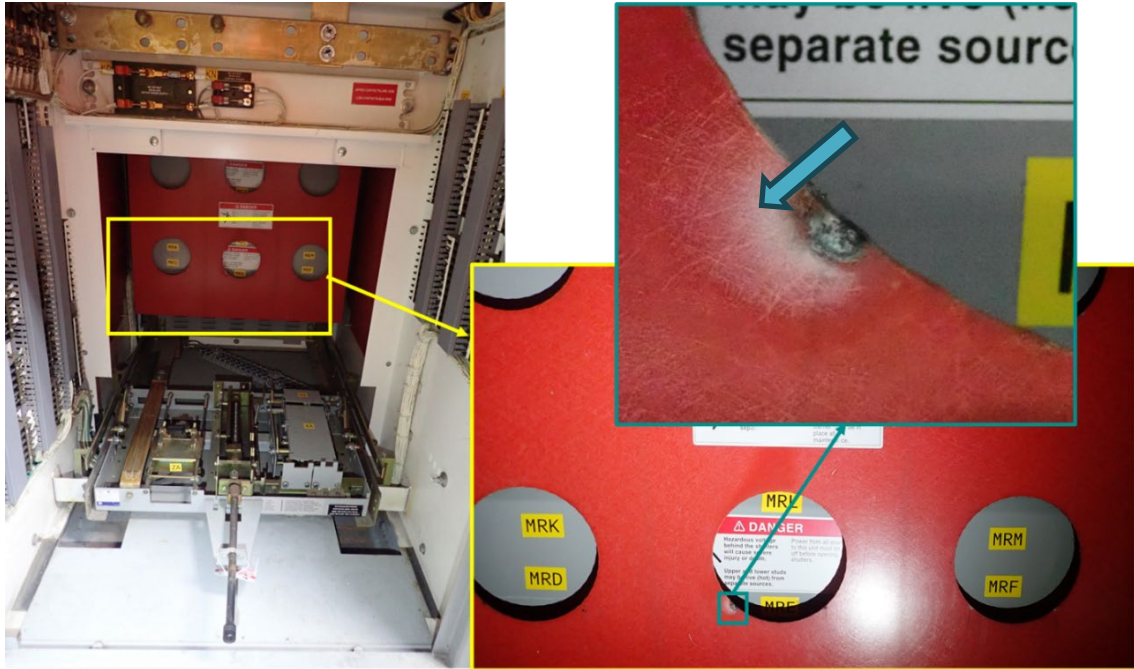
Figure 20. Evidence of contact between the barrier insulating board and circuit breaker arm at another cubicle (NX-2/22, Cell No. 6) (blue arrow)

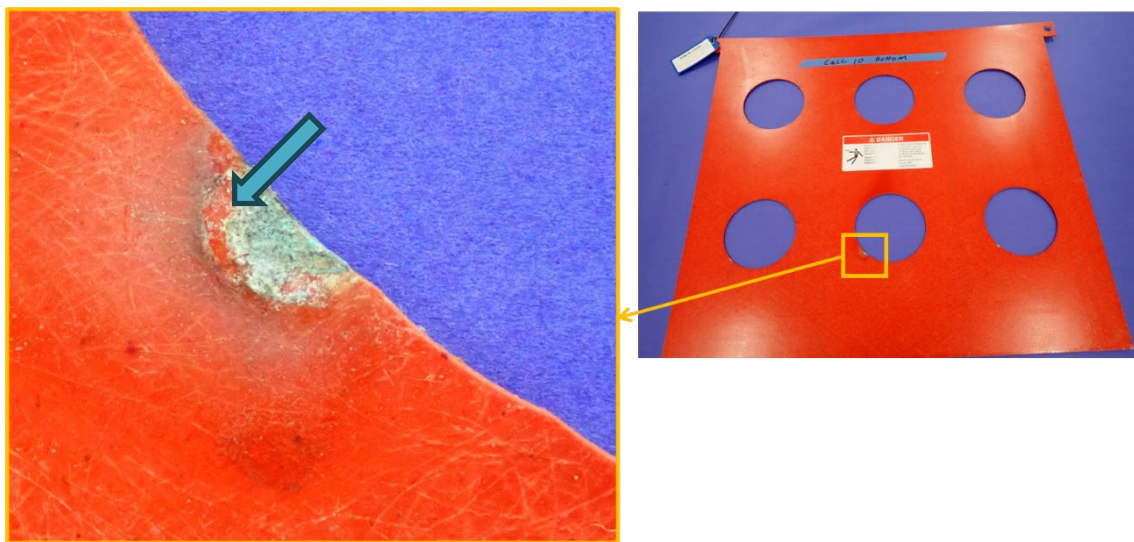
Additionally, barrier insulating boards retrieved from other breaker cells within the 12 kV bus section D switchgear at the Mission Substation exhibit similar damage patterns, indicating contact between the edges of the through-holes and the breaker arms. The similarity in contact locations and damage patterns across multiple cells further supports that the breaker arms contacted the edges of the through-holes (Figure 21).

Figure 21. Barrier insulating board from Cell No. 9, bottom cubicle (blue arrow).

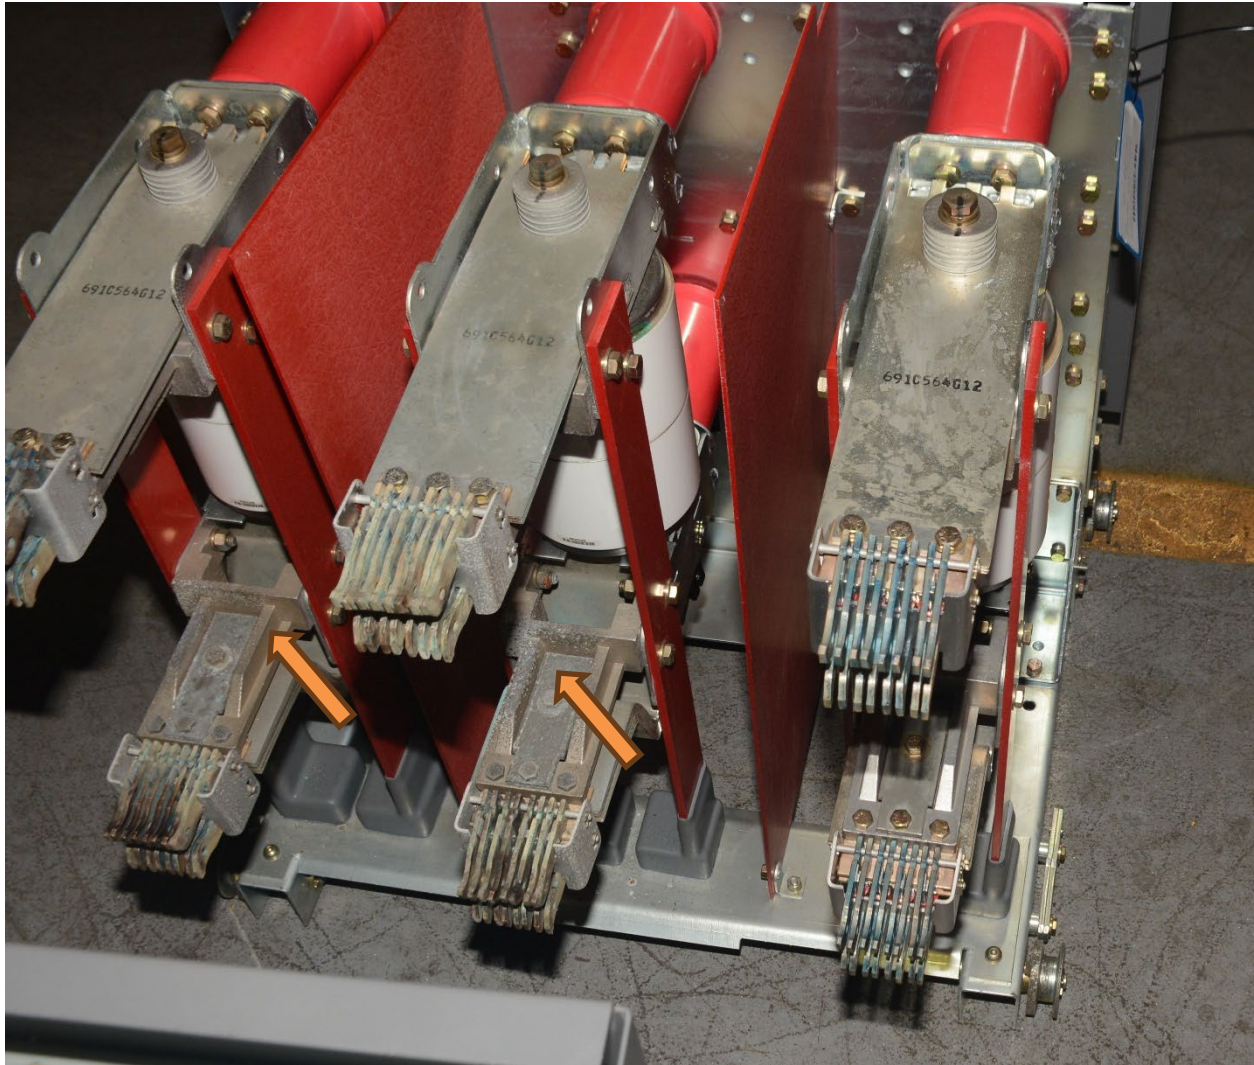
Figure 22. Metal damage and discoloration on lower connecting arms Circuit Breaker No. 94 (orange arrows).

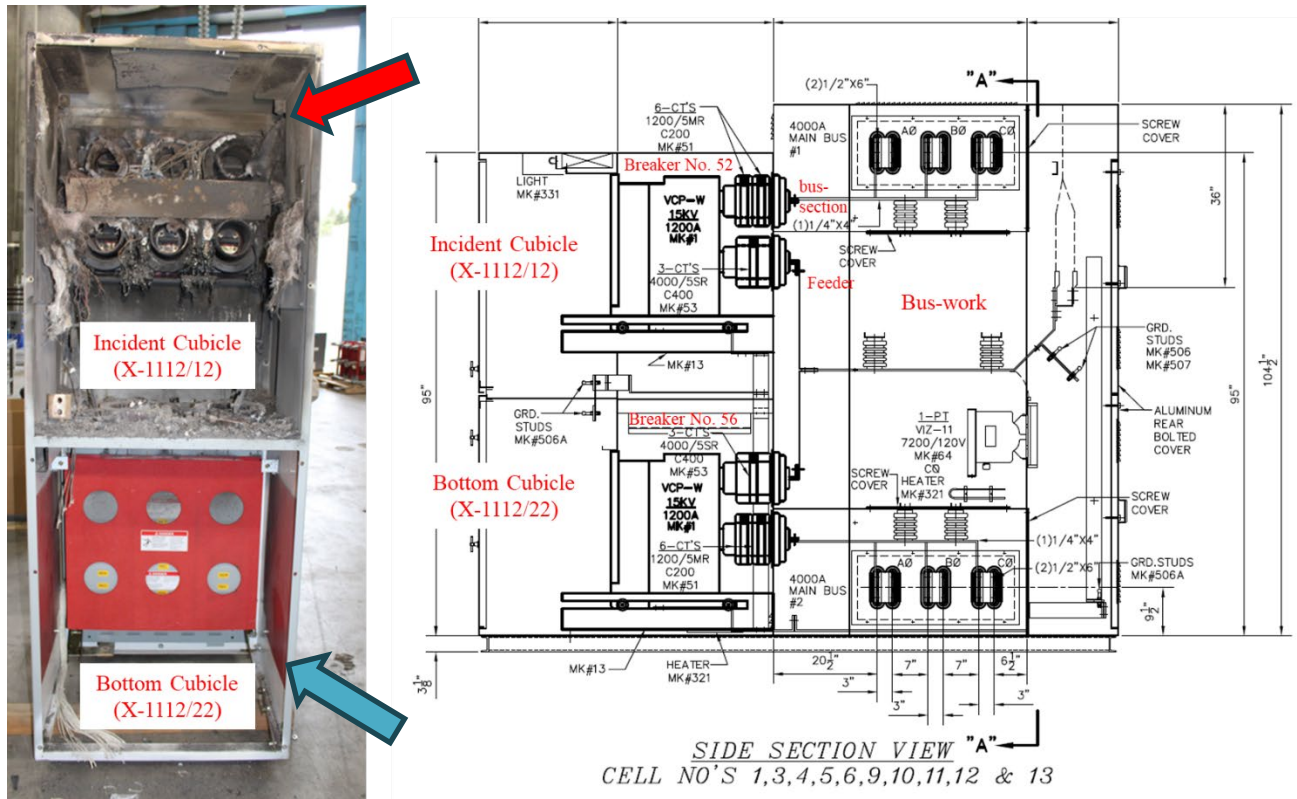
Cell No. 5 housed Incident Breaker No. 52 in the top cubicle (X-1112/12 cubicle) and Circuit Breaker No. 94 in the bottom cubicle (X-1112/22 cubicle) at the time of the incident. Significant thermal damage occurred to the top cubicle of Cell No. 5. Damage generally increased from front to back (see Figure 23 and Figure 24).

Figure 23. Cell No. 5 with the top cubicle that housed the Incident Breaker No. 52 (red arrow) and the relatively undamaged bottom cubicle (blue arrow).

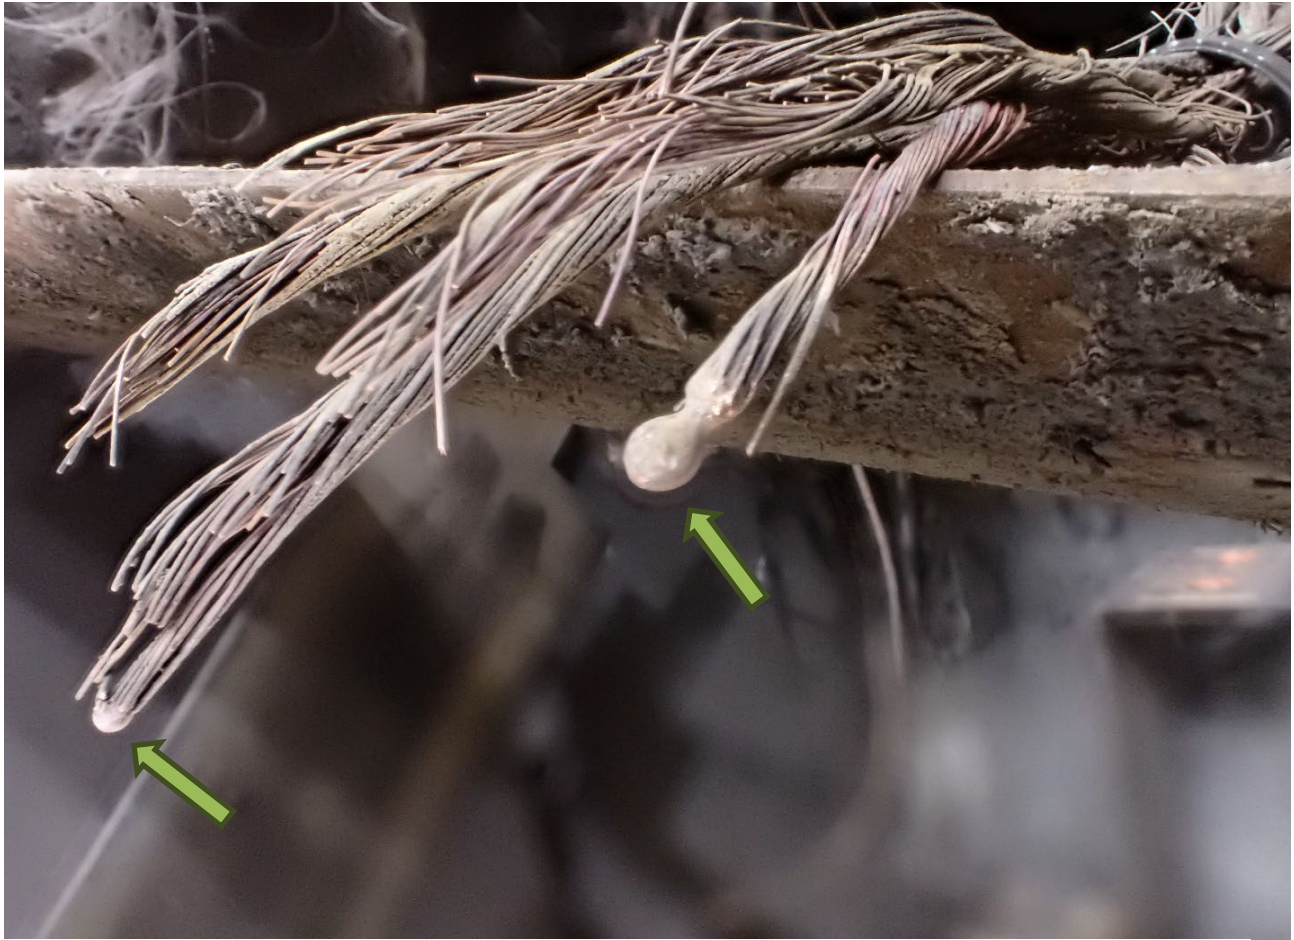
Three Current Transformers (CTs) on the bus side A and B phases fell down during the incident and subsequent transportation as their housings melted during the incident and were found on the floor of the top cabinet at the time of the inspection. The internal wiring of these three CTs did not show visible evidence of copper erosion or melting. Housings of the CTs that did not fall down also partially melted and exposed internal windings. These exposed CT areas also did not show visible evidence of internal arcing. However, beading of copper wires was observed away from the CTs. Attempts to trace the wires were halted due to the fragility of the wires; however, the location of the beaded wires suggests that they are most likely CT wires.

Figure 25. Evidence of electrical arcing on CT wires (green arrows).

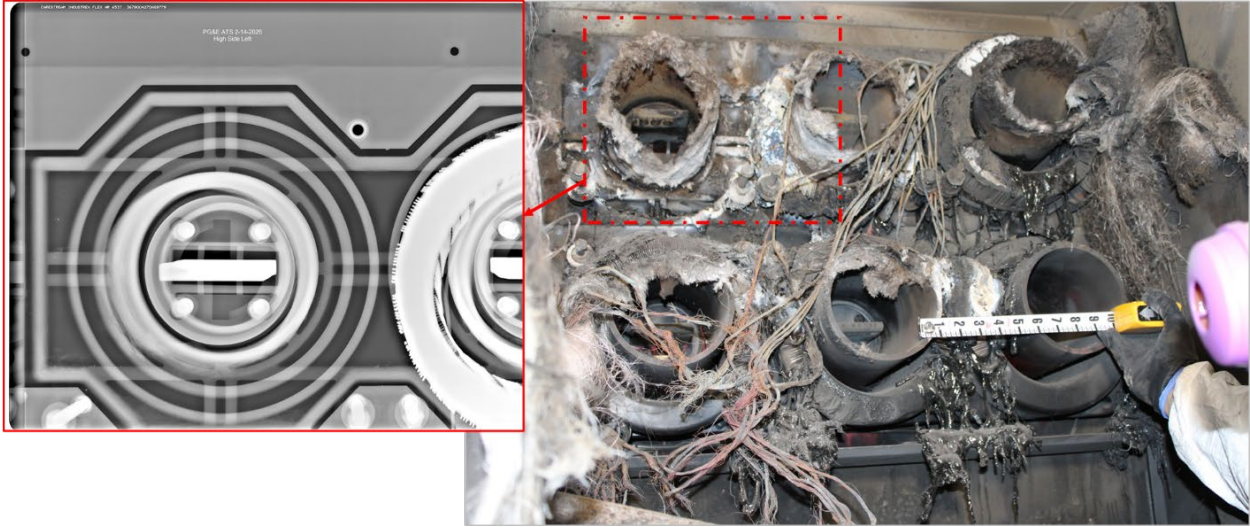
The bus work connections in the top of Cell No. 5 did not show metal erosion or evidence of arcing. There was light smoke and debris in the bottom compartment of Cell No. 5. Bus work and insertion taps in the back of Cell No. 5 also did not show evidence of arcing. This was further confirmed by X-ray imaging and destructive examination of the Incident Cubicle.

Figure 26. X-ray imaging at the back of the Incident Cubicle did not show evidence of metal erosion and arcing at the current transformers or the busbar tabs entering the cubicle.

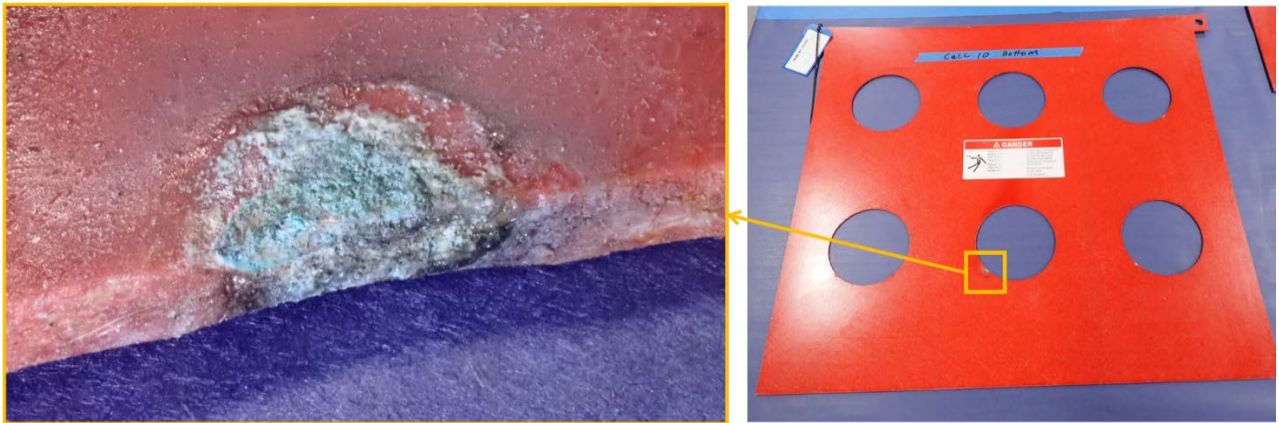
Several of the barrier insulating boards exhibited signs of mechanical damage as well as thermal damage, consistent with previously observed damage patterns indicating contact between the breaker arms and the edges of the through-holes. Two boards showing more pronounced damage, specifically the barrier insulating boards from Cell No. 6 and Cell No. 10, bottom cubicles, were selected for additional examination (Figure 29 and Figure 30). The barrier insulating board from Cell No. 10, bottom cubicle, also showed signs of mechanical damage indicating physical contact with the breaker arm (Figure 31).

Figure 29. Thermal damage on the barrier insulating board from Cell No. 10 (bottom) of the 12 kV bus section D.

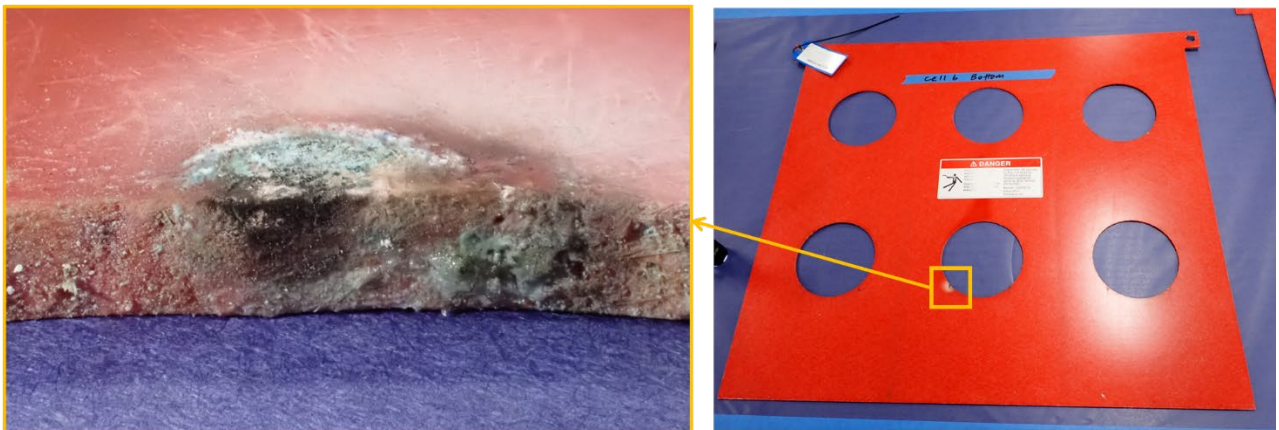
Figure 30. Thermal damage on the barrier insulating board from Cell No. 6 (bottom) of the 12 kV bus section D.

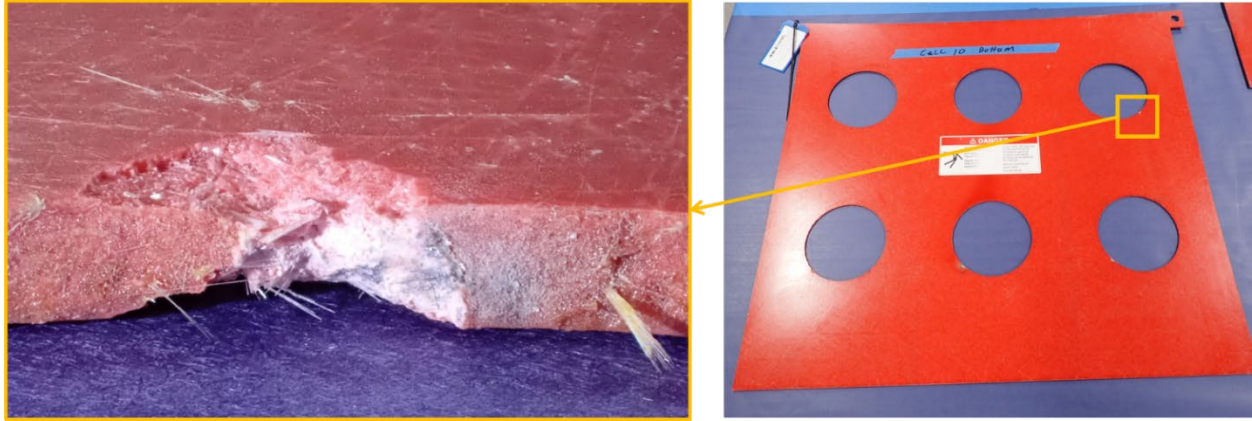
Figure 31. Mechanical damage on the barrier insulating board from Cell No. 10 (bottom) of the 12 kV bus section D.

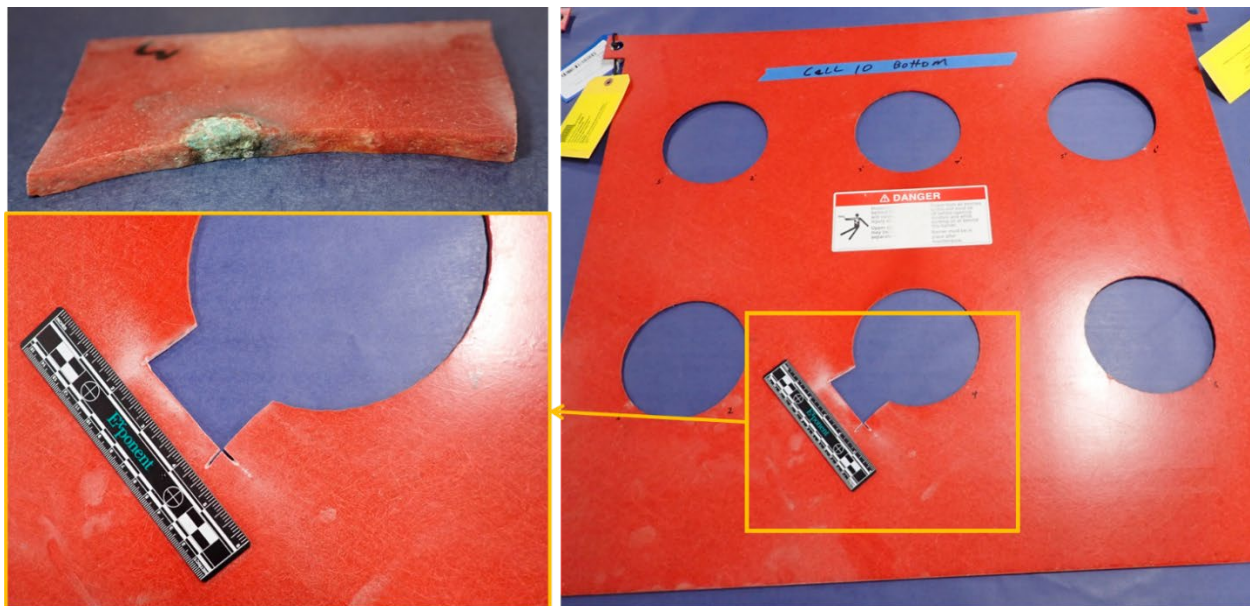
Next, the areas with the most visible damage at the edges of the through-holes on the barrier insulating boards from Cell No. 6 and Cell No. 10 were carefully cut out of the boards. The cuts were made sufficiently far from the visible damage locations to preserve the integrity of the damaged regions within the extracted samples (Figure 35 and Figure 36). No visible carbonization channels or internal material charring indicative of insulation degradation were observed at the cut edges (Figure 37). This suggests that the insulation failure at the Incident Insulating Board was external to the board rather than within its width.

Figure 35. Area with most damage cut from the Cell No. 10 (bottom) barrier insulating board

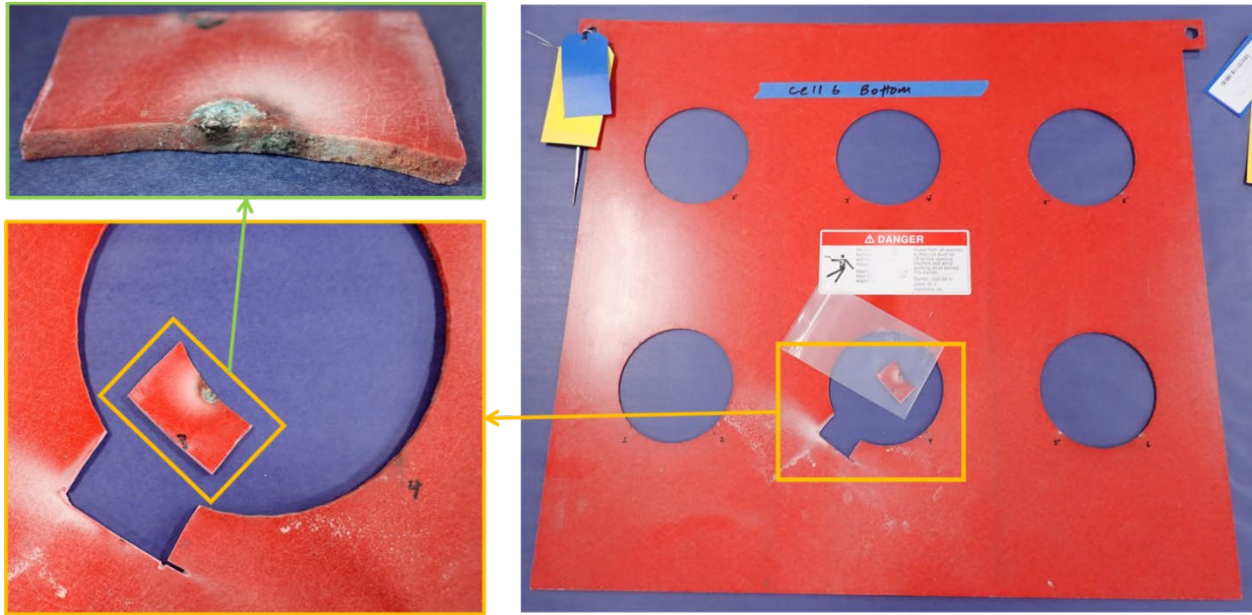
Figure 36. Area with most damage cut from the Cell No. 6 (bottom) barrier insulating board

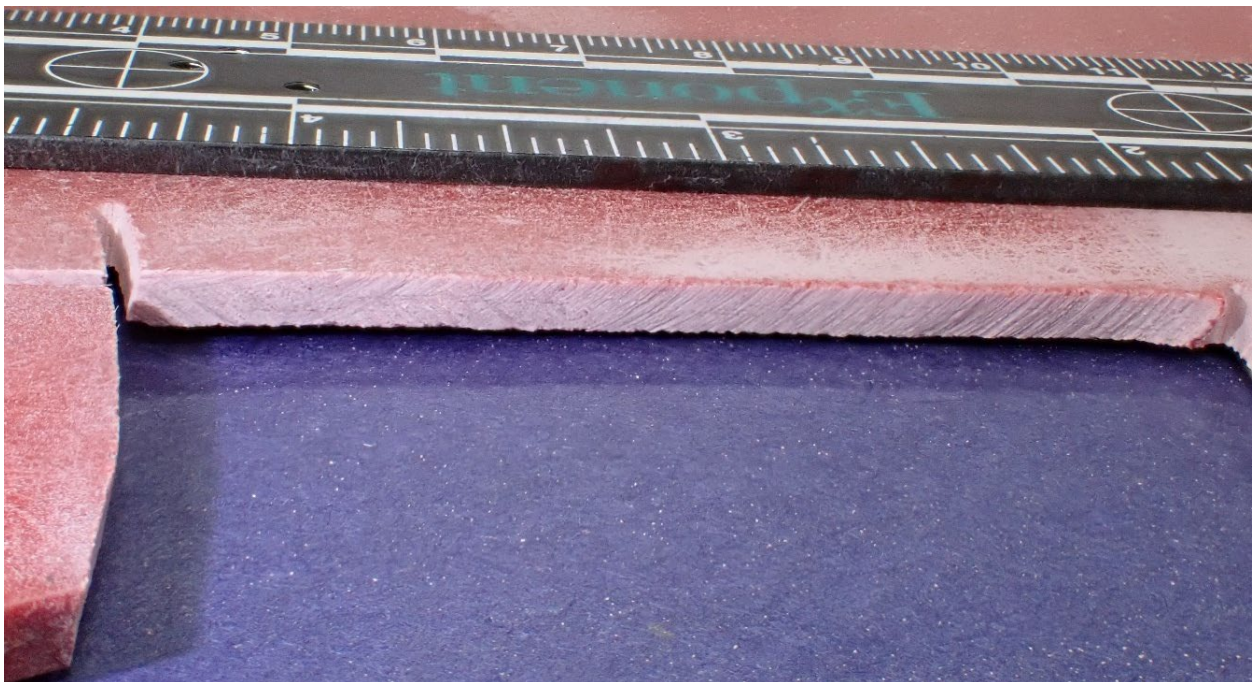
Figure 37. No visible evidence of carbonization channels at the cut edges of the examined barrier insulating boards
