File No. 260035

Hearing to discuss the cause(s), escalation, response, and impacts of the widespread power outages that began on December 20, 2025, and which have disproportionately affected residents and small businesses in the Richmond, Sunset, Presidio, Civic Center, South of Market (SOMA), and other San Francisco neighborhoods, to understand how a localized substation incident escalated to affect nearly one-third of the City; to assess communication failures and gaps in emergency response protocols; to evaluate economic impacts on small businesses and hardships faced by seniors, persons with disabilities, and other vulnerable residents; to discuss and understand the remedies, claims processes and support being provided to affected residents and businesses; and requesting the Pacific Gas and Electric Company (PG&E) to report.

Direct Cause Evaluation

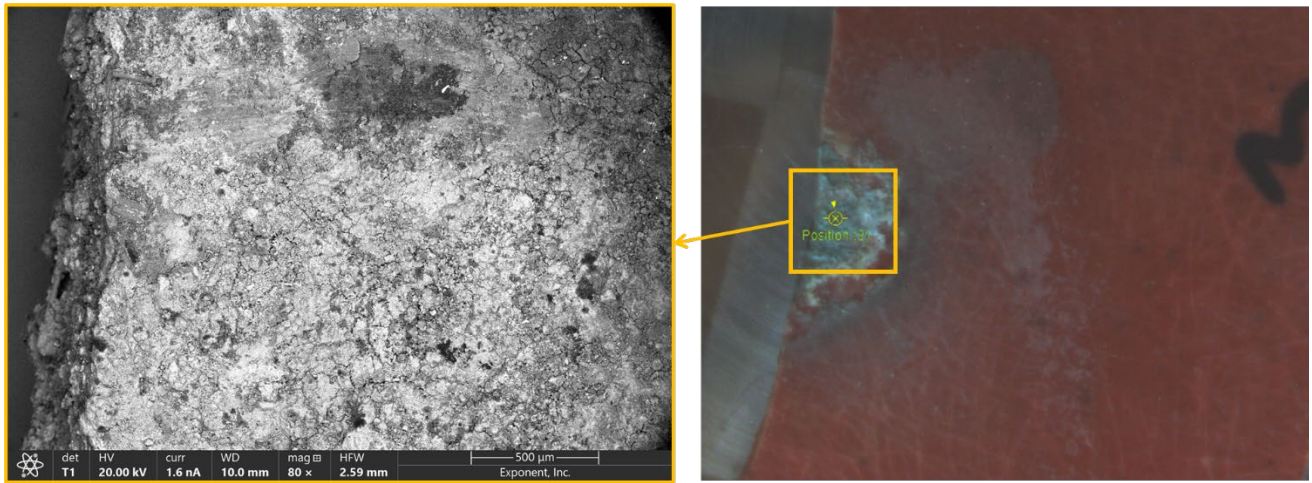
The cut samples were then mounted in epoxy and polished to target surfaces. The polished cross sections indicate that the observed damage originated from the outside of the board inward (Figure 40). This further suggests that the insulation failure at the Incident Insulating Board was external to the board.

Figure 38. SEM image of the damaged surface of the barrier insulating board from Cell No. 10 (bottom)

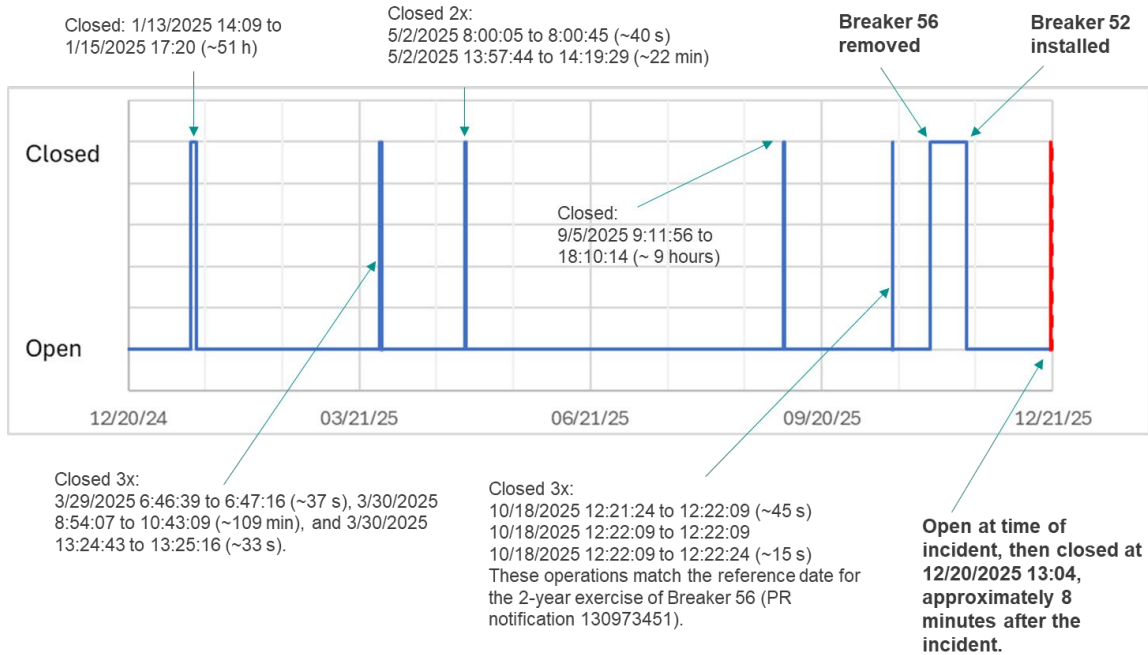
Figure 42. 1112/12 switching history in the year prior to the arc-flash event. Close Breaker position after the arc-flash event cannot be verified.
