November 19, 2017

Prepared for San Francisco Arts Commission

Condition Assessment

This site specific artwork is the Diamond Heights Safety Wall, 1968, by Stefan Alexander Novak (b.1918-2006).

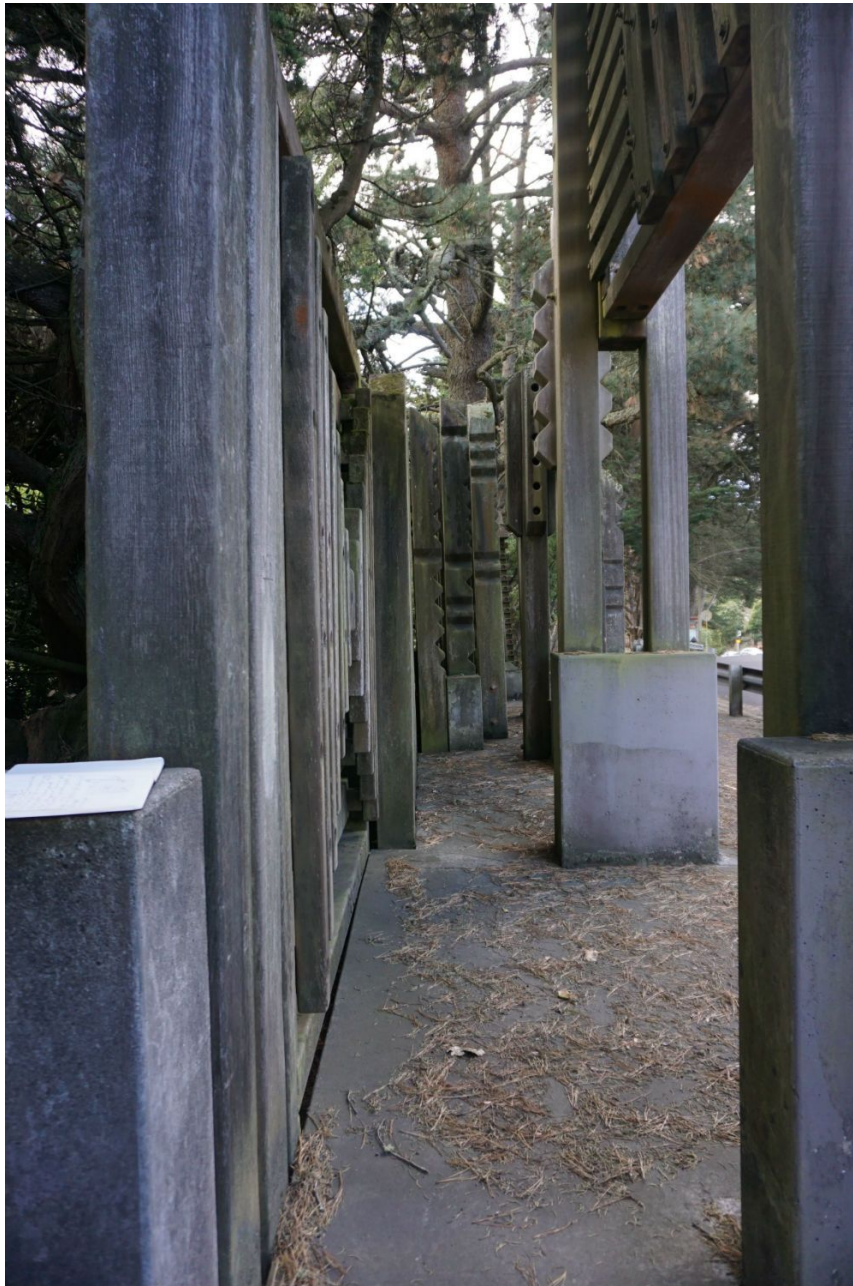
- Structural: There appears to be some subsidence of the concrete slab footing the artwork. It appears to be sinking and below grade towards the rear wall from the road, (towards the South). An examination of the foundation beneath the artwork could not be accessed since it is located in a private yard, although assessing the condition is a priority. (See Figure 1)

- Structural: The rear wall could also be impacted by the attachment of garden fences to the rear Southern side of the artwork.
- Structural: The concrete slab may also be below grade on the Proper Right End, so sinking towards the West.

Figure 1: A View of the Interior of the Artwork Looking Towards the East. The slab appears to be subsiding towards the rear wall.

- A full review by a structural engineer is recommended to assess the subsidence of the structure, foundations, impact of the pine tree and garden fences, and integrity of the bolting system to ensure the long term preservation of the artwork.

Structural repairs as recommended by the structural engineer

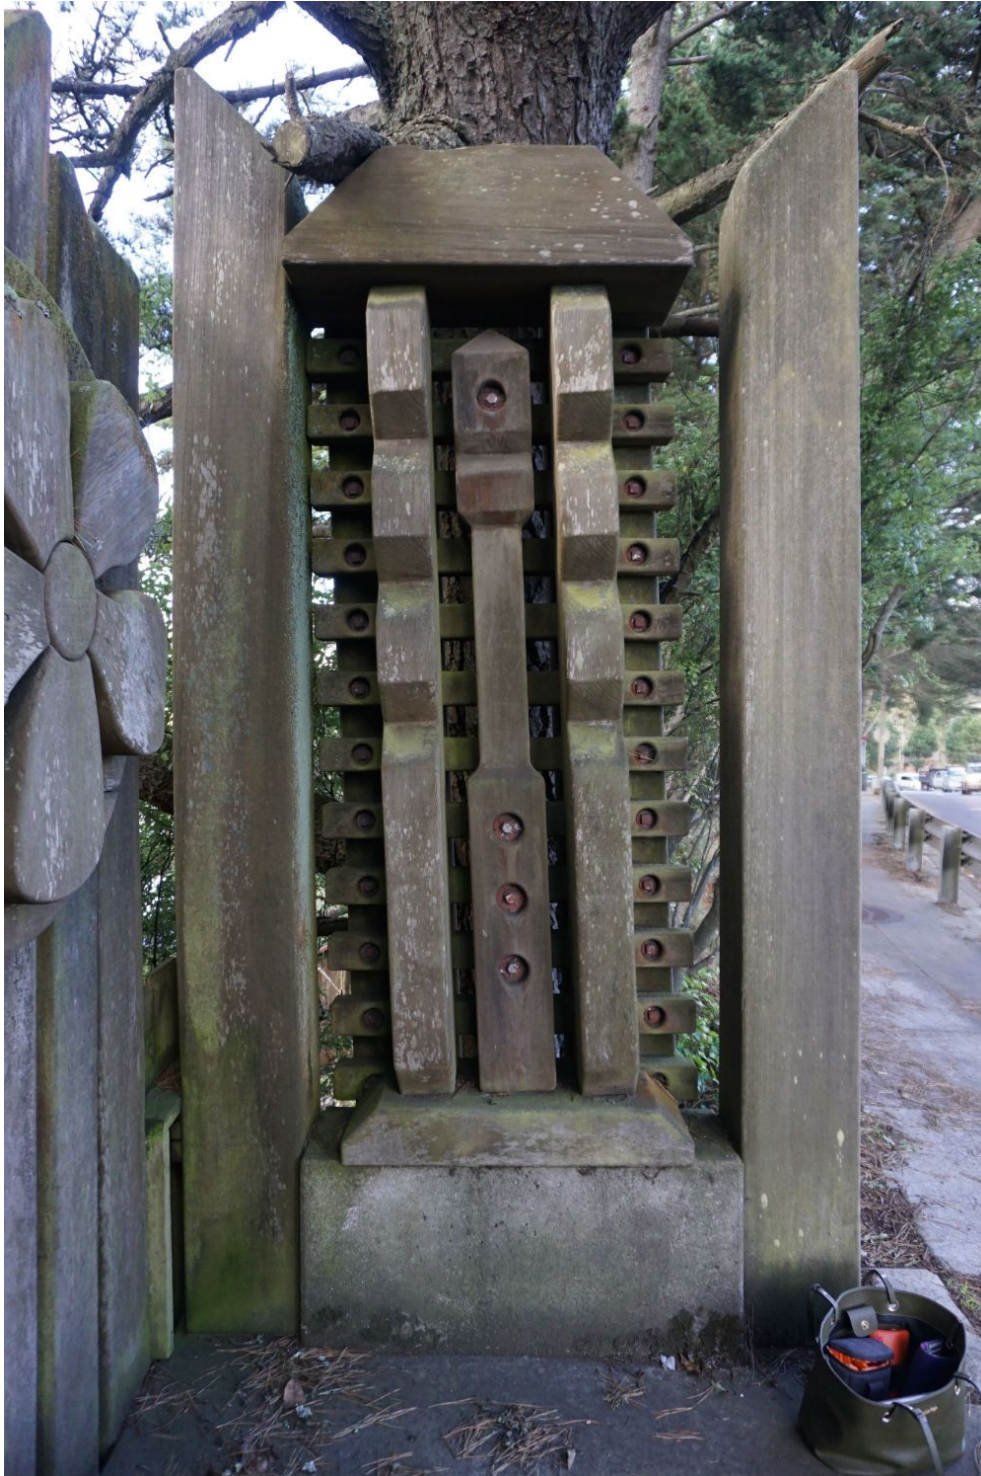
- Structural: Another concern is the proximity of trees to the artwork, in particular a large pine tree to the Eastern end. There were no trees when the artwork was installed, and the artist's intent was to enable the sunlight to penetrate uninterrupted through the structure. The branches of the tree have been trimmed, but branches are still leaning onto the eastern end of the artwork, and pushing the upright posts out of the vertical orientation. This, and the tree roots may also be undermining the foundation. (See Figure 2)

Figure 2: Group 1
Verticals Leaning Under Pressure of the Tree Branch

Removal of the trees

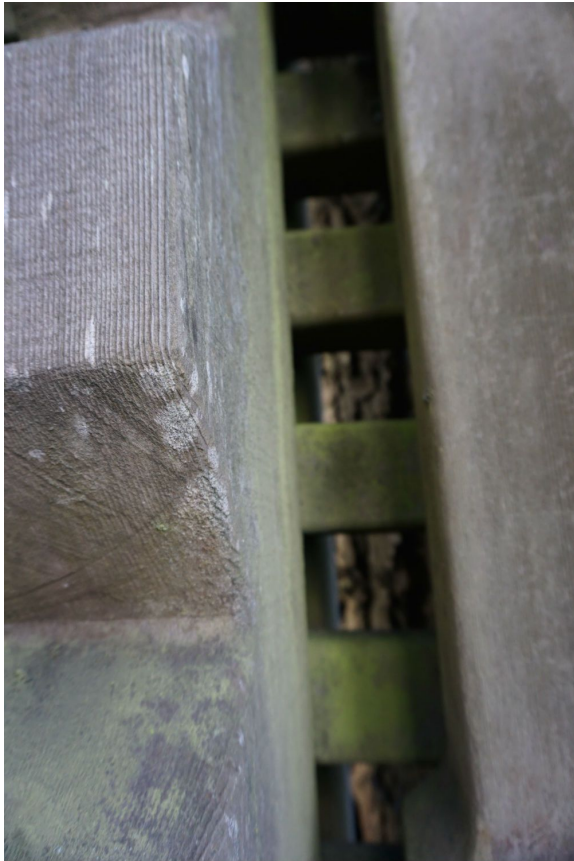
- The proximity of the trees is also an issue since it is forming a microclimate encouraging biogrowth. The area where the artwork is located is a particularly foggy part of San Francisco, however the extent of biogrowth on the piece is excessive. Green biogrowth was noted overall in addition to orange and brown algae and lichens and moss. There was also a covering of pine needles and other organic material on most surfaces. (See Figure 4)

Figure 3: Green Biogrowth Present on Group 1 (Left)

Overall cleaning to remove biogrowth and organic material

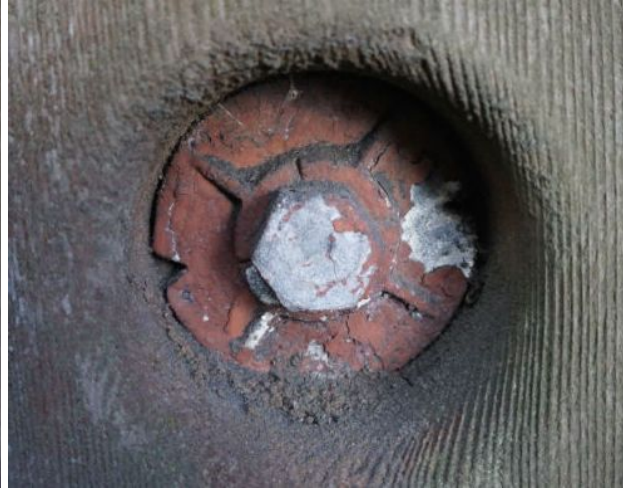
- Structural: The bolts and rods connecting the elements appeared to be generally in good condition, although some rusting of exposed surfaces was noted, especially where the paint had deteriorated. Approximately 50% of the paint on washers and bolt heads was deteriorated across the artwork. All fasteners should be checked for tightness and stability. (See Figure 3)

Figure 4: Bolt Head and Washer with Deteriorated Paint Layer (Right)

Repainting of the bolt heads and washers

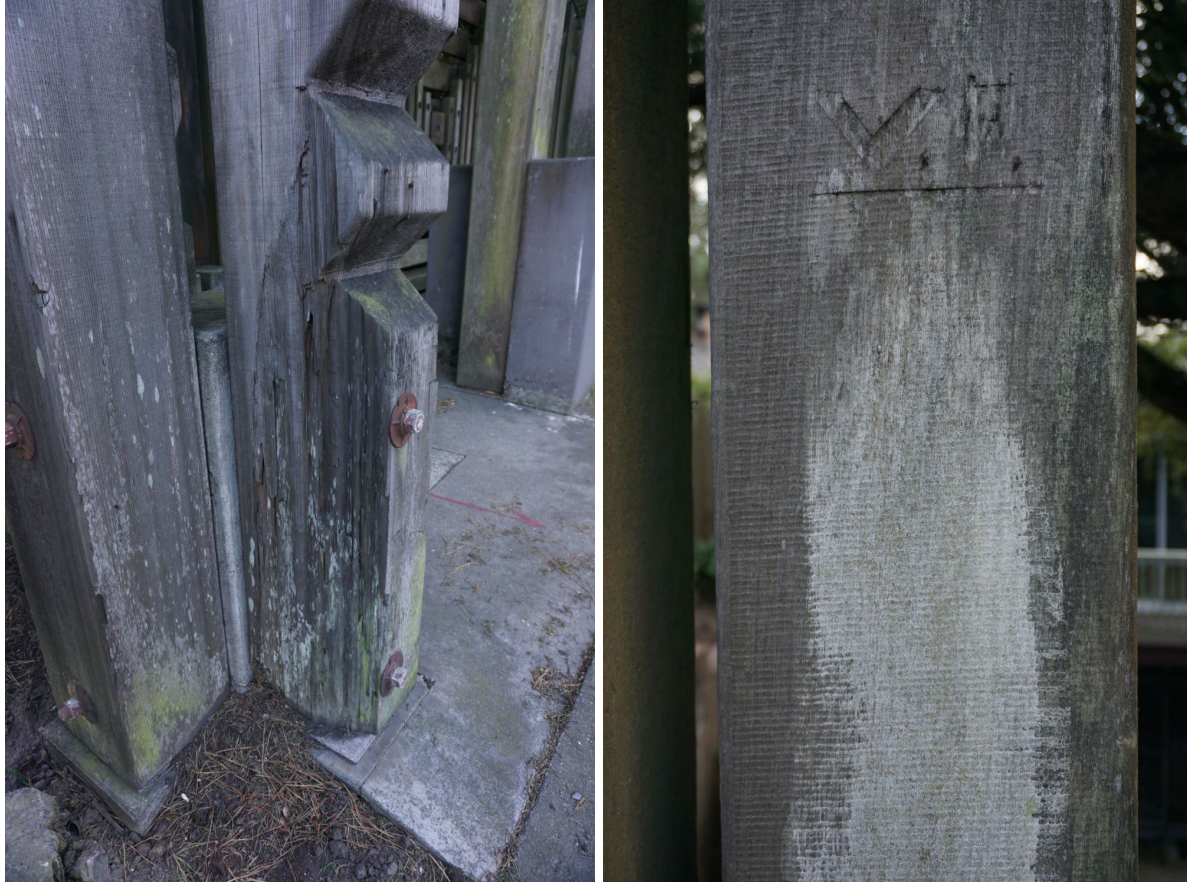
- The outermost post of group 8 that faces the road, has a large loss to the timber at the bottom of the post. This is possibly from a collision or vandalism, and does not appear to appear to be from wood rot or infestation. (See Figure 5)

- There are a number of areas where graffiti has been scratched in and tags painted over. Painted over tags were noted on both redwood posts and most of the concrete blocks. It also appears that people may have climbed the 'tower' and graffitied in white paint on upper areas. (See Figure 6)

Figure 5: Group 8-Loss of Timber to Outermost Post (Left)

Figure 6: Scratched in Graffiti and Painted Out Tags

Fill of the large loss to the post in group 8

Removal of tags and overpaint
