STATUTORY EXEMPTION APPEAL

Embarcadero Fountain (a.k.a. “Vaillancourt Fountain”) Removal

RE: **Board File No. 251202**
Planning Record No. 2025-010275APL
Appeal of Statutory Exemption for Embarcadero Fountain Removal

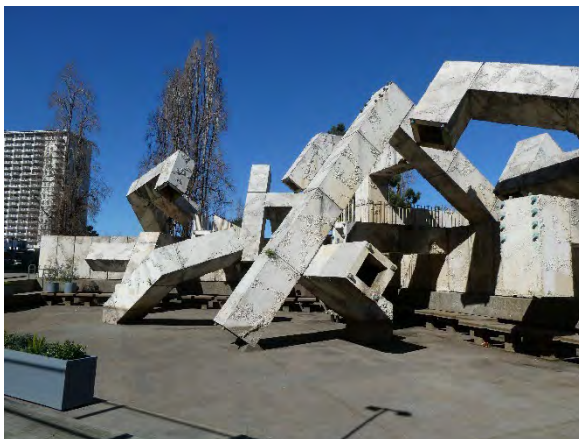
Typical overall condition of concrete pool, looking north.

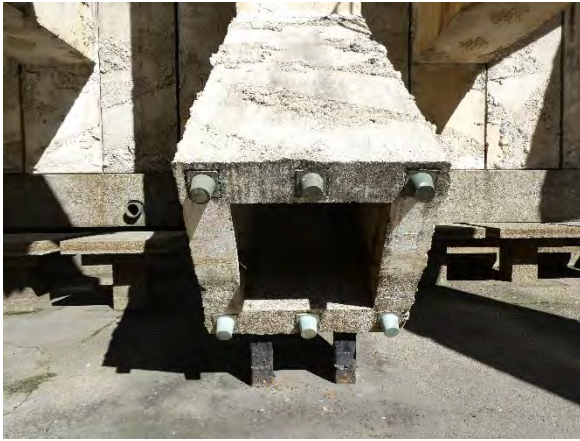
Typical condition of concrete pool and connections between concrete pool and hollow pre-cast concrete “arms,” showing cracking, biological growth, soiling, and corrosion at connections.

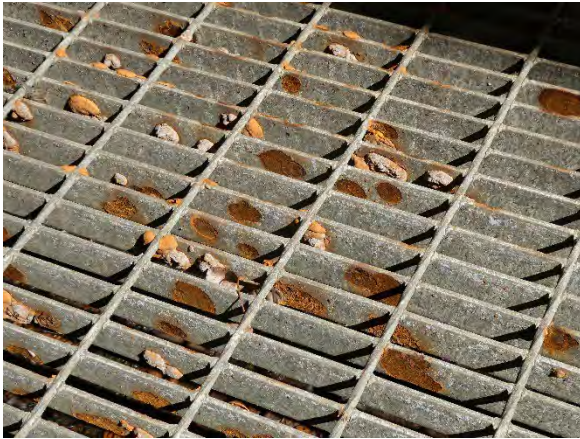
Typical corrosion at metal grate over sump pit.

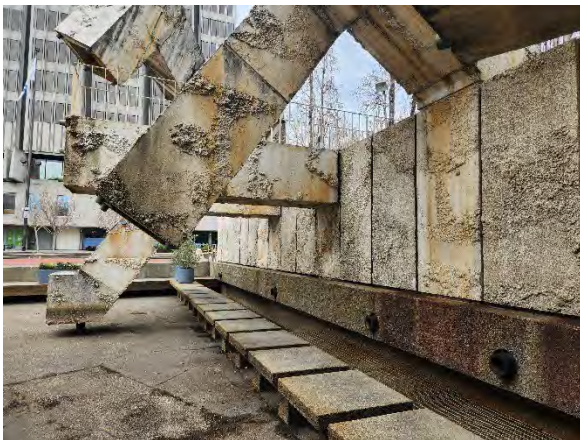
The concrete pedestals are generally in good condition, exhibiting some chipping at the edges and soiling, but otherwise appear sound without significant cracking, incipient spalls, or other spalling.

Typical overall condition of concrete “lily pad” pedestals, north side of fountain, looking west.

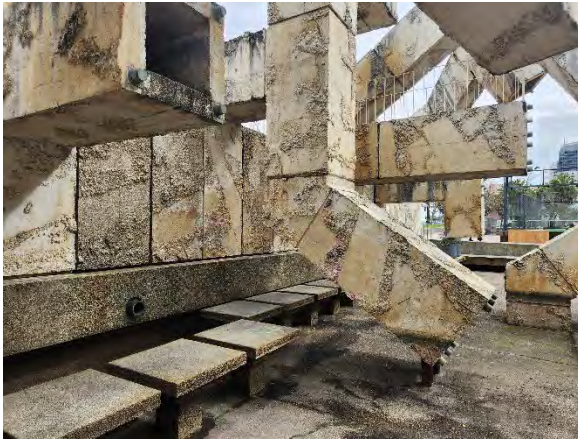
Typical overall condition of concrete “lily pad” pedestals, east side of fountain, looking southeast.

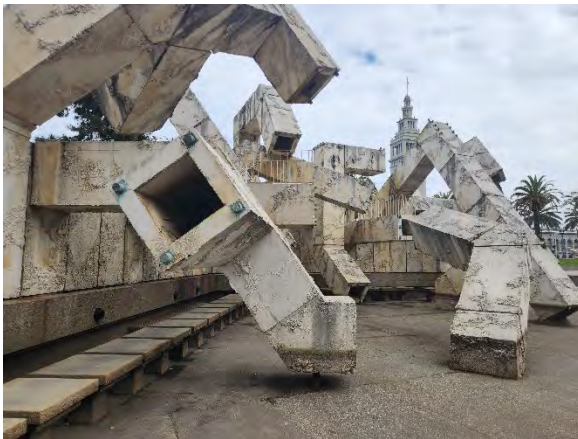
Typical overall condition of concrete “lily pad” pedestals, north side of fountain, looking east.

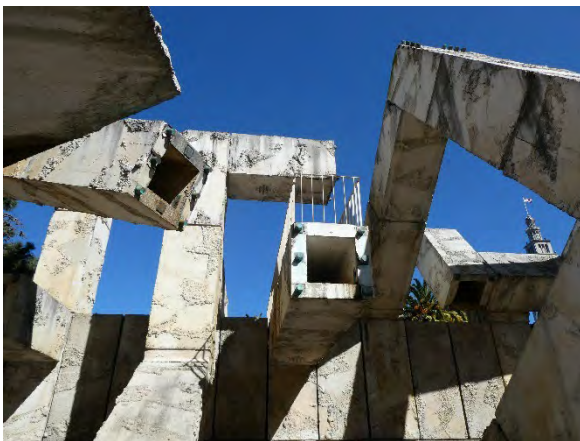
Overall view and condition of hollow, pre-cast concrete arms of fountain, looking east.

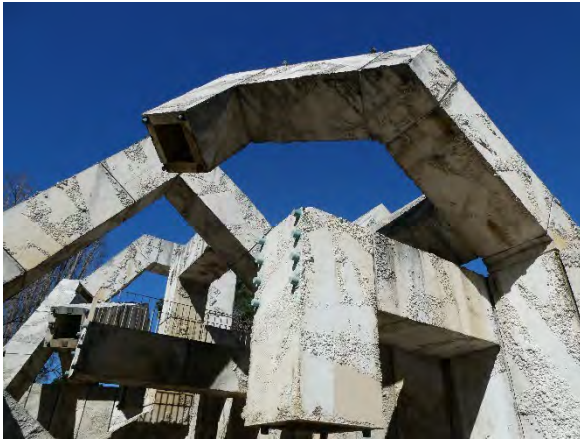
Overall view and condition of hollow, pre-cast concrete arms of fountain, looking north.

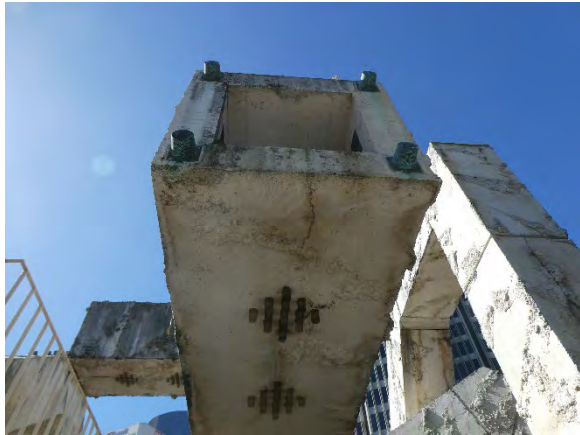
Central crack at lower side of projecting column, typical condition. Northeast elevation pictured.

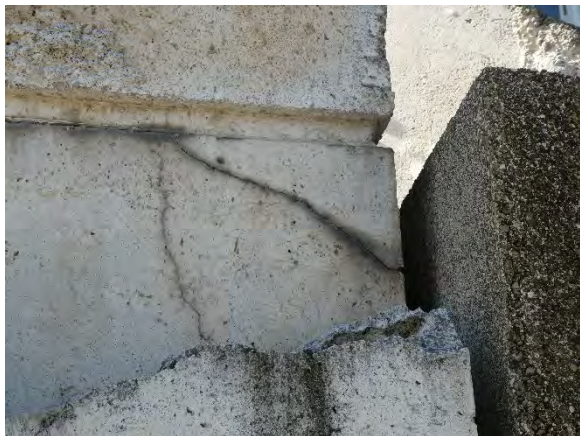
Incipient spalling and cracking at joint of vertical column, typical condition. Northeast elevation pictured.

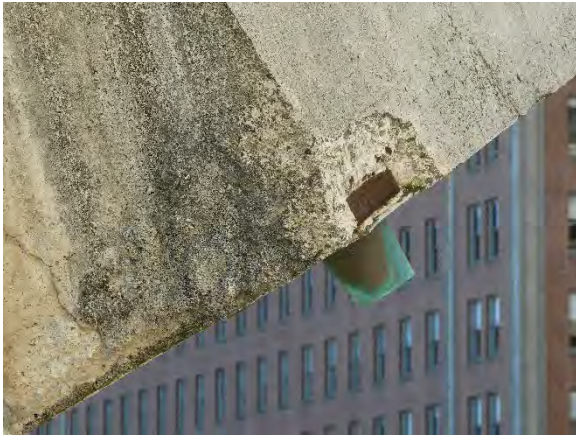
Spalling at the outer corners of the projecting column, typical condition. Image taken facing south.

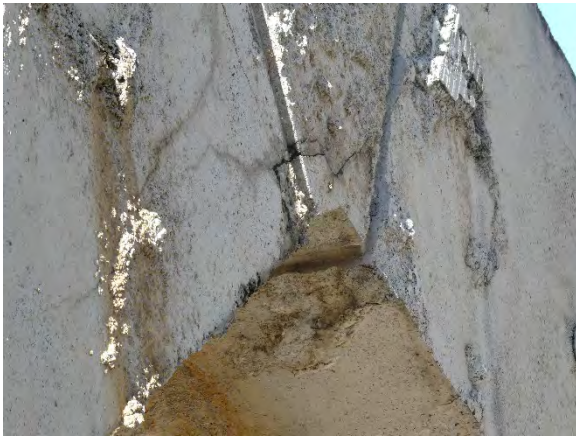
Incipient spall and cracking at joint of projecting column, typical condition.

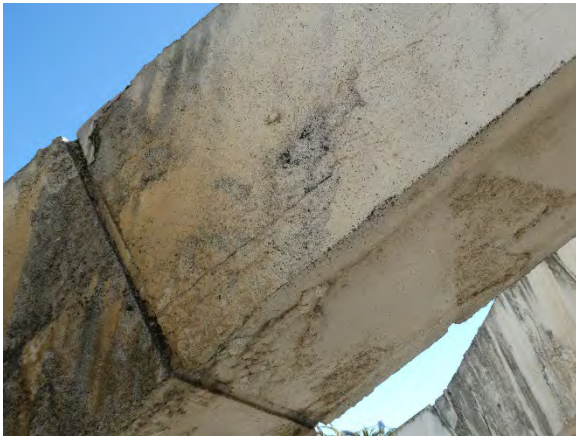
Cracking at the joint along the underside and side of projecting column, typical condition.

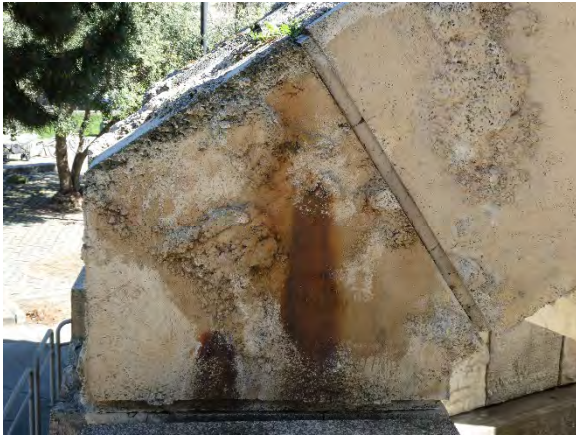
Corrosion of metal fixtures, typical condition. Photo facing west from viewing platform.

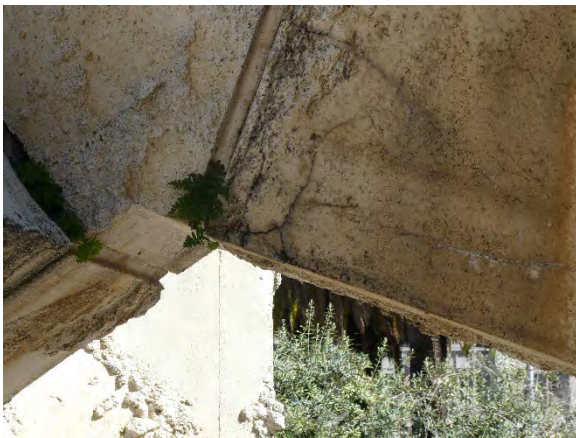
Incipient spalling and cracking at joint of projecting column, typical condition. Biological growth within several cracks.

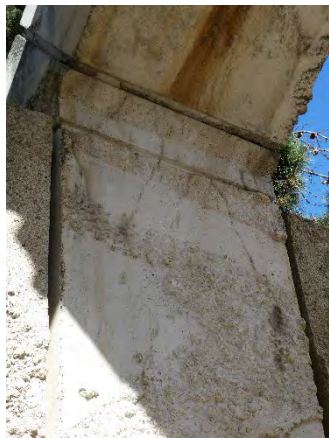
Cracking at joint along the underside of projecting column, typical condition.

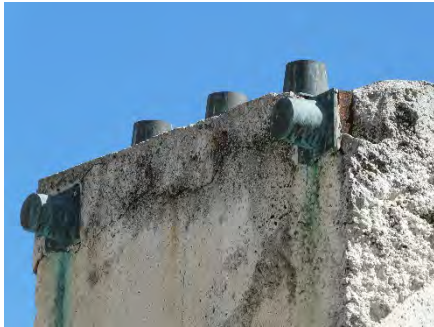
Spalling, incipient spalling, cracking, and corrosion of copper fixtures. Typical condition.

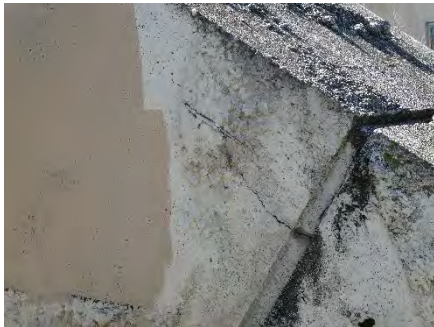
Incipient spalling at upper joint of projecting column. Typical condition.

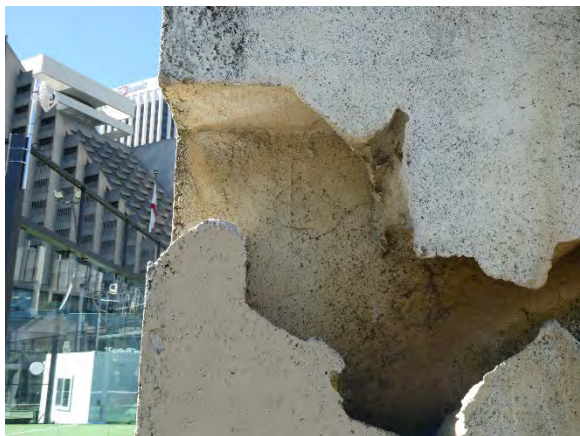
Hairline crack, typical condition. Southern edge of the northeast elevation pictured.

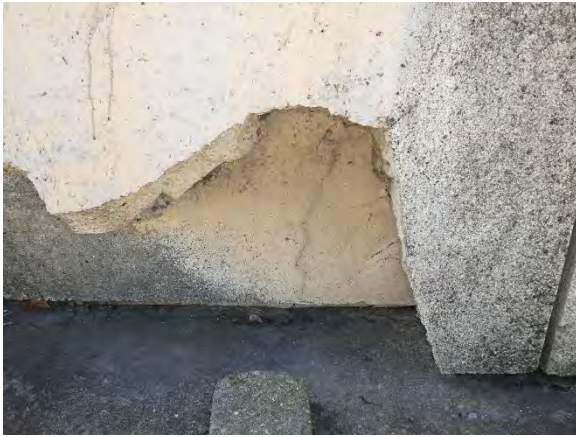
Cracks at base, typical condition. Northeast elevation pictured.

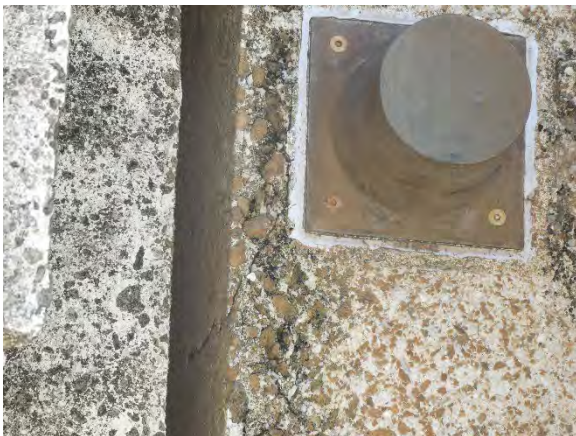
Incipient spalling adjacent to metal fixture, typical condition. Northeast elevation pictured.

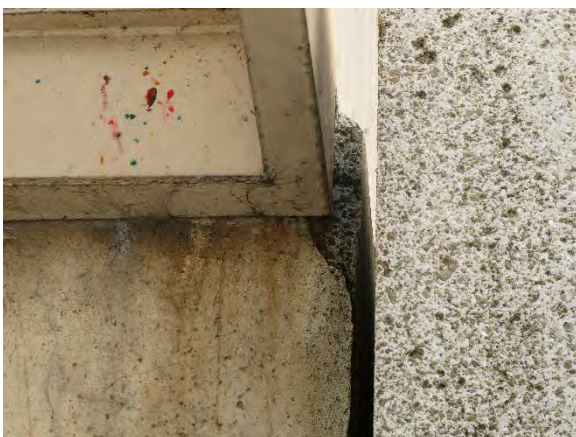
Incipient spalling at the joint beneath metal stair platform, typical condition. Northeast elevation pictured.

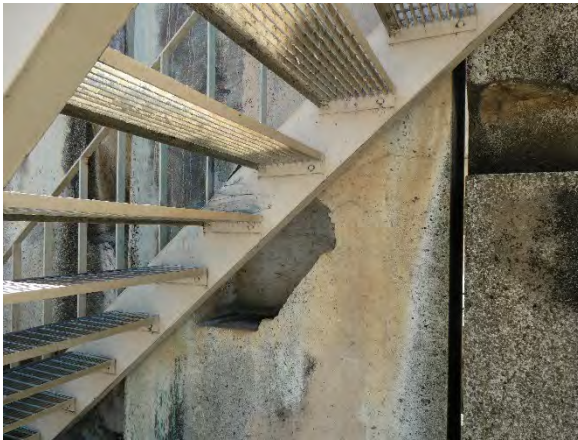
Typical condition of the underside of the painted steel stairs on the east side of the fountain, exhibiting soiling but minimal if any corrosion.

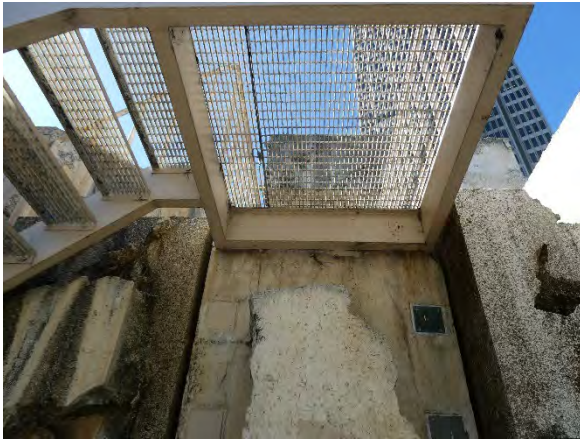
Typical condition of underside of east viewing platform landing and stairs.

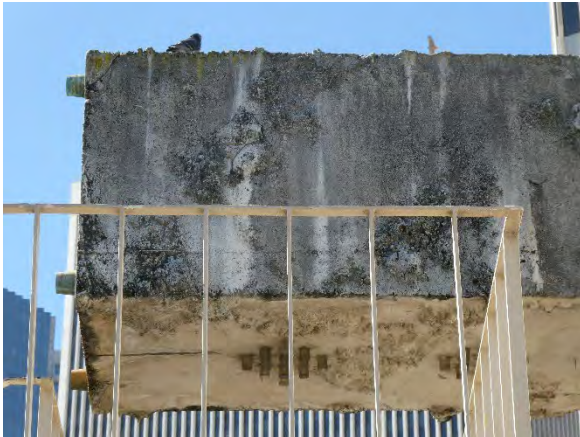
Typical condition of platform and landing railings.

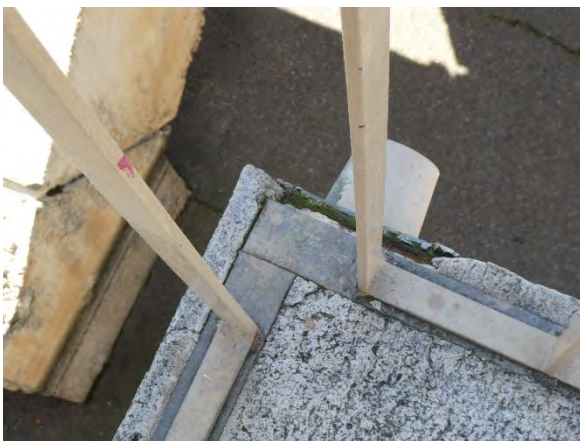
Detail of spalled concrete at the edge of the railing attachment.

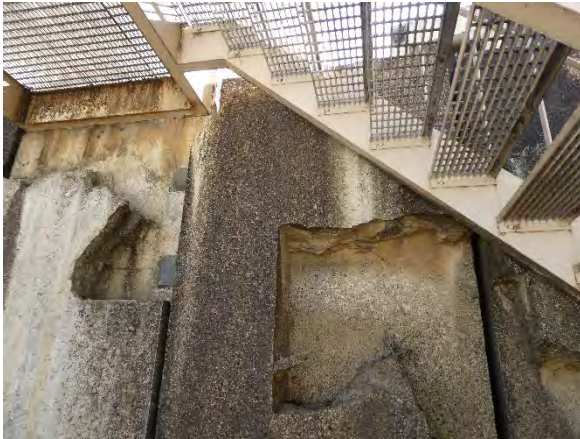
Typical condition of the painted steel stairs with soiling, and some minor surface corrosion at edges of the landing frame.

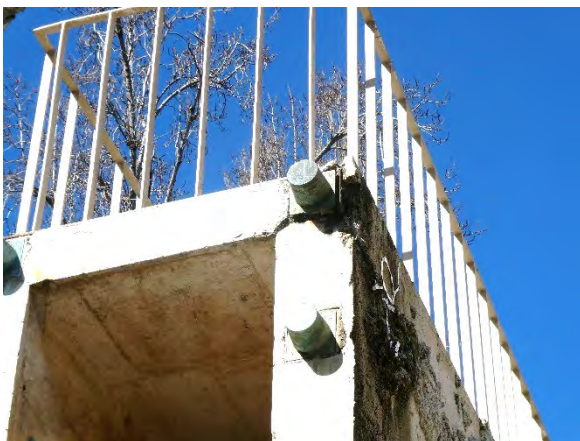
Detail of typical cracking and spalling around the bottom of the viewing platforms due to corrosion of the supporting and reinforcing steel.

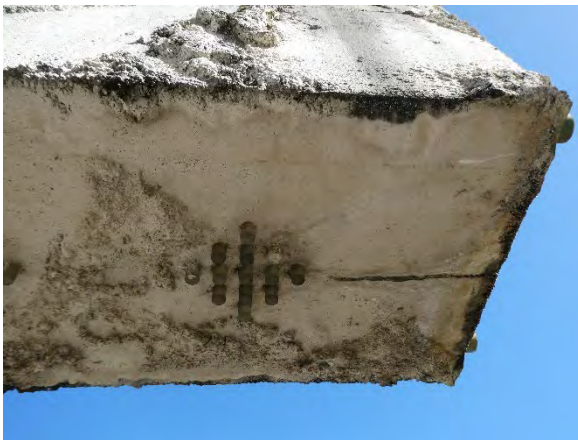
Detail of glass cylinders in the hollow pre-cast concrete arms, associated cracking, and efflorescence.

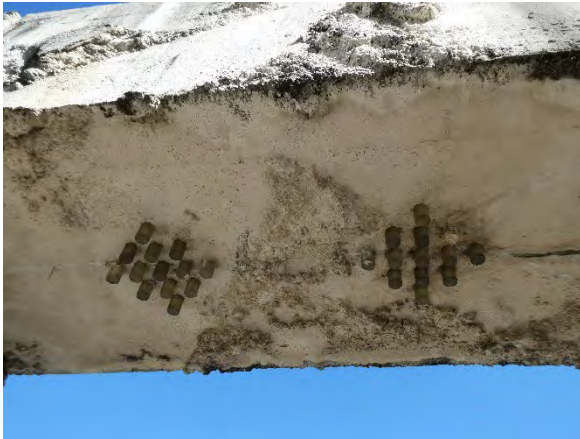
Detail of glass cylinders in the hollow pre-cast concrete arms, associated cracking, and efflorescence.

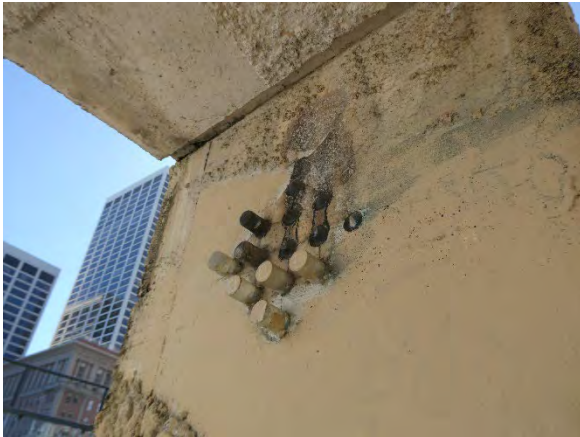
Detail of broken and painted glass cylinders in the hollow pre-cast concrete arms.

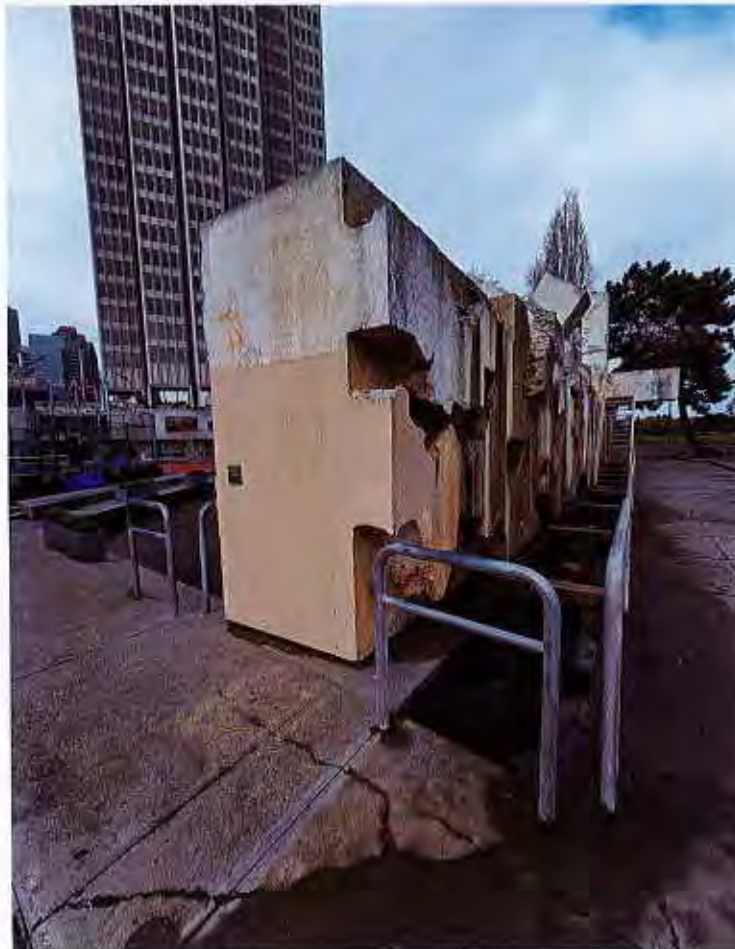
Photo 4. Rear wall – no reinforcing steel was found.

The scanning report also indicated that the precast elements along the back-wall of the fountain are unreinforced. However, the original drawings indicate that these free-standing units are anchored to the mat foundation with $\frac{3}{4}$ " diameter bars at each corner.

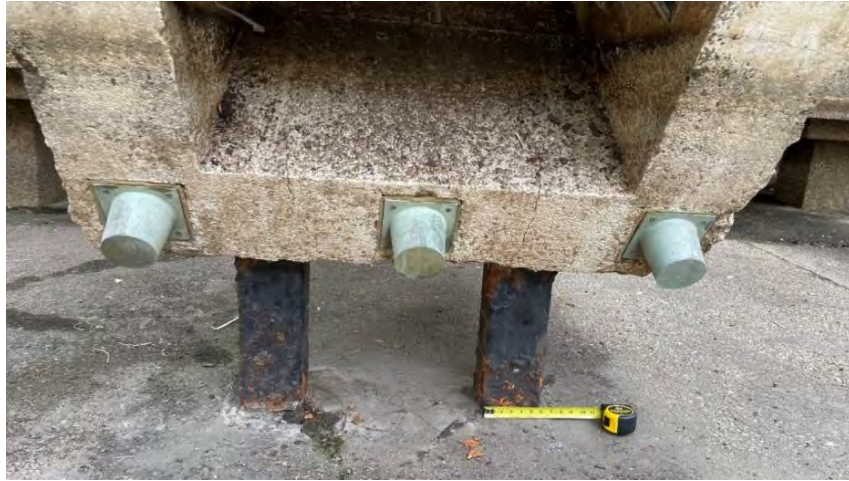
Various signs of structural damage and deterioration due to corrosion were observed during the site observation. At the floor of the sunken pool, various precast frame sections were observed to be supported on 6x6 steel tube pedestals or concrete pedestals. All the steel tubes were noted to be heavily corroded (reference *Figure 8*). This is expected as a result of the constant immersion in water when the fountain was operational, as well as the continued exposure to the corrosive effects of the humid San Francisco marine air. The corrosion damage observed most likely impacts the structural integrity and ultimately the capacity of these steel tubes.

Figure 8: Vaillancourt Fountain - Corroded Steel Tubes and Spalled and Cracked Concrete

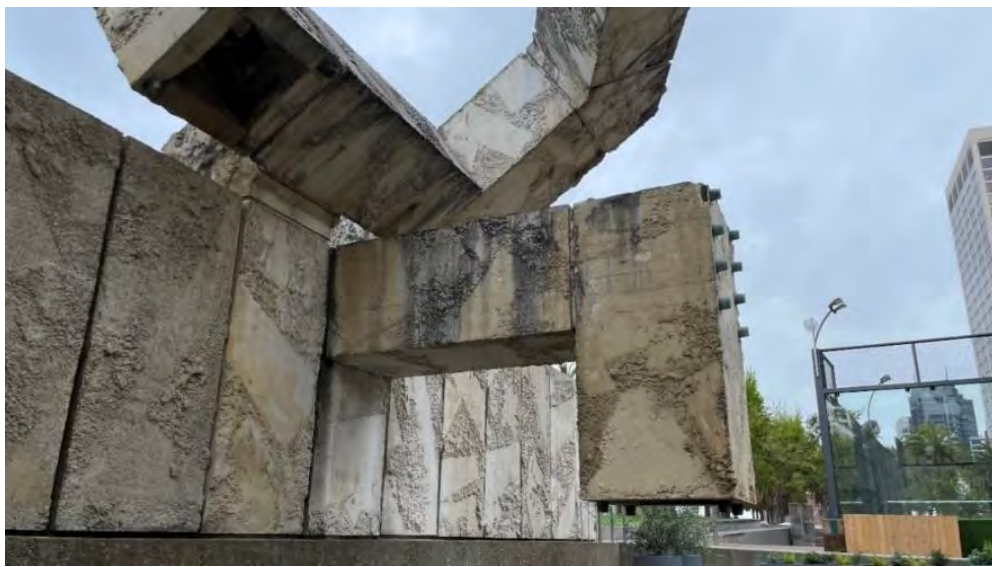
As mentioned, many of the precast concrete tube sections are connected by steel rods inserted through embedded steel tubes. These steel rods are anchored at square steel plates, which are embedded at the ends of the precast concrete tubes. The anchored steel rods are then covered with the previously noted conical caps to protect them from weather. At multiple sections, significant concrete spalling was documented behind the anchor plates. In addition, spalling at the joints between the precast concrete sections was observed in numerous locations. These spalled areas have further exposed the embedded steel anchor plates, as well as the reinforcement within the concrete, and facilitated extensive corrosion of the steel elements. Although it is not observable, the documented corrosion suggests the steel liner plates within the vertical precast concrete tubes are also likely experiencing significant corrosion and degradation.

Figure 9: Vaillancourt Fountain - Showing Spalled Ends

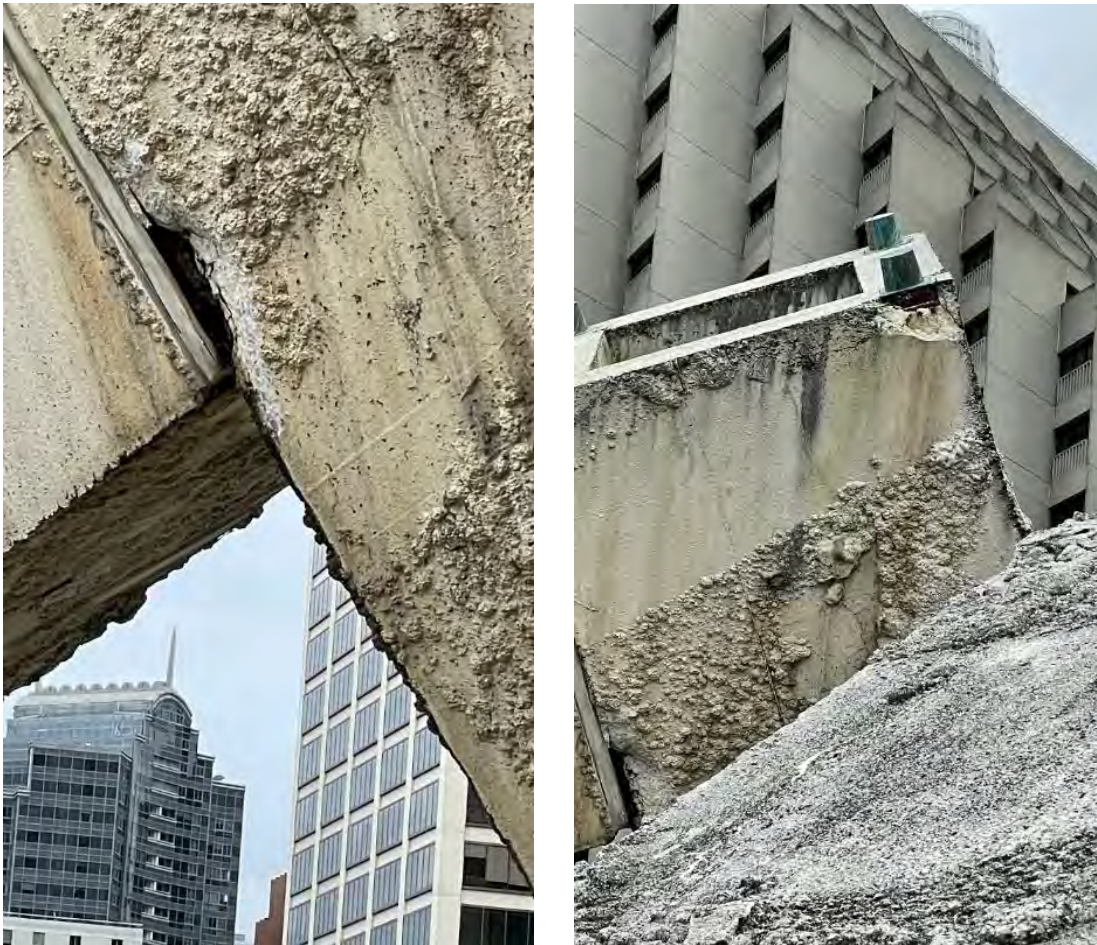
Figure 10: Vaillancourt Fountain - Spalled and Cracked Concrete and Corrosion of Steel Elements

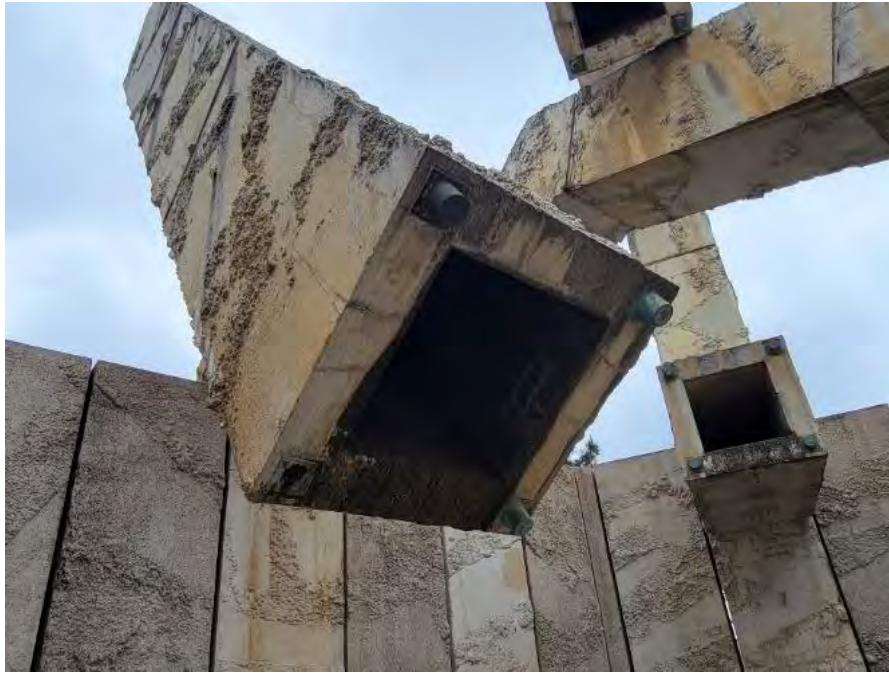
Figure 11: Vaillancourt Fountain – Showing Corroded End Plate and Absence of Thru Rod and Spalled Concrete Surface

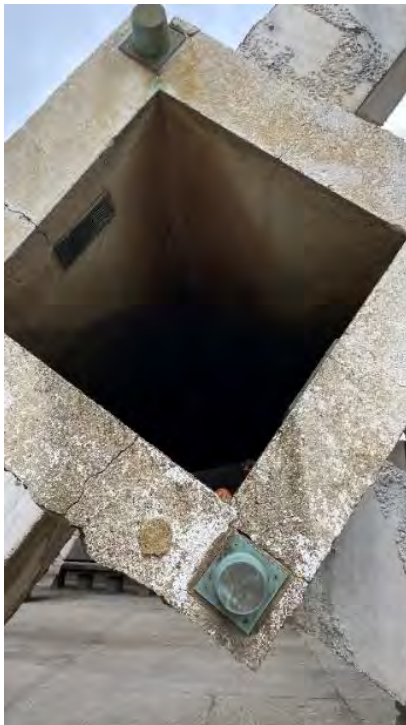
Figure 12: Vaillancourt Fountain Cracked and Spalled Concrete and Water Damage Stains

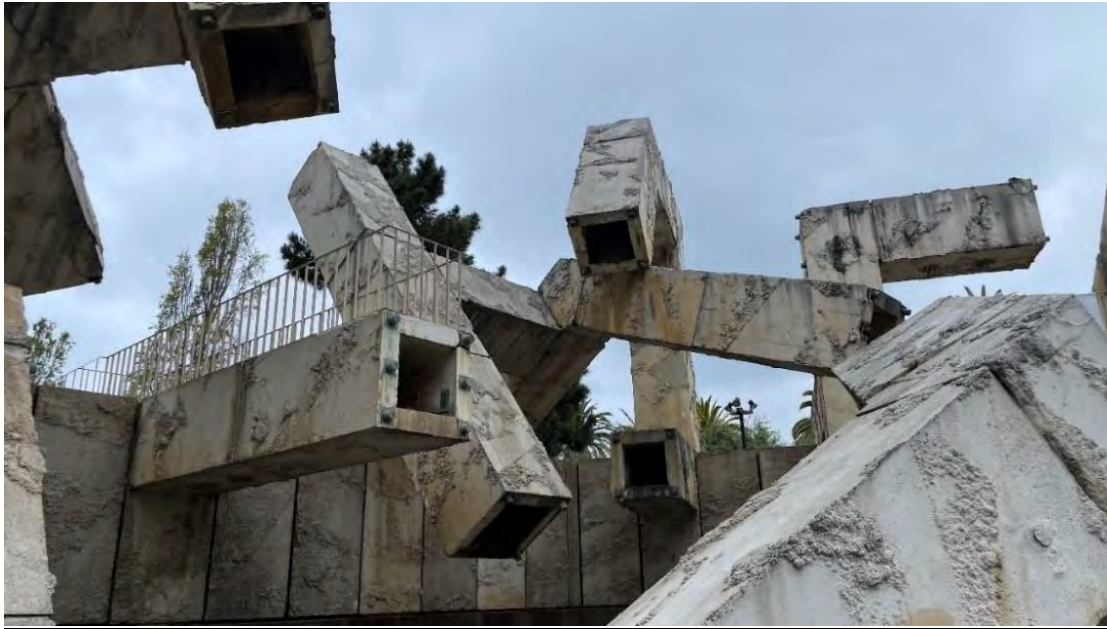
DCI Engineers identified a particularly critical condition involving the cane-shaped tube (T6), which has settled onto and is now physically bearing on the H-shaped (T4–T5) section below it.

DCI concluded that the stress cracks observed in the H-shaped section were likely caused by these unanticipated forces, resulting from the deformation and settlement of the cane-shaped tube due to yielding of the internal steel plates and corrosion of the reinforcing and post-tensioning rods that once stabilized the connections.

Figure 13: Vaillancourt Fountain – TS6 Frame on TS4-TS5 Assembly - Cracks and Corrosion

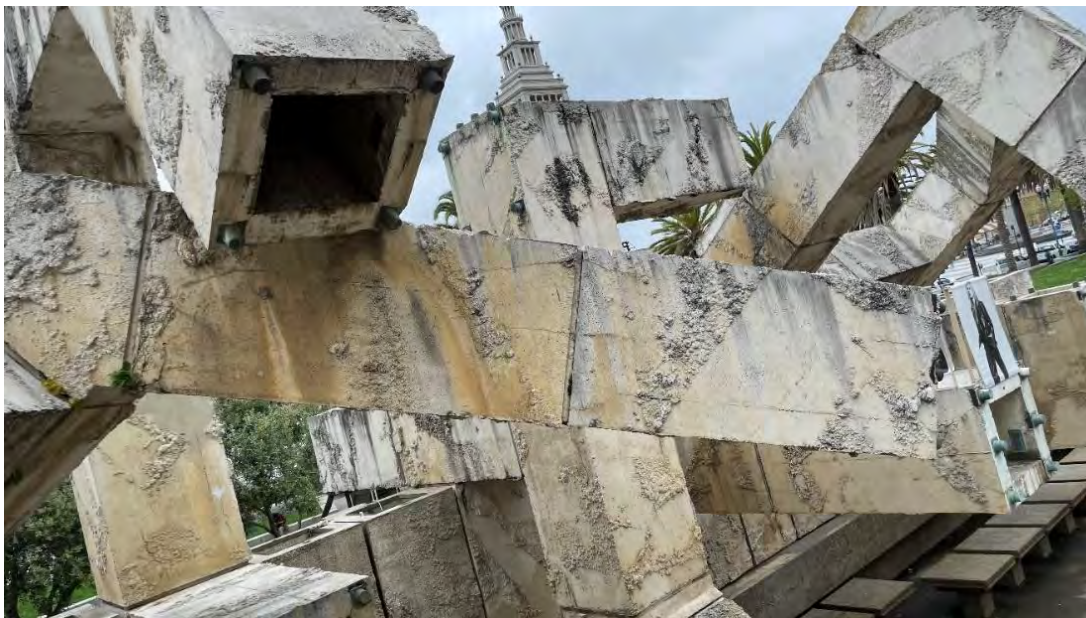
Figure 14: Vaillancourt Fountain – TS6 Frame resting on TS4-TS5 Assembly with Cracks and Corrosion Close Up
