# STATUTORY EXEMPTION APPEAL

## Embarcadero Fountain (a.k.a. “Vaillancourt Fountain”) Removal

**RE:** **Board File No. 251202**  
**Planning Record No. 2025-010275APL**  
**Appeal of Statutory Exemption for Embarcadero Fountain Removal**

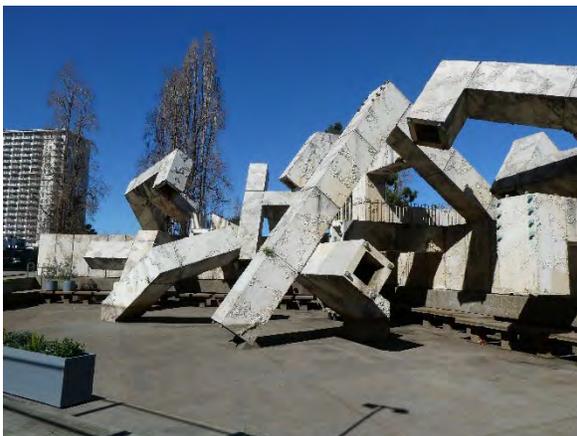
Typical overall condition of concrete pool, looking north.

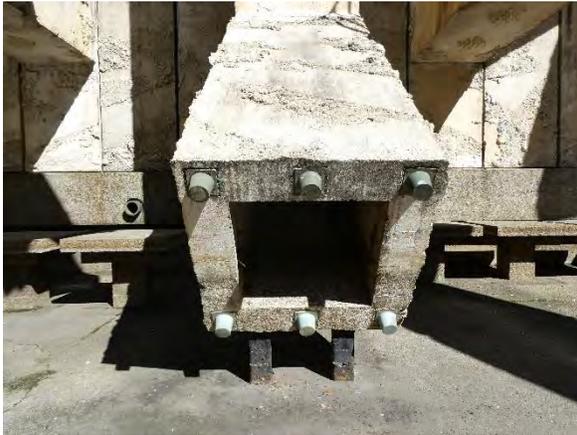
Typical condition of concrete pool and connections between concrete pool and hollow pre-cast concrete “arms,” showing cracking, biological growth, soiling, and corrosion at connections.

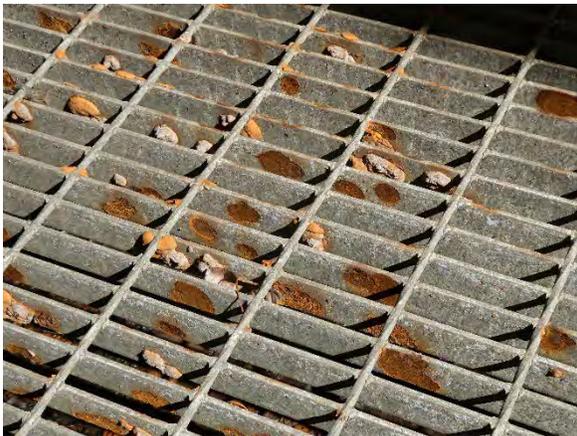
Typical corrosion at metal grate over sump pit.

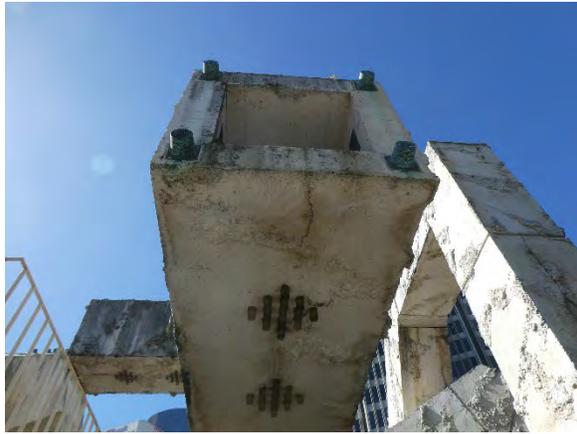
Central crack at lower side of projecting column, typical condition. Northeast elevation pictured.

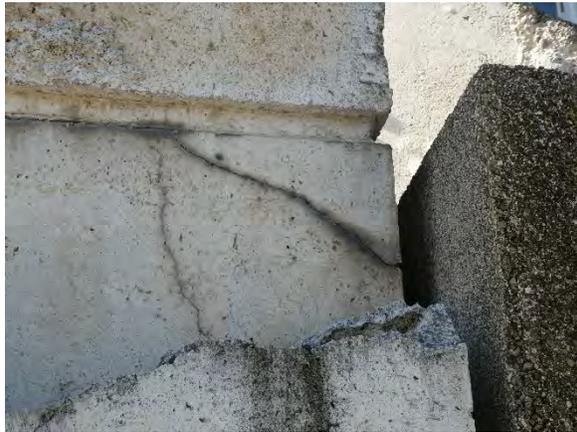
Incipient spalling and cracking at joint of vertical column, typical condition. Northeast elevation pictured.

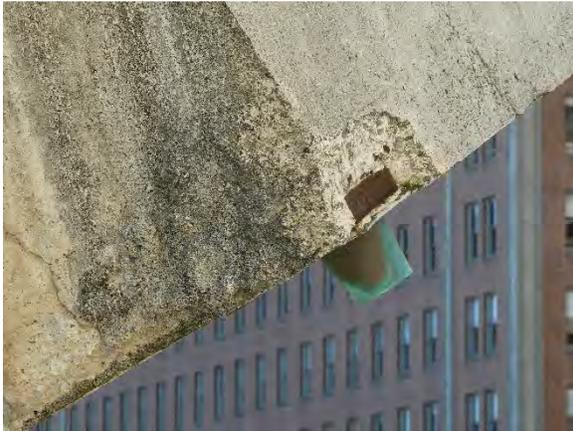
Spalling at the outer corners of the projecting column, typical condition. Image taken facing south.

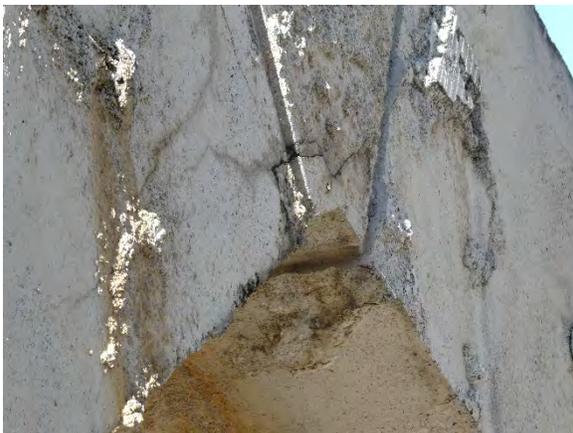
Incipient spall and cracking at joint of projecting column, typical condition.

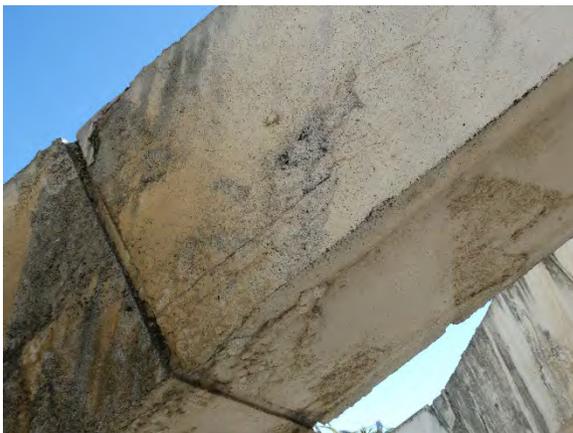
Cracking at the joint along the underside and side of projecting column, typical condition.

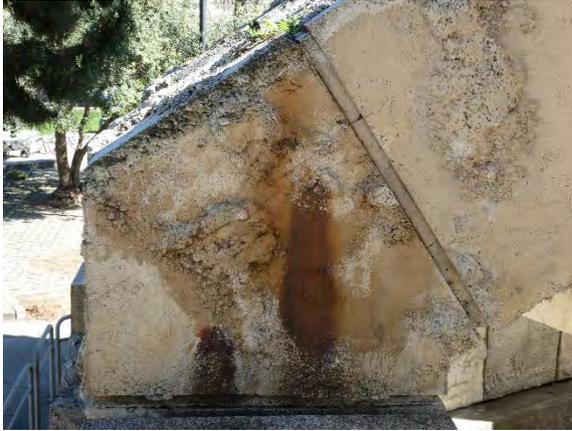
Corrosion of metal fixtures, typical condition. Photo facing west from viewing platform.

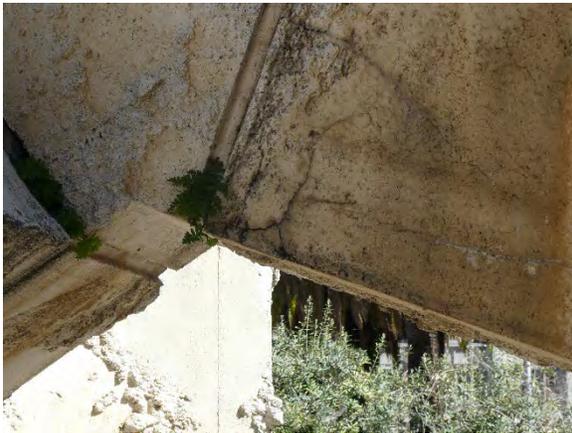
Incipient spalling and cracking at joint of projecting column, typical condition. Biological growth within several cracks.

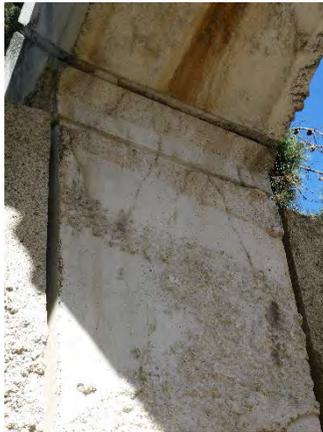
Cracking at joint along the underside of projecting column, typical condition.

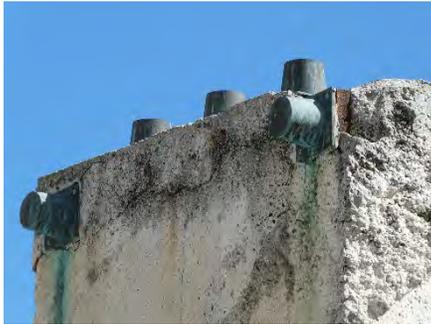
Spalling, incipient spalling, cracking, and corrosion of copper fixtures. Typical condition.

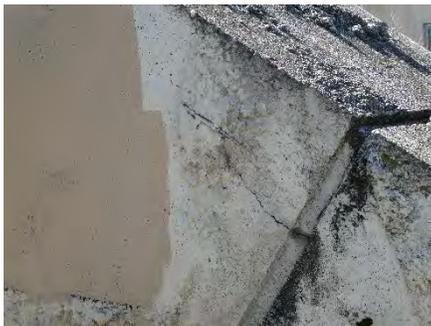
Incipient spalling at upper joint of projecting column. Typical condition.

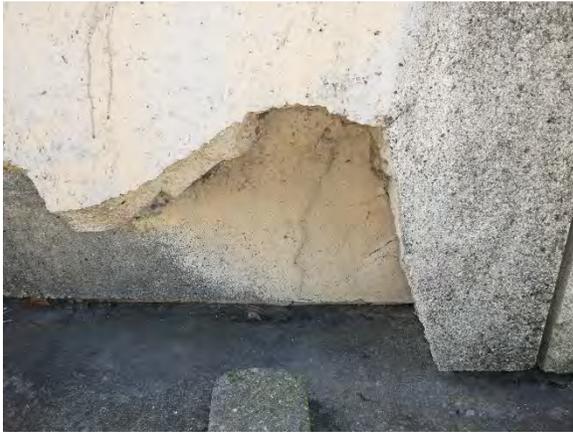
Cracks at base, typical condition. Northeast elevation pictured.

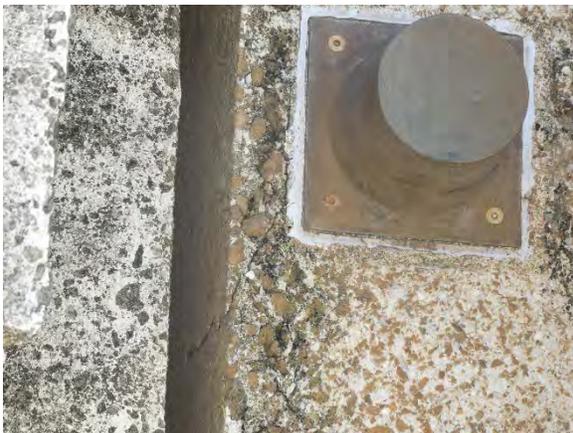
Incipient spalling adjacent to metal fixture, typical condition. Northeast elevation pictured.

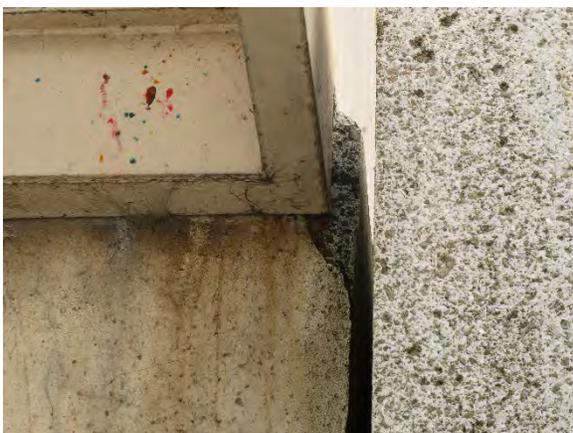
Incipient spalling at the joint beneath metal stair platform, typical condition. Northeast elevation pictured.

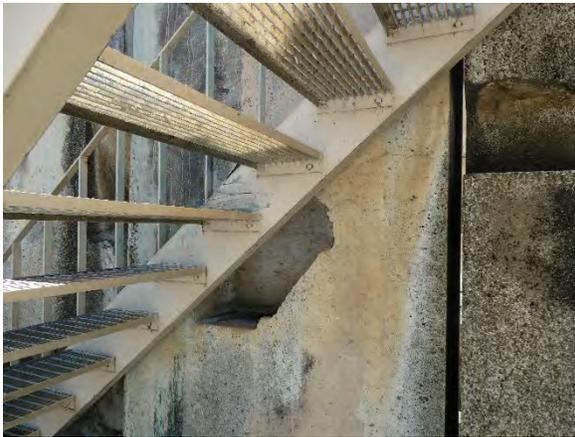
Typical condition of the underside of the painted steel stairs on the east side of the fountain, exhibiting soiling but minimal if any corrosion.

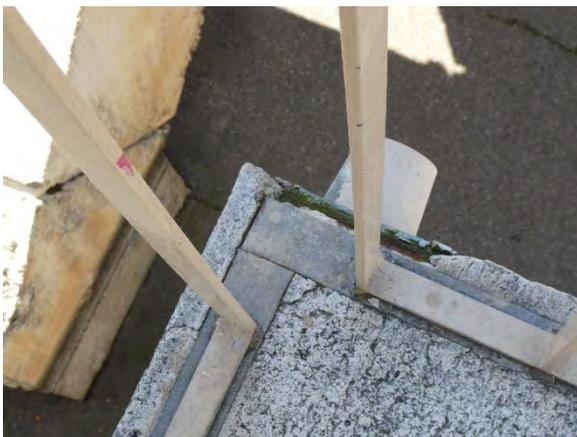
Detail of spalled concrete at the edge of the railing attachment.

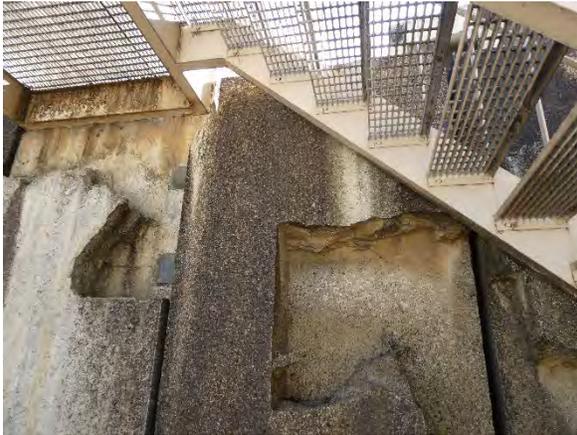
Typical condition of the painted steel stairs with soiling, and some minor surface corrosion at edges of the landing frame.

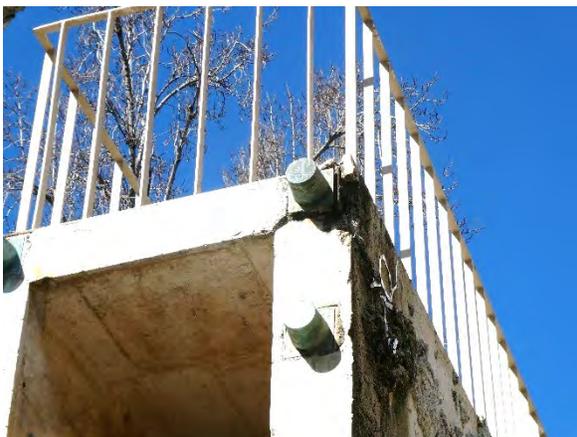
Detail of typical cracking and spalling around the bottom of the viewing platforms due to corrosion of the supporting and reinforcing steel.

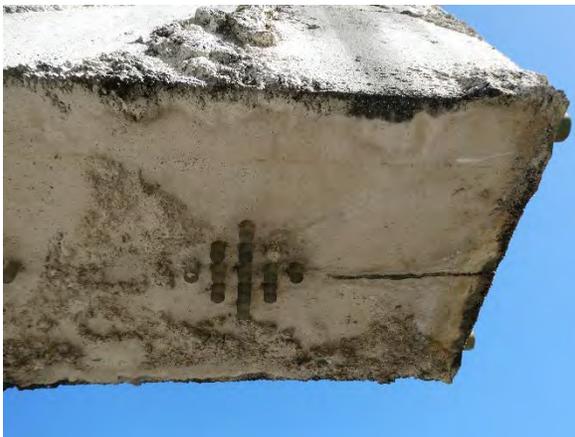
Detail of glass cylinders in the hollow pre-cast concrete arms, associated cracking, and efflorescence.

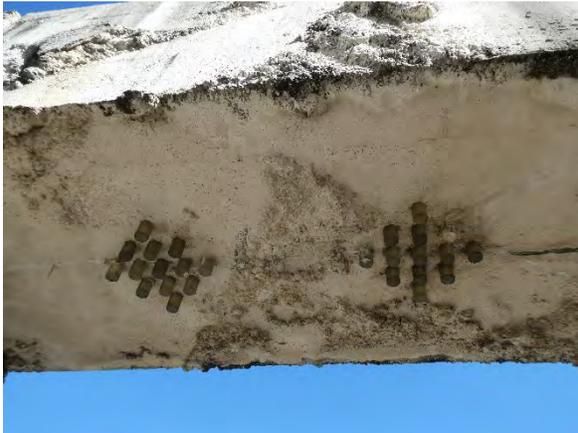
Detail of glass cylinders in the hollow pre-cast concrete arms, associated cracking, and efflorescence.

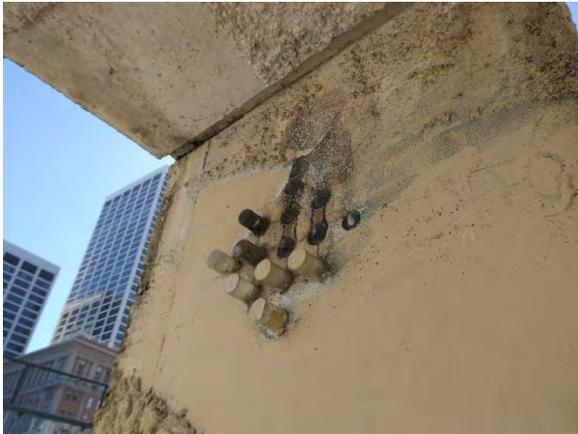
Detail of broken and painted glass cylinders in the hollow pre-cast concrete arms.

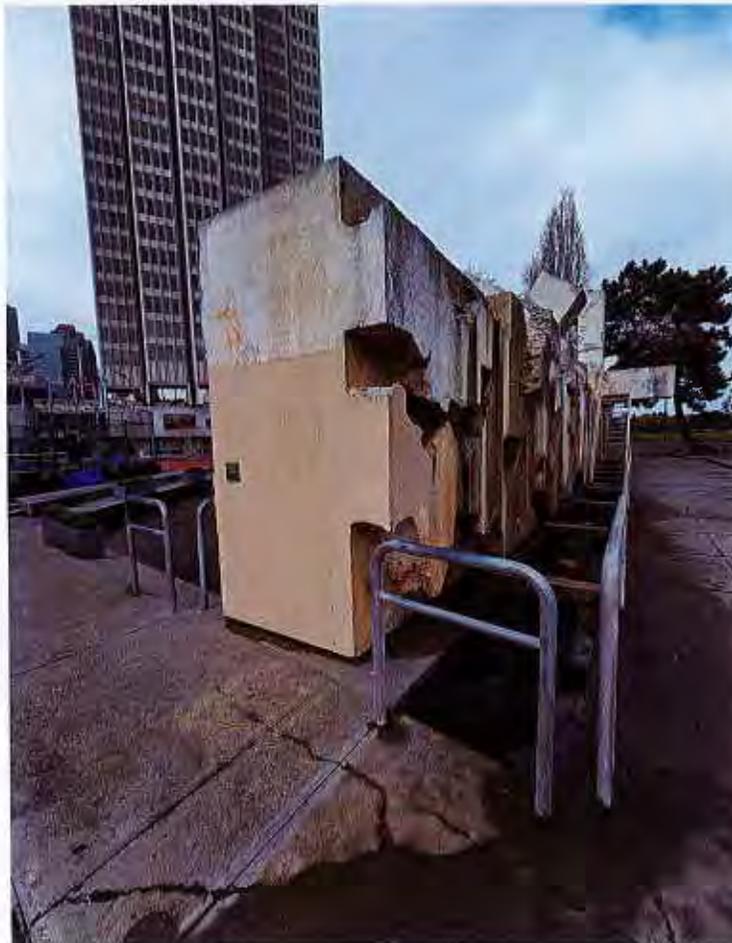
**Photo 4. Rear wall – no reinforcing steel was found.**

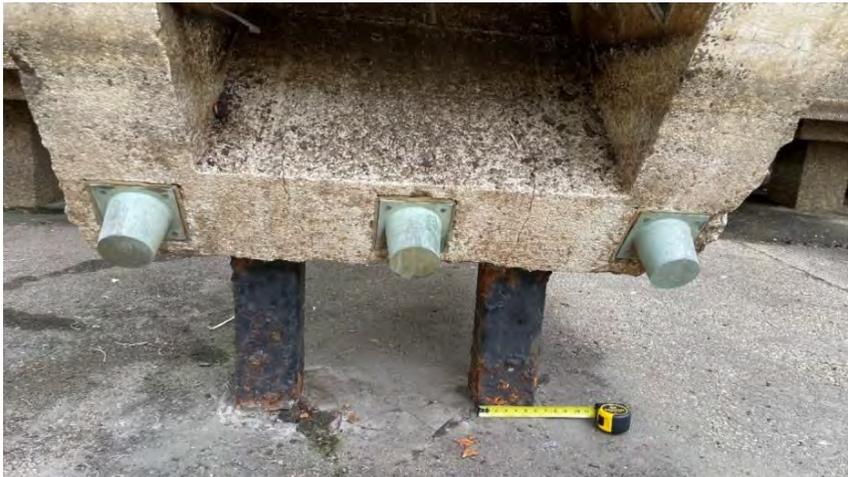
Figure 8: Vaillancourt Fountain - Corroded Steel Tubes and Spalled and Cracked Concrete

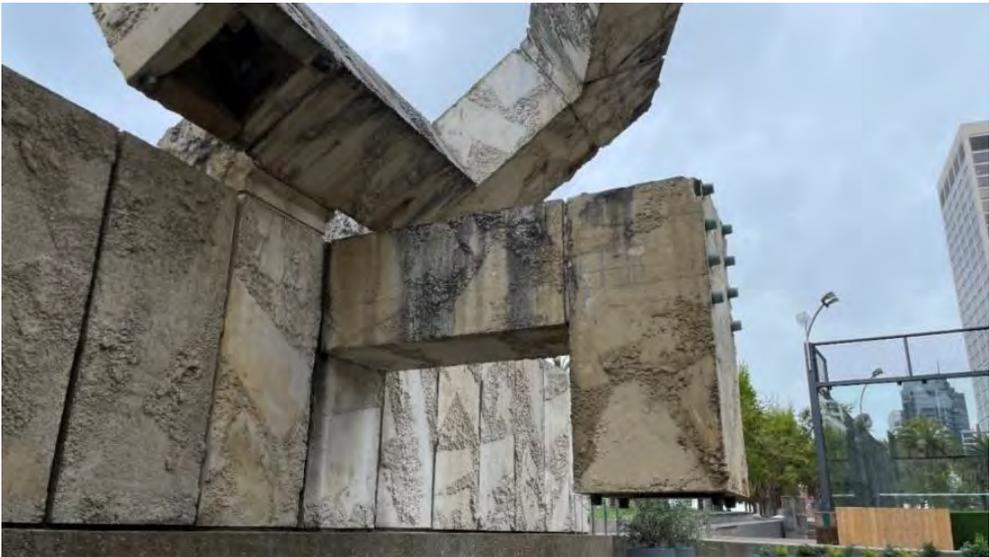
Figure 9: Vaillancourt Fountain - Showing Spalled Ends

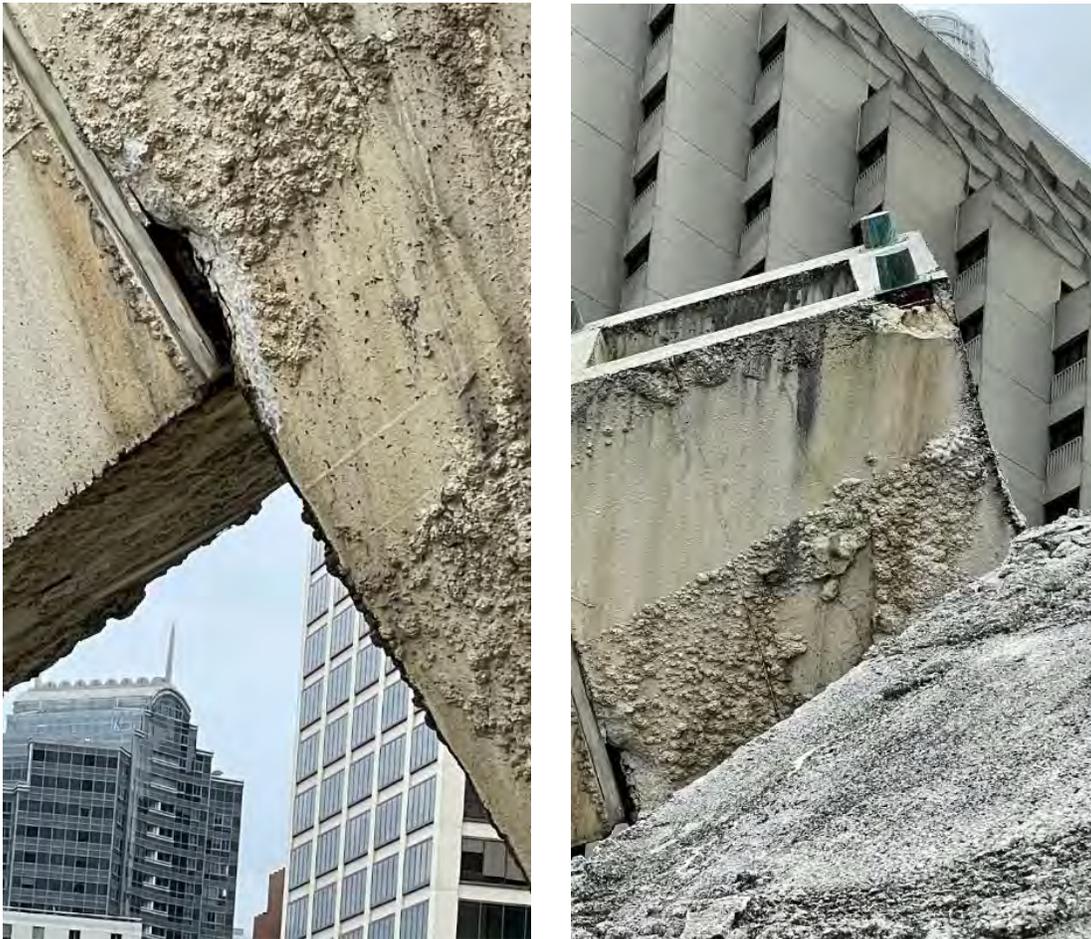
*Figure 10: Vaillancourt Fountain - Spalled and Cracked Concrete and Corrosion of Steel Elements*

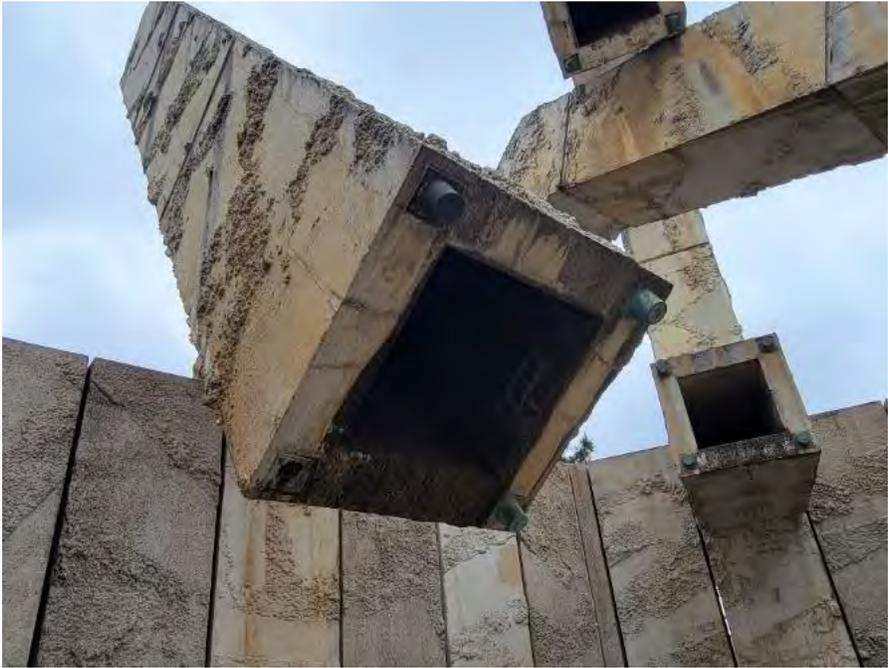
Figure 11: Vaillancourt Fountain – Showing Corroded End Plate and Absence of Thru Rod and Spalled Concrete Surface

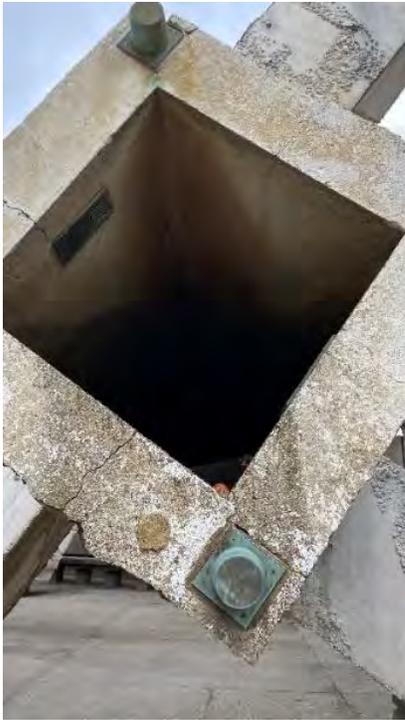
Figure 12: Vaillancourt Fountain Cracked and Spalled Concrete and Water Damage Stains

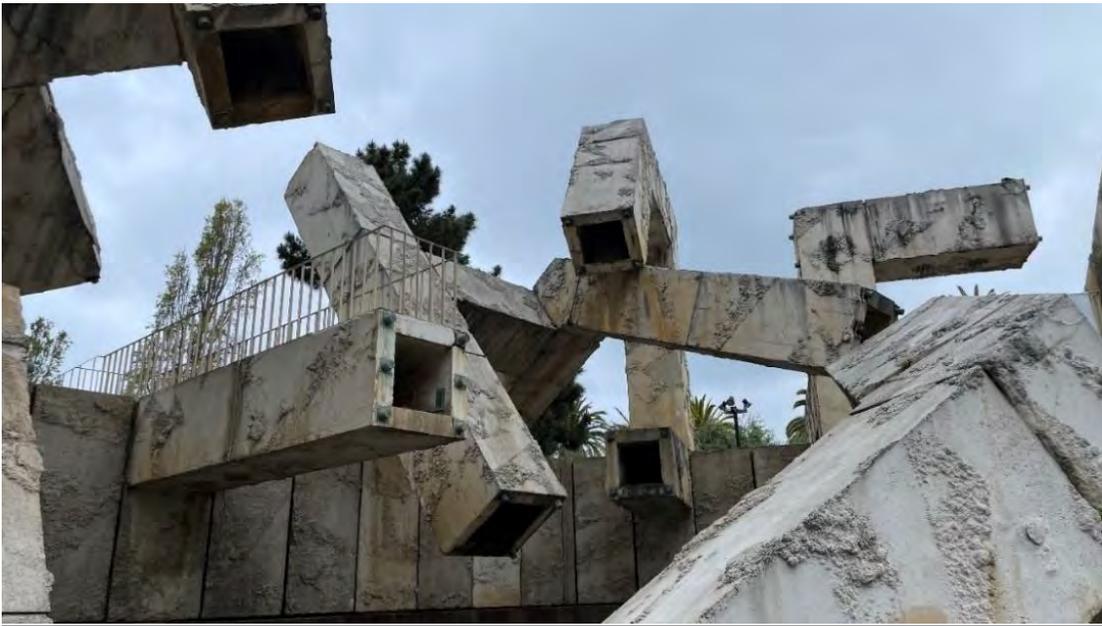
DCI Engineers identified a particularly critical condition involving the cane-shaped tube (T6), which has settled onto and is now physically bearing on the H-shaped (T4–T5) section below it.

DCI concluded that the stress cracks observed in the H-shaped section were likely caused by these unanticipated forces, resulting from the deformation and settlement of the cane-shaped tube due to yielding of the internal steel plates and corrosion of the reinforcing and post-tensioning rods that once stabilized the connections.

Figure 13: Vaillancourt Fountain – TS6 Frame on TS4-TS5 Assembly - Cracks and Corrosion

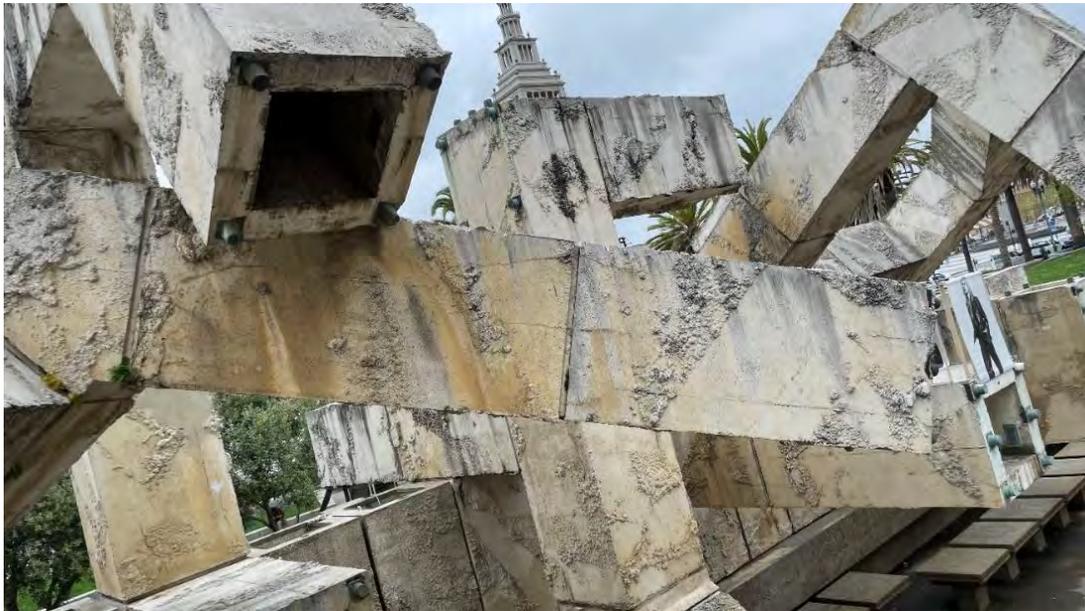
Figure 14: Vaillancourt Fountain – TS6 Frame resting on TS4-TS5 Assembly with Cracks and Corrosion Close Up
