# HISTORICAL STRUCTURE REPORT

1338 Filbert LLC

LANDMARK DESIGNATION REPORT  
DATE: JULY 12, 2001  
CASE NO.: 2001.0232L

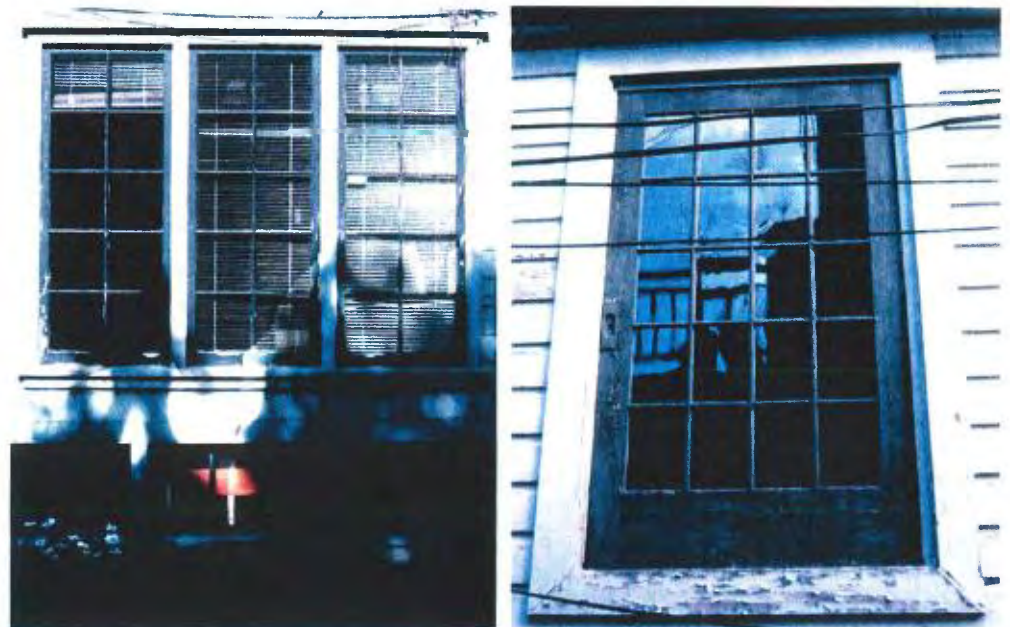
During the mid-century alterations salvaged glazed sliding doors, fixed in place, were installed in upper unit west facades of Cottages B and C. These are wood frame multi-lite doors with their original handle hardware. They provide near floor-to-ceiling glazing. Exterior trim at these doors consist of simple 6" plus wood surrounds with either mitered or butt joints and no sills. These doors appear to be in fair condition exhibiting some signs of weather deterioration and diminishing paint. Glazing is intact.

*Figure 23 (right):  
Salvaged door installed  
fixed at upper unit.*

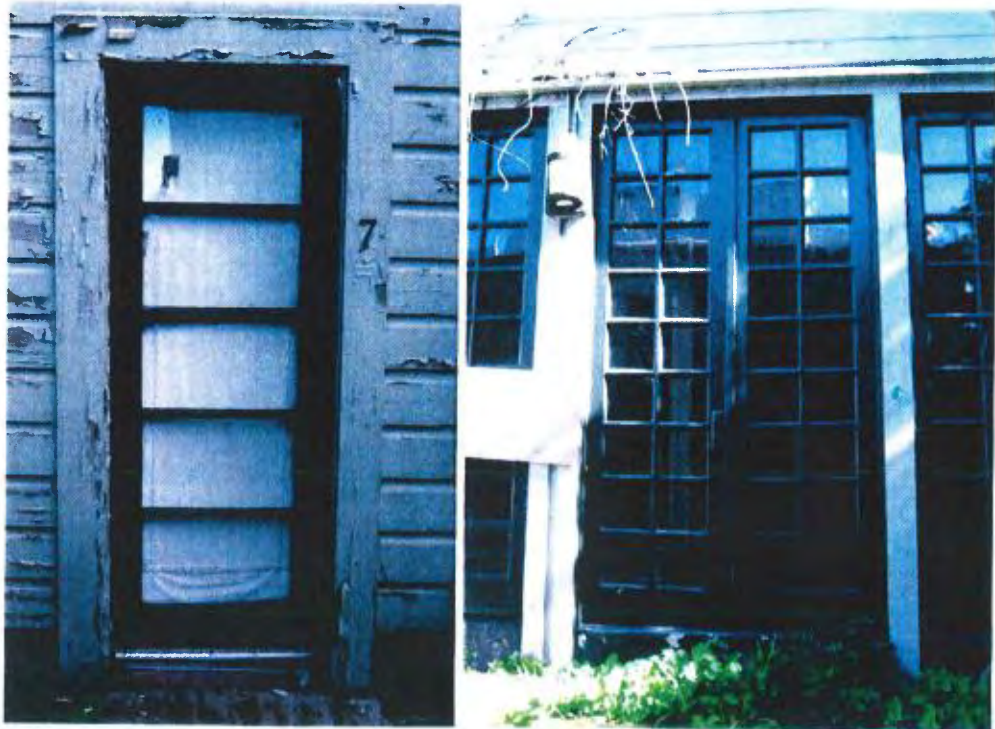
French doors are prevalent through out the property on both cottages and additions. Most are non-contributing. The Studio, however, features a series of four tall narrow French doors - each leaf divided into 18 lites. These doors share continuous trim and are separated by mullions. Only one of the doors retains intact hardware and serves as the primary entrance to the Studio. These four pairs of doors are considered significant. The wood frames and dividing members of the doors appear in fair condition. All doors are operable. The condition of the glazing varies, some lower panes are missing.

**Figure 25 (right):**  
 Series of tall, narrow  
 french doors set in a  
 row at the Studio west  
 facade.

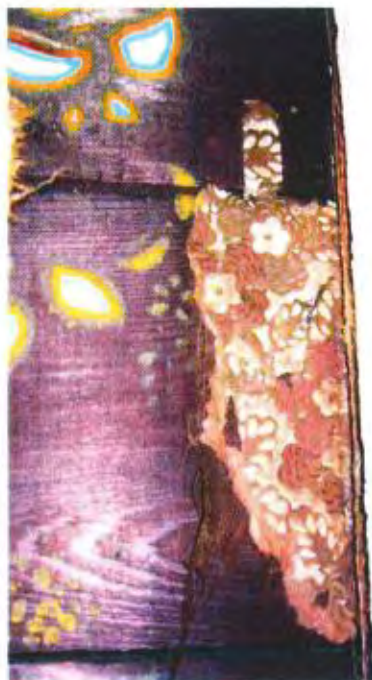
Interior surfaces are either press board, gypsum board, or wood bead board in a few locations (Cottage A). These materials are non-contributing. However, the substrate should be investigated further to determine its historical value and condition.

**Figure 29 (left):**  
Early wall paper mounted to horizontal wood board substrate, exposed in Cottage C.

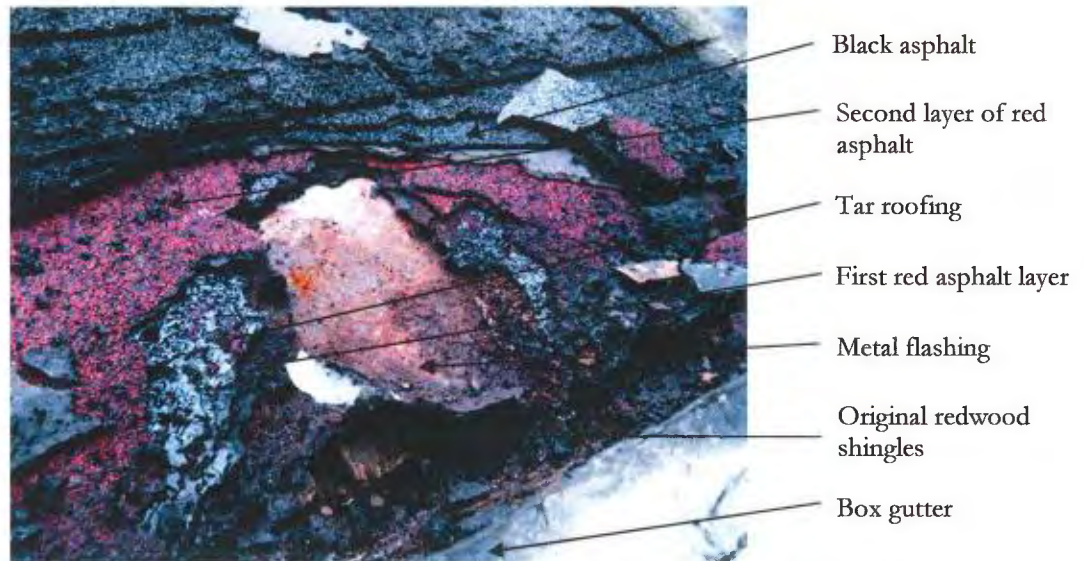
Figure 2. Detail of layers of roofing material at Sample Area 1. Note wood shingles on bottom, followed by metal flashing, red asphalt, tar, another layer of red asphalt and finally black asphalt.

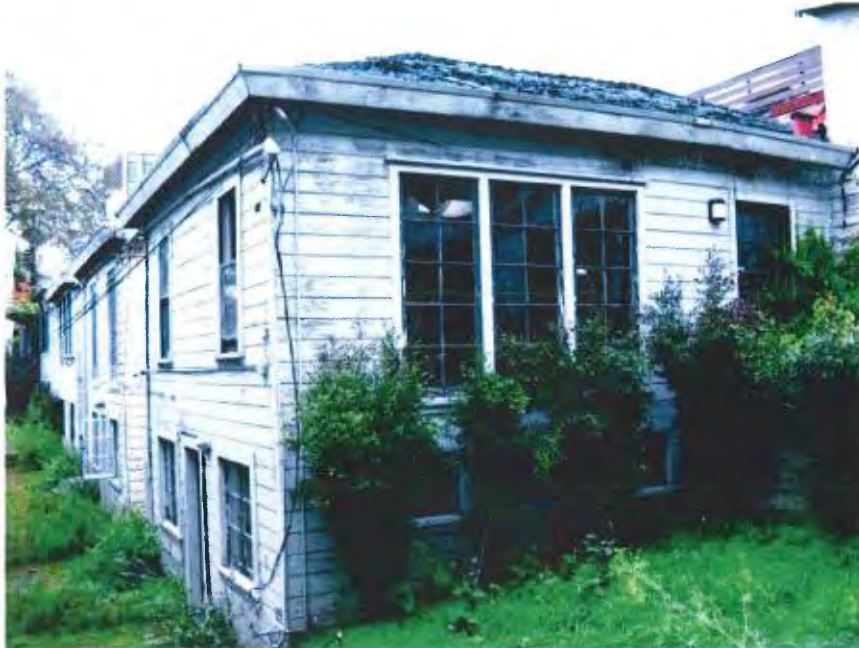
Figure 3: View of the primary (west) facades of the cottages and south façade of Cottage A. Note boxed eaves.

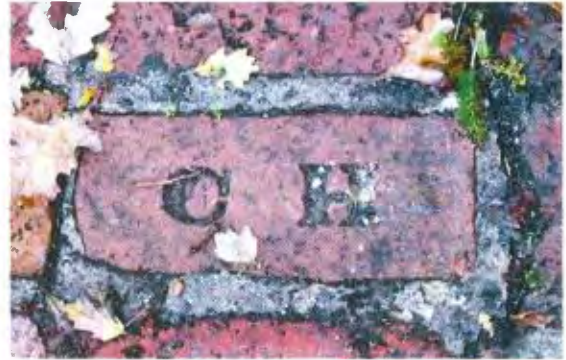
- Cracked, spalled and missing masonry units
  - Cracked, eroded and missing mortar joints
  - General soiling of the brick surface

Figure 2: Stamped brick
