28 December 2021
(Revised 4 January 2022)

Project 147041.10 – 301 Mission Street
Perimeter Pile Upgrade
Projection of Building Settlement Through Construction Completion

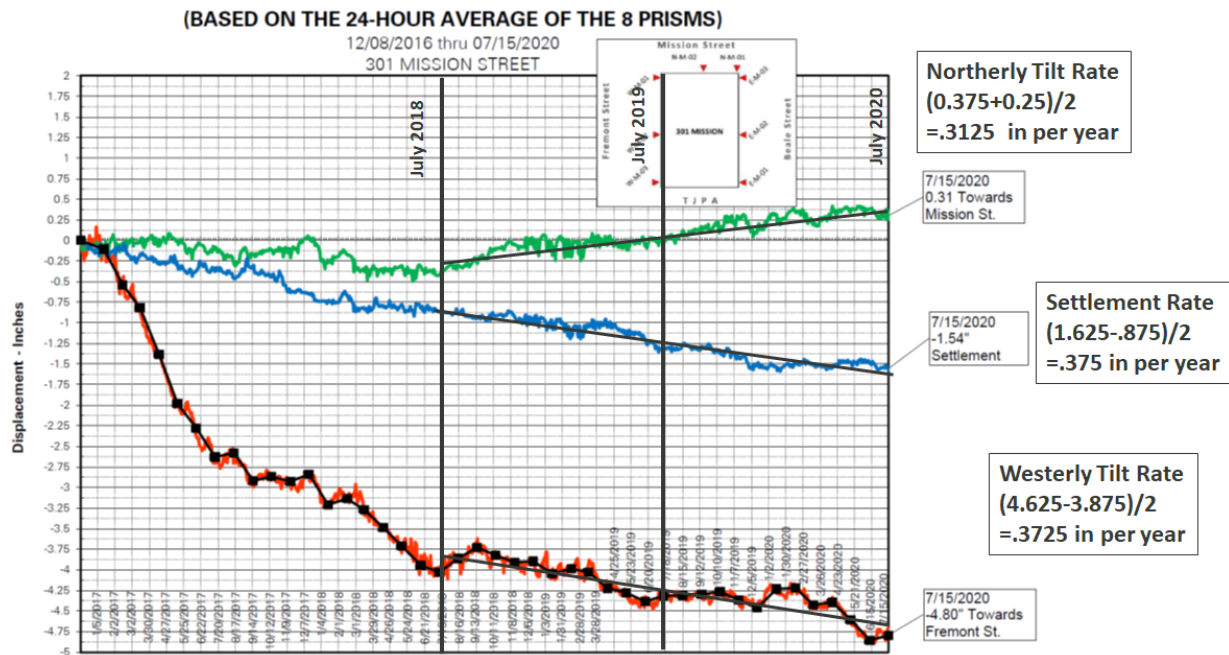
Figure 2 - Langan Survey Data – January 2017- July 2020

Figure 2 presents a summary of data obtained by Langan as produced in their final report in July 2020. This graph shows the average vertical settlement, tilt to the west and tilt to the north, as measured by Langan using the exterior-mounted prisms during the period extending

from January 2017 through July 2020. Superimposed over the top of the plots are a series of straight lines indicating the long-term rate of increase of settlement and tilt during the period July 2018 – July 2020. In July 2020, Langan reported 16 in. of average vertical settlement, relative to the initial design elevations, 16.5 in. of tilting to the west, and 6.6 in. of tilting to the north, as measured using prisms at the top of the exterior facade. It should be noted that the scale of settlement shown in the figure has been adjusted to “zero” at the time Langan initiated their surveys. During the two-year period from July 2018 through July 2020, the data indicates average vertical settlement at a rate of approximately 0.37 in. per year, tilting to the north at a rate of approximately 0.31 in. per year and tilting to the west at a rate of approximately 0.38 in. per year.

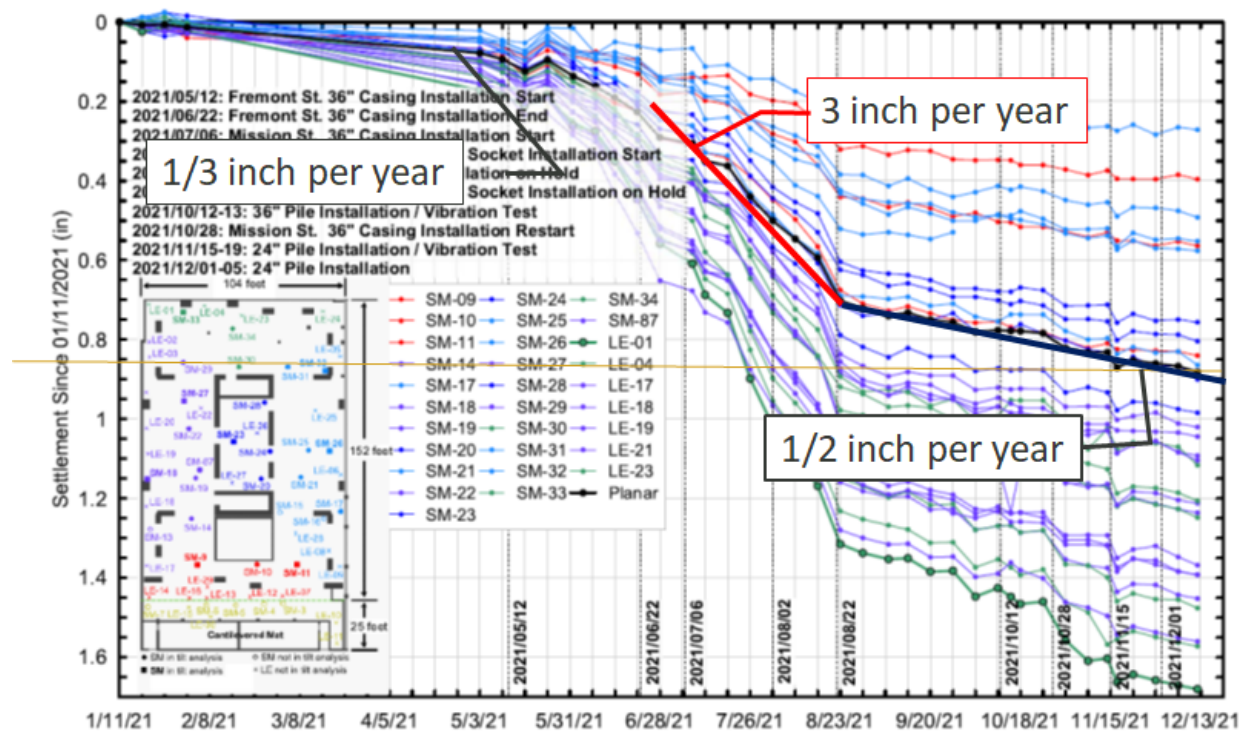
Figure 3 - Survey Data by Slate Geotechnical, January – December 2021

Figure 3, prepared by Slate Geotechnical Consultants, shows the survey data obtained from settlement markers on the base mat starting in January 2021 through the present. The figure shows the settlement over time measured at each of thirty individual settlement markers and the average of all thirty markers indicated as “average planar” in the figure. Four periods of activity are noteworthy in this figure: 1) the period from January 2021 through April 2021, during which construction activity was limited to clearance of utilities and site obstructions and the test pile program previously described; 2) the period from 1 May 2021 through 22 August 2021, during which the installation of thirty-three 36 in. diameter steel casings and six 24 in. piles occurred; 3) the period extending between 22 August 2021 and 12 October 2021, during which there was a moratorium on construction activity; and lastly, the period between 12 October 2021 and 15 December 2021, during which the pilot pile installation program

occurred. We refer to these four periods as: 1) pre-construction; 2) production piling; 3) moratorium; and 4) pilot program, respectively. During the pre-construction period, the average planar settlement increased at a rate of approximately 1/3 in. per year, which is similar to the 0.38 in. per year shown by Langan during the prior two years. During the production piling period, settlement increased to a rate of 3 in. per year, increasing as more casings and piles were installed. Following the institution of the moratorium, the settlement quickly returned to an average rate of about 1/2 in. per year, slightly more than before the piling, but still similar to that recorded by Langan in the period 2018-2020. The rate of 1/2 in. per year has been maintained throughout the pilot program period.

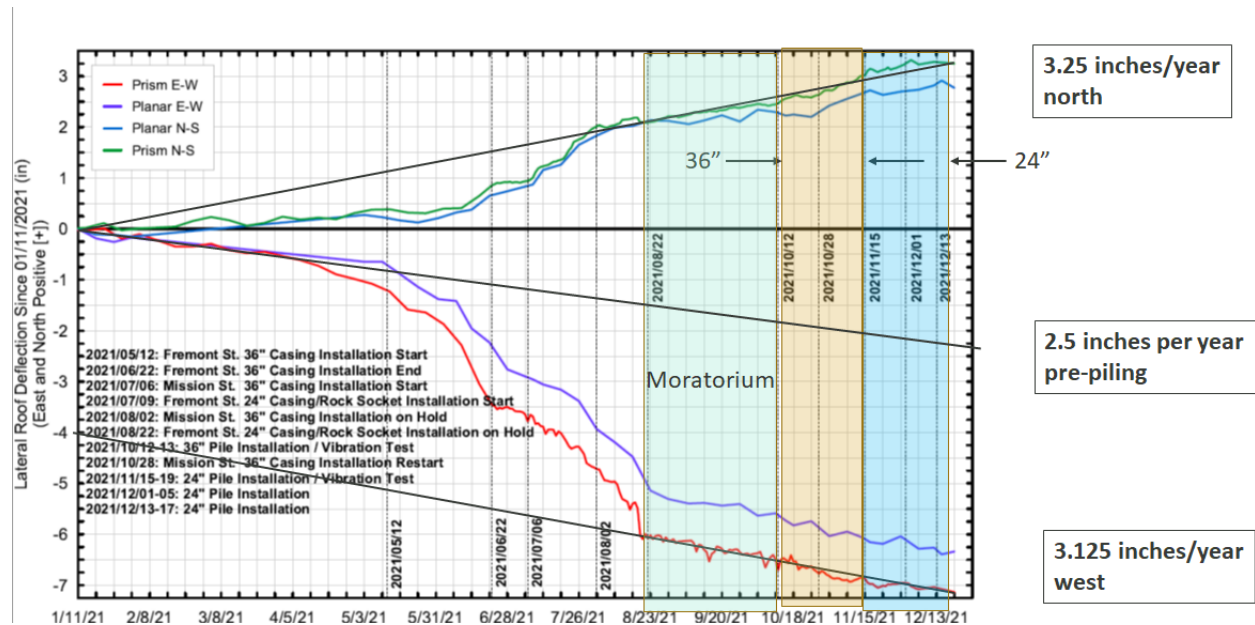
Figure 4 Building Tilt Survey Data January – December 2021

Figure 4 presents a plot of building tilt from January 2021 through the present as measured by the lateral deflection of the roof using the same prisms installed by Langan. Four plots are included in the figure: 1) east-west prism data (red); 2) east-west roof deflection inferred by calculation from an assumed rigid body rotation of the building (light blue); 3) north-south prism data (green) and 4) north-south deflection inferred by calculation assuming rigid body rotation (dark blue). The figure shows tilting to the west at a rate of 2-1/2 in. per year in the pre-construction period and 3-1/8 in. per year during the moratorium and pilot program periods. Similarly, tilt to the north is shown as: approximately 1 in. per year during the pre-construction period and 3-1/4 in. per year during the moratorium and pilot program periods.

The pilot program has not significantly affected the tilting rate either to the north or west relative to that which occurred during the moratorium, and in fact, the plot shows some decrease in the rate of tilt to the north and west during the 24 in. pilot pile installations.

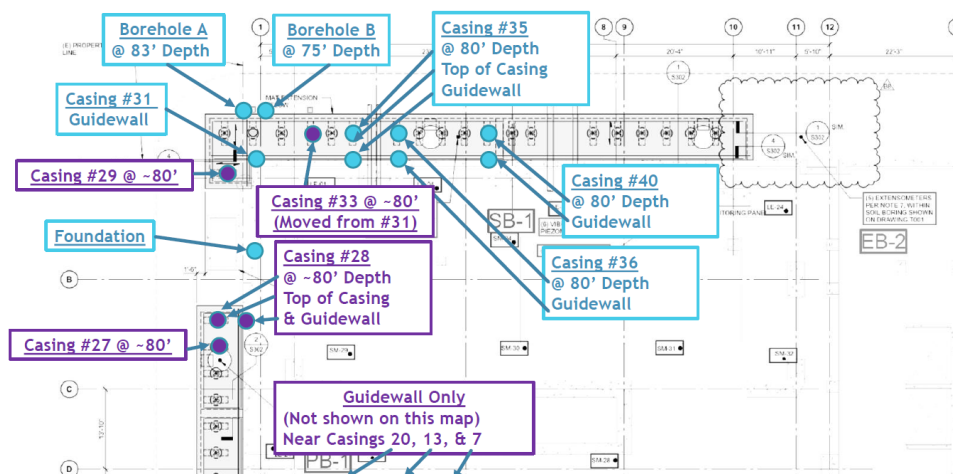
Figure 5 - Locations of Vibration Sensors

Figure 5 shows the locations of vibration sensors during the pilot installations of 36 in. casings, at locations 32, 33 and 34, and also during the installation of 24 in. pilot piles at locations 30 and 31. Figure 6 shows the mean and maximum root mean square velocities recorded within the Colma formation during the installation of the 36 in. casing at location 33. The maximum vibration amplitudes recorded at depth were on the order of 600 micro-m/s and occurred during excavation of soil from within the casing using the auger bucket, as the casing tip was extended from the 70 ft to 90 ft depth, that is within the lower Colma formation.

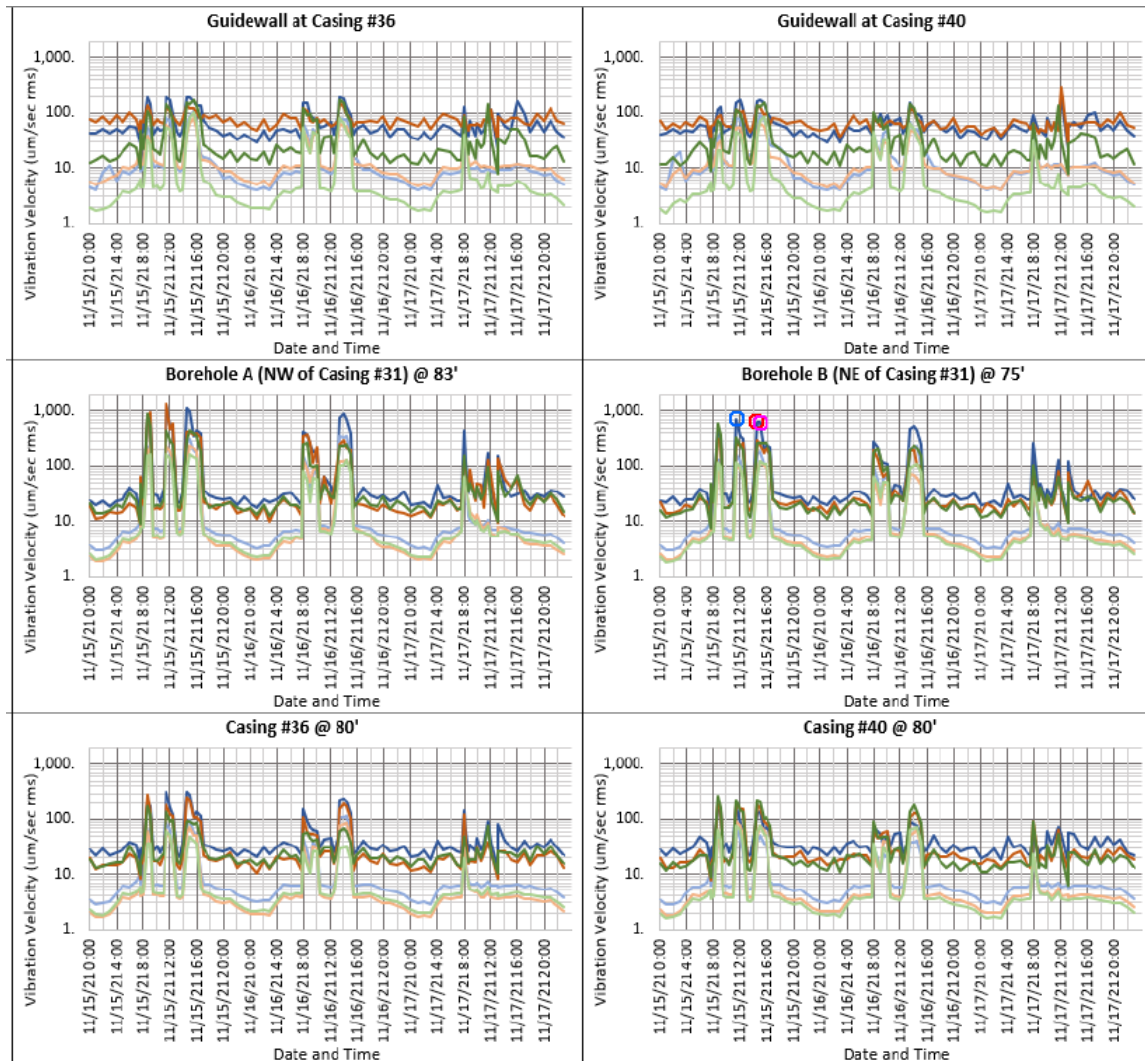
Figure 7 - Mean and Maximum Vibration Levels within the Colma Formation and at the Guide Wall During Installation of Pilot Pile 30

Figure 7 shows the mean and maximum root mean square velocities recorded at depth and at the guide wall during the installation of the 24 in. pile at location 30. The maximum vibration amplitude within the Colma sand was somewhat higher than for the installation of the 36 in. casing, with peak root mean square velocity of about 1,000 micro-m/s. This amplitude occurred as the 24 in. pile was advanced through the soil plug within the 36 in. casing at 100 ft below grade and decreased as the drill tip progressed deeper into the underlying soil. Also, the amplitude of velocity at the guide wall was approximately 1/5 that recorded at depth within the soils. Not shown in the figure but evident from spectral analysis of the vibration waveform is that the frequency of maximum energy content within the Colma sands matches the firing rate for the drill bit. We interpret this as evidence that vibration within the Colma formation during 24 in. pile installation is primarily caused by firing of the drill bit, that transmission of vibration from the guide wall through the casings is not a significant factor, and that isolation of the guide walls from the casings and the crane from the guide wall is not necessary. This is particularly evident given that the installation of pilot pile No. 26 occurred without separation of

the casings from the guide wall and did not have a significant effect on building settlement or tilt.
