FOCUSED HISTORIC STRUCTURE REPORT
WOODS HALL
WOODS HALL ANNEX
SAN FRANCISCO, CALIFORNIA
[17112]

PREPARED FOR: WOOD PARTNERS

APRIL 2017

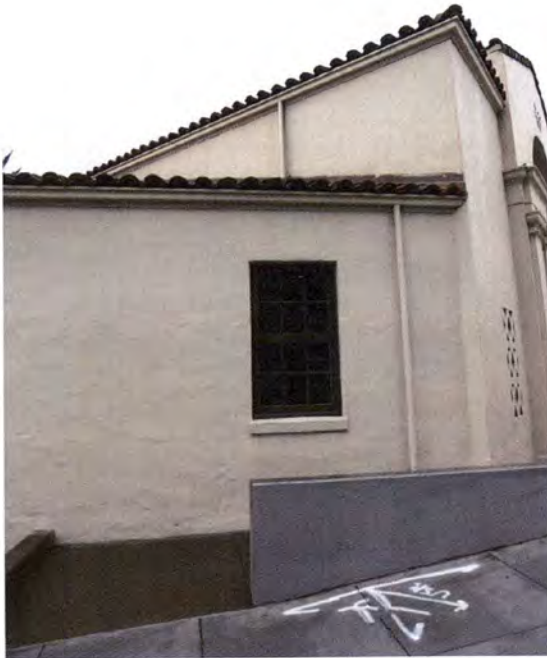
The exterior walls of Woods Hall are in good condition. Walls show no evidence of cracking or spalling and are recently painted. Proper gutter placement and operation is an issue. Some areas of mud splashback are evident around the building where water comes off the roof directly and not into gutters (which can deteriorate the paint and harm the walls over time). In one location, run off from the entry tower's gutters washes on to the roof of the Haight street wing and directly on to the ADA ramp and not into a gutter.

Figure 12 - The downspout from the upper roof sheds water onto this area of the lower roof, which bypasses the gutter and spills onto the ADA ramp into the Entry Pavilion. Photo by Page & Turnbull, 2017.

Gutter systems should be cleaned and regularly inspected for proper function. A solution for the run-off at the ADA ramp should be considered. The building exterior should be cleaned for debris and accumulated dirt, especially at drip ledges. Every 5-7 years, evaluate the exterior for cracks or spalls, patching as needed. Approximately every 10 years, repaint the exterior.

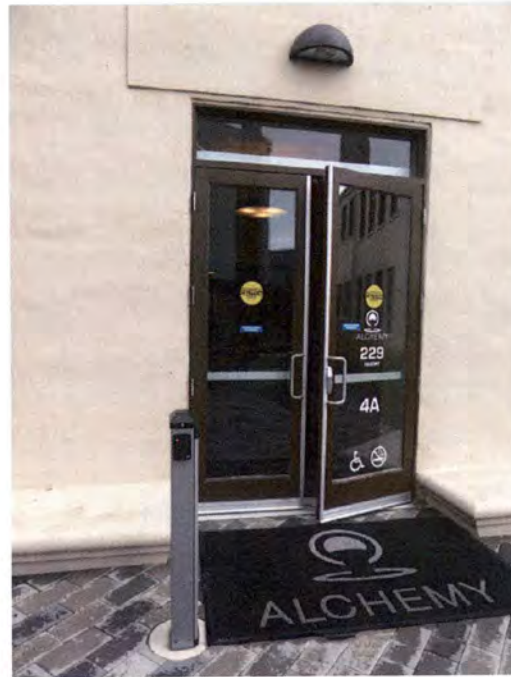
ADA pathways to doorways are well-marked, but in fair condition. In multiple locations, ADA equipment was inoperable or malfunctioning. ADA hardware should be frequently verified for proper functionality.

Figure 13 - The ADA pushplates at these courtyard doors only open the door this much. Photo by Page & Turnbull, 2017.

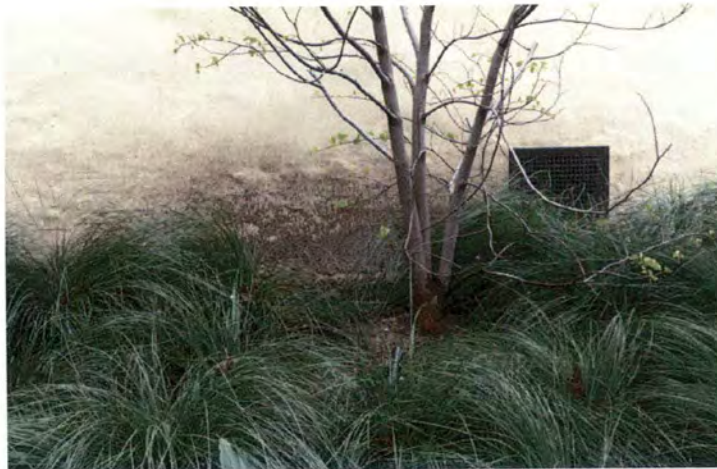
Figure 14 - Splashback on the exterior walls. Photo by Page & Turnbull, 2017.

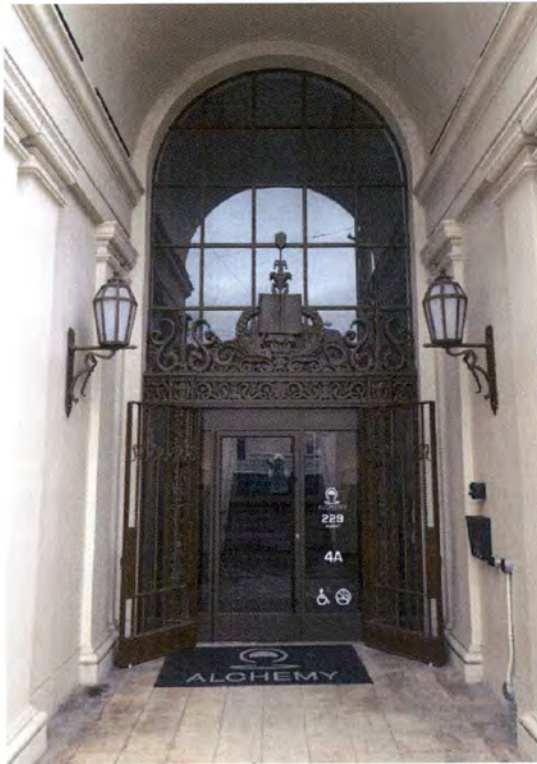
The current aluminum doors at the exterior are new, having been replaced as part of the rehabilitation; they are in good condition. At the entry pavilion, the cast metal grillwork and sconces are also in good repair. The bolts securing the sconces into the concrete entry portal, however, are already showing rust and should be checked regularly for security.

Figure 15 - (above) A rusting bolt anchoring the sconces.
Photo by Page & Turnbull, 2017

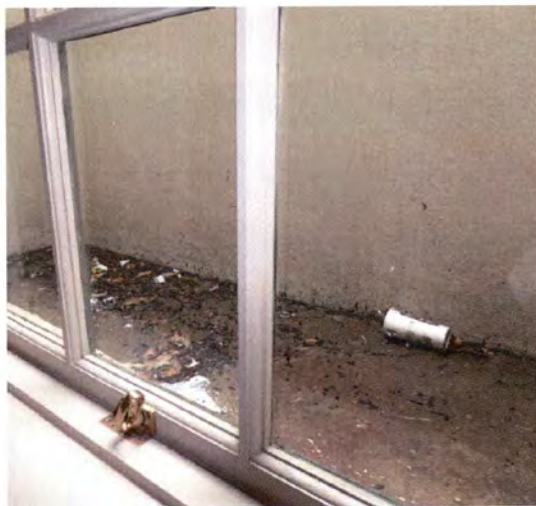
Figure 17 - Debris and trash in the lightwell. Photo by Page & Turnbull, 2017

Site condition is good; areas are manicured and well taken care of. Lightwells at the windows along Buchanan and Haight streets should be regularly surveyed and cleaned for accumulating build-up of leaves, trash, and other debris.

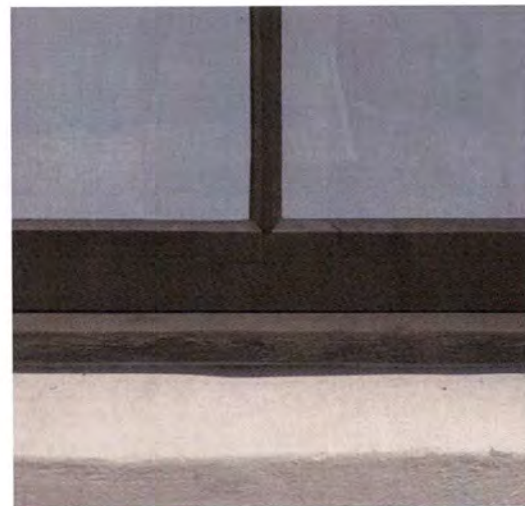
Figure 18 - UV degradation and fading of the paint on the windows in the courtyard. Photo by Page & Turnbull, 2017

historic insertions are fixed, non-divided, insulated glass windows. Windows along the courtyard, facing south and east, already show signs of UV damage (bleaching or delaminating) of the paint on the window sashes. No broken or cracked glazing was seen. Windows should be regularly inspected for glass breakage and any paint deterioration. Repaint or repair as needed. Windows should be repainted approximately every 10 years.

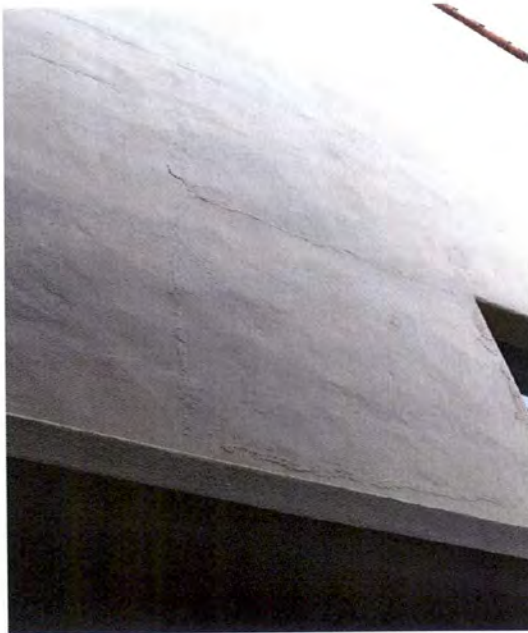
Figure 22 - Visible bulging at the crack repair on the east facade of the Annex; there is the potential here for failure in the future. Photo by Page & Turnbull

The painted exterior of the Woods Hall Annex is in good condition, including the features at the decorative entry portal. Walls, especially those along access walkways should be annually evaluated for evidence of cracking and spalling. Recent repairs are not completely flush within the historic surfaces and may prematurely crack or spall onto pathways below. Drip ledges and projecting elements along the walls should be regularly cleaned to prevent particulate accumulation or crusting over time, especially under the tree on Haight Street.

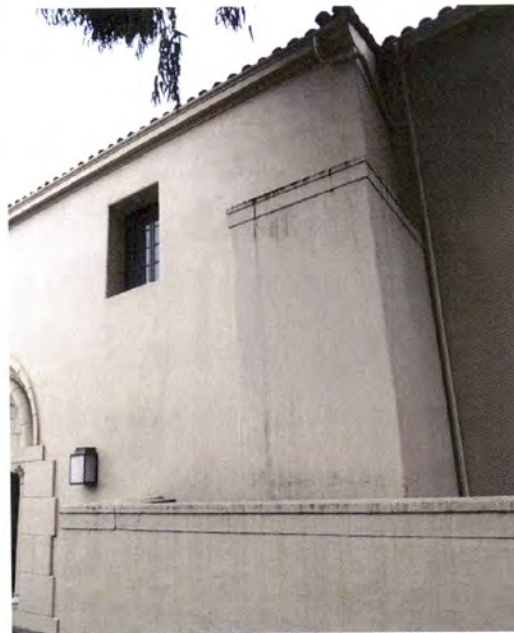
Figure 23 - Areas under this tree on Haight Street could be cleaned, and will require it more regularly than others on the facade. Photo by Page & Turnbull

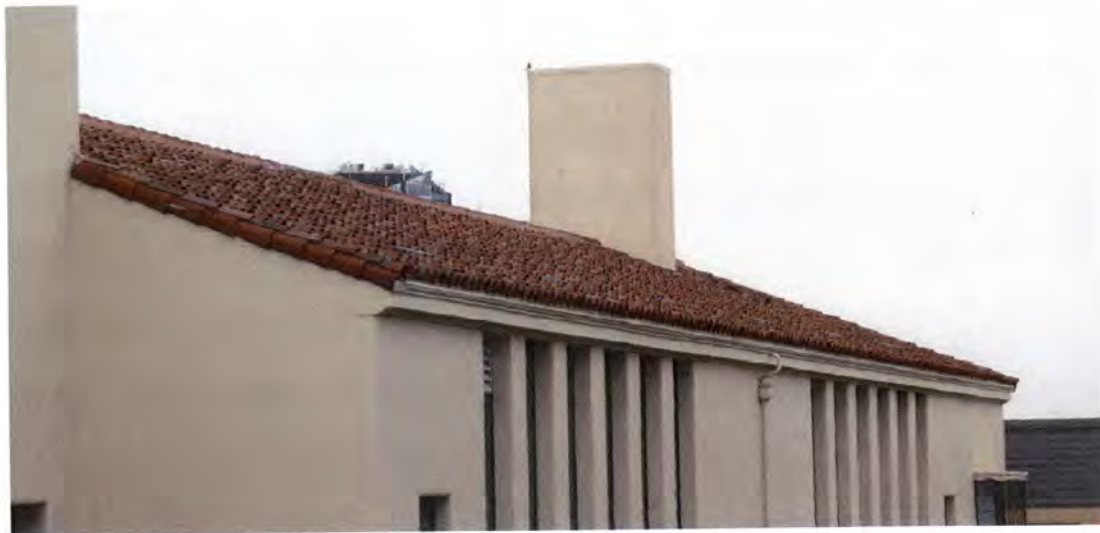
Figure 24 - The roof on Woods Hall Annex in good condition. Photo by Page & Turnbull

The clay tile roof is in good condition. No areas of debris accumulation are visible, and no leaks were evident in accessible areas inside the building. Functionality or stability of the chimney atop the gabled roof was not evaluated.

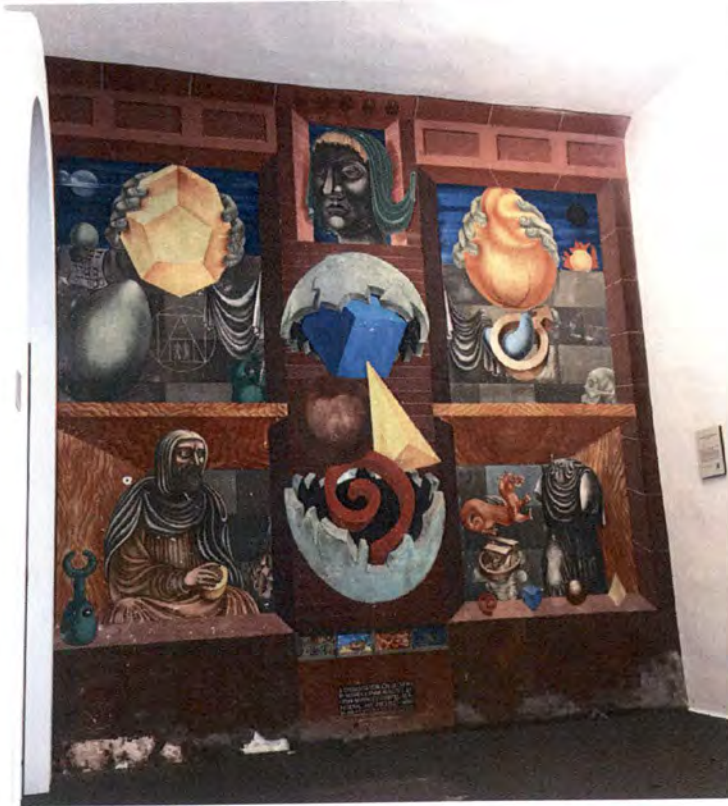
The mural at the top of the main staircase, "A Dissertation on Alchemy", is in fair condition. Some graffiti remains and should be cleaned. Cracking, areas of spalling, and a hole are also present. Each should be sensitively patched or repaired by a fine art restorer with fresco experience. An interpretive plaque has already been installed adjacent to the mural. At a minimum, stabilization of the damaged areas should be undertaken to prevent further damage.

Figure 29 - "The Dissertation of Alchemy" on the second floor landing of the east stair.

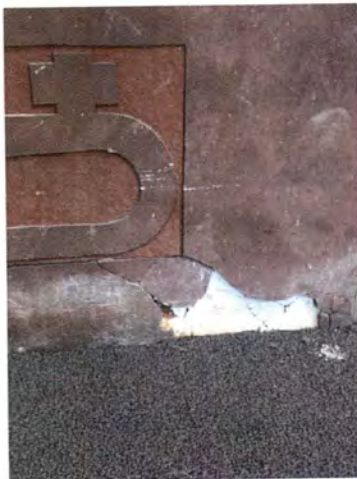
Figure 30 - Spalling and cracks at the mural base

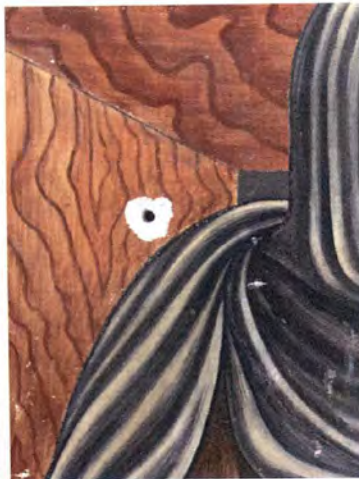
Figure 31 - Hole in the mural

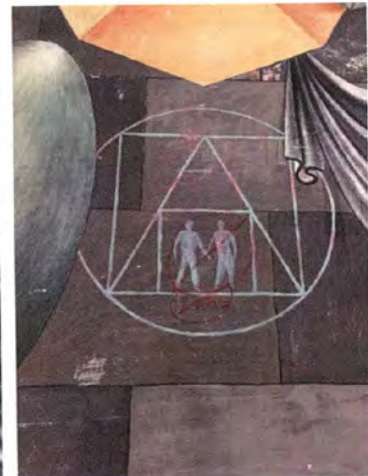
Figure 32 - Graffiti
