## FIRST AMENDMENT TO LEASE NO. L-16274

# RAPID STRUCTURAL ASSESSMENT REPORT

We are pleased to submit this report summarizing the findings and recommendations of our Rapid Structural Assessment of Pier 33 in San Francisco, California.

Subject: Permit No. B 2018-0121  
Pier 31.5 Substructure Repair, San Francisco

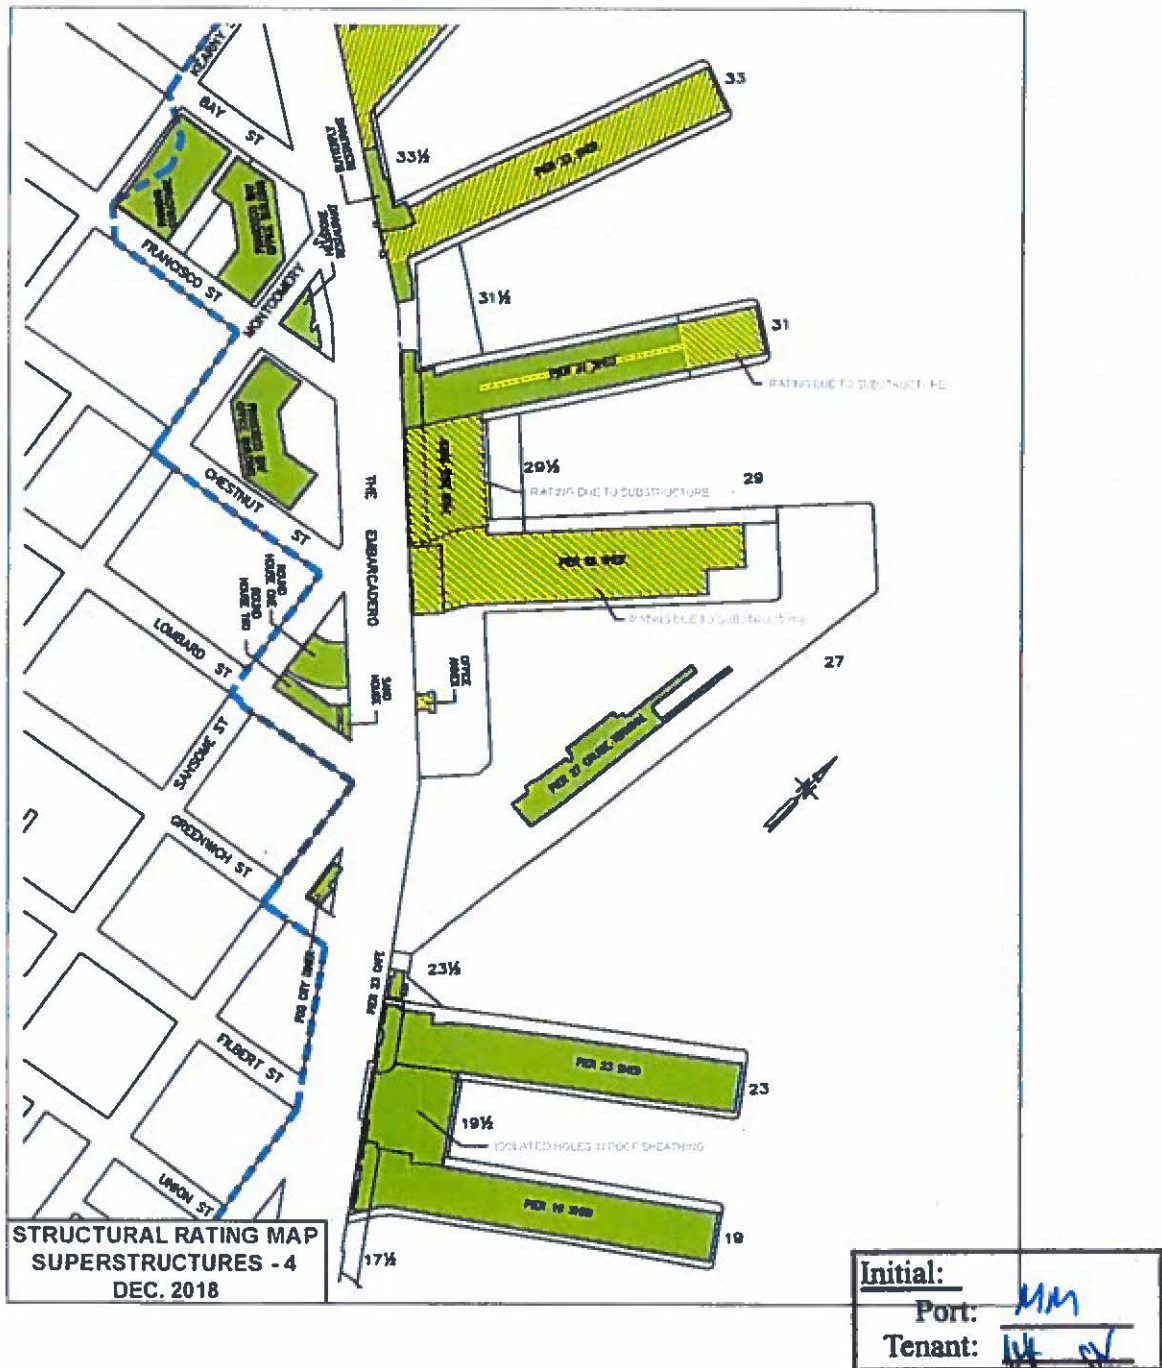
Photo 1. Superstructure rating map updated for Pier 33

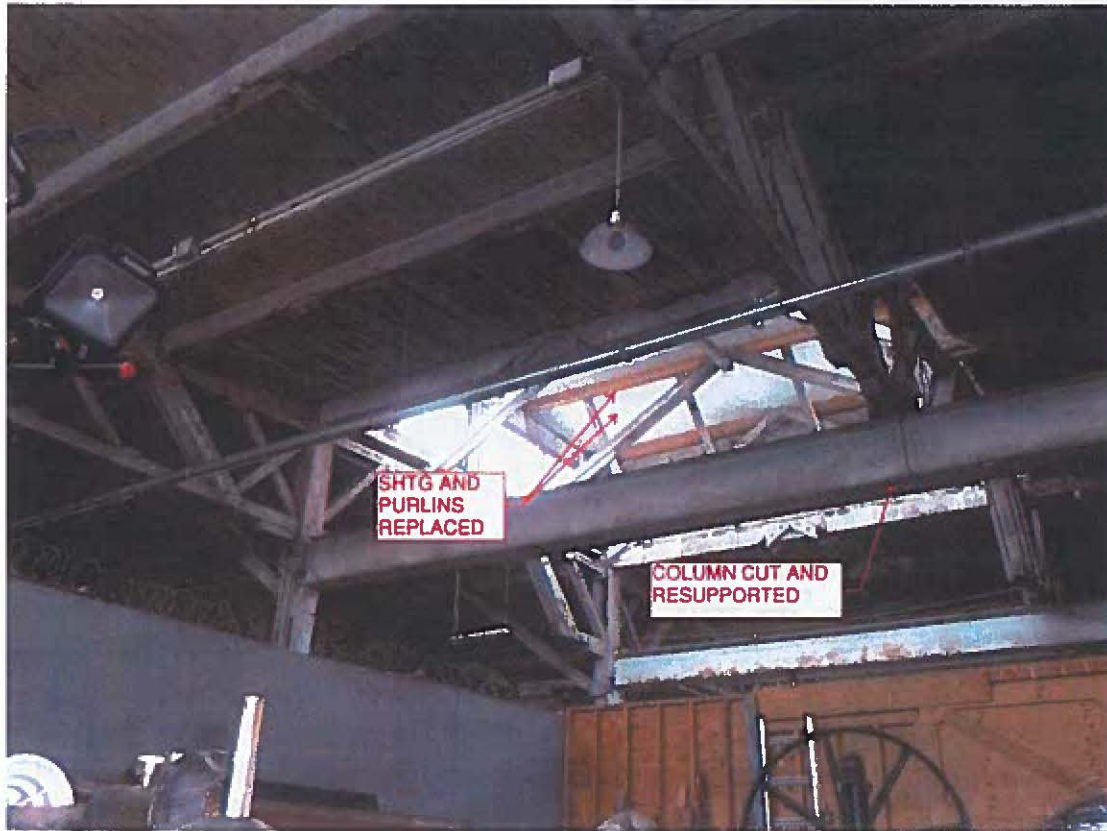
4. Roof sheathing and framing shows signs of water damage. Some areas have already been replaced, but other areas may have progressed to the point of requiring replacement. See Figures 4 and 8.
5. A shed roof purlin has split. See Figure 10. Roof access should be restricted until it is replaced.
6. Fire damage can be observed at project east end of shed (approx. Grid 44). Char is visible on roof solid 2x sheathing, truss members, and fire baffle. Damaged structure should be replaced or evaluated for depth of char and adequacy of remaining capacity. See Figures 12 and 13.
7. Exterior concrete walls show significant spalling throughout. See Figures 14-20. Spalling is primarily on exterior face, but some locations are noted on interior face as well. Some

Figure 4 - Previously cut and resupported column. Previously replaced roof framing.

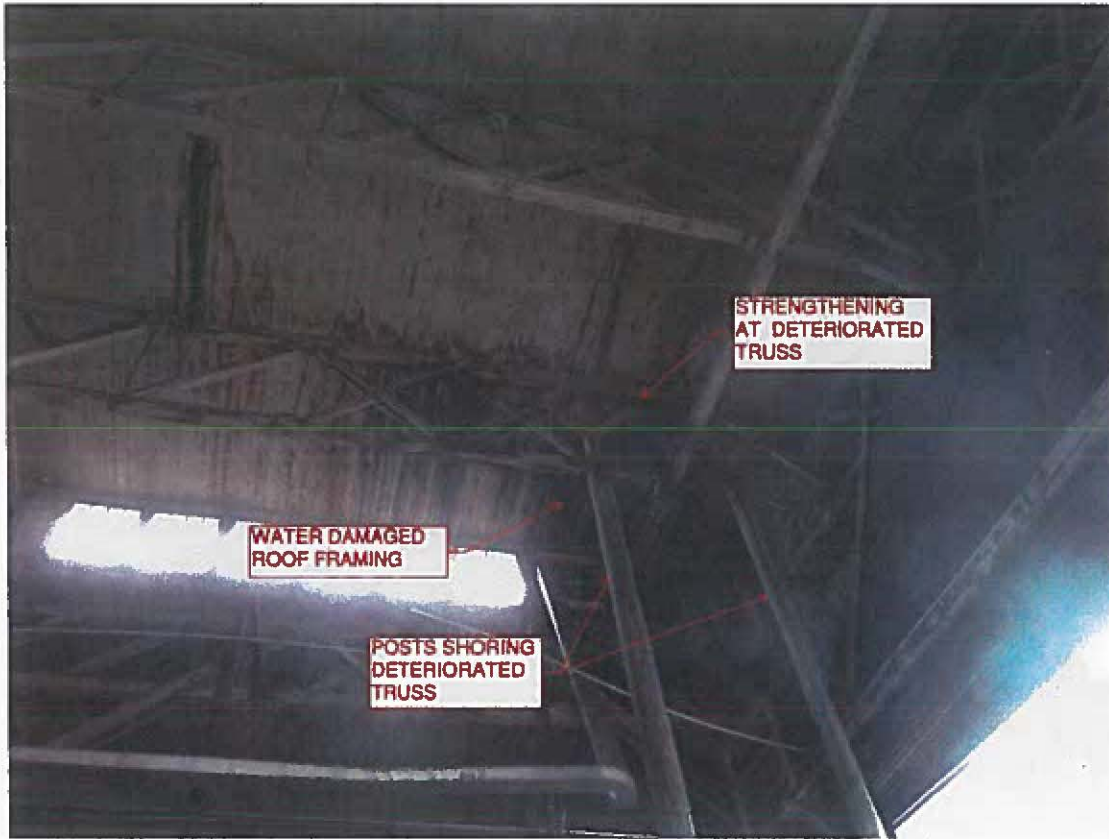
1. Truss near east edge of bulkhead main entrance and sheathing above shows significant deterioration and has received some strengthening and temporary shoring. A permanent repair should be designed. See Figure 5.
2. Hole exists in ground level slab in space to east of main aisle in bulkhead. Hole should be repaired, and barricaded until repair can be effected.
3. Several exterior wood columns in shed show deterioration and damage at bases. It appears this may typically be related to frequent wetting as part of fish processing operations and/or water intrusion from adjacent bay doors.
  - a. Most columns observed showed evident dry rot. See Figure 11.
  - b. Some locations also showed significant corrosion of connection to base plate, and corrosion of bolts appears to be the cause of splitting at base of columns. See Figure 9.

Figure 5 – Temporary shoring at damaged roof truss and framing, installed April 2017.

**Long Term Actions:** Permanent repair of shored framing near main entrance, and dry-rot at column bases.

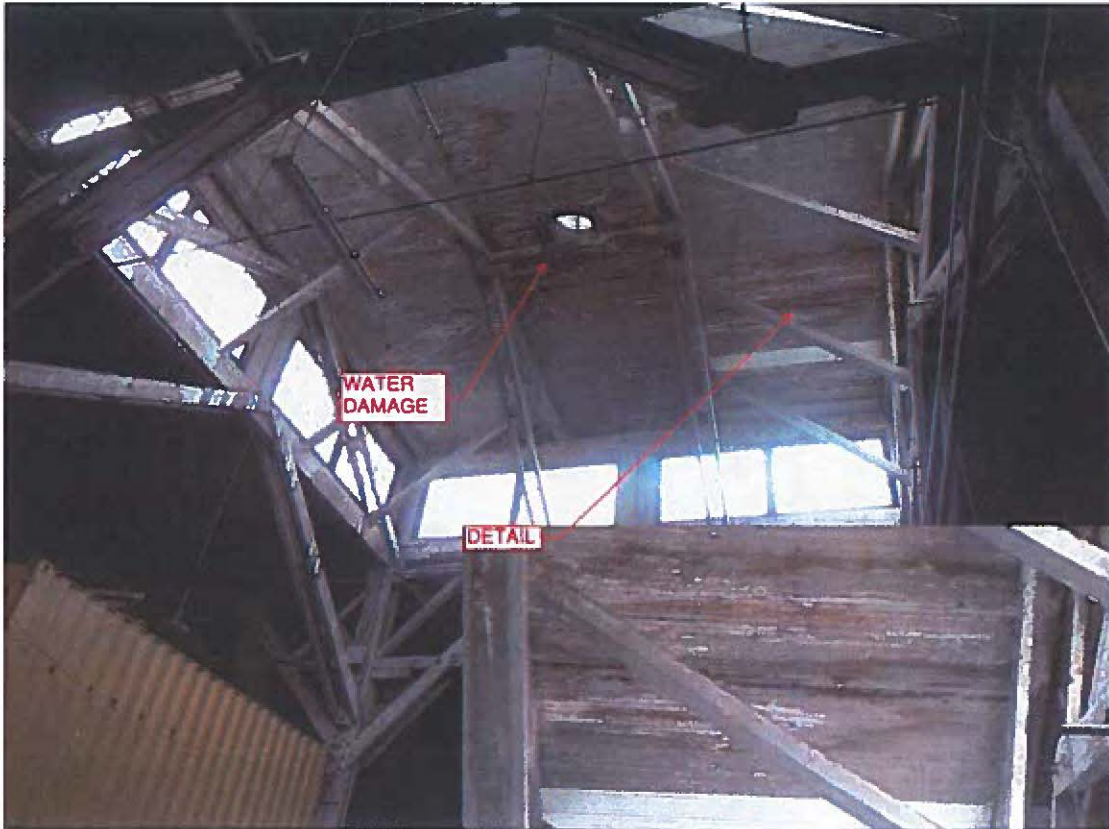
Figure 8 - Monitor water damage

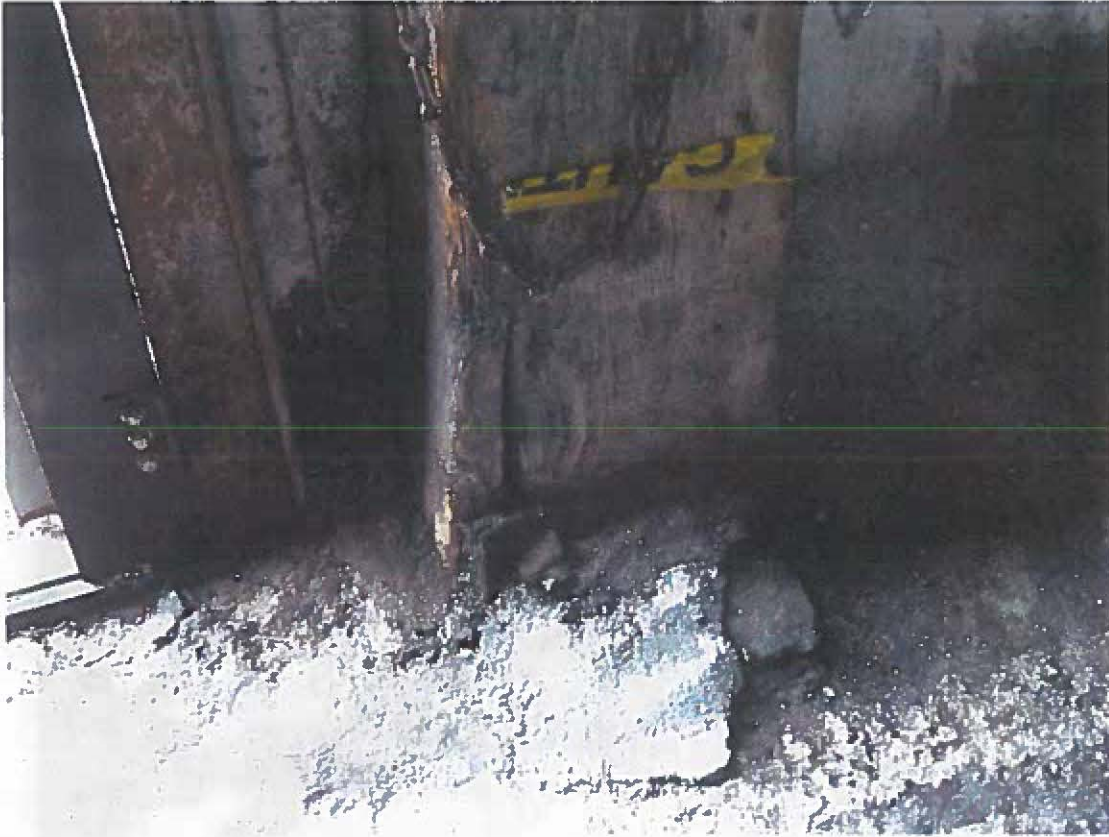
Figure 9 - Split column base at corroding base plate bolt next to bay door

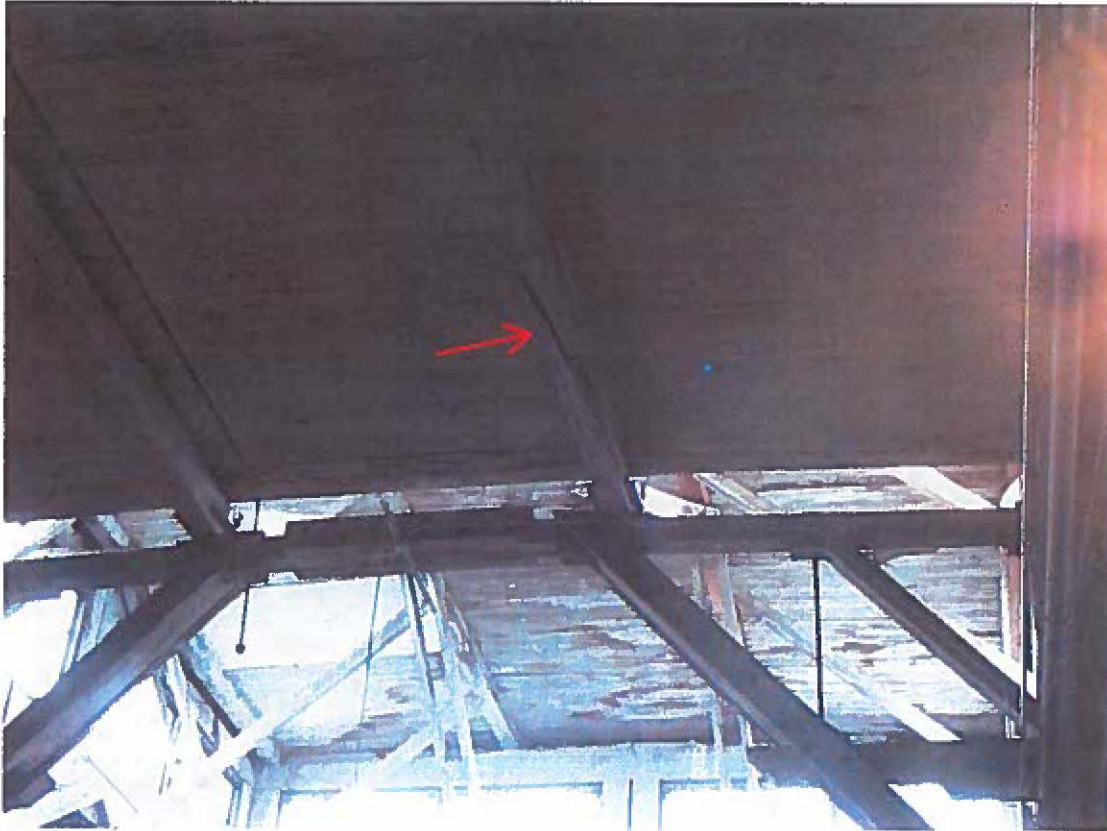
Figure 10 - Split purlin beam near grid 34

**Required Repairs:** Repair hole in floor level slab south of main entrance, repair split purlin.

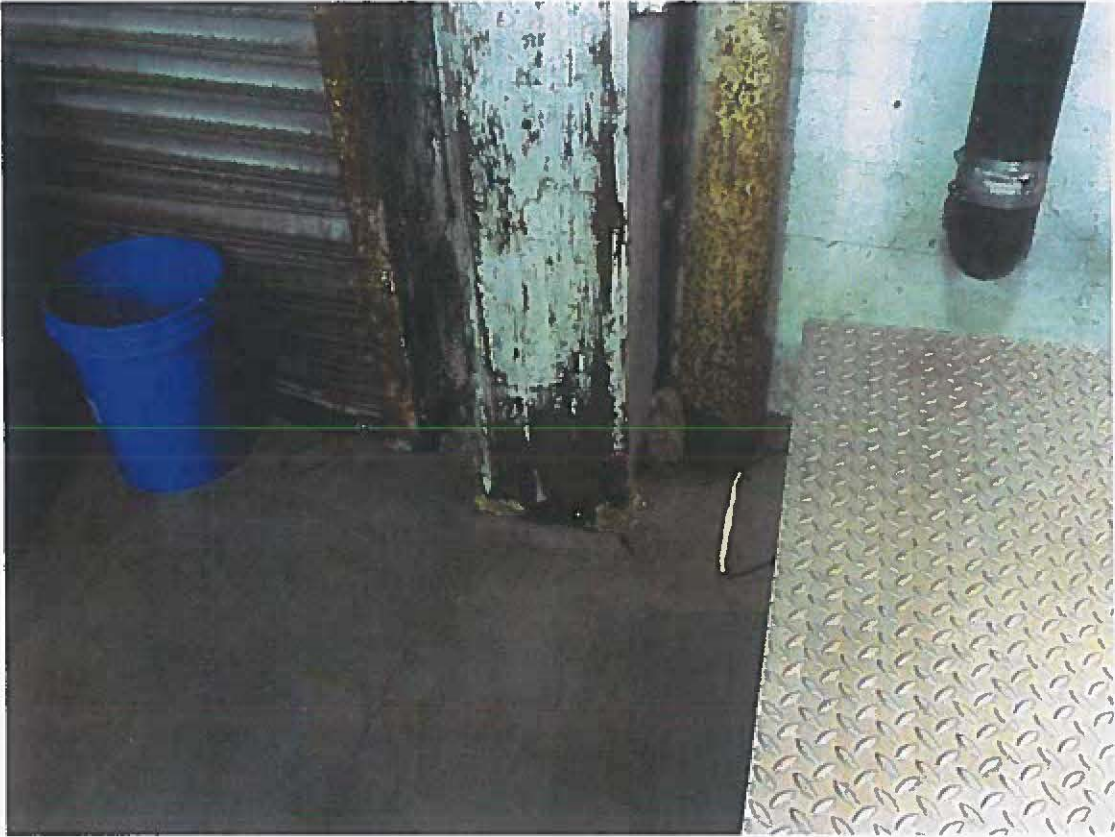
Figure 11 - Dry rot at column base next to bay door. Typical condition of timber column bases along exterior walls near bay doors and where it appears floors are frequently wetted.

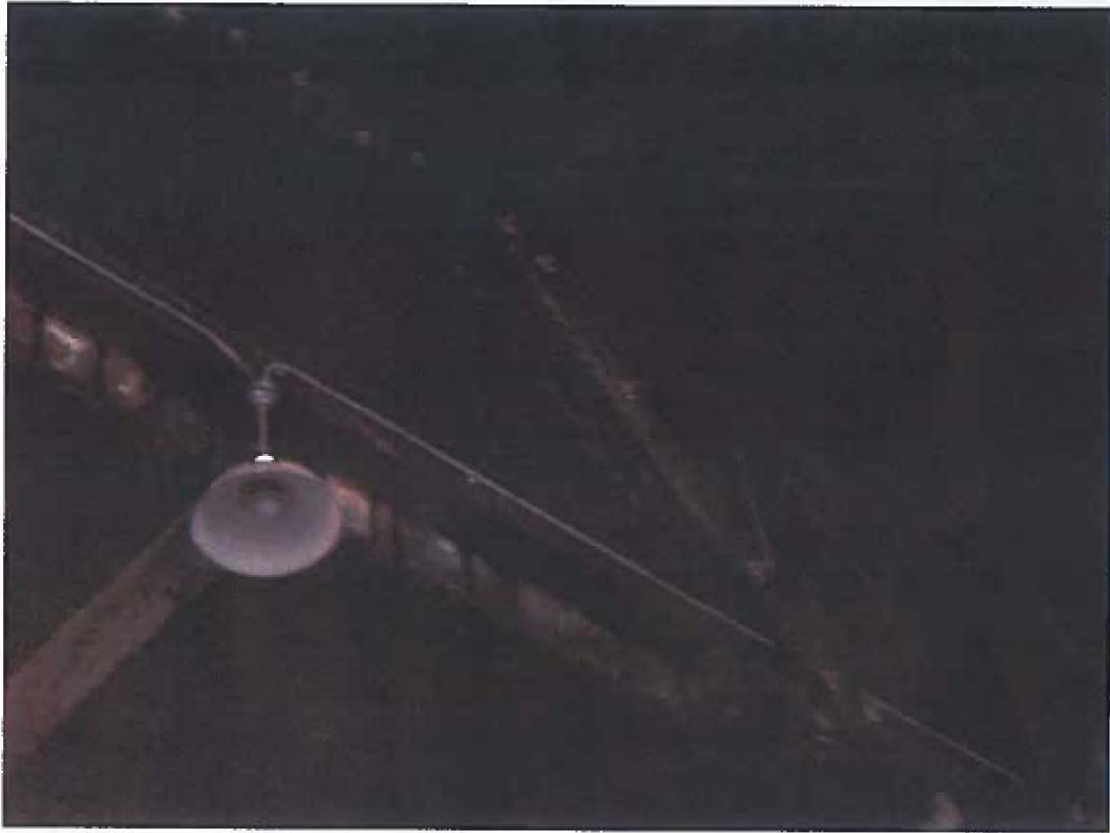
Figure 12 - Charred truss near grid 50

**Detailed Structural/Geotechnical Evaluation Required:** Recommend evaluation to determine adequacy of water and fire damaged members if not replaced.

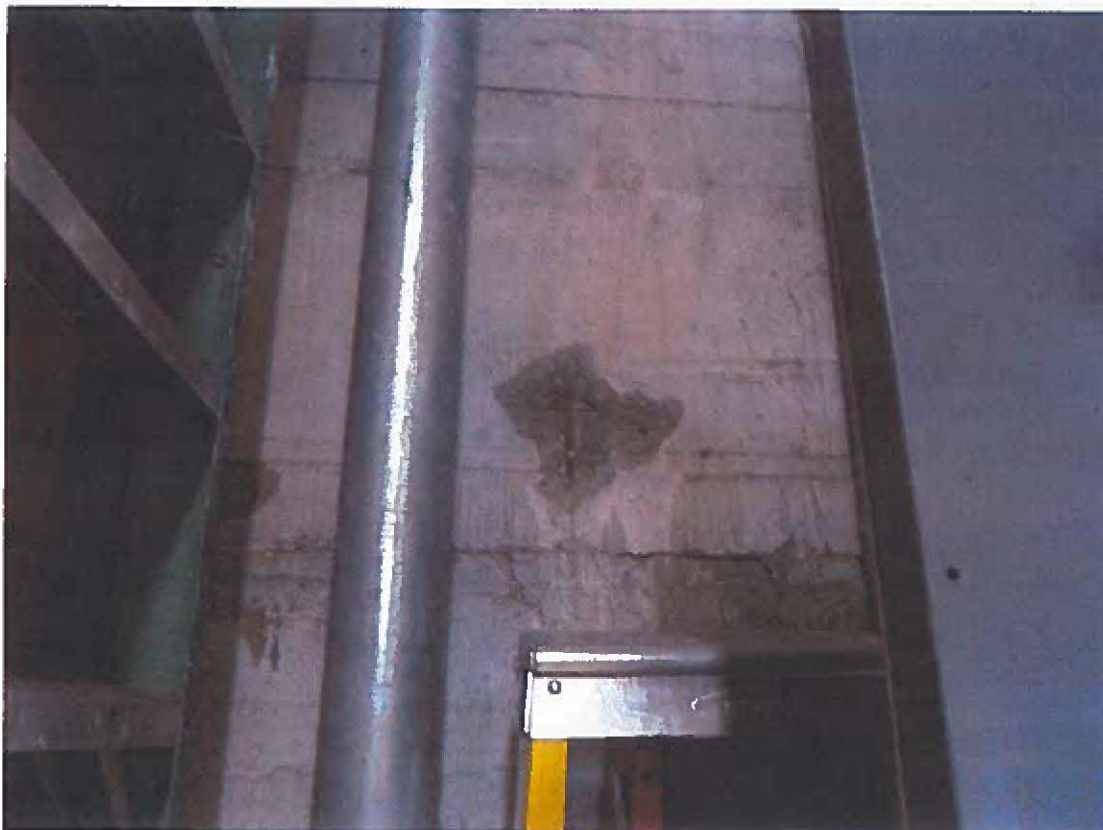
These could pose a falling hazard and will lead to more significant corrosion if not repaired.

Figure 14 - Spalling at interior face of concrete wall

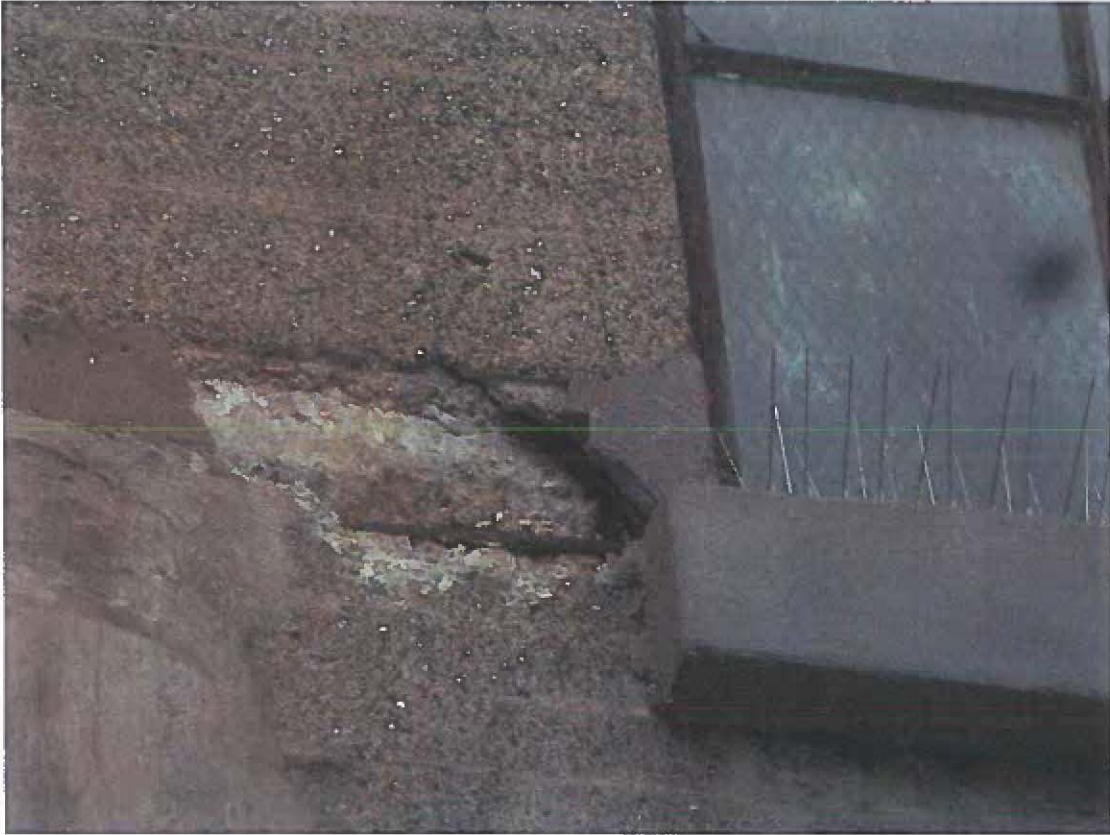
Figure 15 - Spalling at window corner

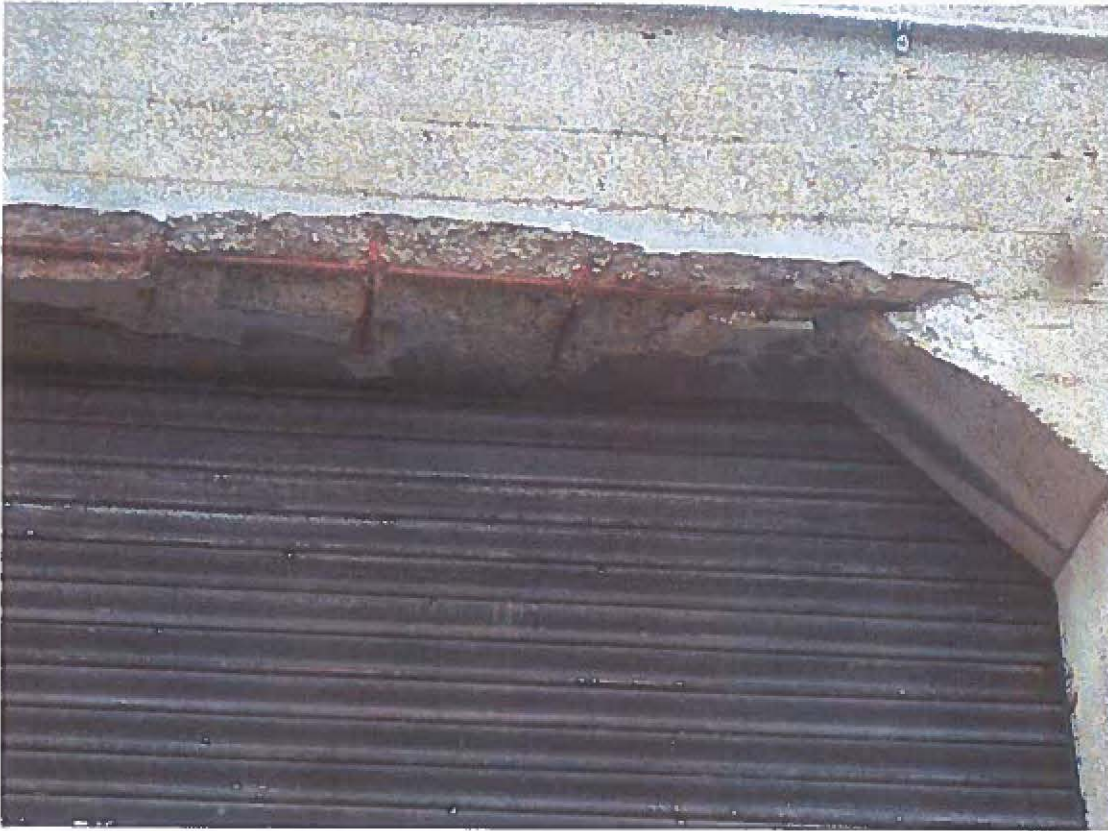
Figure 16 - Bay door header spalling. It appears a previous concrete repair has re-spalled.

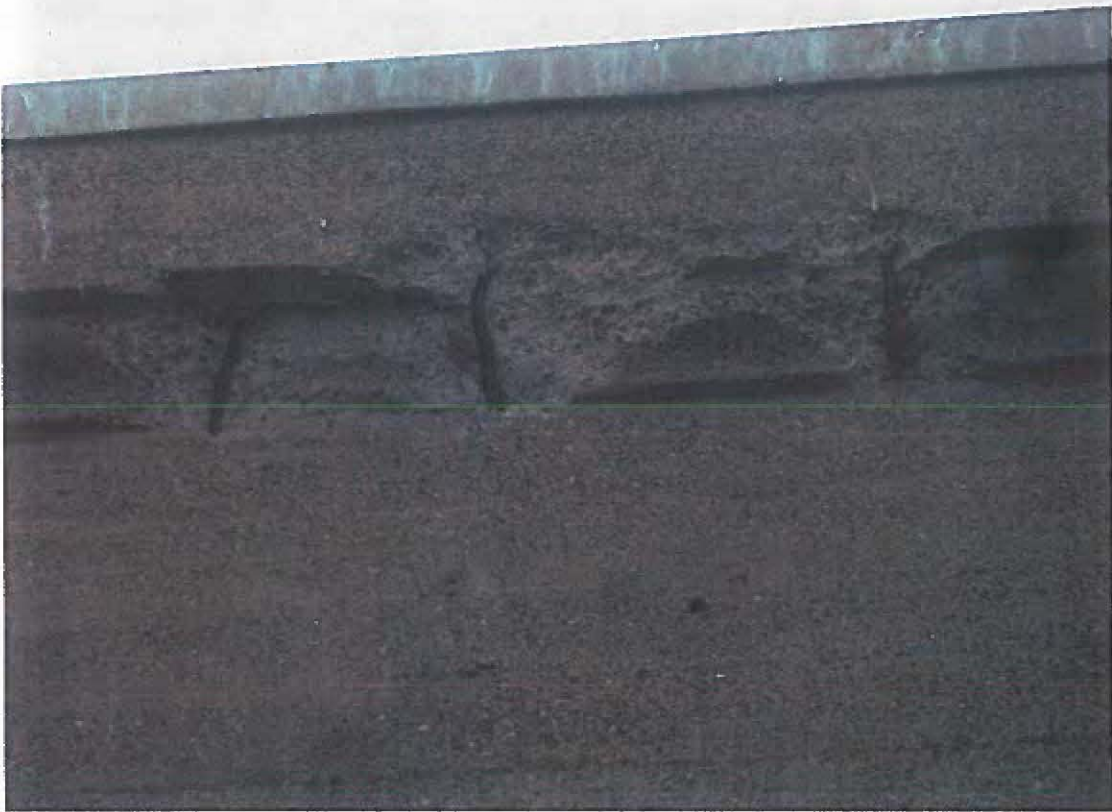
Figure 17 - Parapet spalling

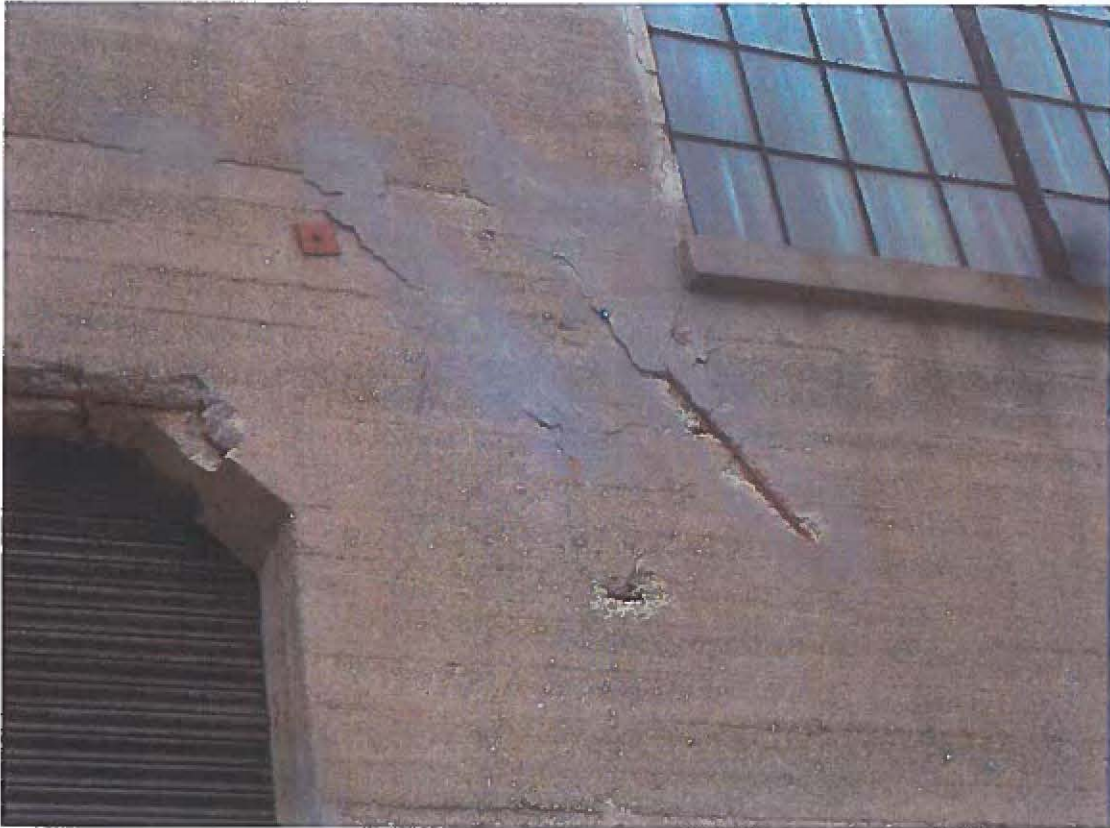
Figure 18 - Mid-wall patch re-spalling

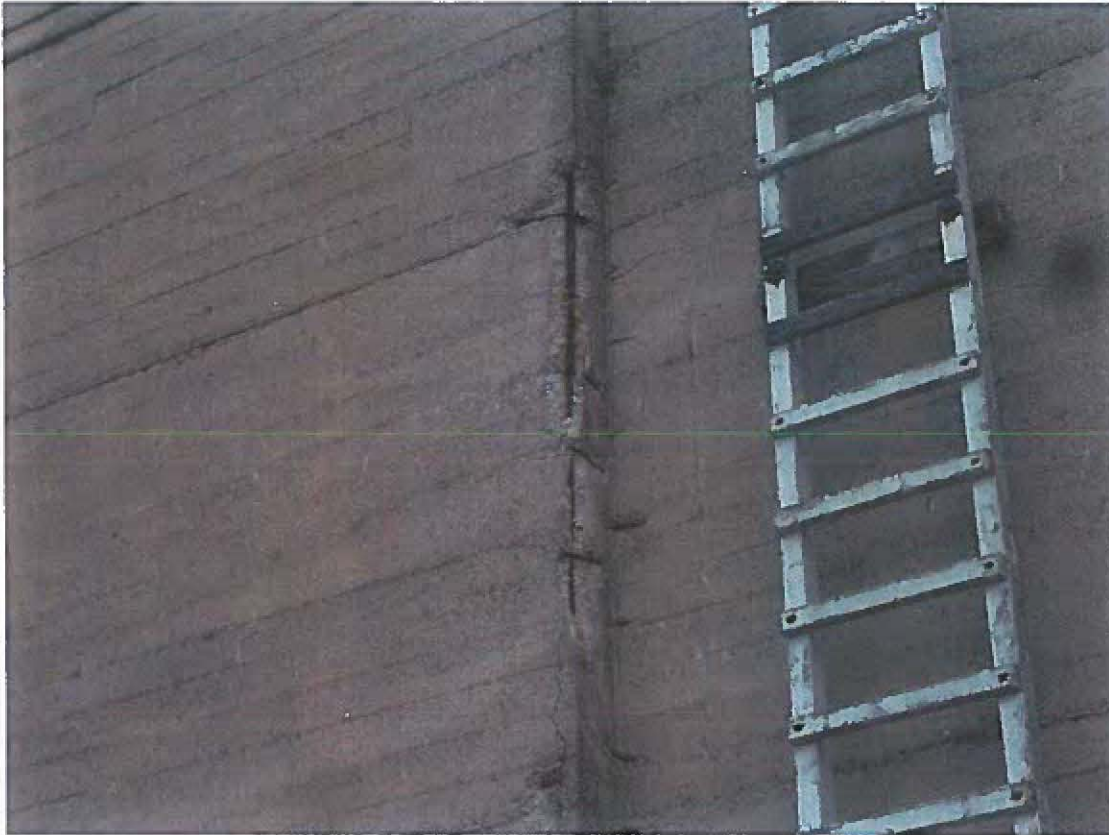
Figure 19 - Wall corner spalling

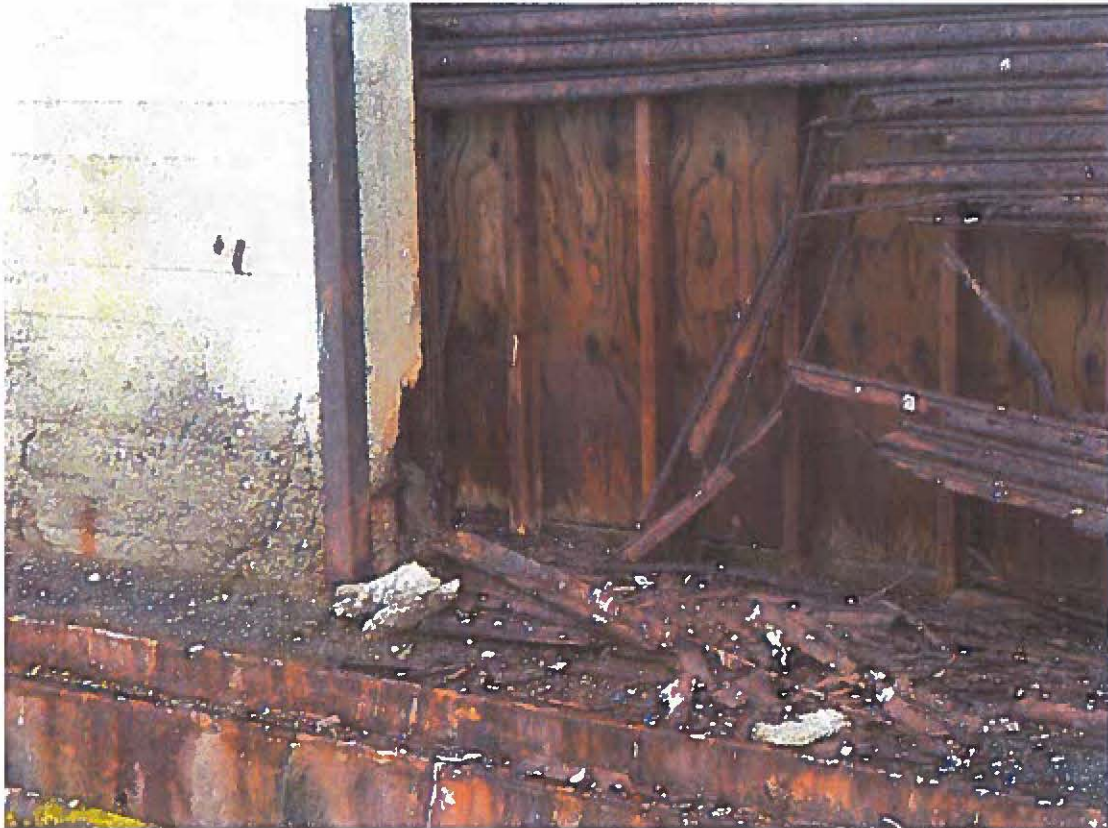
Figure 20 - Corrosion, spalling, and water intrusion at bay door along north apron.

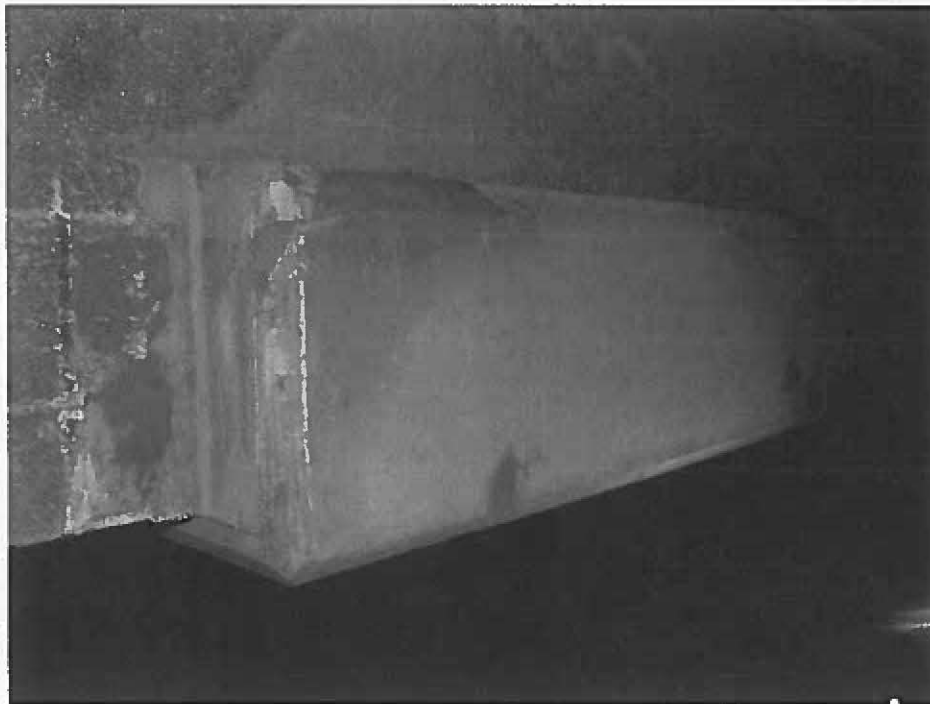
Figure 6 - Typical Cast in Place Beam Repair (5/14/2019)

Cast in place beam repairs were performed in accordance with the following detail as shown in Figure 5 and Figure 6.

- ✓ Chamfered edges as noted in general notes
- ✓ Approximate adequate cover
- ✓ No noticed damage, rust straining, or cracks
- ✓ General conformance with design details

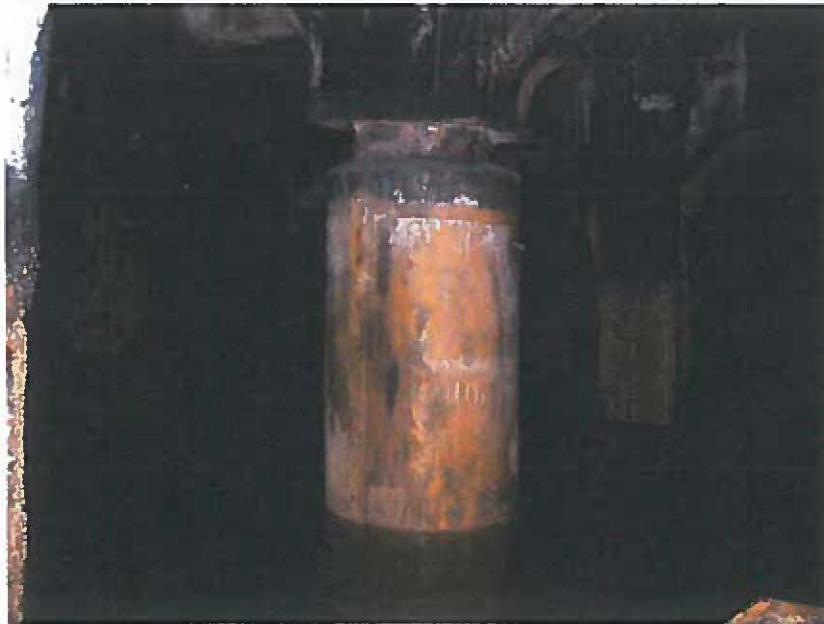
Figure 8 - Pile Repair (5/14/2019)

The pile sleeve repair were performed in accordance with design details. The design details and photo of typical repair are shown in Figure 7 and Figure 8.

- ✓ Chamfer at top to prevent water pooling
- ✓ Pile sleeve installed with general conformance with drawings
- ✓ Pile sleeve left on to increase durability

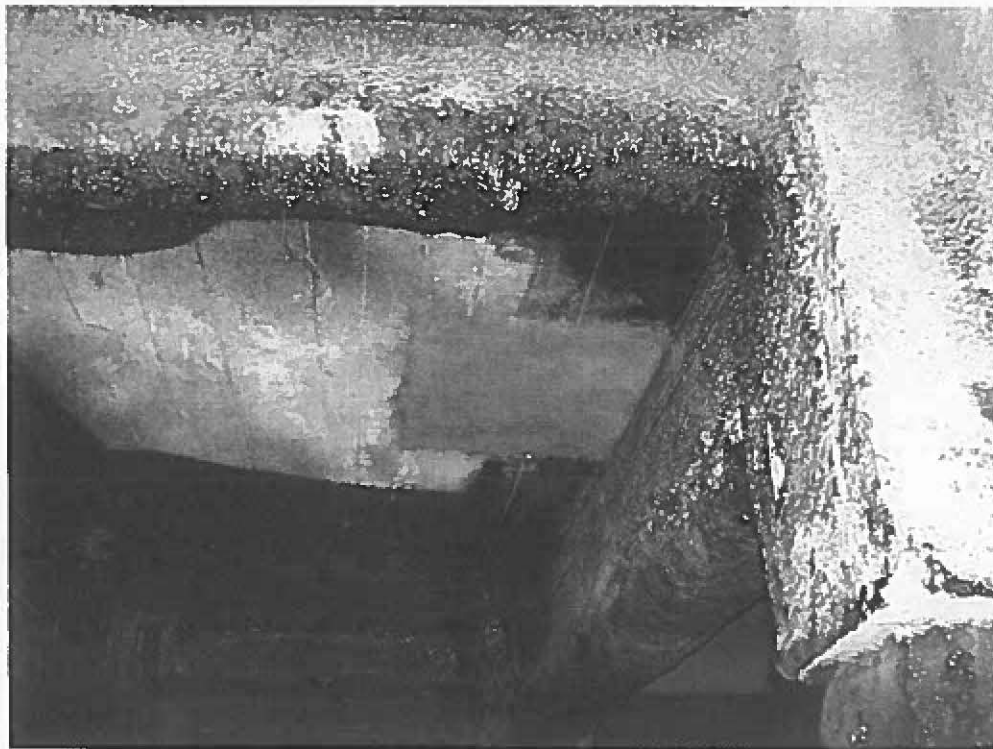
Figure 12 - Typical Slab Patch Repair (5/14/2019)

The slab patch repairs are in conformance with the design details. Slab design details and typical photo is shown in Figure 11 and Figure 12

- ✓ Clear perimeter indicating 1/2" saw cut around edges.
- ✓ No damage, rust stains, or noticeable cracks.
- ✓ General conformance with design detail

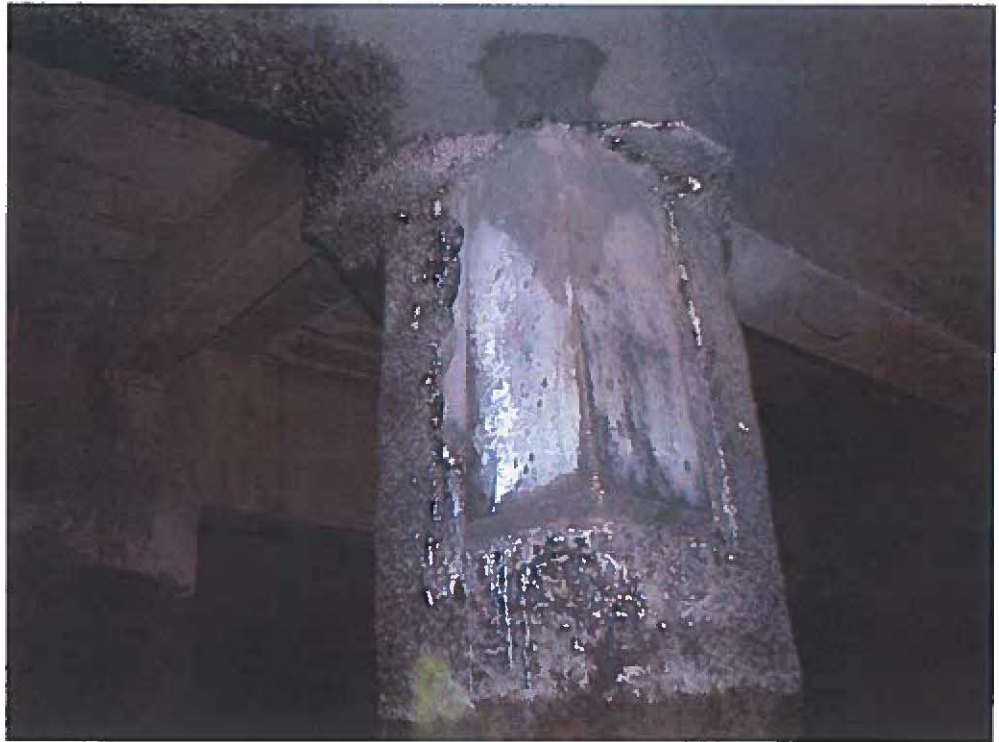
Figure 15 - Small Concrete Pile Cap Repair

The contractor chose the alternative option to form and pour the pile cap repairs. The form and pour details are outlined in the details in Figure 13 and Figure 14. Photos of repairs are shown in Figure 15 and Figure 16. The drawing shows shotcrete repair; the form and pour repair method was not drawn but outlined in notes. The pile cap repair is in accordance with design drawings.

- ✓ Chamfered Edges
- ✗ Cover looks to be adequate
- ✗ General conformance with design drawings
- ✓ No damage or rust staining

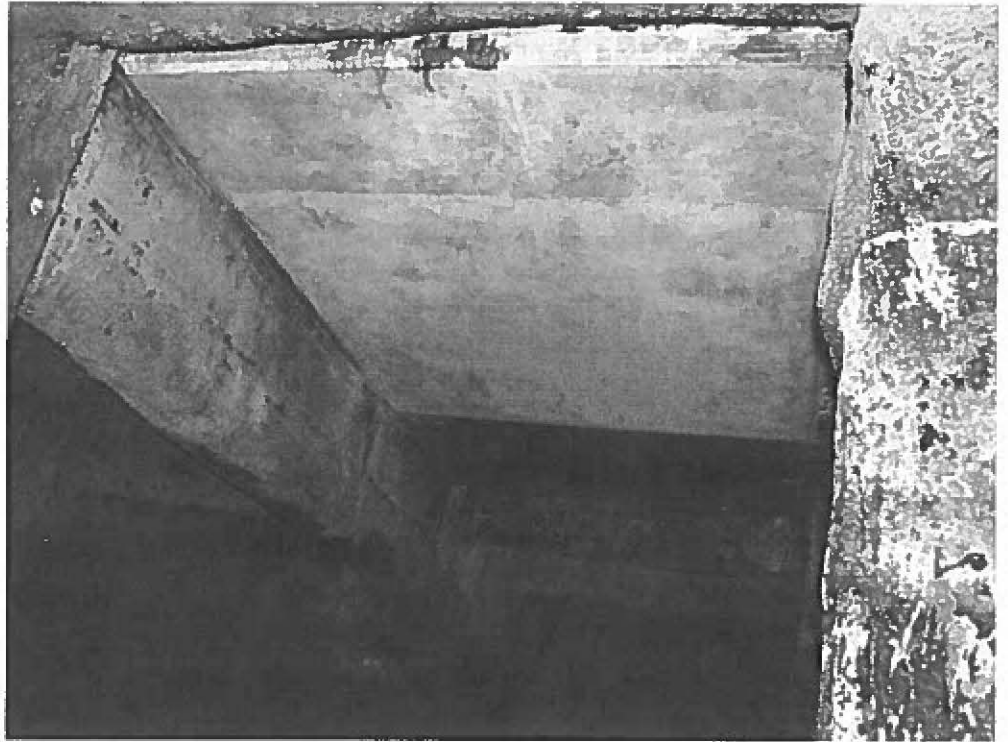
*Figure 18 - Access Hole 1 Replacement*

The access hole replacement slab and the top sunken slab replacement were in conformance with the design details. See detail and photos in Figure 17, Figure 18, and Figure 19.

- ✓ Chamfered Edges
- ✓ General conformance with design drawings
- ✓ No damage or rust staining

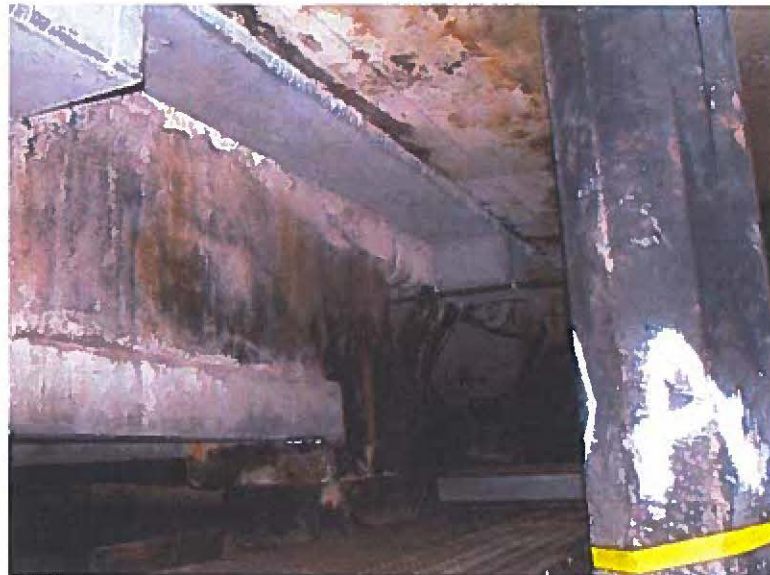
Figure 23 - Cantilever Beam Repair Photo (11/13/18)\*

The cantilever repair is in conformance with the design drawings. The design detail and photo are shown in Figure 22 and Figure 23.

- ✓ Chamfered edges
- ✓ General Conformance with design drawings
- ✓ No visible rust staining, significant cracking, or damage

\*The cantilever beam was inspected in the 5/14/19 inspection and the 11/13/18 inspection. Photos for cantilever beam in recent inspection turned out blurry due to boat movement.

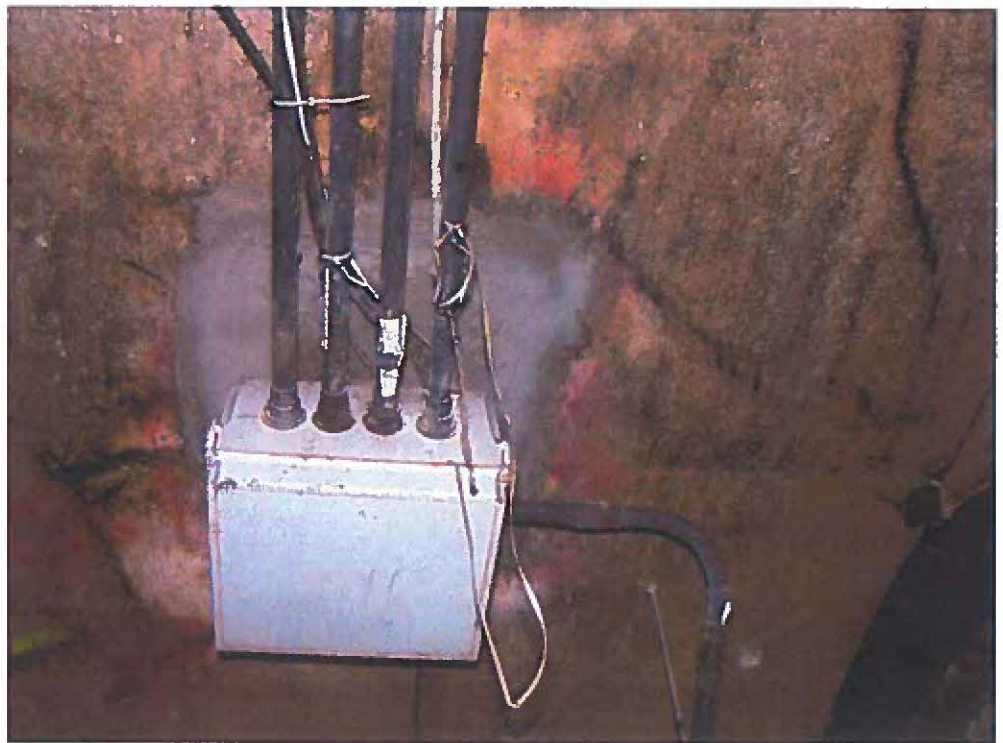
Figure 25 - Electrical Box Repair Photo (5/14/19)

The electrical box repair is in conformance with the design drawings/notes as shown in Figure 24 and Figure 25.

- ✓ Patch around equipment
- ✓ Equipment looks undamaged
- ✓ Patch follows general requirements of patch repair
- ✓ No rust staining, damage, or significant cracking

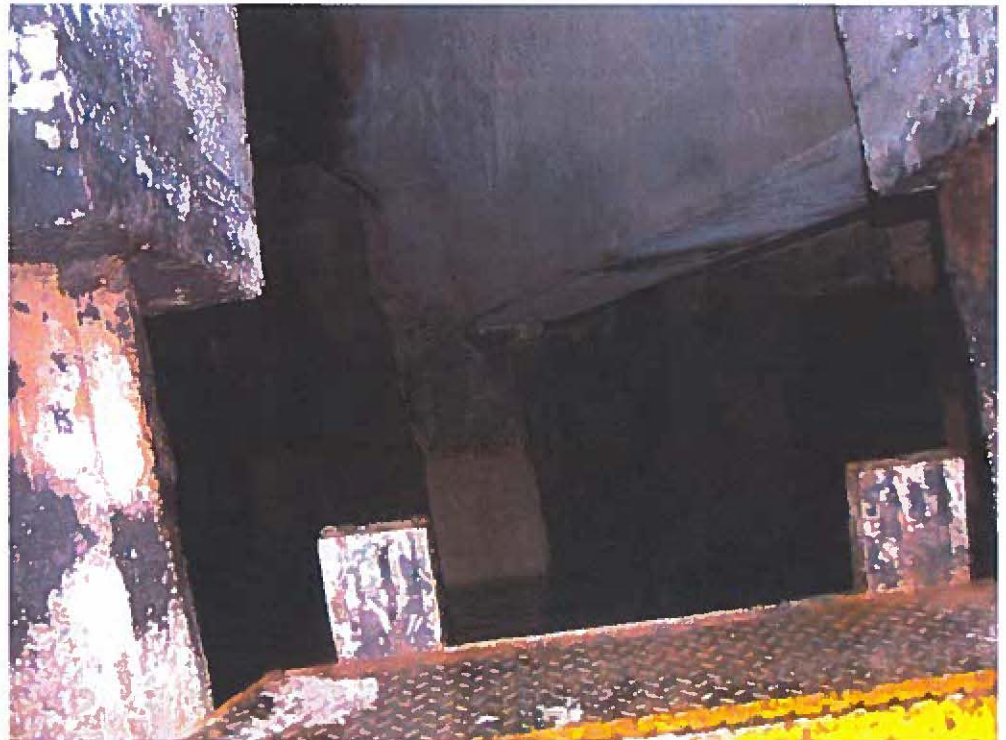
Figure 27 - Sunken Slab on Pier 31.5 (5/15/19)

The sunken slab repair is in conformance with the design drawings. The detail and photos are shown in Figure 26, Figure 27, and Figure 28.

- ✓ Form lower section and shotcrete upper section
- ✓ Chamfer Corners
- ✓ No visible rust staining or significant cracking

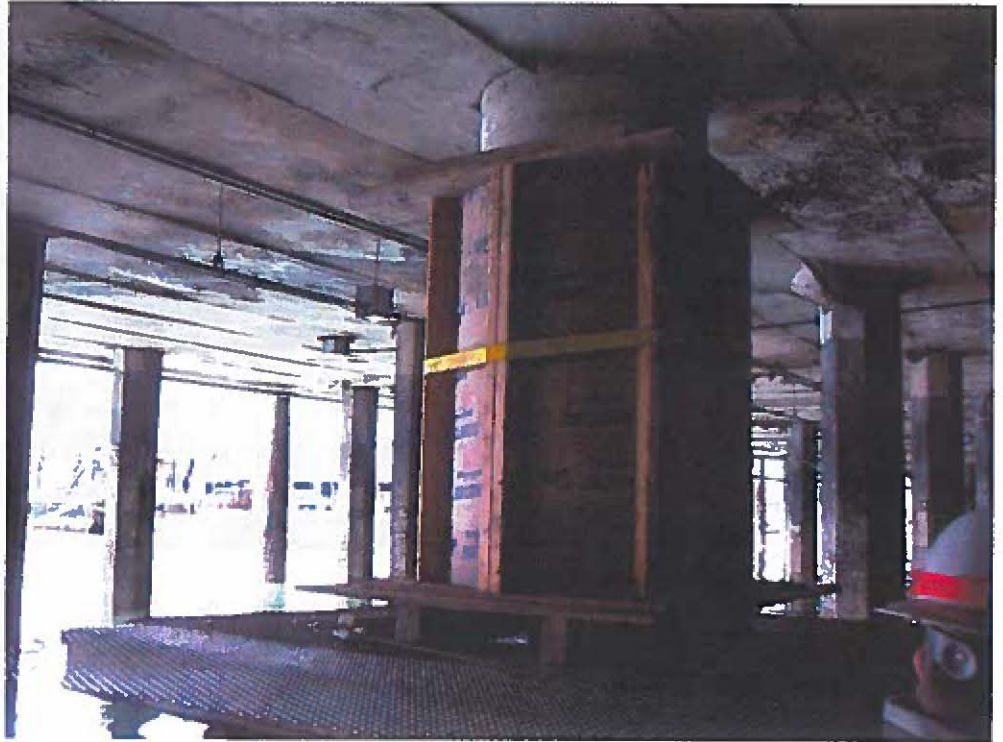
Figure 29 - Concrete Encasement Repair

The concrete encasement is still encased in forms. The encasement follows general details and procedures. COWI has requested photos of the encasement repairs once the form work is removed for visual confirmation the repair follows design details.
