Supplemental Report for Foundation Settlement Investigation

The building at 301 Mission Street, San Francisco, California is a fifty-eight-story residential structure founded on a pile-supported mat foundation. The building, which was completed in 2009, has experienced and continues to experience significant foundation settlement. Paul Hastings, LLP retained Simpson Gumpertz & Heger Inc. in 2014 to conduct an evaluation of the impact of site settlement on the building's structural stability and earthquake resistance. We performed initial evaluations in 2014 and updated these in 2016 to consider additional settlement that occurred in the interim period. In an October 2016 report we concluded that settlement had not compromised the building's stability or its ability to resist strong earthquakes.

**SUPPLEMENTAL REPORT
FOUNDATION SETTLEMENT INVESTIGATION
301 MISSION STREET
SAN FRANCISCO, CALIFORNIA**

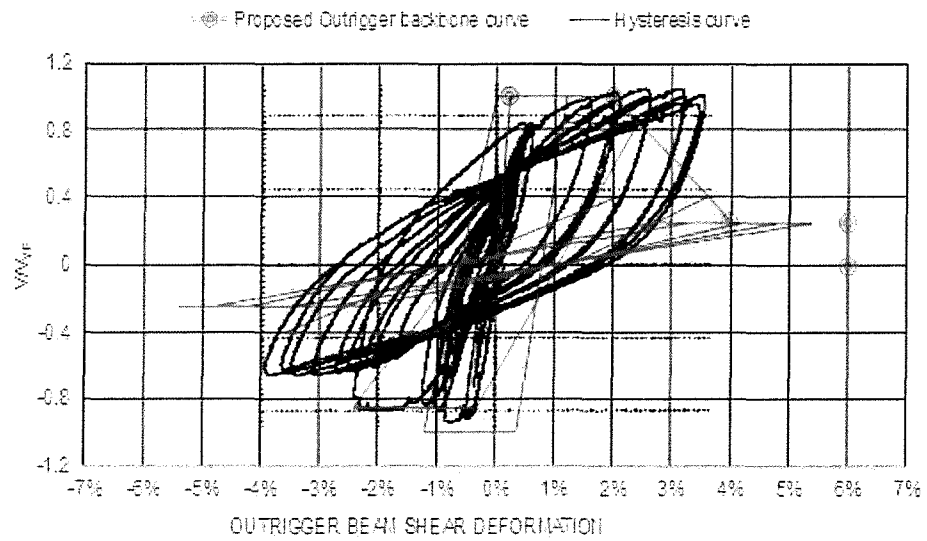
Figure 13. Coupling Beam Degrading Hysteretic Model

For these elements, we implemented the degrading hysteretic model illustrated in Figure 13. The cyclic backbone for this model maintains elastic-perfectly-plastic behavior through a shear deformation of 2% radians then degrades to a residual strength equal to 25% of the yield strength at a shear deformation of 4% radians. The model retains this residual displacement through shear deformation of 6% radians, after which it has nil residual strength. Figure 14 shows an overlay of the response obtained from this hysteretic model with that recorded in the University of Michigan testing discussed in Section 2.1.2 of this report. The hysteretic model conservatively represents the behavior obtained in the test and exhibits greater strength and stiffness degradation than did the tested specimen.

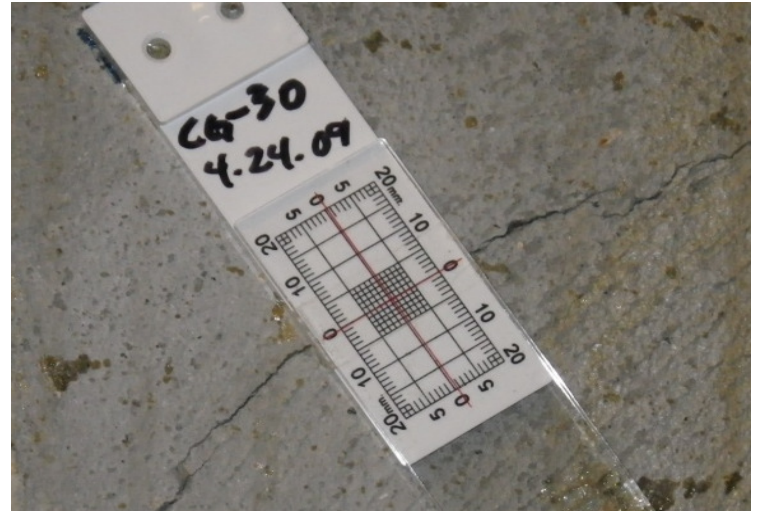
Crack Gauge	Distance of Movement	Direction of movement, relative to the Crack	Variation from previous reading	Picture of Movement
CG-30	0.5 mm	Parallel	+0.1 mm

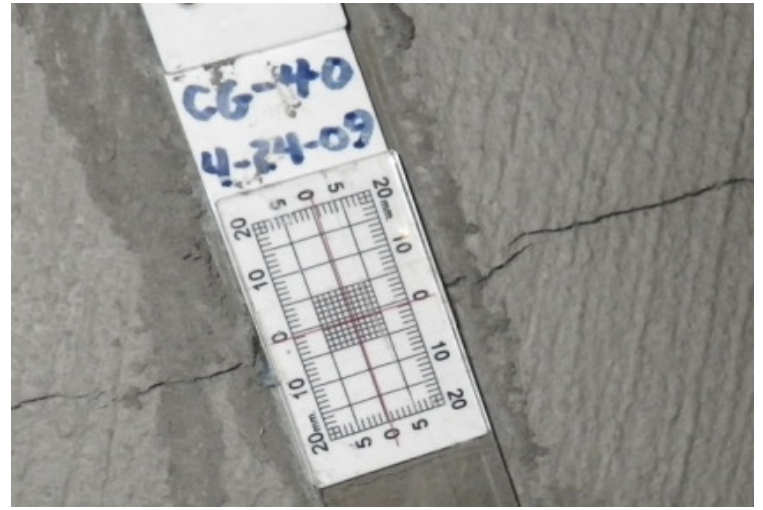
CG-40	0.9 mm 0.7 to 0.2 mm	Parallel Perpendicular	+0.9 mm +0.7 to +0.1 mm

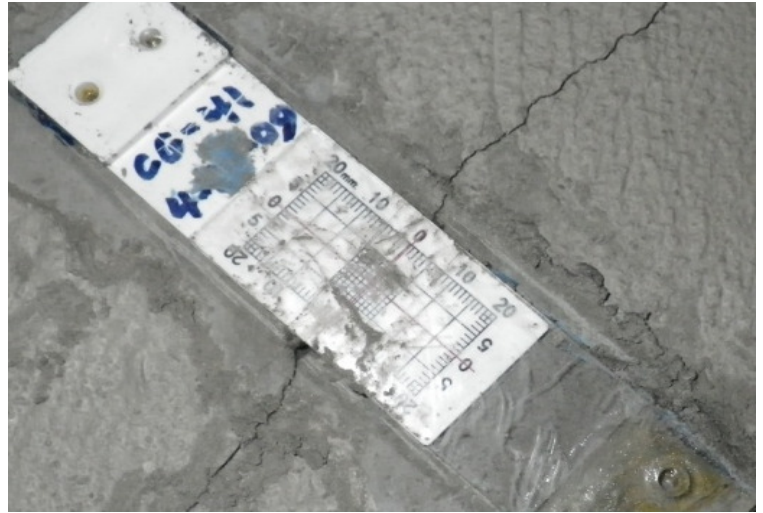
Crack Gauge	Distance of Movement	Direction of movement, relative to the Crack	Variation from previous reading	Picture of Movement
CG-41	0.5 mm	Parallel	+0.5 mm

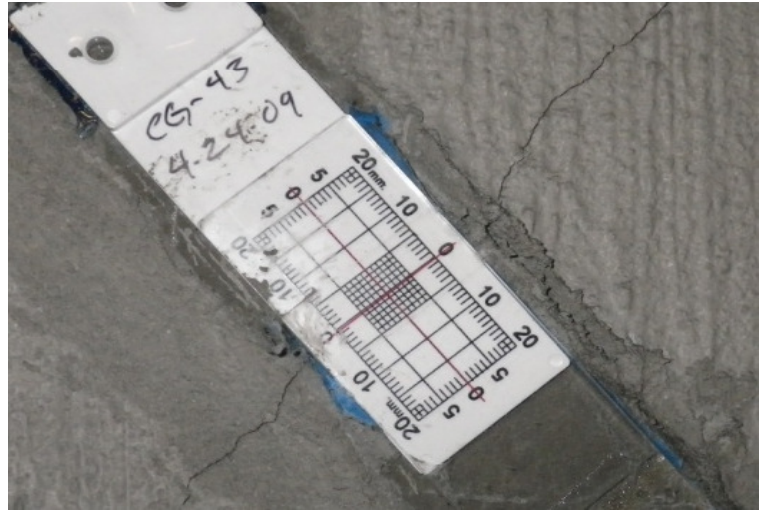
CG-43	0.3 mm	Perpendicular	Same as previous reading

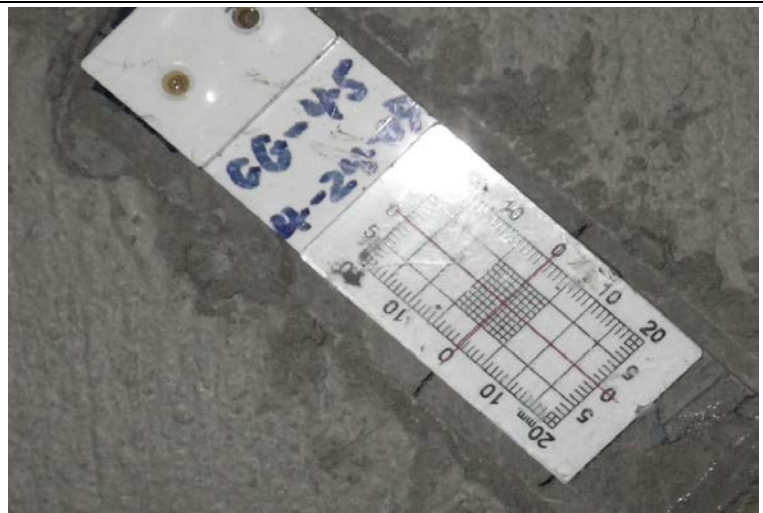
CG-45	0.4 mm	Perpendicular	+0.4 mm

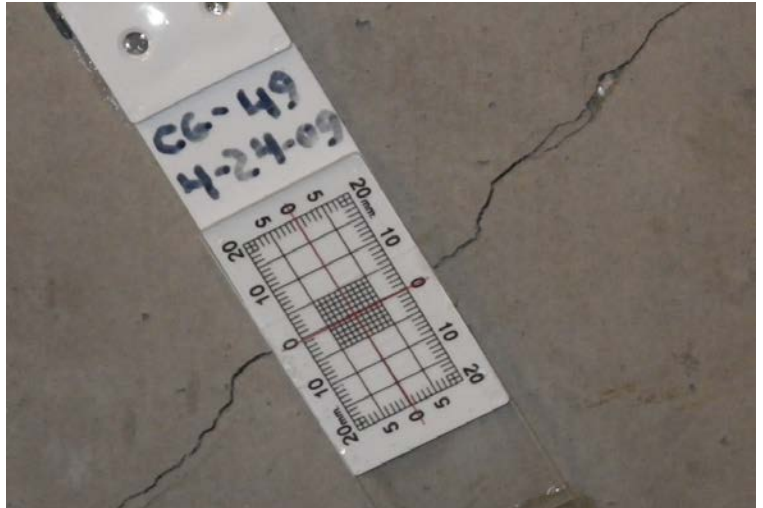
CG-49	0.4 mm	Perpendicular	+0.4 mm

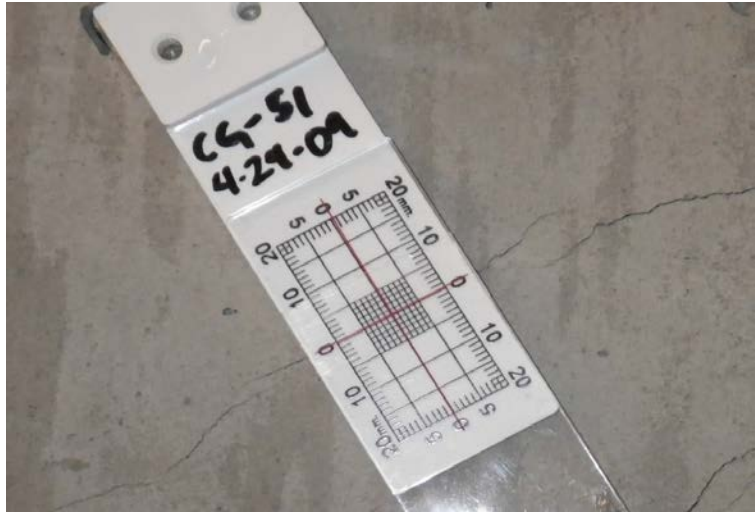
Crack Gauge	Distance of Movement	Direction of movement, relative to the Crack	Variation from previous reading	Picture of Movement
CG-51	0.5 mm	Parallel	Same as previous reading

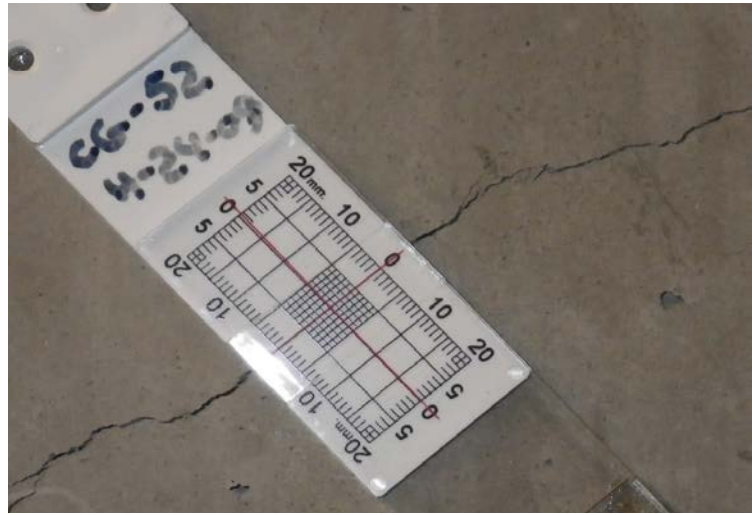
CG-52	0.5 mm	Parallel	Same as previous reading

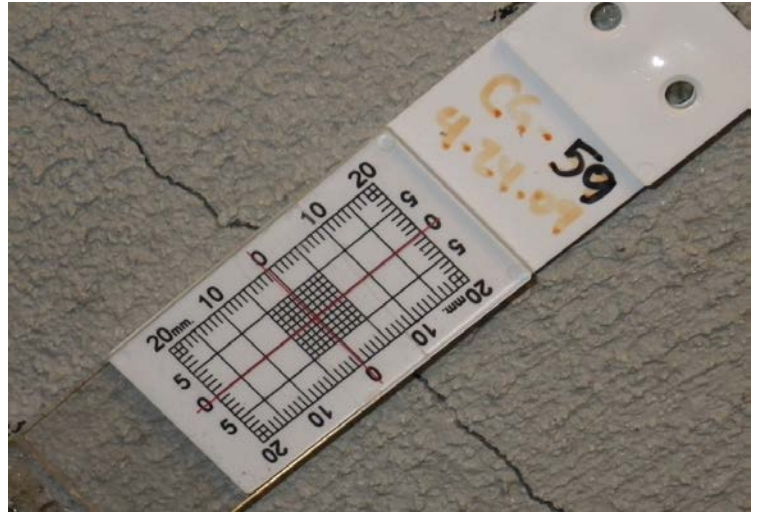
Crack Gauge	Distance of Movement	Direction of movement, relative to the Crack	Variation from previous reading	Picture of Movement
CG-59	0.5 mm	Perpendicular	+0.5 mm

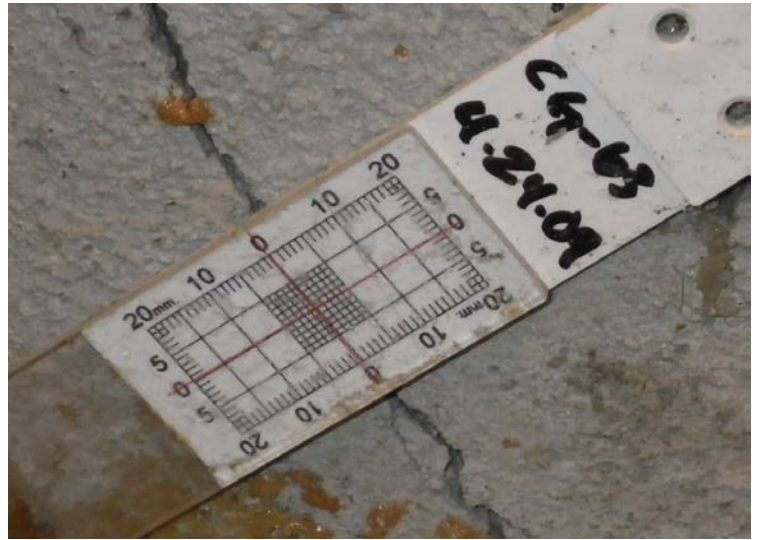
CG-63	0.4 mm	Perpendicular	+0.3 mm

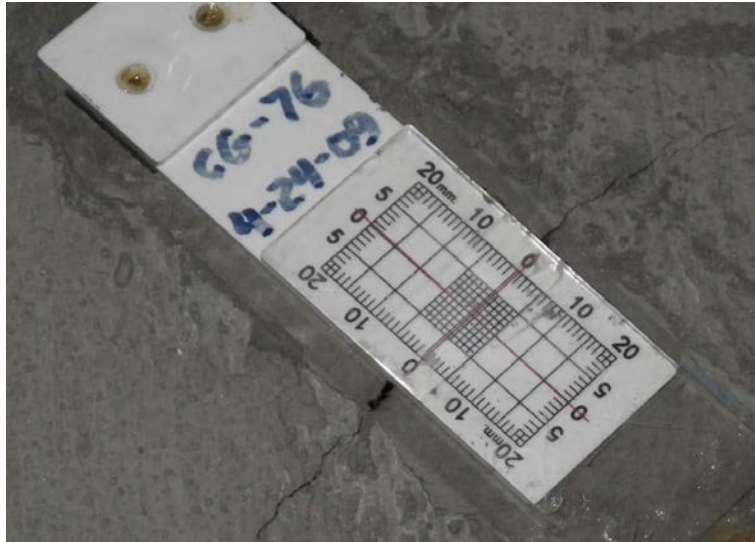
Crack Gauge	Distance of Movement	Direction of movement, relative to the Crack	Variation from previous reading	Picture of Movement
CG-76	0.5 mm	Perpendicular	+0.5 mm

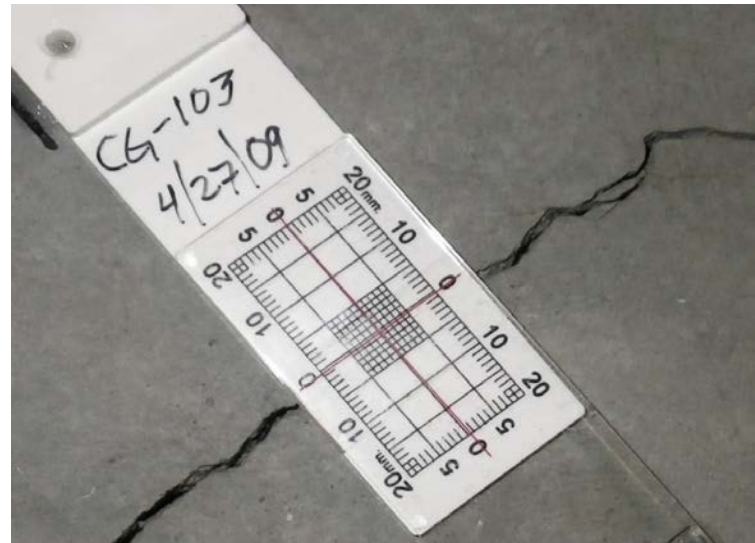
CG-103	0.5 mm 0.1 to 0.4 mm	Perpendicular Parallel	+0.5 mm +0.1 to +0.4 mm

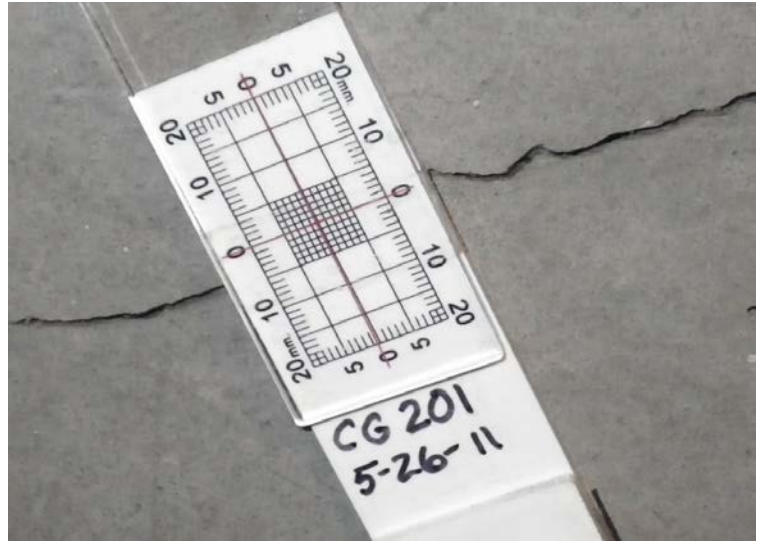
Crack Gauge	Distance of Movement	Direction of movement, relative to the Crack	Variation from previous reading	Picture of Movement
CG-201	0.4 mm	Parallel	+0.4 mm (from installation reading)

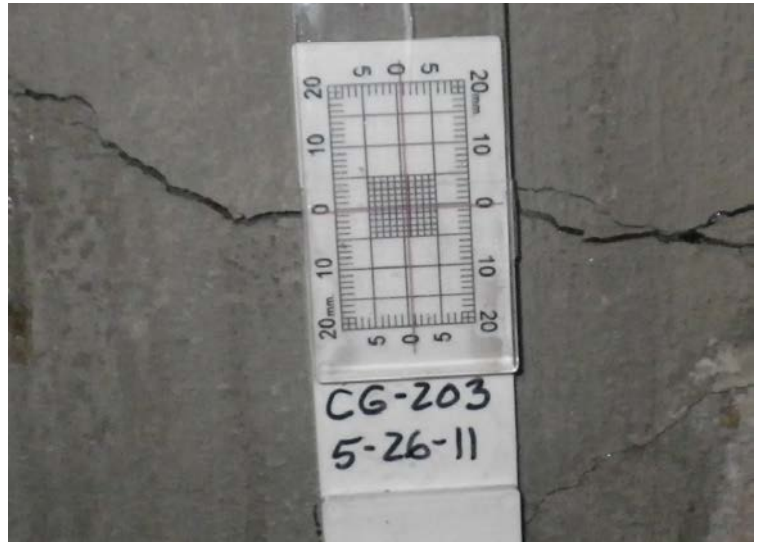
CG-203	0.3 mm 0.8 mm	Perpendicular Parallel	+0.3 mm +0.8 mm (from installation reading)

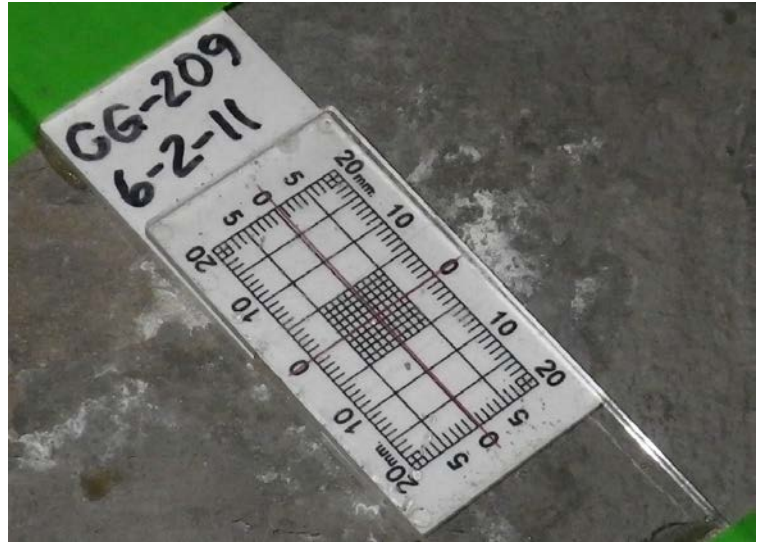
Crack Gauge	Distance of Movement	Direction of movement, relative to the Crack	Variation from previous reading	Picture of Movement
CG-209	0.5 mm	Parallel	+0.5 mm (from installation reading)

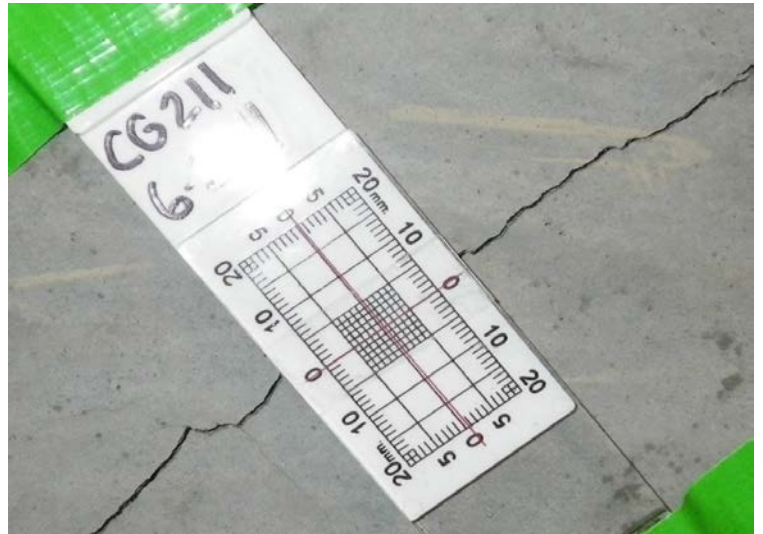
CG-211	0.5 mm	Parallel	+0.5 mm (from installation reading)

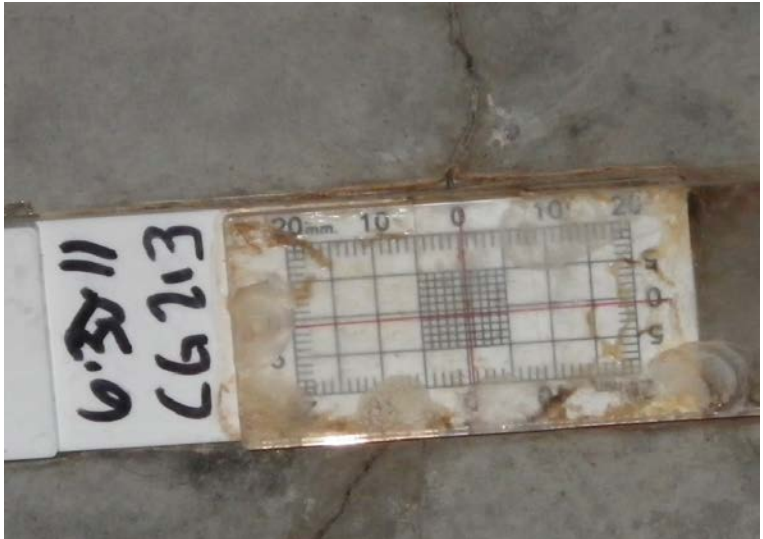
Crack Gauge	Distance of Movement	Direction of movement, relative to the Crack	Variation from previous reading	Picture of Movement
CG-213	0.5 to 1.0 mm 0.5 mm	Parallel Perpendicular	+0.5 to +1.0 mm +0.5 mm (from installation reading)

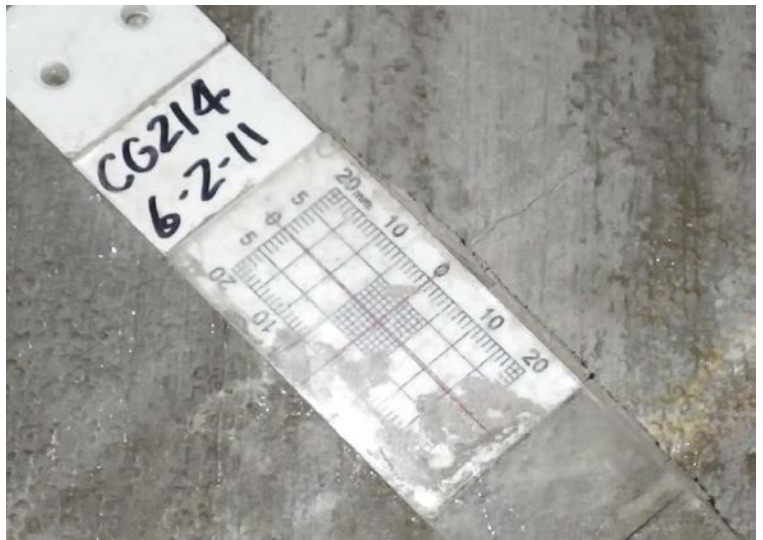
CG-214	0.5 mm	Parallel	+0.5 mm (from installation reading)

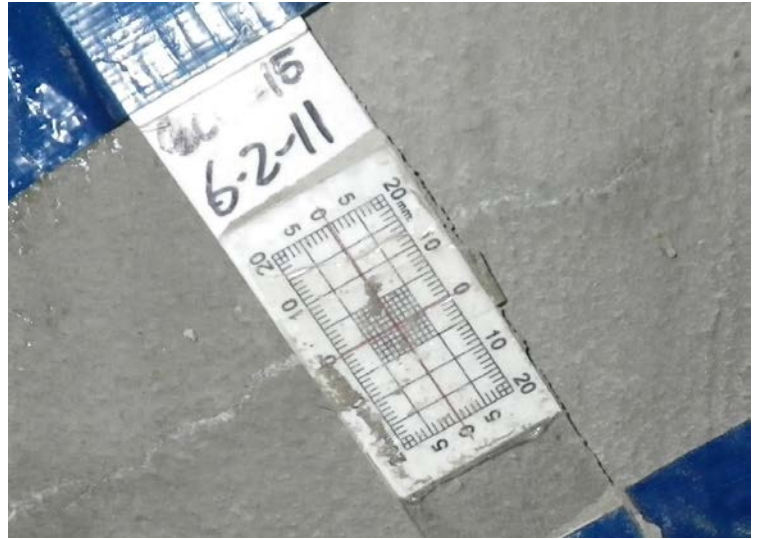
Crack Gauge	Distance of Movement	Direction of movement, relative to the Crack	Variation from previous reading	Picture of Movement
CG-215	0.1 to 0.5mm 0.5 mm	Parallel Perpendicular	+0.1 to +0.5 mm +0.5 mm (from installation reading)

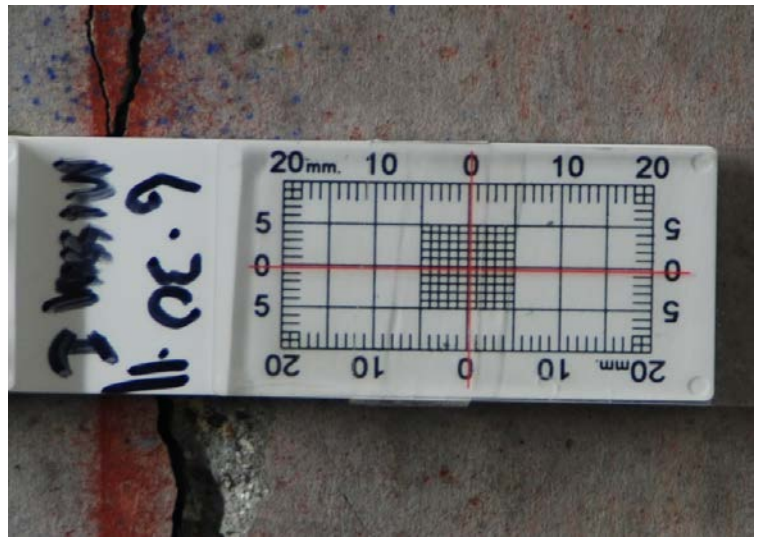
MISSION 1	0.1 to 0.4 mm	Parallel	Same as installation reading

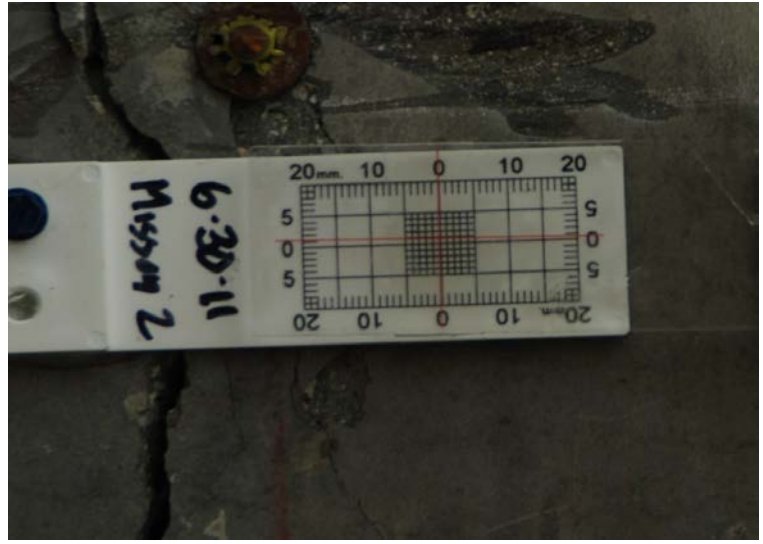
Crack Gauge	Distance of Movement	Direction of movement, relative to the Crack	Variation from previous reading	Picture of Movement
MISSION 2	0.7 to 1.1 mm	Parallel	+0.7 to 1.1 mm (from installation reading)
