*Board of Supervisors
City and County of San Francisco*

Government Audit and Oversight Committee

Supplemental Report for Foundation Settlement Investigation

**SUPPLEMENTAL REPORT
FOUNDATION SETTLEMENT INVESTIGATION
301 MISSION STREET
SAN FRANCISCO, CALIFORNIA**

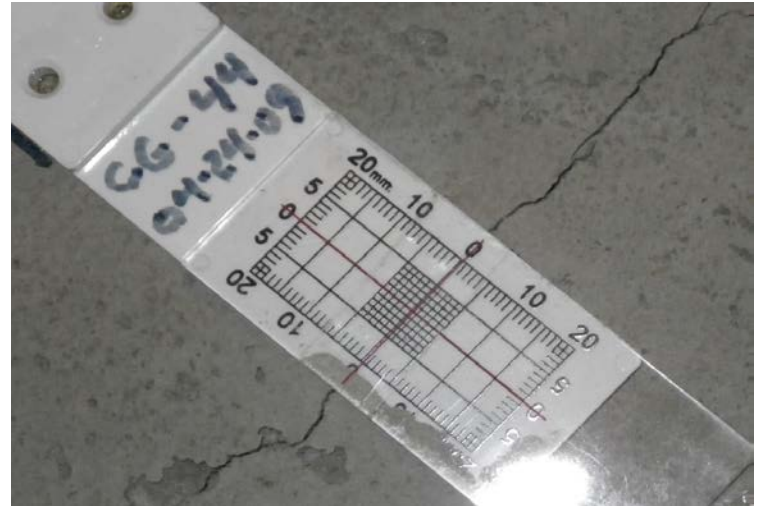
Crack Gauge	Distance of Movement	Direction of movement, relative to the Crack	Variation from previous reading	Picture of Movement
CG-44	0.3 mm	Perpendicular	+0.3 mm

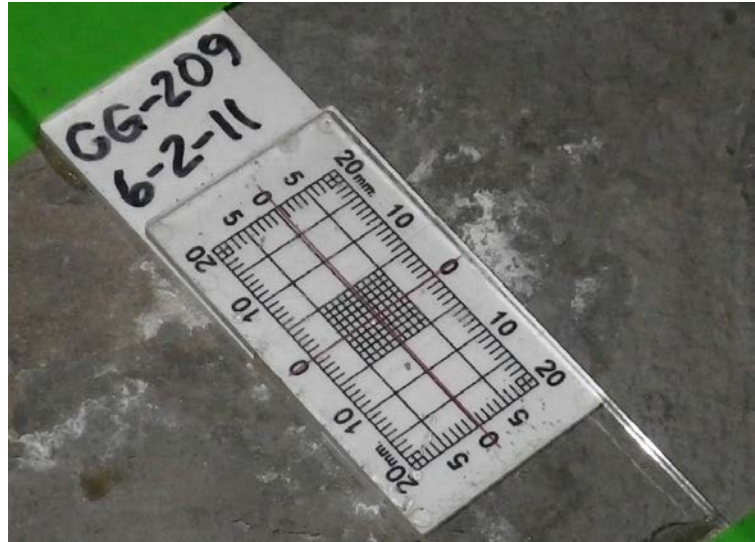
Crack Gauge	Distance of Movement	Direction of movement, relative to the Crack	Variation from previous reading	Picture of Movement
CG-209	0.5 mm	Parallel	+0.5 mm (from installation reading)

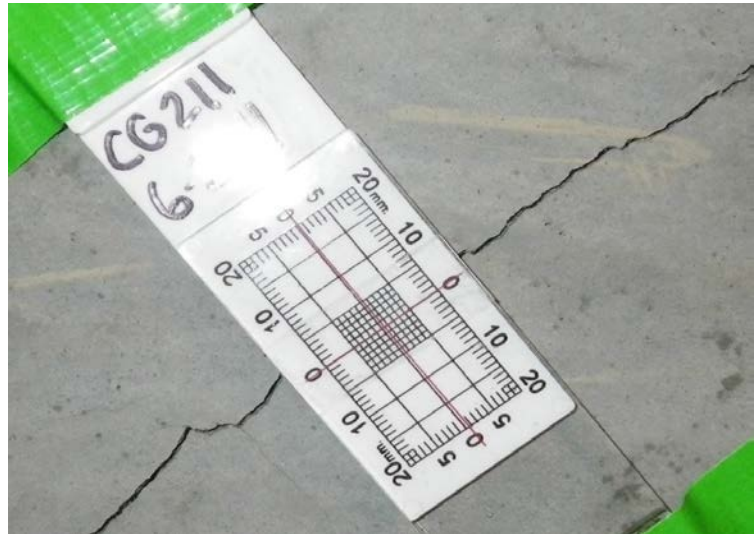
CG-211	0.5 mm	Parallel	+0.5 mm (from installation reading)
