*Board of Supervisors
City and County of San Francisco*

Government Audit and Oversight Committee

Supplemental Report for Foundation Settlement Investigation

**SUPPLEMENTAL REPORT
FOUNDATION SETTLEMENT INVESTIGATION
301 MISSION STREET
SAN FRANCISCO, CALIFORNIA**

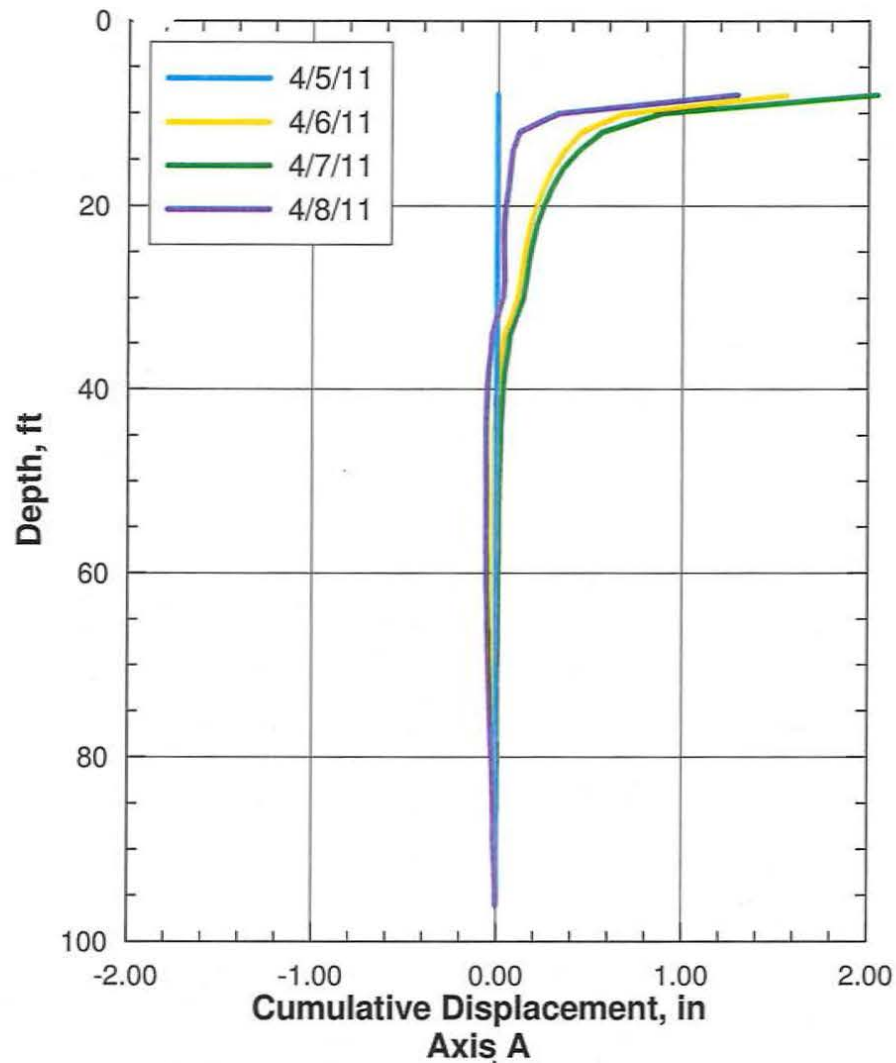
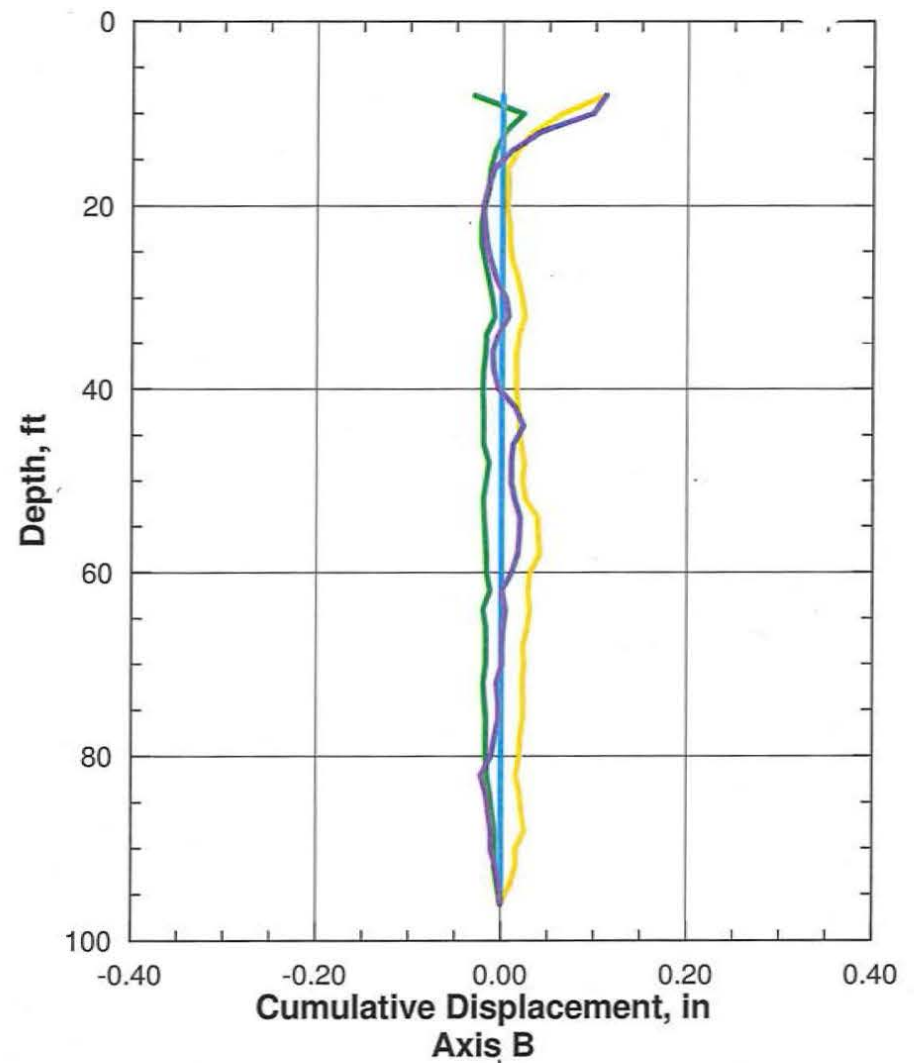
PLATE 3-2

NOTE: Inclinator was damaged during work on 4/5/11. It collapsed about 7 feet below the surface. The inclinometer was dug out and cut-off. A new baseline reading was taken after it was fixed on 4/5/11. Large movements may be from it not being protected at the surface and sloughing ground due to excavation for pile removal.

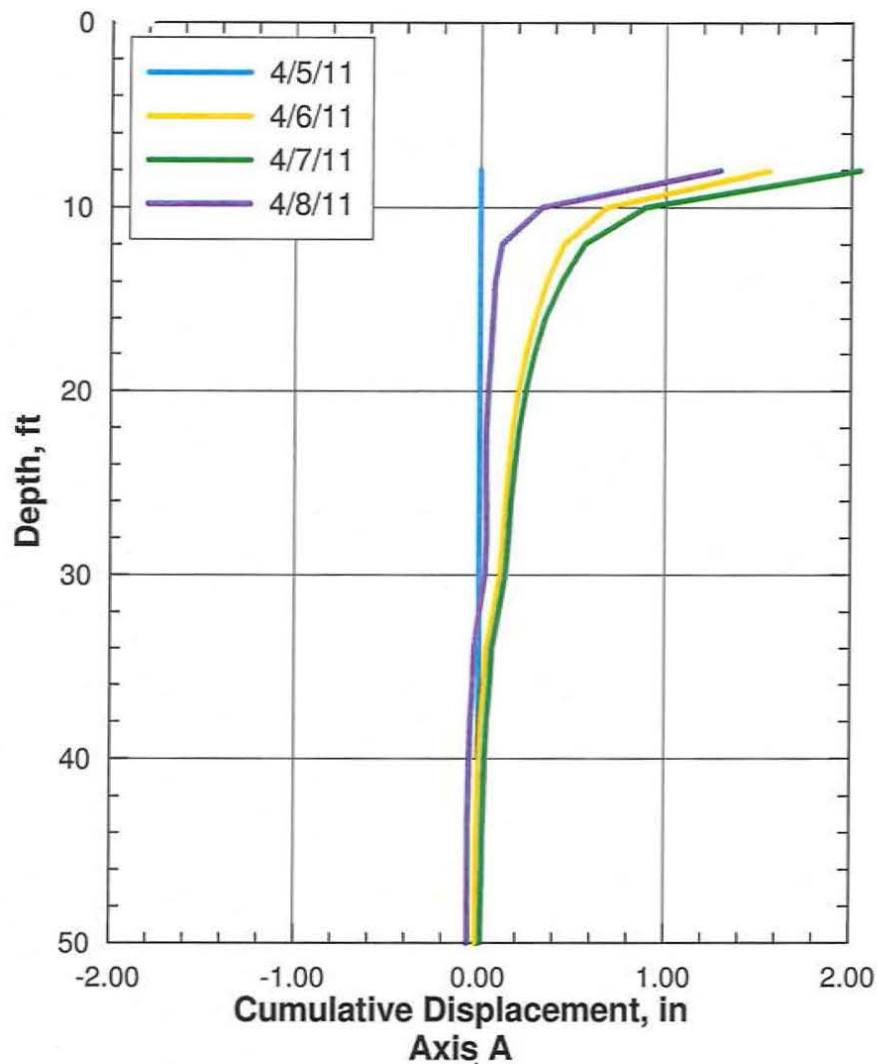
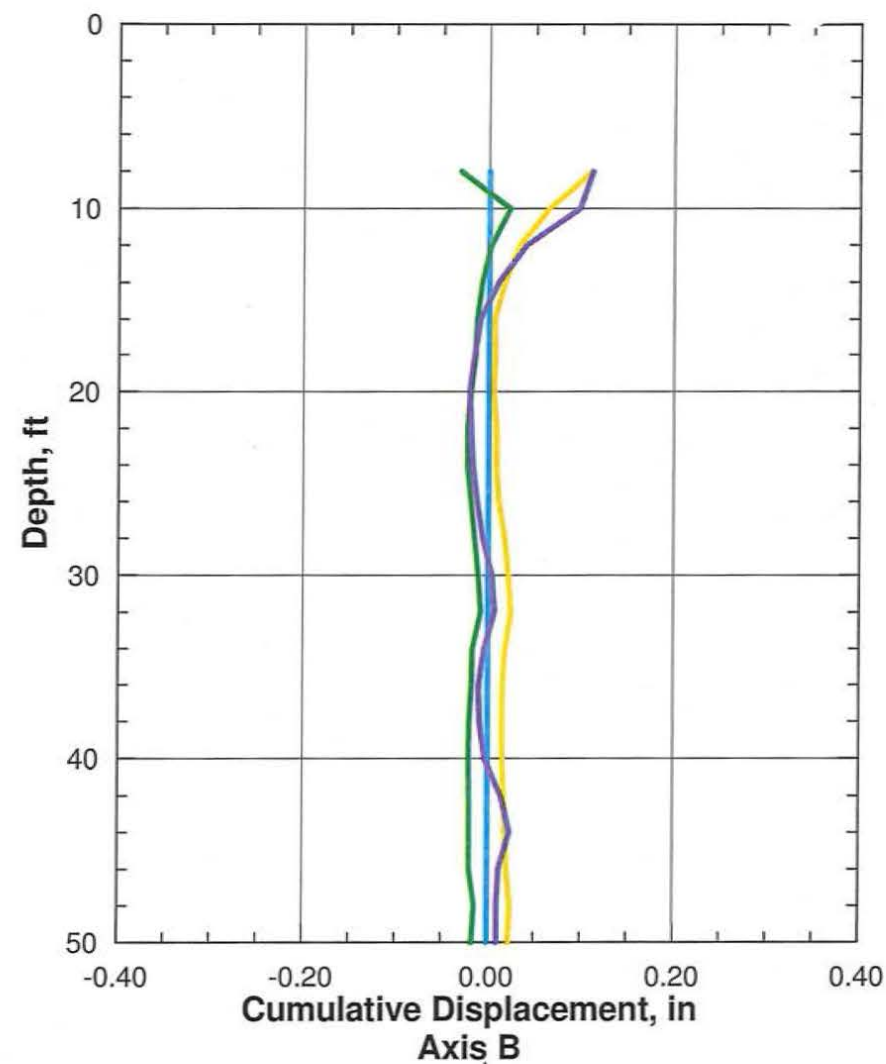
PLATE 4-1

NOTE: Inclinator was damaged during work on 4/5/11. It collapsed about 7 feet below the surface. The inclinometer was dug out and cut-off. A new baseline reading was taken after it was fixed on 4/5/11. Large movements may be from it not being protected at the surface and sloughing ground due to excavation for pile removal.

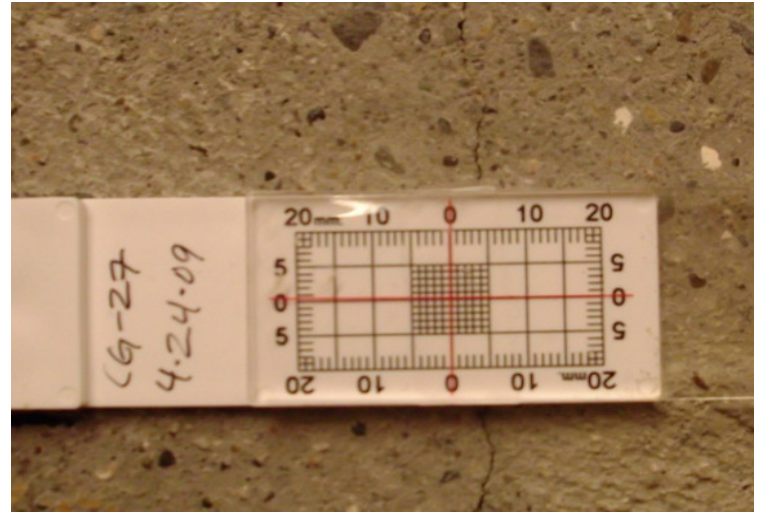
CG-27	0.5 mm	Parallel	Same as previous reading

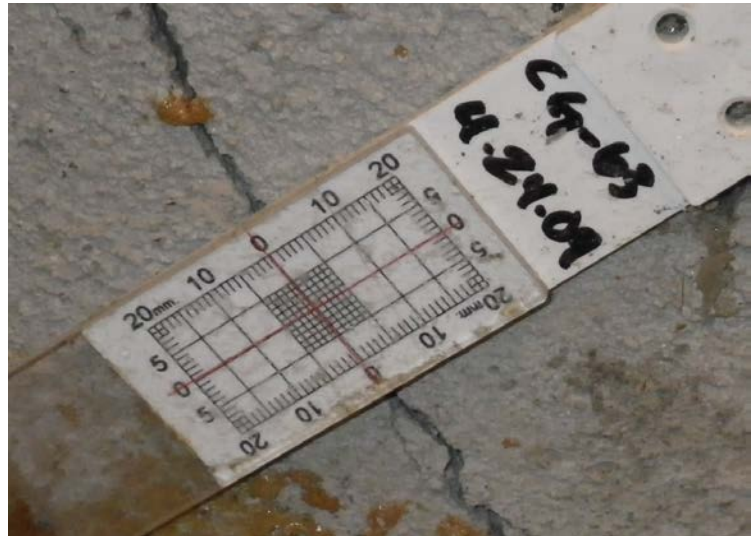
CG-63	0.4 mm	Perpendicular	+0.3 mm
