File No. 150148

Re: Transmittal of Planning Department Case Number 2013.0910L:
149-155 9th Street, Article 11 Change of Designation
BOS File No: _____ (pending)
Historic Preservation Commission Recommendation: Approval

ARTICLE 11 HISTORIC BUILDING REPORT

MAINTENANCE PLAN

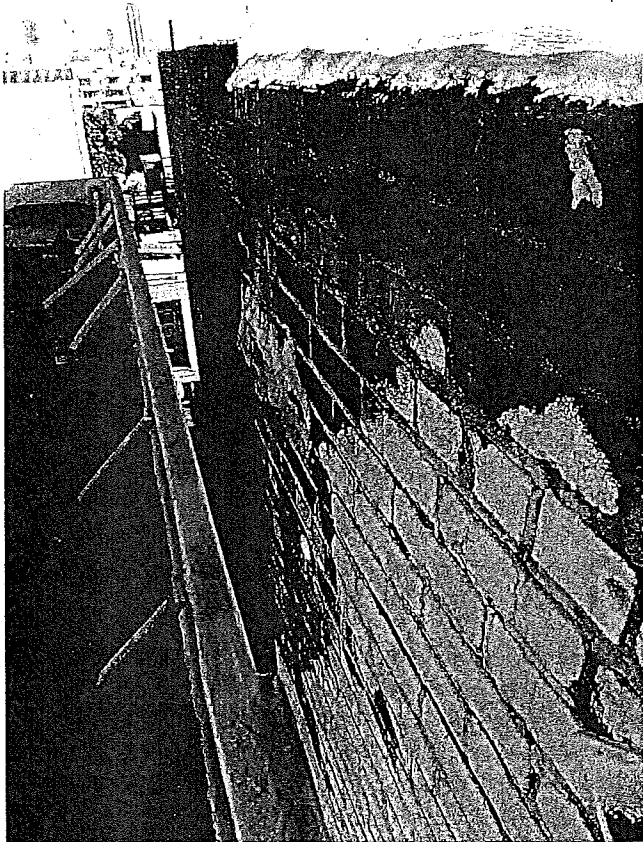
Figure 3. North wall; note paint and general condition of bricks for cleaning.

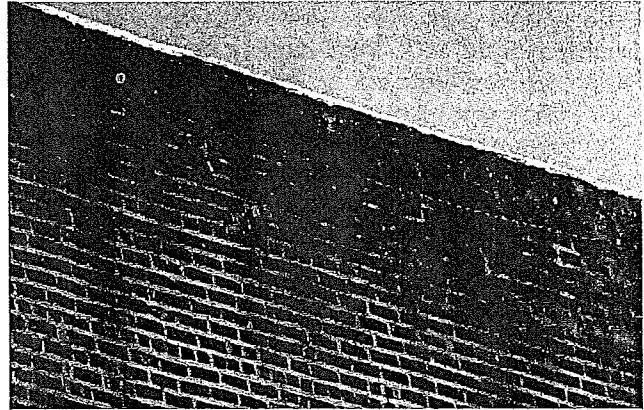
Figure 5. East elevation at roof parapet; note bio-growth and discoloration to be addressed prior to rehabilitation work.

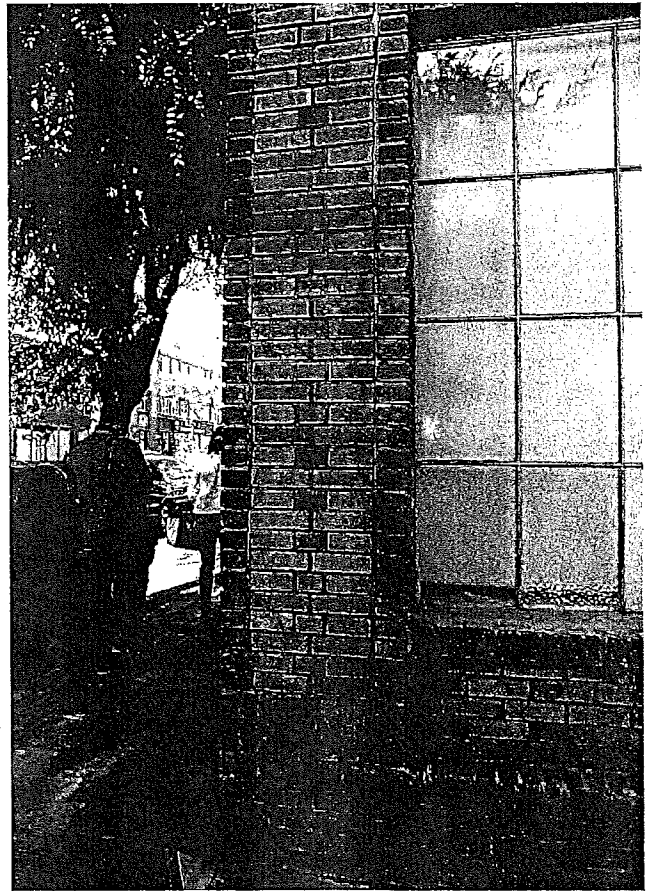
Figure 5. Typical condition of brick at south & west walls, clean all surfaces prior to further rehabilitation work.

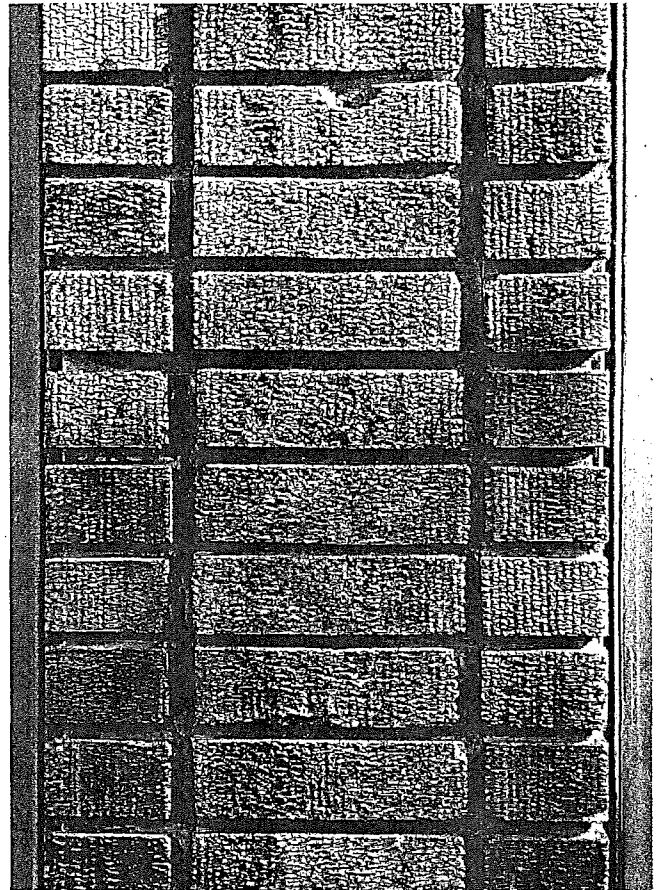
Figure 1. Typical brick pier; note mortar coloring and condition; deep recessed joint to be maintained.

Perform visual inspection of brick wall with binoculars, spotting scope, or similar every 5 years for brick and mortar deterioration. Repair and repoint as needed.

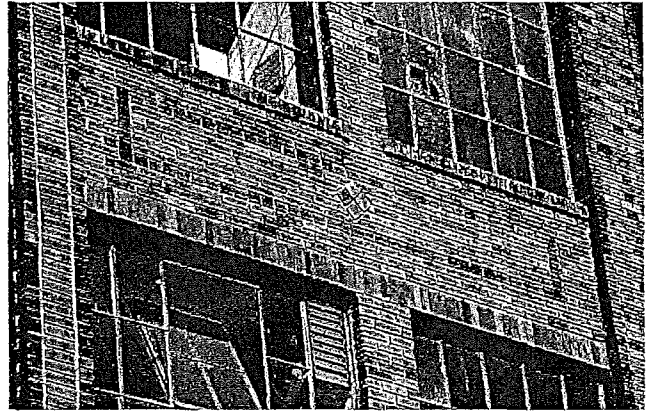
Figure 3. South elevation; note recessed mortar joints to be maintained and replicated in re-pointing.

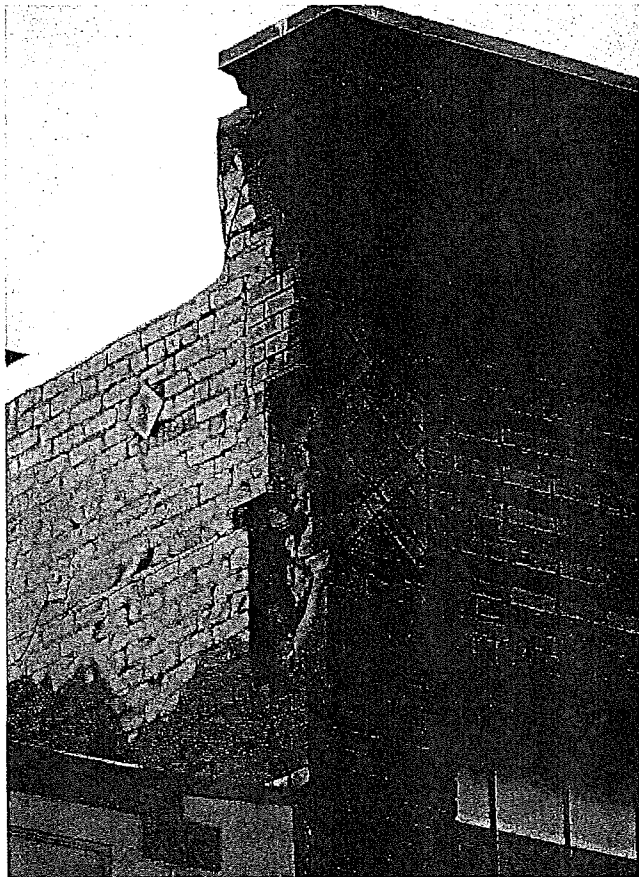
Figure 2. Northwest corner, note missing facing and decorative bricks for replacement.

The northwest corner along 9th Street requires immediate attention to replace the damaged and missing sections of brick. A temporary cover should be used while assessment and repairs are planned. Work with a masonry restoration contractor/specialist to remove a few selective bricks at column piers or to make inspection openings to assess cause of joint separation/cracking at the brick piers. This will aid in identifying an approach to repair at the piers.

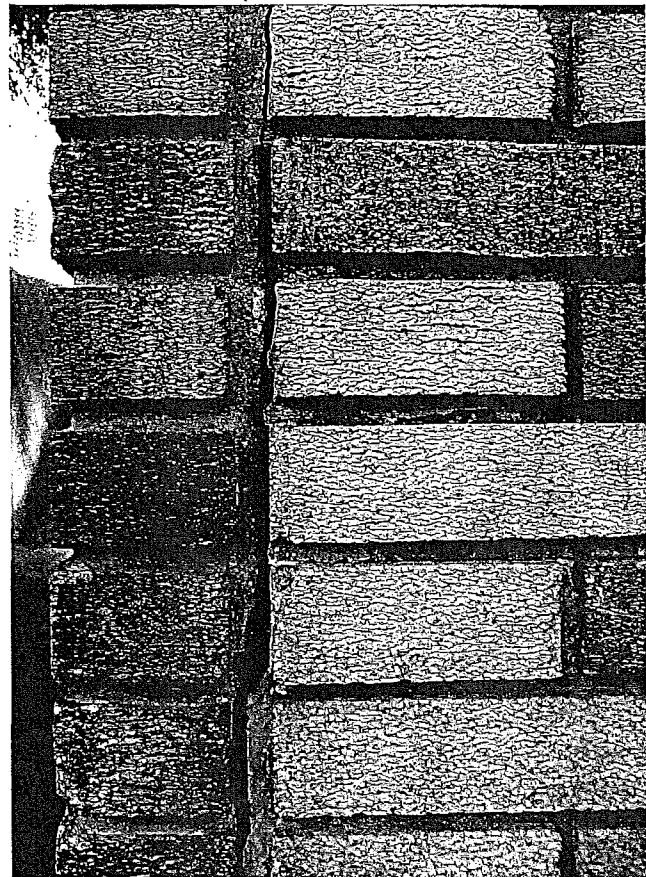
Figure 4. Southwest pier; note cracking and mortar conditions for re-pointing.

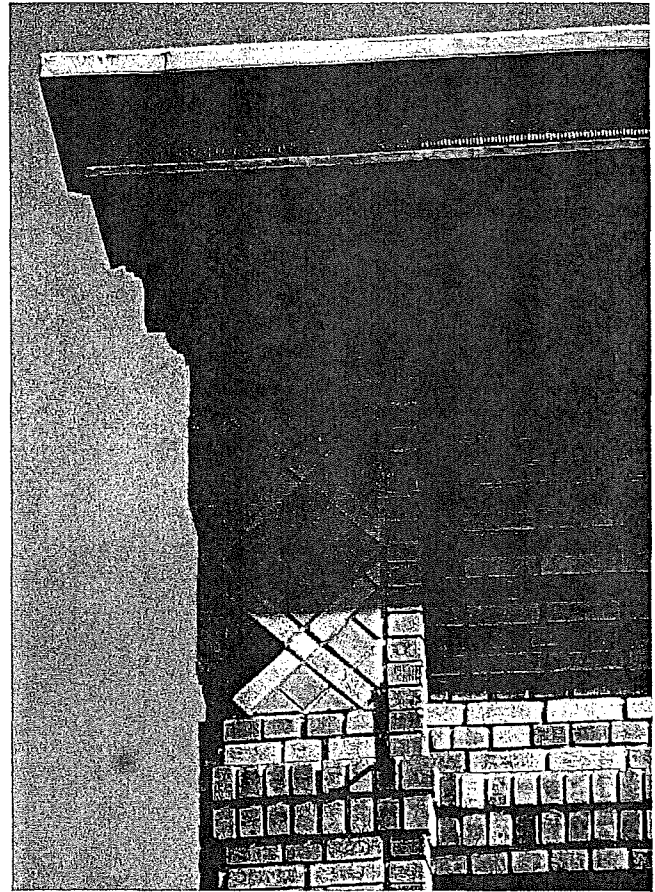
Figure 1. Northwest Corner; note missing facing and decorative brick.

The northwest corner along 9th Street requires immediate attention to replace the damaged and missing sections of brick and decorative brick/tile. A temporary cover should be used while assessment and repairs are planned. Work with a masonry restoration contractor/specialist to remove a few selective bricks at column piers or to make inspection openings to assess cause of joint separation/cracking at the brick piers. This will aid in identifying an approach to repair at the piers.

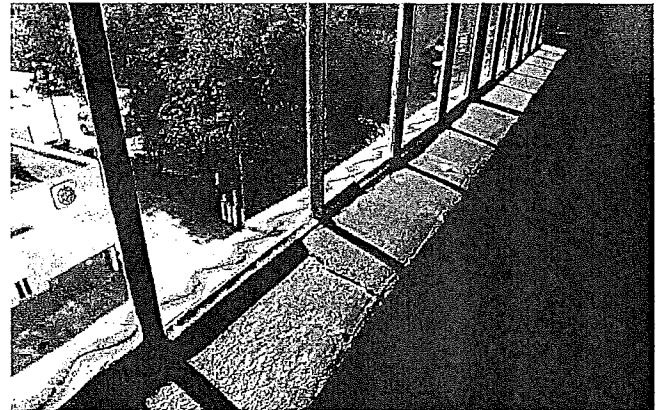
Figure 2: Concrete parge at south window sills, typical. Note level of localized cracking.

Prepare, prime, & seal parged concrete and install new sealant every 10 years, or as needed.

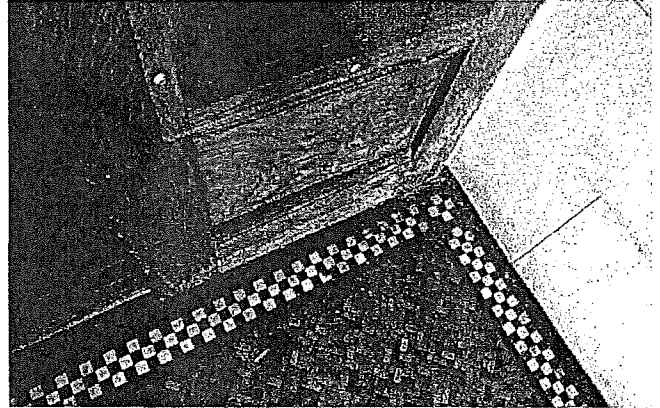
Figure 3: Sidelight at entry door; note replacement of glazing for Plexiglas in response to security concerns.

Due to noted security issues at northwest entrance door, consider replacement of security gates at entrances. Replacement gates should be comparable with existing gates along Natoma Street.

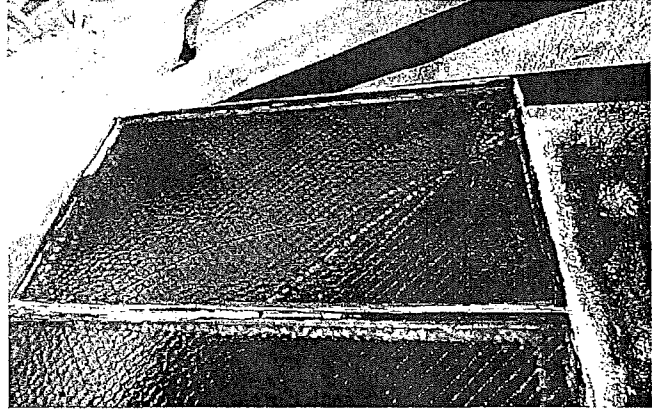
Figure 5. Skylight; note cracked glazing.

Inspect steel framed skylight for deterioration annually. Repair as needed. Install sealant and/or glazing putty as needed.

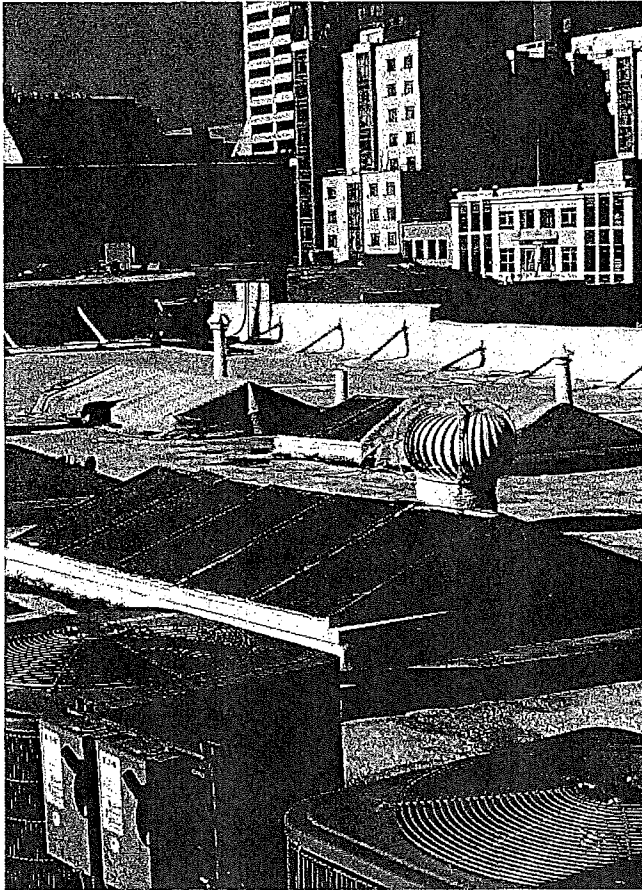
Figure 4. Skylight; note covered ventilation grilles.

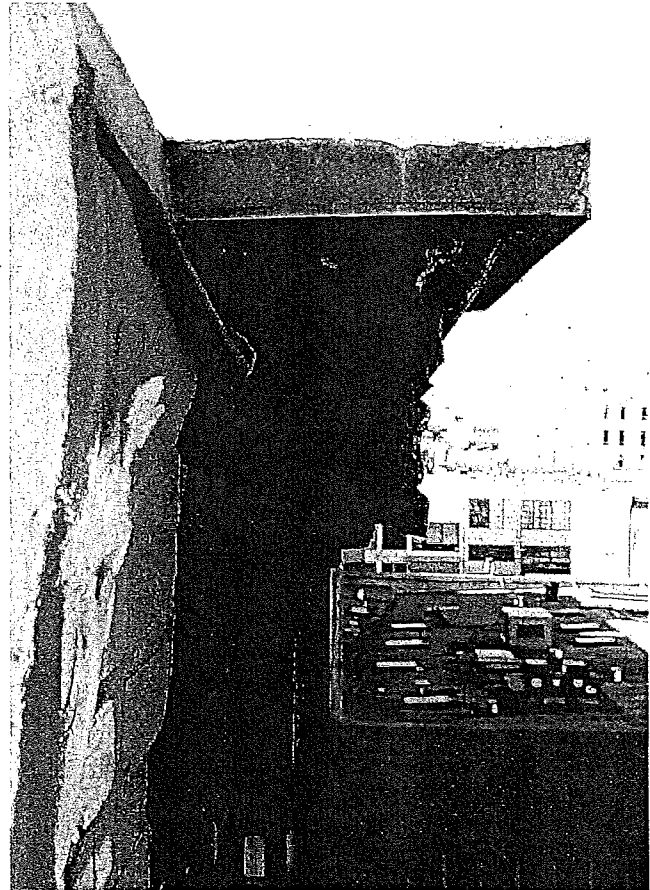
Figure 1. Cornice at northwest corner; note level of corrosion, this is worst condition observed and atypical of overall cornice.

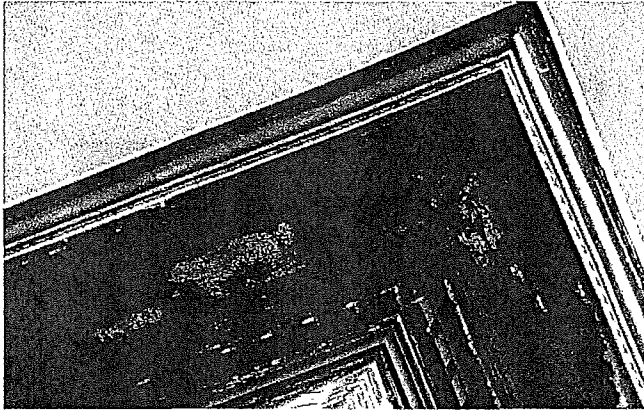
Figure 2. Cornice at southwest corner; note discoloration and localized corrosion, conditions are considered typical.

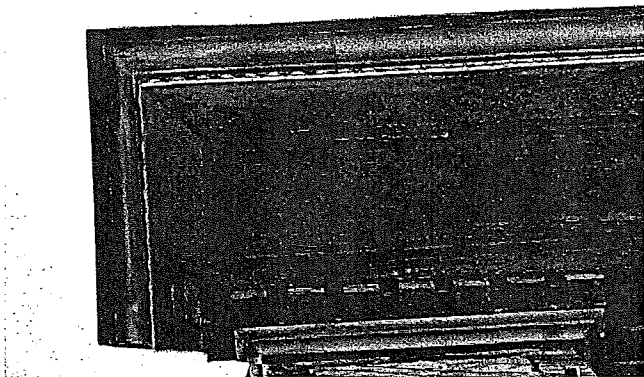
Figure 3. Cornice at northwest corner; localized areas of severe damage observed & requiring immediate repair.

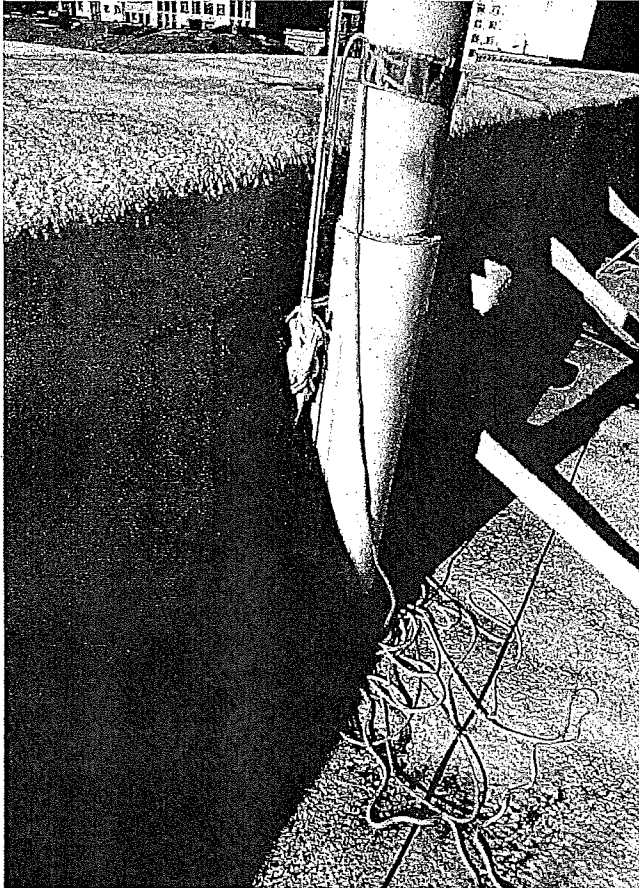
Figure 2. Flagpole anchor; note fastener conditions and localized signs of corrosion.

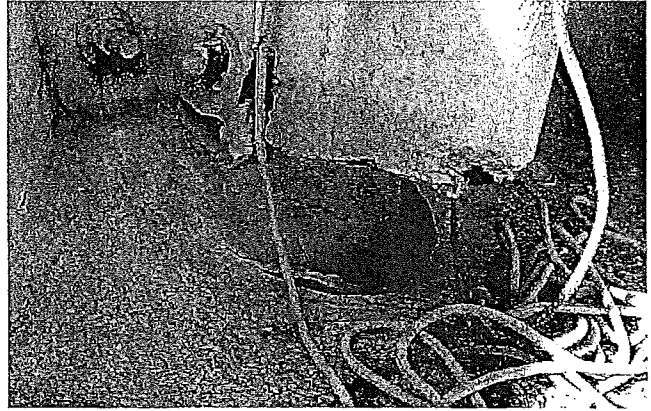
Figure 3. Detail of flagpole anchor; note corrosion and damage to roofing.

A few locations of distress were noted at the roofing membrane, resulting in what appear to be small tears. A larger puncture below the flag pole appears to be related to installation/adjustment of the flag pole.

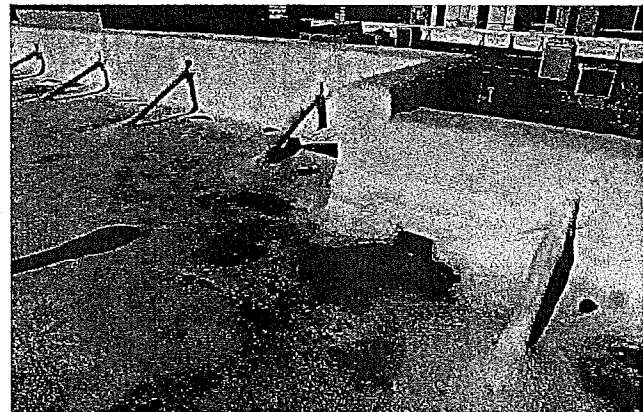
Figure 2. Roof at drainage opening in parapet; note parapet bracing and conditions near opening.

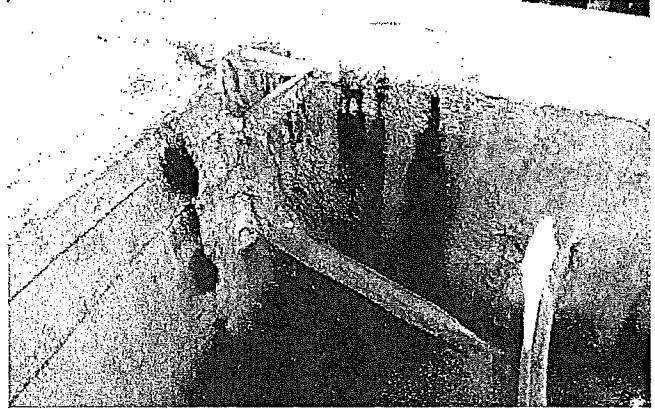
Figure 5. Bio-growth and water stains at roof. Investigate to if determine localized water damage exists.

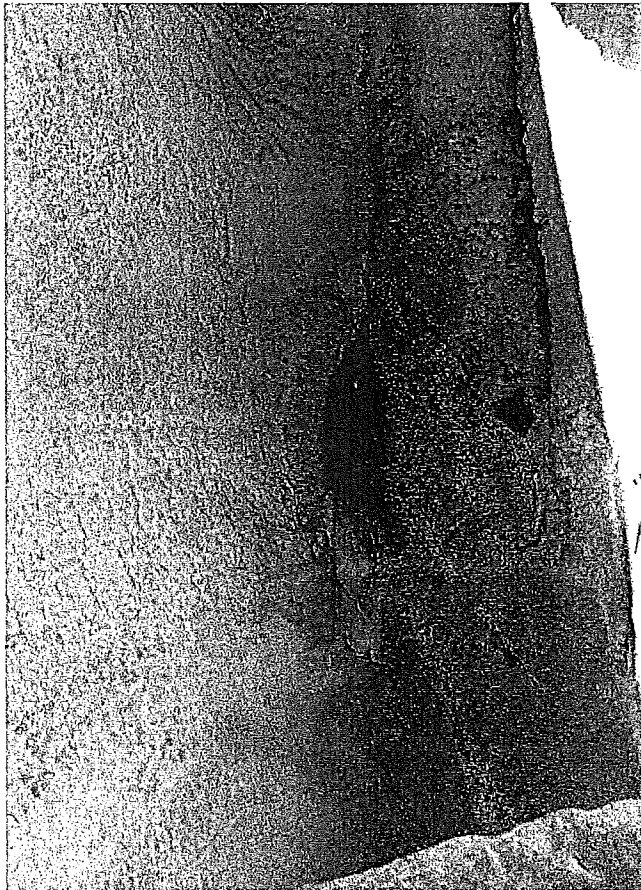
Figure 4. Detail of roofing membrane and localized damage; assess conditions throughout.

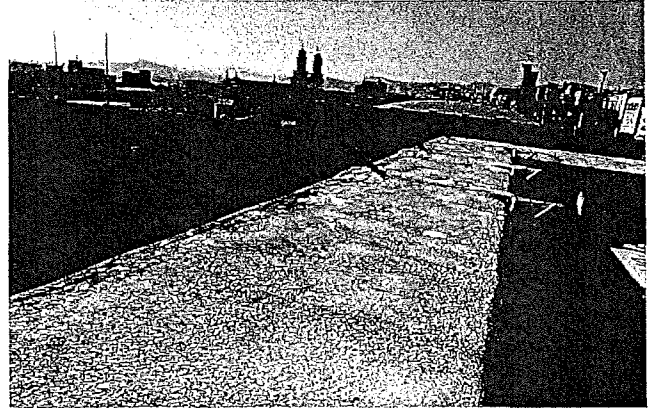
Figure 1. Parapet at southwest corner; note roofing membrane conditions at parapet cap.
