File No. 150148

Committee Item No. 3

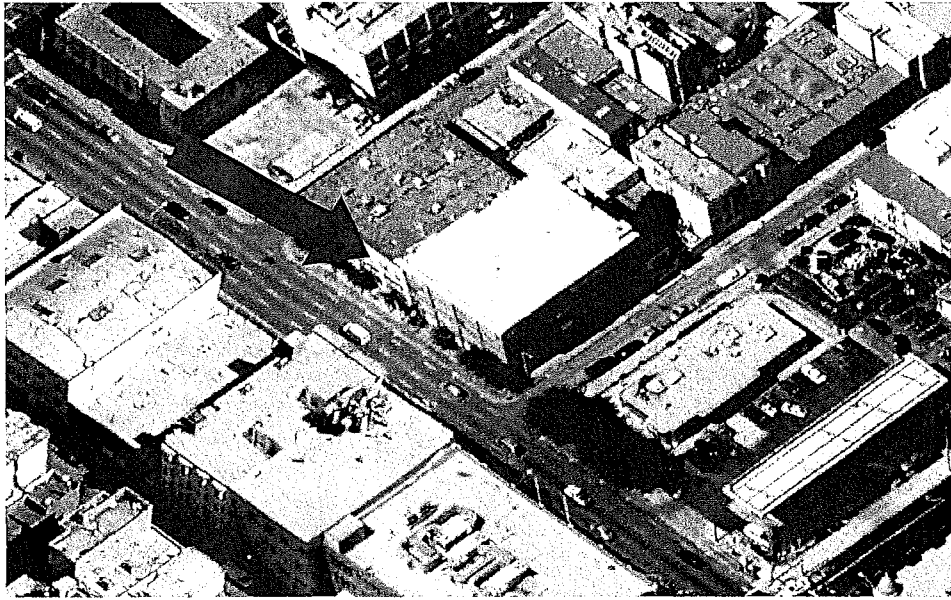
Satellite photo showing 149-155 9th Street.
(Google maps, 2013, edited by author)

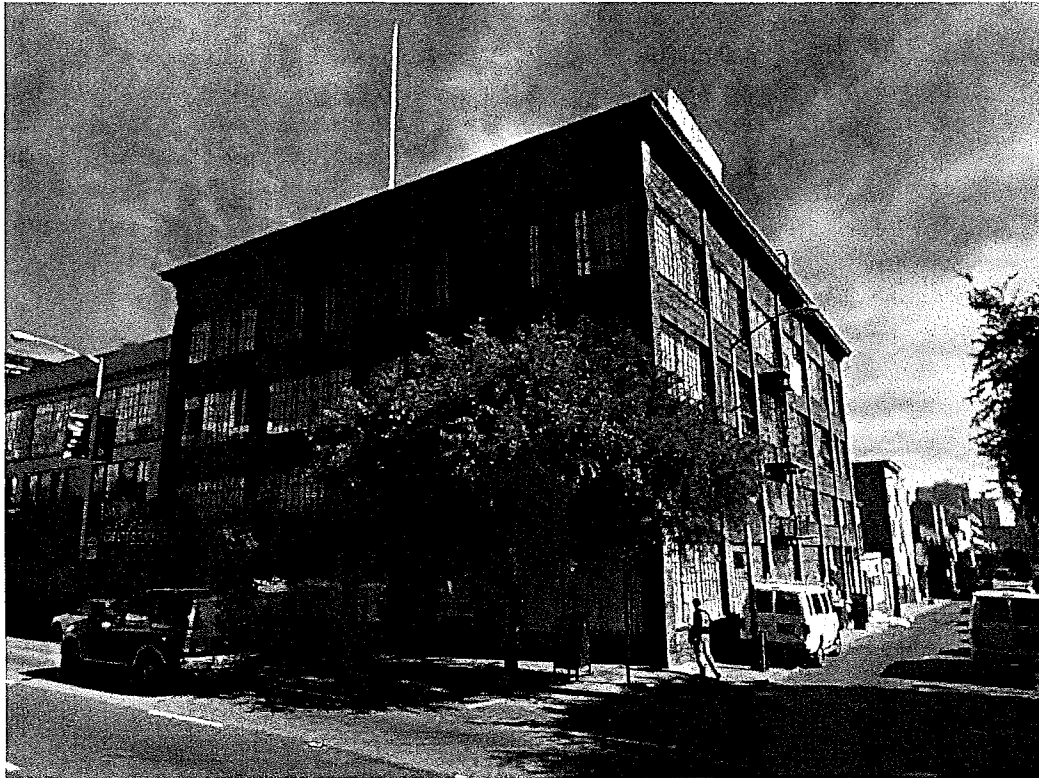
View east of the primary (west) and south facades
(Google Maps ©2013)

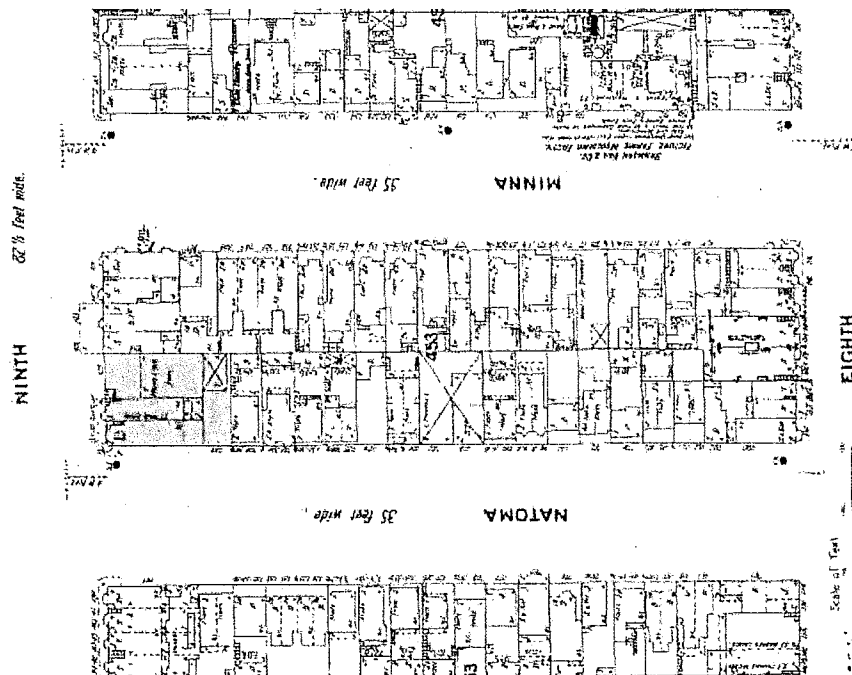
1899 Sanborn map with the subject parcel highlighted.

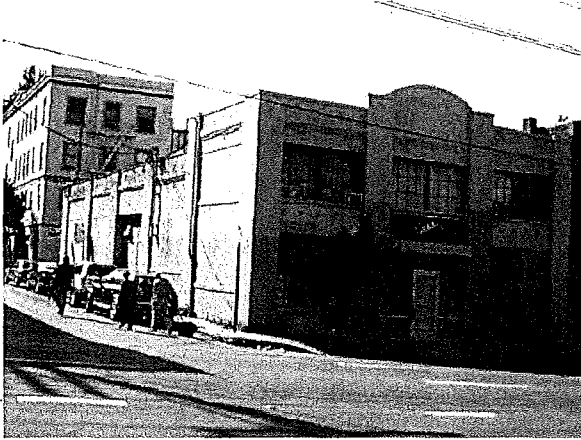
453 Bryant Street (1923)
(Google maps, 2013)

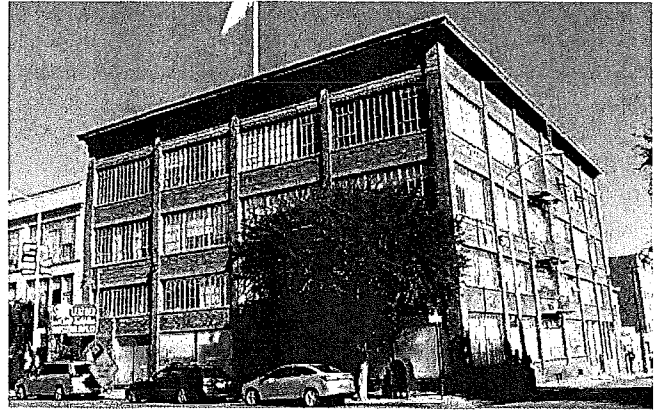
Figure 1. 149 9th Street; view from 9th Street looking east.

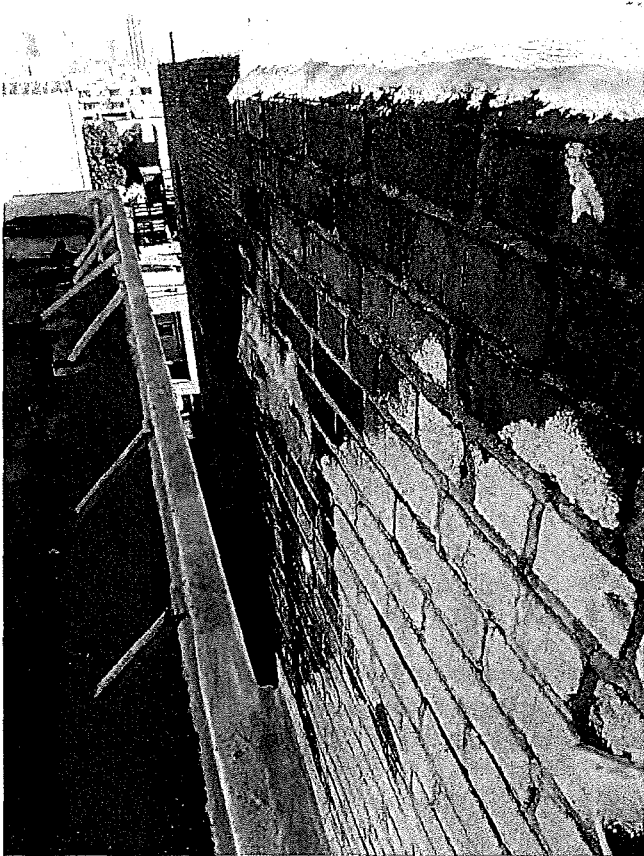
Figure 3. North wall; note paint and general condition of bricks for cleaning.

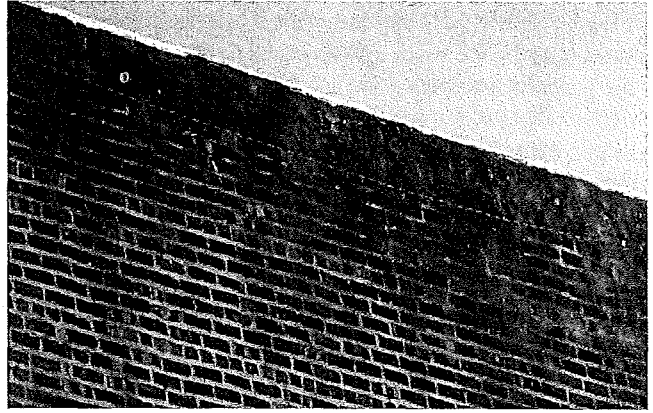
Figure 5. East elevation at roof parapet; note bio-growth and discoloration to be addressed prior to rehabilitation work.

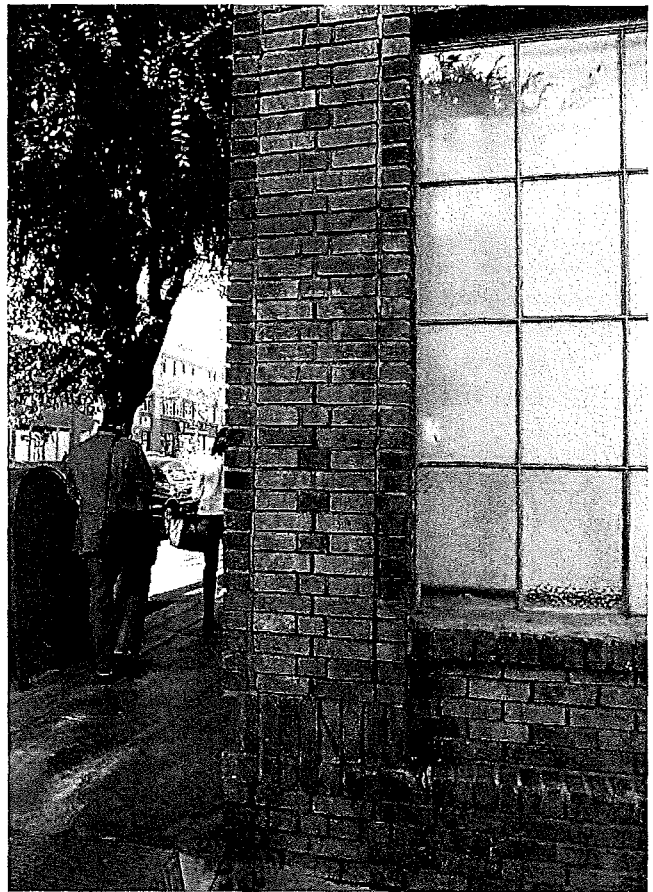
Figure 5. Typical condition of brick at south & west walls, clean all surfaces prior to further rehabilitation work.

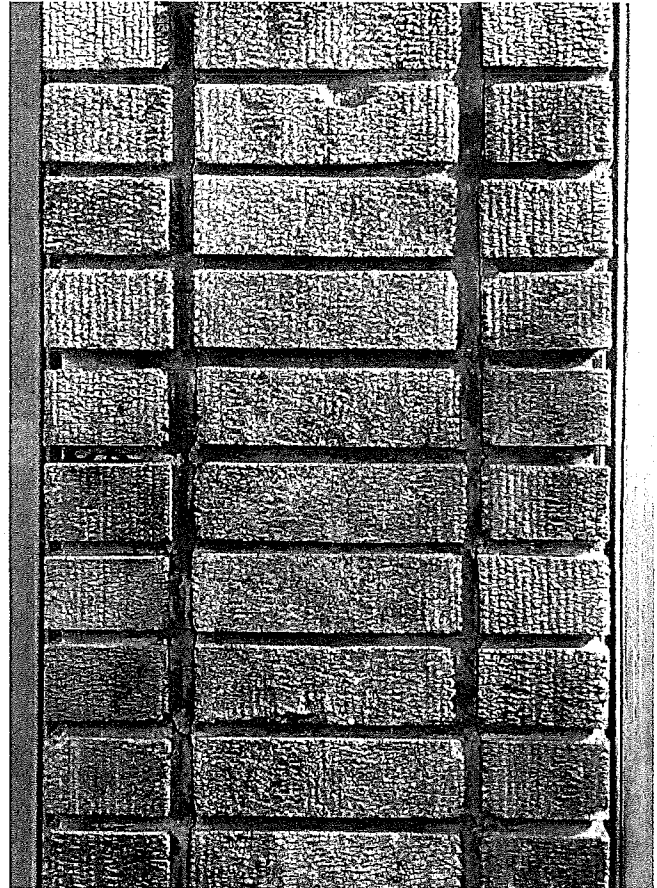
Figure 1. Typical brick pier; note mortar coloring and condition; deep recessed joint to be maintained.

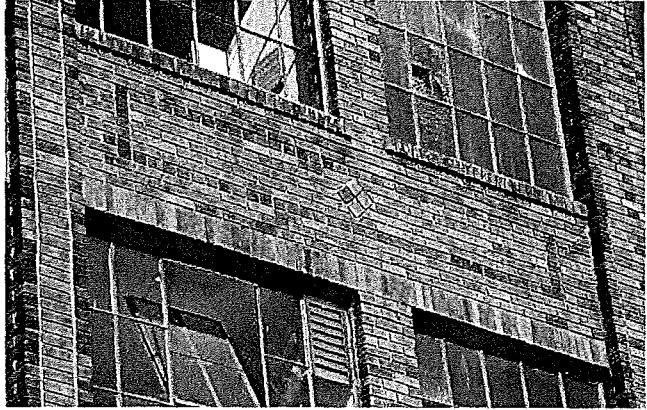
Figure 3. South elevation; note recessed mortar joints to be maintained and replicated in re-pointing.

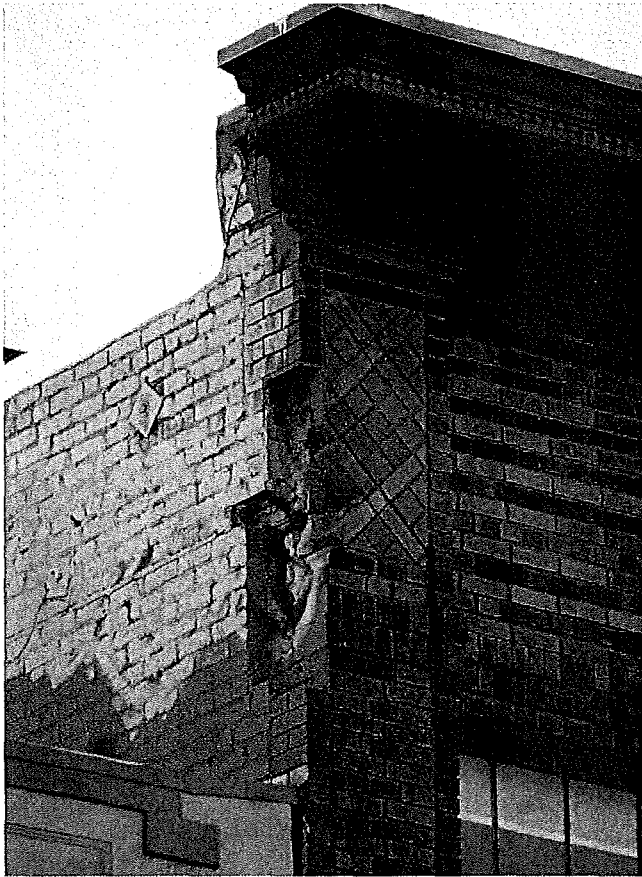
Figure 2. Northwest corner, note missing facing and decorative bricks for replacement.

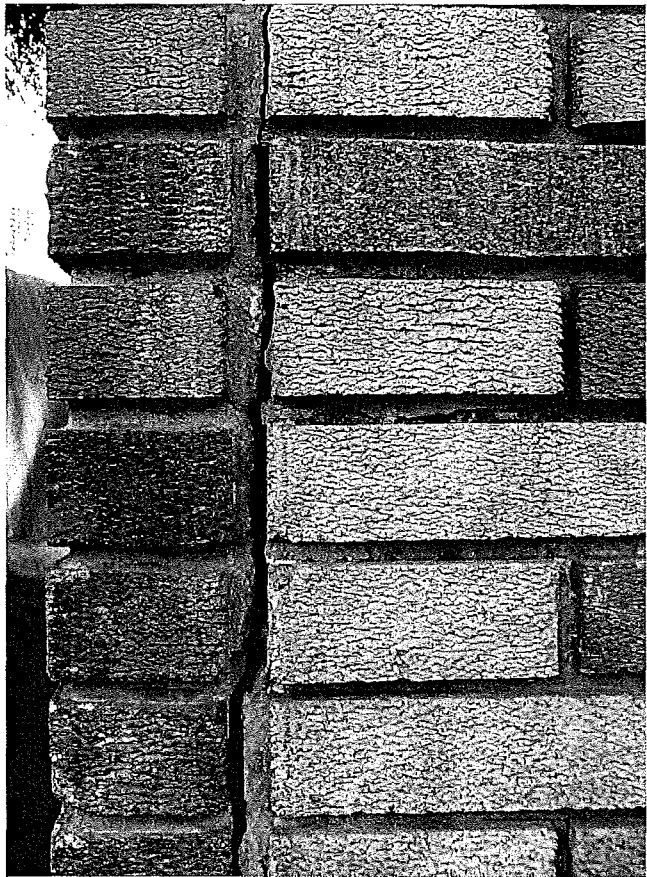
Figure 4. Southwest pier; note cracking and mortar conditions for re-pointing.

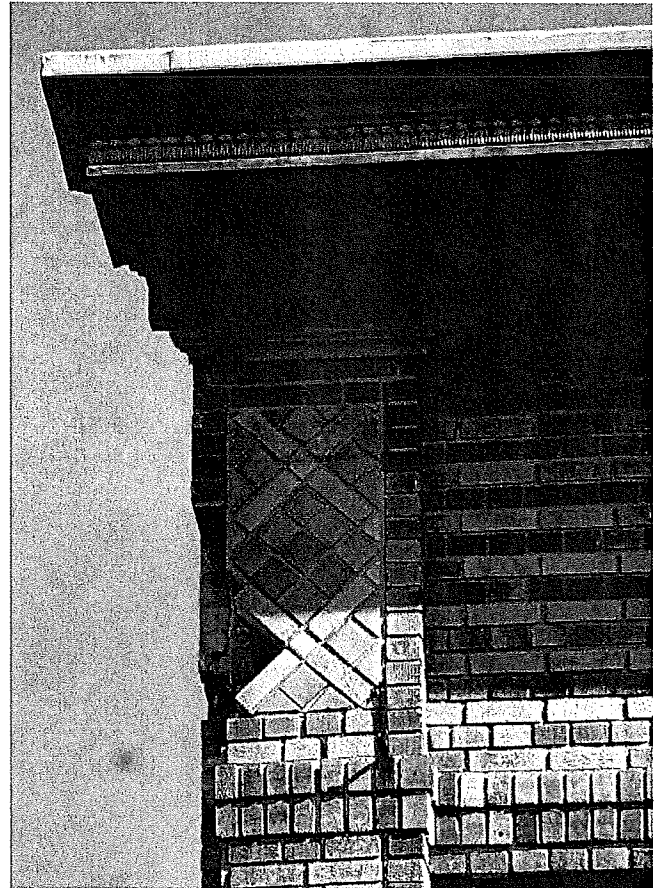
Figure 1. Northwest Corner; note missing facing and decorative brick.

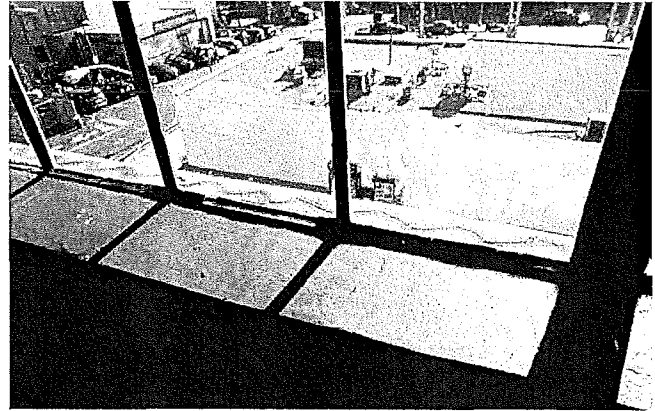
Figure 1: Window sills with concrete parge, typical.

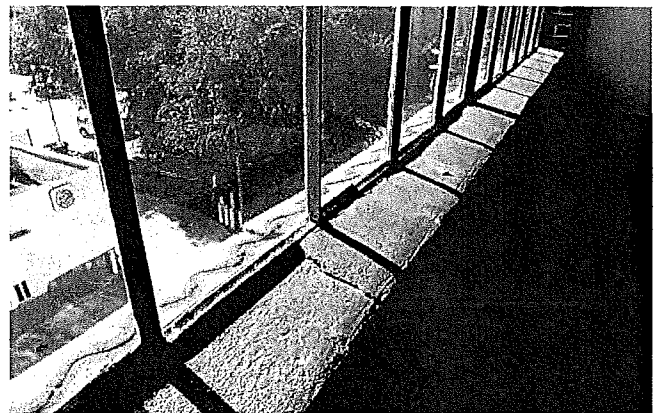
Figure 2: Concrete parge at south window sills, typical. Note level of localized cracking.

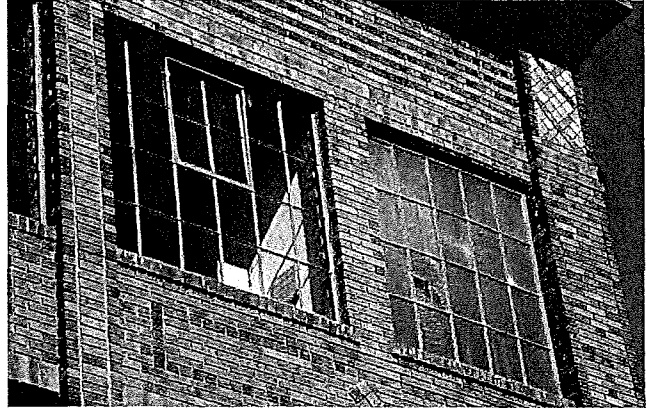
Figure 1. Typical multi-lite steel windows; note operable sections and glazing types.

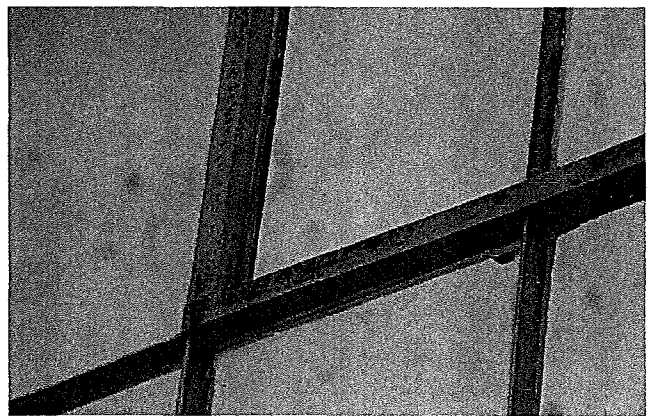
Figure 2. Steel window frame details

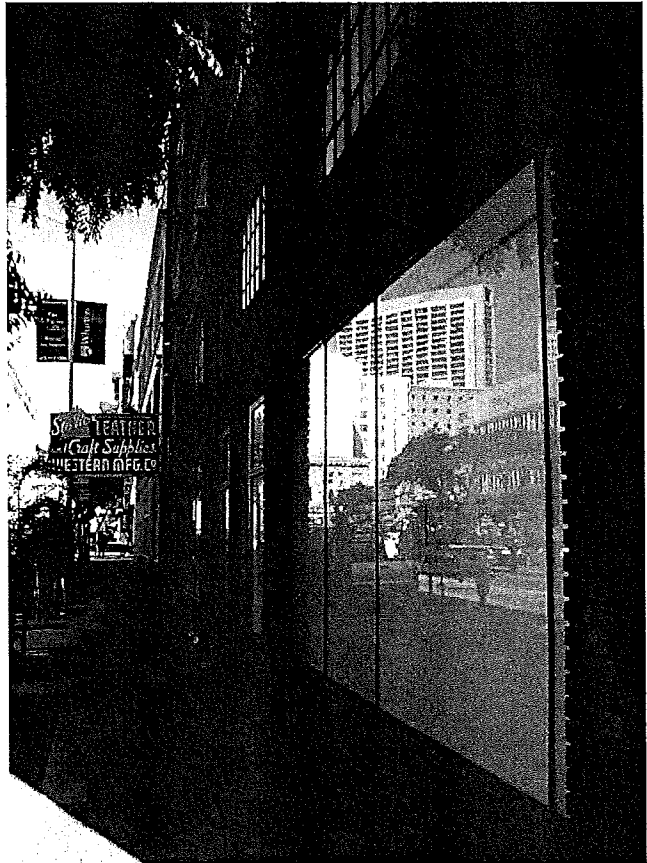
Figure 1. Typical Storefront at west elevation.

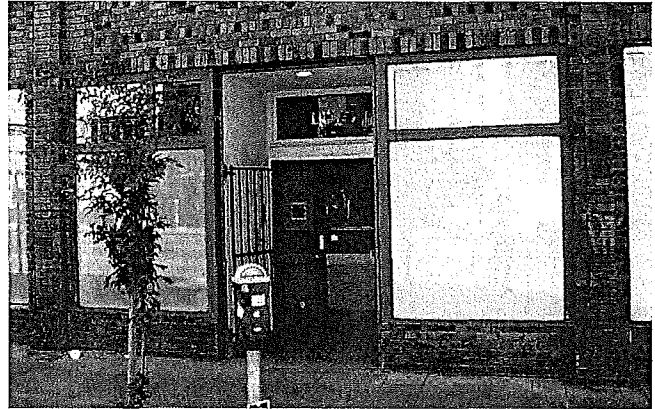
Figure 1. Storefront at west elevation.

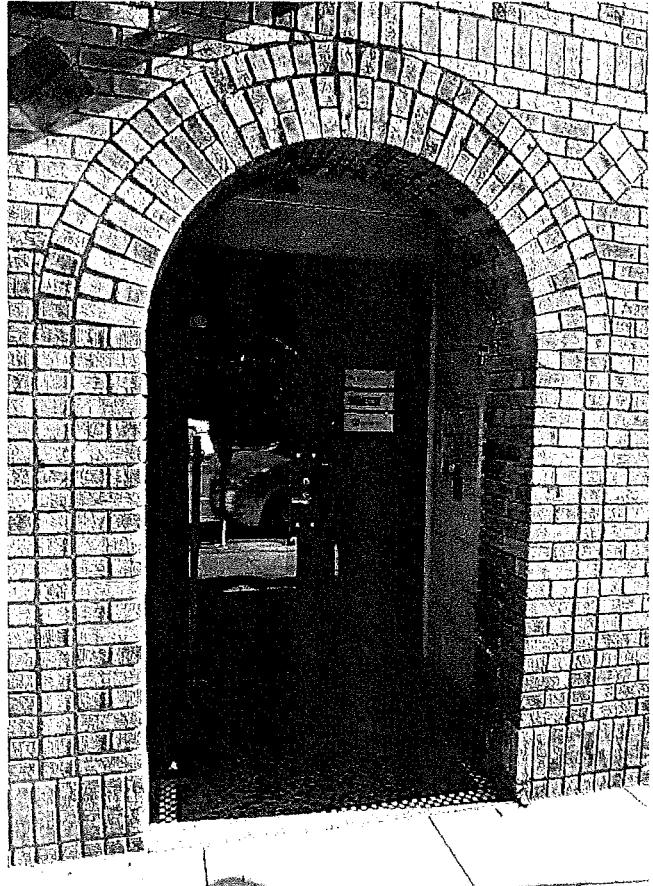
Figure 1. Entrance at northwest corner.

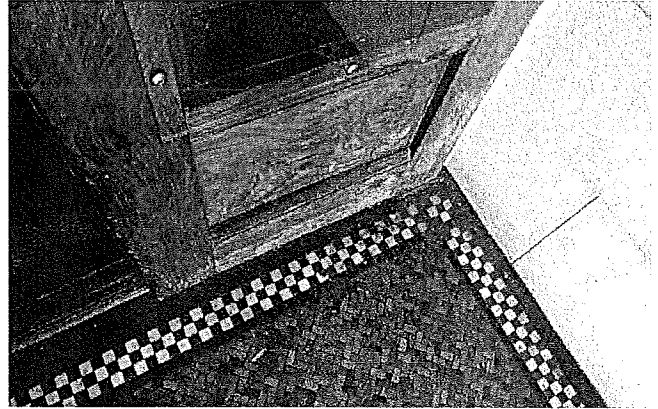
Figure 3: Sidelight at entry door; note replacement of glazing for Plexiglas in response to security concerns.

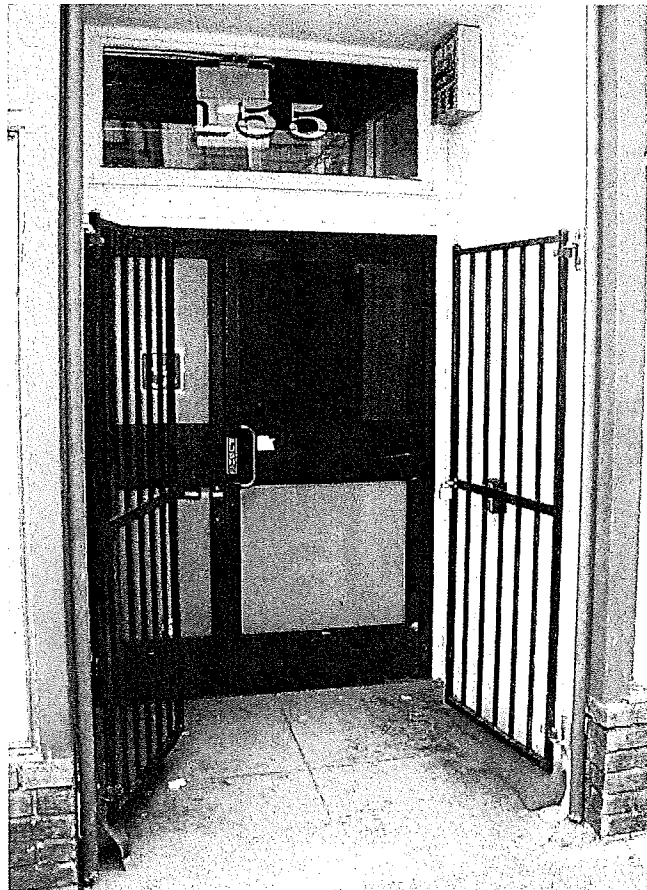
Figure 1. Metal entry door at west elevation.

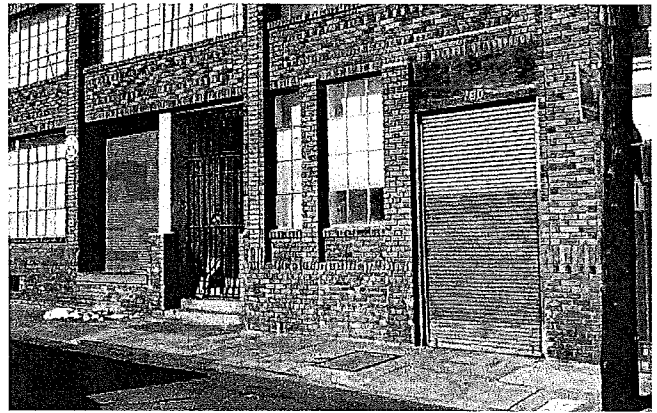
Figure 1. Service doors along south elevation.

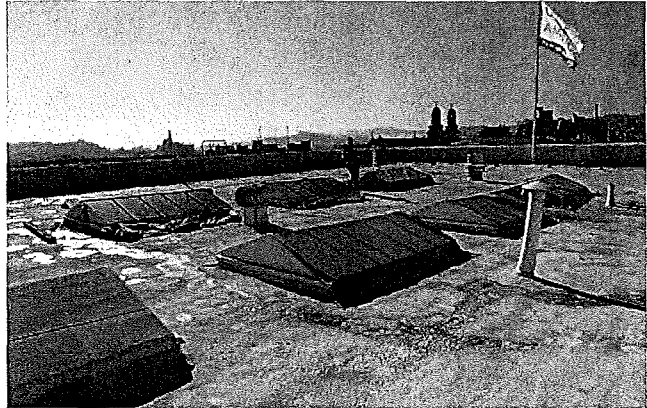
Figure 1. Roof overview; note skylights.

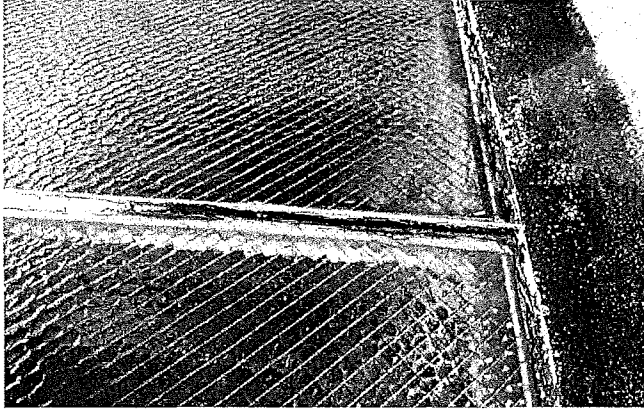
Figure 3. Skylight typical frame conditions.

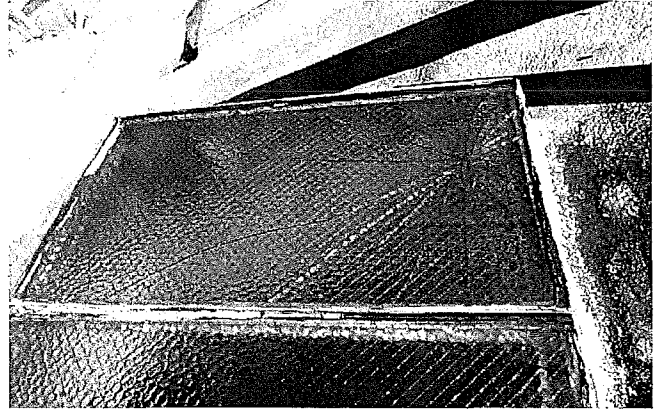
Figure 5. Skylight; note cracked glazing.

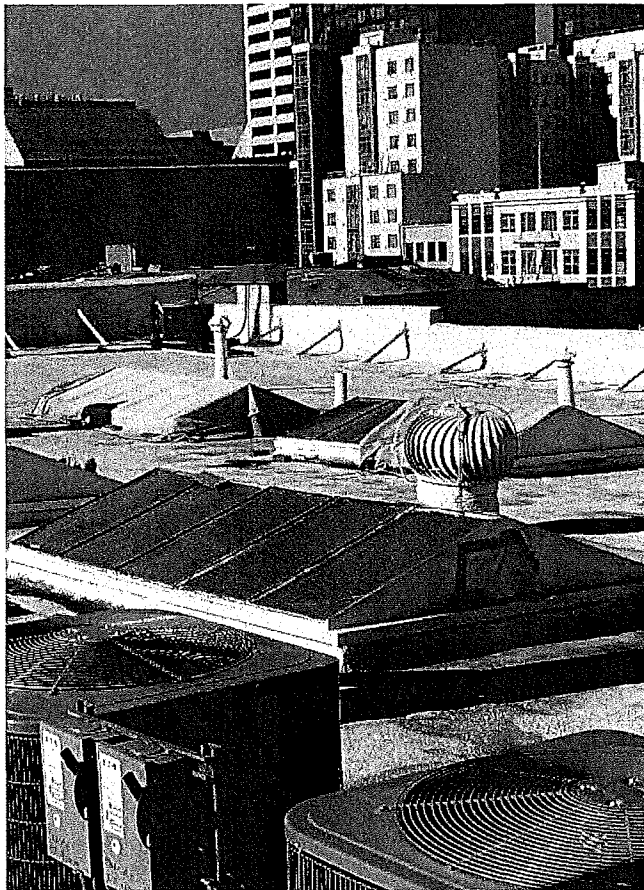
Figure 4. Skylight; note covered ventilation grilles.

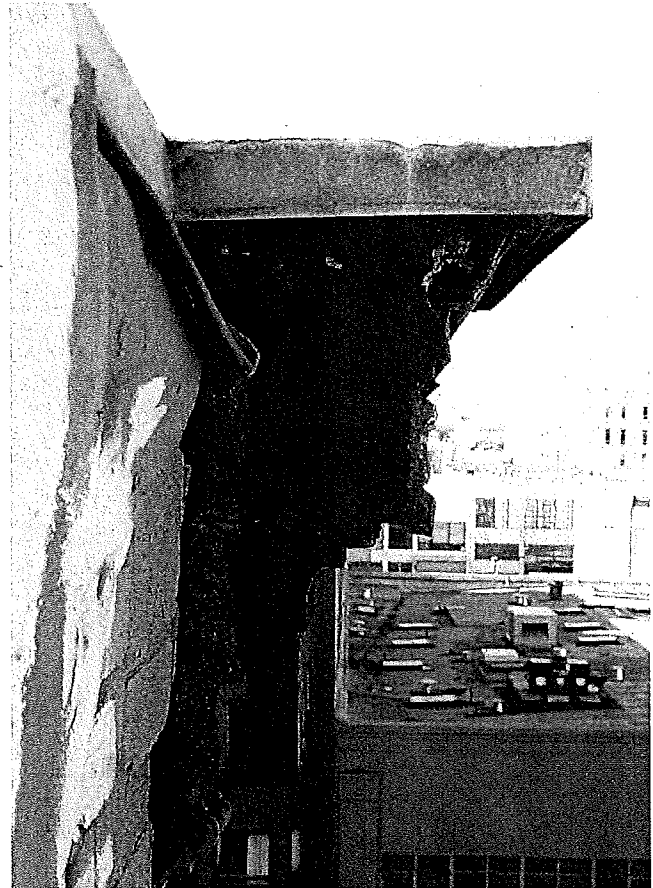
Figure 1. Cornice at northwest corner; note level of corrosion, this is worst condition observed and atypical of overall cornice.

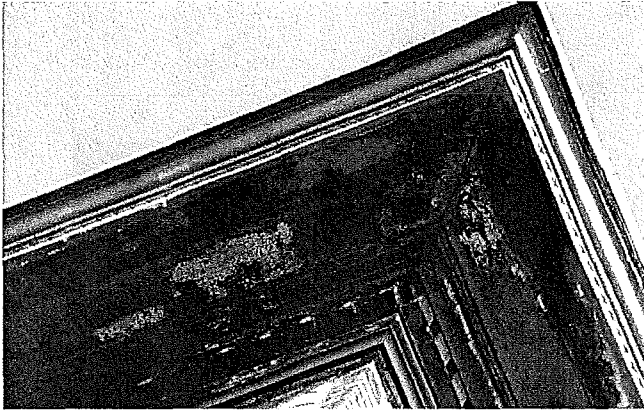
Figure 2. Cornice at southwest corner; note discoloration and localized corrosion, conditions are considered typical.

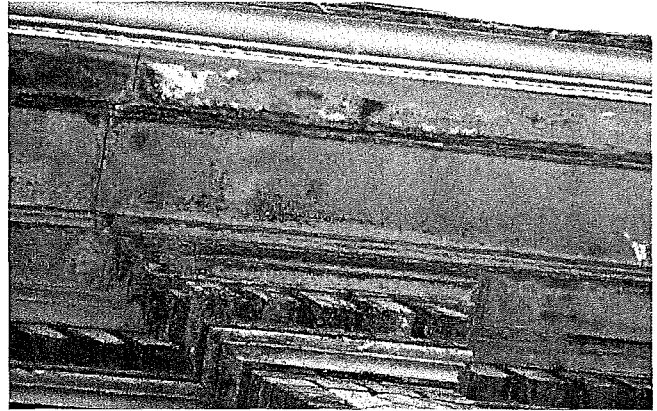
Figure 4. Cornice; conditions noted as typical.

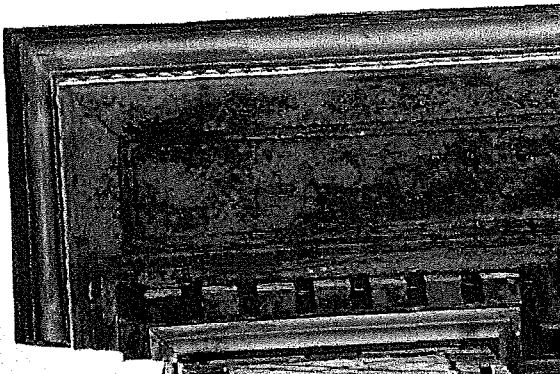
Figure 3. Cornice at northwest corner; localized areas of severe damage observed & requiring immediate repair.

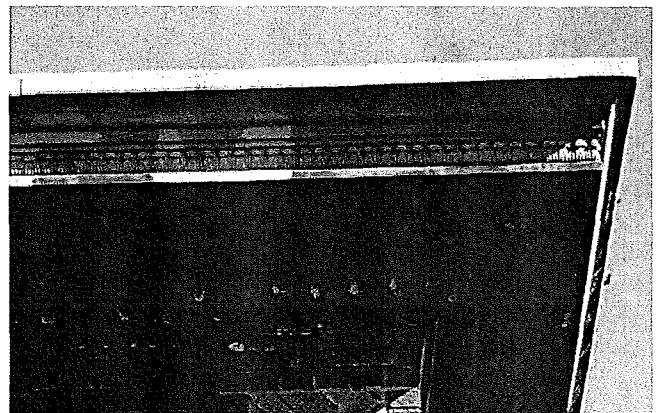
Figure 5. Cornice at southwest corner.

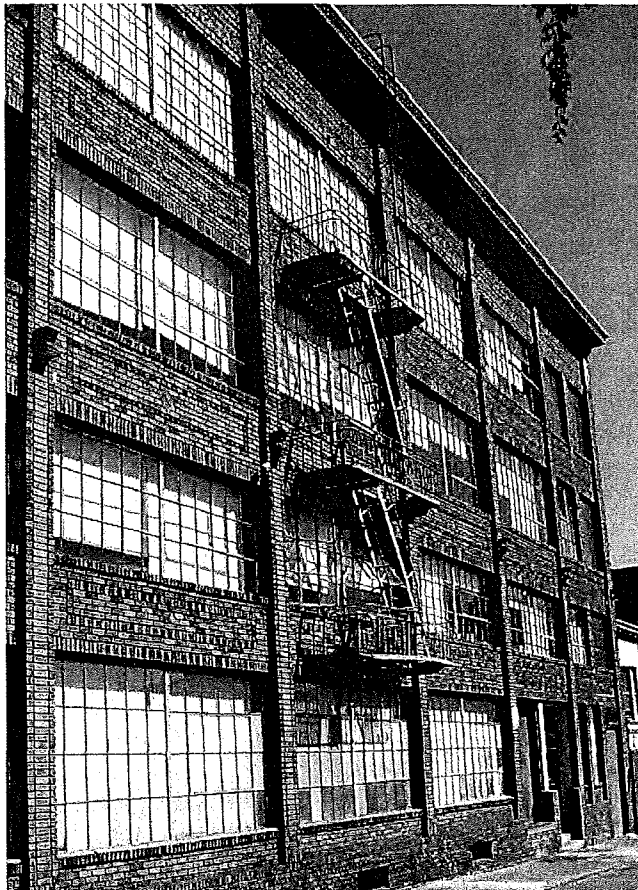
Figure 1. Metal fire escape at south elevation.

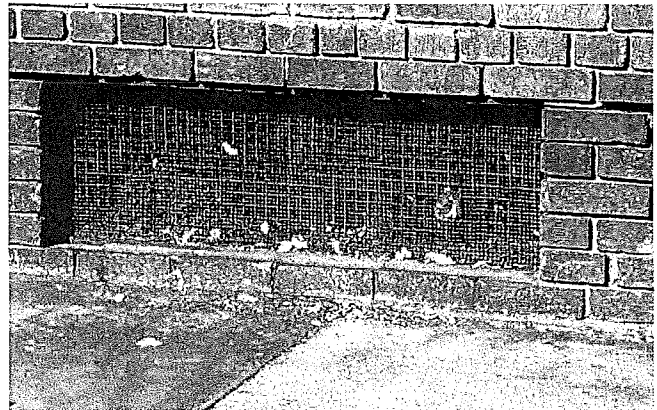
Figure 1. Ventilation grilles; note 1"x1" historic iron grille.

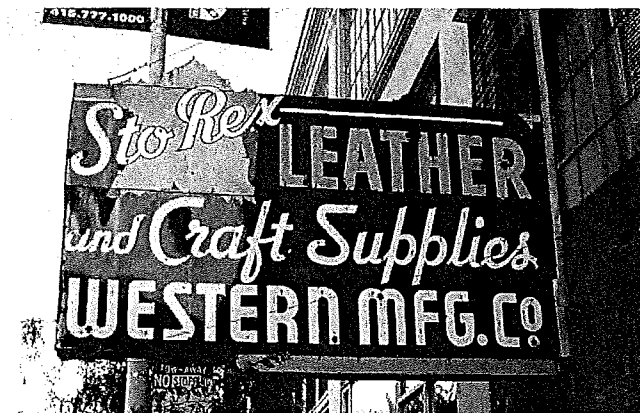
Figure 1. Projecting Sign along 9th Street (west elevation).

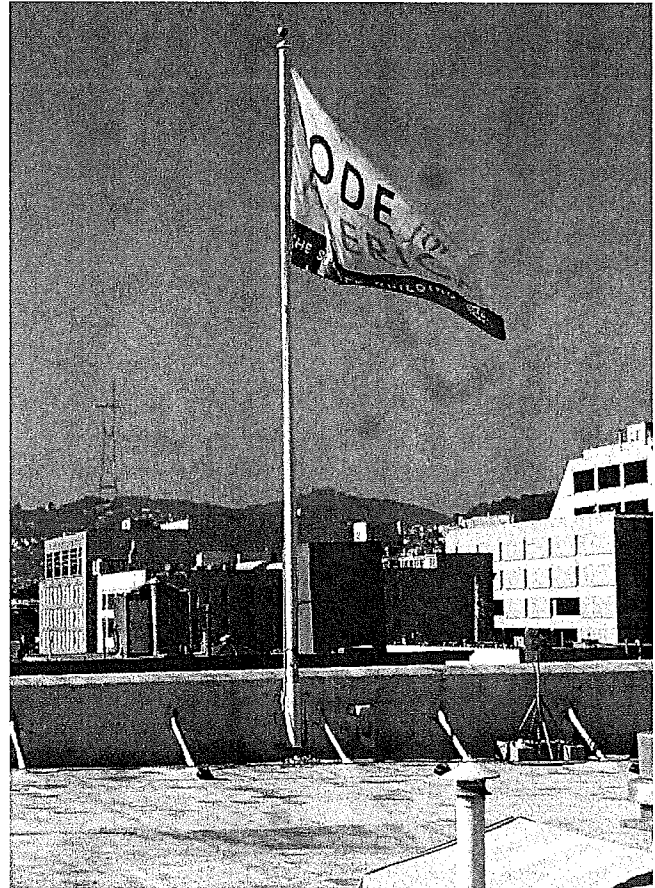
Figure 1. Flagpole along west elevation.

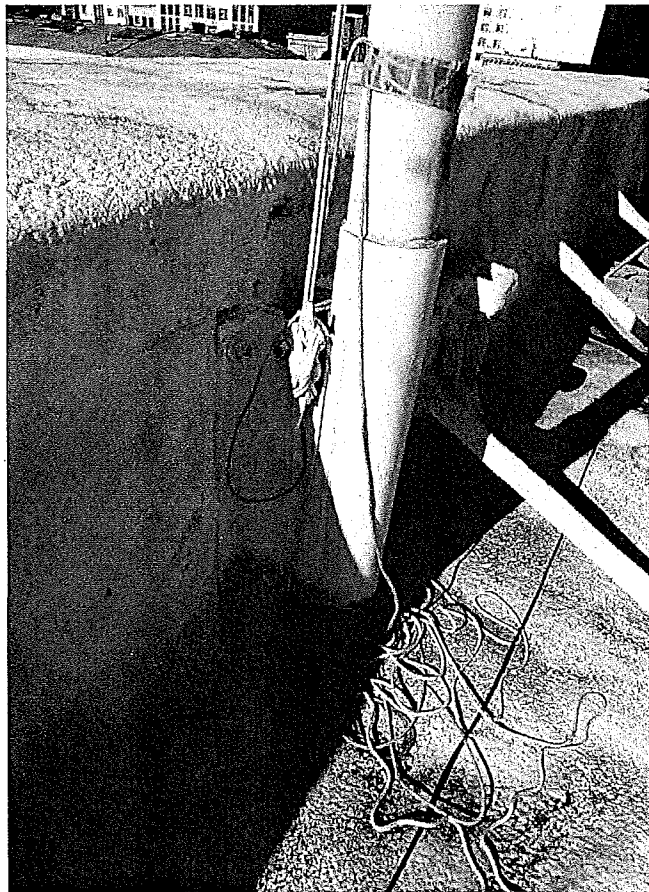
Figure 2. Flagpole anchor; note fastener conditions and localized signs of corrosion.

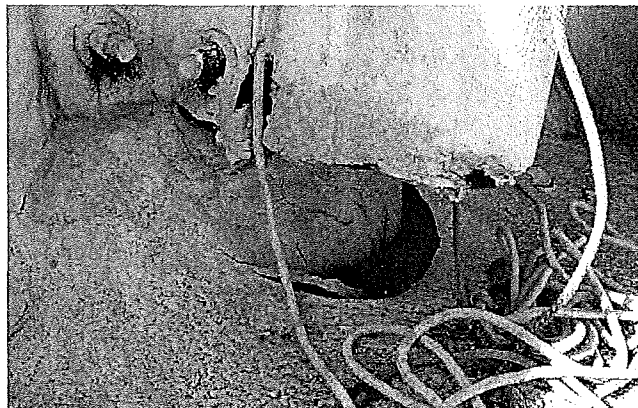
Figure 3. Detail of flagpole anchor; note corrosion and damage to roofing.

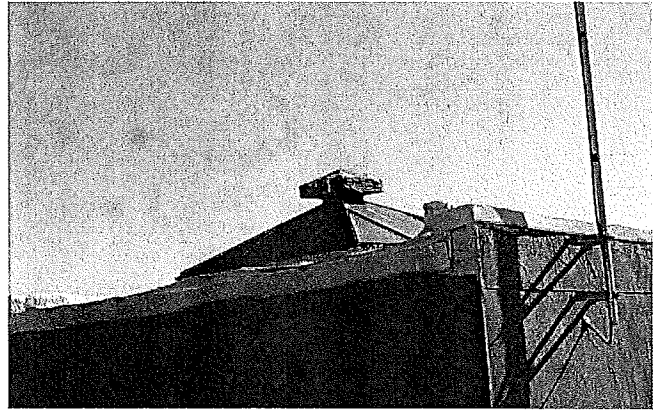
Figure 1. Roof & ventilator at penthouse.

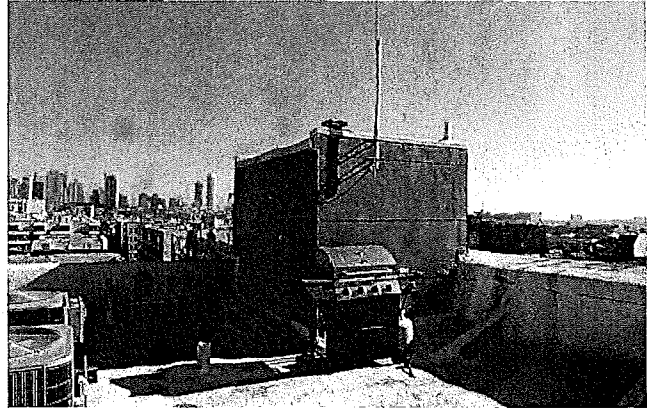
Figure 1. Penthouse from roof, typical.

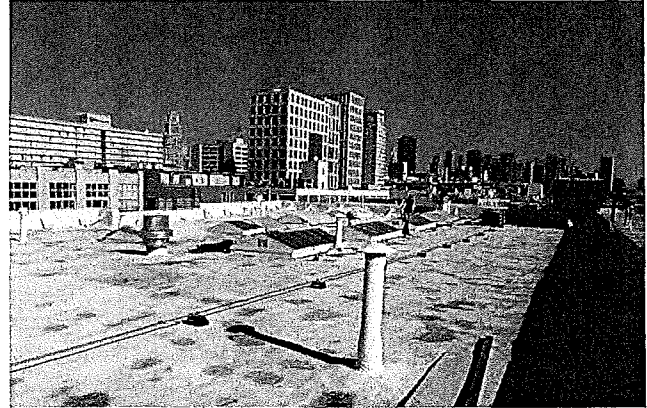
Figure 1. Roof of 149 9th Street, typical.

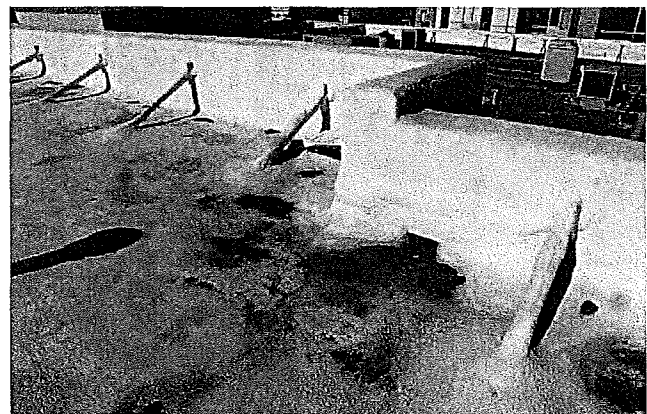
Figure 2. Roof at drainage opening in parapet; note parapet bracing and conditions near opening.

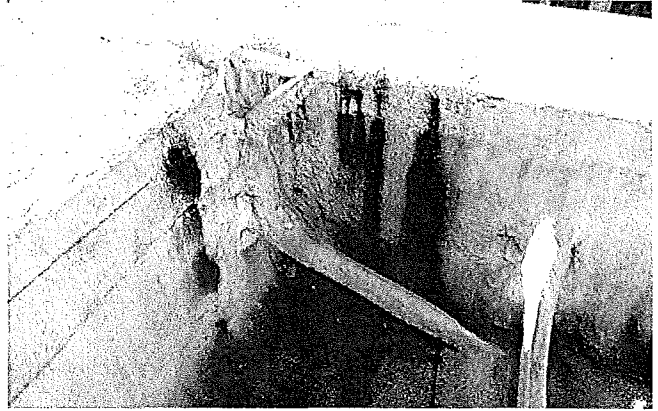
Figure 5. Bio-growth and water stains at roof. Investigate to if determine localized water damage exists.

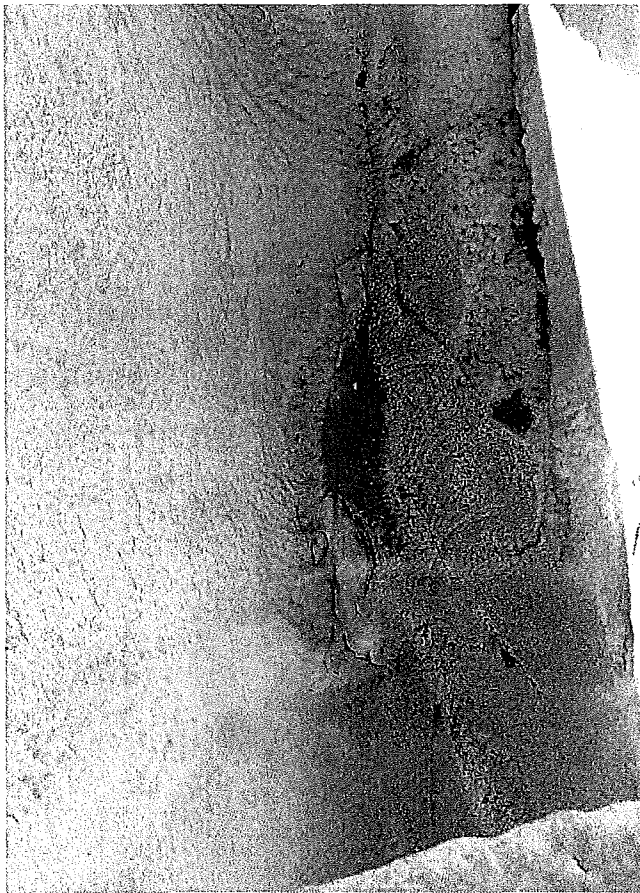
Figure 4. Detail of roofing membrane and localized damage; assess conditions throughout.

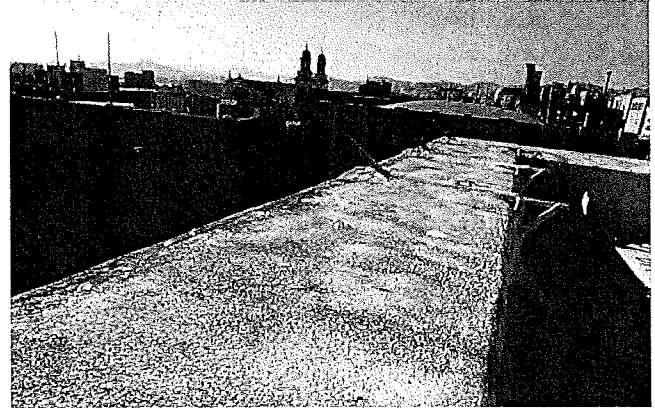
Figure 1. Parapet at southwest corner; note roofing membrane conditions at parapet cap.

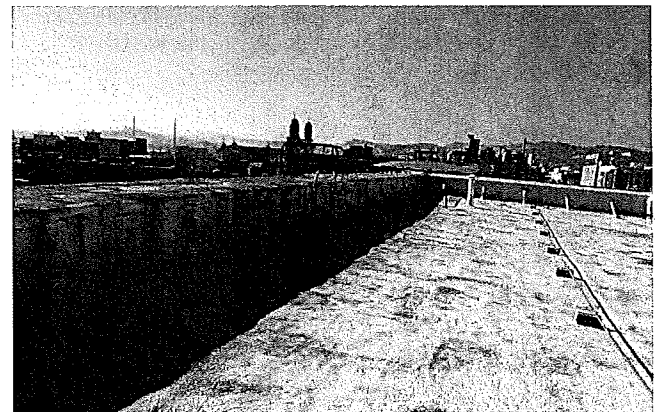
Figure 3. Parapet with bracing, typical.

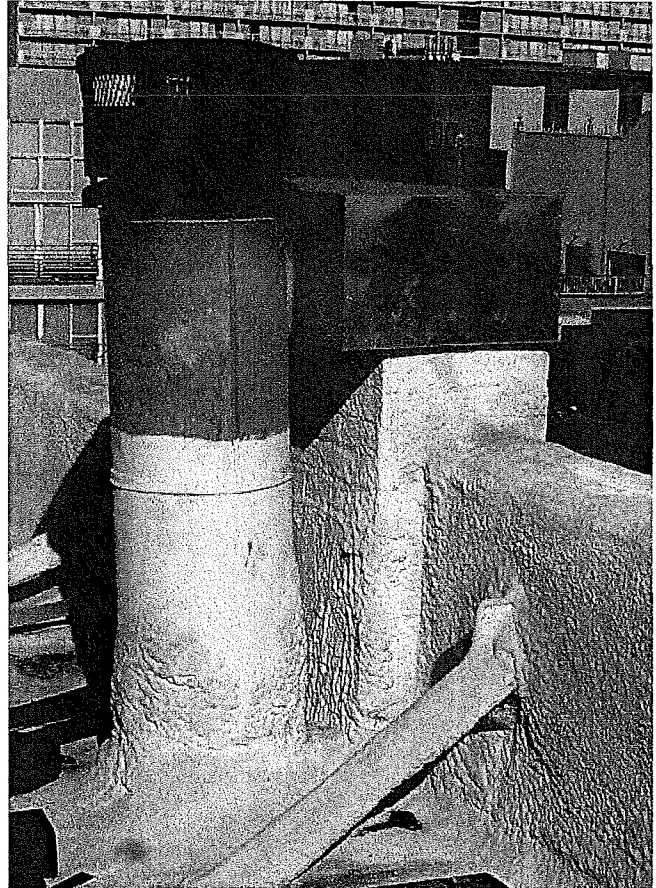
Figure 1. Unbraced ventilation stack with sheet metal cap, typical.
