MILLS ACT APPLICATION  
1315 WALLER STREET  
SAN FRANCISCO, CALIFORNIA  
[I8364A]

PREPARED FOR: TJARKO & AIMEE LEIFER

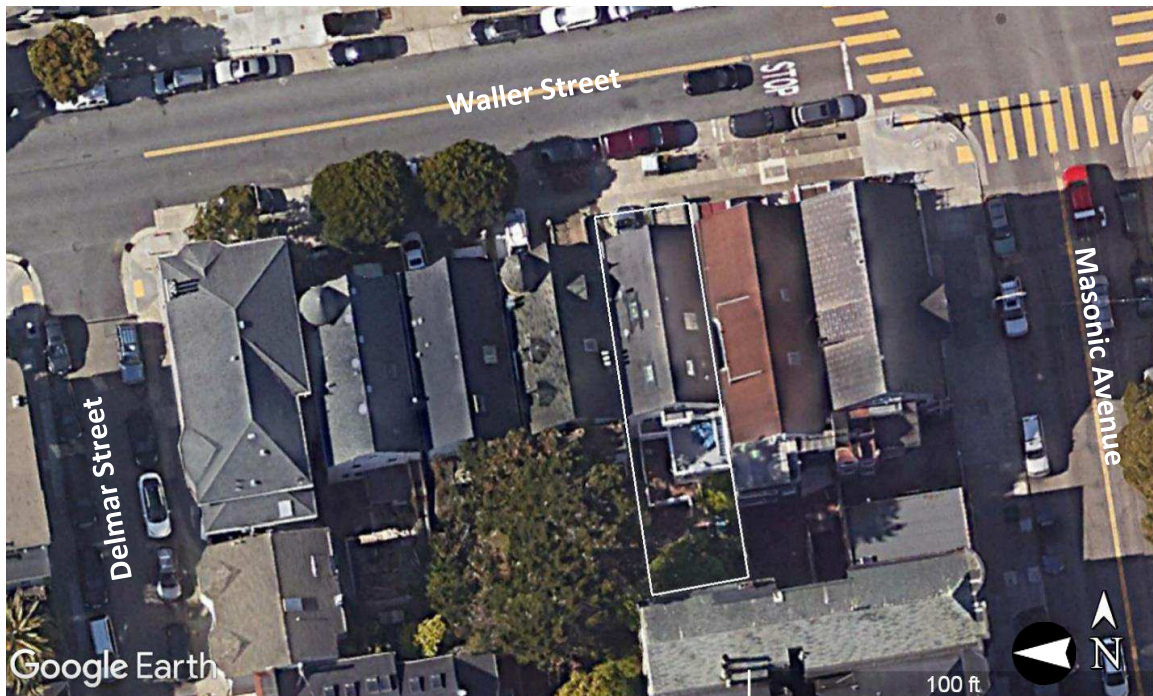
Figure 1: Aerial imagery of 1315 Waller Street. Google Earth Pro 2019.

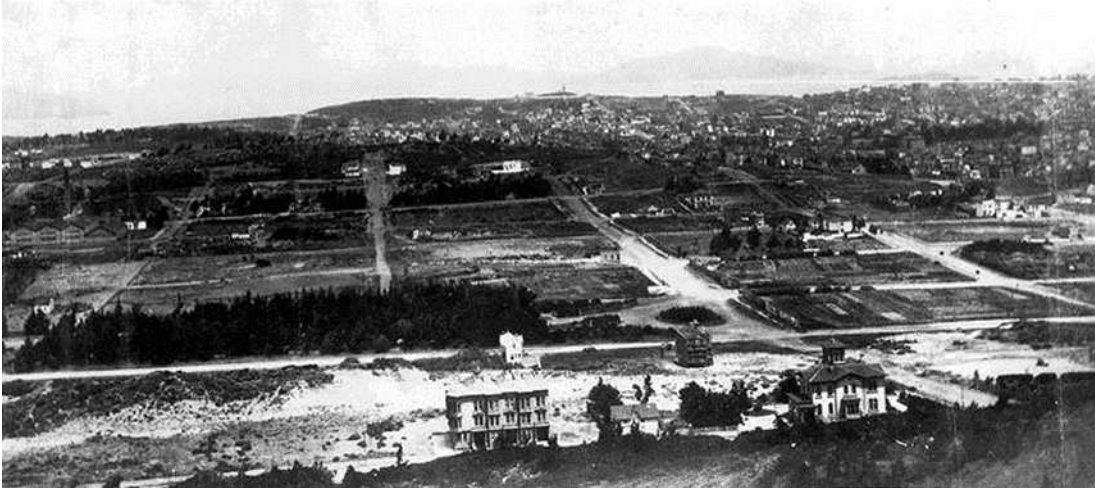
**Figure 1. Golden Gate Park Panhandle from Buena Vista Park, view north, 1882. Very little development had taken place before the establishment of the Haight Street Railroad in 1883. Source: FoundSF**

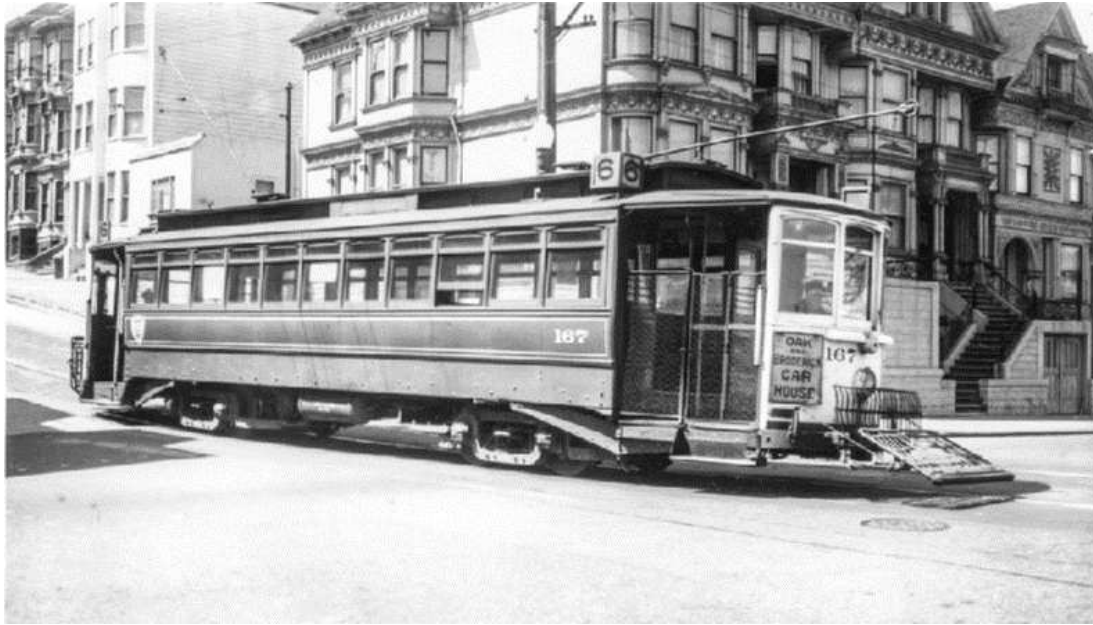
**Figure 4. Masonic Avenue and Waller Street, 1937, Whelan House visible far right.**

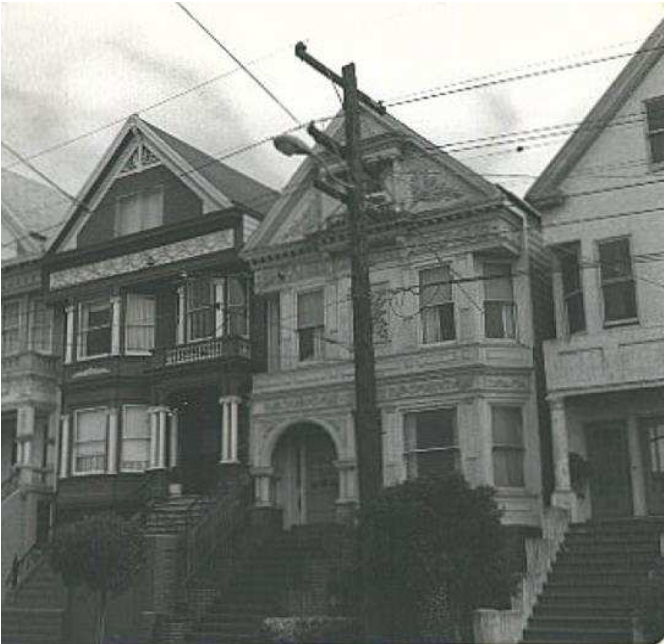
**Figure 5. Four Seasons Houses at 1315-1343 Waller Street, Whelan House is the third house from the left, behind utility pole. Source: San Francisco Department of City Planning, Architectural Survey Form, 1976.**

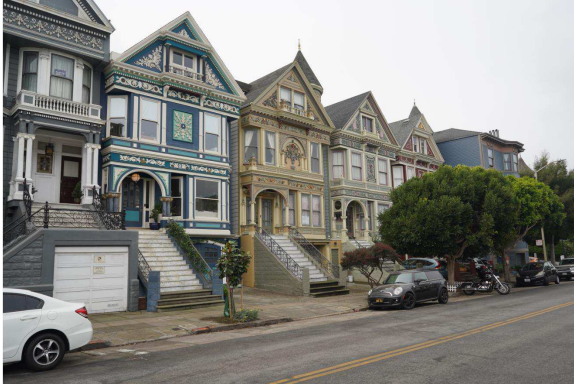
**Figure 9. Four Seasons Houses with 1315 Waller St. as the second house from the left, view southwest.**

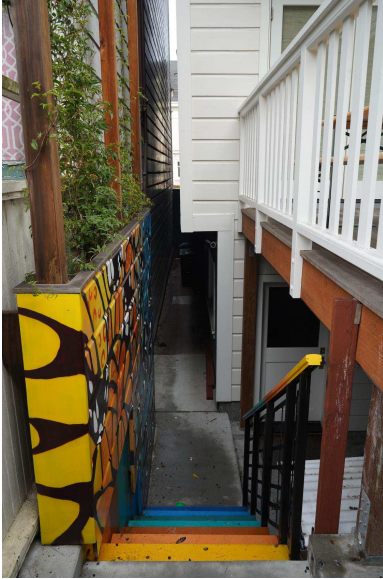
**Figure 15. Steps from backyard to excavated basement level at southeast façade, view northwest.**

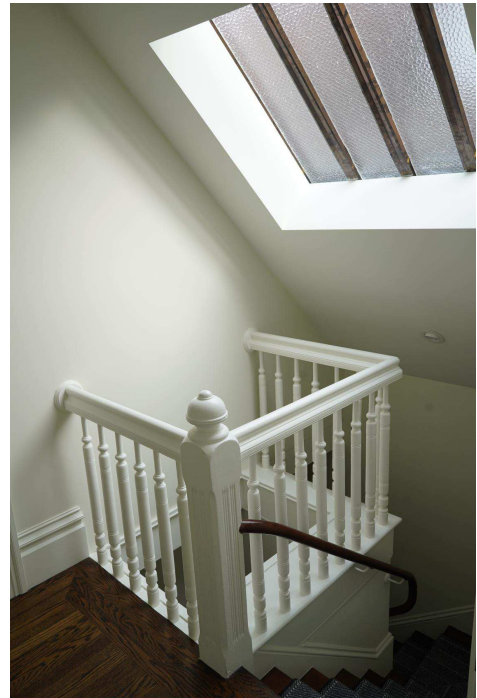
Figure 23. Staircase landing and third-story skylight, view north.

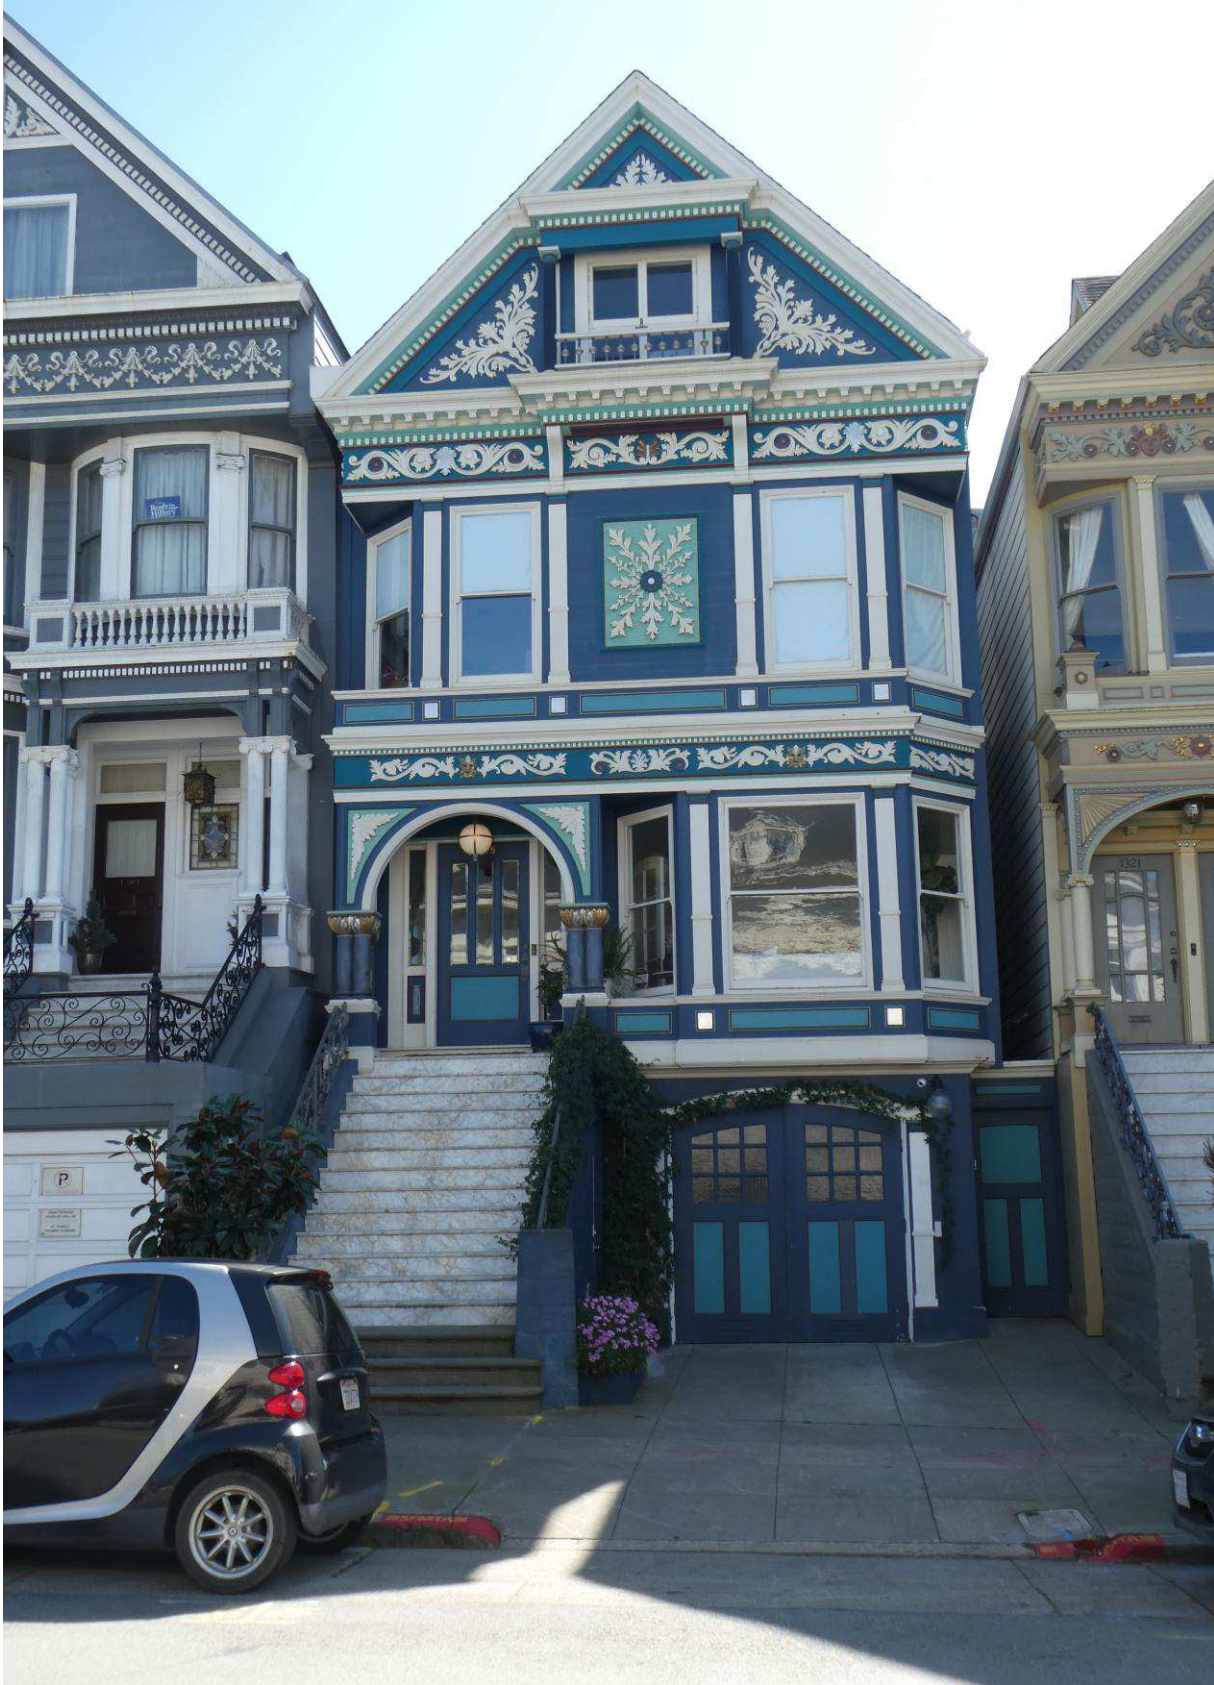
Figure 24: Overall photo showing the primary Waller Street Façade.

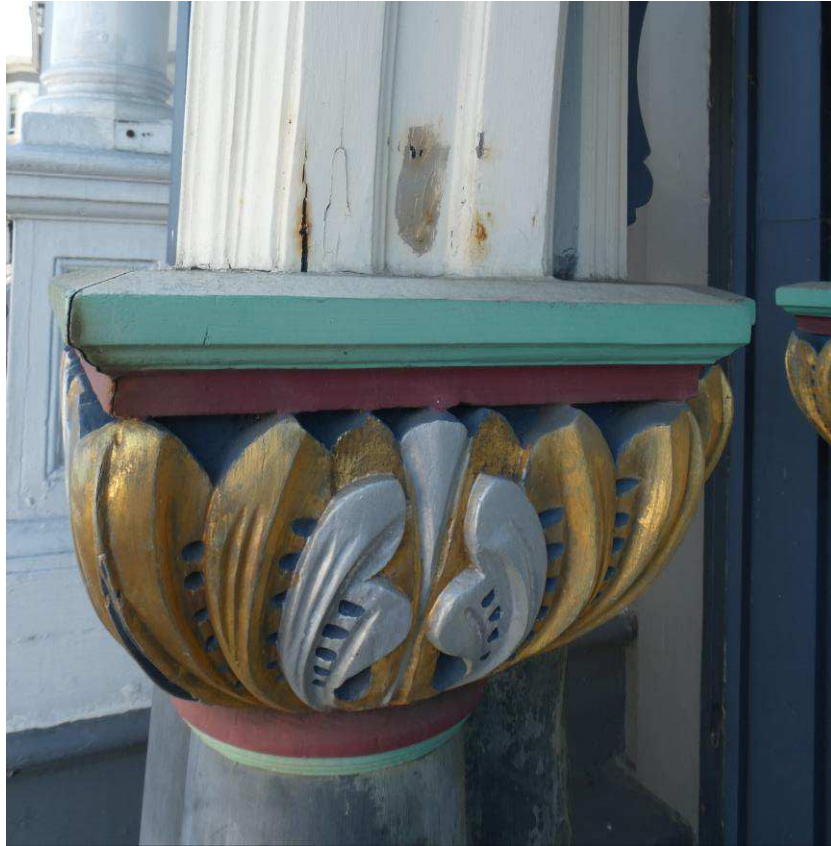
**Figure 25: Detail of wood deterioration and checking/splitting at the main entry.**

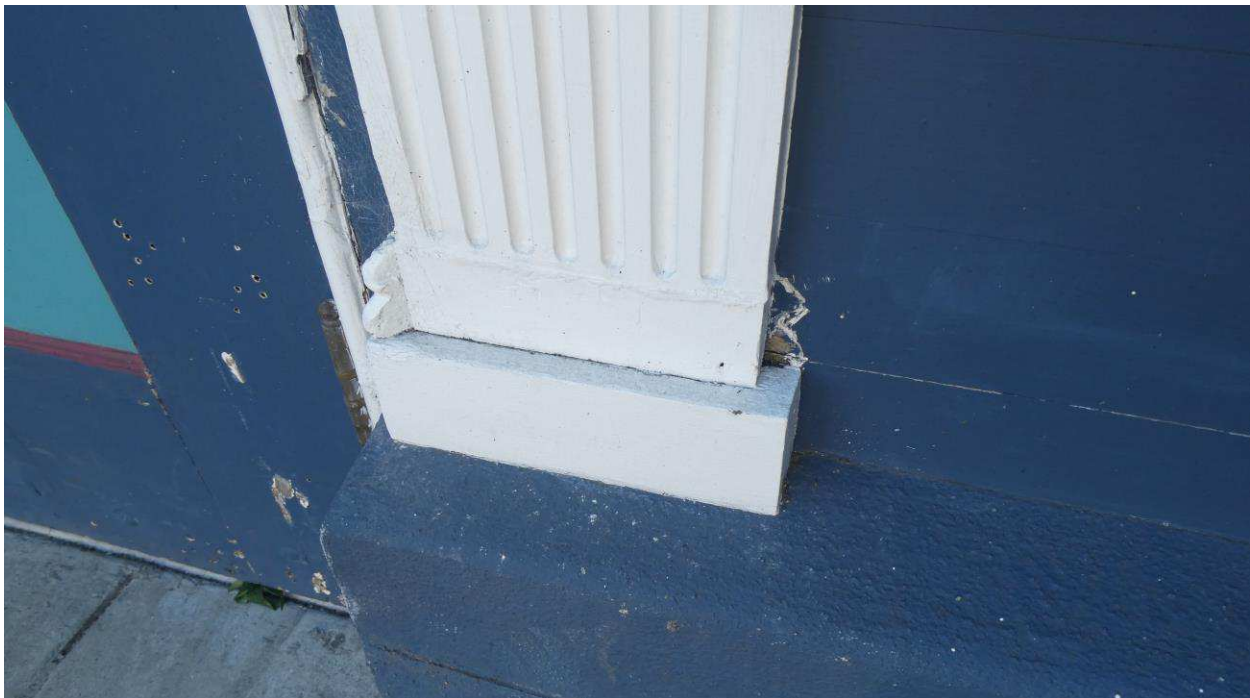
**Figure 26: Detail showing missing profiled trim at the garage door surround.**

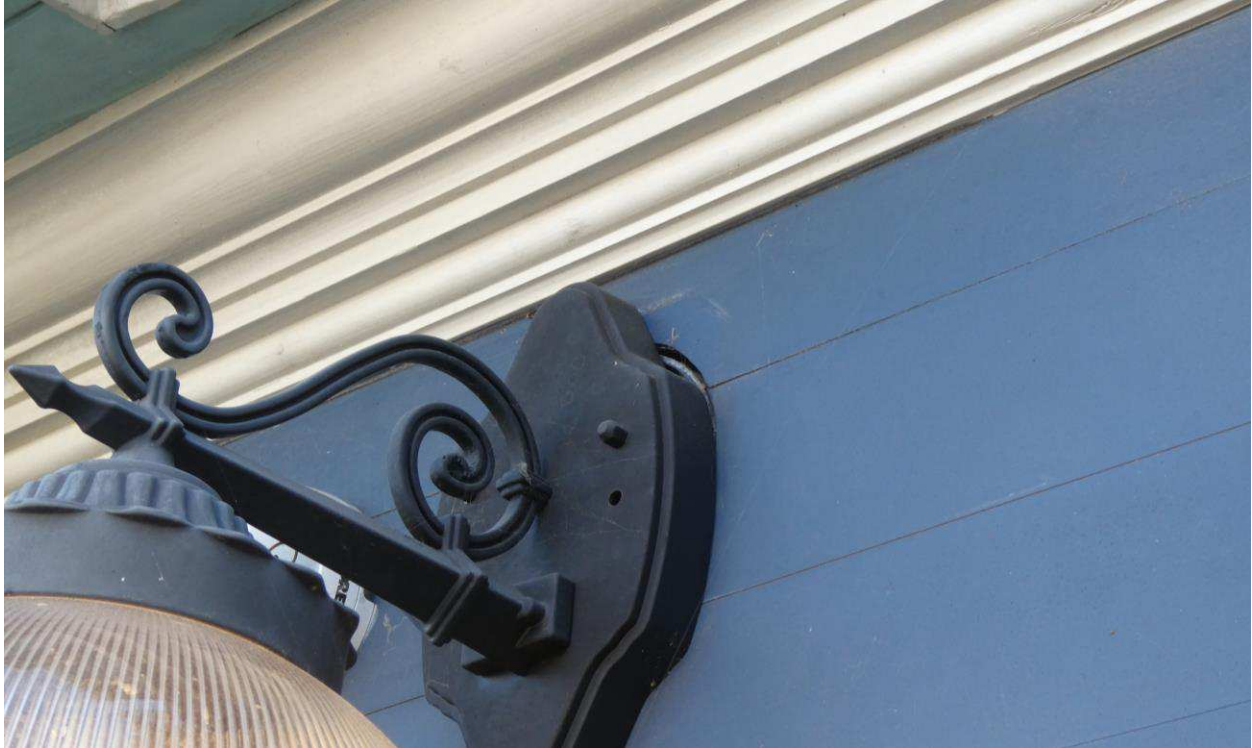
**Figure 27: Detail showing gap between garage sconce escutcheon and wood siding.**

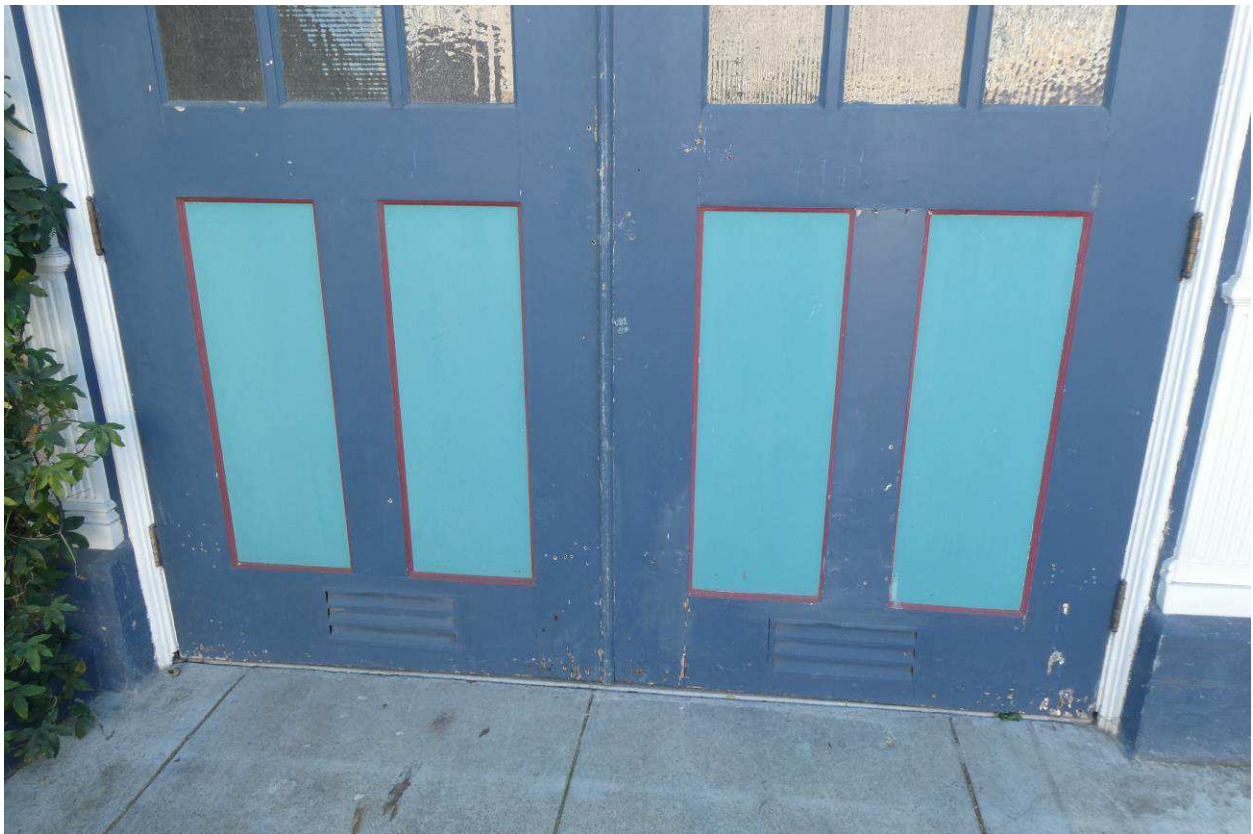
**Figure 30: Detail showing deteriorated wood at the bottoms of both garage doors.**

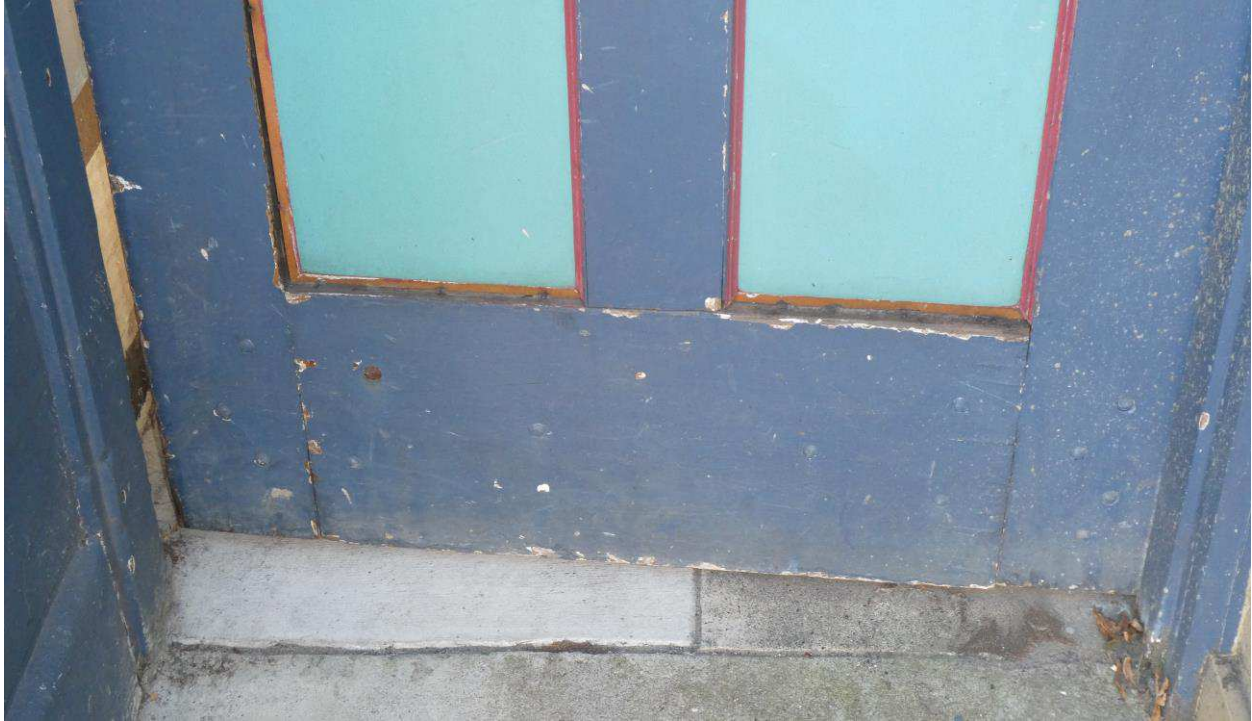
**Figure 31: Detail showing bottom of walkway door adjacent to the garage with deteriorated mortise and tenon joints and missing trim at the perimeter of the panels.**

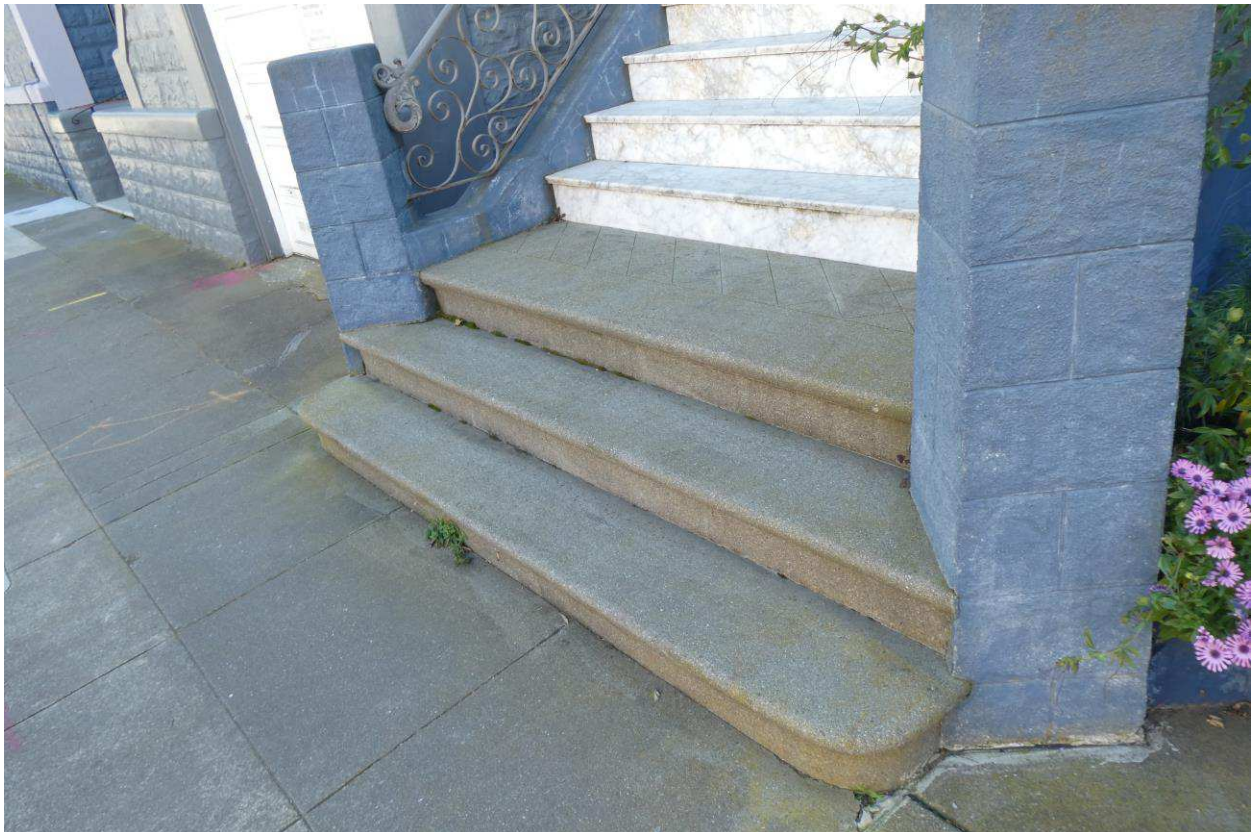
**Figure 32: Detail showing plants and biological growth at joints in the concrete and marble stairs as well as beneath some of the bullnose marble stair treads.**

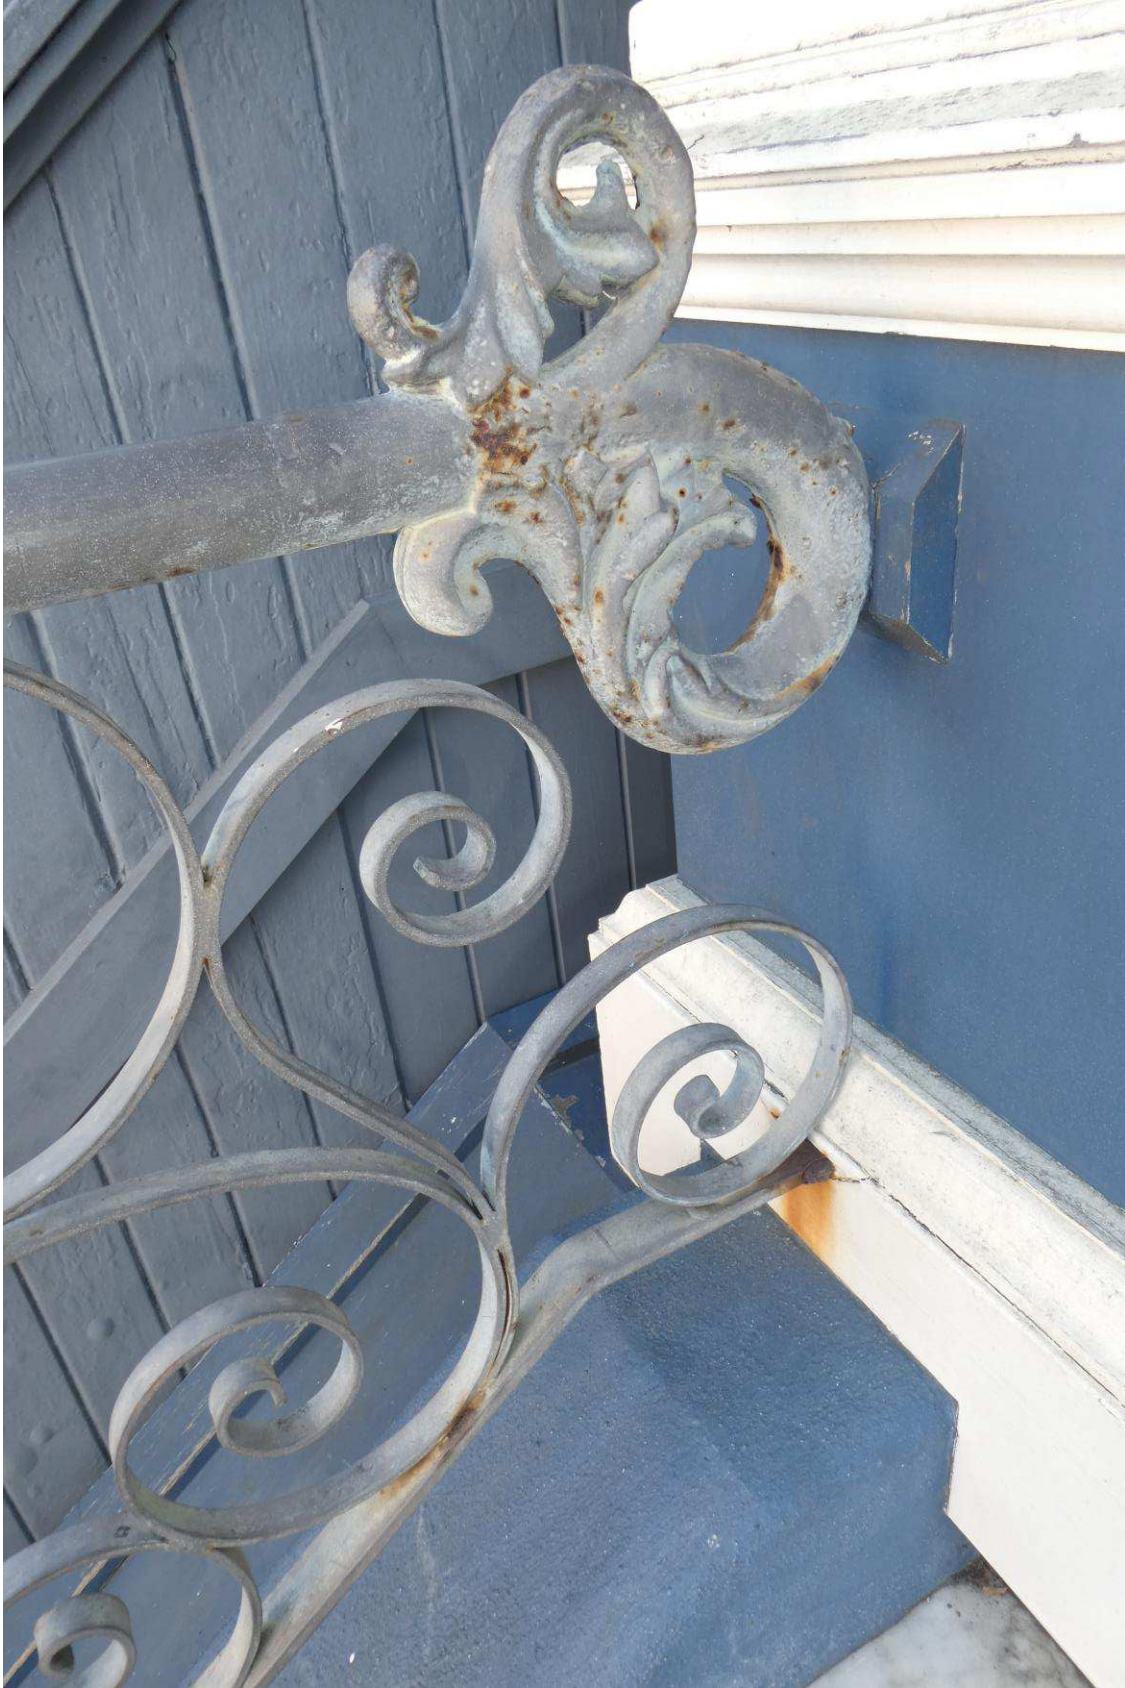
**Figure 33: Detail of typical corrosion at the wrought and cast iron stair rail.**

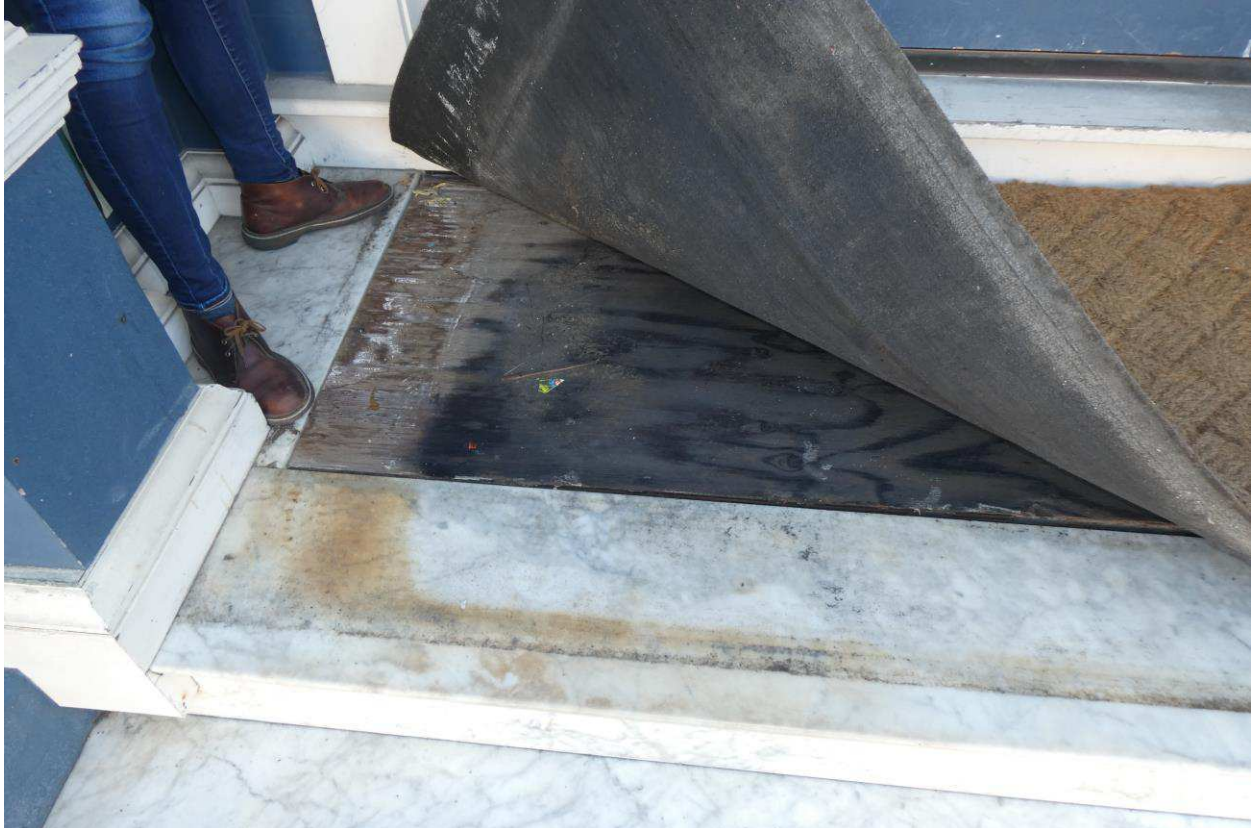
**Figure 34: Detail of top entry landing showing plywood infill and ferrous staining of the marble.**

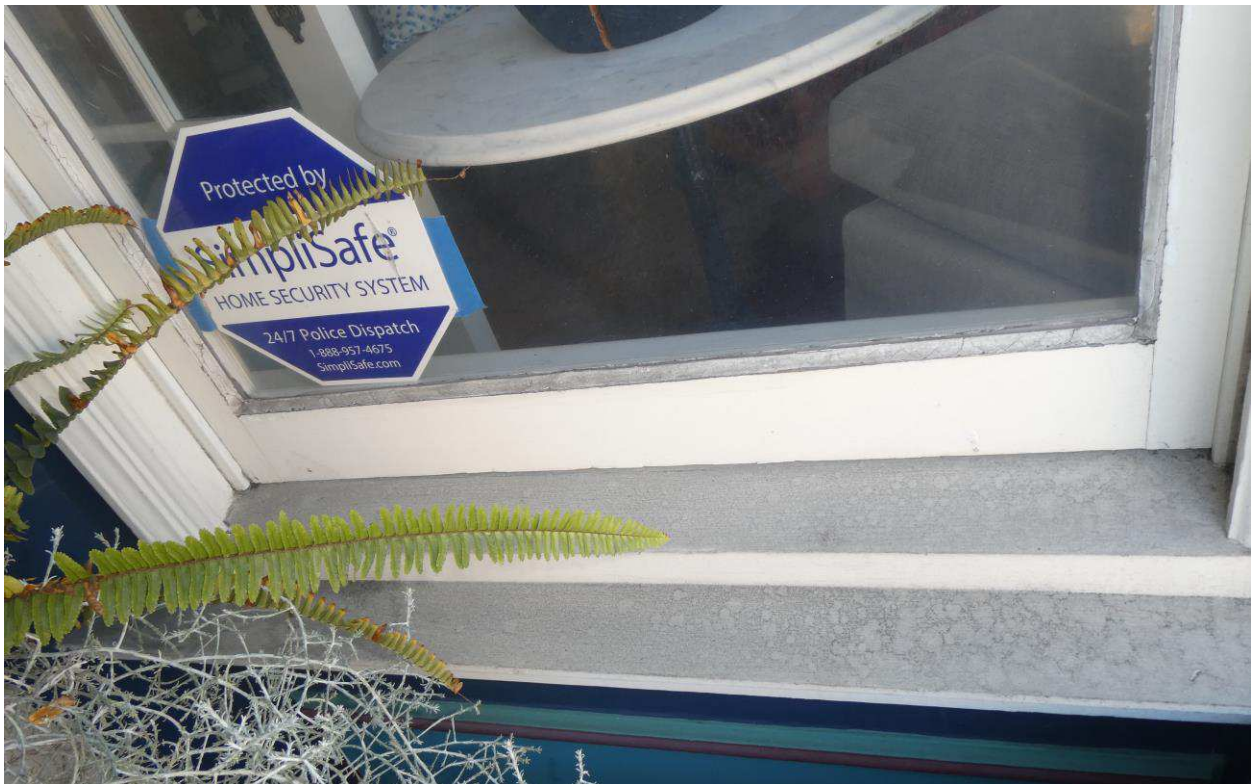
**Figure 35: Detail showing cracked and deteriorated glazing putty at the first story windows.**

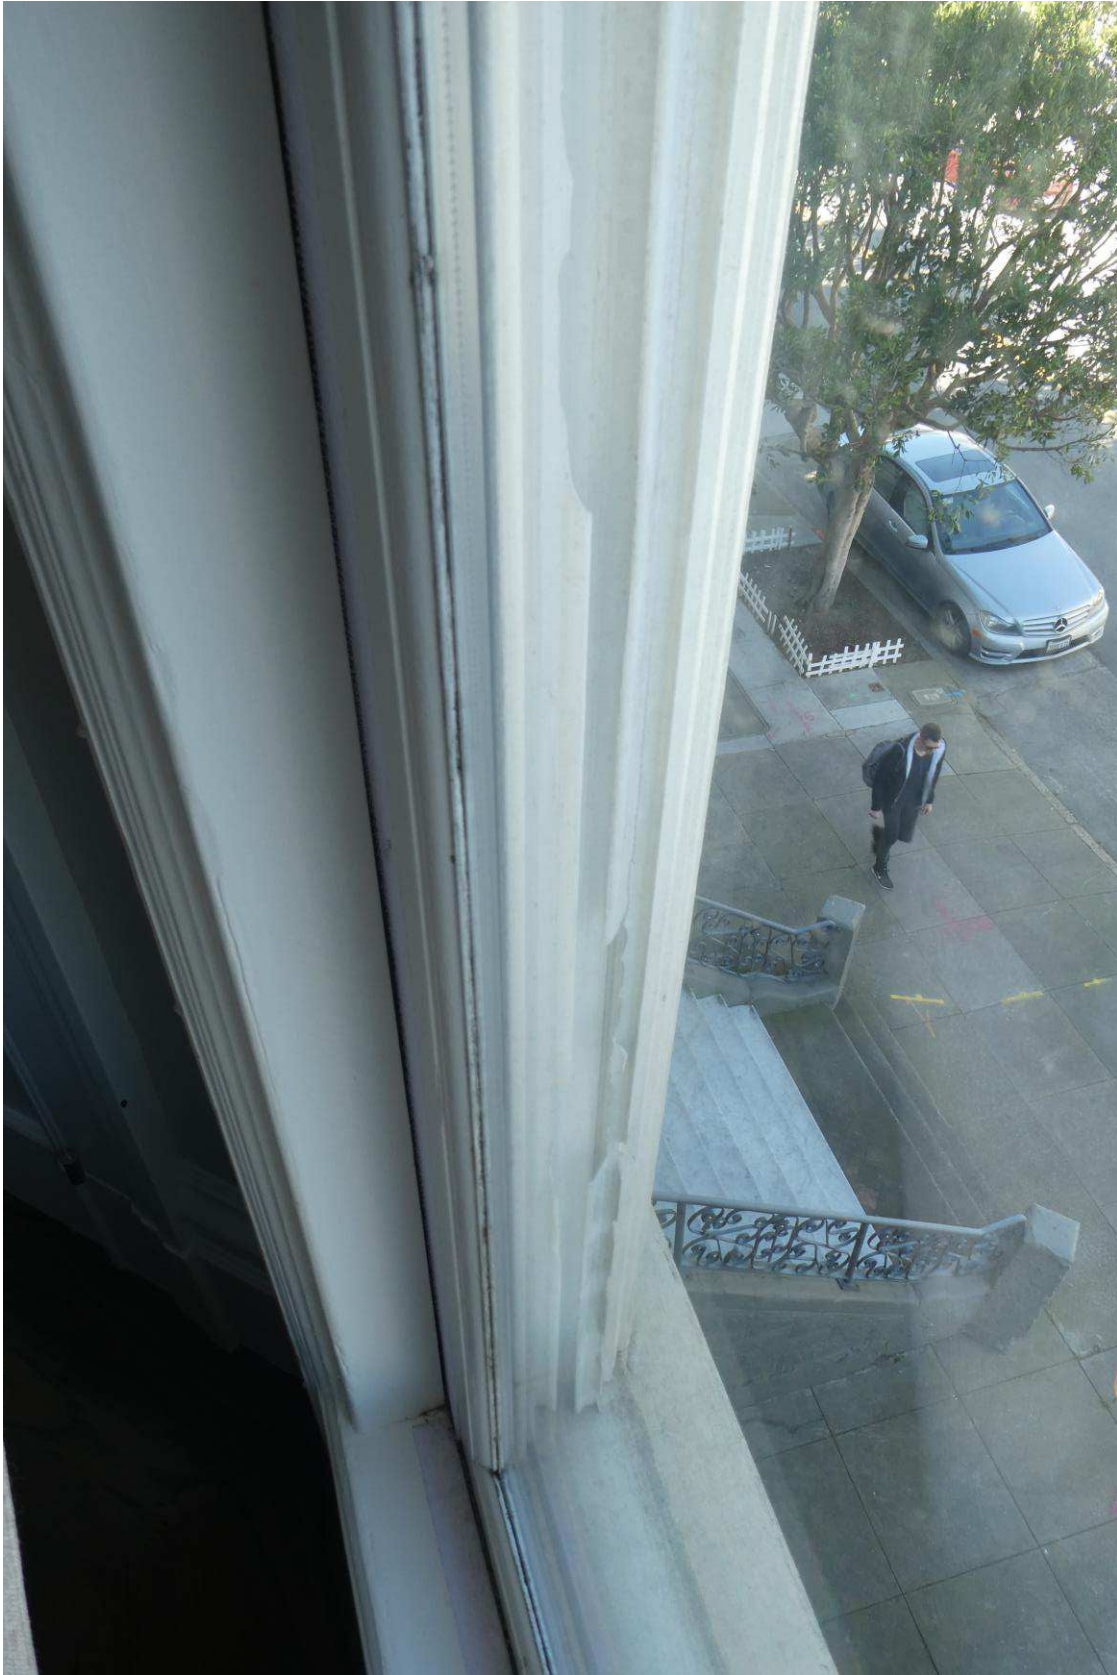
**Figure 36: Detail of the damaged/broken vinyl jambs at the Waller Street second story window exterior.**

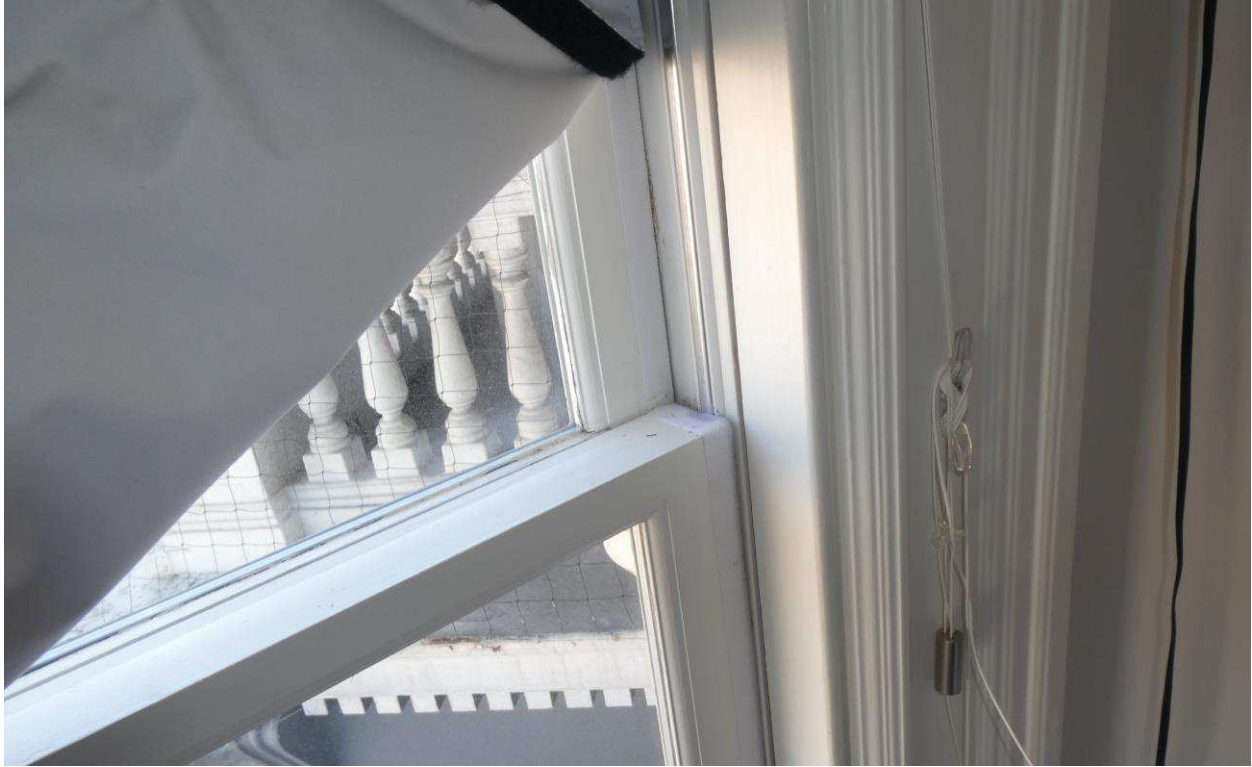
**Figure 37: Detail of the second story Waller Street window showing window treatments and Velcro attempt to mitigate air infiltration at the non-historic insert windows.**

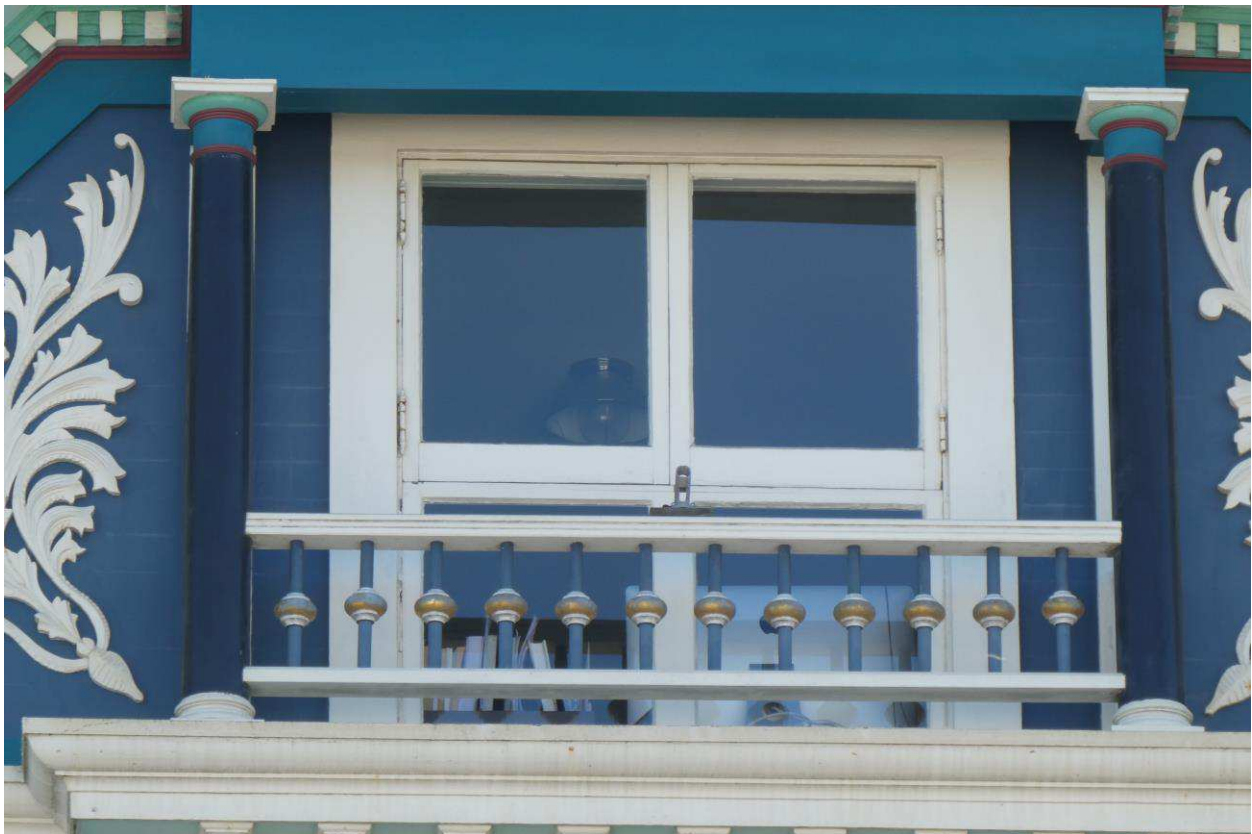
**Figure 38: Exterior detail of the attic window at the Waller Street gable end.**

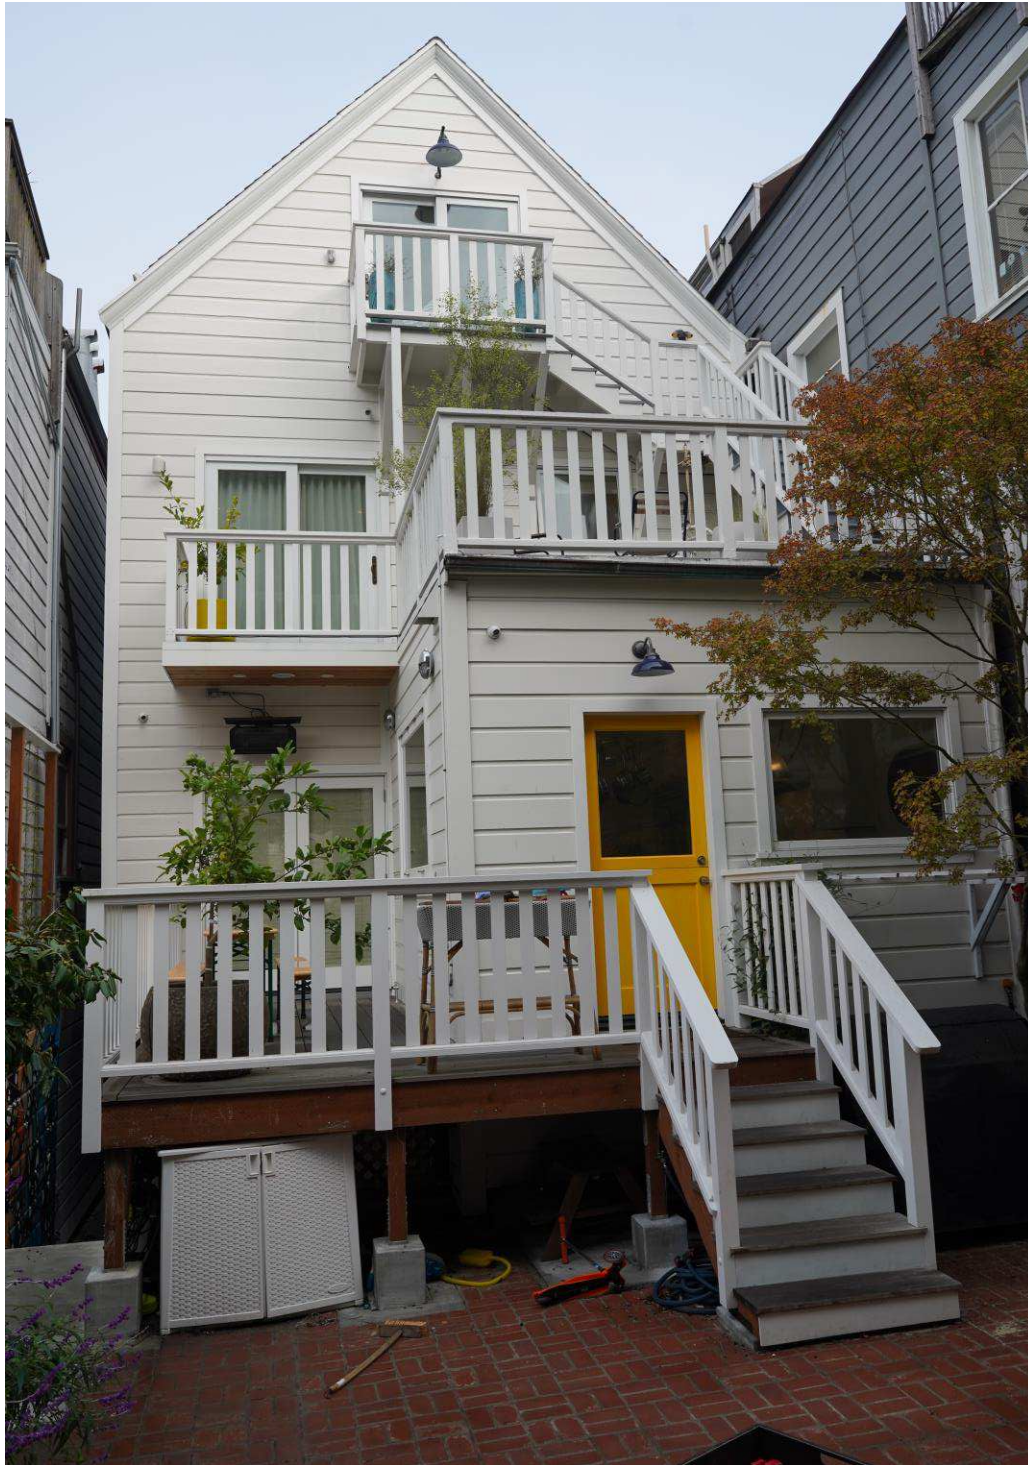
**Figure 41. Overall view of the rear, southeast facade, view northwest.**

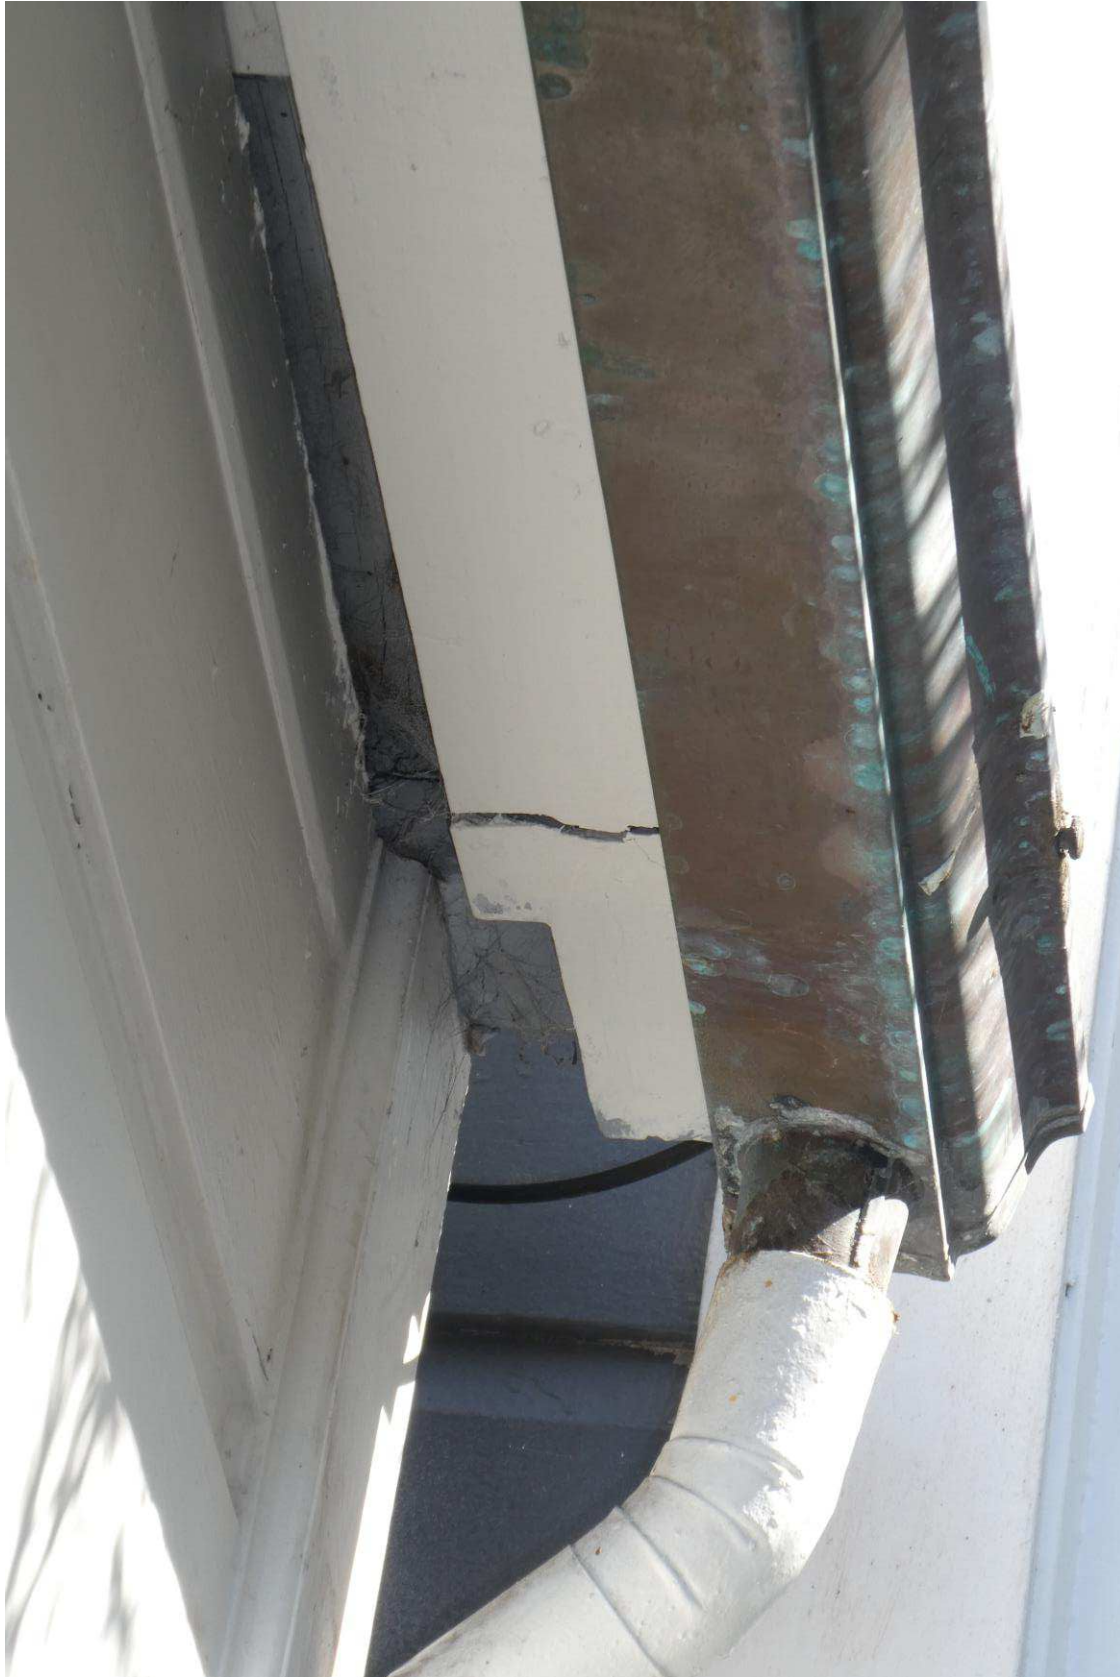
**Figure 42: Detail showing the split/damaged wood at the southeast side of the first floor kitchen.**
