MILLS ACT APPLICATION  
1315 WALLER STREET  
SAN FRANCISCO, CALIFORNIA  
[I8364A]

PREPARED FOR: TJARKO & AIMEE LEIFER

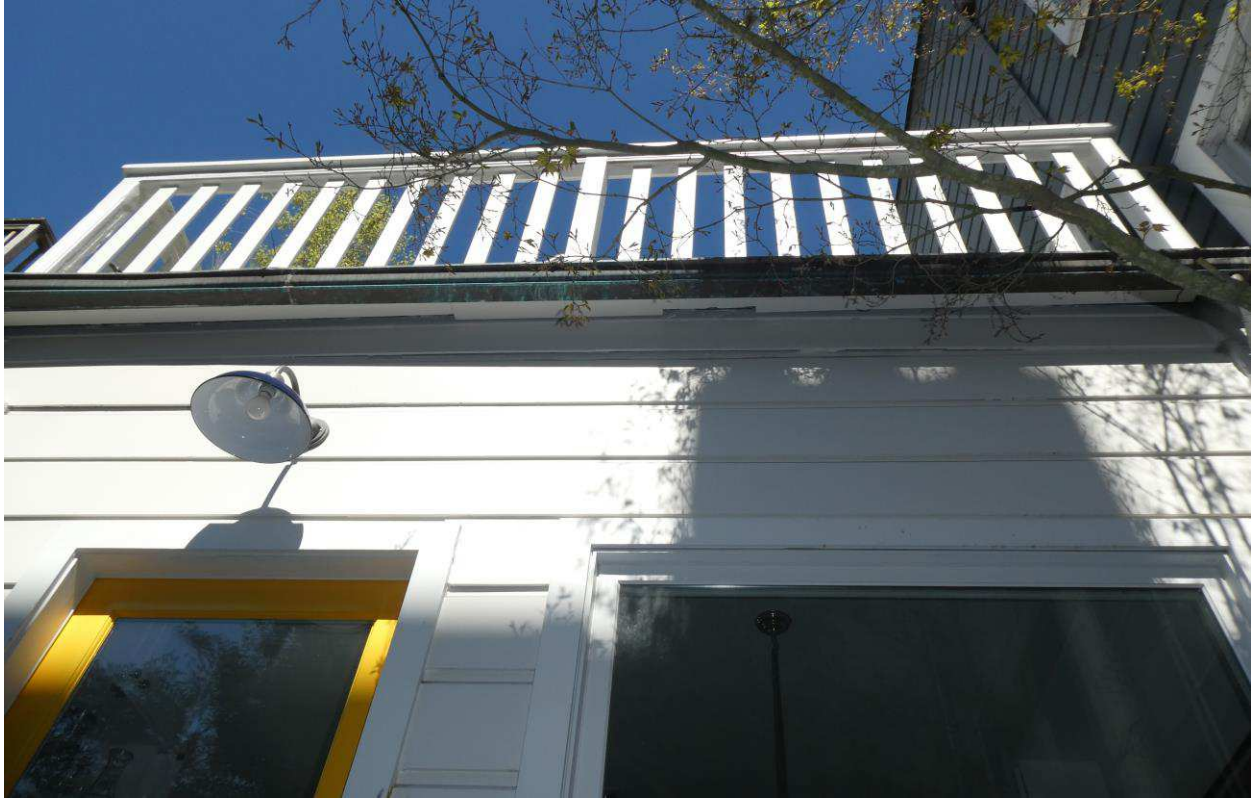
**Figure 43: Detail of the bulging top siding board at the southeast side of the first floor kitchen.**

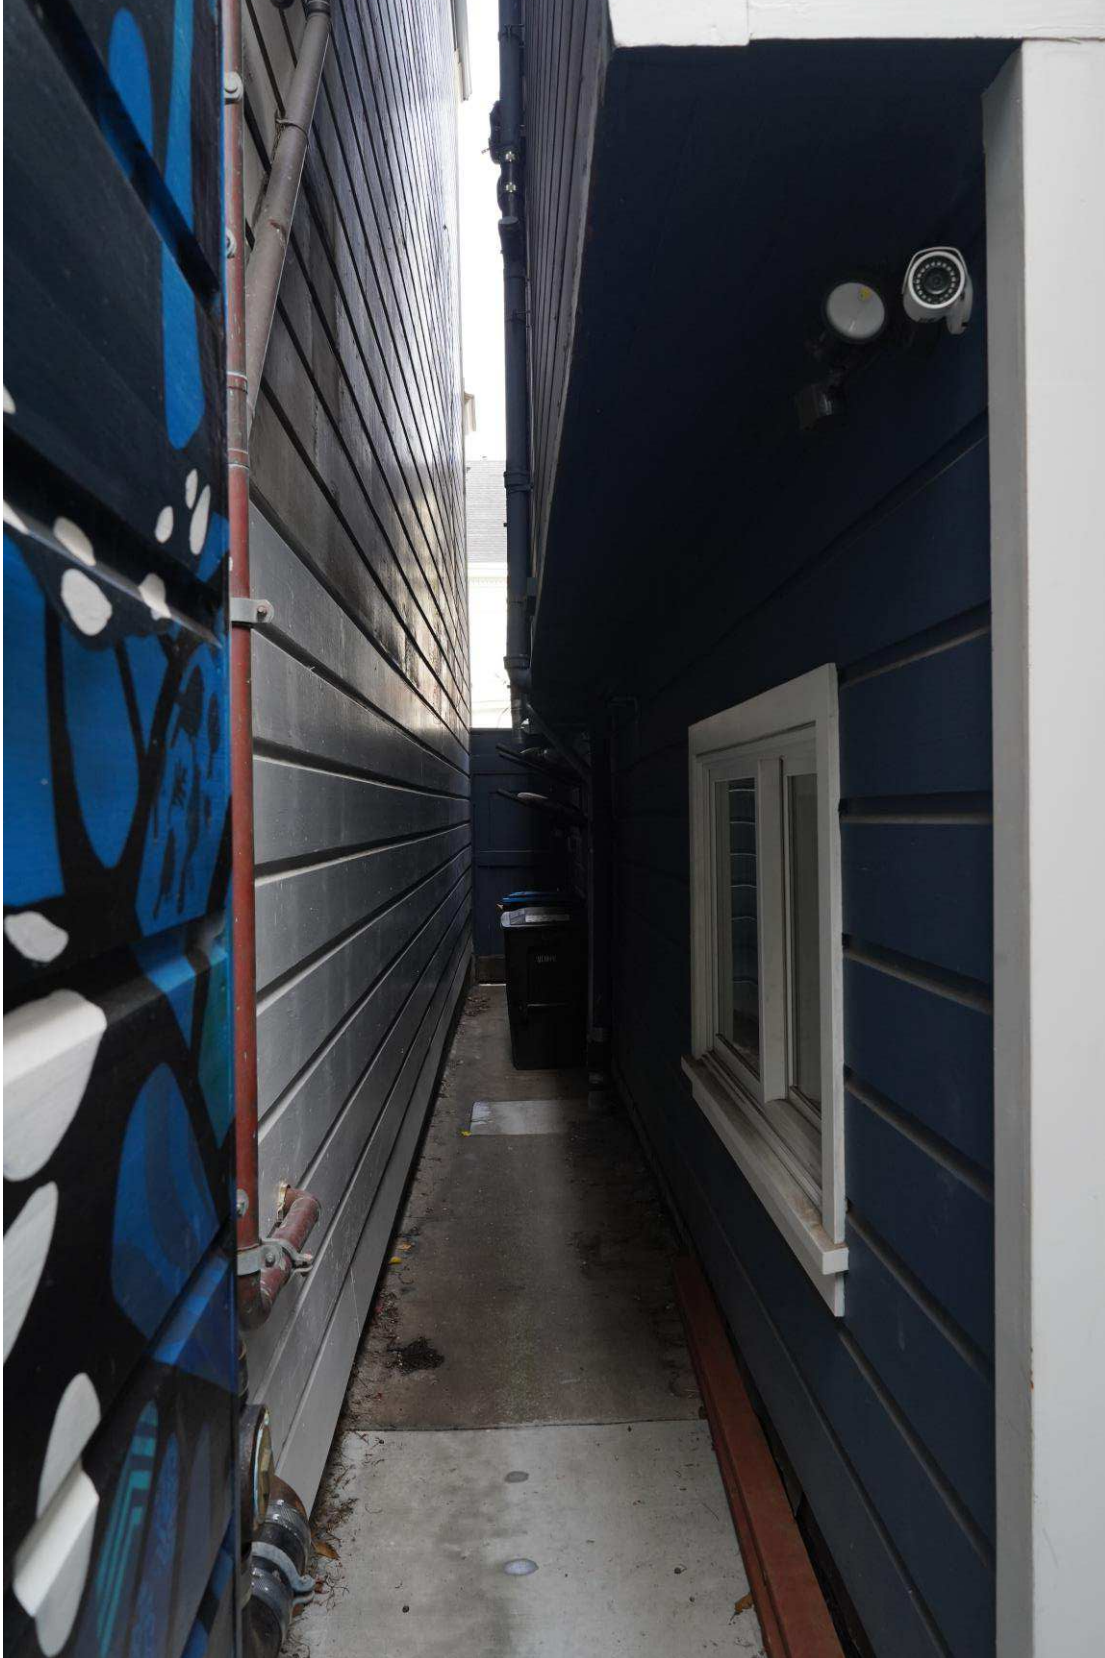
**Figure 46: Overall view of the walkway at the southwest side of the building. Note the mechanical and plumbing flues/piping at the upper portion of the wall in the distance. See also (Figure 48).**

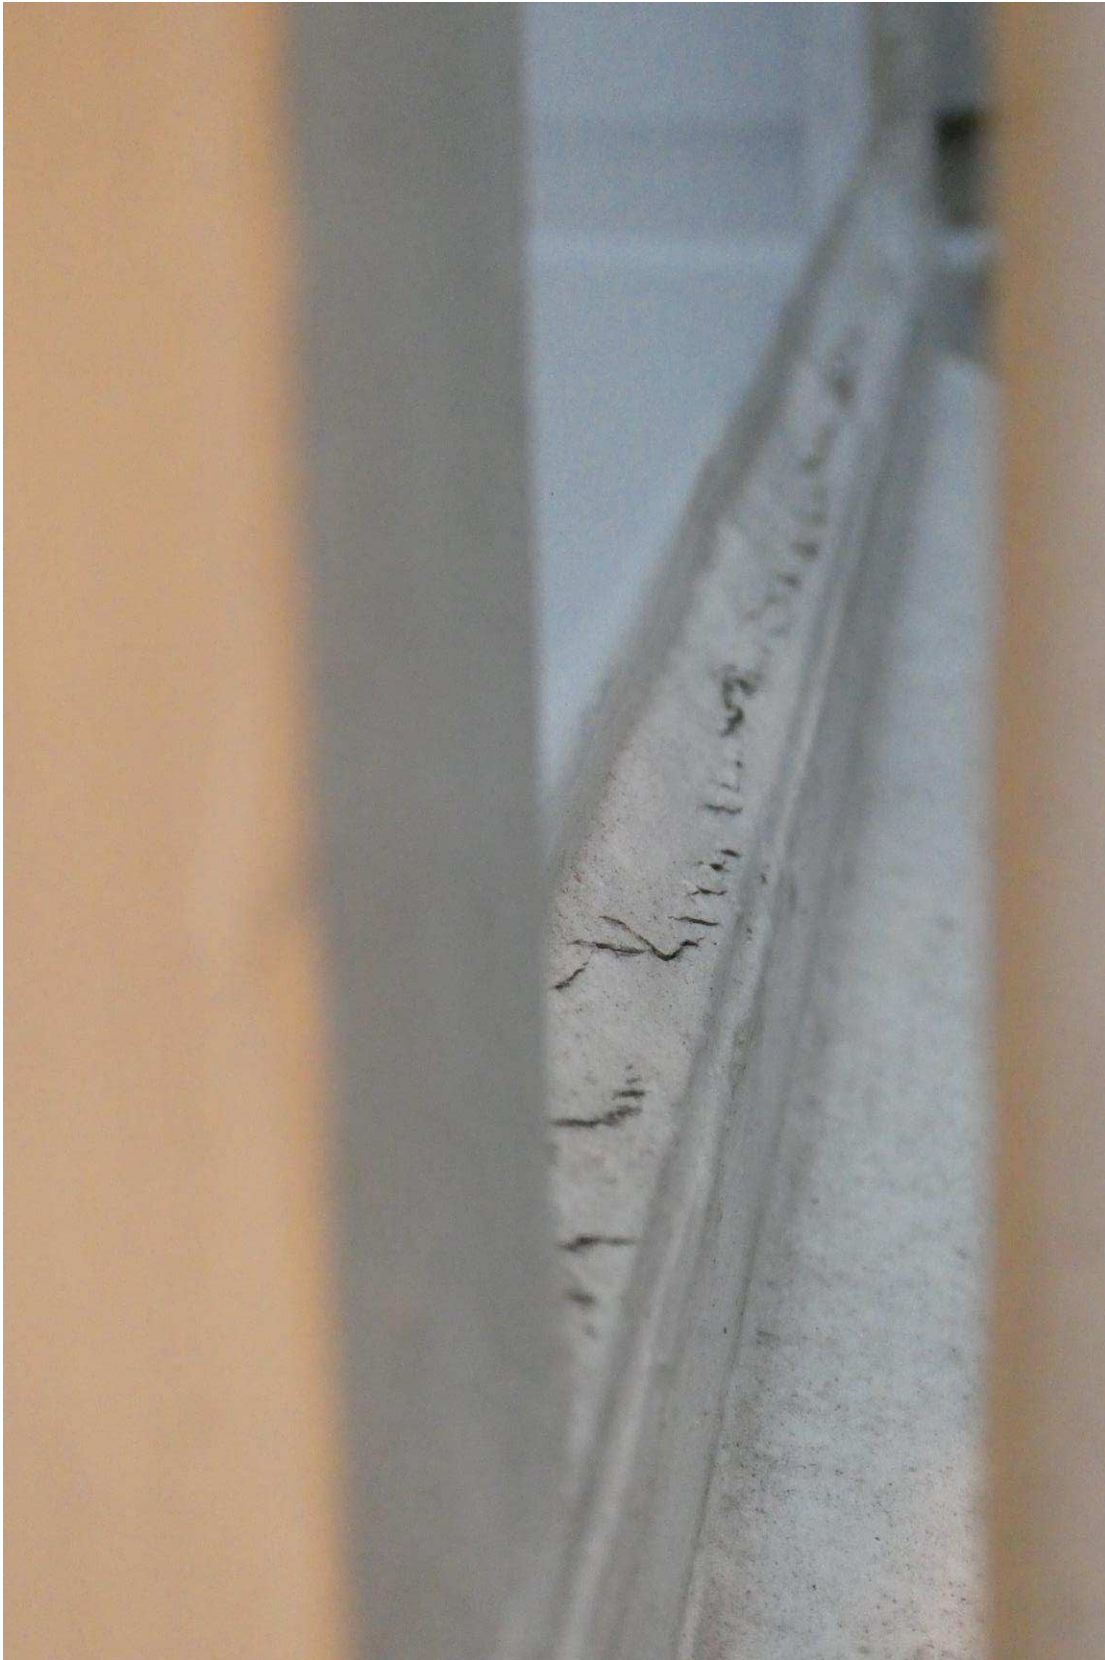
**Figure 50: Detail showing deteriorated glazing sealant at the Plexiglas, second floor non-historic casement sash, northeast lightwell.**

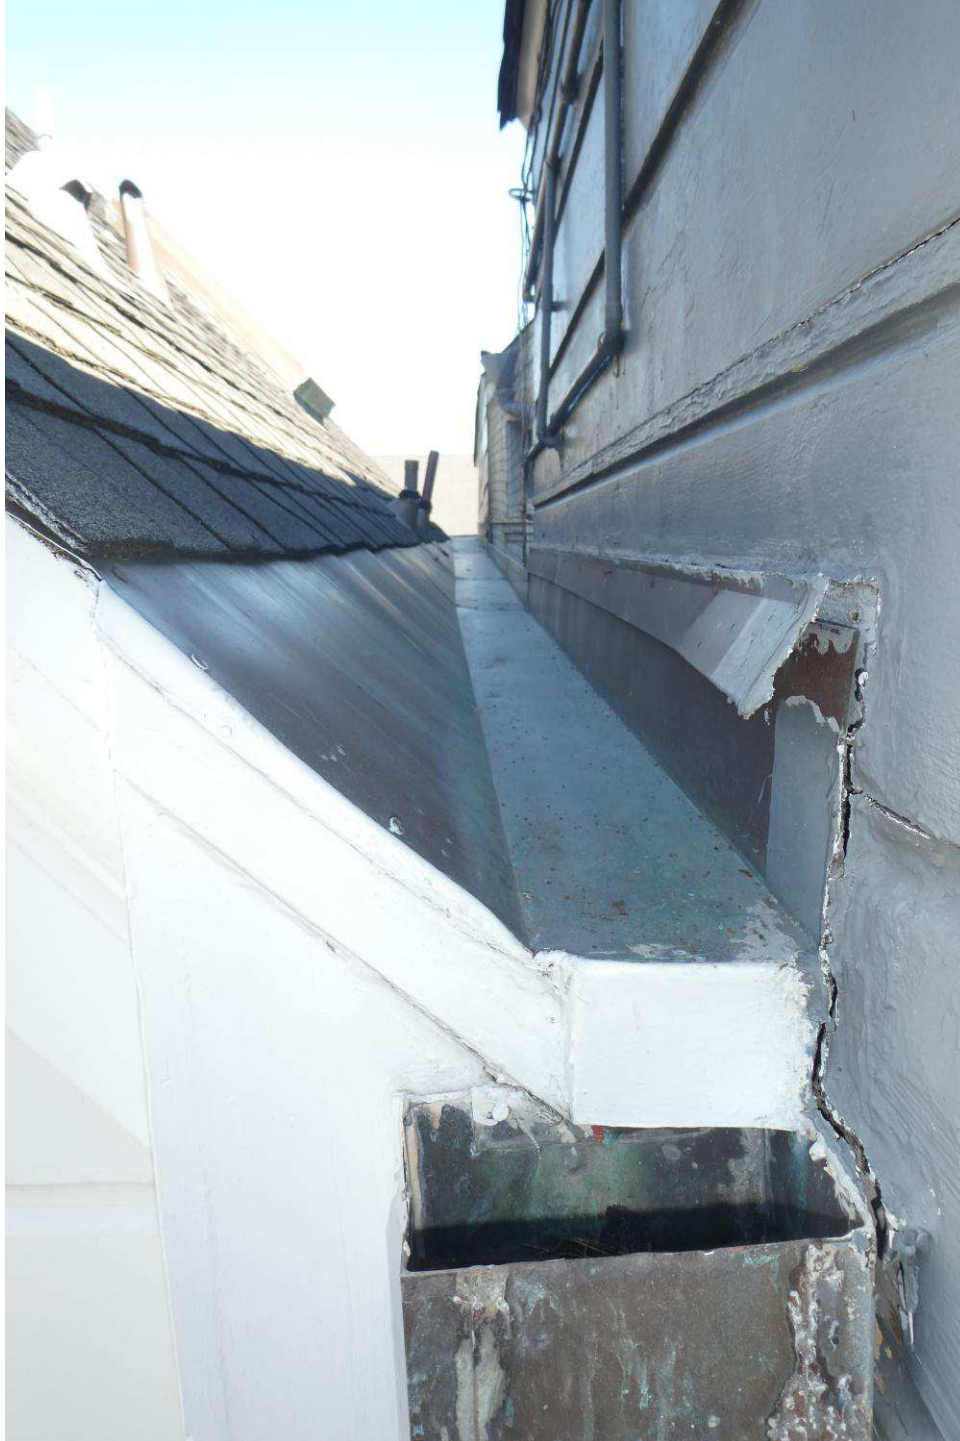
**Figure 51: Copper gutter, counterflashing, and leader head where the main roof meets the neighboring building to the northeast.**

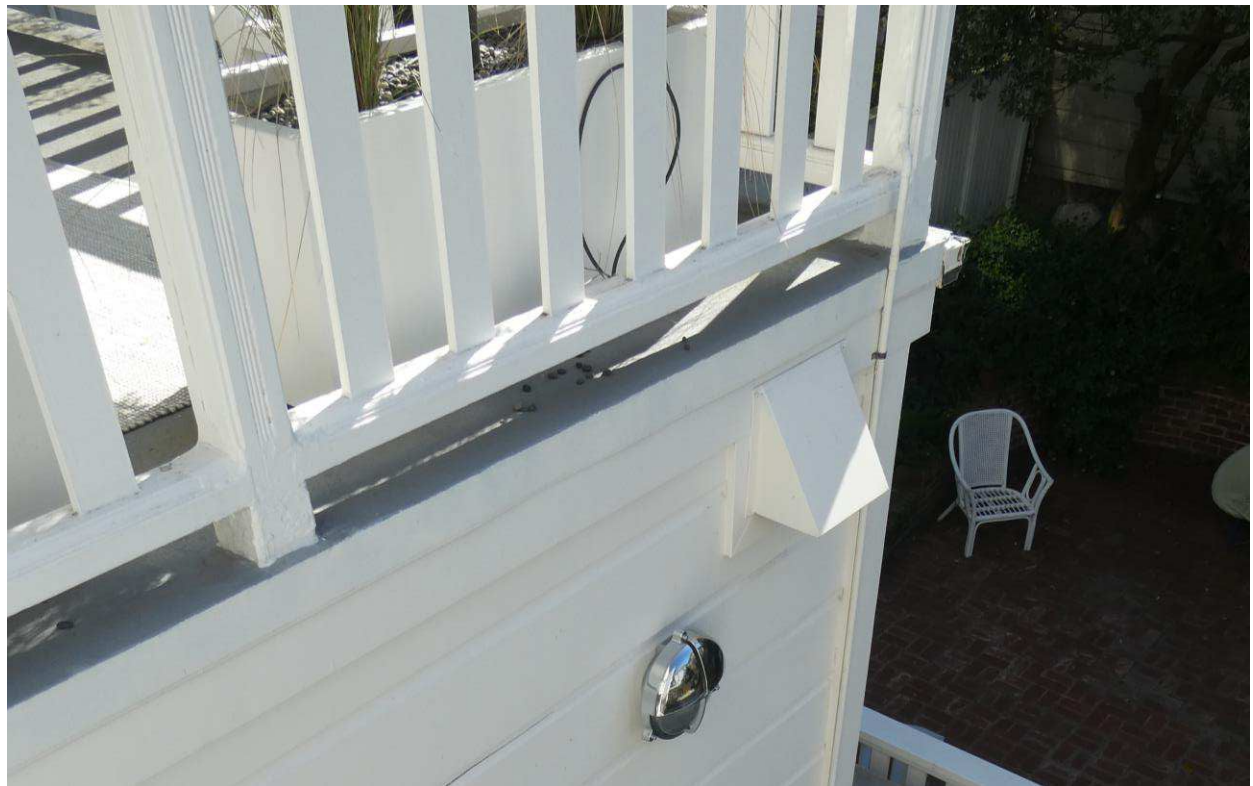
**Figure 55: Detail showing the asphaltic roof at the decking above the first floor kitchen.**
