## **Exhibit A: Rehabilitation/Restoration Plan for 354-356 San Carlos Street**

## **Exhibit B: Maintenance Plan for 354-356 San Carlos Street**

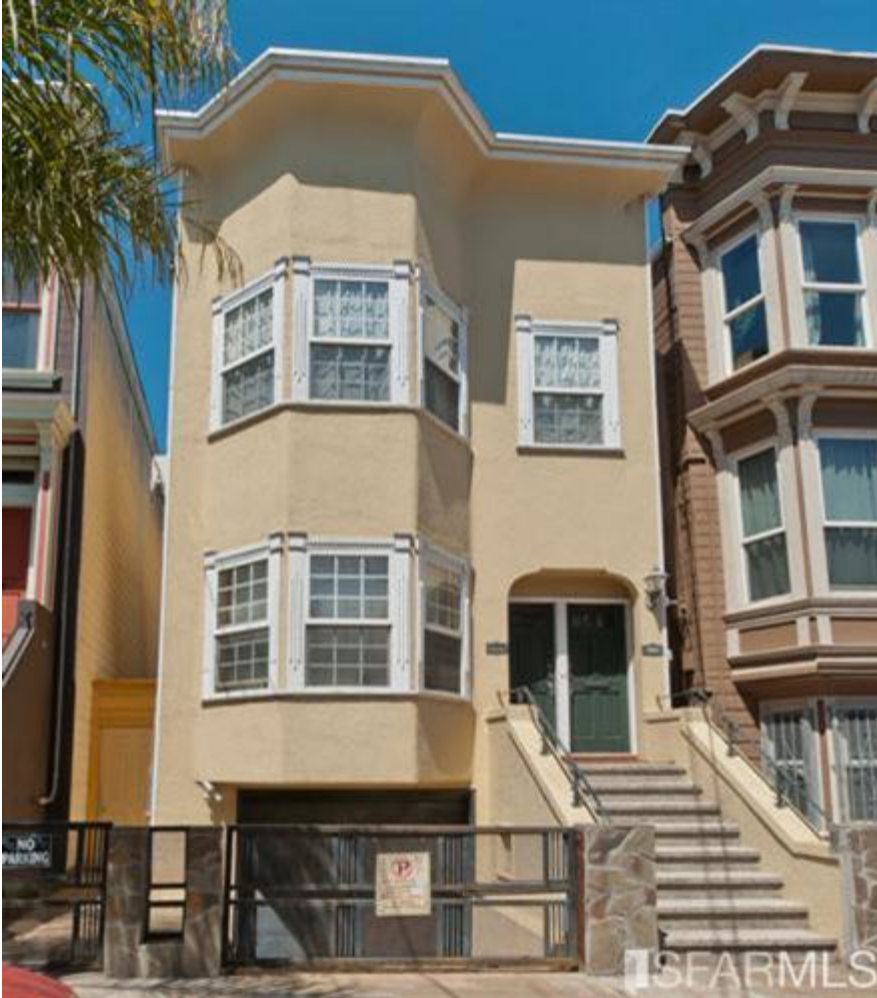
*Figure 1. Before image of 354-356 San Carlos St. taken in 2012. Front facade view looking east.*

Non-original stucco was carefully removed from the front façade of the building to reveal the original wood siding. Non-original windows were removed from the house. The non-original stair and site work at the front of the building was also removed. Best preservation practices were utilized to protect existing features to remain from damage. Work was performed by qualified persons with experience with historic buildings.

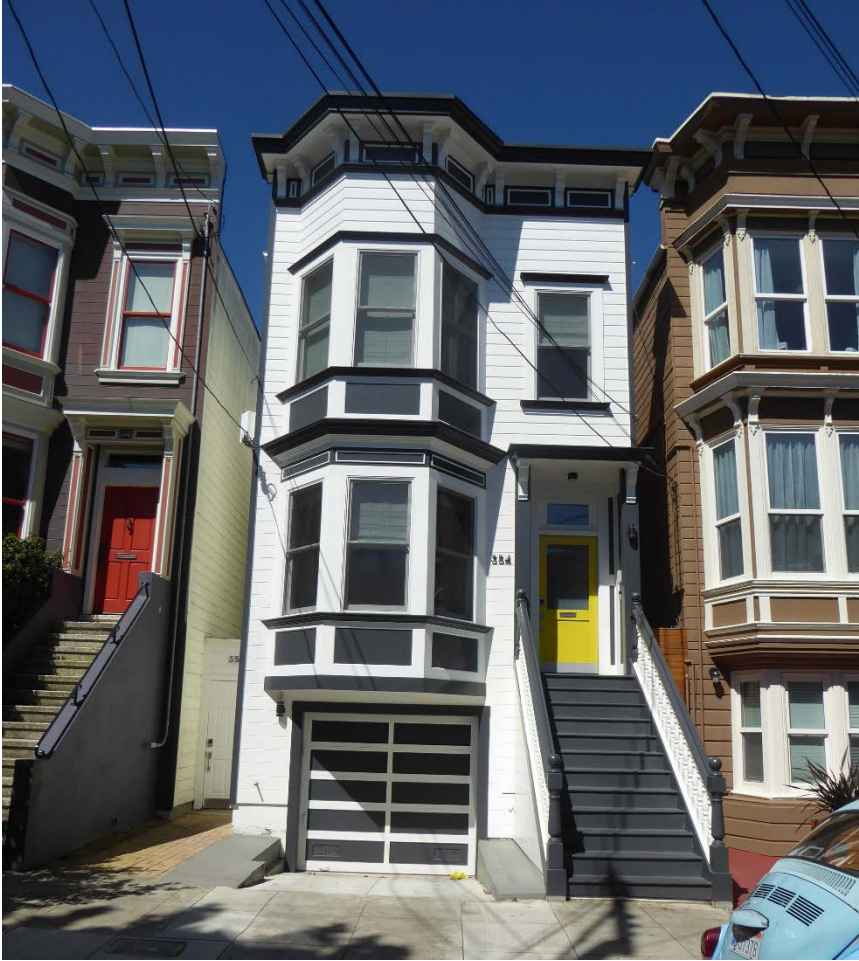
*Figure 2. After image of 354-356 San Carlos taken in 2016. Front facade, view looking east.*

Once the stucco was removed all exterior wood elements were evaluated for repair. Missing elements were recreated to match existing similar. Broken elements were repaired with a wood patch if larger than 2” or epoxy if smaller. All rot was removed and patched or repaired. Best preservation practices were utilized. Work was performed by qualified persons with experience with historic wood elements.

Most of the windows were non-original and removed and replaced with new to match the existing original. The original wood windows were repaired in place. Each one was inspected for operation and deterioration. Wood was repaired by Dutchman patch or epoxy and repainted. Glass was replaced where necessary. Ropes and hardware were replaced where missing or broken. Sealants and weather-stripping was installed to be minimally visible. Best preservation practices were utilized. Work was performed by qualified persons with experience with historic wood windows and was in conformance with NPS Preservation Brief #9 *The Repair of Historic Wooden Windows*.

The entire house was repainted once repairs were completed. Best preservation practices were utilized. Work was performed by qualified persons with experience with historic

The non-original stair was replaced with a reconstruction of the original. Best preservation practices were utilized. Work was performed by qualified persons with experience with historic buildings.
