1 [Planning Code - Designation of 149-155 9th Street (aka the Western Manufacturing  
2 Company Building)]

**ARTICLE 11 HISTORIC BUILDING REPORT**

Detailed Exterior Cleaning Recommendations

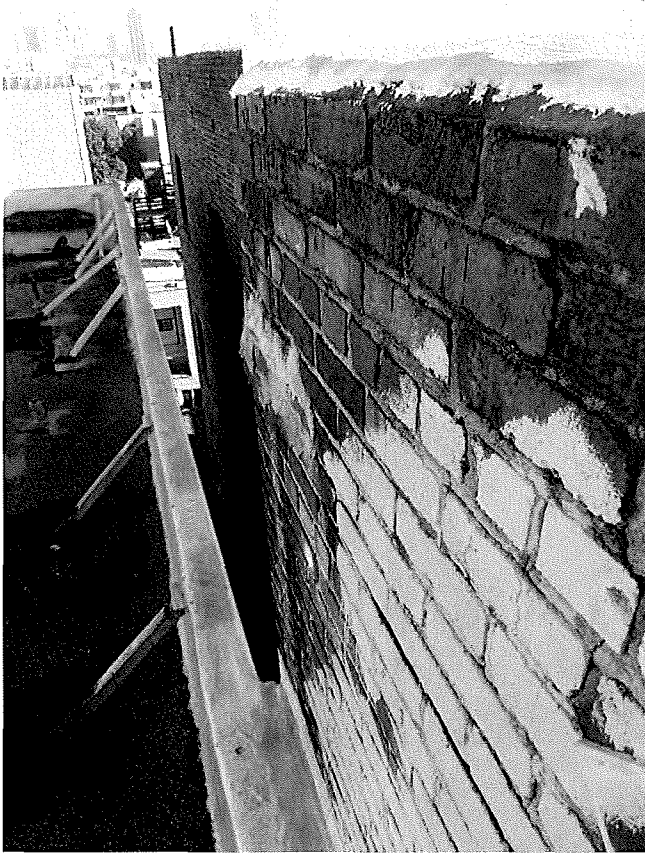
**Figure 3. North wall; note paint and general condition of bricks for cleaning.**

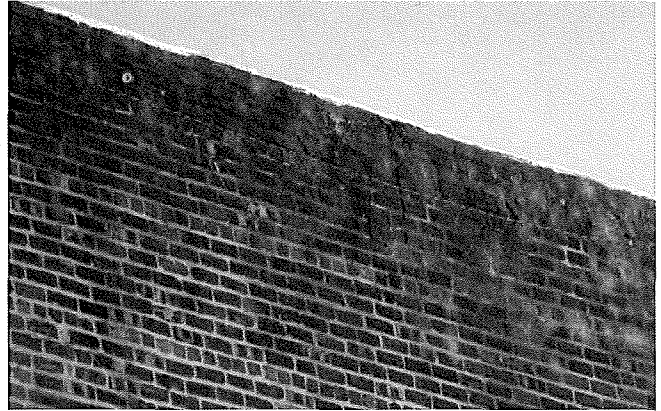
**Figure 5. East elevation at roof parapet; note bio-growth and discoloration to be addressed prior to rehabilitation work.**

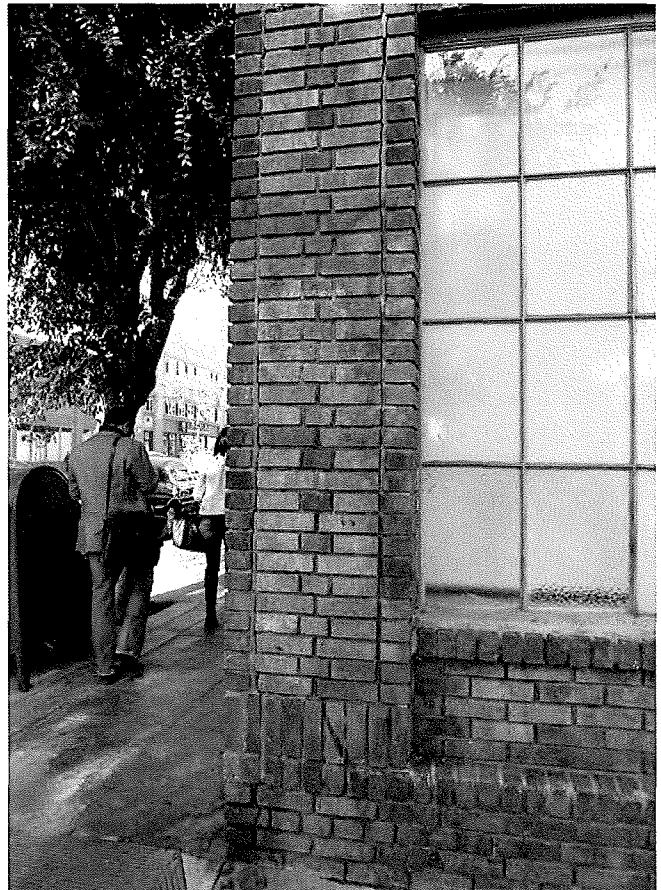
**Figure 5. Typical condition of brick at south & west walls, clean all surfaces prior to further rehabilitation work.**

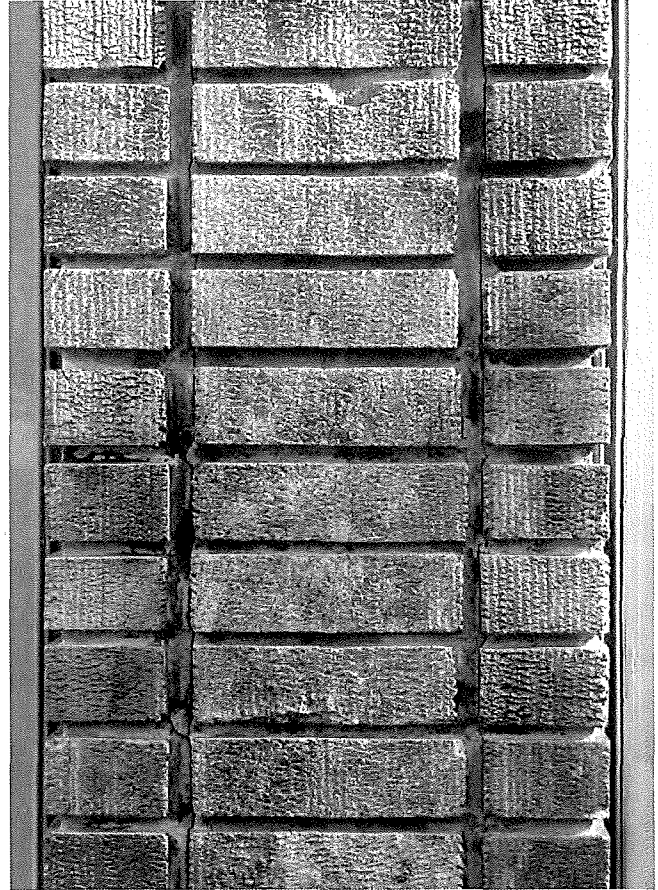
**Figure 1. Typical brick pier; note mortar coloring and condition; deep recessed joint to be maintained.**

Perform visual inspection of brick wall with binoculars, spotting scope, or similar every 5 years for brick and mortar deterioration. Repair and repoint as needed.

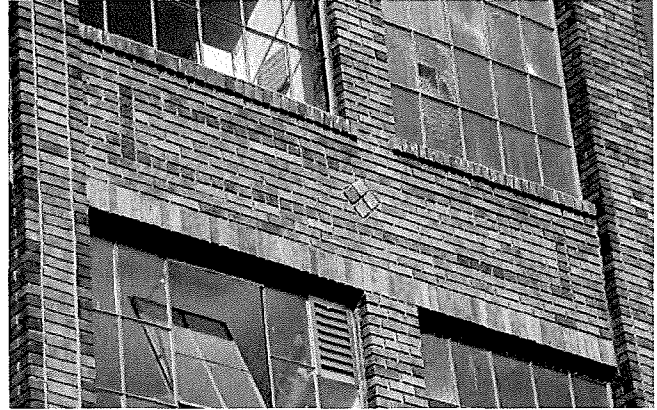
**Figure 3. South elevation; note recessed mortar joints to be maintained and replicated in re-pointing.**

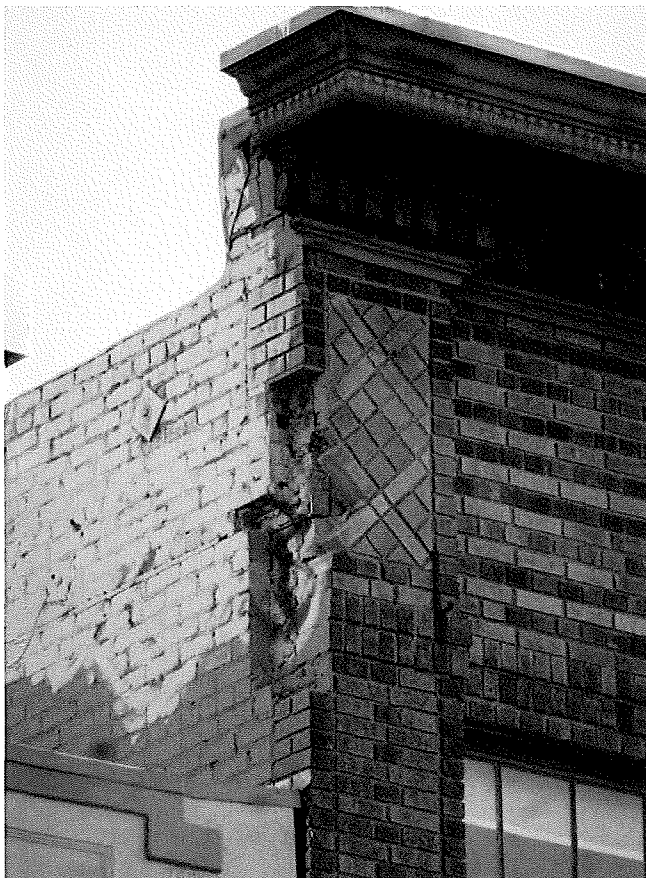
The northwest corner along 9<sup>th</sup> Street requires immediate attention to replace the damaged and missing sections of brick. A temporary cover should be used while assessment and repairs are planned. Work with a masonry restoration contractor/specialist to remove a few selective bricks at column piers or to make inspection openings to assess cause of joint separation/cracking at the brick piers. This will aid in identifying an approach to repair at the piers.

**Figure 2. Northwest corner, note missing facing and decorative bricks for replacement.**

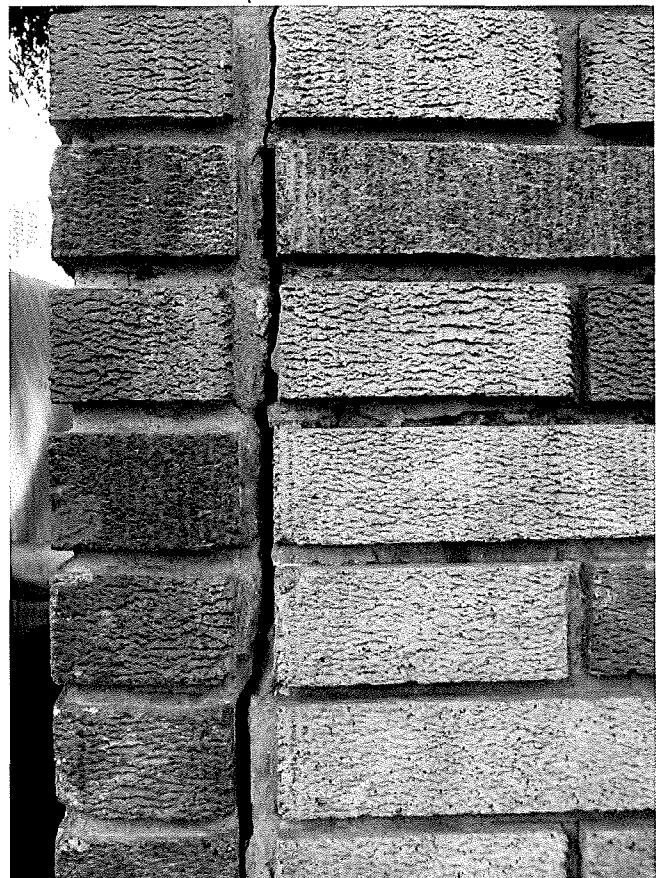
**Figure 4. Southwest pier; note cracking and mortar conditions for re-pointing.**

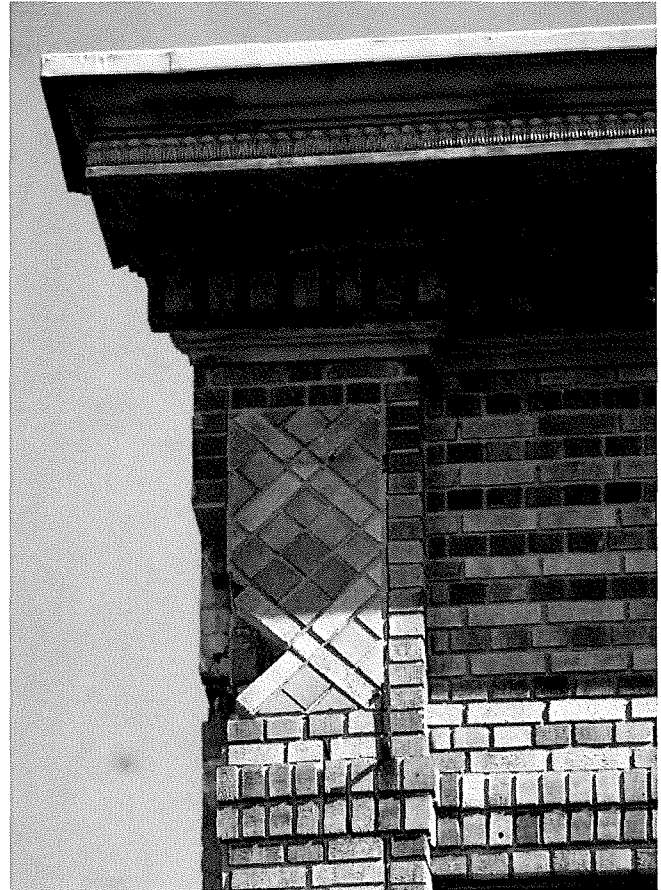
The northwest corner along 9th Street requires immediate attention to replace the damaged and missing sections of brick and decorative brick/tile. A temporary cover should be used while assessment and repairs are planned. Work with a masonry restoration contractor/specialist to remove a few selective bricks at column piers or to make inspection openings to assess cause of joint separation/cracking at the brick piers. This will aid in identifying an approach to repair at the piers.

**Figure 1. Northwest Corner; note missing facing and decorative brick.**

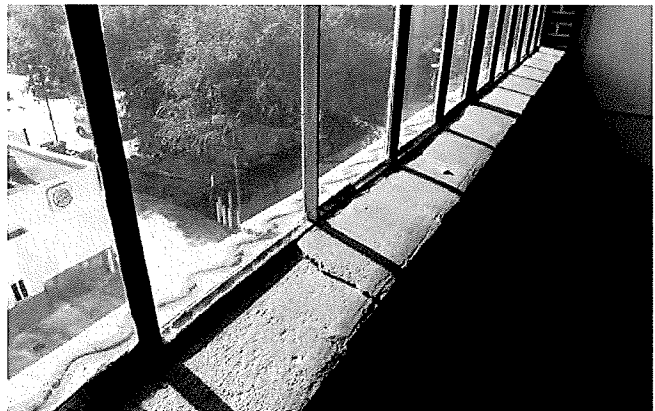
Figure 2: Concrete parge at south window sills, typical. Note level of localized cracking.

Prepare, prime, & seal parged concrete and install new sealant every 10 years, or as needed.

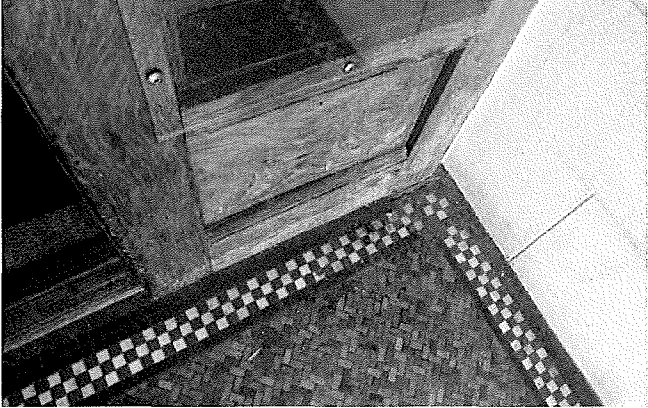
**Figure 3: Sidelight at entry door; note replacement of glazing for Plexiglas in response to security concerns.**

Due to noted security issues at northwest entrance door, consider replacement of security gates at entrances. Replacement gates should be comparable with existing gates along Natoma Street.

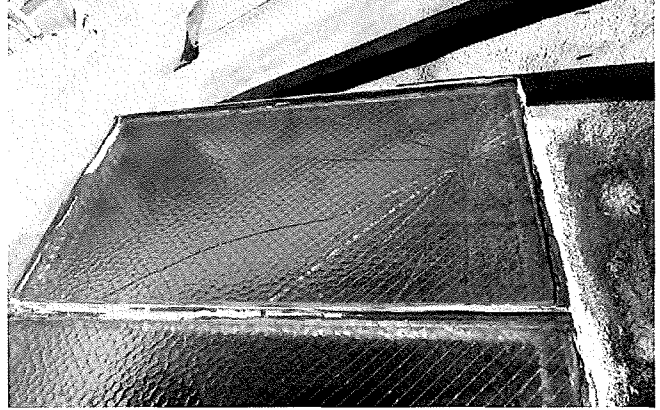
*Figure 5. Skylight; note cracked glazing.*

Inspect steel framed skylight for deterioration annually. Repair as needed. Install sealant and/or glazing putty as needed.

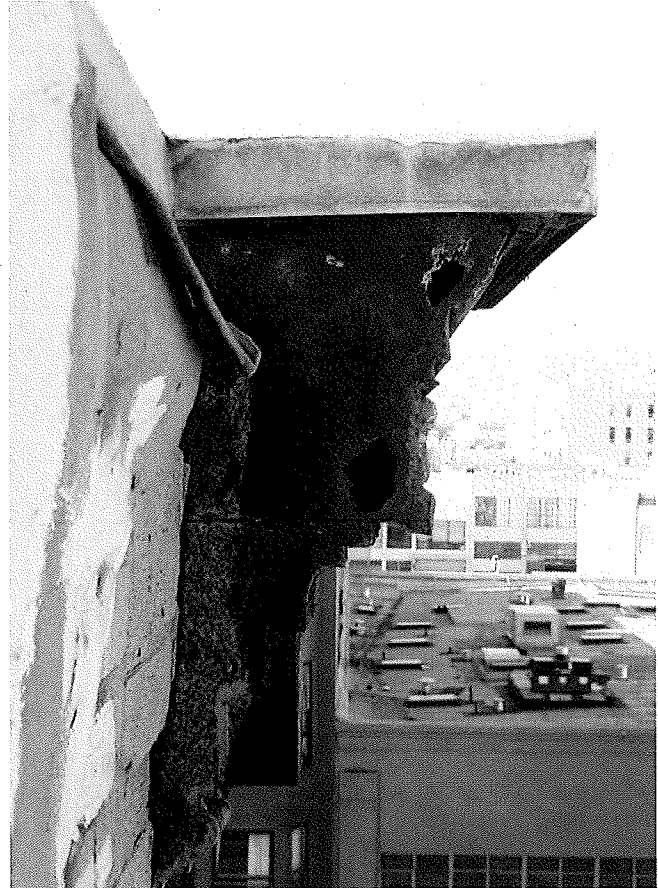
**Figure 1. Cornice at northwest corner; note level of corrosion, this is worst condition observed and atypical of overall cornice.**

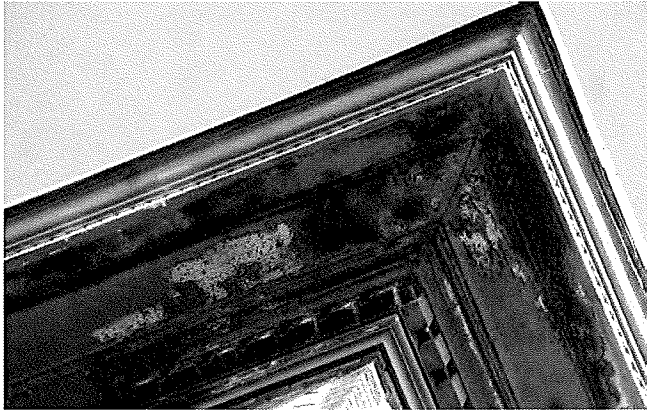
**Figure 2. Cornice at southwest corner; note discoloration and localized corrosion, conditions are considered typical.**

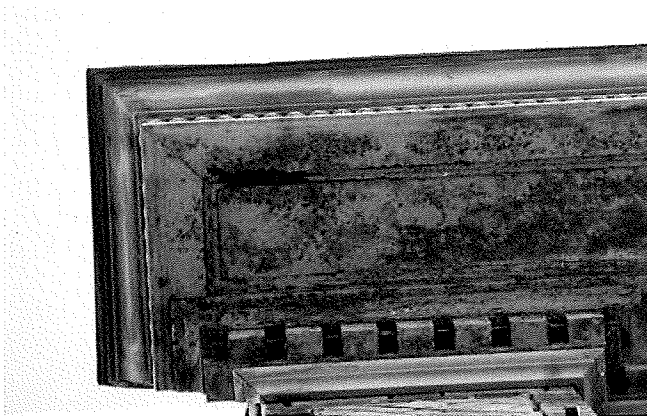
**Figure 3. Cornice at northwest corner; localized areas of severe damage observed & requiring immediate repair.**

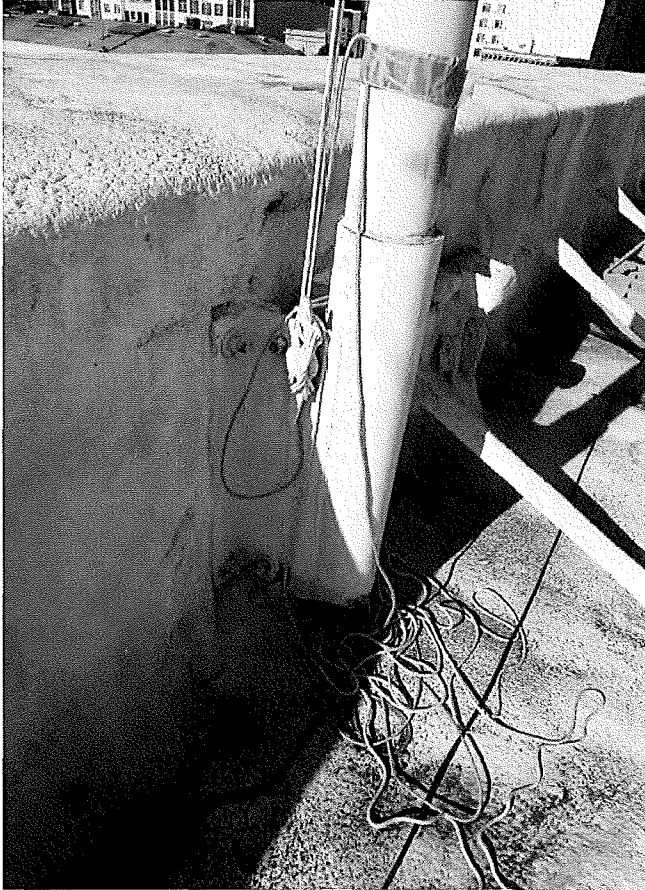
**Figure 2. Flagpole anchor; note fastener conditions and localized signs of corrosion.**

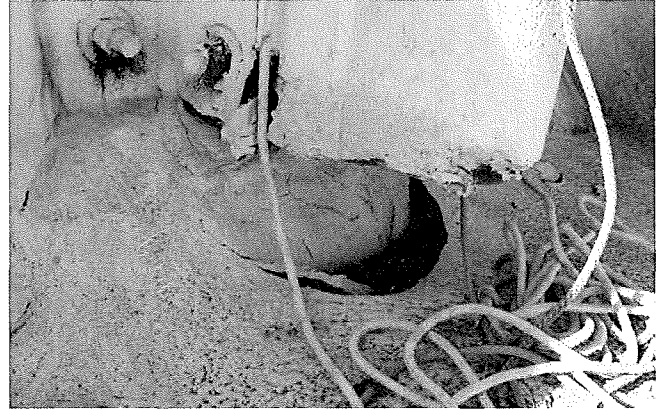
**Figure 3. Detail of flagpole anchor; note corrosion and damage to roofing.**

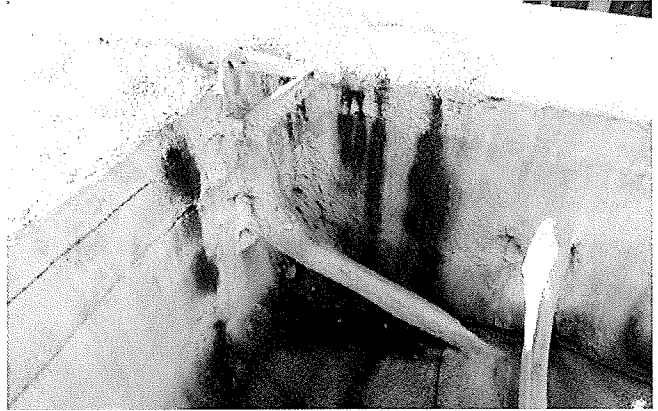
**Figure 5. Bio-growth and water stains at roof. Investigate to if determine localized water damage exists.**

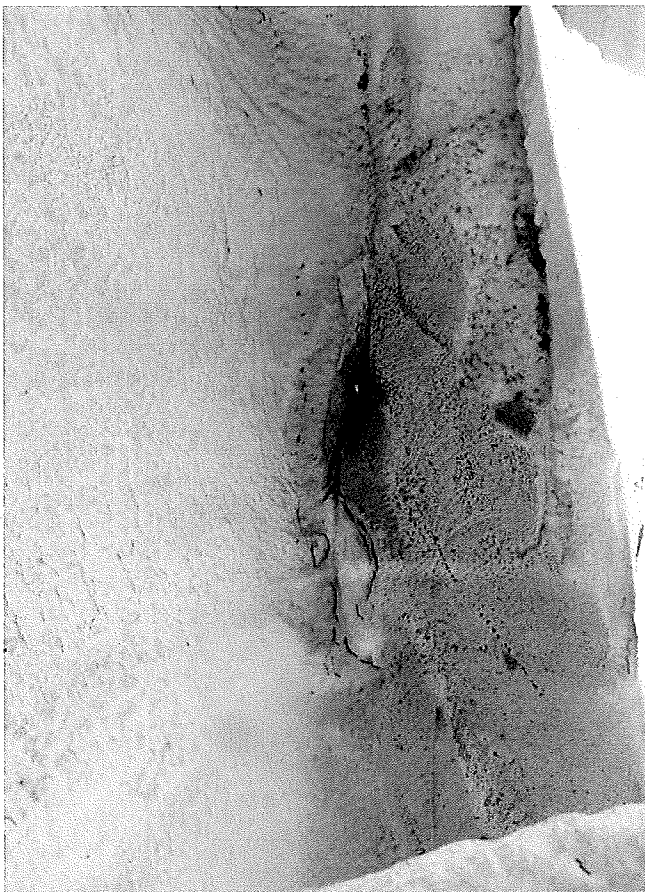
**Figure 4. Detail of roofing membrane and localized damage; assess conditions throughout.**

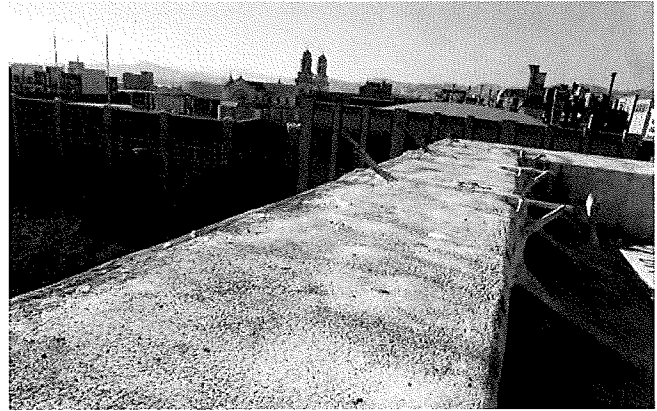
Figure 1. Parapet at southwest corner; note roofing membrane conditions at parapet cap.

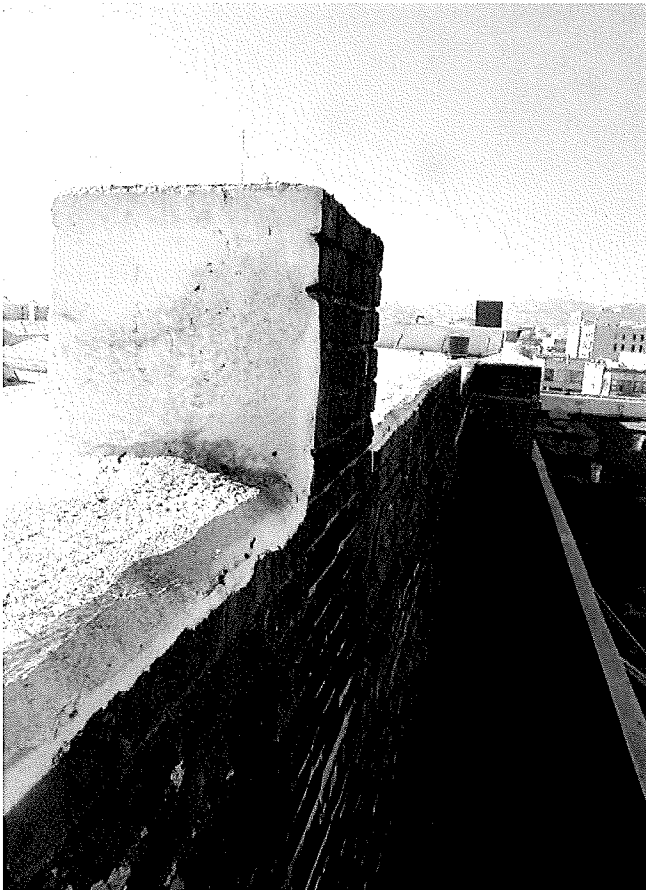
**Figure 3. Unbraced ventilation stack at north wall.**
