Re: Transmittal of Planning Department Case Number 2013.0910L:
149-155 9th Street, Article 11 Change of Designation
BOS File No: _____ (pending)
Historic Preservation Commission Recommendation: Approval

RESOLUTION TO RECOMMEND TO THE BOARD OF SUPERVISORS AN ARTICLE 11 CHANGE OF DESIGNATION FOR 149-155 9TH STREET, LOT 048 IN ASSESSOR'S BLOCK 3728, AS A CATEGORY III (CONTRIBUTORY) BUILDING PURSUANT TO SECTION 1106 OF THE PLANNING CODE

ARTICLE II HISTORIC BUILDING REPORT

MAINTENANCE PLAN

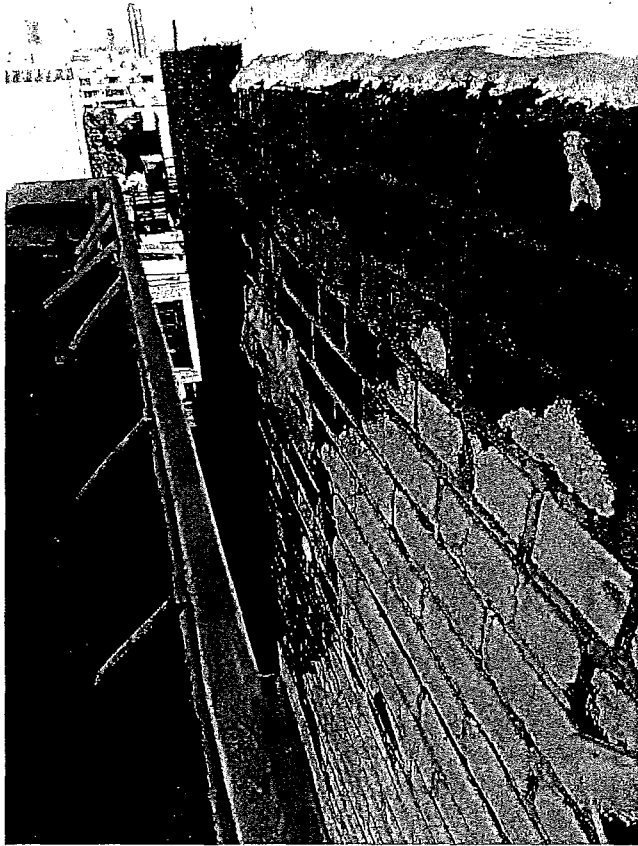
General building features appear in good to fair condition. Any specific concerns or points of note are detailed within each individual section. There is some noticeable soiling of the building base and trash/debris at sidewalks along both the south and west (Natoma Street and 9th Street respectively). The north and east elevations have some locations of noted paint/graffiti.

Figure 3. North wall; note paint and general condition of bricks for cleaning.

Power wash exterior of building prior to maintenance work. Utilize low-pressure spray only (100-800 psi), keeping fan tip nozzle minimum of 6 inches away from surface being cleaned. Higher pressure washing can damage masonry.

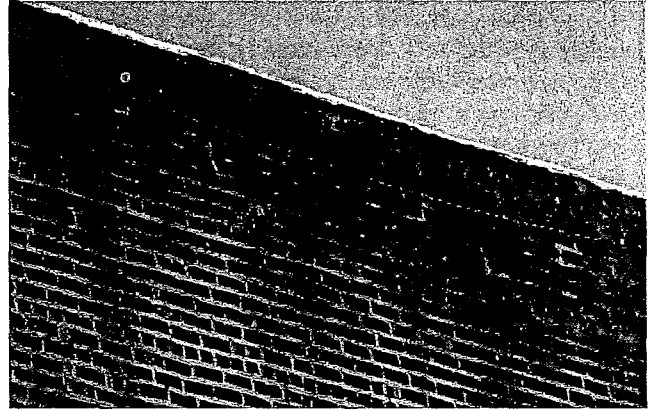
Figure 5. East elevation at roof parapet; note bio-growth and discoloration to be addressed prior to rehabilitation work.

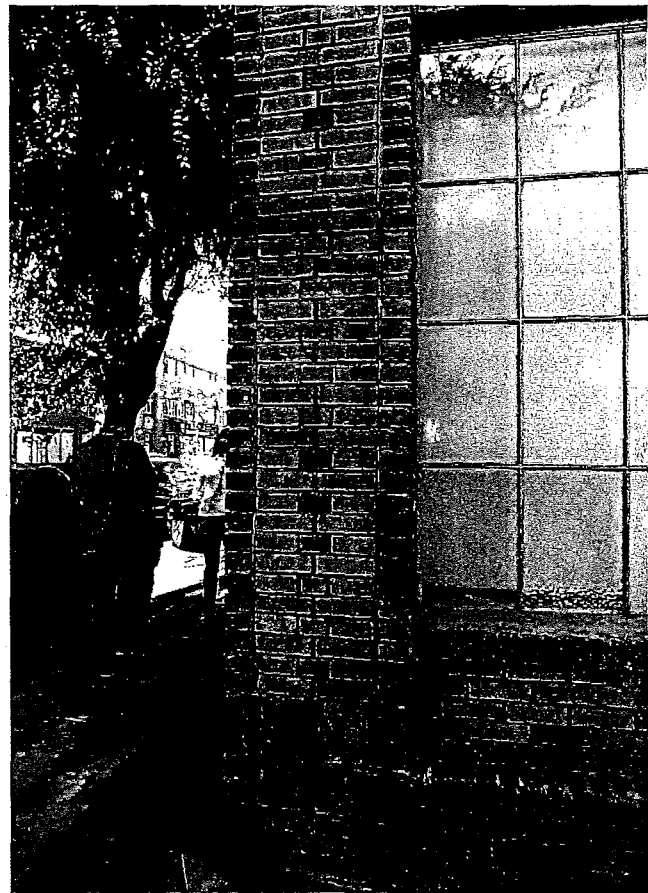
Figure 5. Typical condition of brick at south & west walls, clean all surfaces prior to further rehabilitation work.

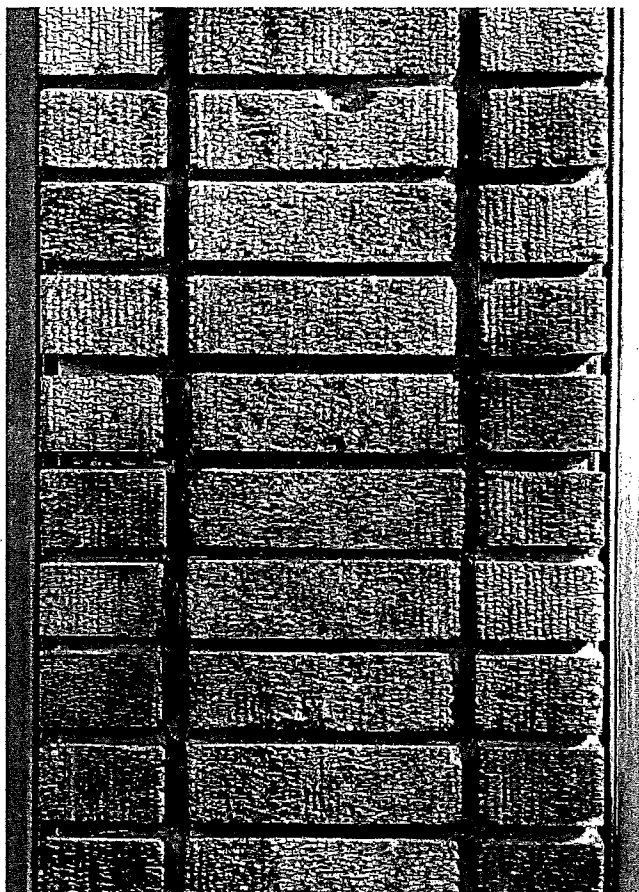
Figure 1. Typical brick pier; note mortar coloring and condition; deep recessed joint to be maintained.

Perform visual inspection of brick wall with binoculars, spotting scope, or similar every 5 years for brick and mortar deterioration. Repair and repoint as needed.

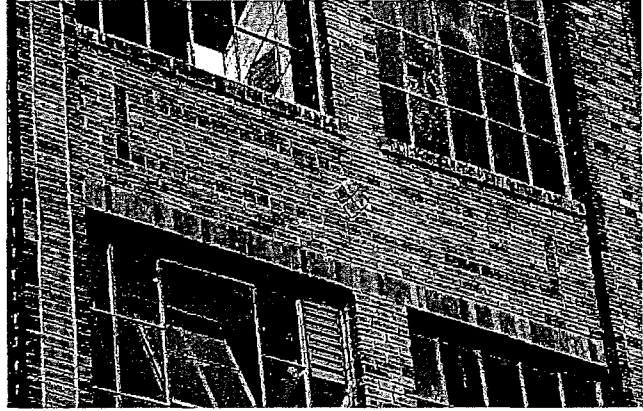
Figure 3. South elevation; note recessed mortar joints to be maintained and replicated in re-pointing.

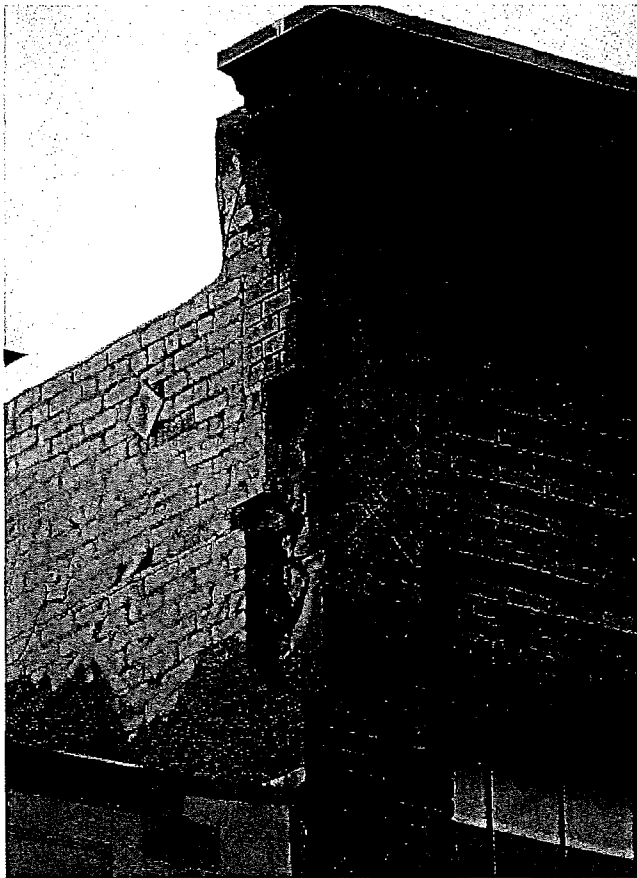
Figure 2. Northwest corner, note missing facing and decorative bricks for replacement.

The northwest corner along 9th Street requires immediate attention to replace the damaged and missing sections of brick. A temporary cover should be used while assessment and repairs are planned. Work with a masonry restoration contractor/specialist to remove a few selective bricks at column piers or to make inspection openings to assess cause of joint separation/cracking at the brick piers. This will aid in identifying an approach to repair at the piers.

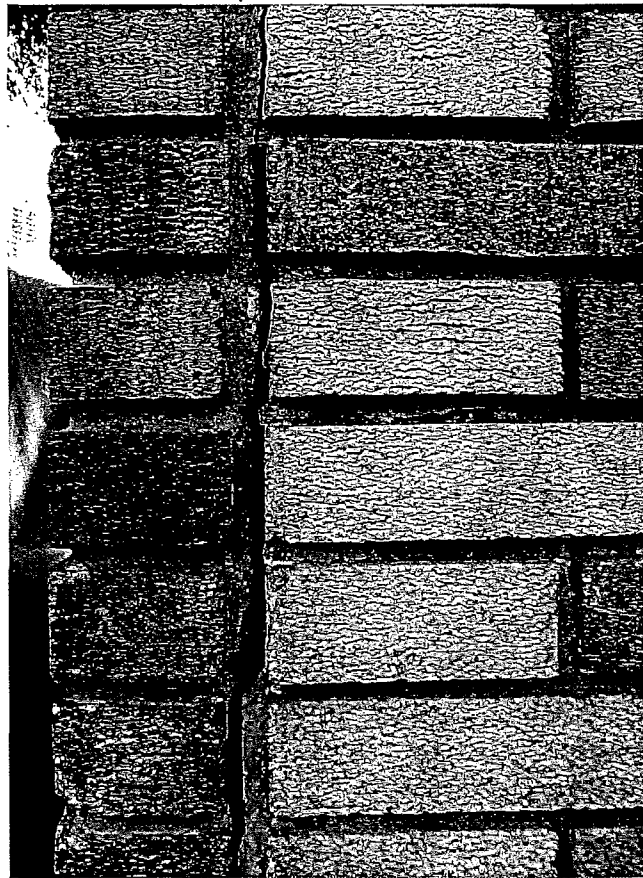
Figure 4. Southwest pier; note cracking and mortar conditions for re-pointing.

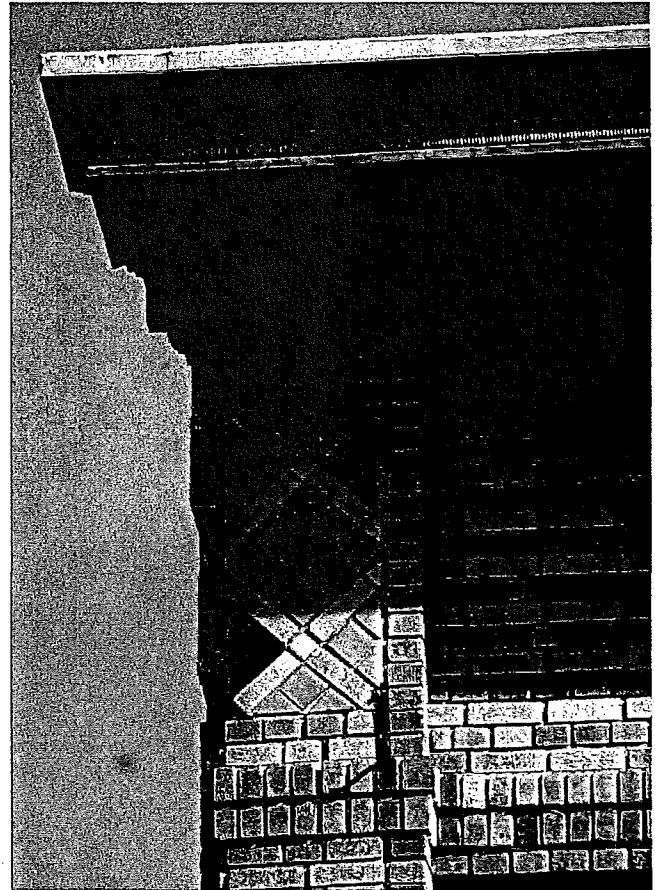
Figure 1. Northwest Corner; note missing facing and decorative brick.

The northwest corner along 9th Street requires immediate attention to replace the damaged and missing sections of brick and decorative brick/tile. A temporary cover should be used while assessment and repairs are planned. Work with a masonry restoration contractor/specialist to remove a few selective bricks at column piers or to make inspection openings to assess cause of joint separation/cracking at the brick piers. This will aid in identifying an approach to repair at the piers.

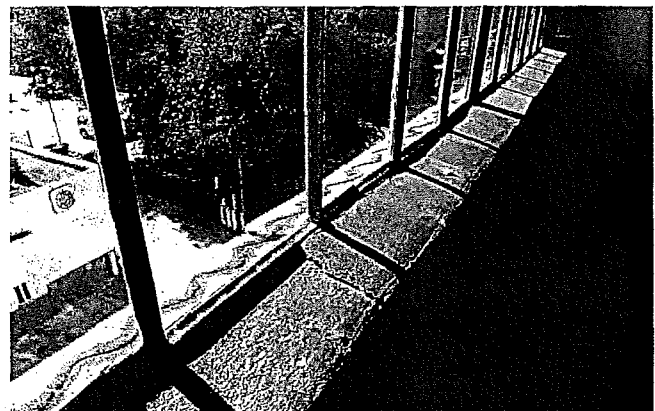
Figure 2: Concrete parge at south window sills, typical. Note level of localized cracking.

Prepare, prime, & seal parged concrete and install new sealant every 10 years, or as needed.

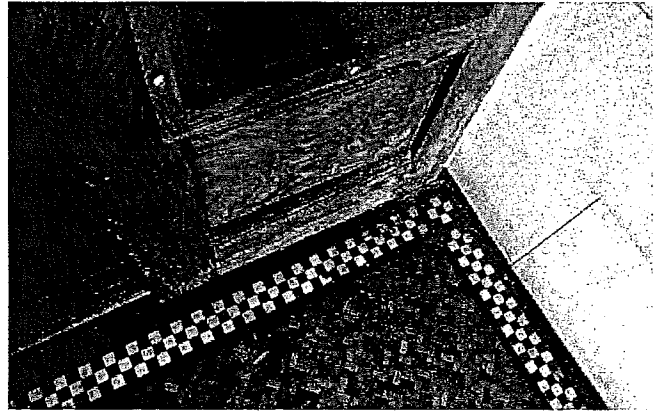
Figure 3: Sidelight at entry door; note replacement of glazing for Plexiglas in response to security concerns.

Due to noted security issues at northwest entrance door, consider replacement of security gates at entrances. Replacement gates should be comparable with existing gates along Natoma Street.

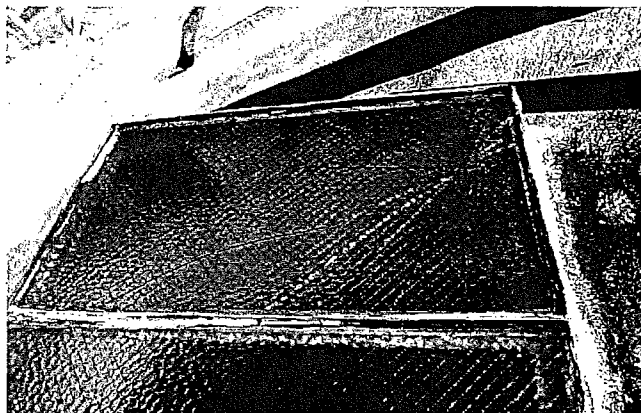
Figure 5. Skylight; note cracked glazing.

Inspect steel framed skylight for deterioration annually. Repair as needed. Install sealant and/or glazing putty as needed.

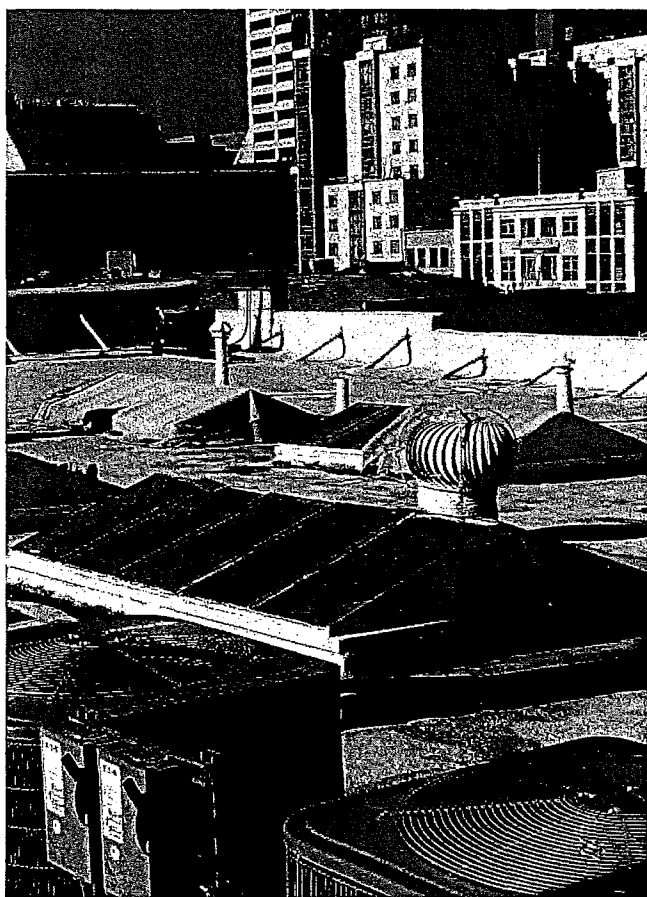
Figure 4. Skylight; note covered ventilation grilles.

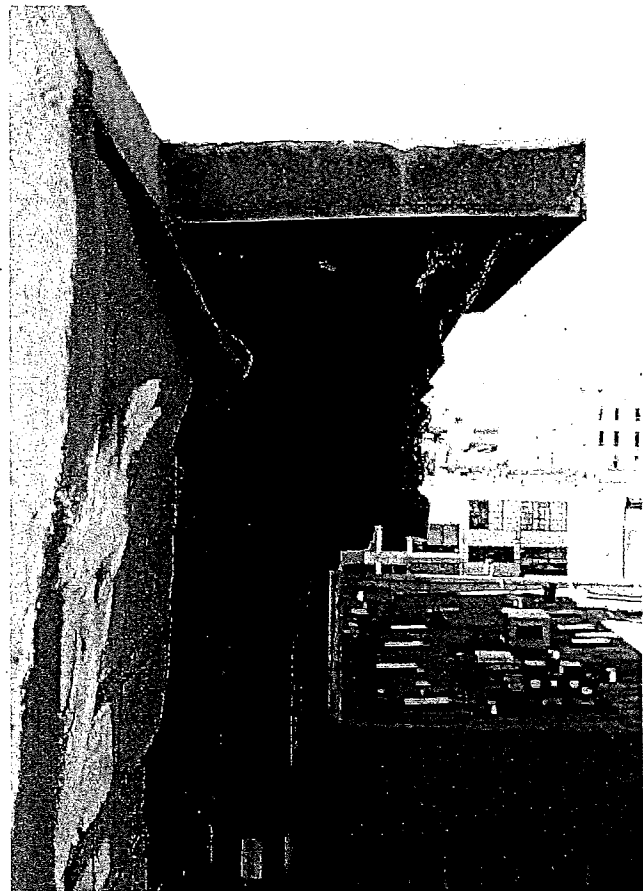
Figure 1. Cornice at northwest corner; note level of corrosion, this is worst condition observed and atypical of overall cornice.

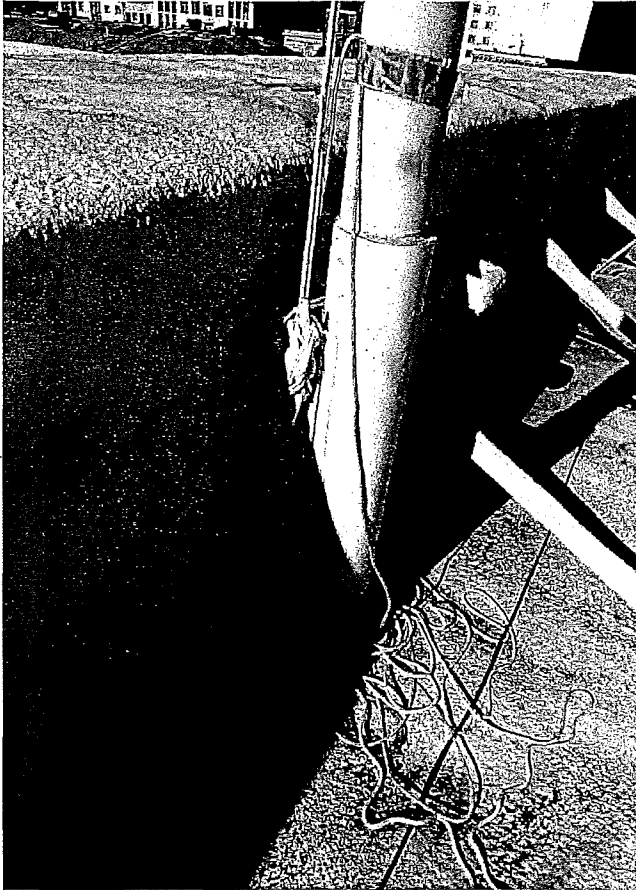
Figure 2. Flagpole anchor; note fastener conditions and localized signs of corrosion.

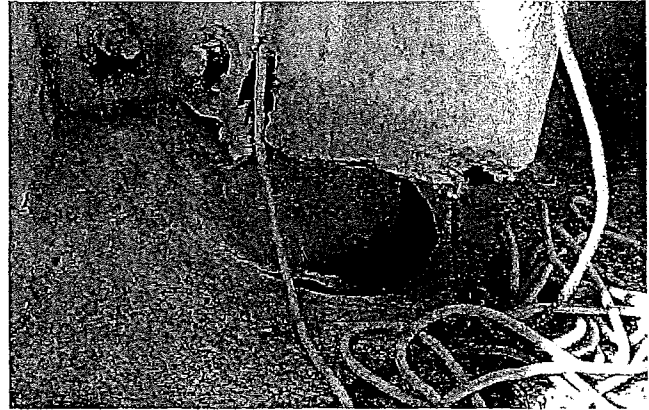
Figure 3. Detail of flagpole anchor; note corrosion and damage to roofing.

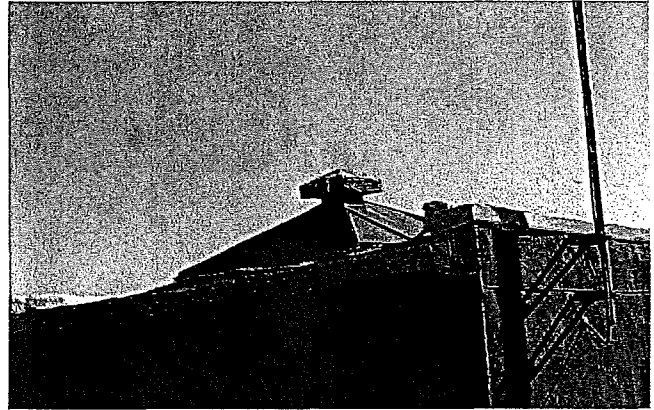
One steel framed skylight is located above the sheet metal penthouse at the southeastern corner of the roof. The skylight is pyramidal with a sheet metal vent at the apex. The skylight was not accessible but appears to be in fair condition, and there are no known water intrusion issues at the skylight. The sheet metal vent also appears to be in fair condition with failing paint.

Figure 1. Roof & ventilator at penthouse.

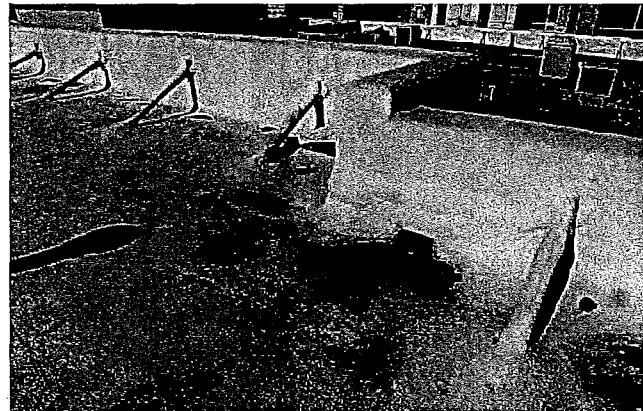
Figure 2. Roof at drainage opening in parapet; note parapet bracing and conditions near opening.

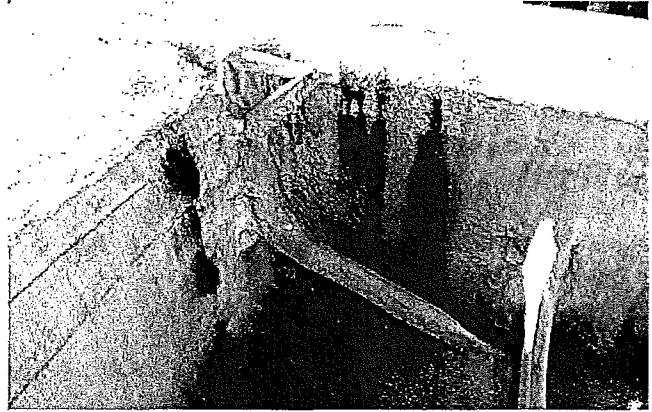
Figure 5. Bio-growth and water stains at roof. Investigate to if determine localized water damage exists.

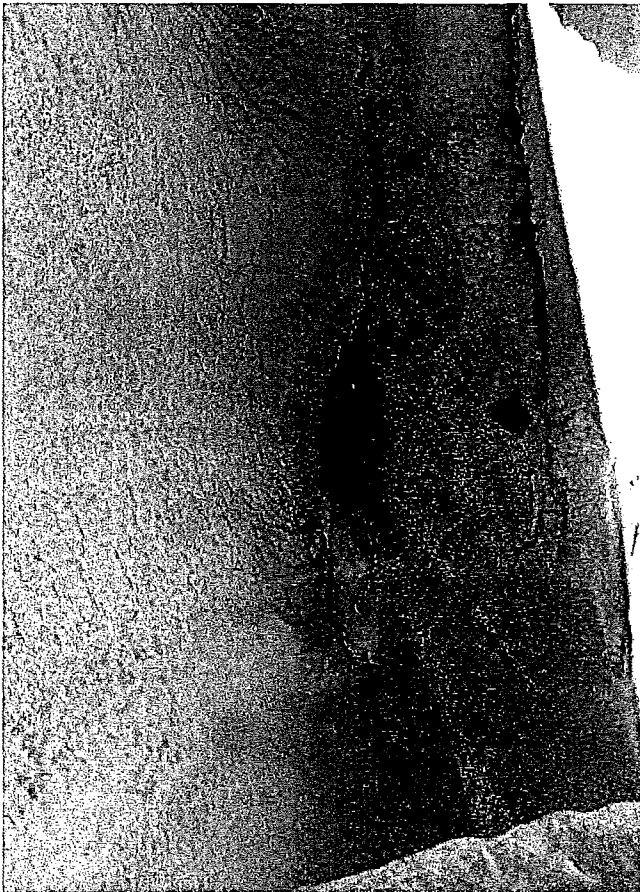
Figure 4. Detail of roofing membrane and localized damage; assess conditions throughout.

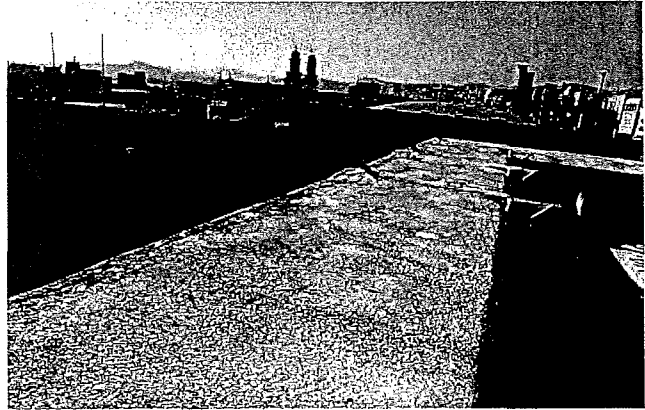
Figure 1. Parapet at southwest corner; note roofing membrane conditions at parapet cap.

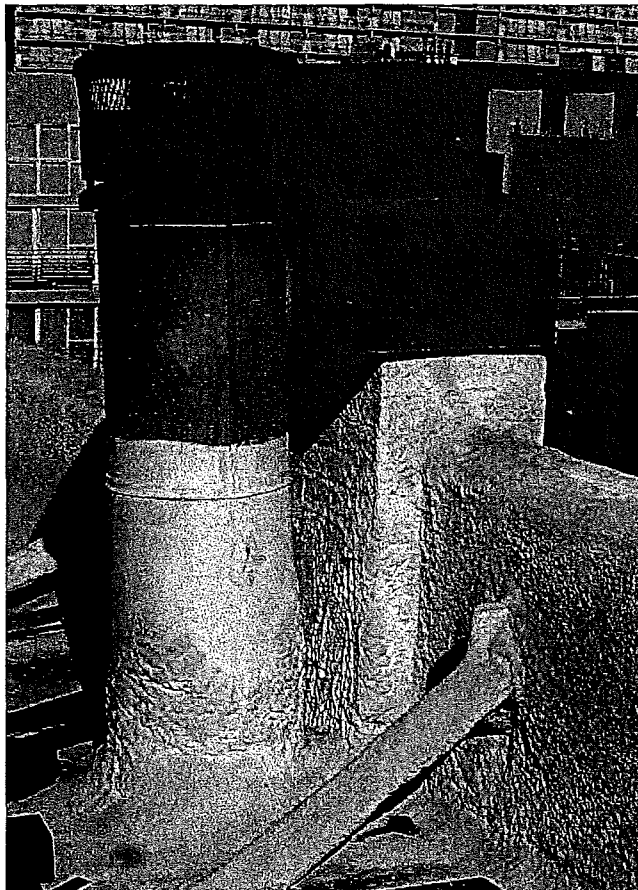
Figure 1. Unbraced ventilation stack with sheet metal cap, typical.
