149-155 9TH STREET  
SAN FRANCISCO, CA

ARTICLE 11 CHANGE OF DESIGNATION DOCUMENTS

- ARTICLE 11 HISTORIC BUILDING REPORT
- MAINTENANCE PLAN

JULY 25, 2014

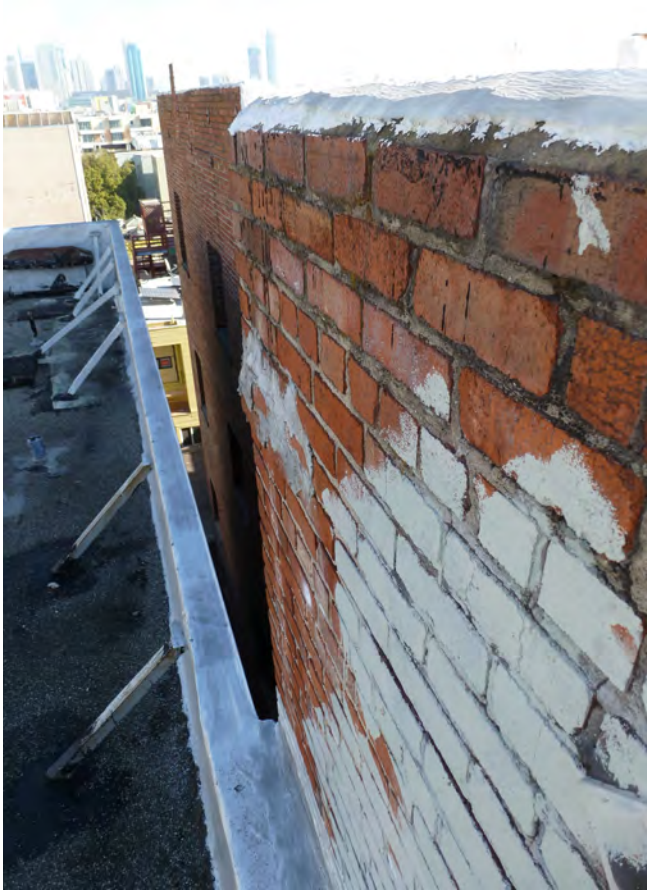
**Figure 3.** North wall; note paint and general condition of bricks for cleaning.

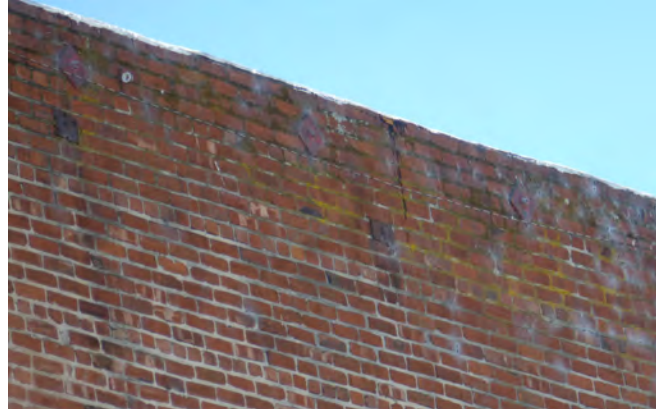
**Figure 5.** East elevation at roof parapet; note bio-growth and discoloration to be addressed prior to rehabilitation work.

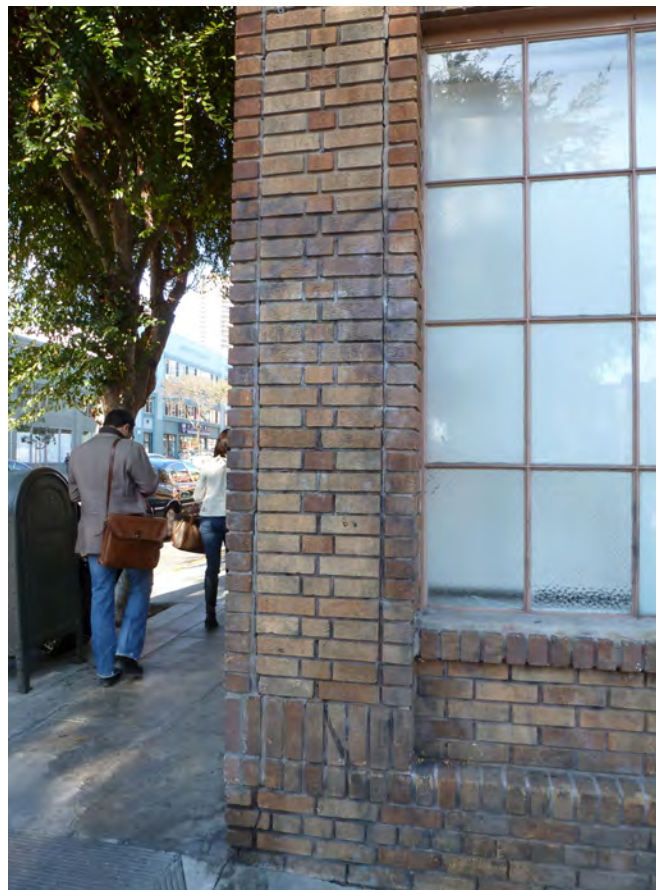
**Figure 5.** Typical condition of brick at south & west walls, clean all surfaces prior to further rehabilitation work.

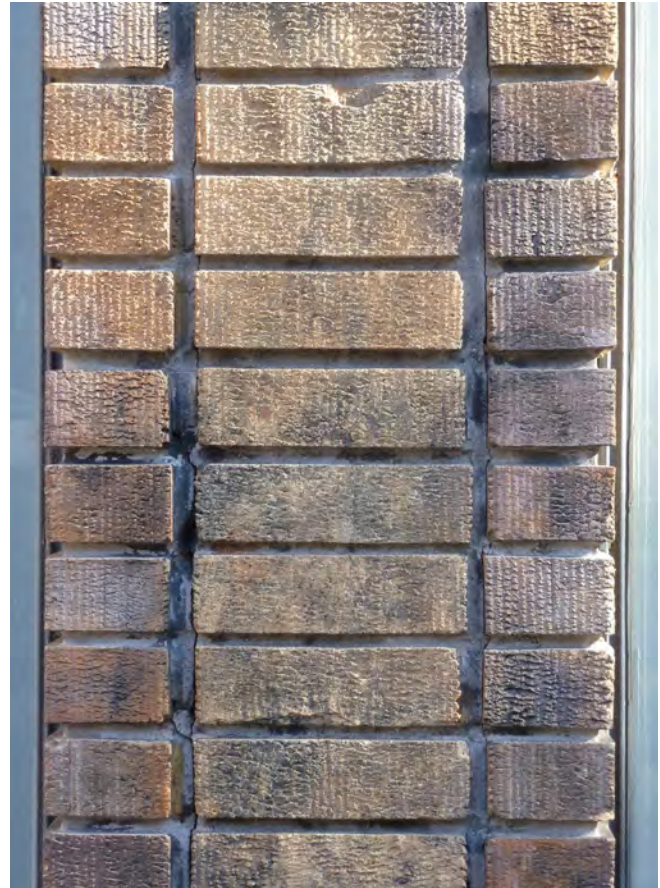
**Figure 1. Typical brick pier; note mortar coloring and condition; deep recessed joint to be maintained.**

Perform visual inspection of brick wall with binoculars, spotting scope, or similar every 5 years for brick and mortar deterioration. Repair and repoint as needed.

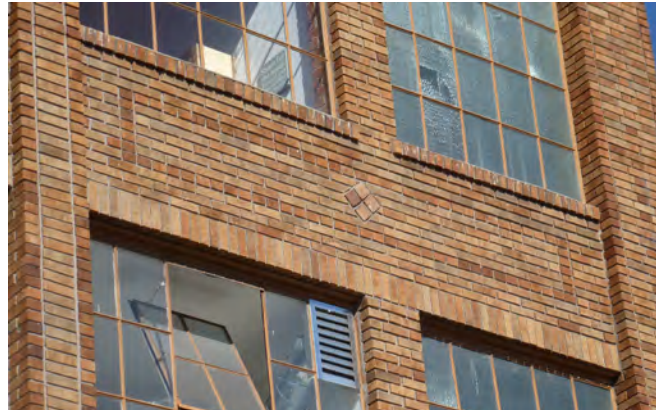
**Figure 3. South elevation; note recessed mortar joints to be maintained and replicated in re-pointing.**

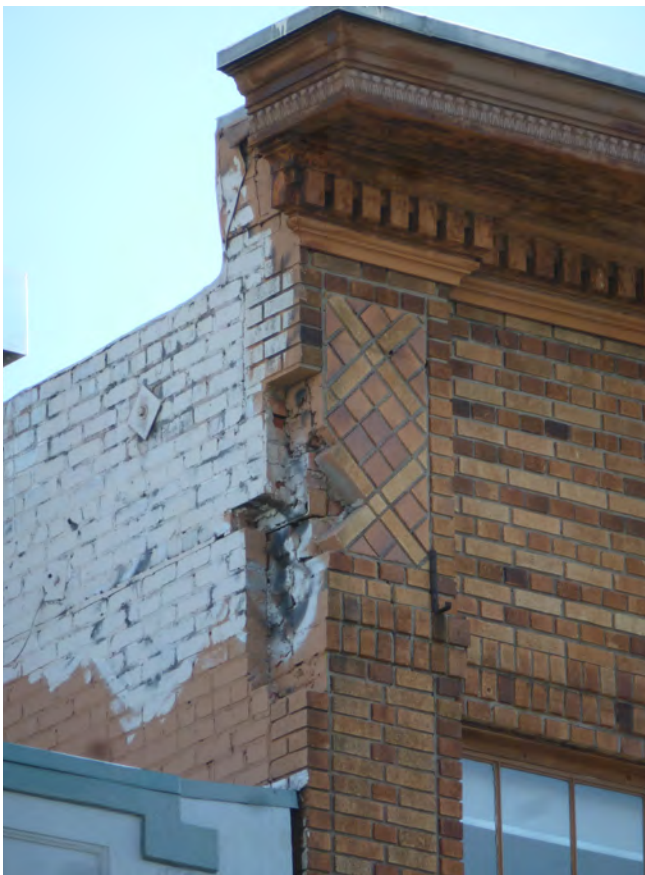
**Figure 2. Northwest corner, note missing facing and decorative bricks for replacement.**

The northwest corner along 9<sup>th</sup> Street requires immediate attention to replace the damaged and missing sections of brick. A temporary cover should be used while assessment and repairs are planned. Work with a masonry restoration contractor/specialist to remove a few selective bricks at column piers or to make inspection openings to assess cause of joint separation/cracking at the brick piers. This will aid in identifying an approach to repair at the piers.

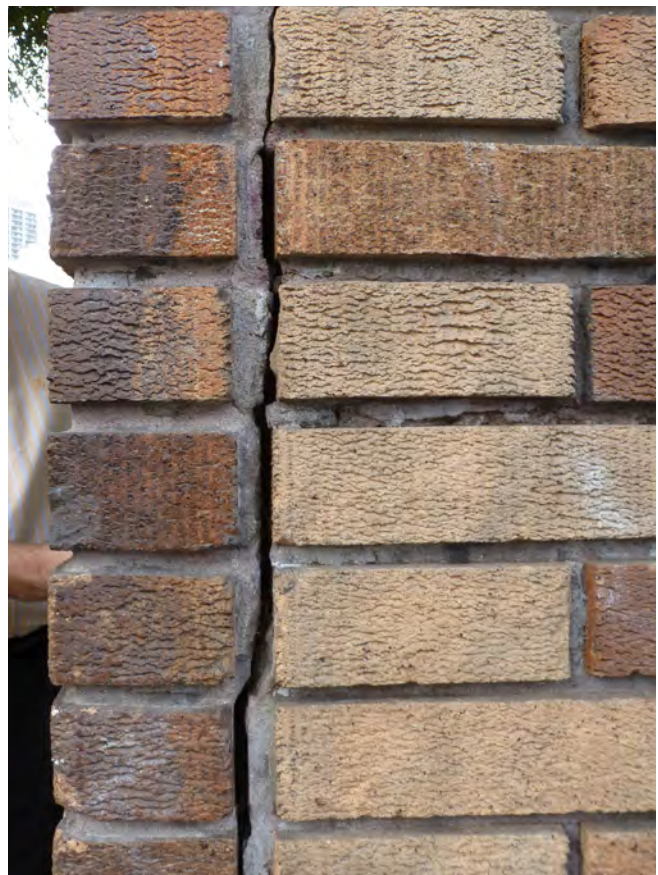
**Figure 4. Southwest pier; note cracking and mortar conditions for re-pointing.**

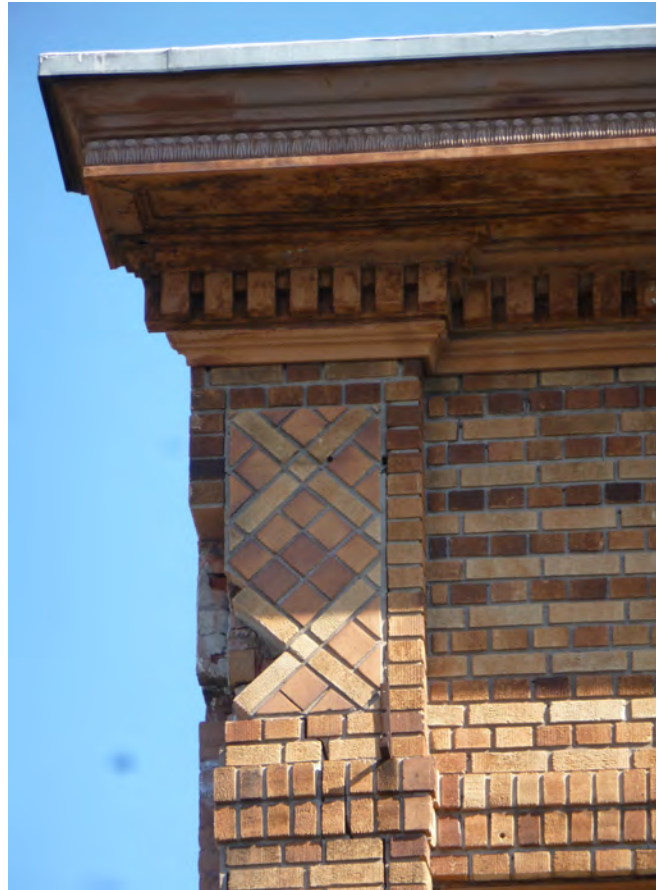
**Figure 1. Northwest Corner; note missing facing and decorative brick.**

The northwest corner along 9th Street requires immediate attention to replace the damaged and missing sections of brick and decorative brick/tile. A temporary cover should be used while assessment and repairs are planned. Work with a masonry restoration contractor/specialist to remove a few selective bricks at column piers or to make inspection openings to assess cause of joint separation/cracking at the brick piers. This will aid in identifying an approach to repair at the piers.

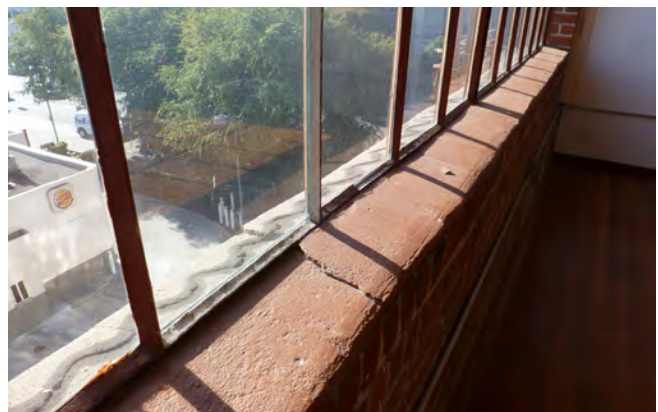
**Figure 2: Concrete parge at south window sills, typical. Note level of localized cracking.**

Prepare, prime, & seal parged concrete and install new sealant every 10 years, or as needed.

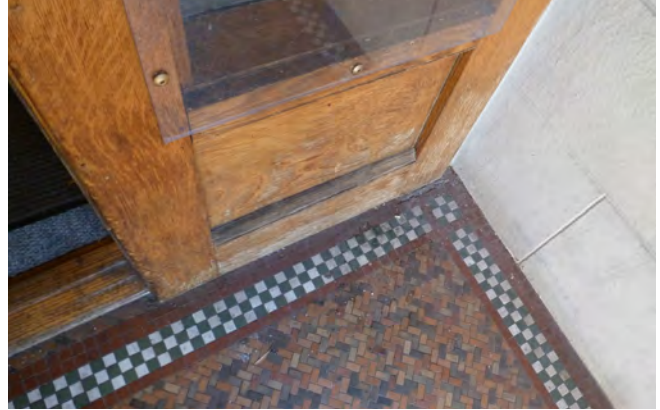
**Figure 3: Sidelight at entry door; note replacement of glazing for Plexiglas in response to security concerns.**

Due to noted security issues at northwest entrance door, consider replacement of security gates at entrances. Replacement gates should be comparable with existing gates along Natoma Street.

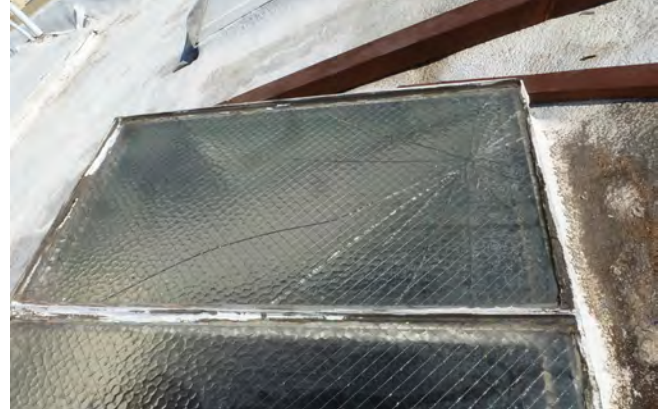
**Figure 5. Skylight; note cracked glazing.**

Inspect steel framed skylight for deterioration annually. Repair as needed. Install sealant and/or glazing putty as needed.

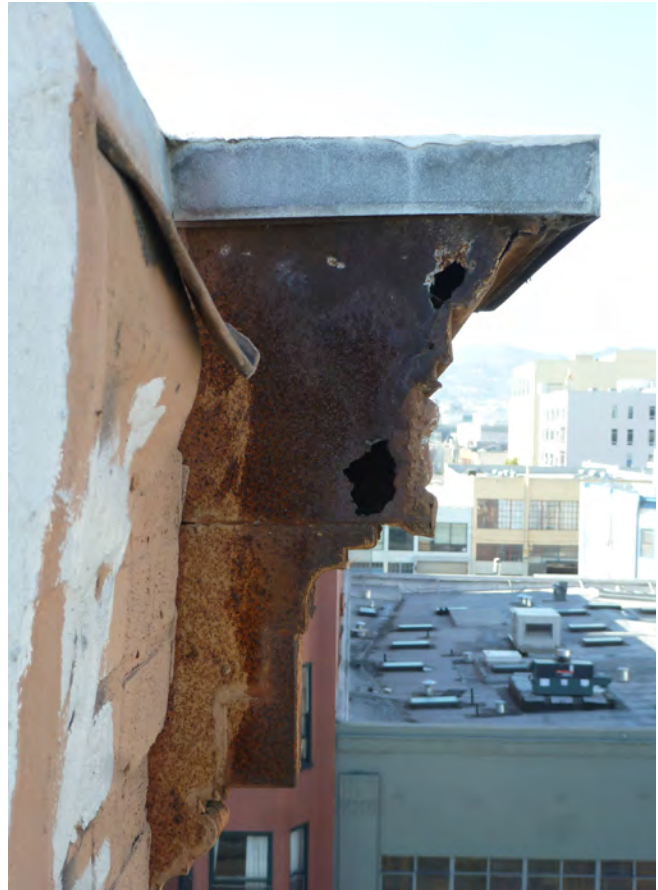
**Figure 1. Cornice at northwest corner; note level of corrosion, this is worst condition observed and atypical of overall cornice.**

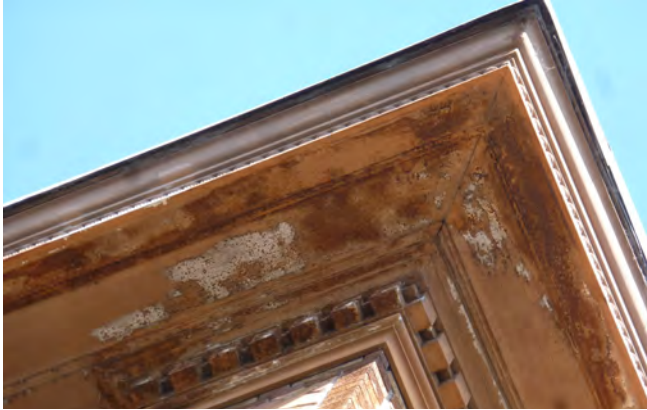
**Figure 2. Cornice at southwest corner; note discoloration and localized corrosion, conditions are considered typical.**

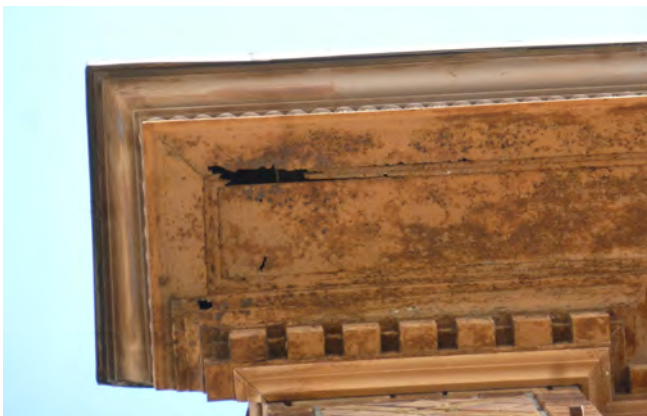
**Figure 3. Cornice at northwest corner; localized areas of severe damage observed & requiring immediate repair.**

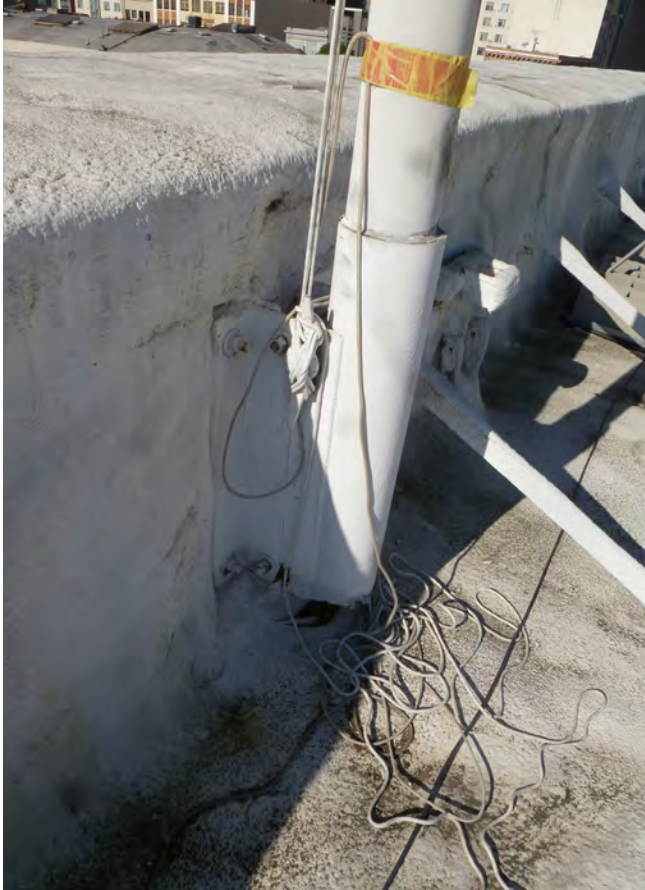
**Figure 2. Flagpole anchor; note fastener conditions and localized signs of corrosion.**

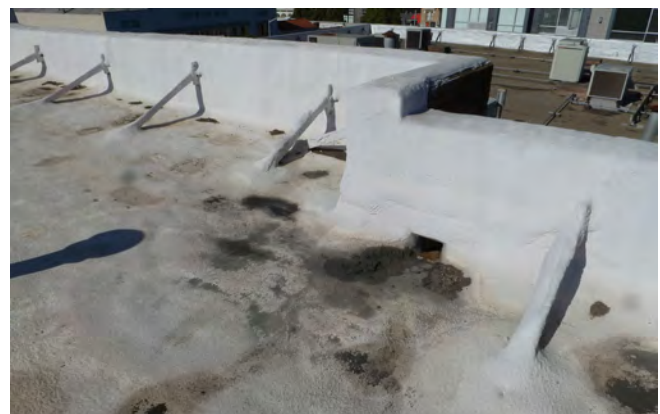
**Figure 2. Roof at drainage opening in parapet; note parapet bracing and conditions near opening.**

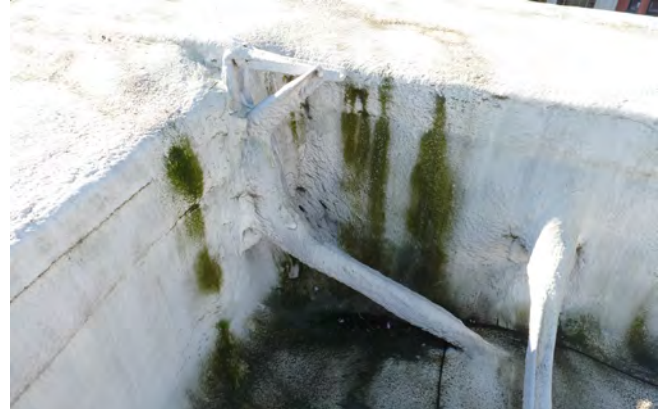
**Figure 5. Bio-growth and water stains at roof. Investigate to if determine localized water damage exists.**

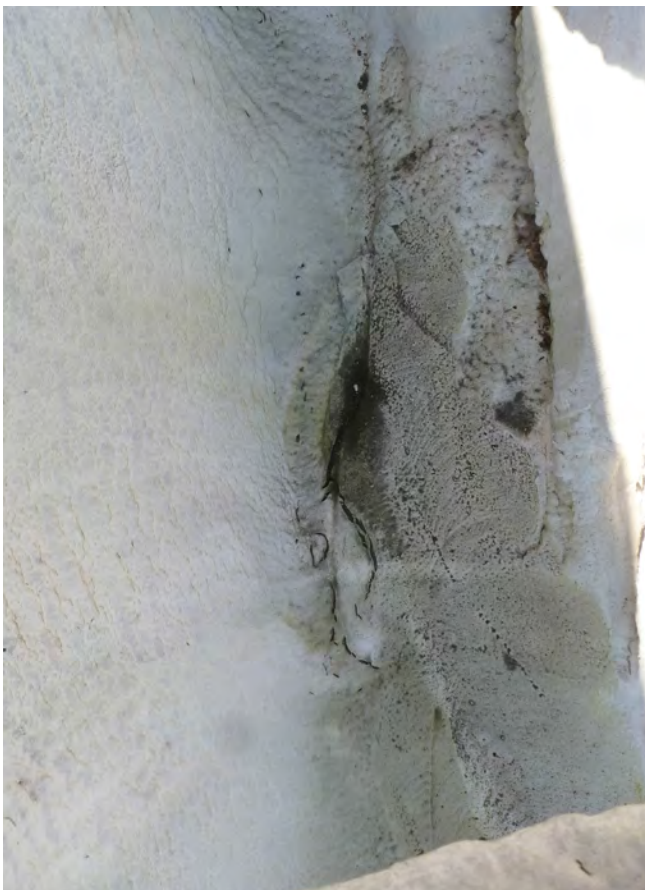
**Figure 4. Detail of roofing membrane and localized damage; assess conditions throughout.**

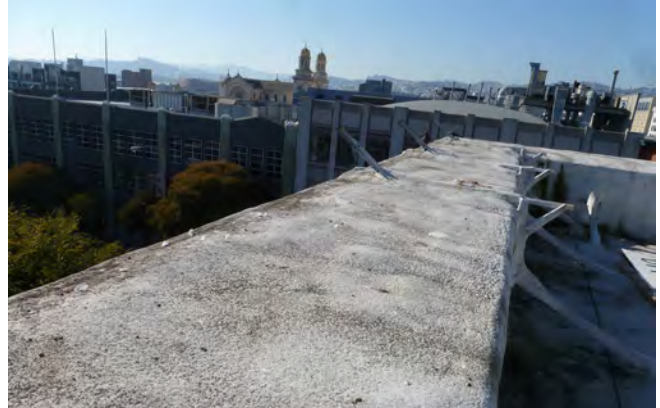
**Figure 1. Parapet at southwest corner; note roofing membrane conditions at parapet cap.**

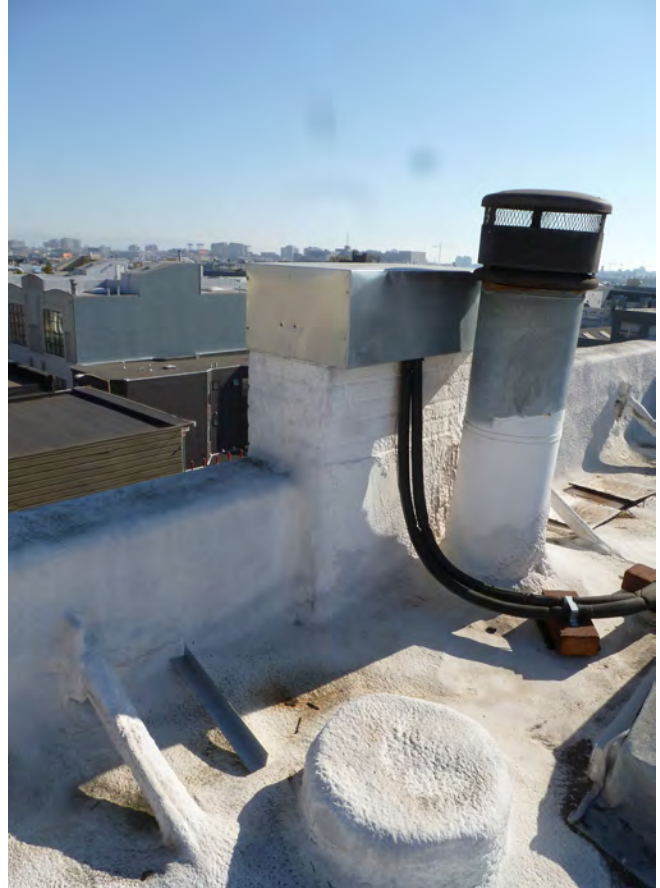
**Figure 4.** Capped ventilation stack and mechanical exhaust flue; note re-use of ventilation stack for services.
