SAN FRANCISCO PLANNING DEPARTMENT

PRE-APPROVAL INSPECTION REPORT

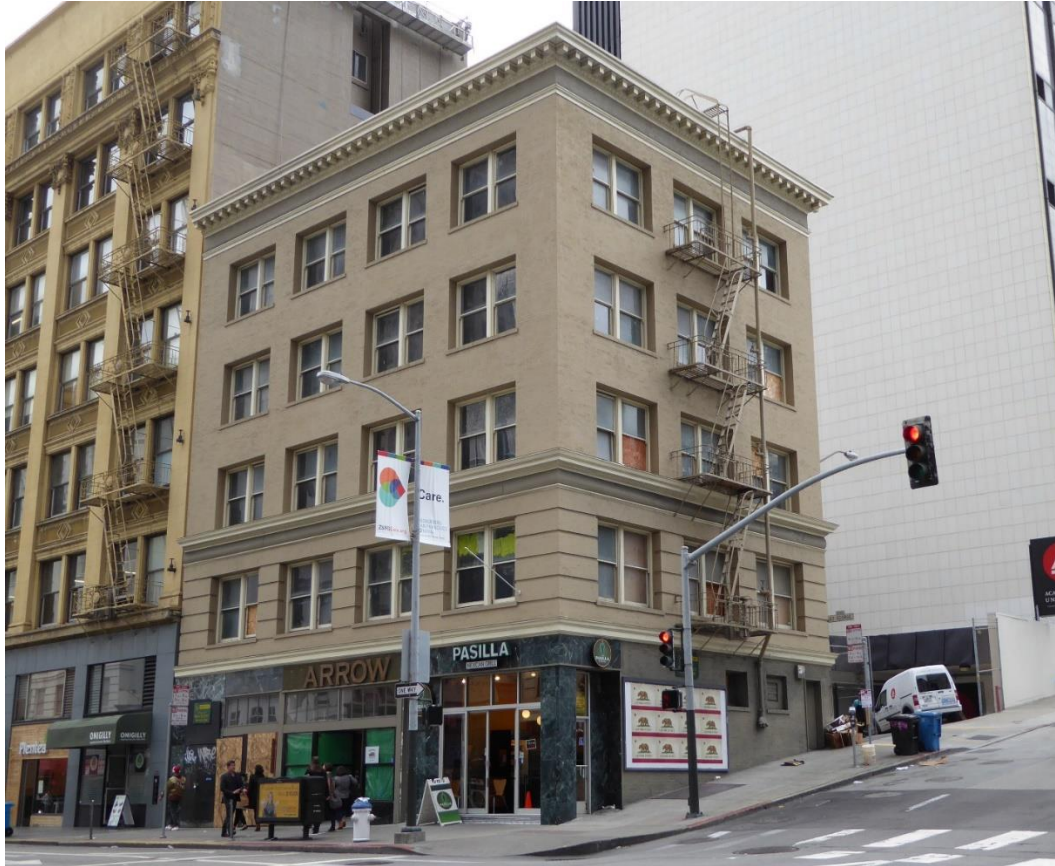
Figure 9: 353 Kearny Street viewed from intersection of Kearny and Pine Streets. Primary (east) facade and north facade (with fire escape) pictured. Looking southwest.

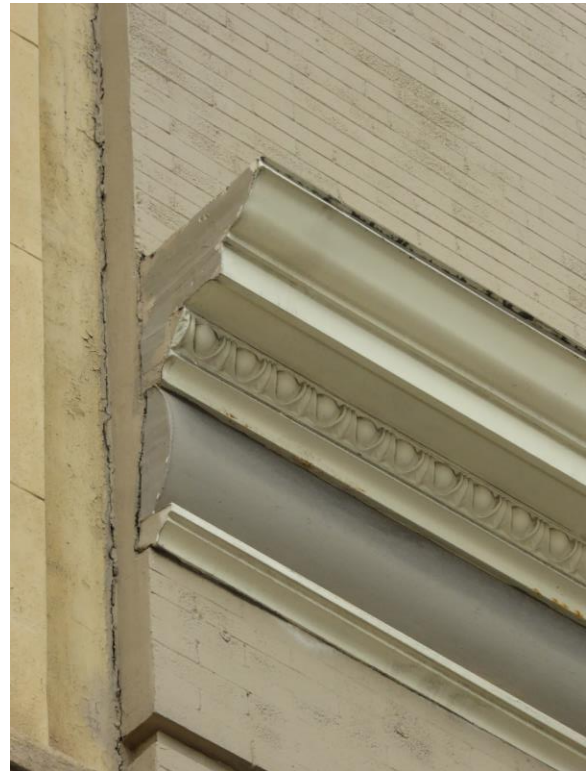
Figure 17: Detail photograph of water table banding at the third floor. Note minor spot corrosion bleeding through the paint (photograph taken on 01/26/2018).

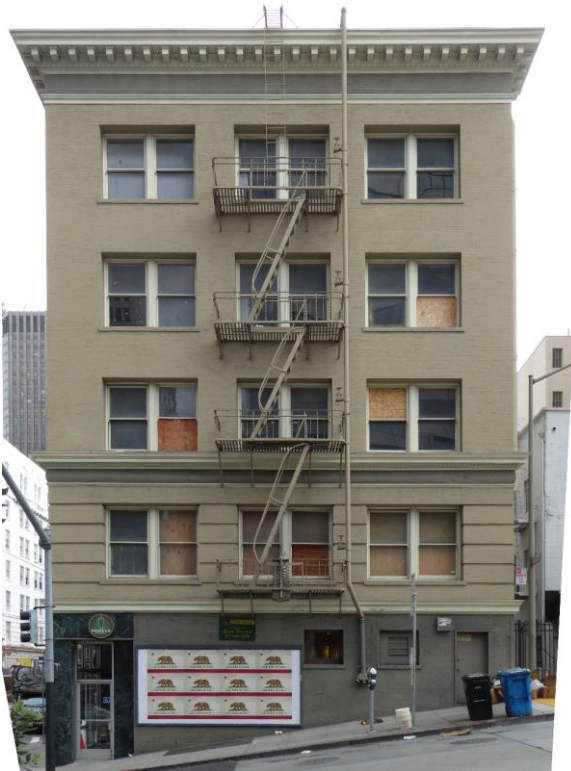
Figure 18: Photograph of Pine Street elevation with contemporary storefront at easternmost bay, and extant metal fire escape (photograph taken 01/26/2018).

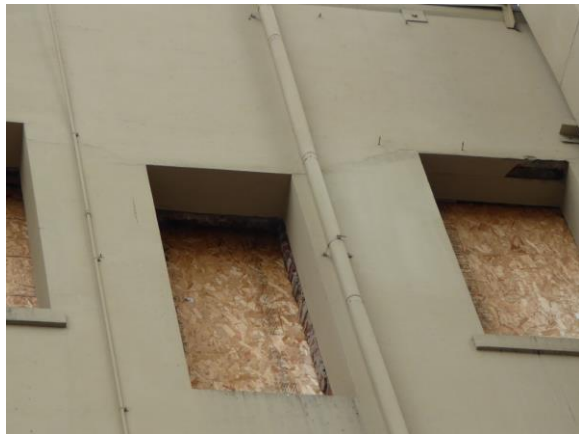
Figure 23: Detail view of punched openings. Note cracked cement plaster between window lintels (photograph taken on 01/26/2018).

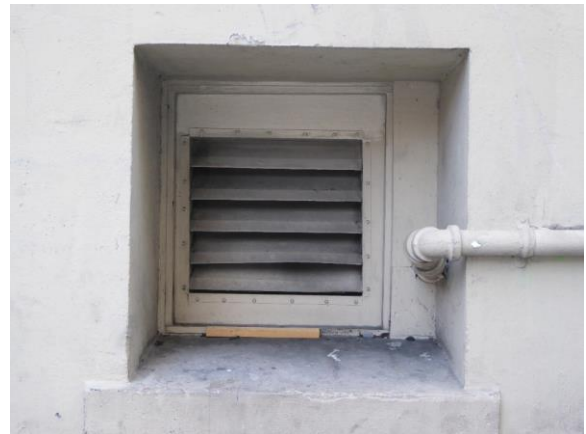
Figure 24: Detail view of punched opening infilled with a louvered vent at ground level (photograph taken on 01/26/2018).

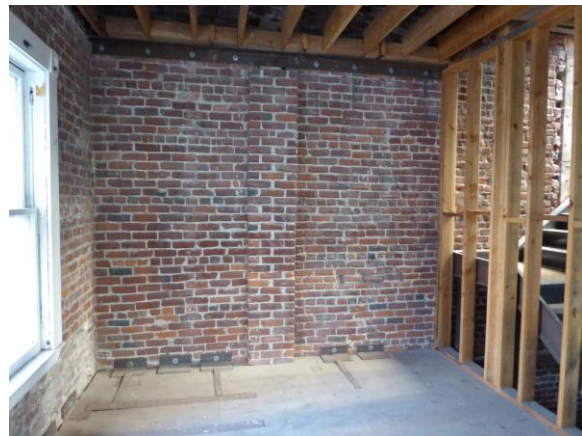
Figure 31: Interior photograph of exposed brick at south wall, fifth floor. Note minor efflorescence and deterioration of mortar (photograph taken on 02/27/2018).

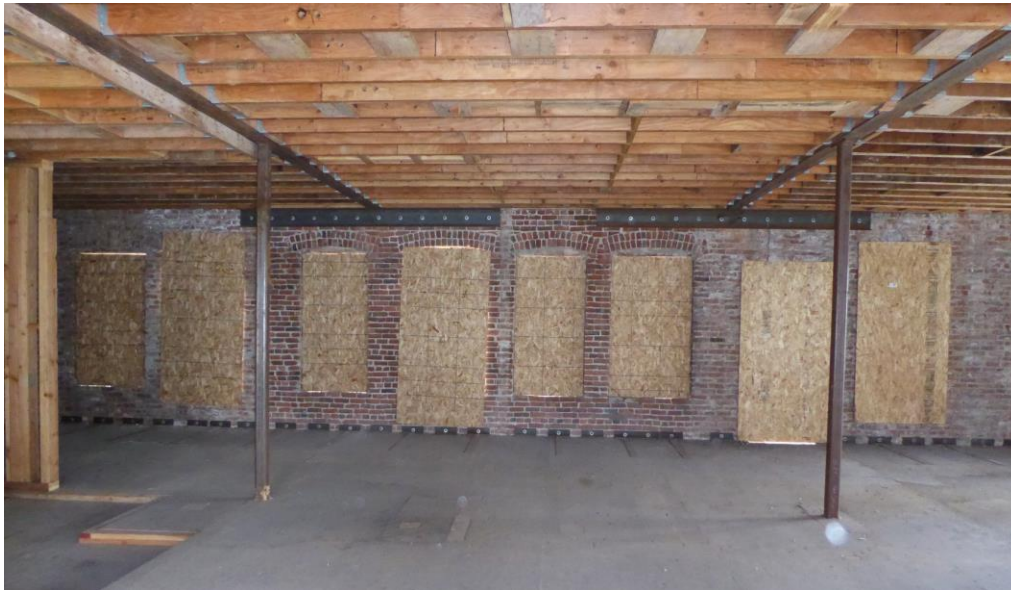
Figure 32: Photograph of typical west interior elevation. Note window openings covered with plywood at interior (photograph taken on 02/27/2018).

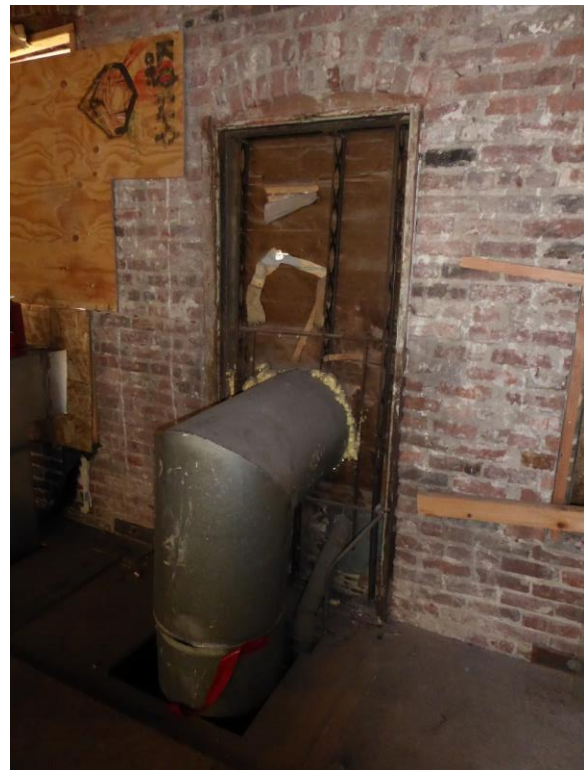
Figure 34: Detail view of punched window (original door) opening with ventilation duct. Note deteriorated wood frame (photograph taken on 02/27/2018).

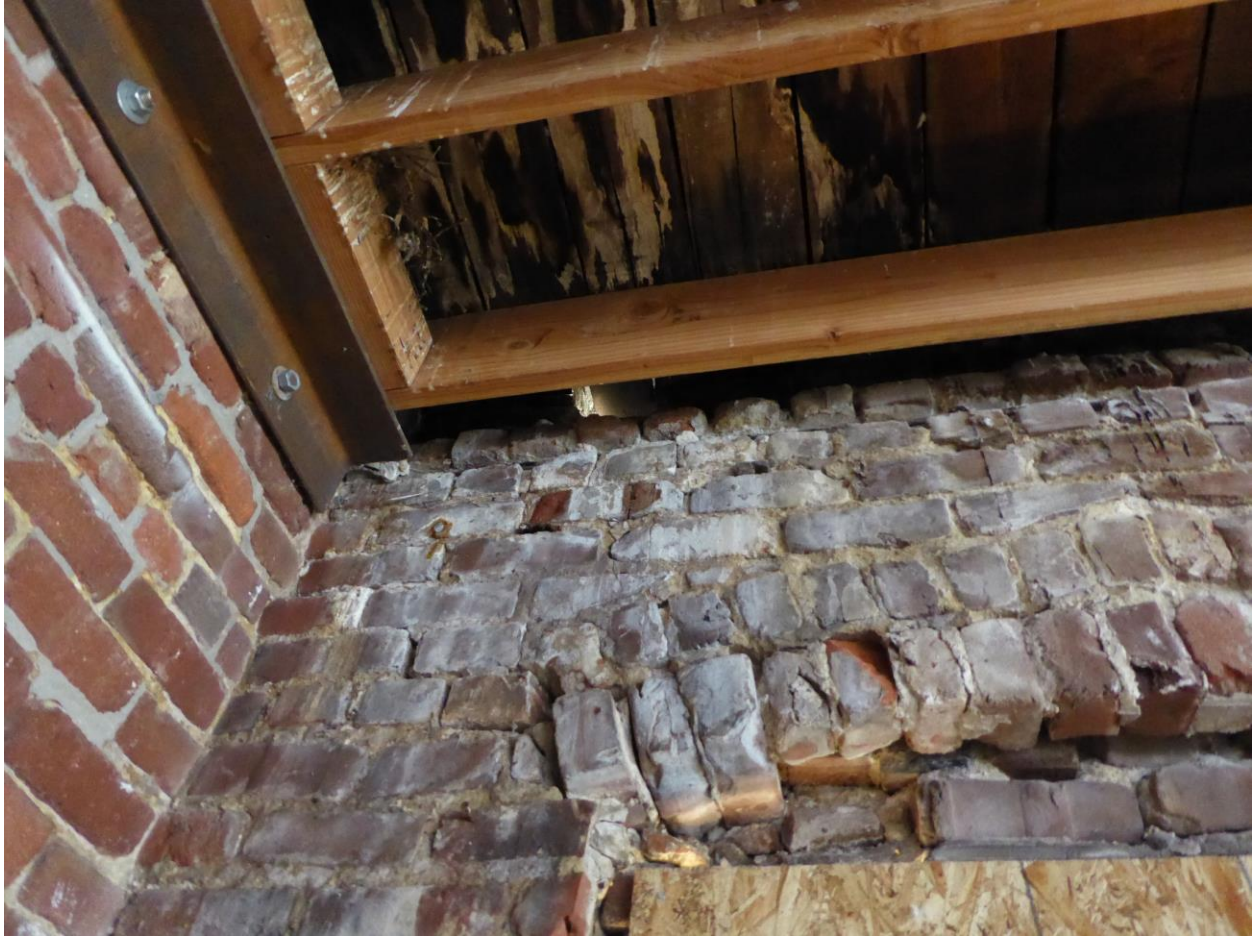
Figure 35: Detail photograph of deteriorated brick mortar joints and efflorescence above southernmost window opening at fifth level. Note rust stains surrounding metal embedments and water stains at underside of roof sheathing (photograph taken on 02/27/2018).

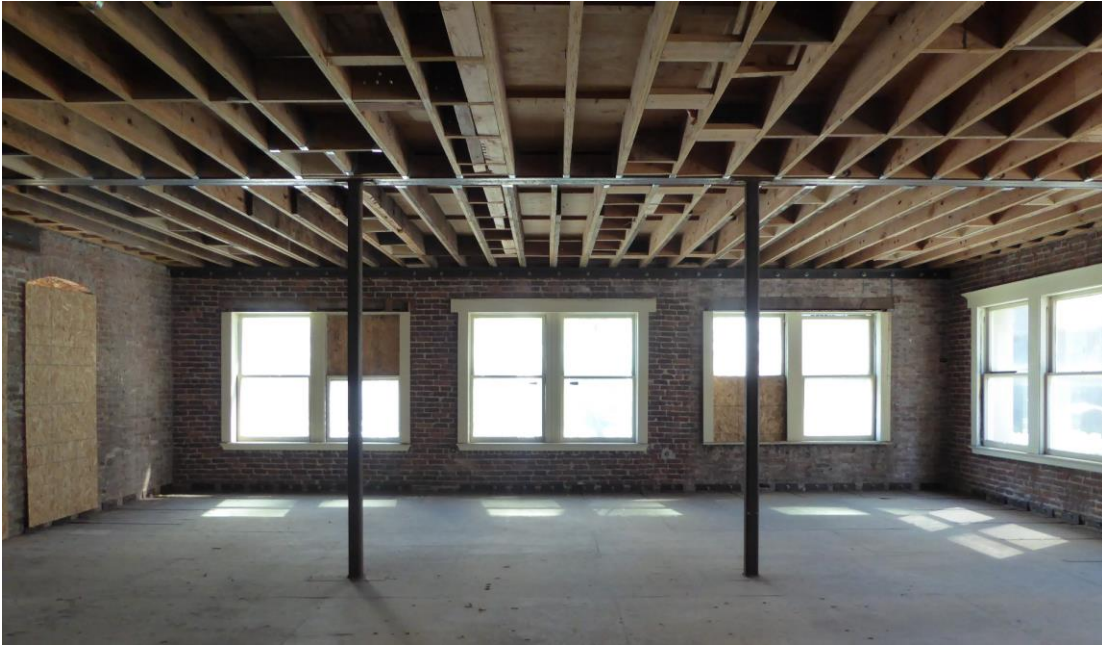
Figure 36: Photograph of typical north interior elevation (photograph taken on 02/27/2018).

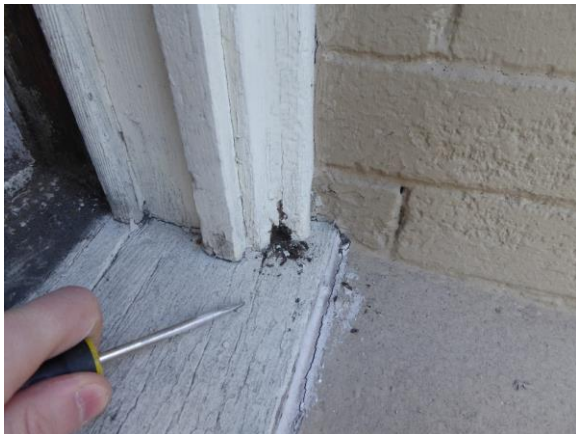
Figure 39: Detail photograph of typical deterioration at window trim (Photograph was taken on 02/27/2018).

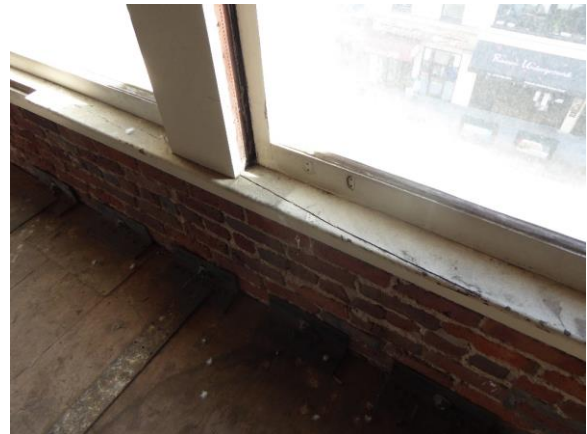
Figure 40: Detail photograph of split window sill (photograph taken on 02/27/2018)

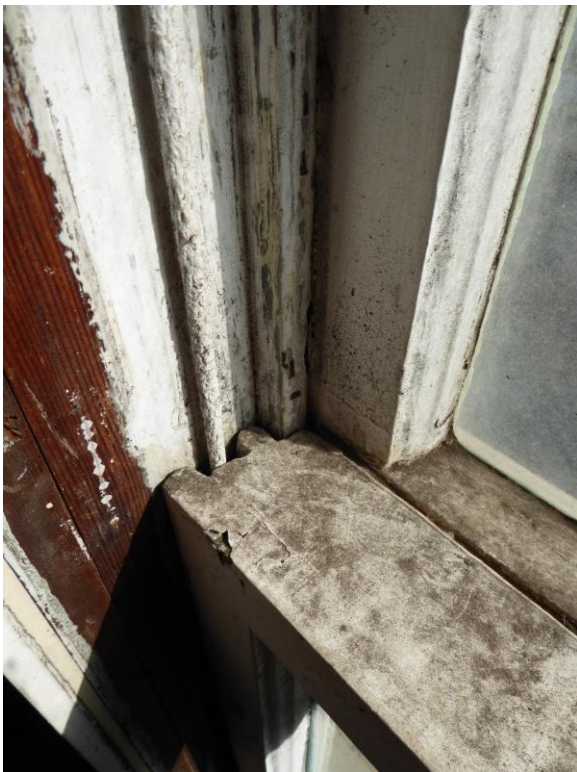
Figure 43: Detail photograph of top edge of lower sash, and sash cord. Note typical paint chipping and missing sash stop (photograph taken on 02/27/2018).

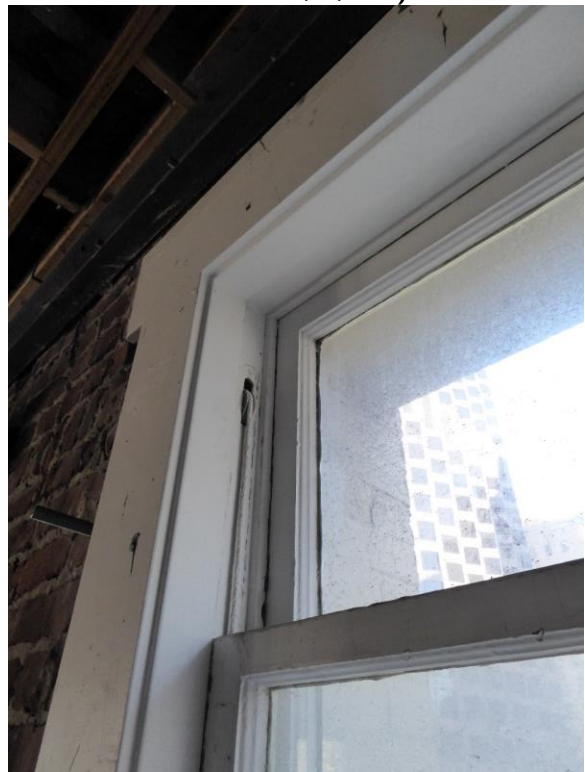
Figure 44: Detail photograph of typical window trim and sash configuration (photograph was taken on 02/27/2018).

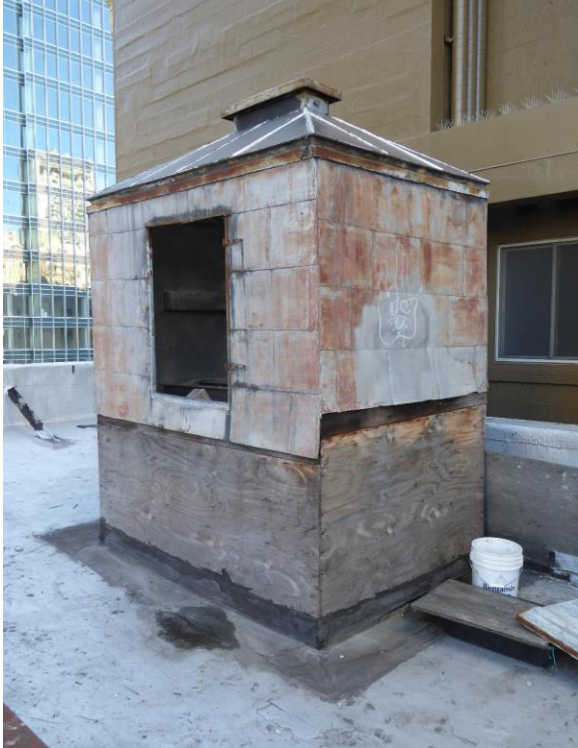
Figure 48: Photograph of elevator penthouse clad in metal panels over wood sheathing. Note surface corrosion on metal panels and missing access door (photograph taken on 02/27/2018)

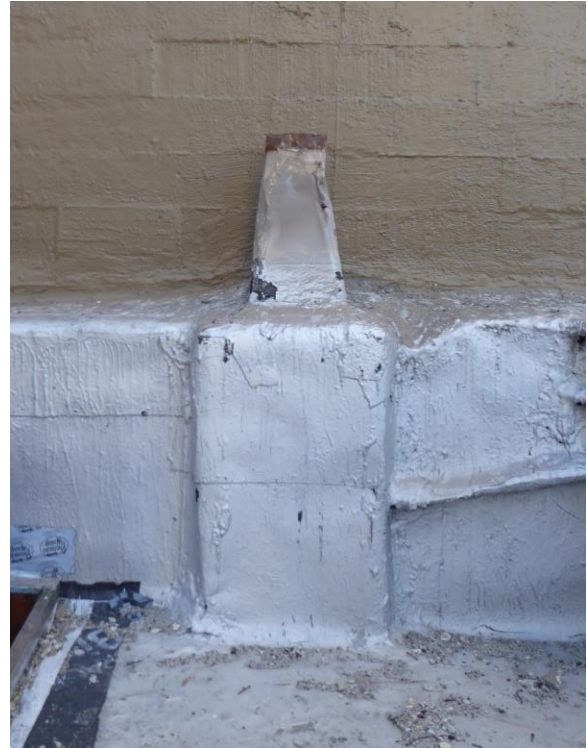
Figure 49: Detail view of open flue at southern parapet wall (photograph taken on 02/27/2018).

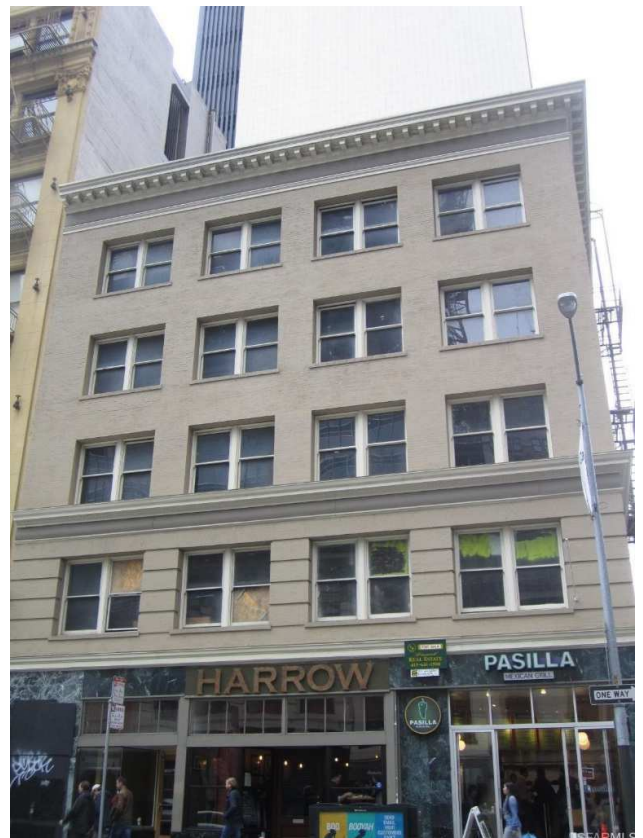
Building Address: 353 Kearny Street, San Francisco, California
