File	No.	160975

Government Audit and Oversight Committee May 16, 2018 ♦ 10:00 a.m.

Supplemental Report for Foundation Settlement Investigation

SUPPLEMENTAL REPORT FOUNDATION SETTLEMENT INVESTIGATION 301 MISSION STREET SAN FRANCISCO, CALIFORNIA

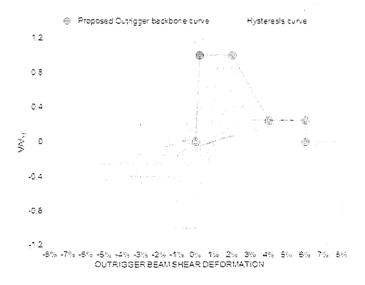
Figure 13. Coupling Beam Degrading Hysteretic Model

For these elements, we implemented the degrading hysteretic model illustrated in Figure 13. The cyclic backbone for this model maintains elastic-perfectly-plastic behavior through a shear deformation of 2% radians then degrades to a residual strength equal to 25% of the yield strength at a shear deformation of 4% radians. The model retains this residual displacement through shear deformation of 6% radians, after which it has nil residual strength. Figure 14 shows an overlay of the response obtained from this hysteretic model with that recorded in the University of Michigan testing discussed in Section 2.1.2 of this report. The hysteretic model conservatively represents the behavior obtained in the test and exhibits greater strength and stiffness degradation than did the tested specimen.

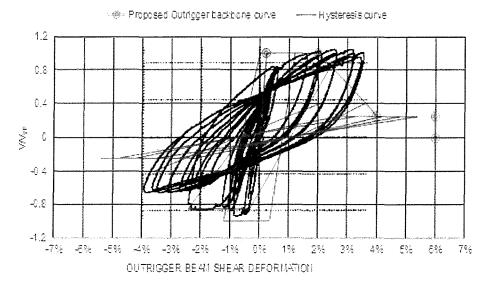
Figure 14. Comparison of Coupling Beam Model with Canbolat Test

Of the available test data for low aspect ratio walls, the tests by Paulay and Binney indicate relatively little strength degradation while the test by Canbolat, et. al. do show some degradation. This is likely because the Canbolat tests used a ramped, fully reversed, cyclic loading protocol similar to that commonly used as the basis for most recent nonlinear response modeling, while the Paulay tests employed a loading protocol more like that of real earthquakes, with little reversed cyclic loading. Recent research, by Lignos³ and others suggests that fully reversed cyclic loading protocols over-estimate the strength degradation that typically occurs in structures in response to earthquakes. However, to be consistent with the modeling approaches used for other elements, and to conservatively model the effects of strength degradation, we adopted the Canbolat tests as the basis for our updated hysteretic model for the coupling beams.

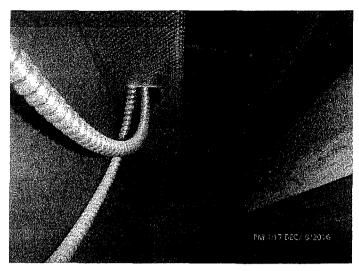
Pre-Test Conditions: Test site ST5 in unit 31B heat pump closet. Note pipe risers routed through closet floor

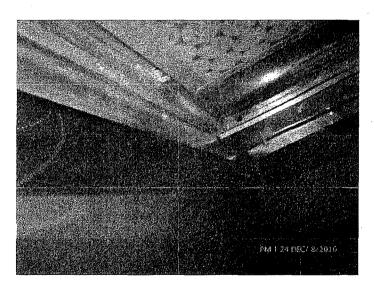
Test site ST5 in unit 31B heat pump closet. Note test smoke flowing up through heat pump closet door opening

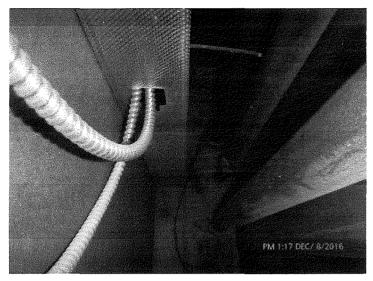
Pre-Test Conditions: Test site ST5 in unit 31B heat pump closet. Note pipe risers routed through closet floor

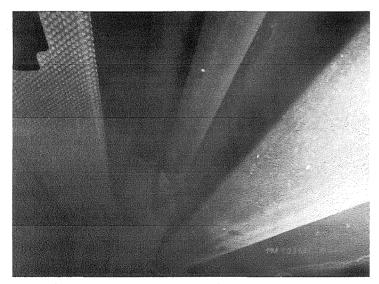
During Smoke Test Conditions – 1/2 minute from start: Test site ST5 in unit 31B heat pump closet. Note white test smoke at pipe risers routed through closet floor

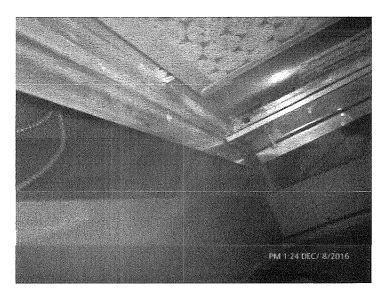
Test site ST5 in unit 31B heat pump closet. Note test smoke flowing up through heat pump closet door opening
