File No. <u>180984</u>

Committee Item No. 2 Board Item No.

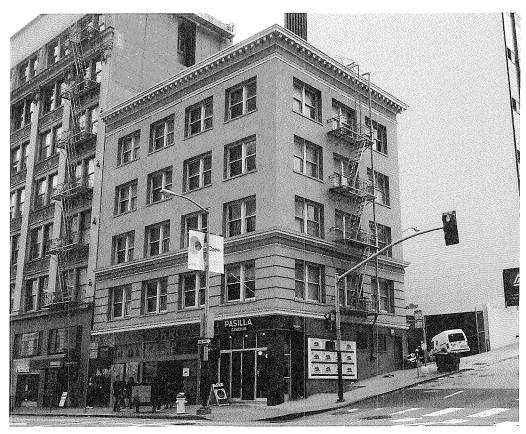
Figure 9: 353 Kearny Street viewed from intersection of Kearny and Pine Streets. Primary (east) facade and north facade (with fire escape) pictured. Looking southwest.

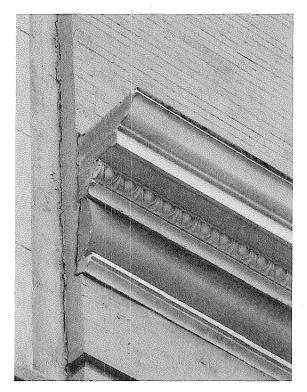
Figure 17: Detail photograph of water table banding at the third floor. Note minor spot corrosion bleeding through the paint (photograph taken on 01/26/2018).

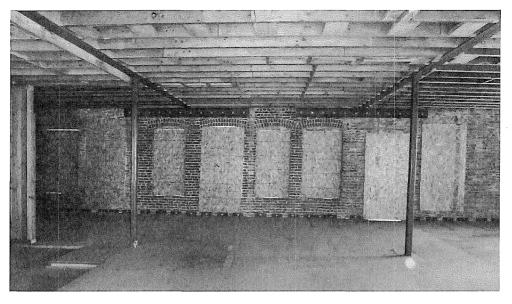
Figure 32: Photograph of typical west interior elevation. Note window openings covered with plywood at interior (photograph taken on 02/27/2018).

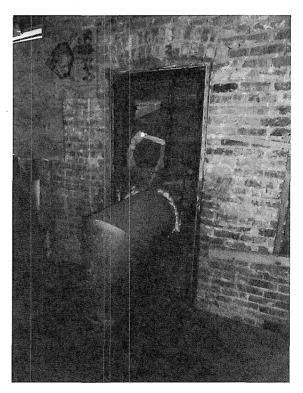
Figure 34: Detail view of punched window (original door) opening with ventilation duct. Note deteriorated wood frame (photograph taken on 02/27/2018).

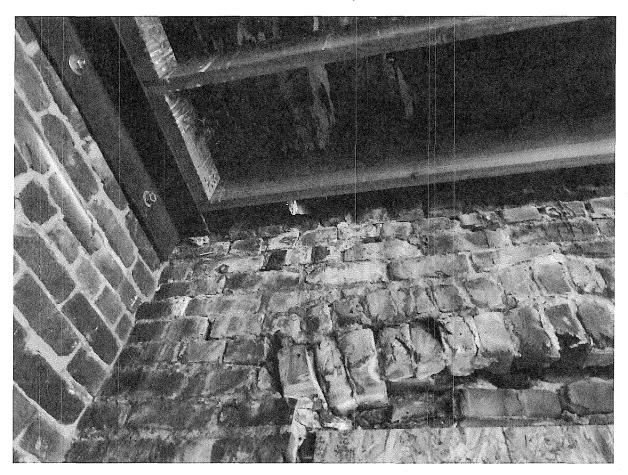
Figure 35: Detail photograph of deteriorated brick mortar joints and efflorescence above southernmost window opening at fifth level. Note rust stains surrounding metal embedments and water stains at underside of roof sheathing (photograph taken on 02/27/2018).

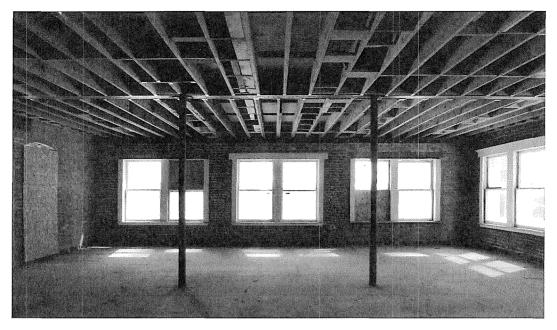
LEVELS 2 – 5 INTERIOR AT NORTH & EAST WALLS

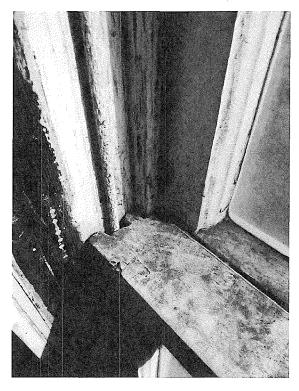
Figure 43: Detail photograph of top edge of lower sash, and sash cord. Note typical paint chipping and missing sash stop (photograph taken on 02/27/2018).

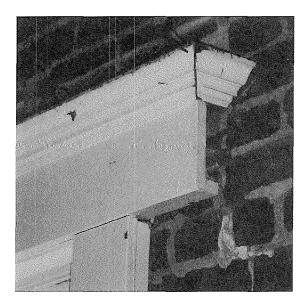
Figure 42: Detail photograph of window cornice and edge of concealed steel lintel behind (photograph taken on 02/27/2018).

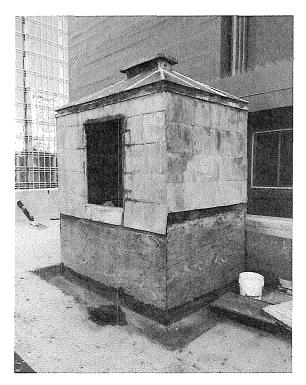
Figure 48: Photograph of elevator penthouse clad in metal panels over wood sheathing. Note surface corrosion on metal panels and missing access door (photograph taken on 02/27/2018)

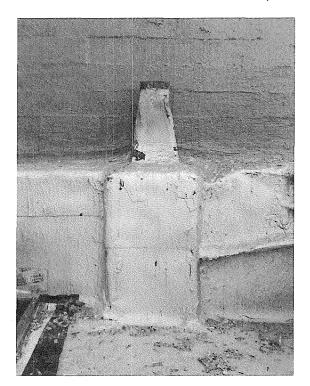
Figure 49: Detail view of open flue at southern parapet wall (photograph taken on 02/27/2018).

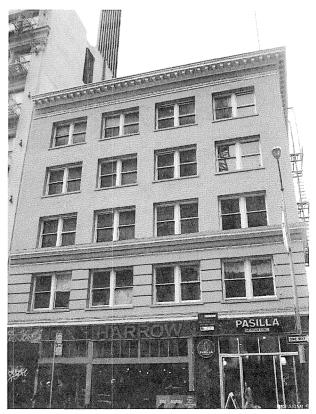
| Building Address: 353 | Kearnv Street | , San Franc | isco, California | | Date: | | 10/25/17 | |
