File No	<u> 191</u>	<u>065 </u>
---------	-------------	-------------

Committee	Item No.	3
Board Item	No.	17

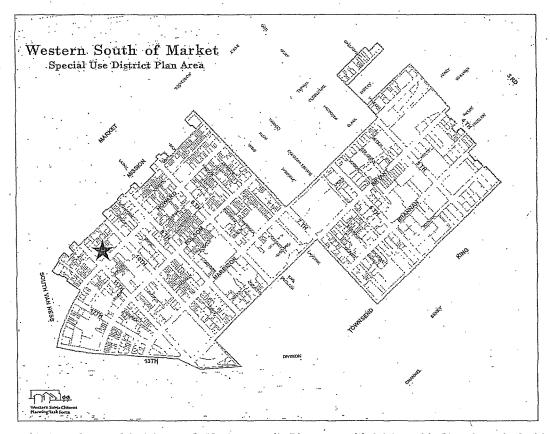
Figure 7. Parcel map of the Western SoMa Community Plan area, with St. Joseph's Church marked with a star. Source: San Francisco Planning Department; altered by author.

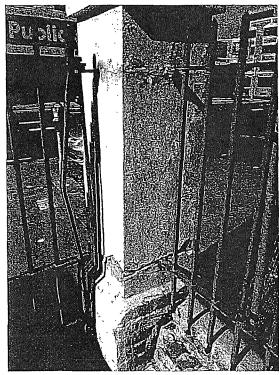
Figure 32a. Pier near west tower, showing large cracks and displaced areas of brick (arrow) and corroded metal fence.

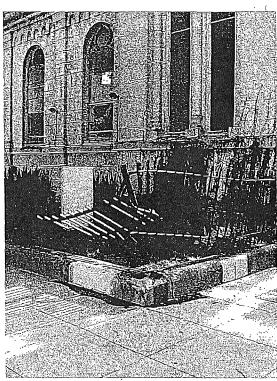
Figure 32b. Damage to metal fence at northeast corner of property.

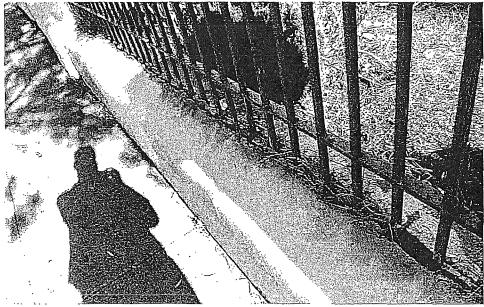
Figure 32c. Low brick wall along Howard Street, showing gaps and voids, corroded metal fence, and graffiti (painted over with mismatched paint).

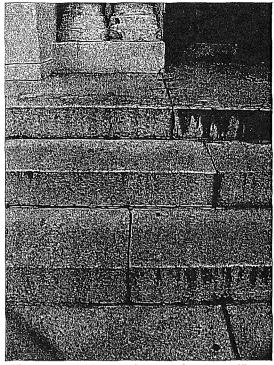
Figure 33a. Main portal steps, showing soiling, paint stains and vertical joints without mortar.

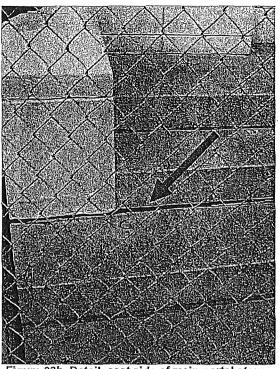
Figure 33b. Detail, east side of main portal steps, showing gap between blocks (arrow) due to uneven settling.

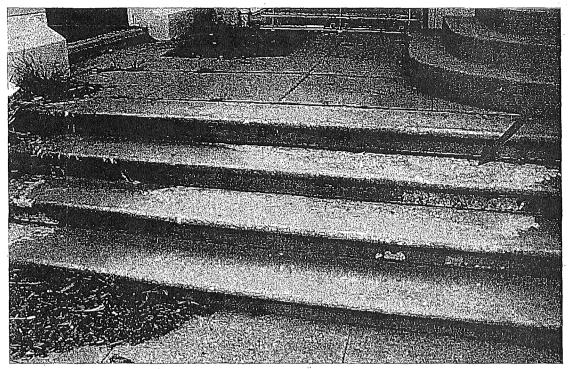
Figure 33d. West transept, south portal steps, showing paint stains (left), soiling and spalling surface (arrow).

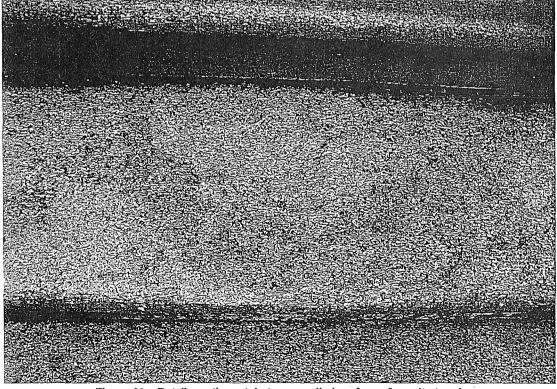
Figure 33e. Detail, south portal steps, spalled surface of granite tread.

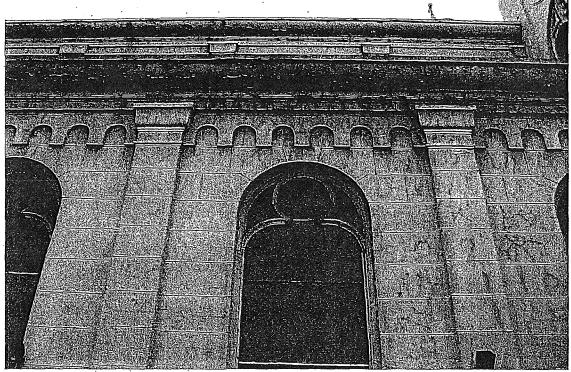
Figure 34a. East nave façade, showing soiling, water staining and hairline cracking of stucco.

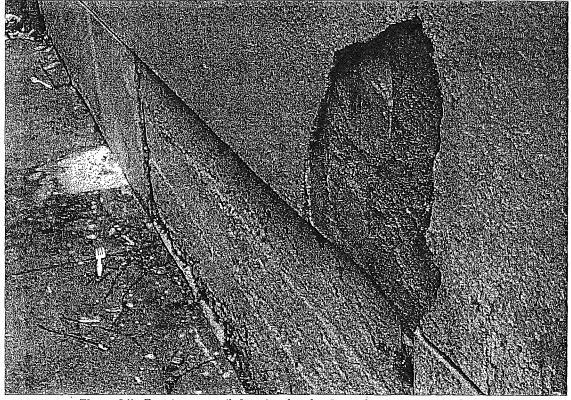
Figure 34b. East tower, north façade, showing loss of stucco at ground level.

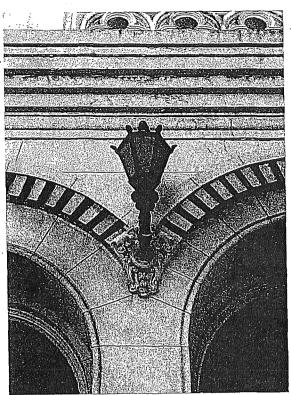
Figure 35a. Light fixtures (now missing) at main entry on north façade in 2007.

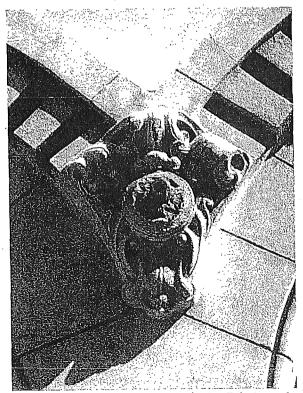
Figure 35b. Detail, original mounting hardware is all that remains in place.

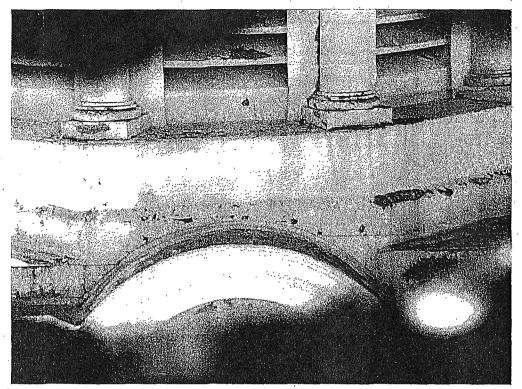
Figure 36a. Detail, rust-through at painted sheet metal cupolas.

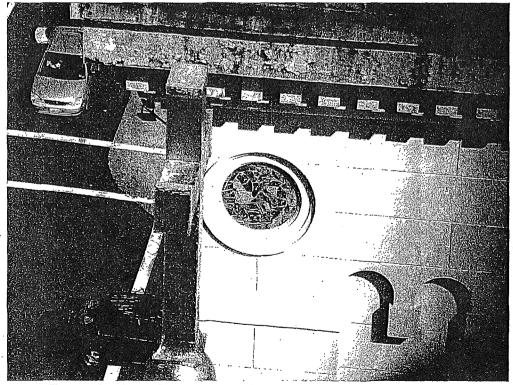
Figure 36b. The rooftop crosses require minor sheet metal and gilding repair.

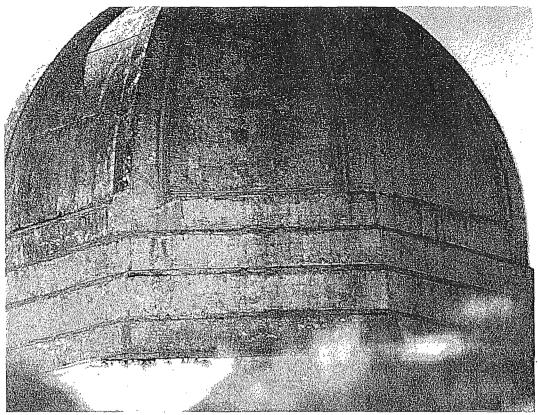
Figure 36c. Detail, corrosion and loss of paint and gilding at domes.

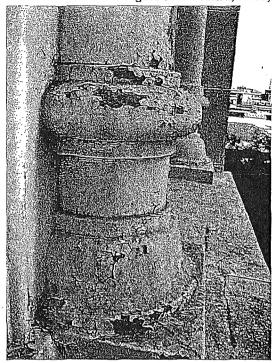
Figure 37a. Column base, south side of east tower, showing flaking and loss of protective paint layer.

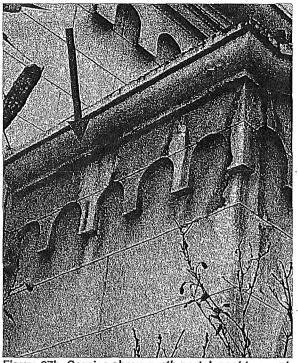
Figure 37b. Cornice above north portal, east transept, showing perforation (arrow) of the metal due to corrosion.

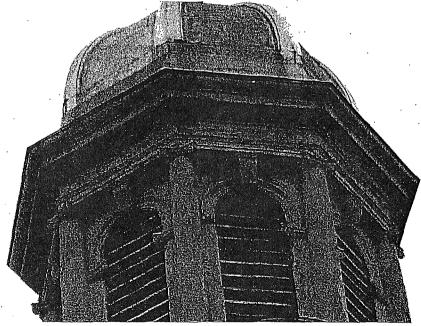
Figure 37c. East tower detail, constructed entirely of pressed sheet metal, showing missing architectural detail, loss of gilding and protective paint, and corrosion stains. Birds were nesting inside the towers.

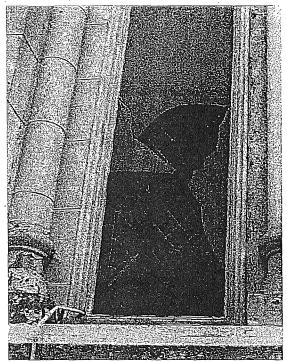
Figure 38a. West tower, north window, showing broken protective glazing.

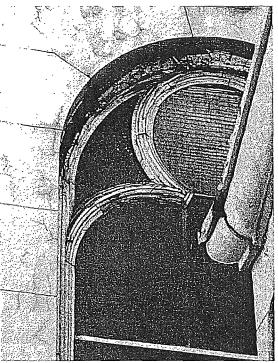
Figure 38b. East façade, transept window, showing soiling, paint loss and rotting/loss of tracery elements.

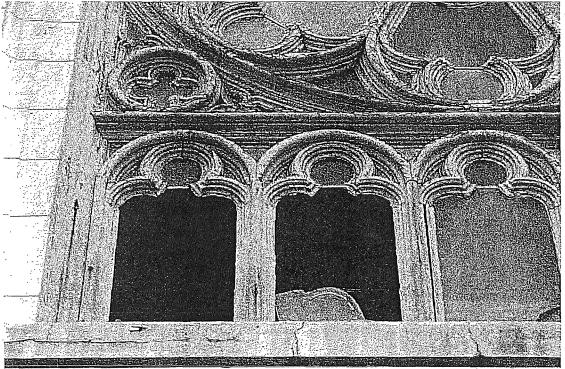
Figure 38c. West transept rose window, showing paint loss and missing glazing.

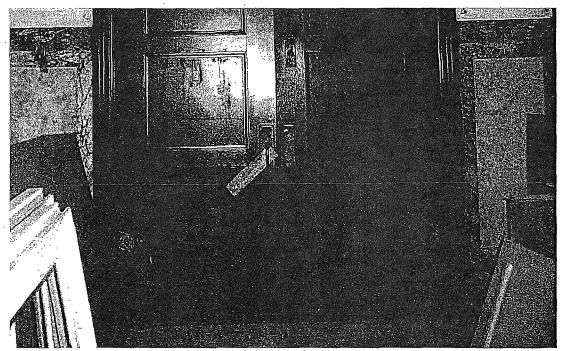
Figure 39a. Marble wainscoting of the narthex, showing soiling of the baseboard, wear of polished surface, and adhered tape. Original marble floor was covered with vinyl tile.

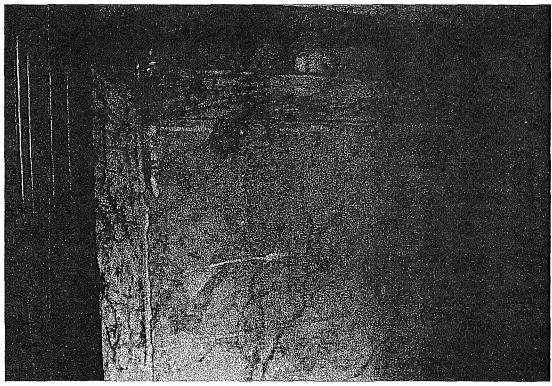
Figure 39b. Detail, showing tape and adhesive residue.

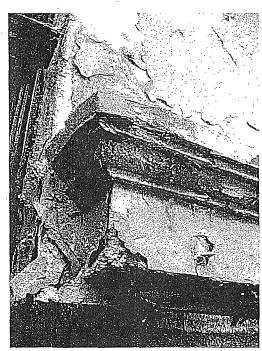
Figure 40c. Softening and deterioration of decorative plaster elements caused by moisture from faulty roofing.

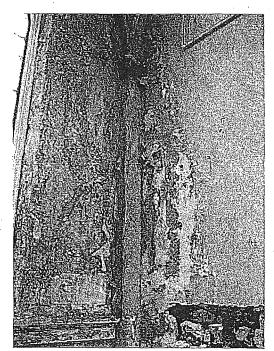
Figure 40d. Structural cracking and separation of plaster details from masonry substrate caused by moisture from blocked drains.

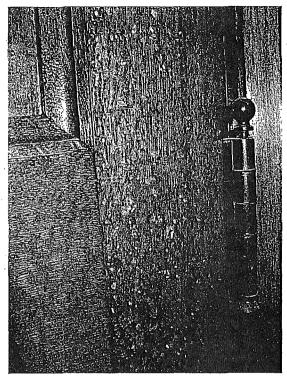
Figure 41a. Blistering of varnish on an oak door caused by moisture penetration.

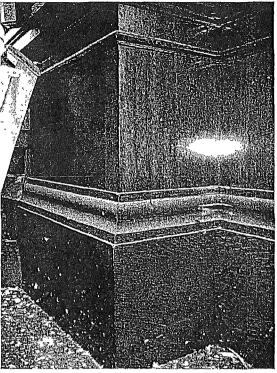
Figure 41b. Dust (on molding) and paint/guano spatters can cause permanent damage to wood finish.

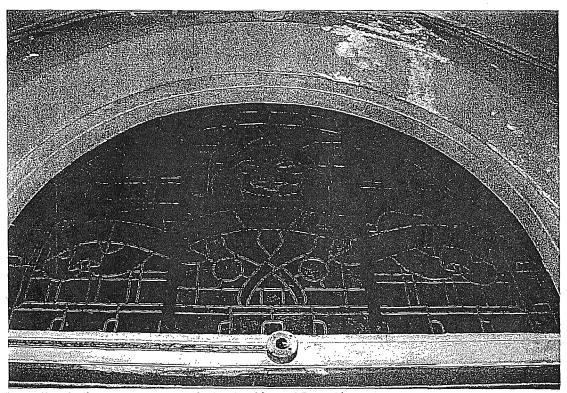
Figure 42a. North-east transept portal, showing blocked figurative stained glass window with heavy soiling and corrosion of steel frame

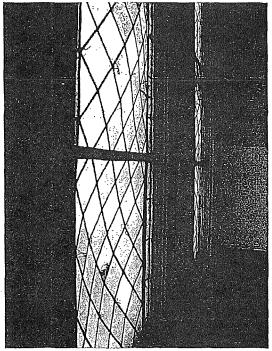
Figure 42 b. East tower, east windows, showing bowing of windows due to sagging lead cames or detachment from saddle bars.

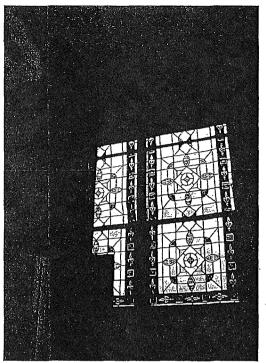
Figure 42d. Kitchen window, showing partition partially covering painted stained glass.

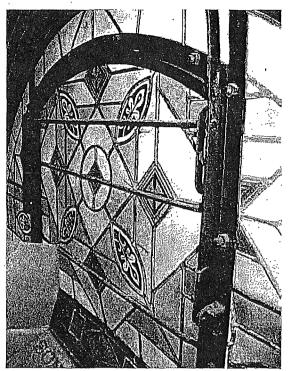
Figure 42 e. Upper portion of window showing corroded hopper-type opening assembly.

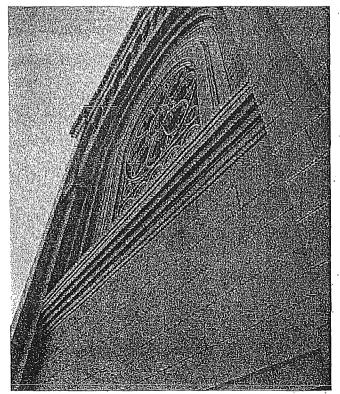
Figure 50. East façade, showing stucco condition after restoration (Page & Turnbull, 05/25/2018).

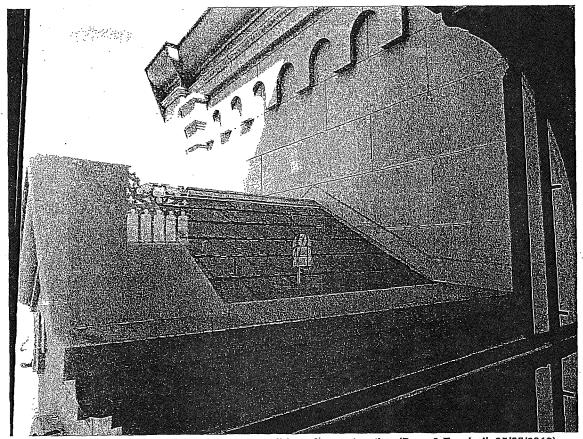
Figure 51. East façade, showing stucco condition after restoration (Page & Turnbull, 05/25/2018)

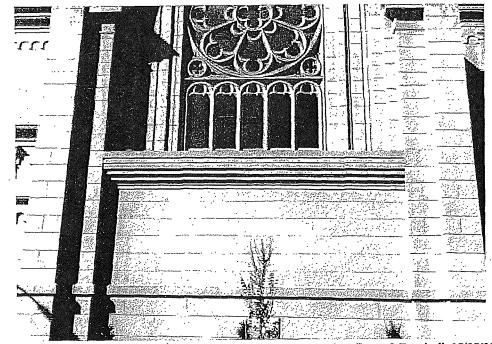
Figure 52. West façade, showing stucco condition after restoration (Page & Turnbull, 05/25/2018).

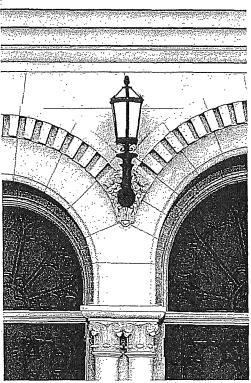
Figure 53. Exterior lighting fixture above main entrance on north façade (Rich Stapleton, 05/21/2018)

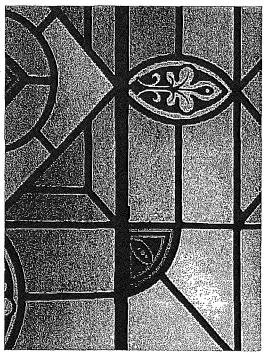
Figure 76. Detail, stained glass window. (Page & Turnbull, 05/25/2018)

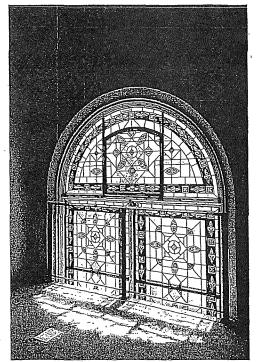
Figure 77. Detail, stained glass window. (Page & Turnbull, 05/25/2018).

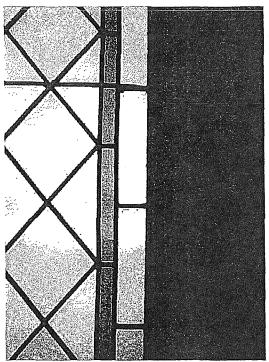
Figure 78. Detail, stained glass window. (Page & Turnbull, 05/25/2018)

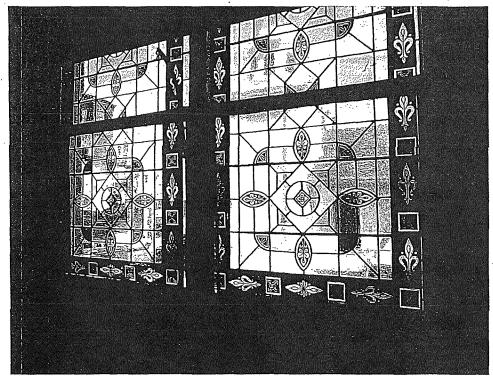
Figure 79. Stained glass window (Rich Stapleton, 05/21/2018)
