SAN FRANCISCO PLANNING DEPARTMENT

PRE-APPROVAL INSPECTION REPORT

Report Date: June 2, 2020
Inspection Date: May 20, 2019; 11:00am¹
Filing Date: May 1, 2020
Case No: 2020-004811MLS
Project Address: **1315 Waller Street**
Block/Lot: 1255/080
Eligibility Concurrent Application for Local Landmark Designation
2019-006264DES
Zoning: RH-3 – Residential-House, Three-Family
Height & Bulk: 40-X
Supervisor District: District 5 (Dean Preston)
Project Sponsor: Aimee Leifer and Tjarko Leifer
Address: 1315 Waller Street
San Francisco, CA 9411
415-730-9300
aimeeleifer@gmail.com
Staff Contact: Michelle Taylor – (415) 575-9197
michelle.taylor@sfgov.org
Reviewed By: Elizabeth Gordon-Jonckheer
elizabeth.gordon-jonckheer@sfgov.org

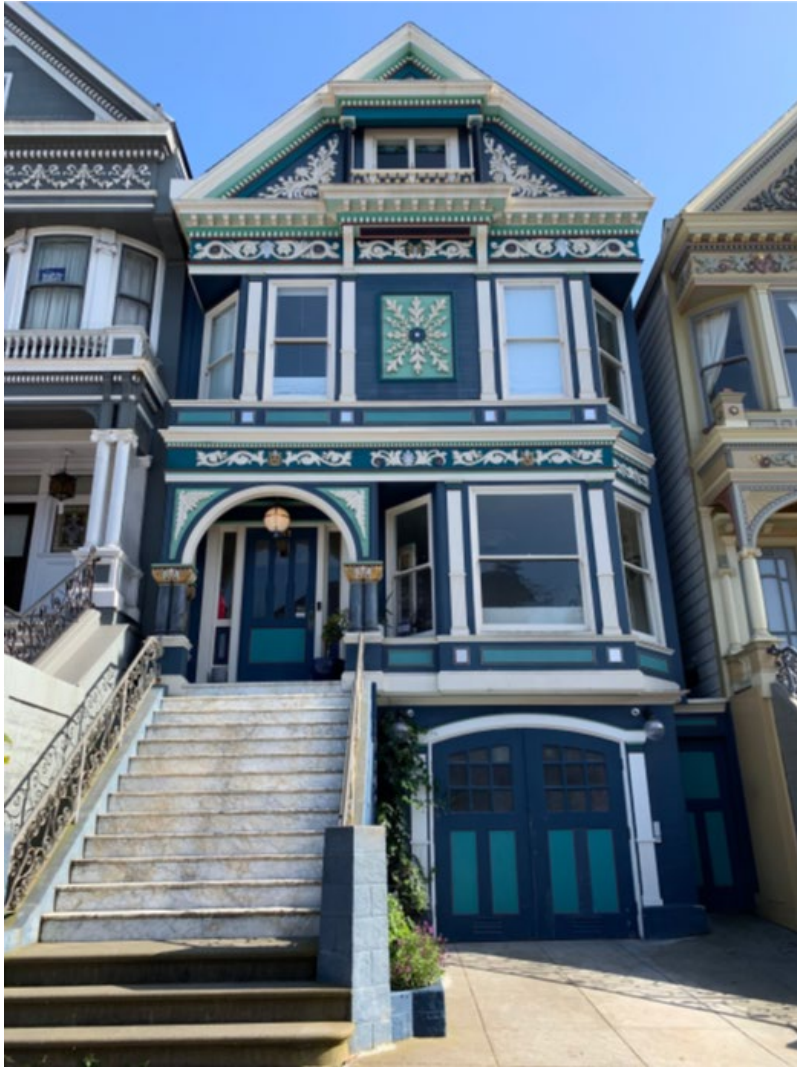
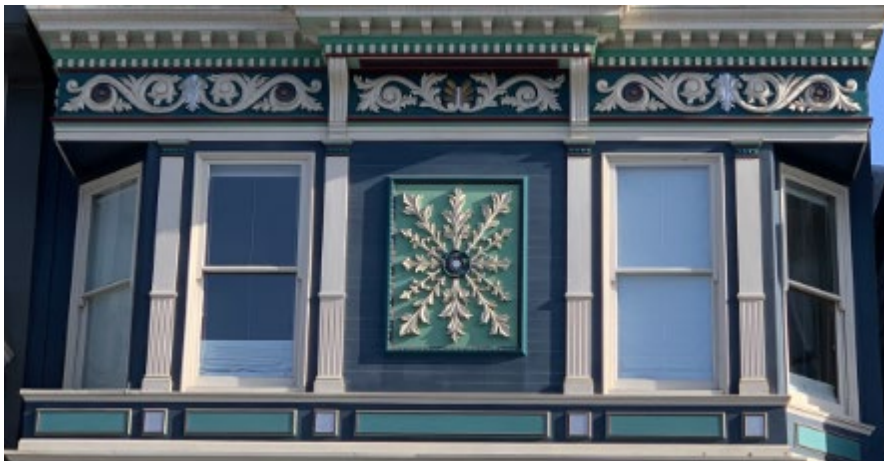
1315 Waller Street Front Façade (above) and detail (below)

The applicant has prepared a Rehabilitation plan that proposes to restore the front entry marble steps and iron handrail, restore missing front entry landing, restore or replace windows, replace roof, and fully repaint and repair all elevations. In 2018, the applicant had replaced the building foundation, added shear walls and structural steel beams. The estimated cost of the proposed rehabilitation work is estimated to cost \$467,000.00
