File No. 180984

353 Kearny Street (built 1907)

MILLS ACT APPLICATION
353 KEARNY STREET
SAN FRANCISCO, CALIFORNIA
[17336]

IV. 353 KEARNY STREET ADDITIONAL PHOTOGRAPHY

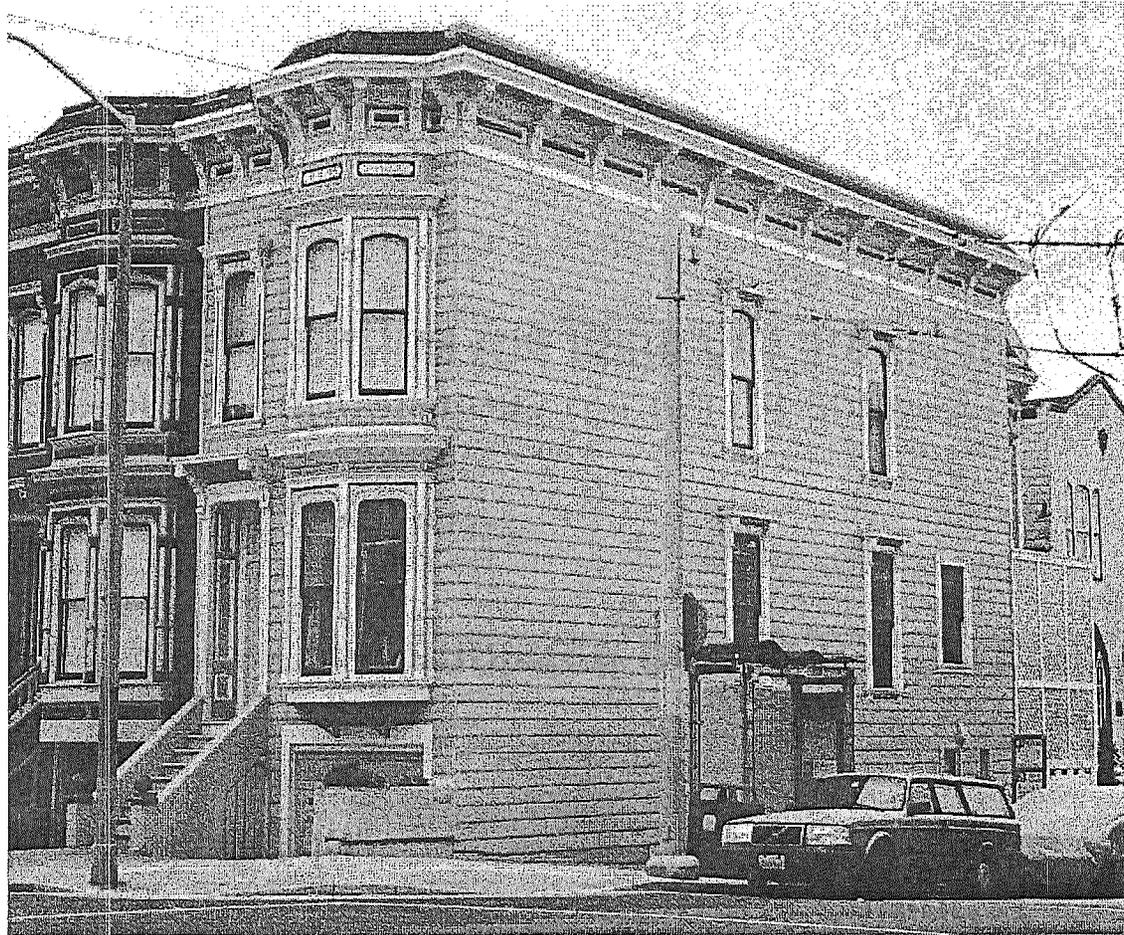
2253 Webster Street (built c. 1900)
Contributor to Webster Street Historic District

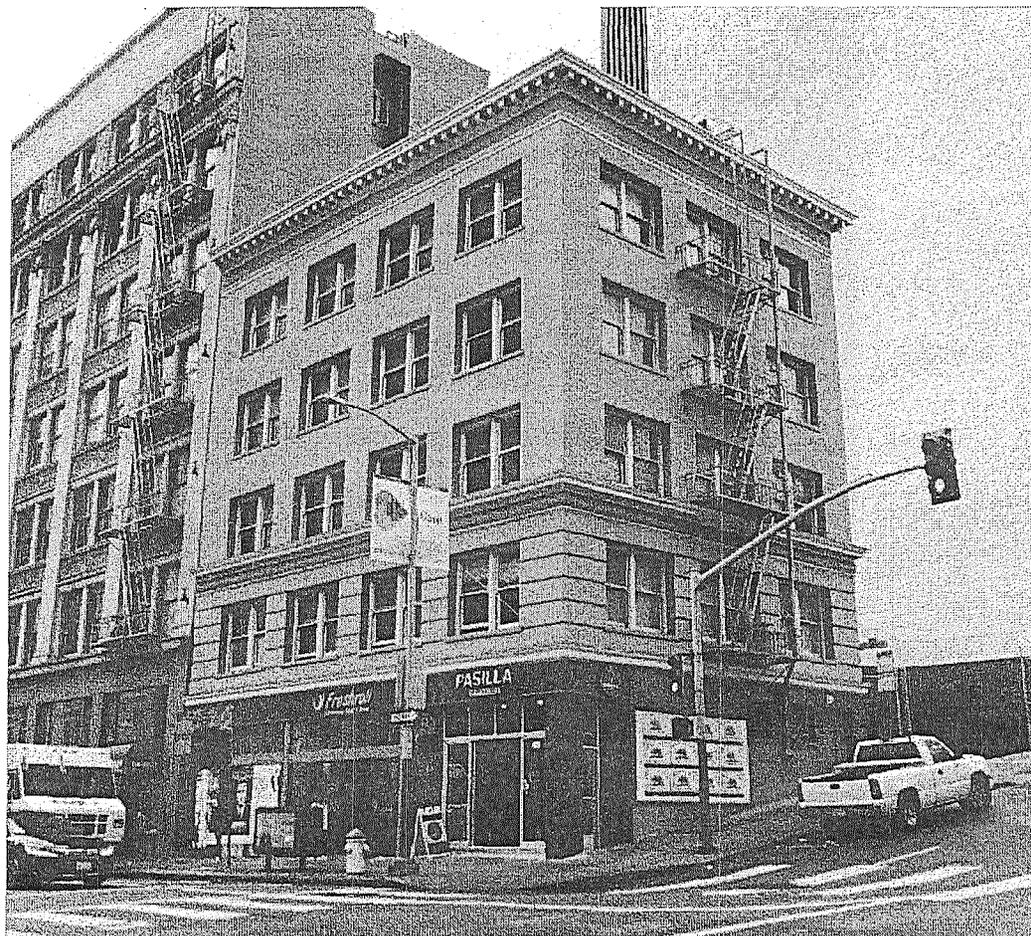
Category IV – Contributory Building to Kearny-Market-Mason-Sutter Conservation District

353 Kearny Retail occupied and Offices vacant. Office space to undergo significant renovation - windows, roof, elevator, exterior repair, interior flooring, ceiling lighting, HVAC, bathroom upgrades, and tenant improvements. Anticipated to take 2-years at an estimated cost of \$2.7 million

The proposed Rehabilitation Plan includes roof replacement, parapet bracing, elevator penthouse repair, brick repair and repointing at the façade and basement under sidewalk, repair and in-kind replacement of wood windows, plaster repair at rear façade, sheet metal cornice repair or in-kind replacement, fire escape repair, historic elevator and stair repair, storefront repair and replacement. Rehabilitation work is estimated to cost \$1,091,077 over ten years.

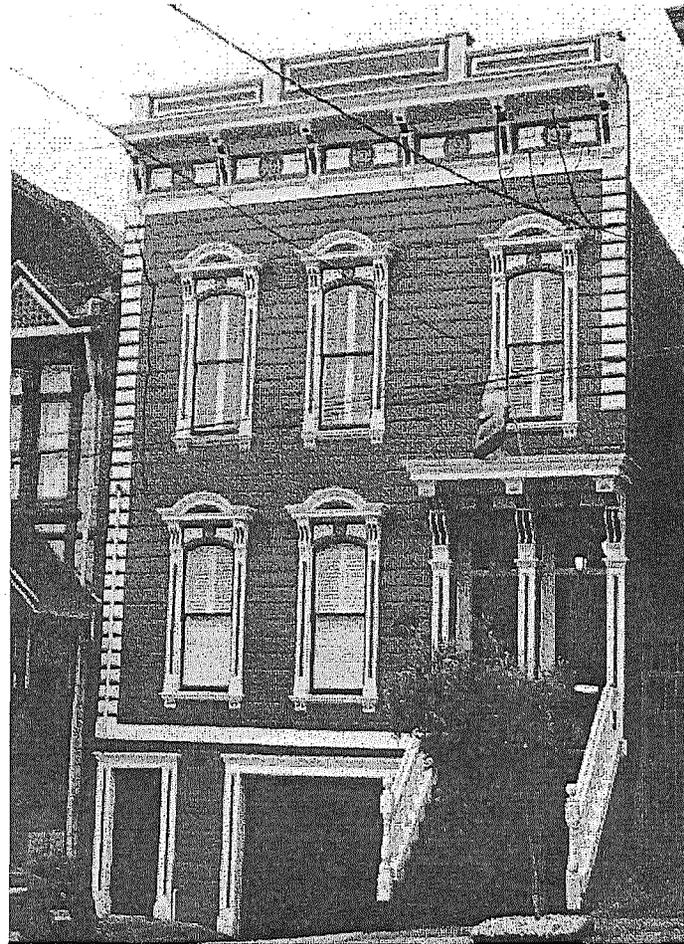
465-467 Oak Street (built 1899)
Hayes Valley Residential California Register Historic District

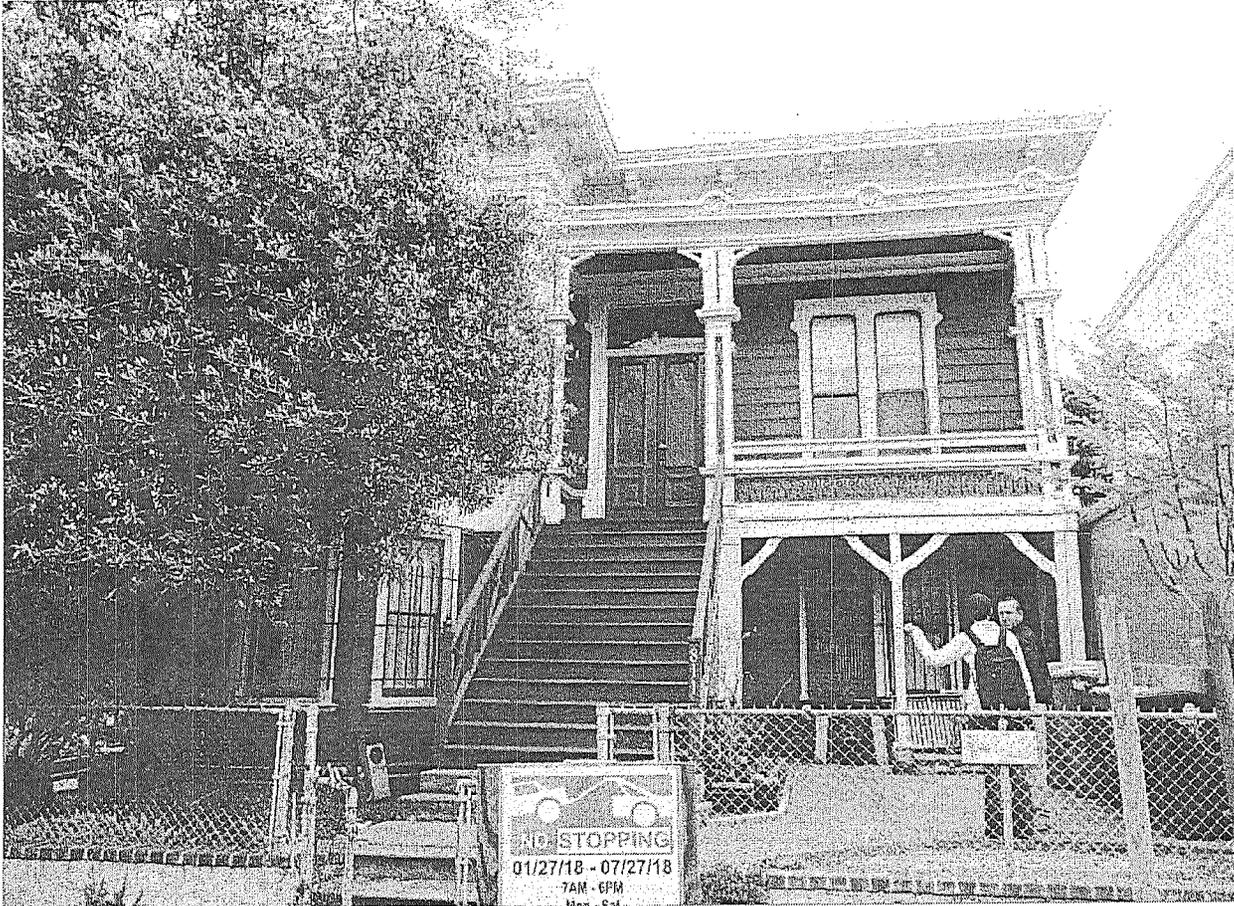
811 Treat Avenue (built c. 1882)
National Register of Historic Places

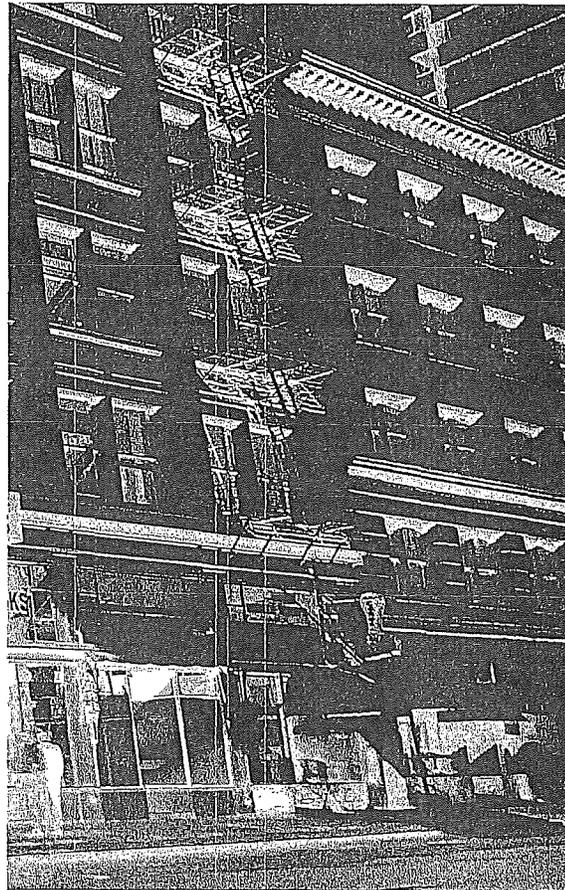
Figure 6: Figure 5: Non-inverted Assessor's negative looking toward 353 Kearny Street. Photograph taken October 15, 1962. Source: San Francisco Public Library.

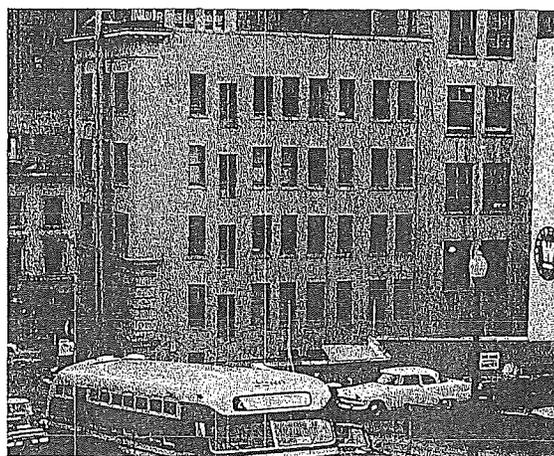
Figure 8: Zoomed view of 353 Kearny from photograph taken January 24, 1957. Source: SFMTA Photography Department & Archive, Photograph X3840_1.

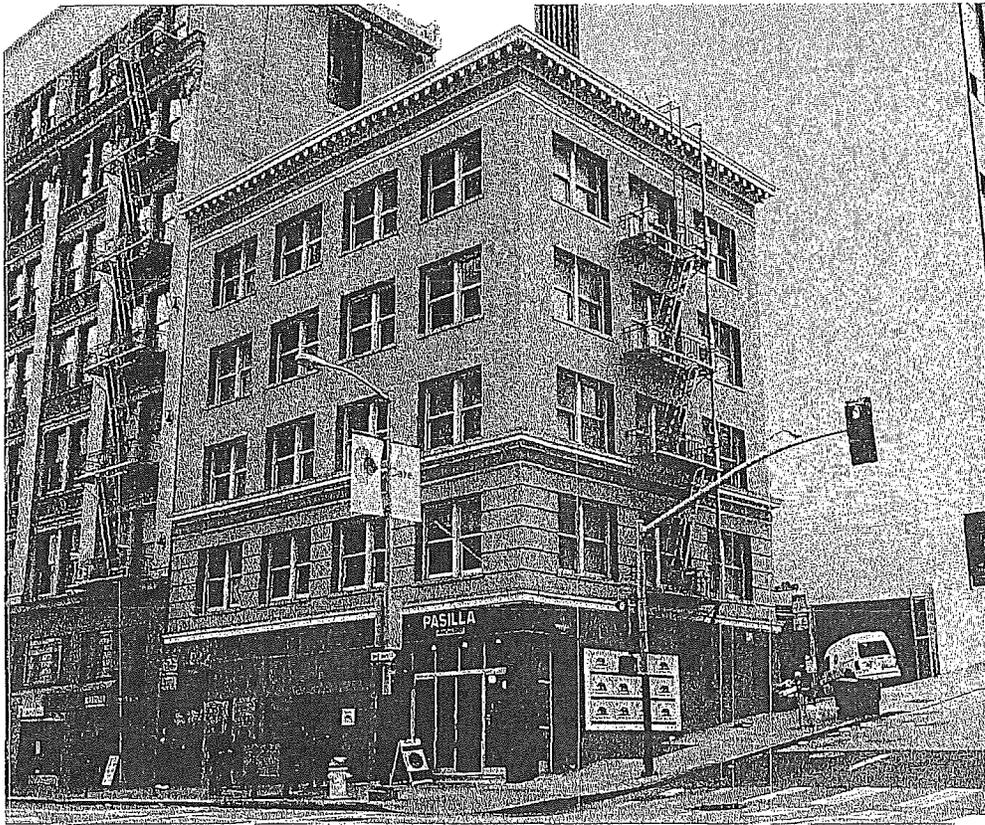
Figure 9: 353 Kearny Street viewed from intersection of Kearny and Pine Streets. Primary (east) facade and north facade (with fire escape) pictured. Looking southwest.

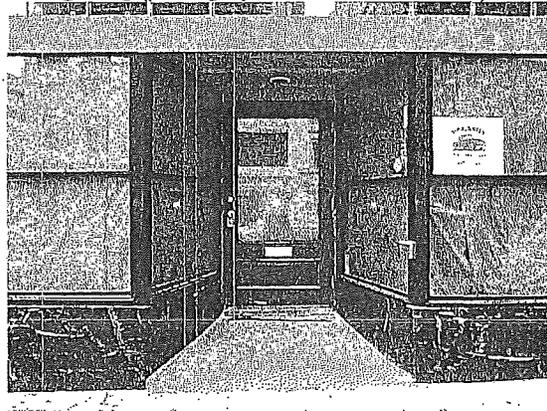
Figure 13: Photograph of the third bay entry from south end with angled storefront glazing system, paneled wood door, wood panel ceiling, and marble cladding (photograph taken on 01/26/2018).

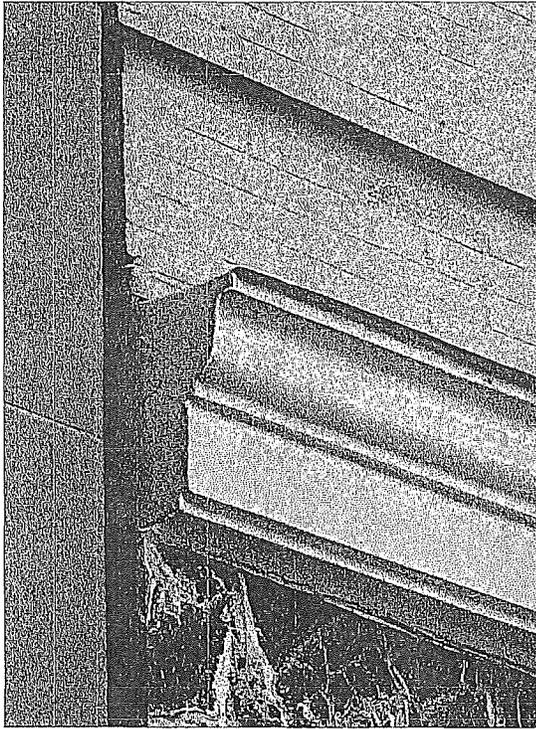
Figure 16: Detail photograph of sheet metal water table banding at second floor. Note brick erosion beneath the paint on the brick substrate (photograph taken on 01/26/2018).

Scope: # 10			
Building Feature: Sheet Metal Cornice and Watertable Banding – Kearny/Pine Elevations			
Rehab/Restoration	<input checked="" type="checkbox"/>	Maintenance	Completed
			Proposed <input checked="" type="checkbox"/>
Contract year work completion: 2019			
Total Cost: \$75,131.00			
Description of work: Repair or replace deteriorated sheet metal elements to match original at cornice and watertable banding. Patch where possible. Remove corrosion, prepare, prime, and paint and every 10 years thereafter or as needed.

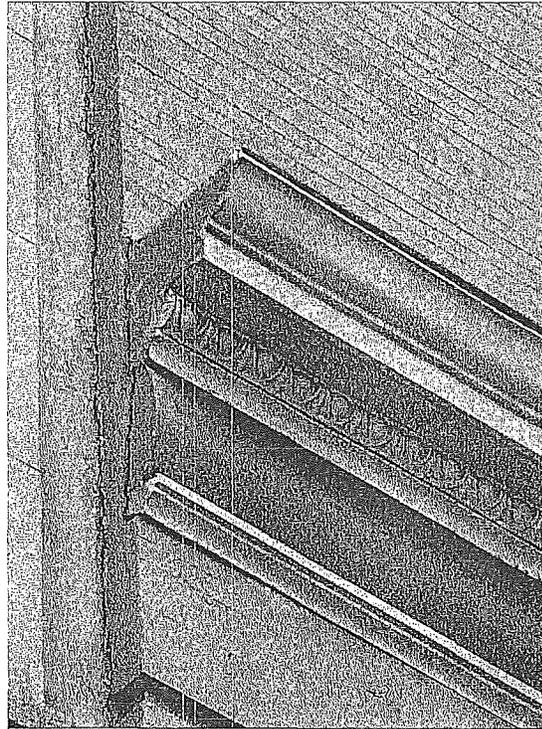
Figure 17: Detail photograph of water table banding at the third floor. Note minor spot corrosion bleeding through the paint (photograph taken on 01/26/2018).

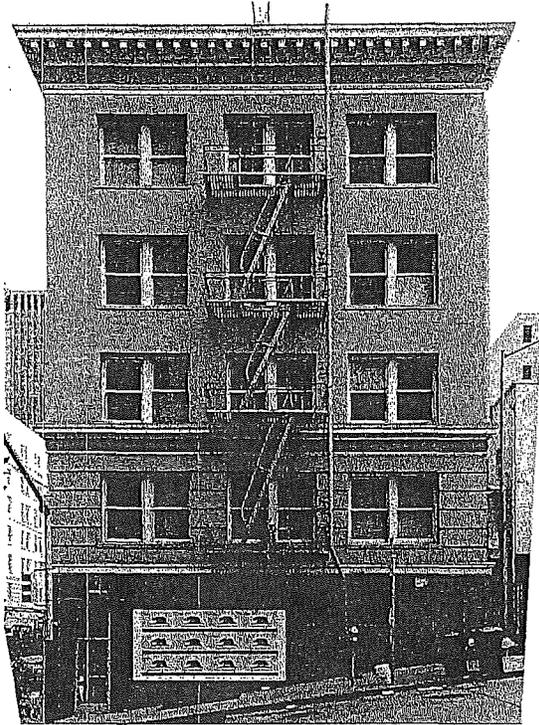
Figure 18: Photograph of Pine Street elevation with contemporary storefront at easternmost bay, and extant metal fire escape (photograph taken 01/26/2018).

Scope: # 12			
Building Feature: Metal Fire Escape – Pine Street Elevation			
Rehab/Restoration	<input checked="" type="checkbox"/>	Maintenance	Completed
			Proposed <input checked="" type="checkbox"/>
Contract year work completion: 2019			
Total Cost: \$3,452.00			
Description of work: Inspect fire escape to comply with codes as needed. Repair deteriorated metal as needed. Remove corrosion, prepare, prime, and paint.

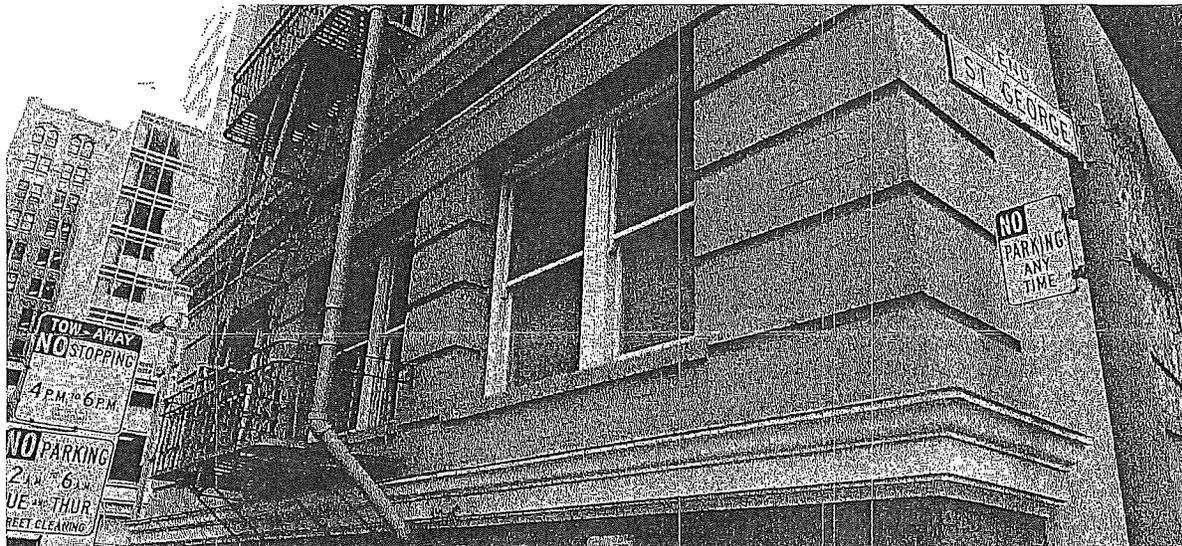
Figure 20: Detail view of brick cladding with horizontal reliefs at second floor, and typical wood double-hung windows. Note materials on the north façade (brick and water table bands) continue onto the west façade for a few feet (photograph taken on 01/26/2018).

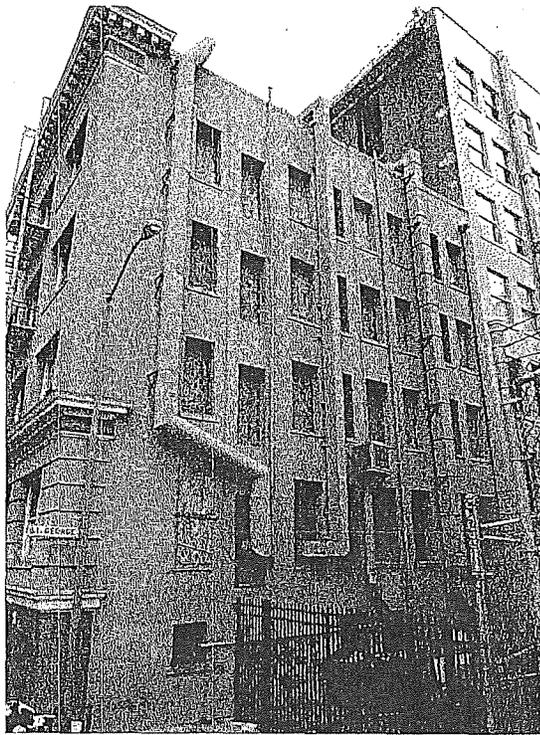
Figure 21: Photography of St. George Alley elevation. Note punched window openings are boarded up with plywood at interior (photograph taken on 01/26/2018).

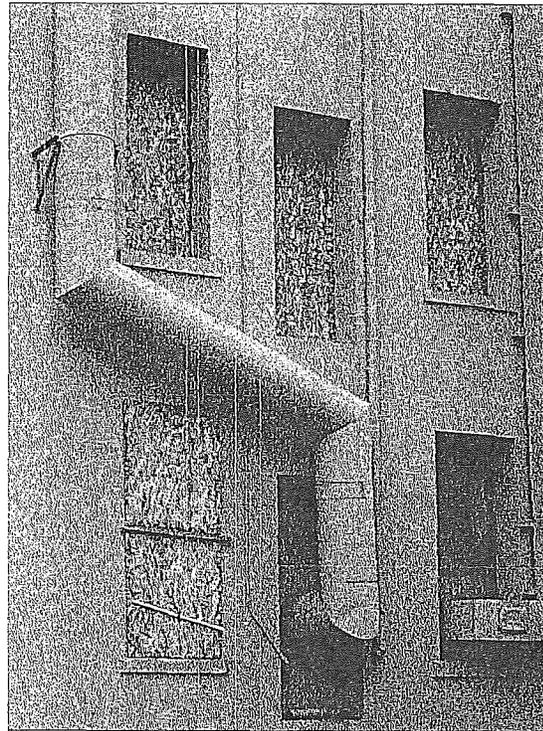
Figure 22: Detail photograph of ventilation ducts projecting through second floor openings. Note size difference between window and door openings (photograph taken on 01/26/2018).

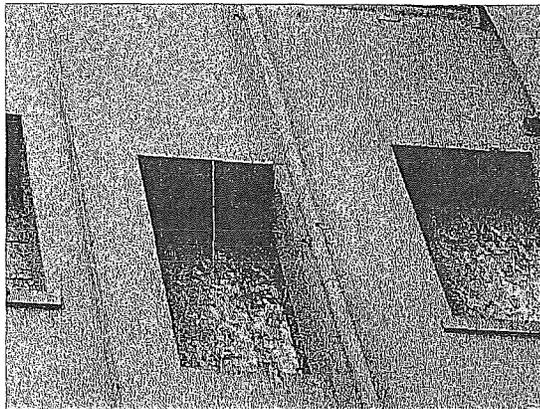
Figure 23: Detail view of punched openings. Note cracked cement plaster between window lintels (photograph taken on 01/26/2018).

Scope: # 7			
Building Feature: Cement Plaster – West Elevation			
Rehab/Restoration	<input checked="" type="checkbox"/>	Maintenance	Completed
			Proposed <input checked="" type="checkbox"/>
Contract year work completion: 2019			
Total Cost: \$131,385.00			
Description of work: Survey and remove deteriorated, unsound, debonded, missing, and cracked cement plaster. Repair substrate as needed and repair and patch cement plaster to match existing adjacent. Remove biological growth at facade by appropriate cleaning using gentle means such as warm water/detergent wash and biocide application. Treat steel exposed during the process, particularly at window heads, and prepare, prime, and paint. Prepare, prime, and repaint cement plaster with appropriate breathable paint.

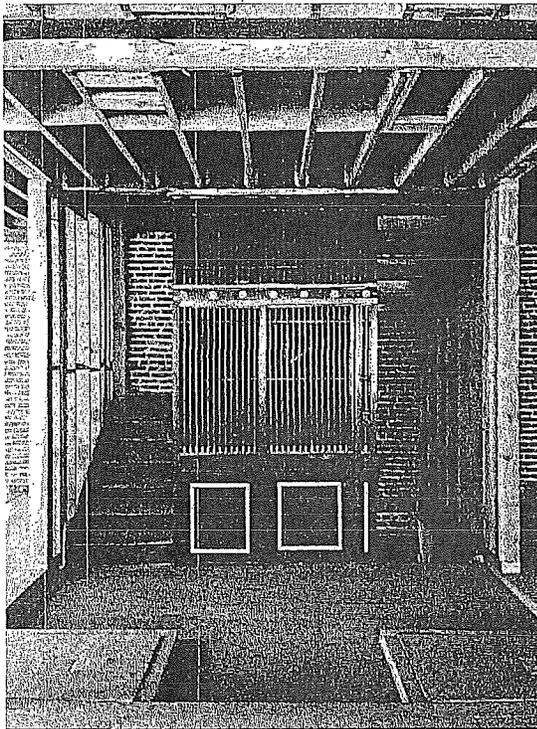
Figure 30: Detail view of stairs and elevator with ornamental metal cage at southern wall. Note differential settlement of elevator landing from the remainder of the building (photograph taken on 02/27/2018).

Scope: # 13			
Building Feature: Elevator and Stair (Structurally Connected System) - Interior			
Rehab/Restoration	<input checked="" type="checkbox"/>	Maintenance	Completed
			Proposed <input checked="" type="checkbox"/>
Contract year work completion: 2019			
Total Cost: \$986.00			
Description of work: Reattach loose elements and make general repairs/stabilize at interior stair and elevator.

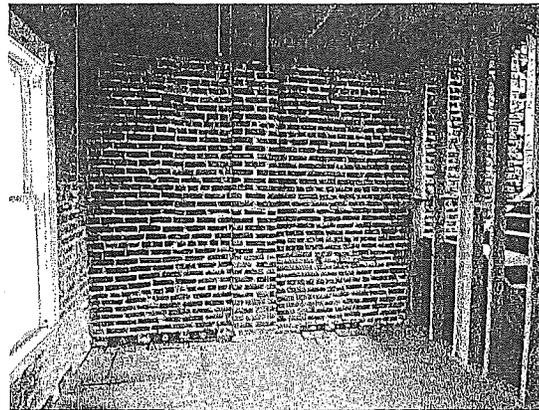
Figure 31: Interior photograph of exposed brick at south wall, fifth floor. Note minor efflorescence and deterioration of mortar (photograph taken on 02/27/2018).

Scope: # 4			
Building Feature: Brick/Masonry -- 4th and 5th Floors South Wall and Southwest Corner (Interior of brick wall)			
Rehab/Restoration	<input checked="" type="checkbox"/>	Maintenance	Completed Proposed <input checked="" type="checkbox"/>
Contract year work completion: 2019			
Total Cost: \$6,576.00			
Description of work: Remove efflorescence and soft/deteriorated mortar caused by moisture infiltration. Spot repoint as needed with compatible/appropriate mortar that matches original in color, texture, and appearance where mortar is deteriorated, loose, unsound, or missing. (Although this area is interior, moisture infiltration is coming from the roof and exterior side of the wall).

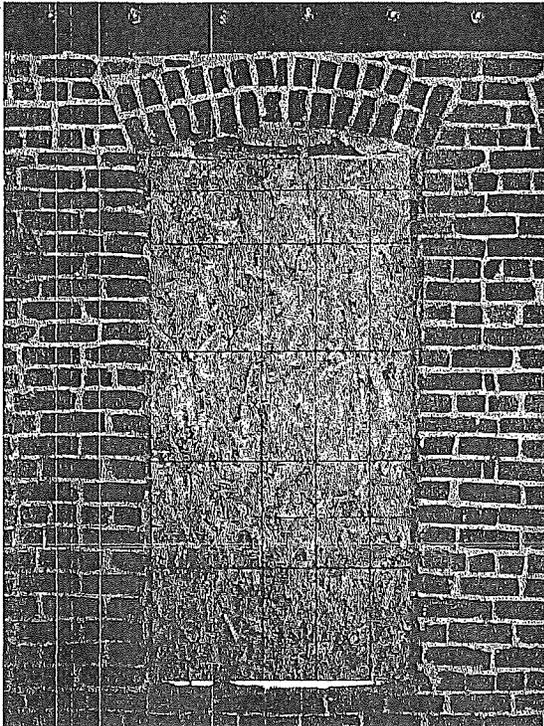
Figure 33: Detail view of typical punched window opening at western wall. Note arched brick lintel (photograph taken on 02/27/2018).

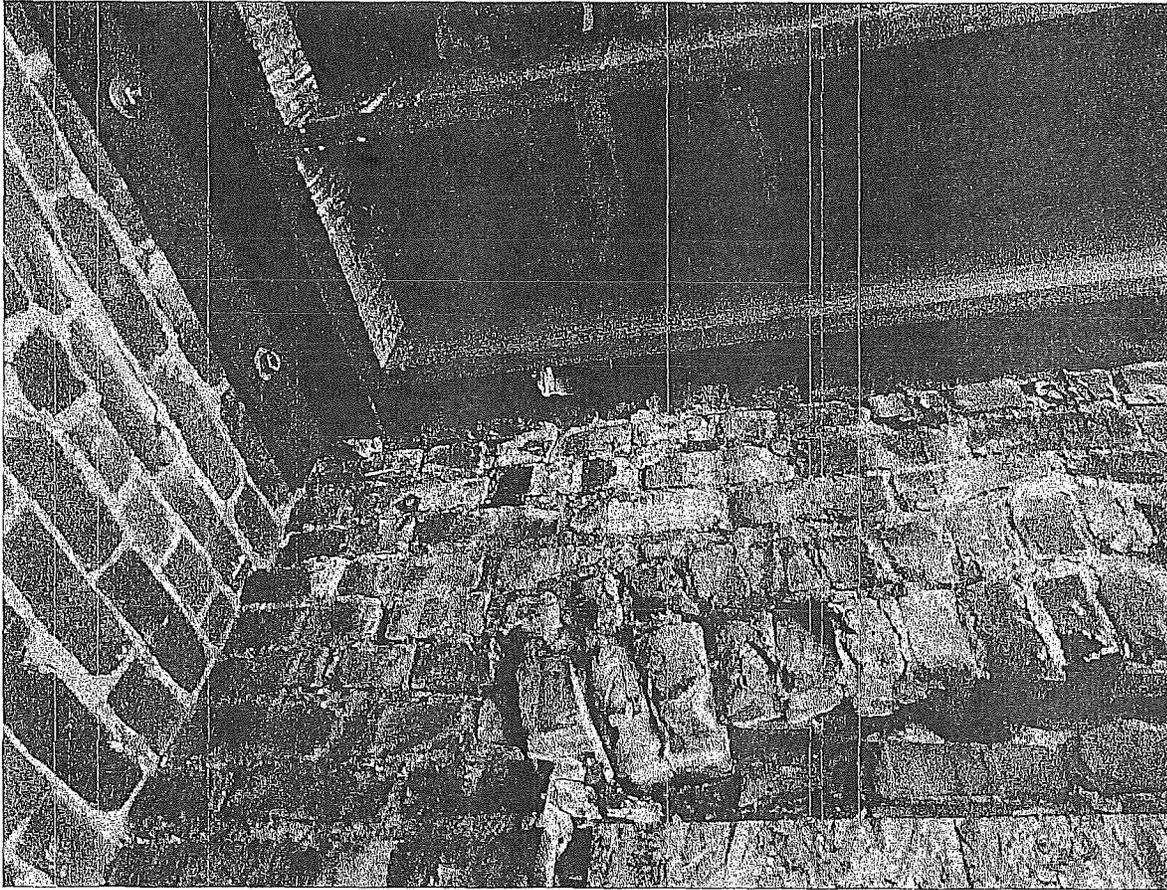
Figure 35: Detail photograph of deteriorated brick mortar joints and efflorescence above southernmost window opening at fifth level. Note rust stains surrounding metal embedments and water stains at underside of roof sheathing (photograph taken on 02/27/2018).

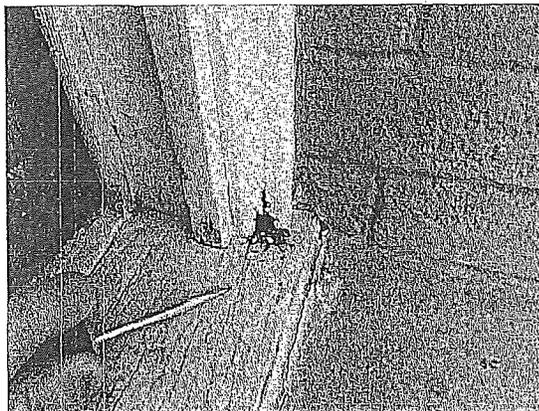
Figure 39: Detail photograph of typical deterioration at window trim (Photograph was taken on 02/27/2018).

Scope: # 6			
Building Feature: Wood Windows – Kearny/Pine Elevations			
Rehab/Restoration	<input checked="" type="checkbox"/>	Maintenance	Completed
			Proposed <input checked="" type="checkbox"/>
Contract year work completion: 2019			
Total Cost: \$125,995.00			
Description of work: Inspect and repair wood windows as needed. Repair deteriorated wood, and replace deteriorated glazing putty as needed. Replace cracked/broken/missing glass. Prepare, prime, and paint. Check sealant at perimeter of frame to masonry and replace if needed. Clean, repair/replace broken/missing hardware, and replace sash cords as needed to allow for proper operation.

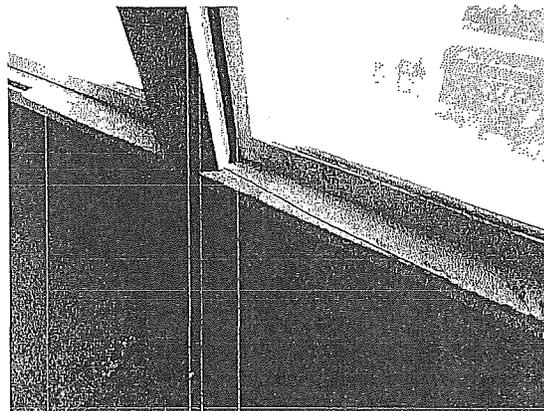
Figure 40: Detail photograph of split window sill (photograph taken on 02/27/2018)

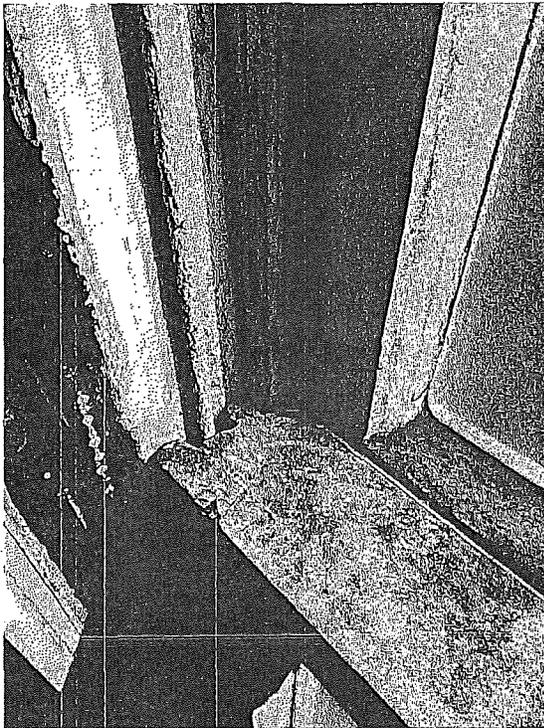
Figure 43: Detail photograph of top edge of lower sash, and sash cord. Note typical paint chipping and missing sash stop (photograph taken on 02/27/2018).

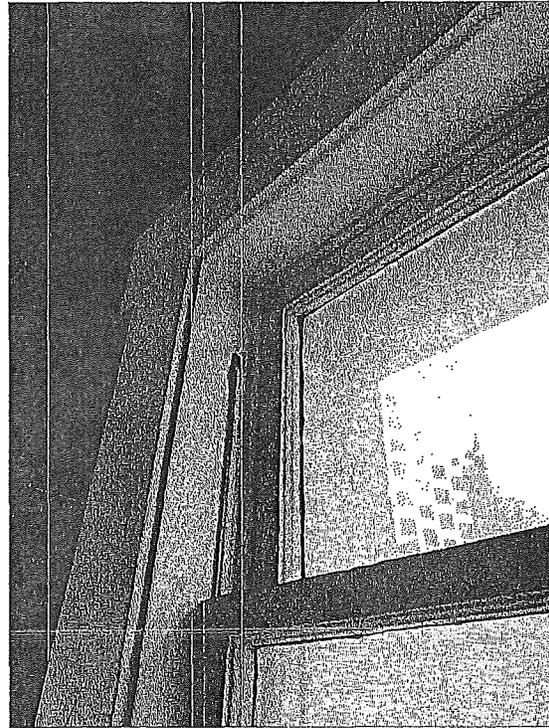
Figure 44: Detail photograph of typical window trim and sash configuration (photograph was taken on 02/27/2018).

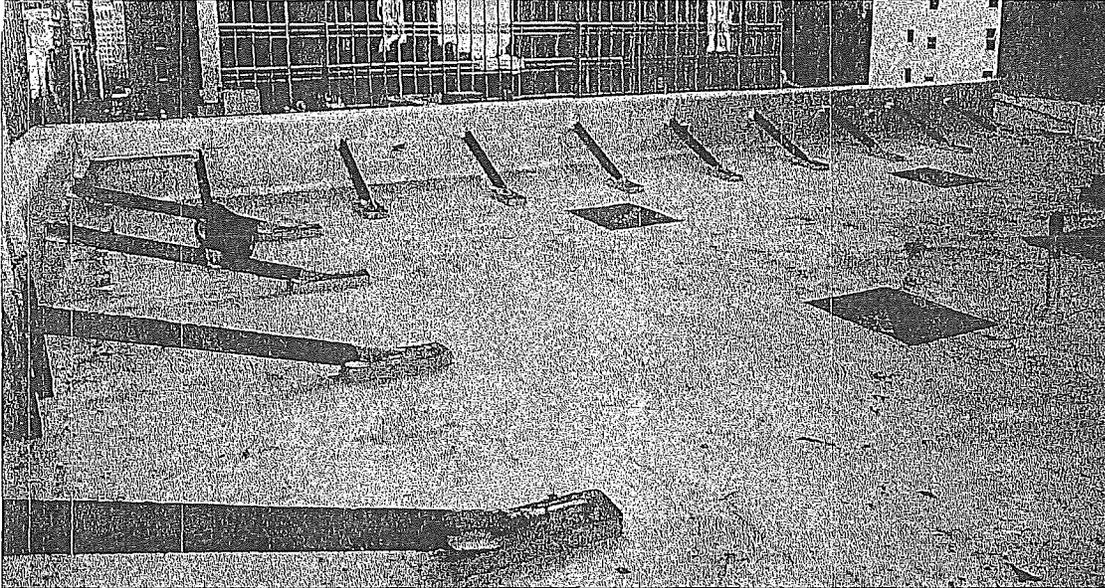
Figure 45: Photograph of built-up roof, looking east. Diagonal seismic bracing supports parapet walls (photograph taken on 02/27/2018).

Scope: # 2			
Building Feature: Existing Steel Seismic Roof Bracing -- Roof & Parapet			
Rehab/Restoration	<input checked="" type="checkbox"/>	Maintenance	Completed Proposed <input checked="" type="checkbox"/>
Contract year work completion: 2019			
Total Cost: \$10,686.00			
Description of work: Inspect to ensure all ties are secure at parapets. Repair as needed. Prepare, prime, and paint.

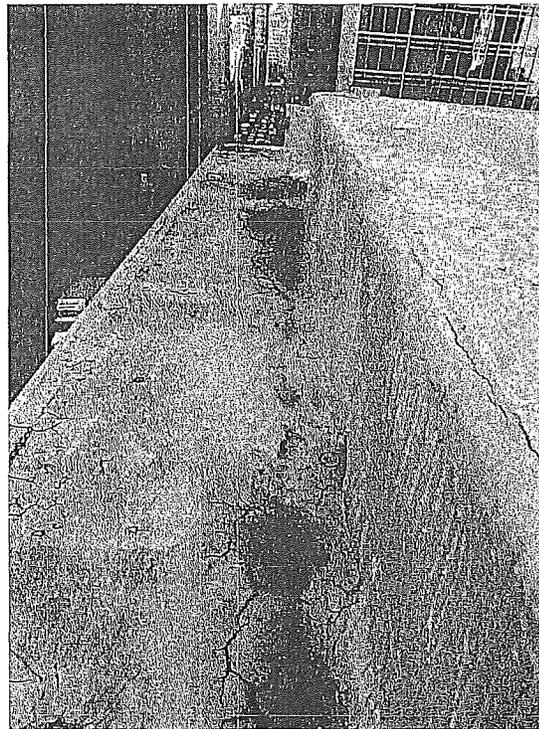
Figure 47: Detail view of parapet and top of cornice. Through-wall scuppers at the northern and eastern parapet walls drain the cornice back to the roof (photograph taken on 02/27/2018).

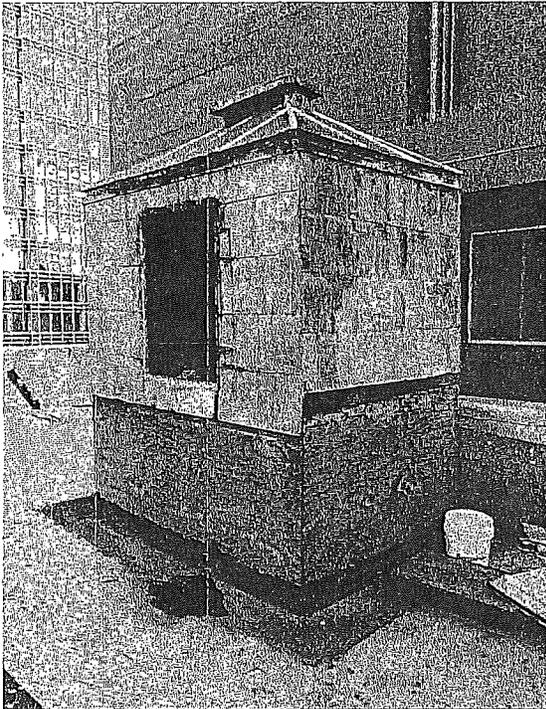
Figure 48: Photograph of elevator penthouse clad in metal panels over wood sheathing. Note surface corrosion on metal panels and missing access door (photograph taken on 02/27/2018)

Scope: # 3			
Building Feature: Elevator Penthouse -- Roof			
Rehab/Restoration	<input checked="" type="checkbox"/>	Maintenance	Completed Proposed <input checked="" type="checkbox"/>
Contract year work completion: 2019			
Total Cost: \$78,481.00			
Description of work: Repair elevator penthouse cladding where removed or damaged. Replace exposed plywood substrate as needed and provide new similar sheet metal paneling to meet new roofing system. Repair existing where feasible. Replace missing door to elevator penthouse for weather resistance, safety, and security. Clean out debris and bird guano, etc. from open/exposed penthouse as needed for proper operation and maintenance of historic elevator. Repair/replace glazing putty/sealant at rooftop skylight as needed. Replace broken/cracked glass as needed. Prepare, prime, and paint glazing putty, metal skylight, and sheet metal at elevator penthouse.
