File No. 171103

**940 Grove Street (1895)**  
Queen Anne Style

*Case No.:* 2017-005887MLS  
*Project Address:* 940 Grove Street  
*Landmark District:* Contributor to the Alamo Square Historic District  
*Zoning:* RH-3 (Residential-House, Three Family)  
*Height and Bulk:* 40-X  
*Block/Lot:* 0798/058  
*Applicant:* Smith-Hantas Family Trust  
940 Grove Street  
San Francisco, CA 94117

940 GROVE STREET, SAN FRANCISCO  
Historic Structure Report

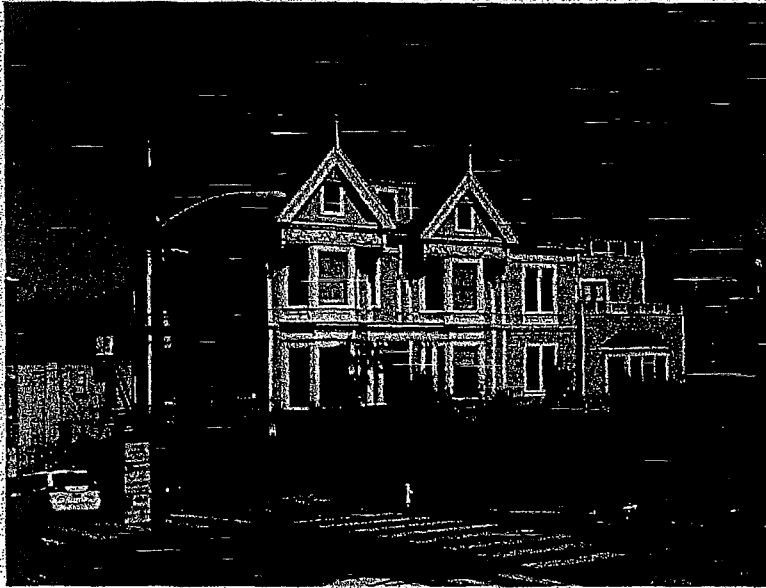
Figure 1. Overall view of 940 Grove Street, looking northeast (Garavaglia Architecture, Inc., October 2016)

940 Grove Street is an important part of San Francisco's historical and architectural heritage (see Figure 1). Designed in 1895 by master architect Albert Pissis of the architecture firm Pissis and Moore, the house was a single-family residence for its first decades. Later, the house served as an educational institution and then as a facility for special-needs children. Several additions were constructed around the house with this change in use, which also led to considerable deterioration of 940 Grove Street's historic fabric. Fortunately, due to the current owner's commitment to preserving this significant historic building, 940 Grove Street has been saved from demolition and rehabilitated.

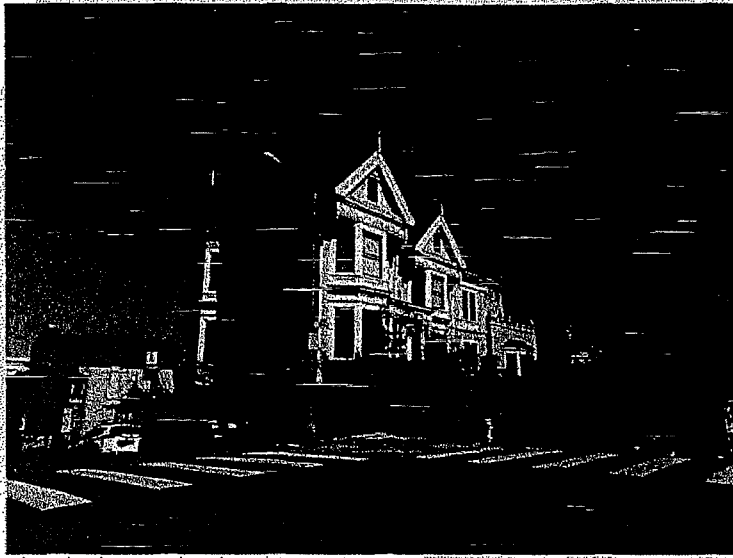
Figure 7. View of 940 Grove Street, with front yard along Grove Street surrounded by concrete retaining wall, looking northeast (Garavaglia Architecture, Inc., October 2016)

940 Grove Street sits on an eastward-sloping corner lot, at the intersection of Grove and Steiner Streets (see Figure 7). The house is elevated above the street level, as are its front and side yards. The house's front yard extends the length of the lot along Grove Street, and leads to a side yard at the eastern end of the property (see Figure 8). The front and side yards are enclosed by a concrete retaining wall built along the south and east property lines that is topped with an iron-post fence along Grove Street and a wood fence near the east end of the lot. The house is built to the west property line facing Steiner Street, while a narrow walkway along the north end of the lot separates the house from the neighboring lot to the north.

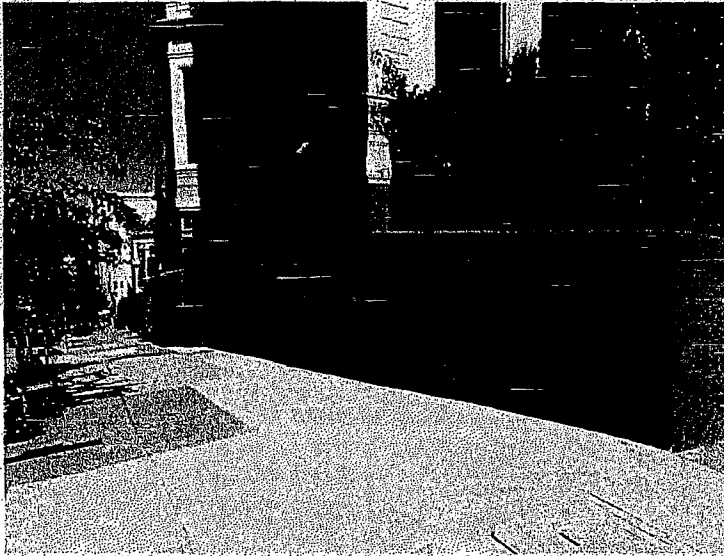
Figure 9. View of concrete retaining wall/ foundation along Steiner Street, with upper portion scored to resemble ashlar masonry, at center of photo, and more recent alteration to concrete retaining wall at right, with board-formed texture differentiating it from the historic retaining wall (Garavaglia Architecture, Inc., October 2016)

The building sits on a concrete and steel foundation, which has been partially scored to resemble ashlar masonry along the building's Grove Street facade and Steiner Street elevation (see Figure 9). Windows at the raised basement are covered with wrought-iron grilles.

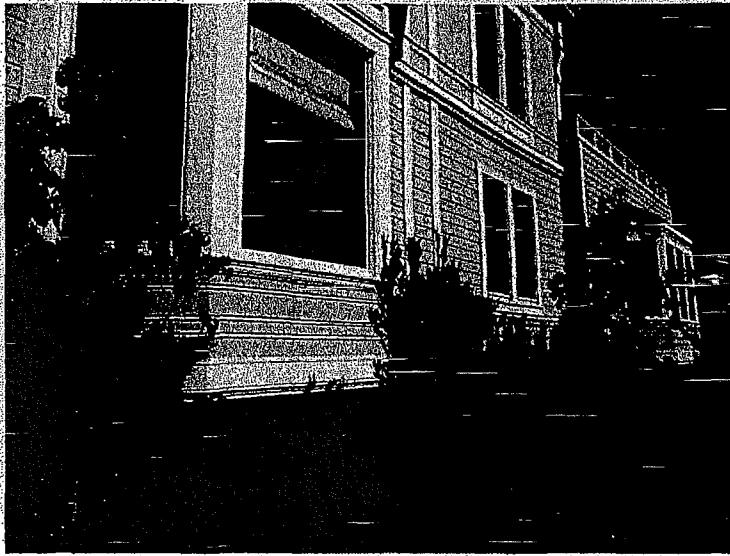
Figure 10. View 940 Grove Street's three types of wood siding along the south facade of the house, with different siding found above the raised basement, at the first floor, and at the upper floors (Garavaglia Architecture, Inc., October 2016)

The house is clad with three types of wood siding at its street-facing south and west elevations (see Figure 10). Profiled horizontal wood siding is found on a thin band between the raised concrete foundation and the first floor. The wood siding found at the first floor is horizontal clapboard siding. The second floor and attic are clad with tongue-and-groove wood siding. The secondary north and east elevations are clad with clapboard wood siding at all levels. The fenestration consists primarily of one-over-one double-hung wood windows.

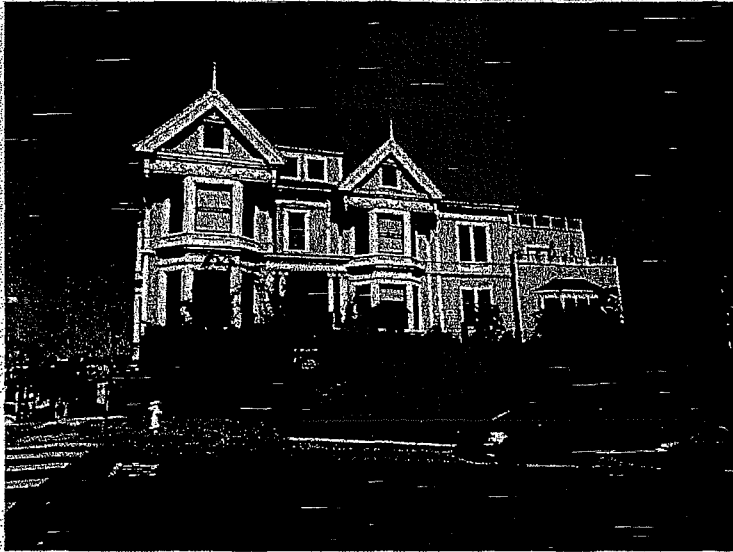
Figure 12. View 940 Grove Street's south facade along Grove Street (Garavaglia Architecture, Inc., October 2016)

The south (Grove Street) facade is accessed via concrete steps toward the west end of the property, which are located in a break in the concrete retaining wall at this elevation (see Figure 12). Another break in the concrete retaining wall provides access to the subbasement-level garage toward the east end of the property.

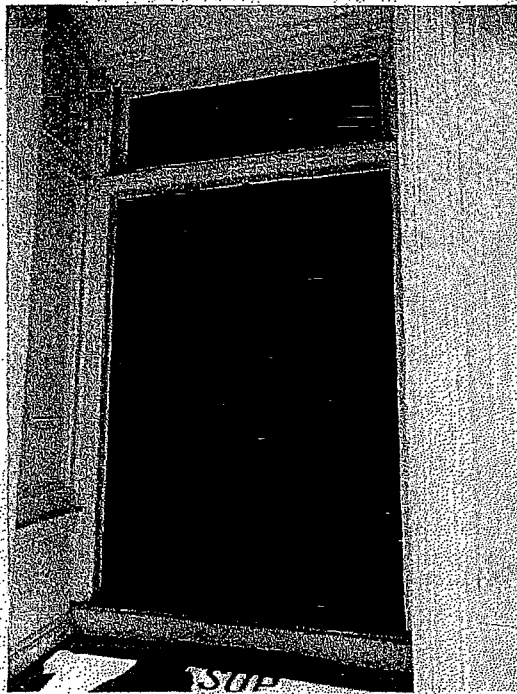
**Figure 14. Carved wood main entrance doors of 940 Grove Street, with encaustic-tile flooring in front of doors (Garavaglia Architecture, Inc., October 2016)**

The concrete entrance steps transition to marble steps in front of the covered main entrance portico (see Figure 13). The entrance portico has encaustic-tile flooring, and is framed by Ionic columns. The paired wood main entrance doors have carved scrolls and profiled paneling, and are topped with a single-lite transom (see Figure 14).

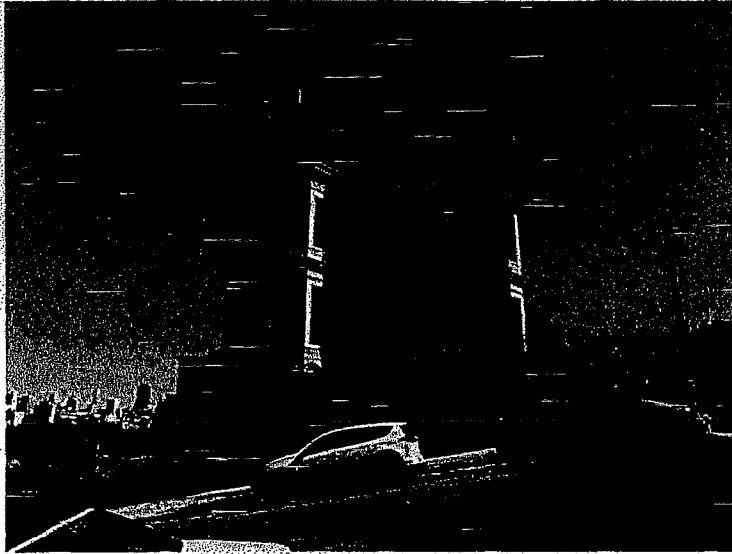
Figure 15. Steiner Street elevation of 940 Grove Street (Garavaglia Architecture, Inc., October 2016)

The west-facing Steiner Street elevation is nearly as decorative as the Grove Street facade, as it is also street-facing (see Figure 15). The house is built up right to the lot line at this elevation, and the raised basement is especially prominent at this facade as Steiner Street slopes downward to the north. There are no entrances to the house at this elevation.

The exposed concrete basement is painted a dark bluish-gray, matching the color of the retaining wall that wraps around to the Grove Street side of the lot. The upper portion of the concrete basement is textured to resemble ashlar masonry. Two small rectangular windows are located along the top of the raised basement, and are covered with wrought-iron grilles. The siding treatment at this elevation is the same as at the Grove Street facade.

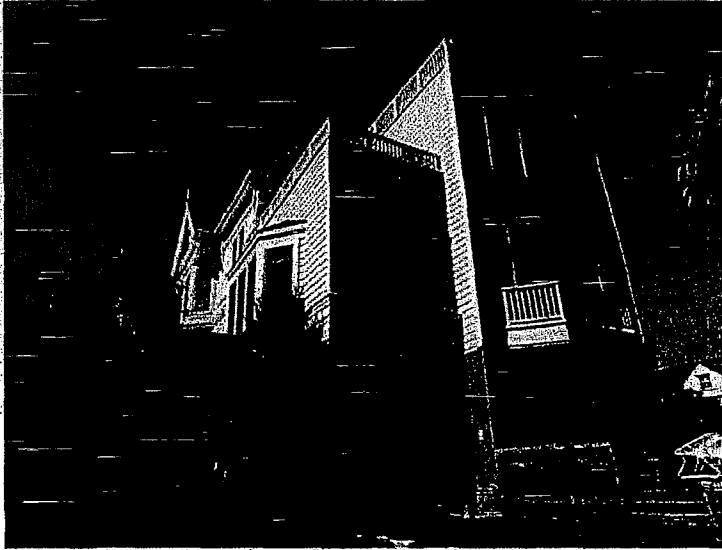
Figure 19. East elevation of 940 Grove Street (Garavaglia Architecture, Inc., October 2016)

The east elevation faces a neighboring lot to the east along Grove Street, and is minimally visible from Grove Street. This elevation is set back further from the lot line than the other elevations, with a large multilevel side yard separating 940 Grove from the neighboring house (see Figure 19).

The concrete basement level is entirely exposed at this elevation, and has one paired window assembly at the left end of the elevation and a secondary entrance to the house at the right end. The upper levels of this elevation are almost entirely clad in wood clapboard siding, with some decorative wood trim elements carried over from the more elaborate Grove Street facade (see Figure 20)

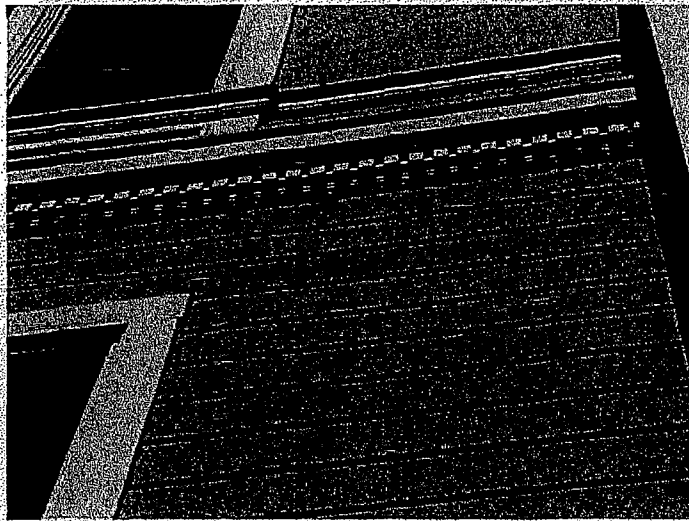
Figure 24. Peeling paint at the south facade (Garavaglia Architecture, Inc., October 2016)

The exterior of the building was painted in 2015. Although recently applied, this paint is already beginning to fail, and this condition has been exacerbated by unusually heavy rains in early 2017 (see Figure 24).
