This memorandum has been prepared to document the findings of the Page & Turnbull exploratory team who were on site at Toland Hall on February 11-12, 2020 and also on February 27, 2020 and to provide a preliminary approach to relocation to inform a rough order of magnitude cost estimate prepared by tbd Consultants (attached). The purpose of these site visits was three-fold: 1) to evaluate the current condition of the Zakheim "History of Medicine" frescoes against conditions that were documented by Anne Rosenthal in 2011, noting further deterioration or changes; 2) to investigate and determine the original installation and construction techniques of the artwork in order to prepare a forthcoming recommended approach for extraction and relocation; and 3) identify initial preparation for relocation. The findings are summarized below as noted by experts in the field of fine art conservation and moving:

CURRENT CONDITION OF THE FRESCOES

Appendix A: Fresco Photographs with Key and Probe Locations

Appendix B: Sketch and Photographs of Existing Conditions

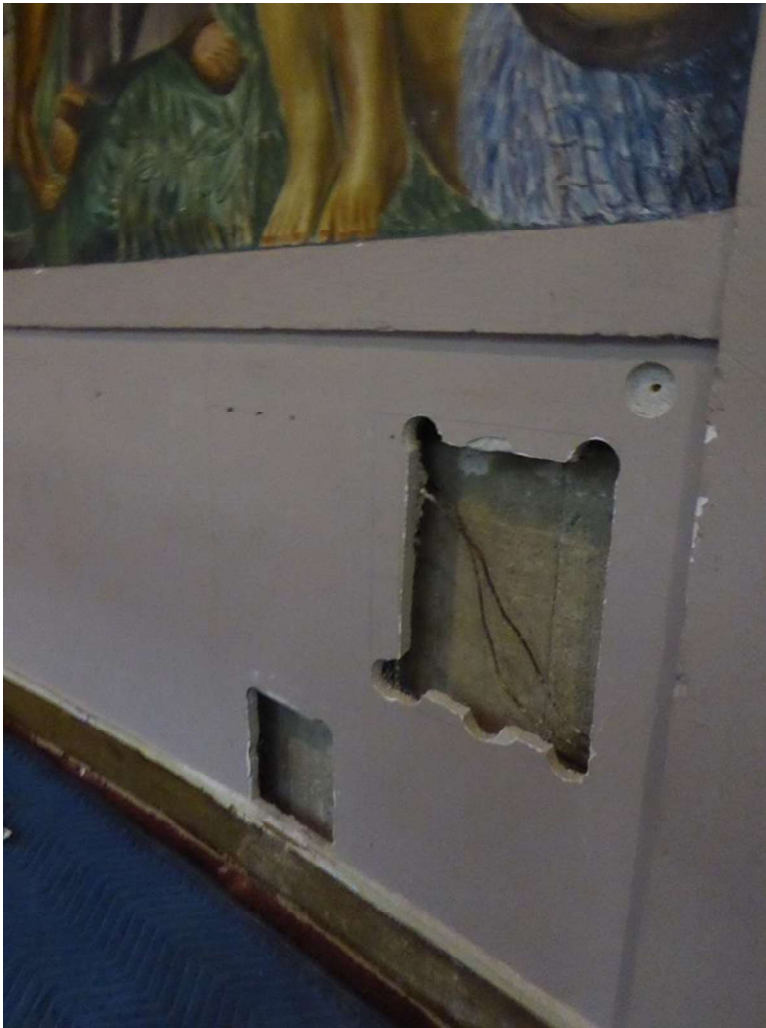
From this investigation Atthowe determined that the soffit ceiling and the wall are made from the same plaster and lathe technique. The fresco wall is constructed using metal vertical supports (furring) with a wooden nailer bound to them by wire clips. It appears that the lathe was nailed to the wooden elements to form the curve of the wall. Atthowe was able to observe the plaster and lathe extending above the image area of the fresco.

Figure 1: two access panels were removed to investigate construction and attachment of fresco wall

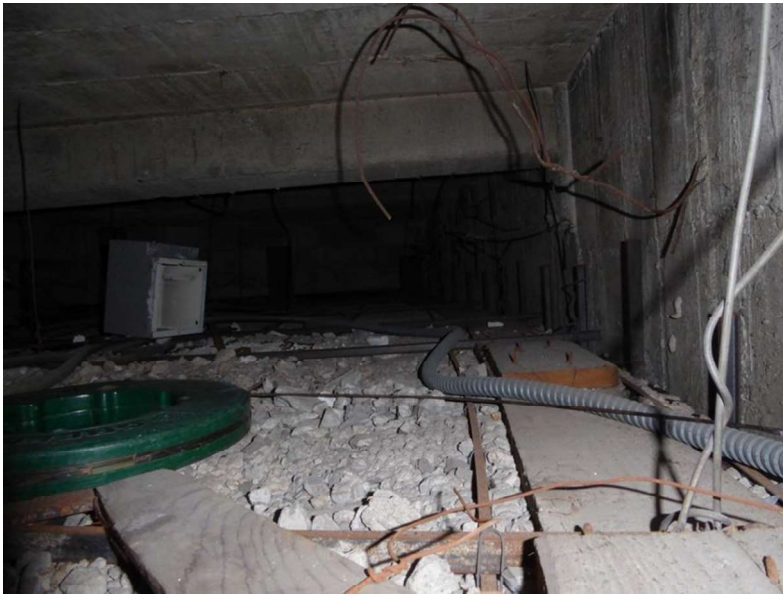
Figure 2: Image looking across plenum space above fresco wall, showing concrete rear wall, ceiling and lathe and plaster soffit.

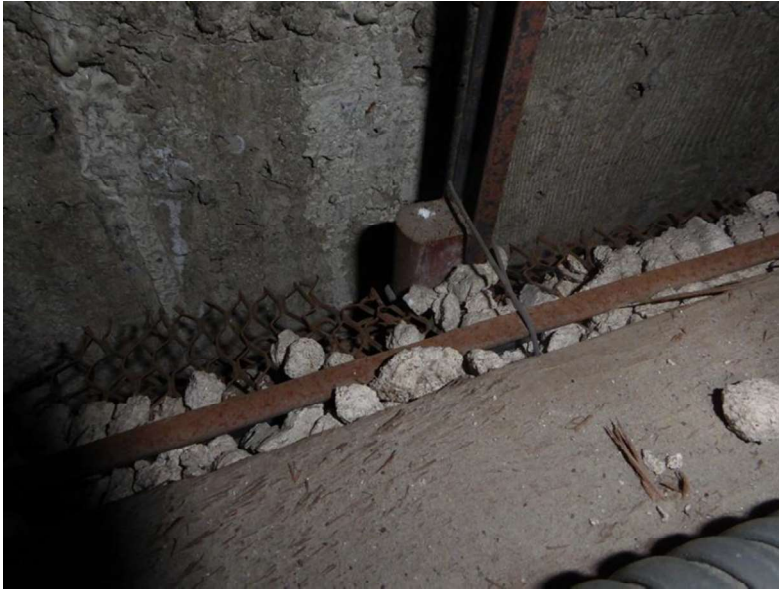
The structural support of the frescoes' plaster wall is constructed from metal furring approximately 1 ½" x 1" that extend from floor to ceiling and are approximately 14" on center. These metal furring strips follow a curved concrete curb form at floor and ceiling and seem to only be attached at those points. The upright metal furring strips do not appear to be secured to the concrete structural wall however it is possible that there are some metal ties that would need to be severed once the fresco is secured in place.

Figure 3: View looking down toward rear of fresco showing metal furring with wood nailer and attachment

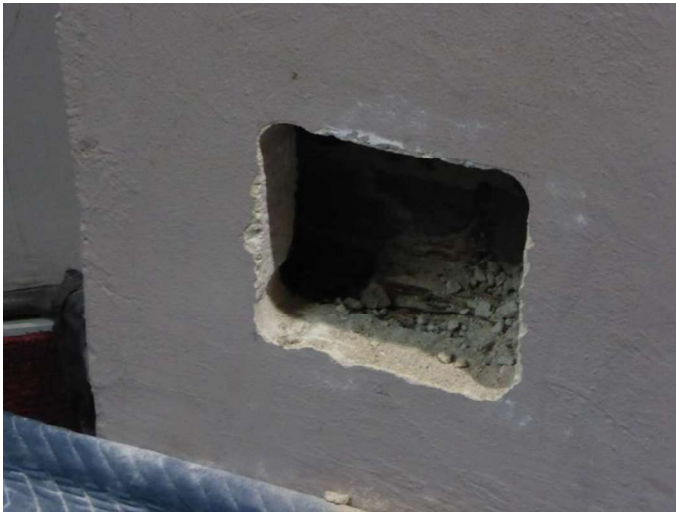
The sides of each fresco are bound by a decorative plaster pilaster, while the base of each fresco panel is framed by a decorative plaster molding strip. The exploration team removed a core sample at the molding strip and a square panel at a pilaster along a flat wall in the front of the auditorium to confirm this construction. The removal of a panel at the pilaster revealed finish paint on the wall below, suggesting that the decorative pilasters may have been installed along with the frescoes in 1936-1938, twenty years after completion of the building. There are two unbound frescoes, one on either side of the flat wall that describe and title the overall work – these would be removed with the same technique as the other flat frescoes.

Figure 4: Decorate plaster pilaster

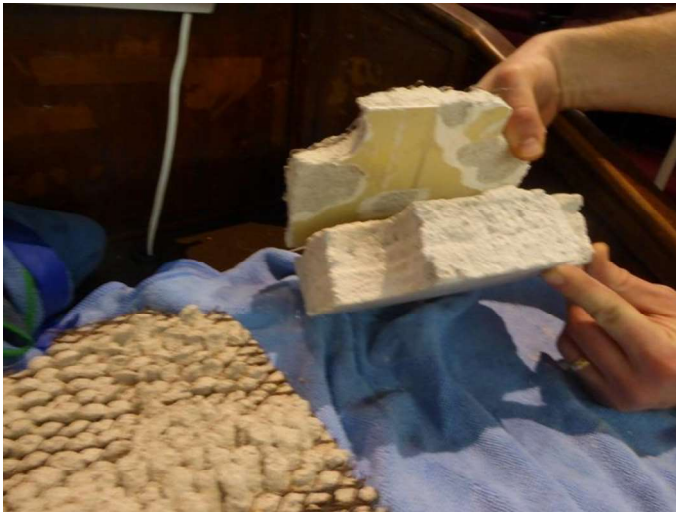
Figure 5: Access panel from pilaster shows finish paint between layers of plaster.

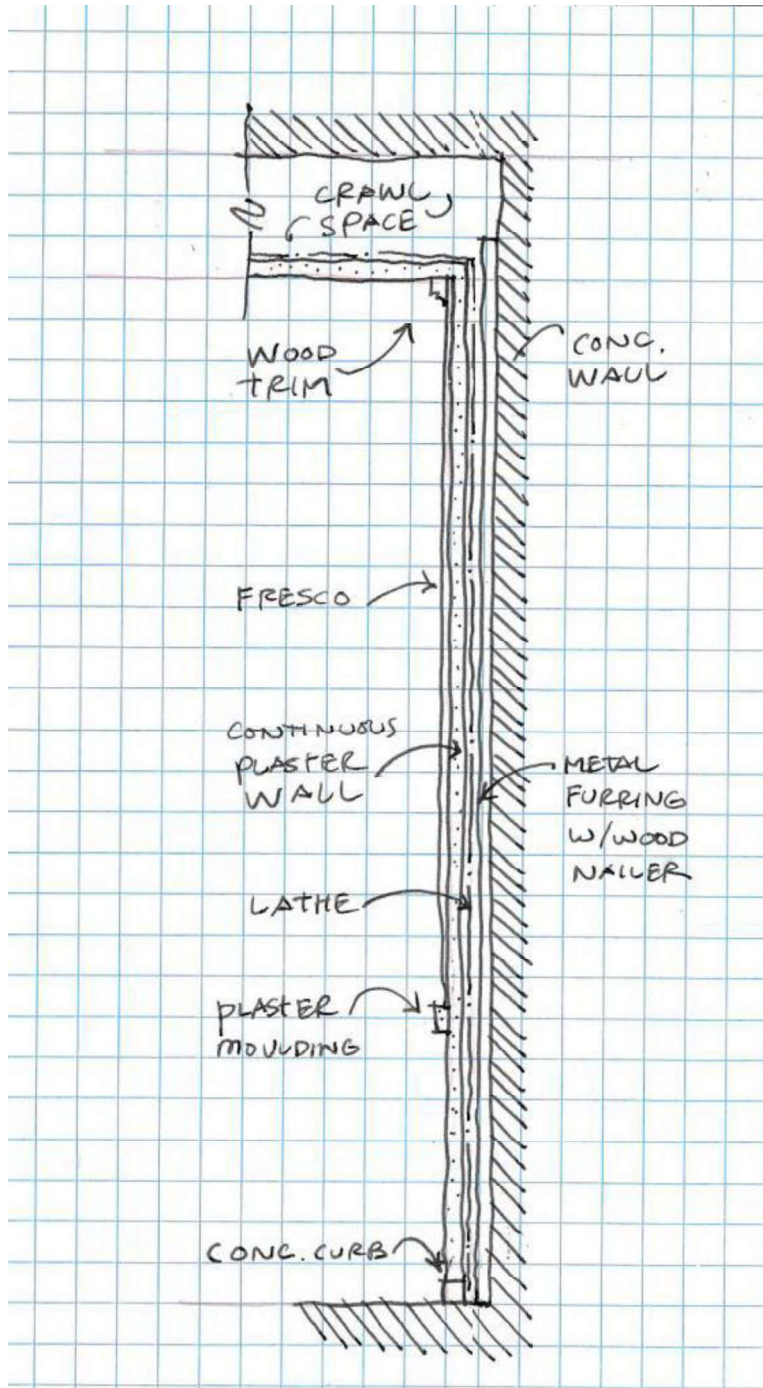
Figure 6: Wall section at typical curved fresco wall

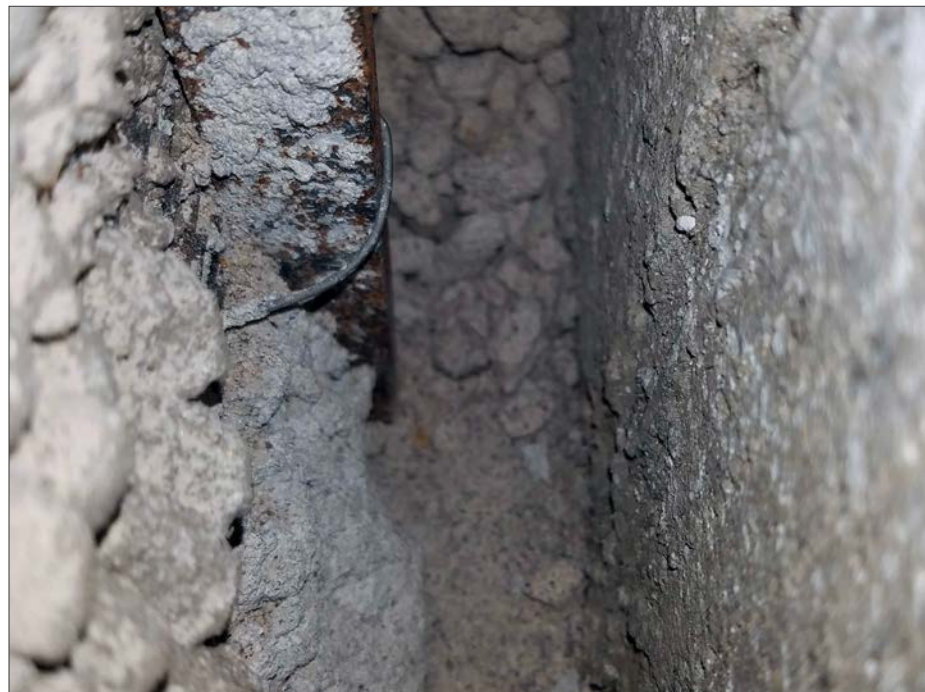
Probe 1, looking down. Note the vertical furring channel with wire tie. The black iron does not appear to be set in the concrete, but sits on top of the concrete. Note the amount of plaster debris in the void space.

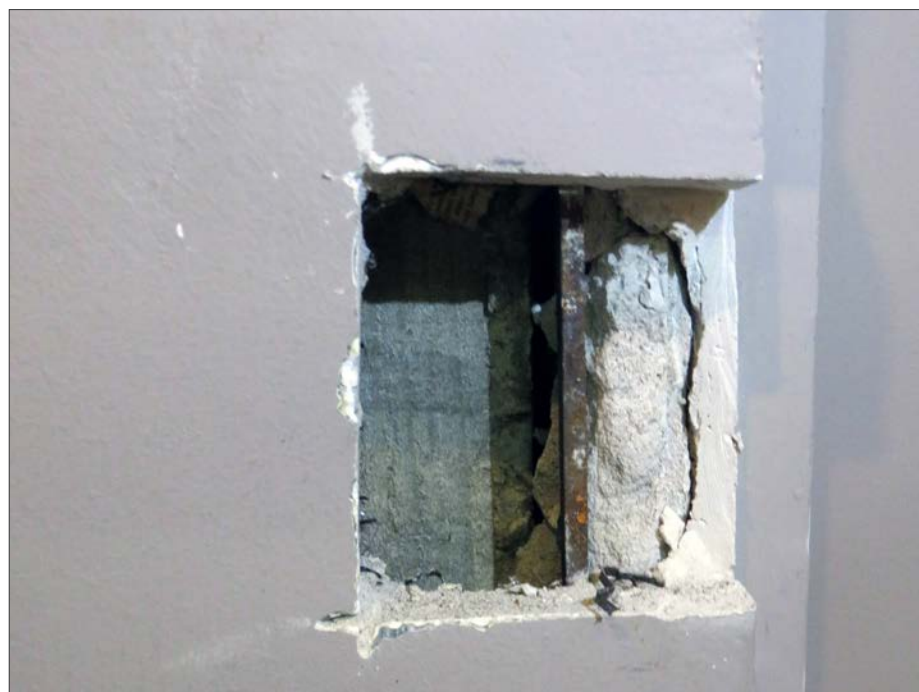
Probe 3. Note the black iron furring channel in the corner. The void space here was not filled with plaster debris, which is consistent with it being an area of repair.

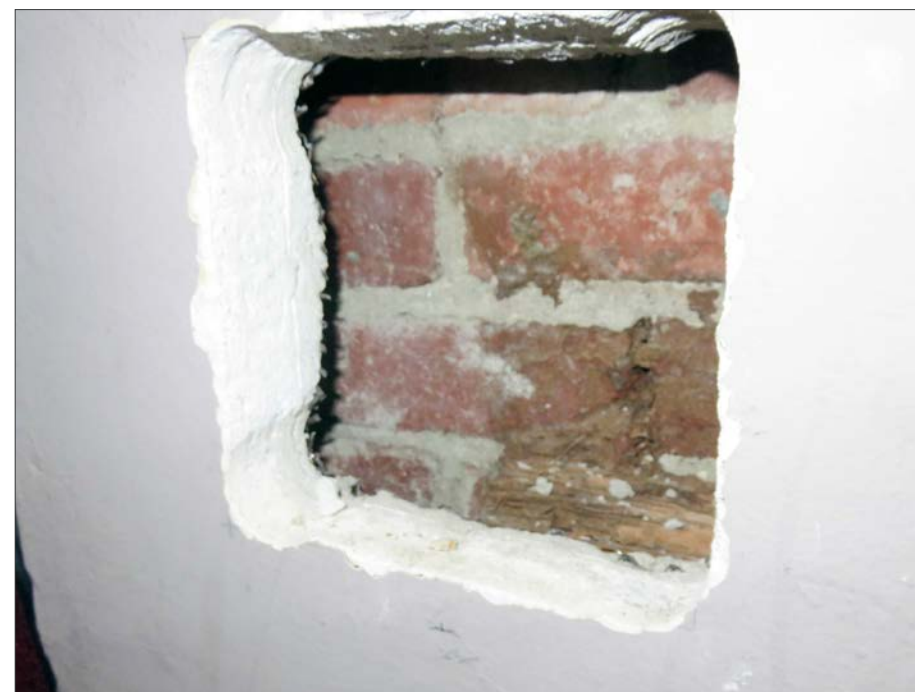
Probe 6. Note the wood block in the lower portion of the opening.

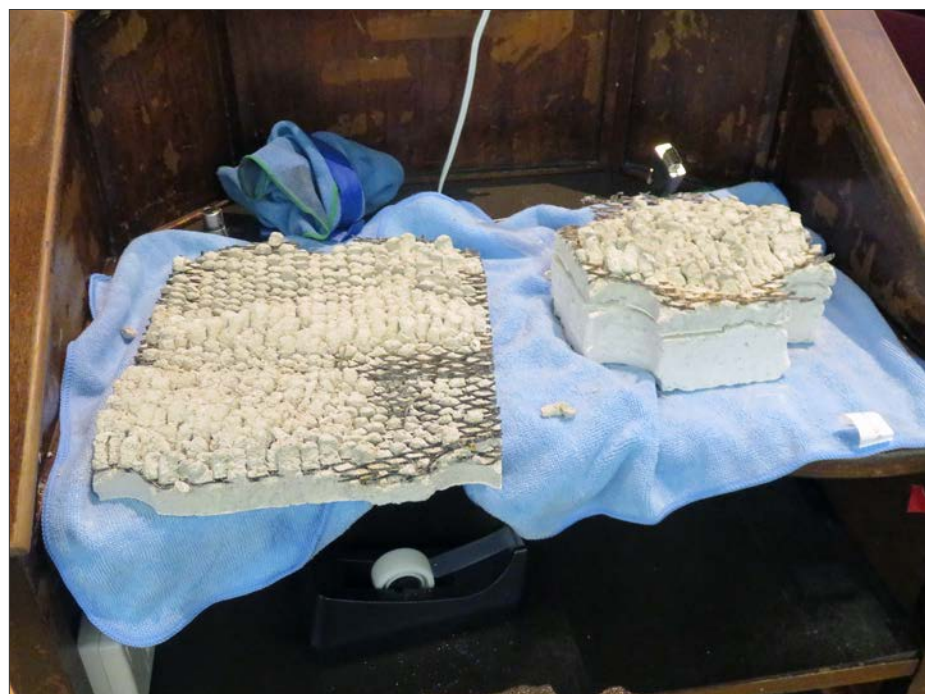
Plaster from Probe 1 and Probe 6. Note the presence of a distinct scratch coat and brown coat.

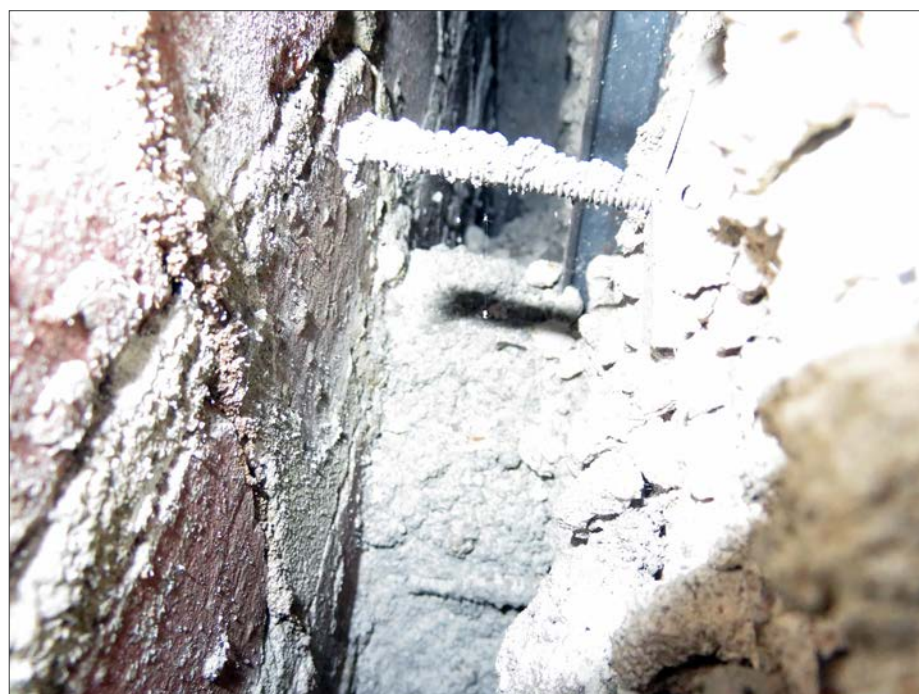
Probe 5, looking to the right and slightly down. Note the wad of mortar in the void at the furring channel. The toggle bolts are part of the handrail installation.

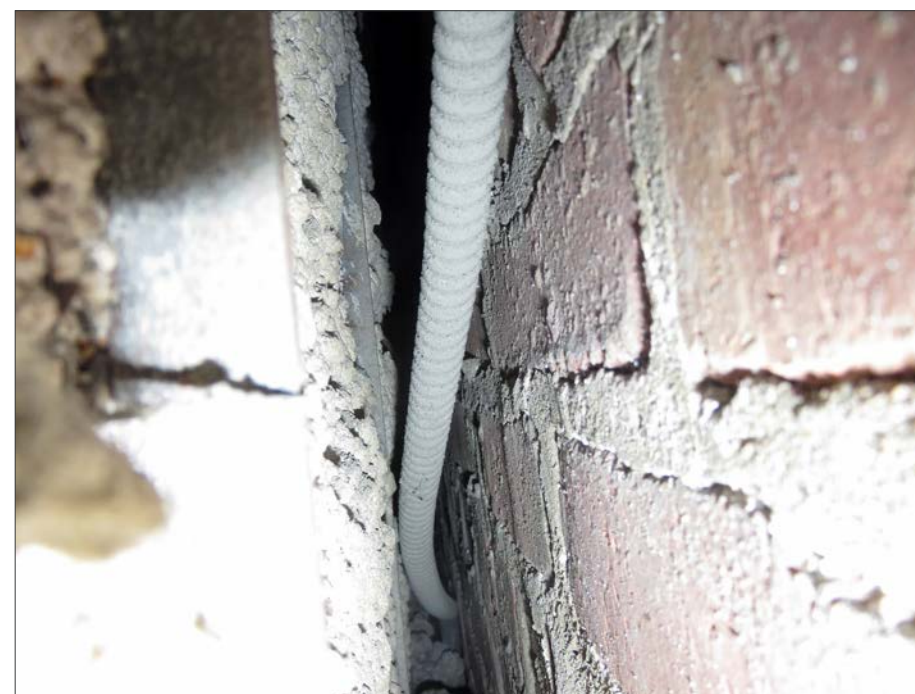
Probe 6 looking up to the left. Note the conduit crossing above the probe opening.

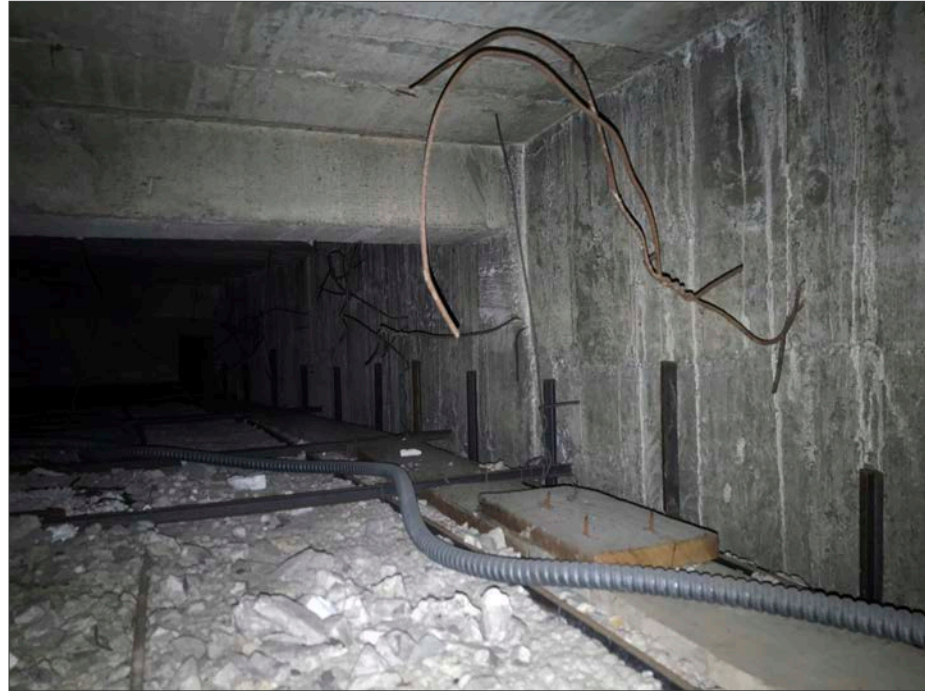
Ceiling above Fresco 3. Note the ceiling framing and the vertical furring channels of the fresco supports. Photo by Tuan and Robinson.

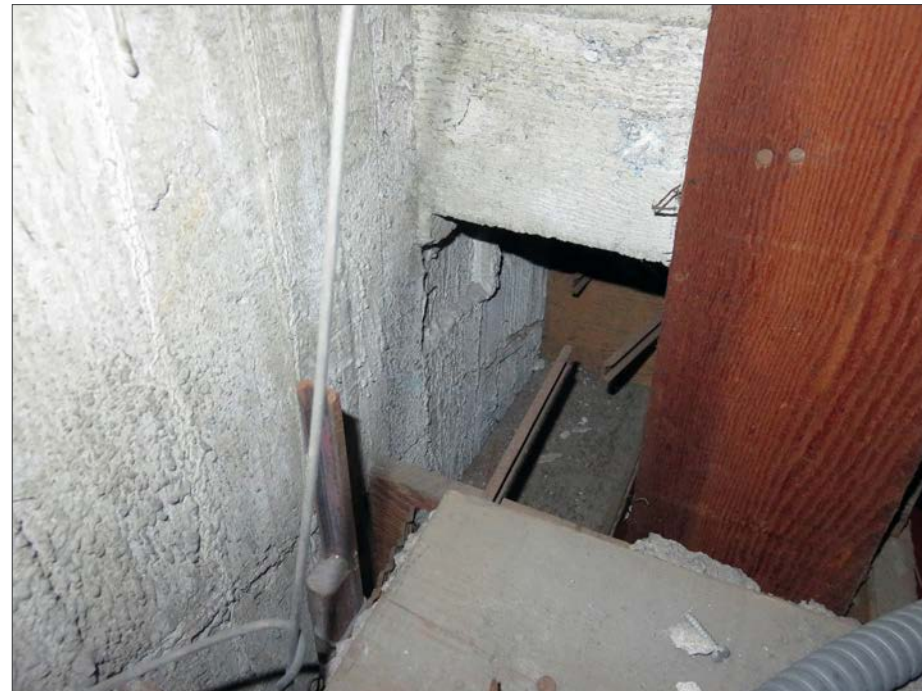
Pilaster between Frescos 3 and 4 from above. Note the board nailed to the concrete and supported furring channels of the ceiling.

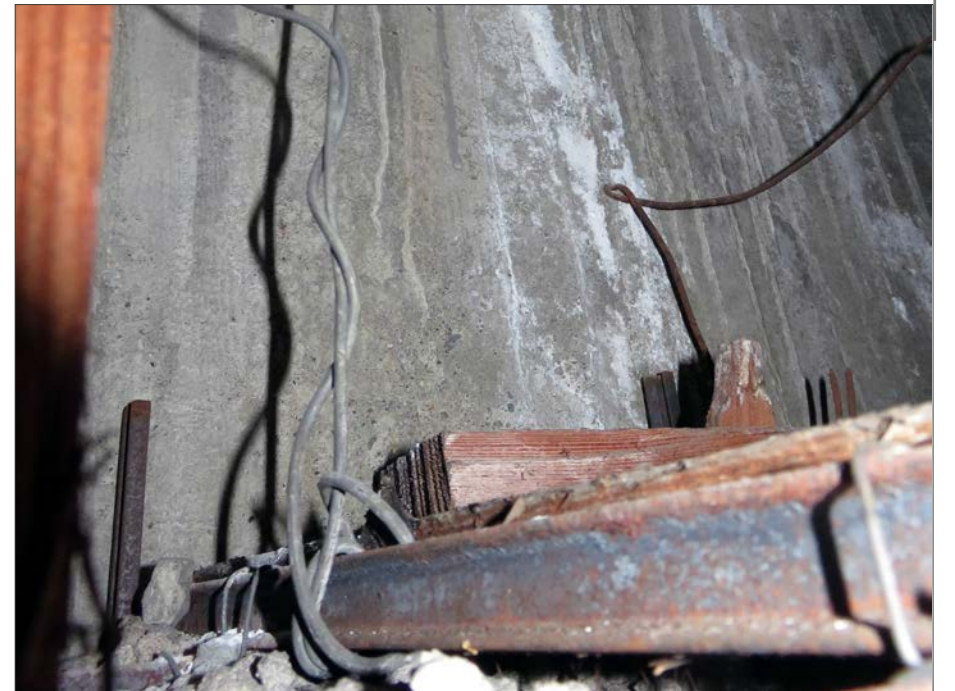
Ceiling above Fresco 7. Note the salts on the concrete from moisture infiltration and the use of the concrete form tie to hang the black iron support of the ceiling.

- Moisture readings indicate that the curved wall of the room retains more water than the flat wall at the front of the room. This higher moisture reading is likely related to the concrete being an exterior wall, portions of which act as a retaining wall.
- Two frescos show significant water damage through finish loss and salt formation on the surface of the frescos. A probe was opened at the west fresco showing signs of moisture damage, as this was an area of heavier damage and salt formation. Moisture readings were taken of the wood and concrete above the wall and indicate that this area is wet. This information was used to develop treatment recommendations for the water damaged panels.

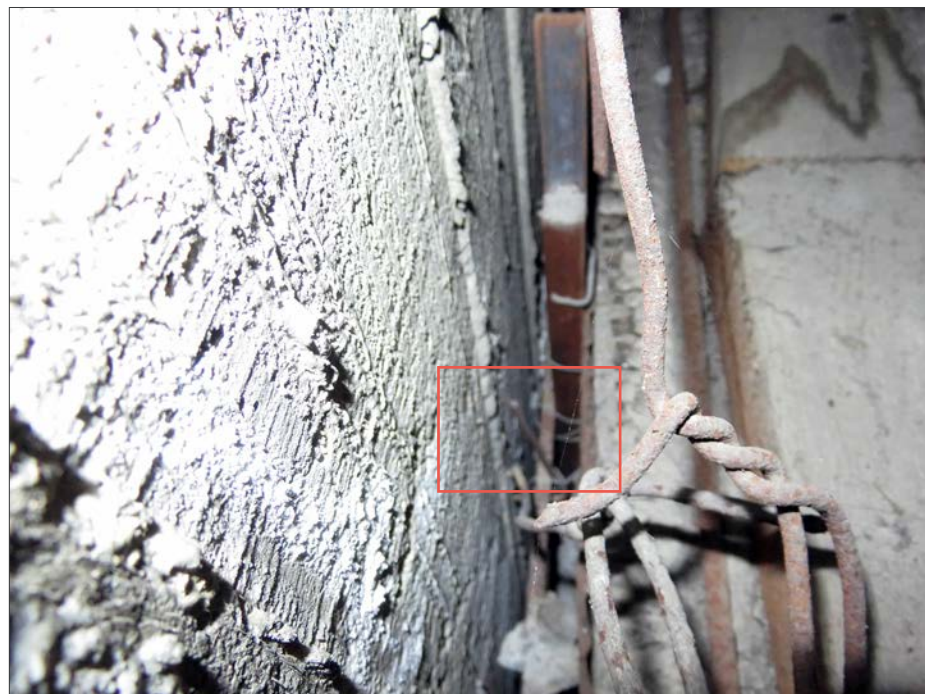
- The curved furred wall assembly has minimal attachment to the reinforced concrete. Only two points of attachment could be verified, at the top and bottom of the fresco panels where the form tie wires from the concrete are wrapped around the vertical furring channels. When viewed from above and below via the ceiling and probe openings, the rebar system noted in the 2006 Baycor Builders report was not seen, and no additional attachment points could be confirmed.

View behind Fresco 3 from above. Note the form tie used to attach the vertical support to the wall.

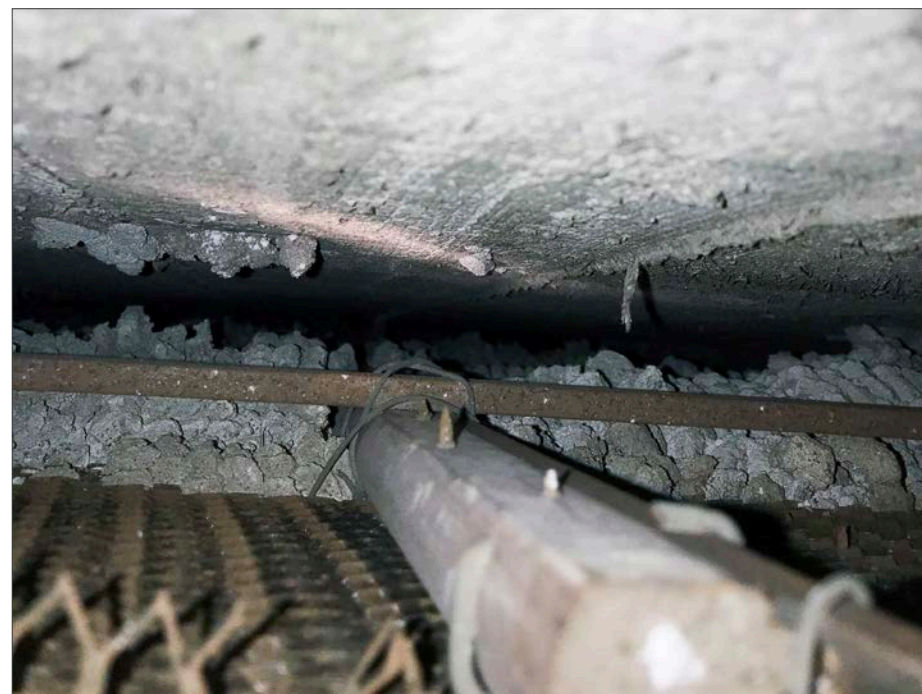
View behind Fresco 3 from above. Note the small void space and horizontal channel wire tied to the vertical furring channel. Photo by Tuan and Robinson.

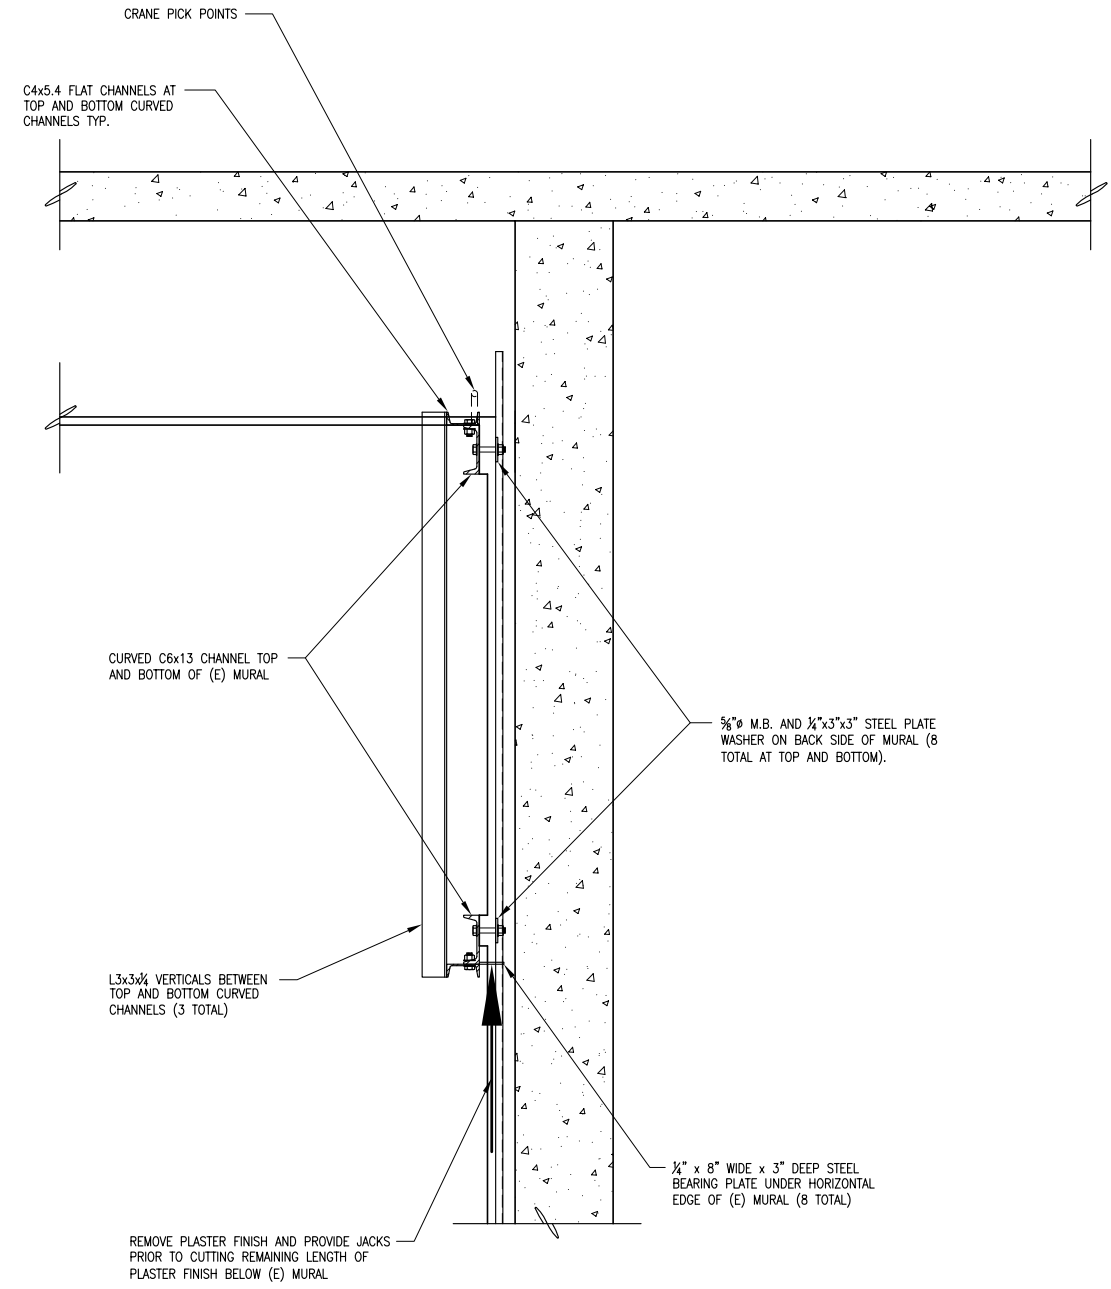
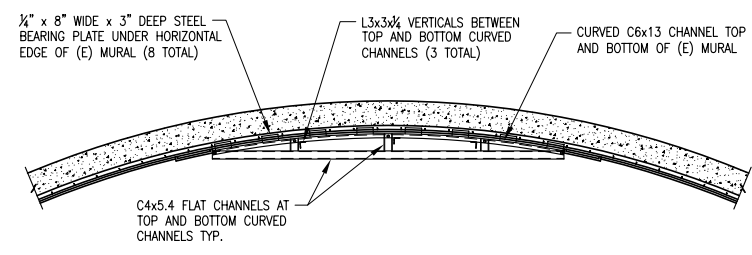
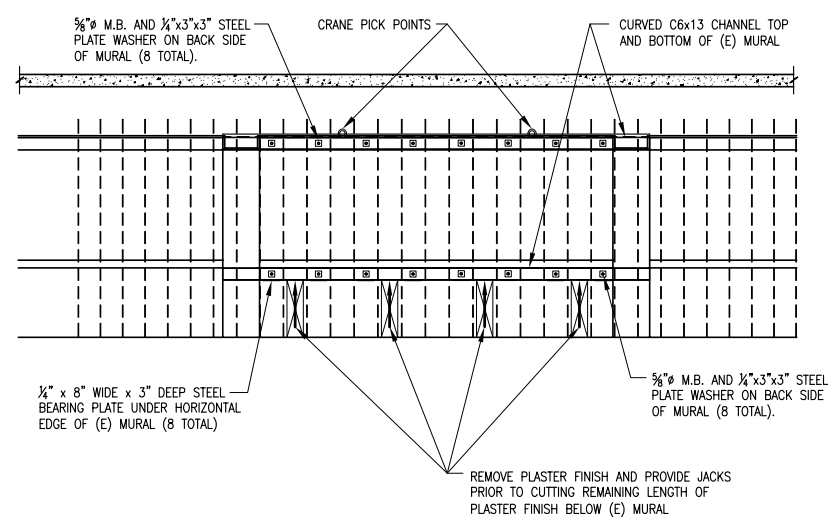
Appendix C: Frame System Sketch by Tuan and Robins Structural Engineers, Inc.

3 MURAL SECTION 1" = 1'-0"

2 MURAL PLAN 1/4" = 1'-0"

1 MURAL ELEVATION 1/4" = 1'-0"

5. PLACE THE UPPER CURVED STEEL CHANNEL ABOVE THE MURAL AND REMOVE THE PLASTER CEILING TO PLACE THE STEEL PLATE WASHERS BEHIND THE MURAL AND ATTACH TO THE CURVED STEEL CHANNEL WITH THROUGH BOLTS.

6. BOLT THE FLAT CHANNELS WITH THE VERTICAL ANGLES TO THE TOP OF THE UPPER CURVED CHANNEL AND BELOW THE LOWER CURVED CHANNEL.
7. REMOVE THE REMAINING WALL AND CEILING PLASTER AROUND THE MURAL TO REMOVE THE MURAL. KEEP MURAL RELATIVELY VERTICAL AND AGAINST THE STEEL FRAMING AND PLACE IN A GANTRY.
