CITY AND COUNTY OF SAN FRANCISCO  
San Francisco Municipal Transportation Agency  
Request for Proposals  
THE PROCUREMENT OF  
30-Foot, 40-FOOT AND 60-FOOT LOW FLOOR  
DIESEL HYBRID COACHES

**Crash Test of a 2001 Ford Taurus  
Into the Right Side of a  
New Flyer Industries SR-1212, Xcelsior D40 2010  
Engineering Bus at 25.6 mph  
TRC Inc. Test Number: 091027-1**

**Final Report  
October - November 2009**

The roof of an Xcelsior 40ft bus was loaded statically to 1.5 x the maximum expected curb weight of any 40ft Xcelsior bus configuration. The test demonstrated that the Xcelsior 40ft bus meets the structural strength requirements of APTA 5.4.1.2.

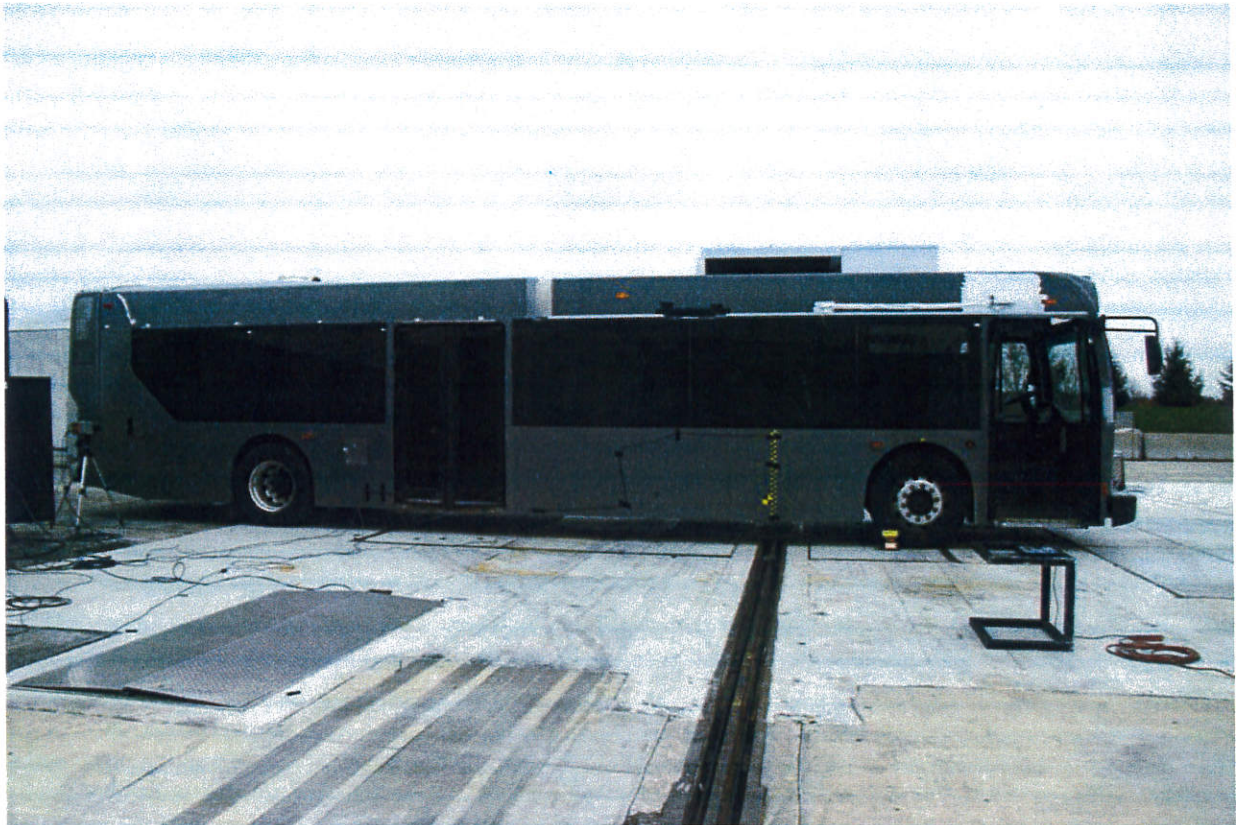
**Figure A-5 Pre-Test Bus Right Side View**

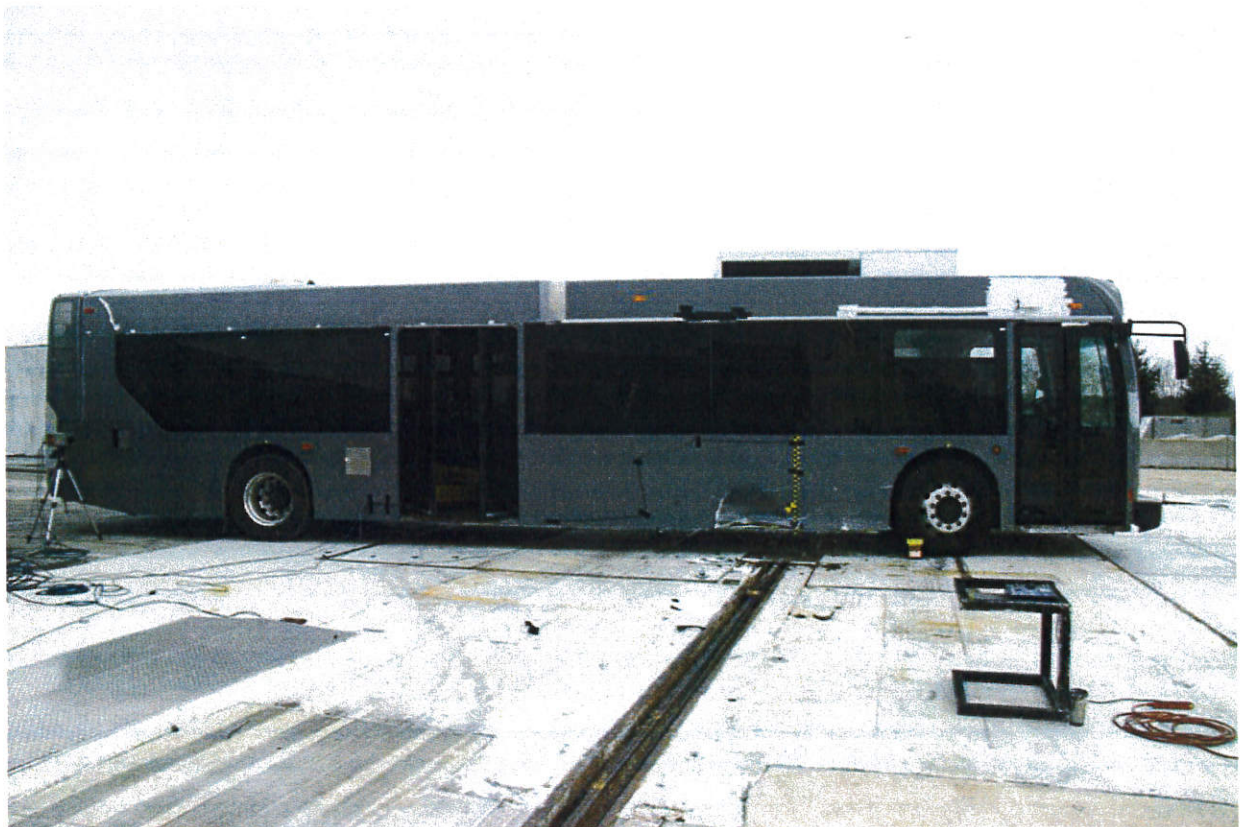
**Figure A-6 Post-Test Bus Right Side View**

Paragraph 5.4.1.2 of the referenced specification requires there be no more than three (3) inches of static deformation at the H-point height. The maximum static deformation for this test was 0.6 inches. In addition, there was no intrusion of the bus side structure into the bus occupant compartment nor were any sharp edges or protrusions generated.

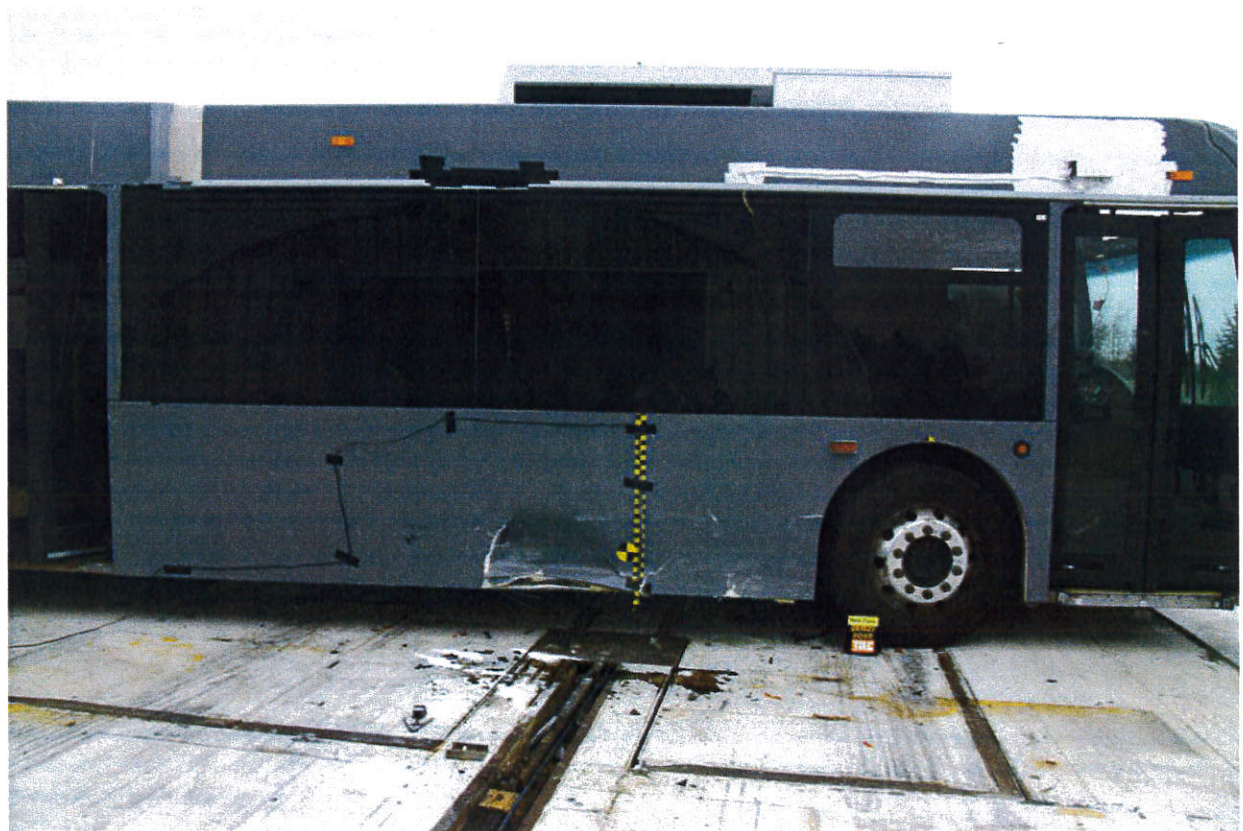
**Figure A-8 Post-Test Bus Right Side Close-up View**

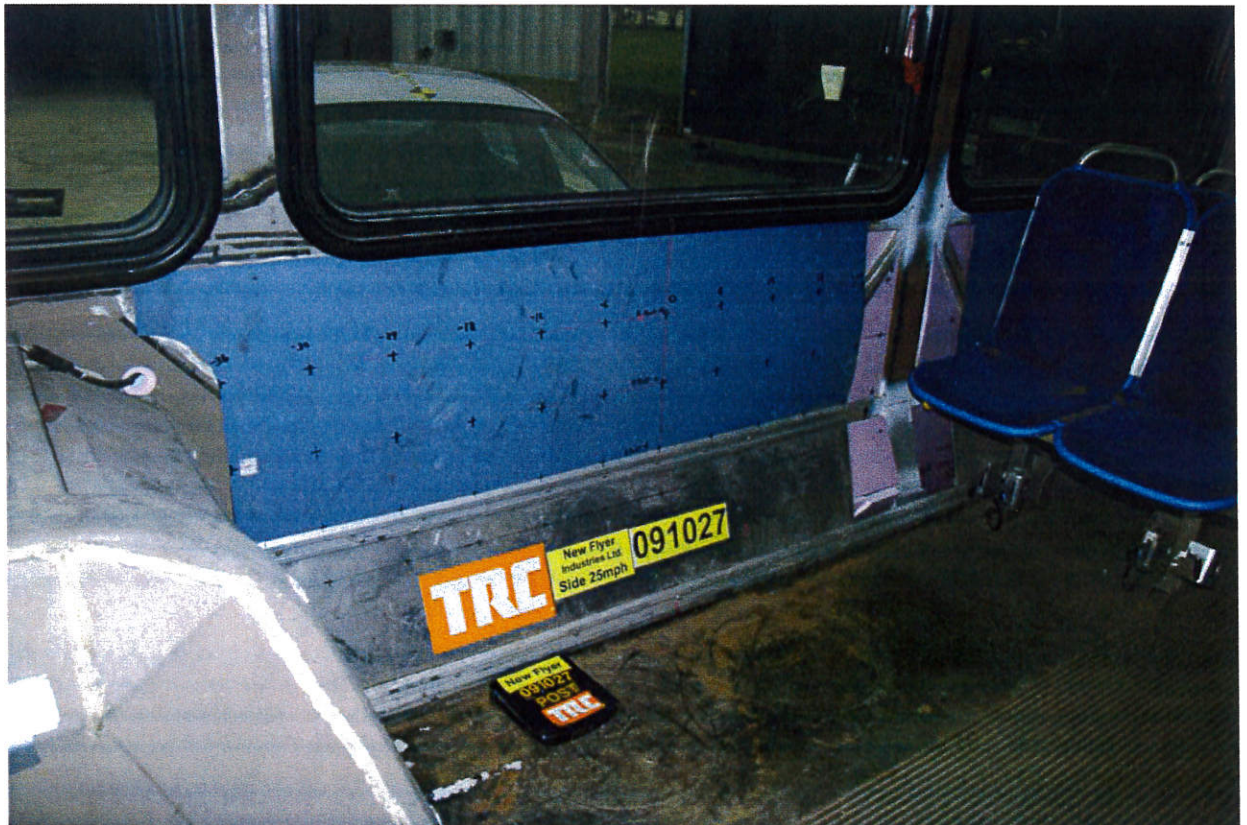
Figure A-20 Post-Test Floor Level Interior - View 1

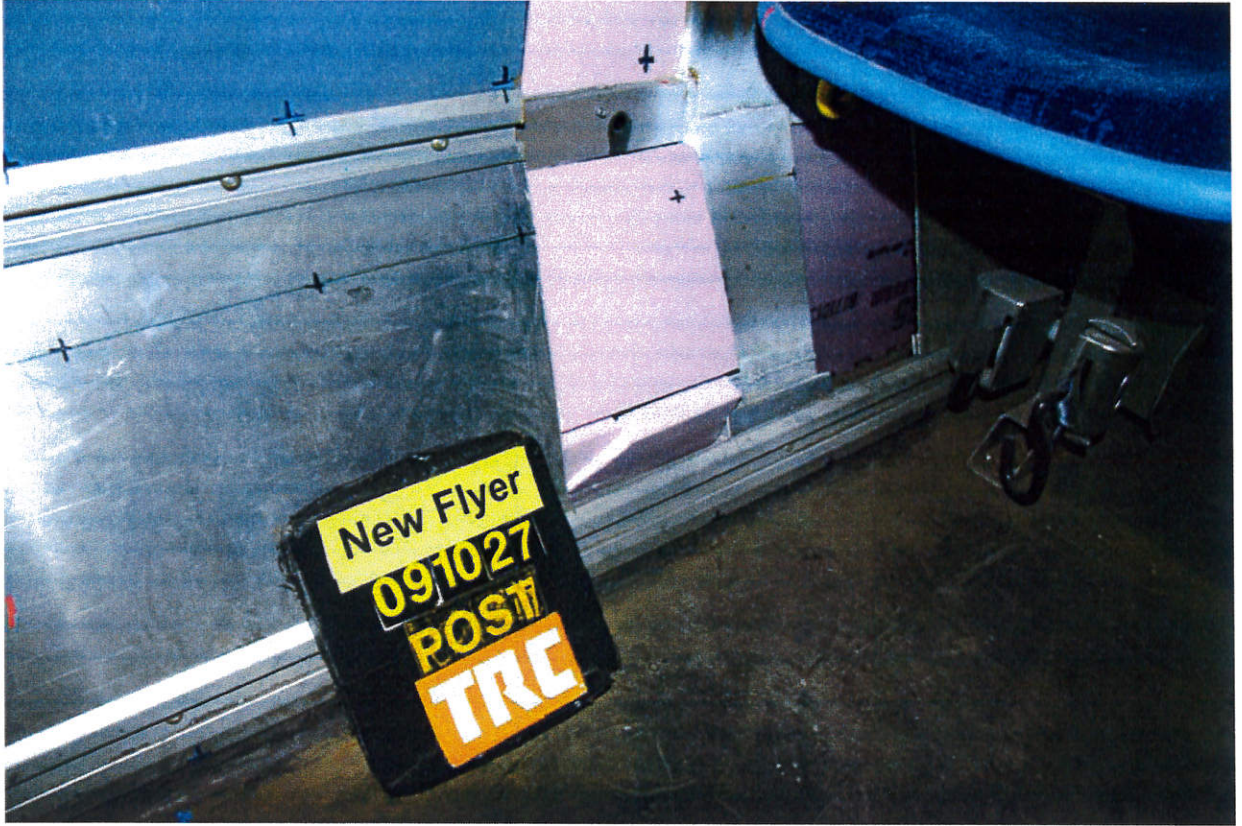
Figure A-21 Post-Test Floor Level Interior - View 2

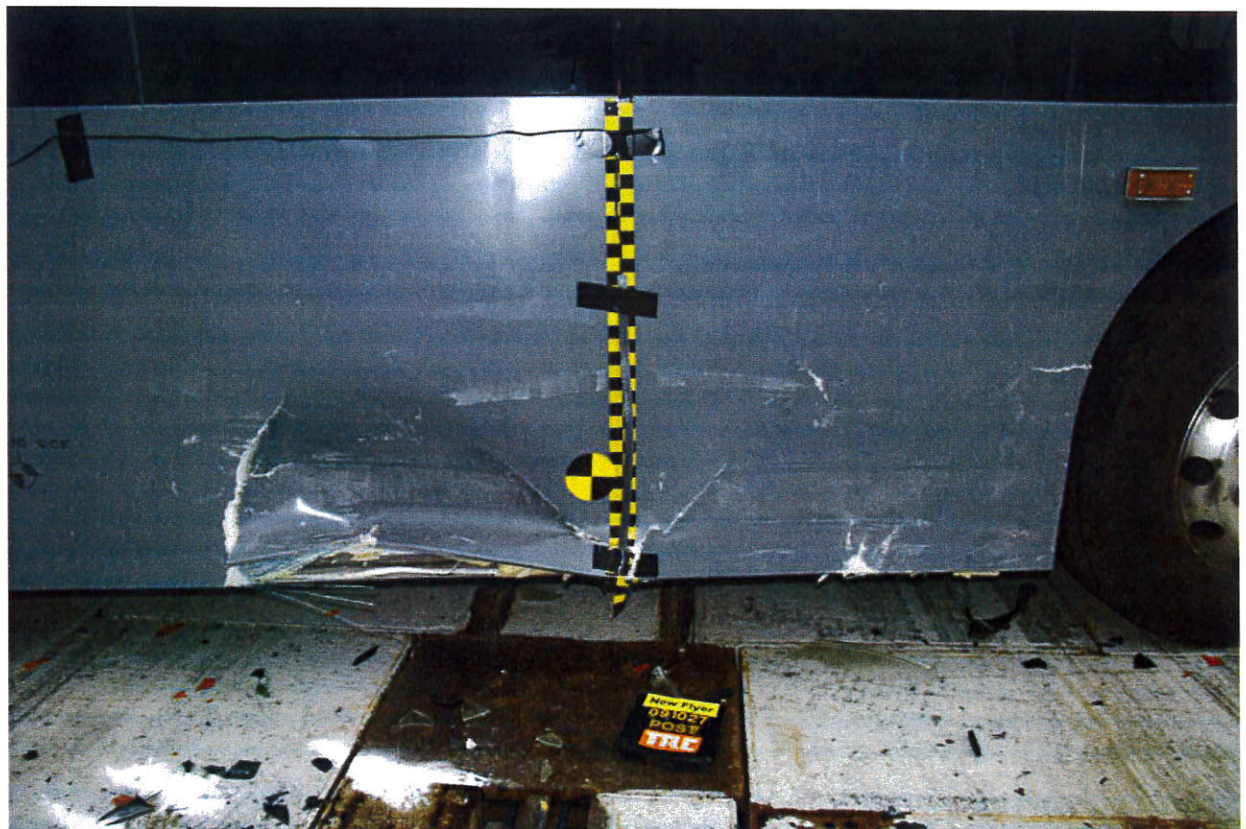
Figure A-23 Post-Test Impact Point View

The test setup was such that the 2001 Ford Taurus struck the bus right side structure 58.3 inches rearward of the front wheel vertical centerline at an angle of 90° relative to the bus' longitudinal axes.

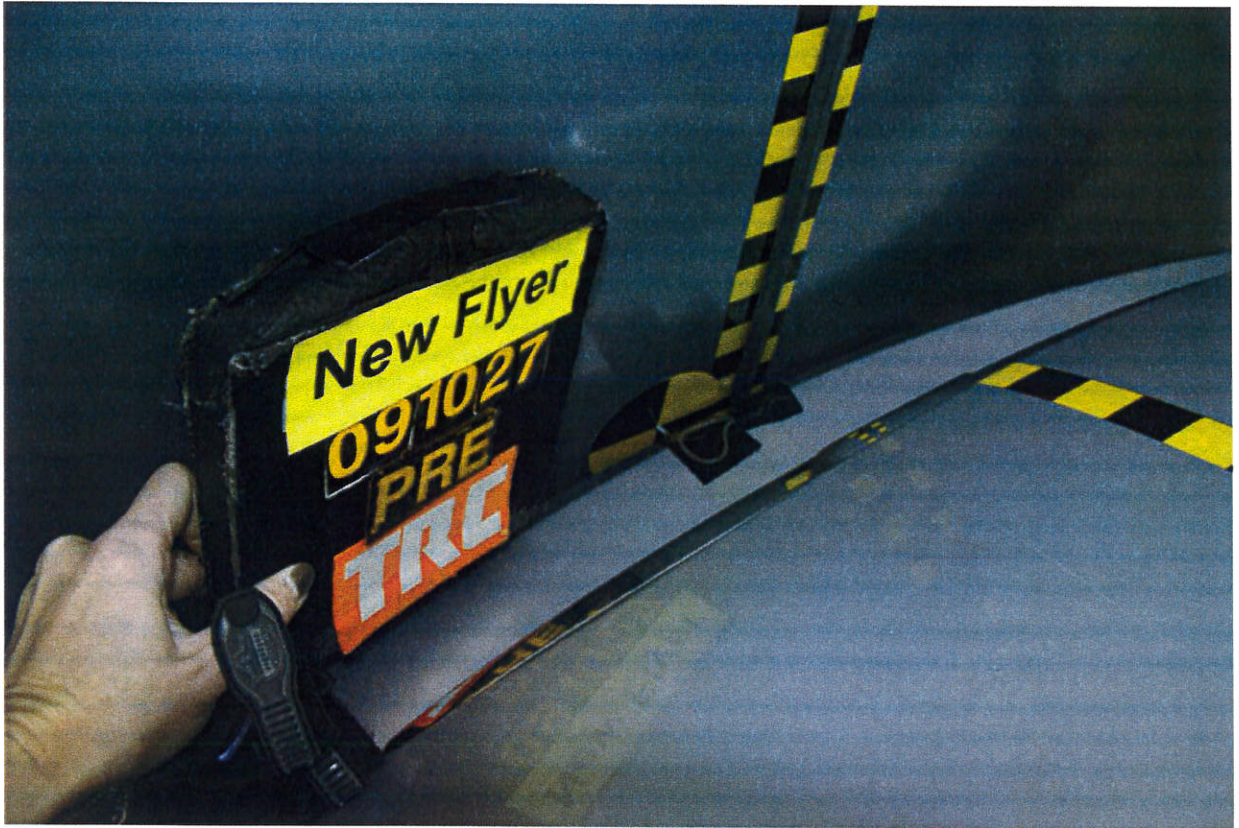
Figure A-24 Pre-Test Impact Point Close-up View

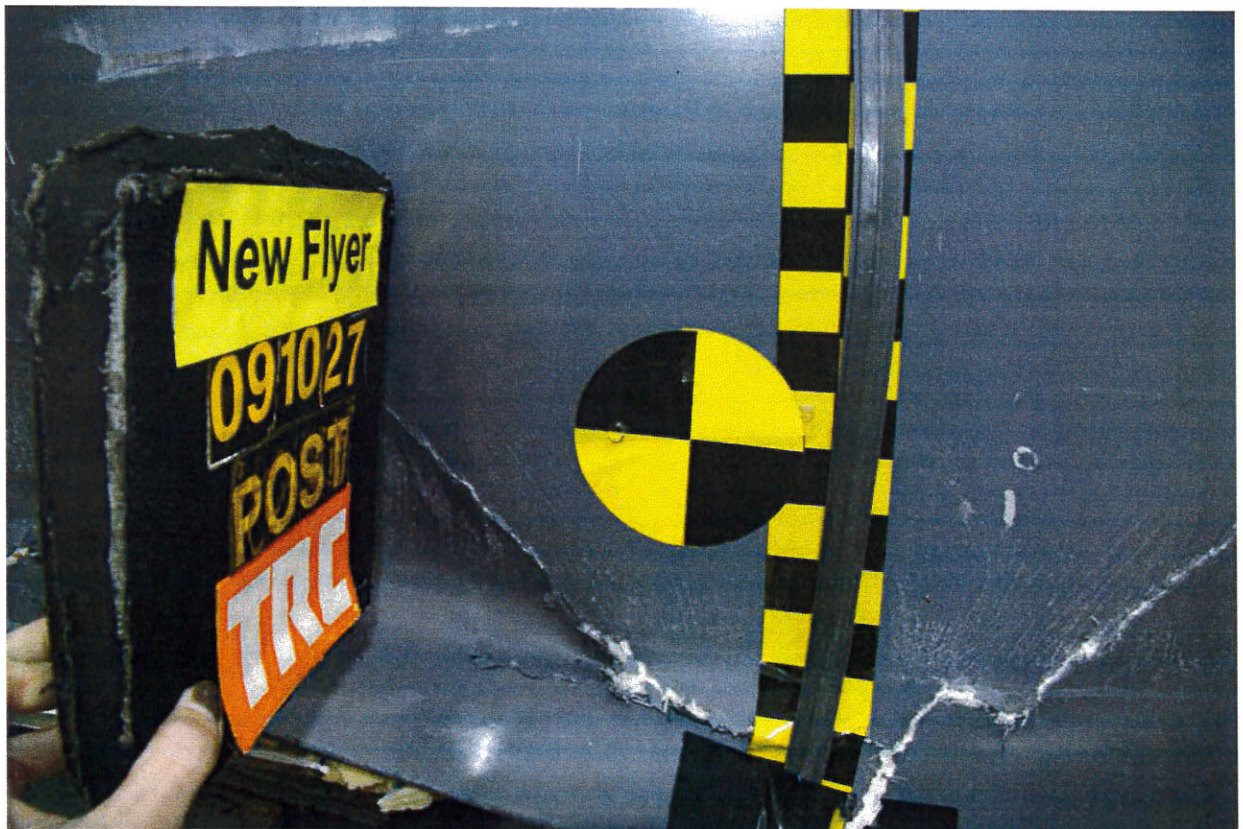
Figure A-25 Post-Test Impact Point Close-up View

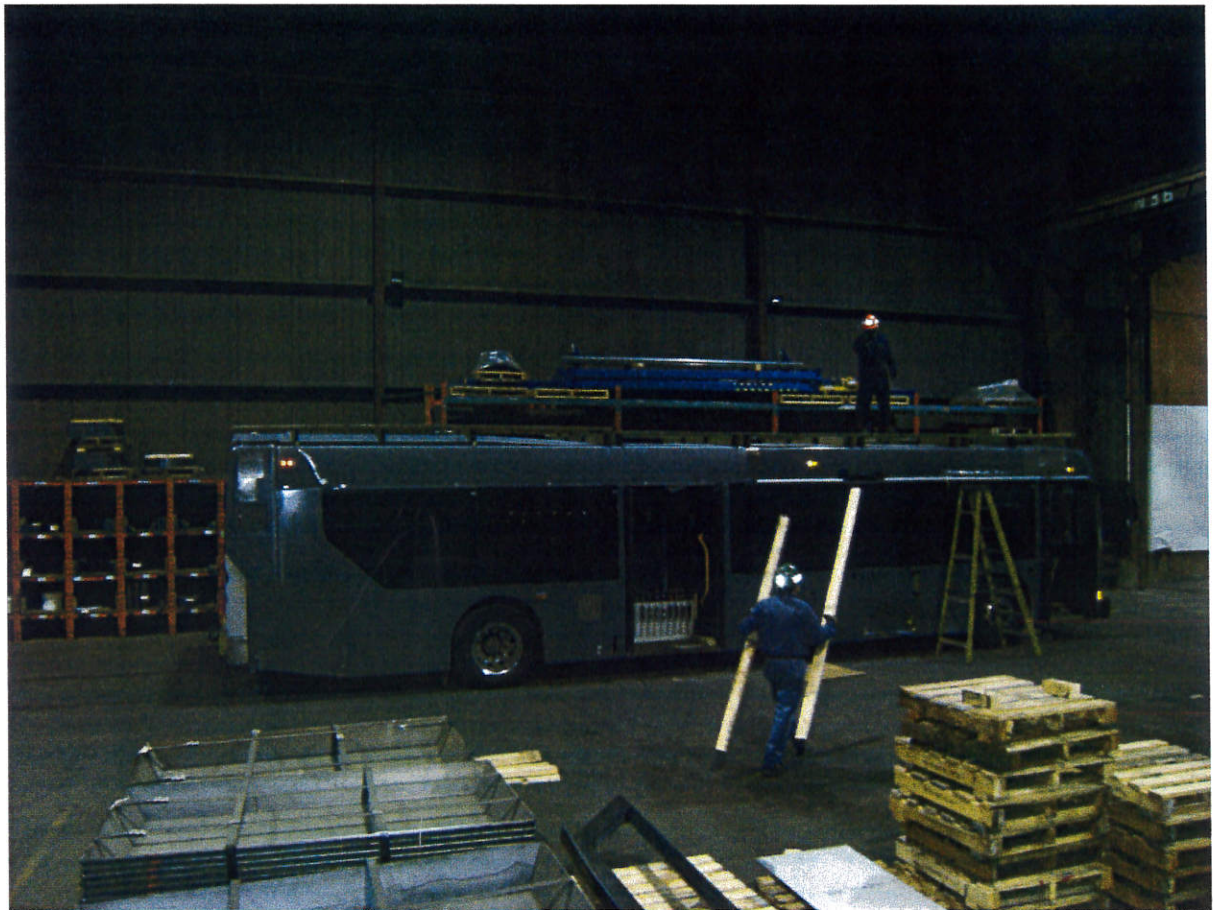
**Figure A.1 – Test configuration**

- All roof equipment was removed from the prototype XD40 bus.
- A level, wooden frame was set on the roof skin of the bus. The frame allowed for even distribution of weight across the roof bows along the full length of the bus.
- The roof structure was loaded evenly by laying steel plate on the wooden frame resting on the roof structure.
- Downward deflection of all of the roofbows was measured using a weight and pulley system as shown in the photos in Appendix B.

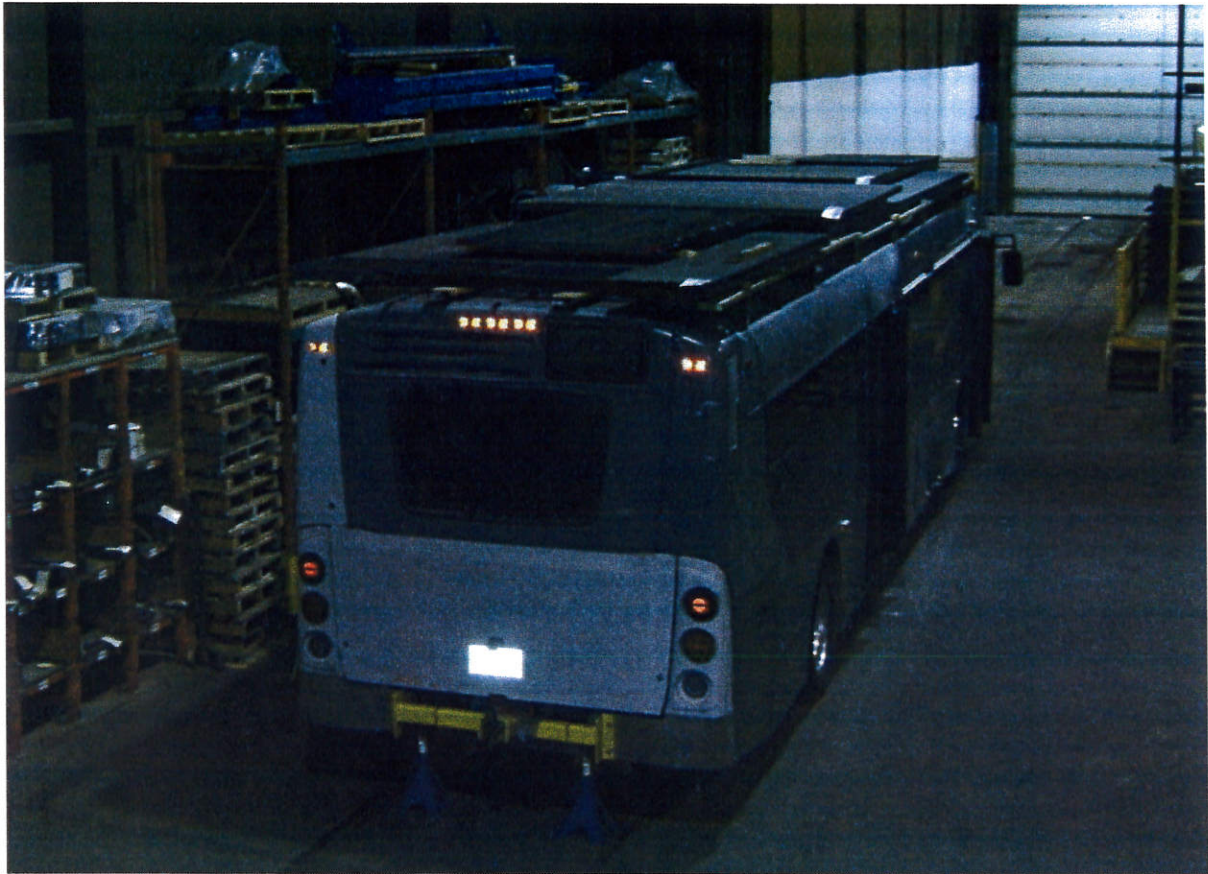
Figure A.2 – Full roof load

Roof loading of the bus was based on a target curb weights of 29,000lb for Xcelsior hybrid and 31,000lb for Xcelsior CNG. The APTA specification requires that the roof withstand a load of 1.5xcurbweight. Thus, the bus roof was loaded in two stages, first to 1.5x29,000lb (43,500lb) and then, 3,000lb were added to achieve 1.5x31,000lb (46,500lb). Table A, below shows the composition of layers to achieve these stages of loading.
