Re: Transmittal of Planning Department Case Numbers 2025-005918DES & 2025-005930DES Alert Alley Early Residential District Landmark District Designation **Chula-Abbey Early Residential District Landmark District Designation**

Landmark Designation Report

Alert Alley Early Residential District

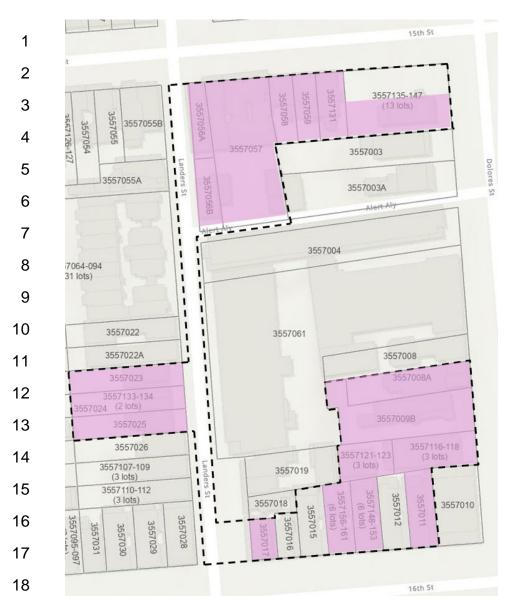
The boundaries of Alert Alley Early Residential District are outlined.

15	the south side of 15th Street between Landers Street and Dolores Street and properties on the east side
16	of Landers Street between 15th Street and Alert Alley; properties on the north side of 16th Street
17	between Dolores Street and Landers Street and a grouping of properties on the west side of Landers
18	Street between Alert Alley and 16th Street. The District includes lots contained within Assessor's Block
19	3557 and shall be as designated on the Alert Alley Early Residential District Map, the original of which
20	is on file with the Clerk of the Board of Supervisors under File No. , which Map is hereby
21	incorporated herein as though fully set forth.
22	
23	
24	
25

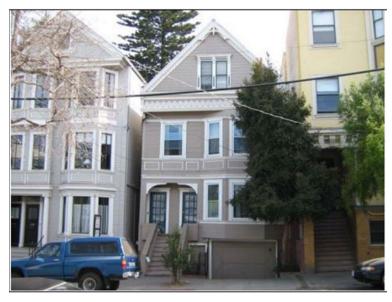
1919-1923 (left) and 1931-1933 15th Street (center)

The district's larger flats buildings, facing onto the wider, primary streets, are typically Classical Revival style, including all the district's Romeo Flats buildings. Buildings in the district in this style feature wide angled or round bay windows, flat roofs, bulky projecting cornices with modillions or dentils, raised panel spandrels, scroll keystones, broken entablatures, and pedimented and columned porch or portico entries.

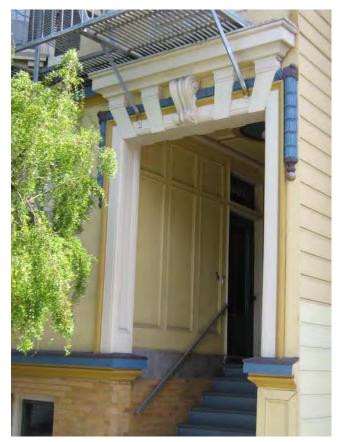
Entry porch detail

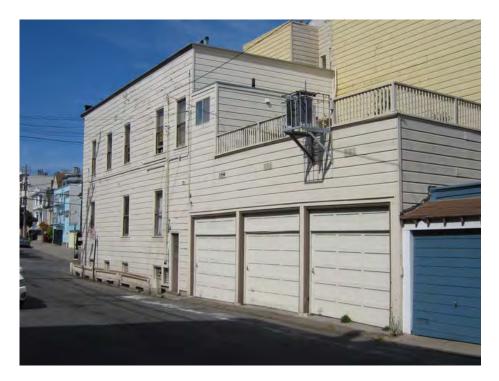
Landers Street elevation

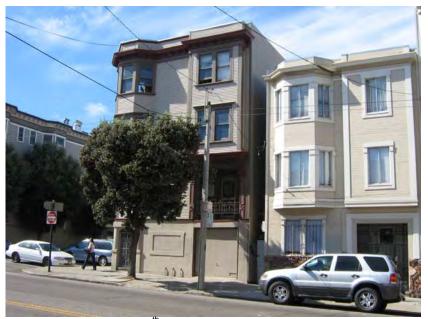
window in the left bay. The right bay windows have pilasters with floral drops and dentil cornices. The Landers Street elevation has four garage entries on the ground floor. The upper stories have paired and single windows with pilaster surrounds and dentil cornices. The right bay of the second and third stories has a semi-hexagonal bay window. All windows have undivided, double-hung wood sash. Both elevations terminate in a deeply projecting cornice with dentils and a plain parapet. The rear elevation has wood egress porches. The building appears to have been lifted to allow for the insertion of garages underneath. The building appears to be in good condition.

16th Street (south) elevation

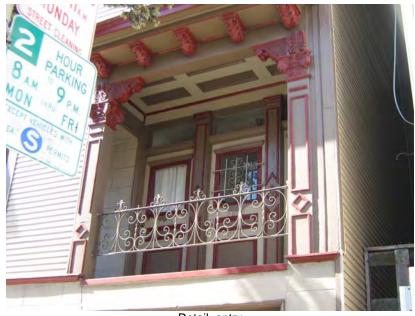
Detail, entry

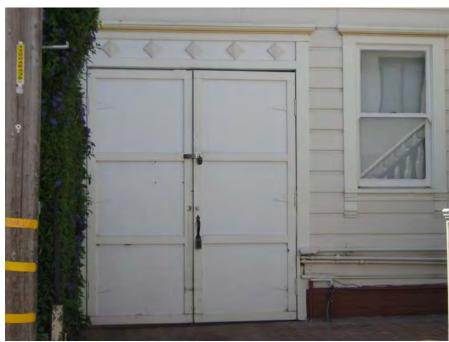
Left bay of the first floor at 156 Landers Street.

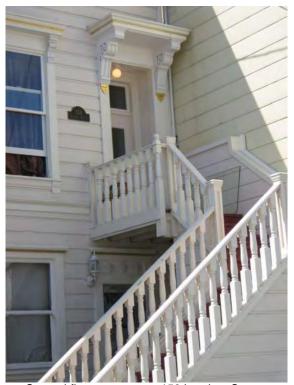
Second-floor entrance at 156 Landers Street.
