**Re: Transmittal of Planning Department Case Number 2011.0310U:  
Mills Act Historical Property Contract Application  
201 Buchanan Street (a.k.a. Nightingale House), Landmark No. 47  
BOS File No: \_\_\_\_\_ (pending)  
Historic Preservation Commission Recommendation: Approval**

## Historic Preservation Commission Resolution No. 0701 HEARING DATE JANUARY 16, 2013

Mills Act Application  
 Case Number 2011.0310U  
 Nightingale House, Landmark #47  
 201 Buchanan Street

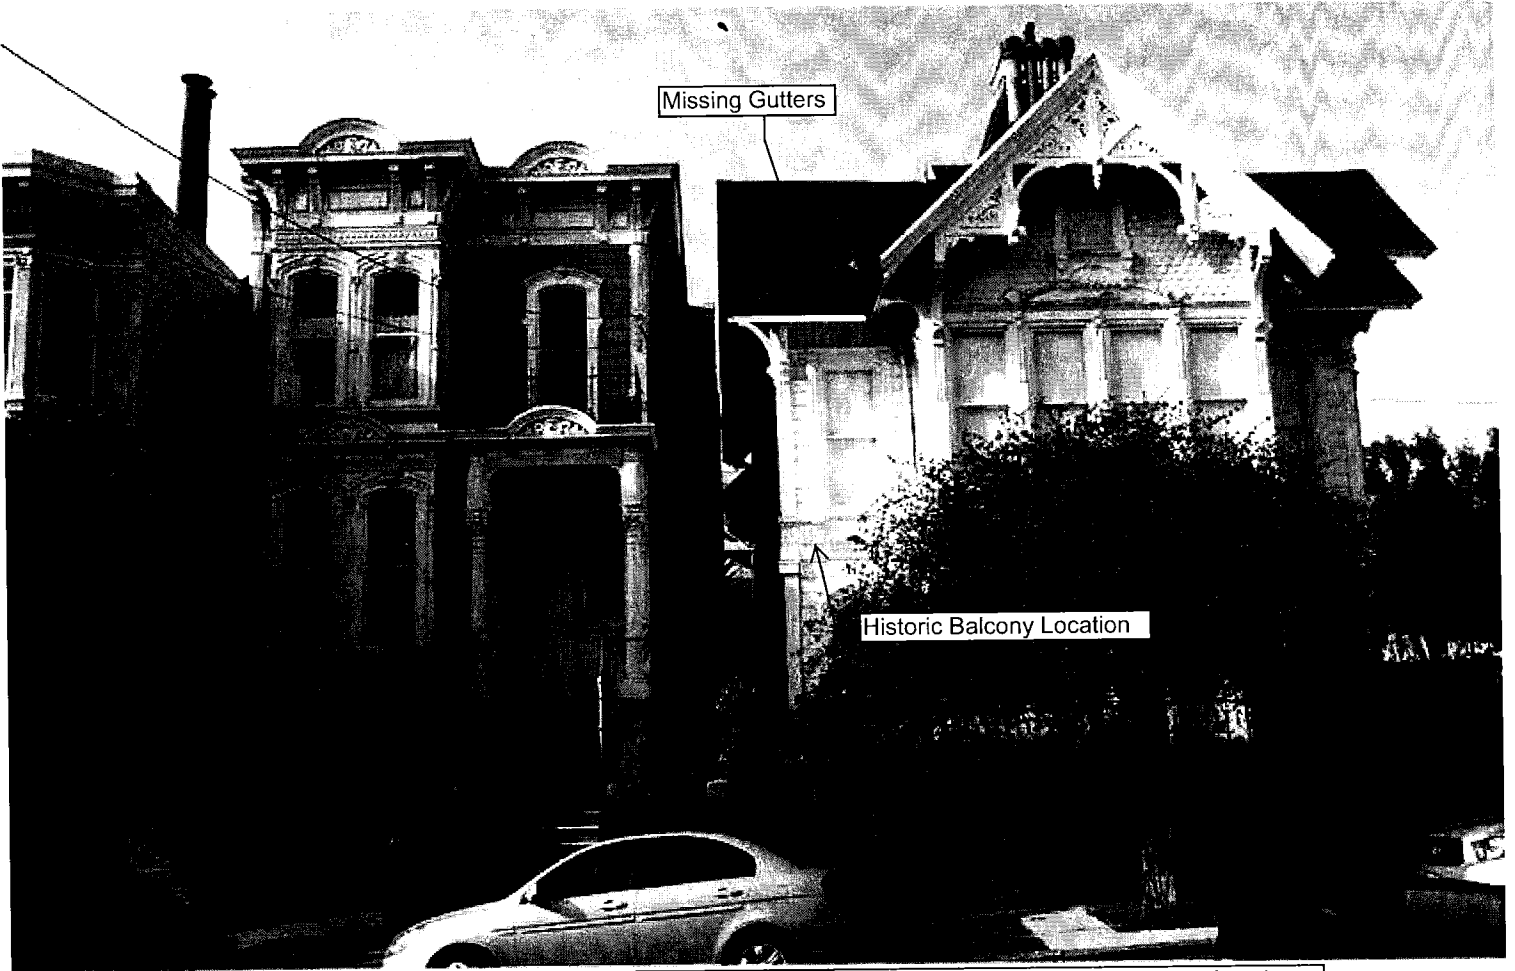
201 Buchanan: Waller Street facade and adjacent residence. Note the sheltered western facade.

Missing Gutters

Historic Balcony Location

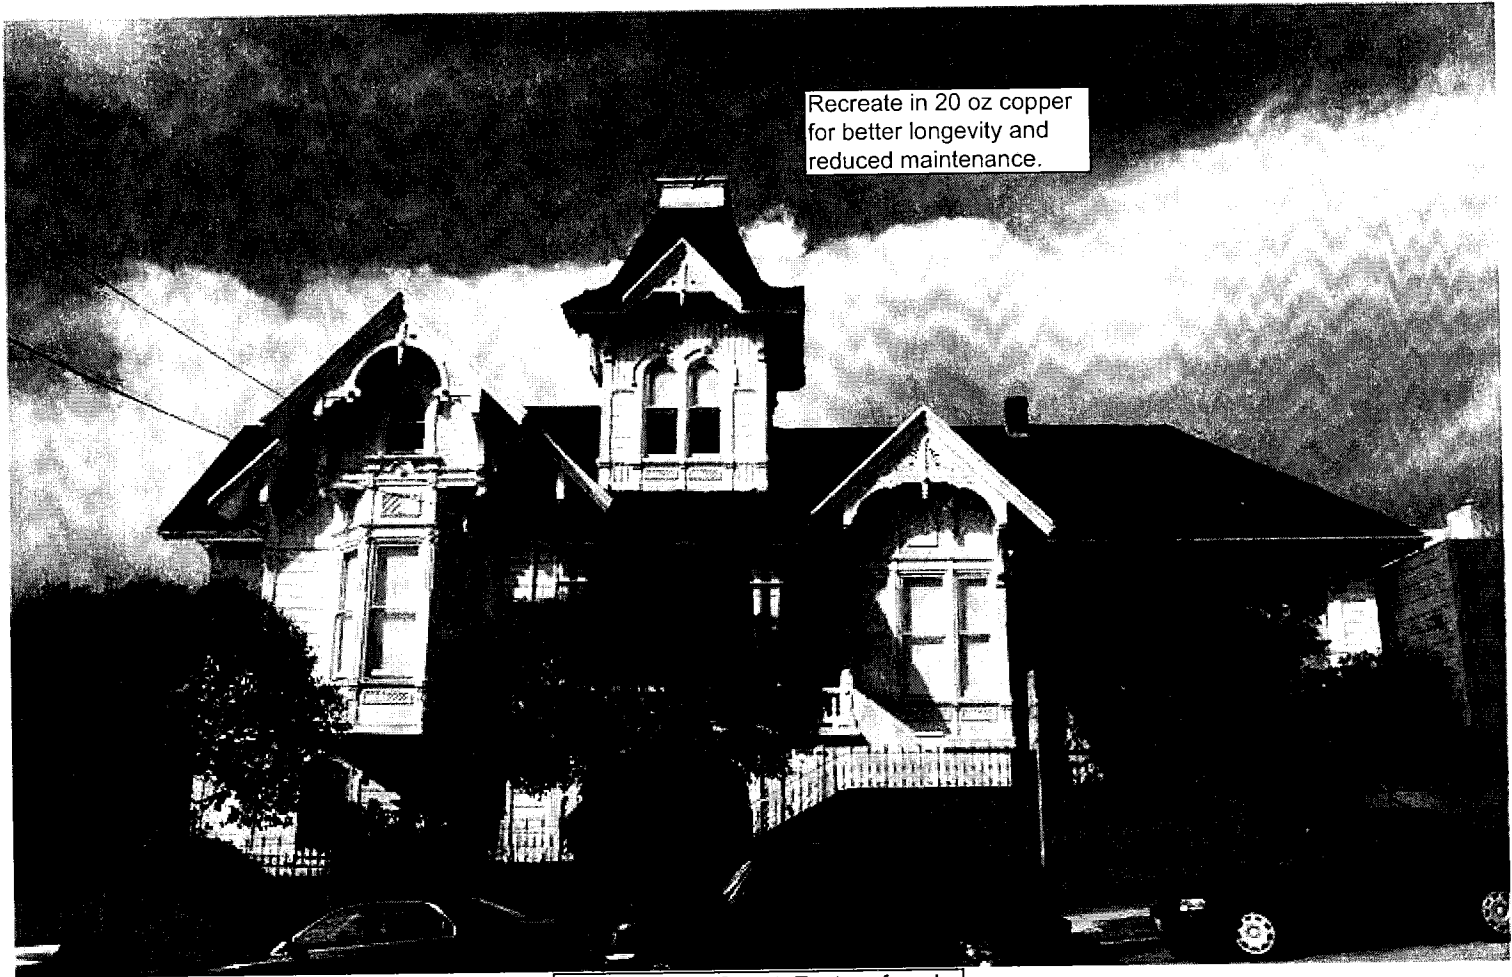
201 Buchanan Street: Eastern facade

Recreate in 20 oz copper  
for better longevity and  
reduced maintenance.

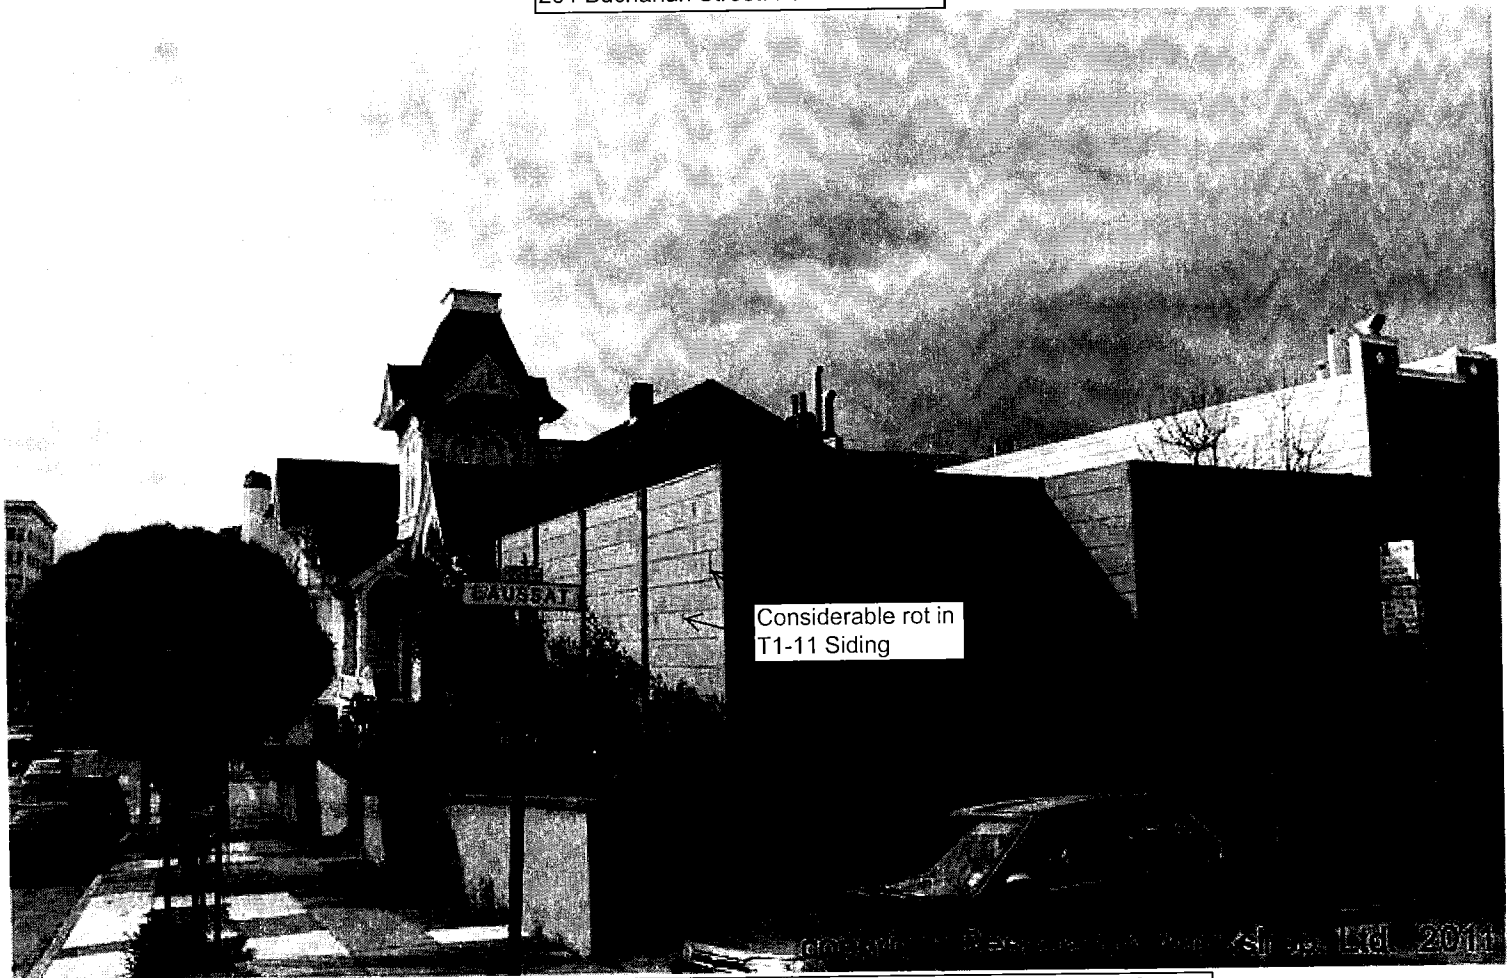
201 Buchanan Street: South elevation, non-historic addition and rear fence.

Considerable rot in  
T1-11 Siding

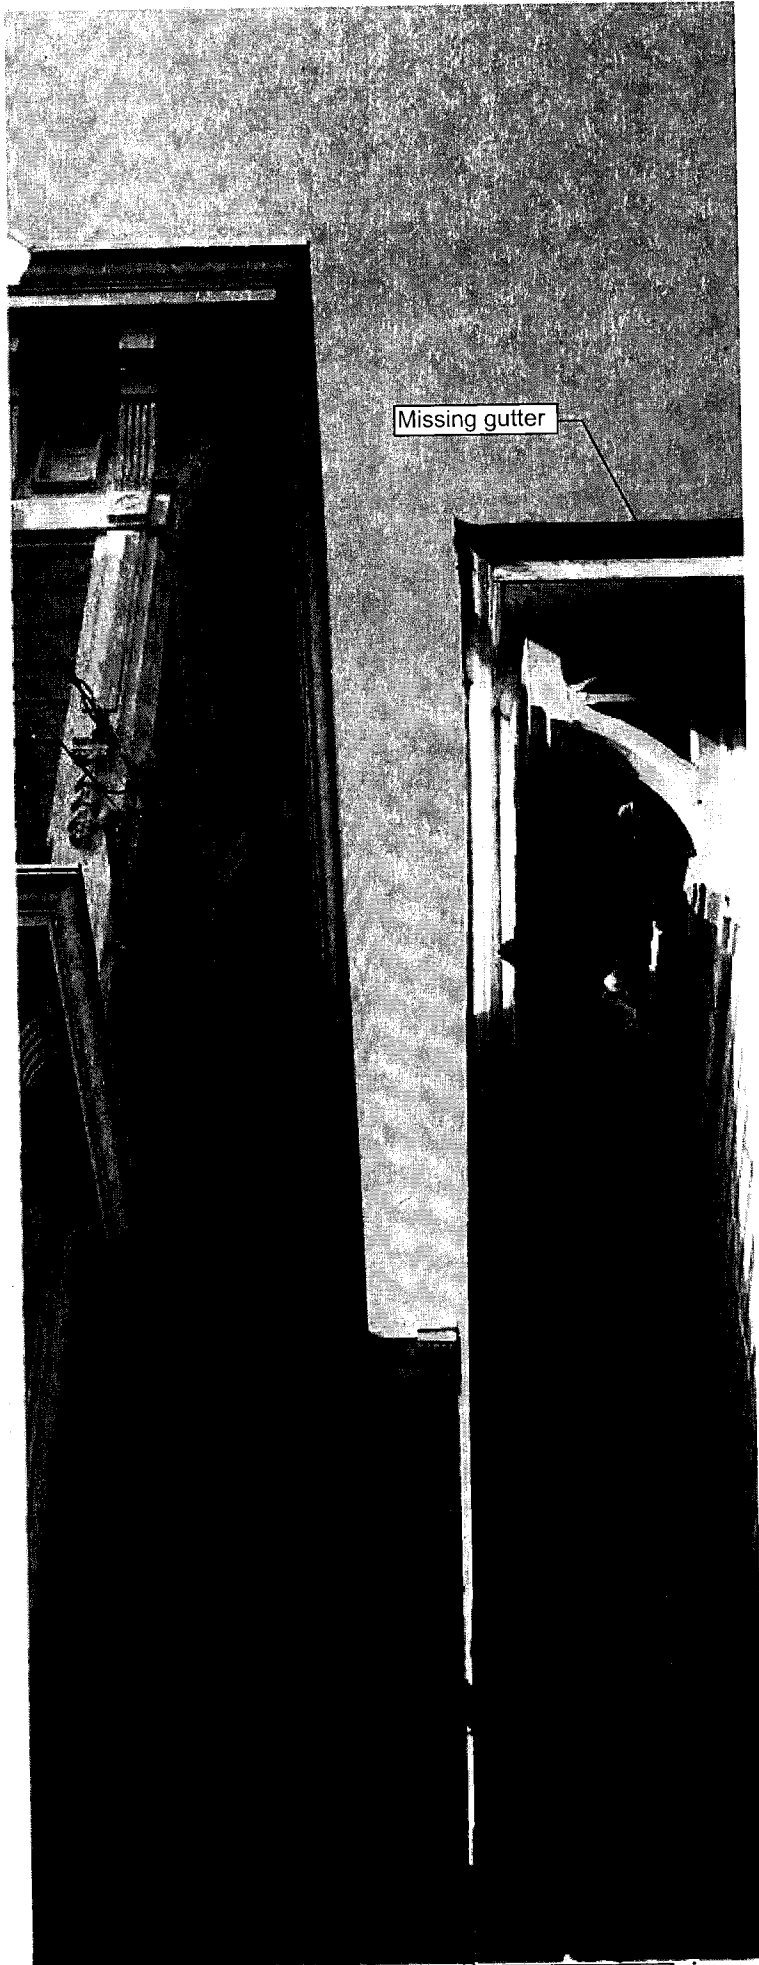
Close up: Proximity of eaves to adjacent property.

Missing gutter

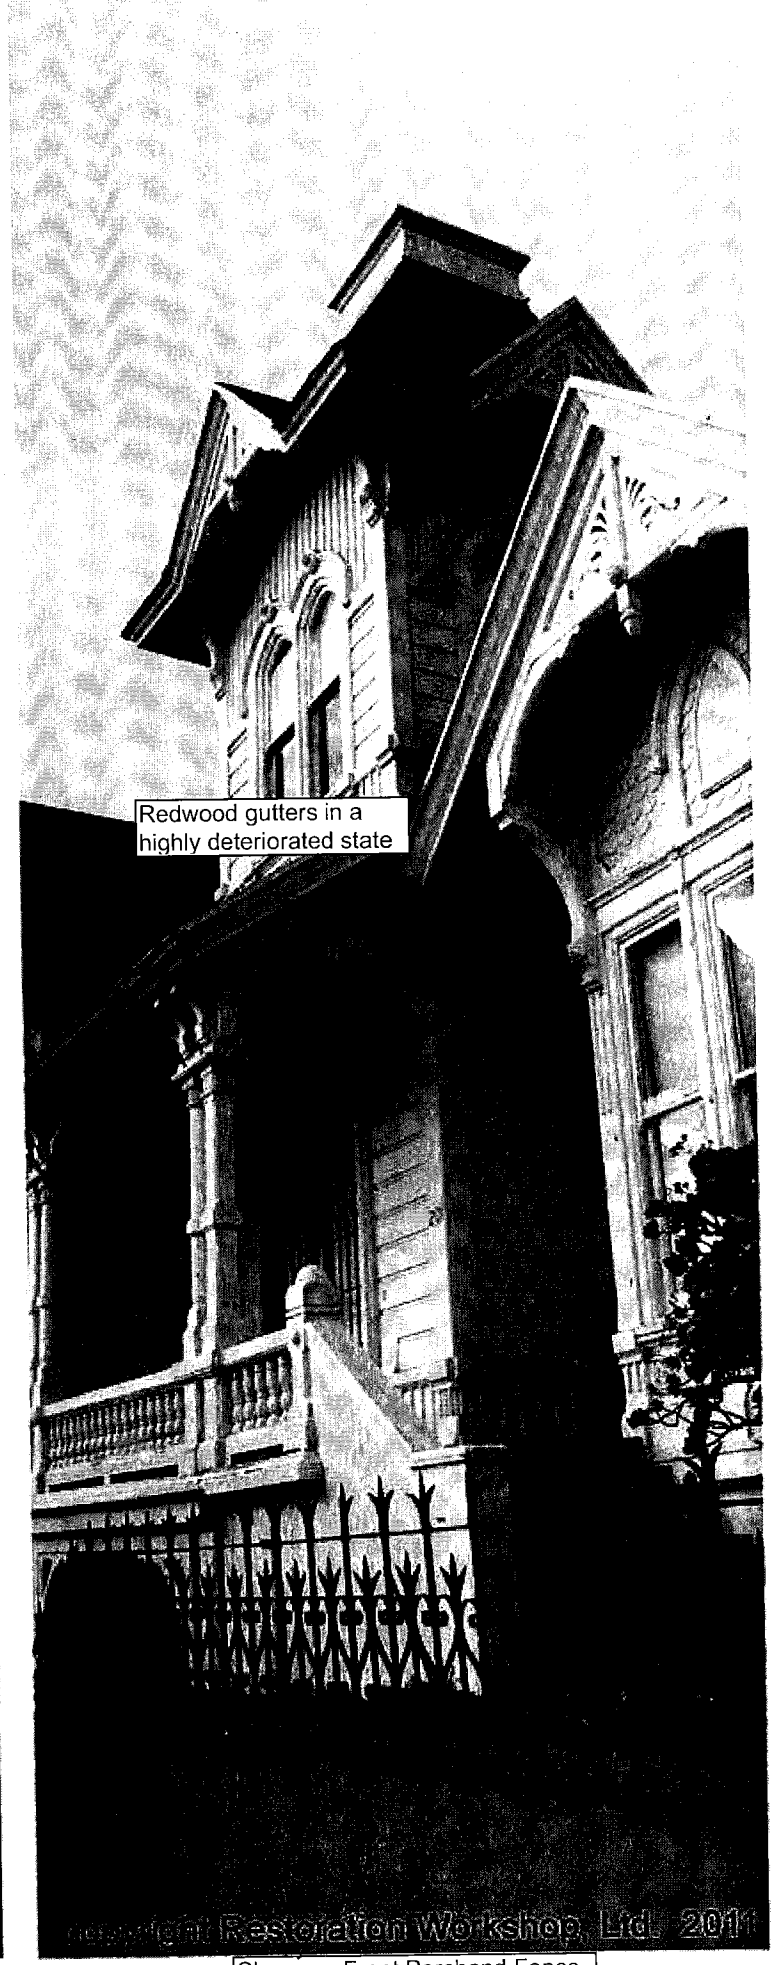
Close up: Front Porch and Fence.

Redwood gutters in a highly deteriorated state

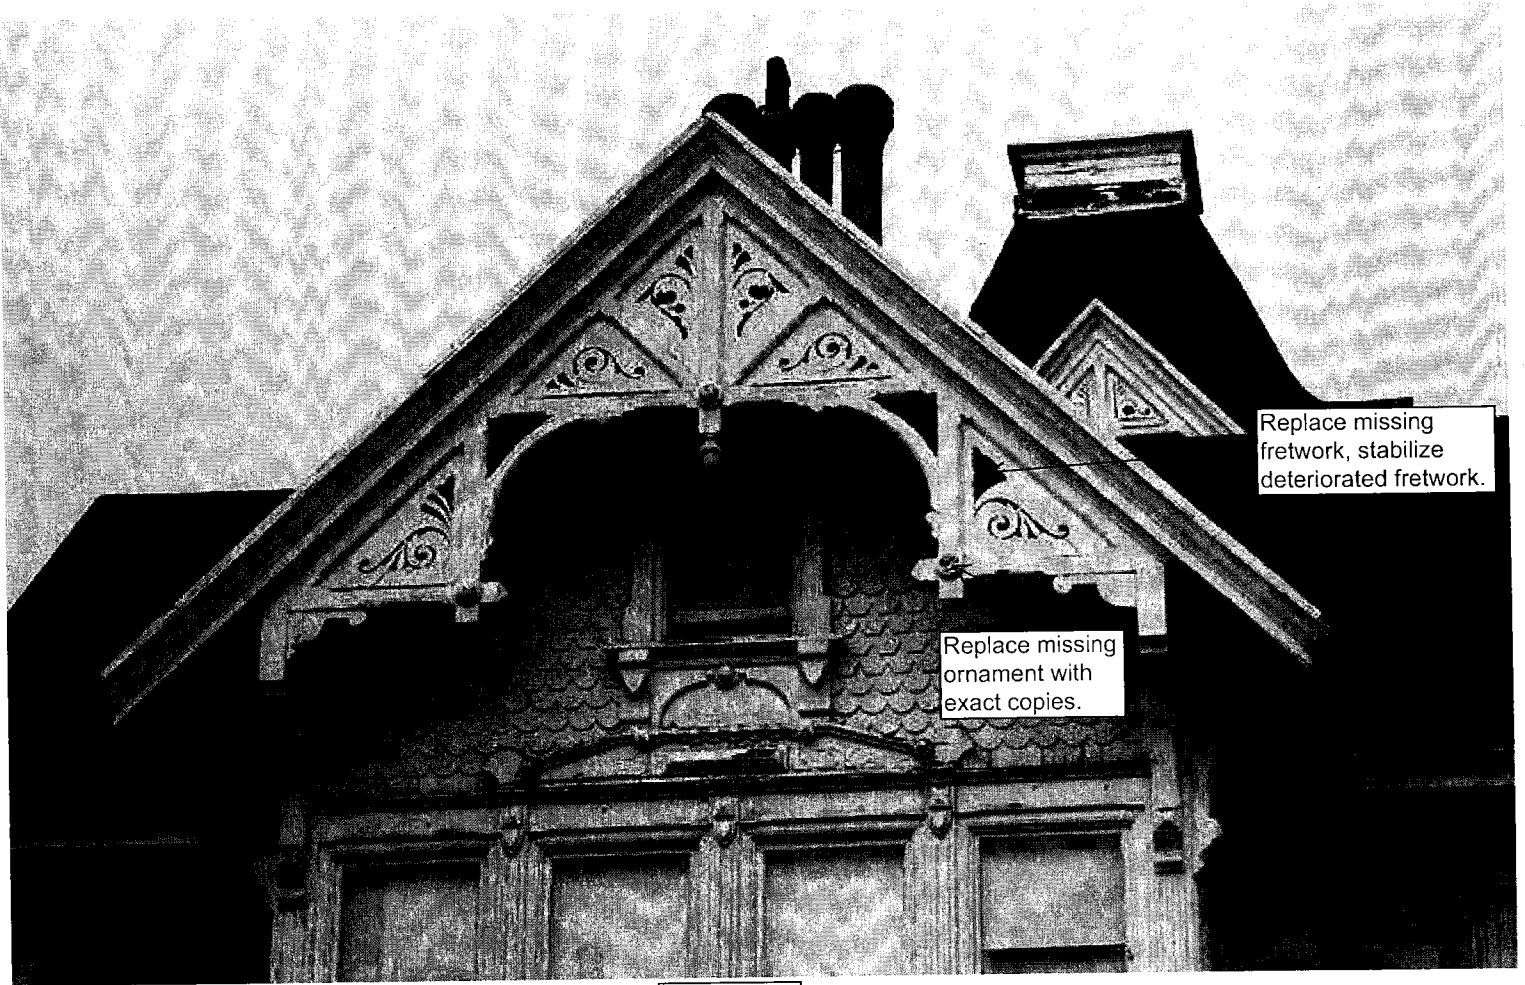
South Gable

Replace missing fretwork, stabilize deteriorated fretwork.

Replace missing ornament with exact copies.

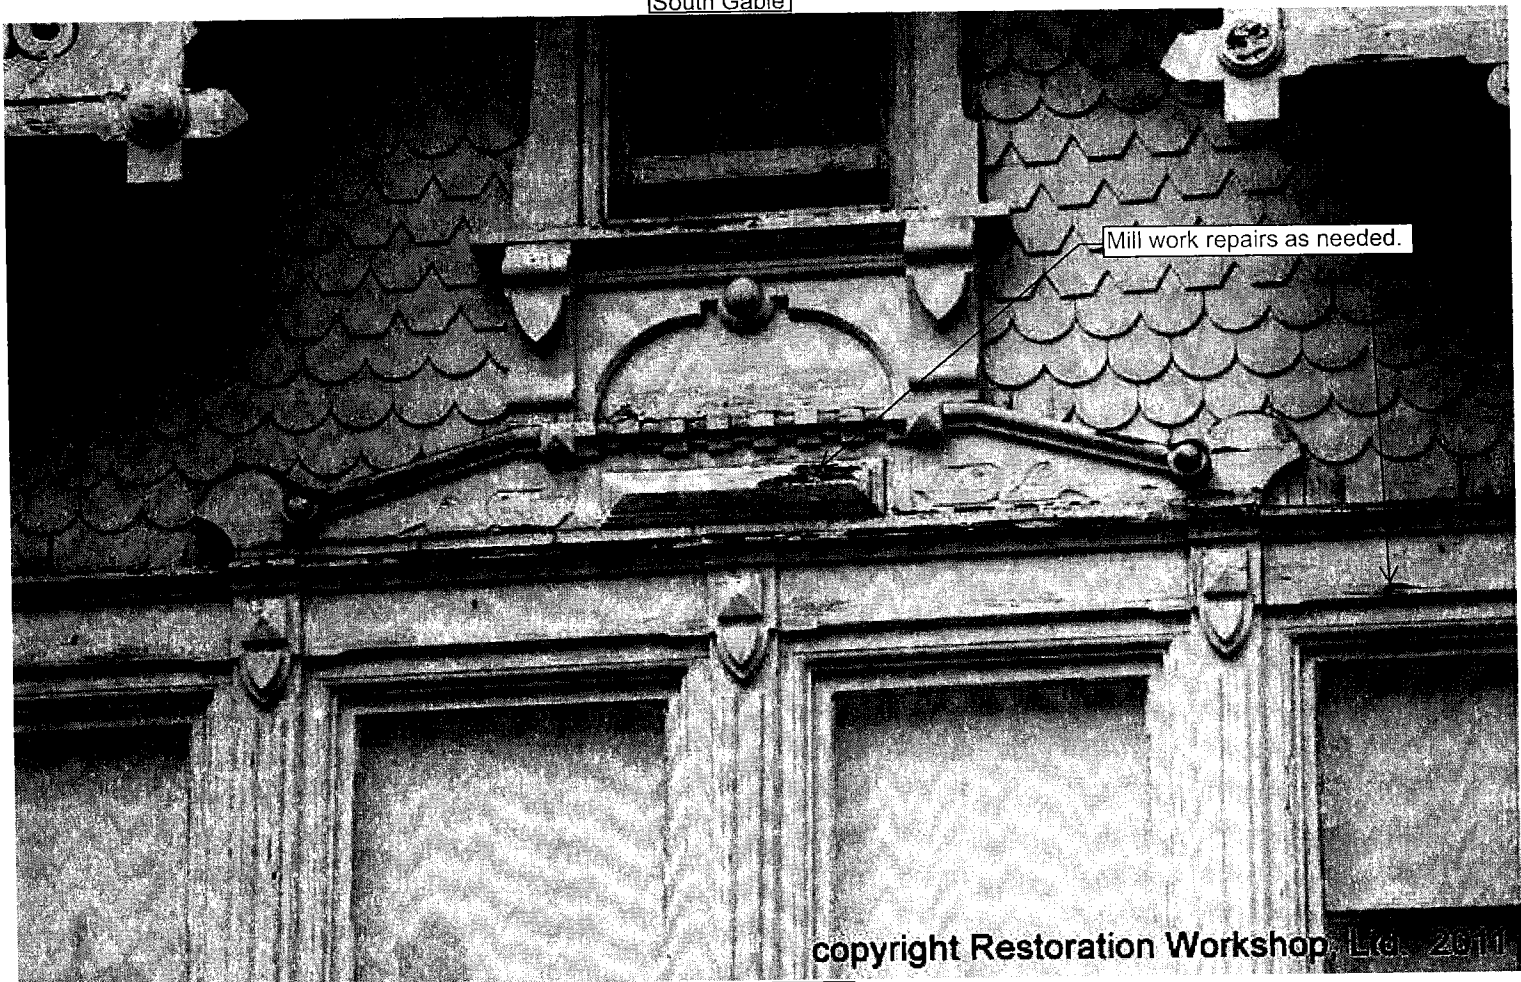
South Gable (detail)

Mill work repairs as needed.

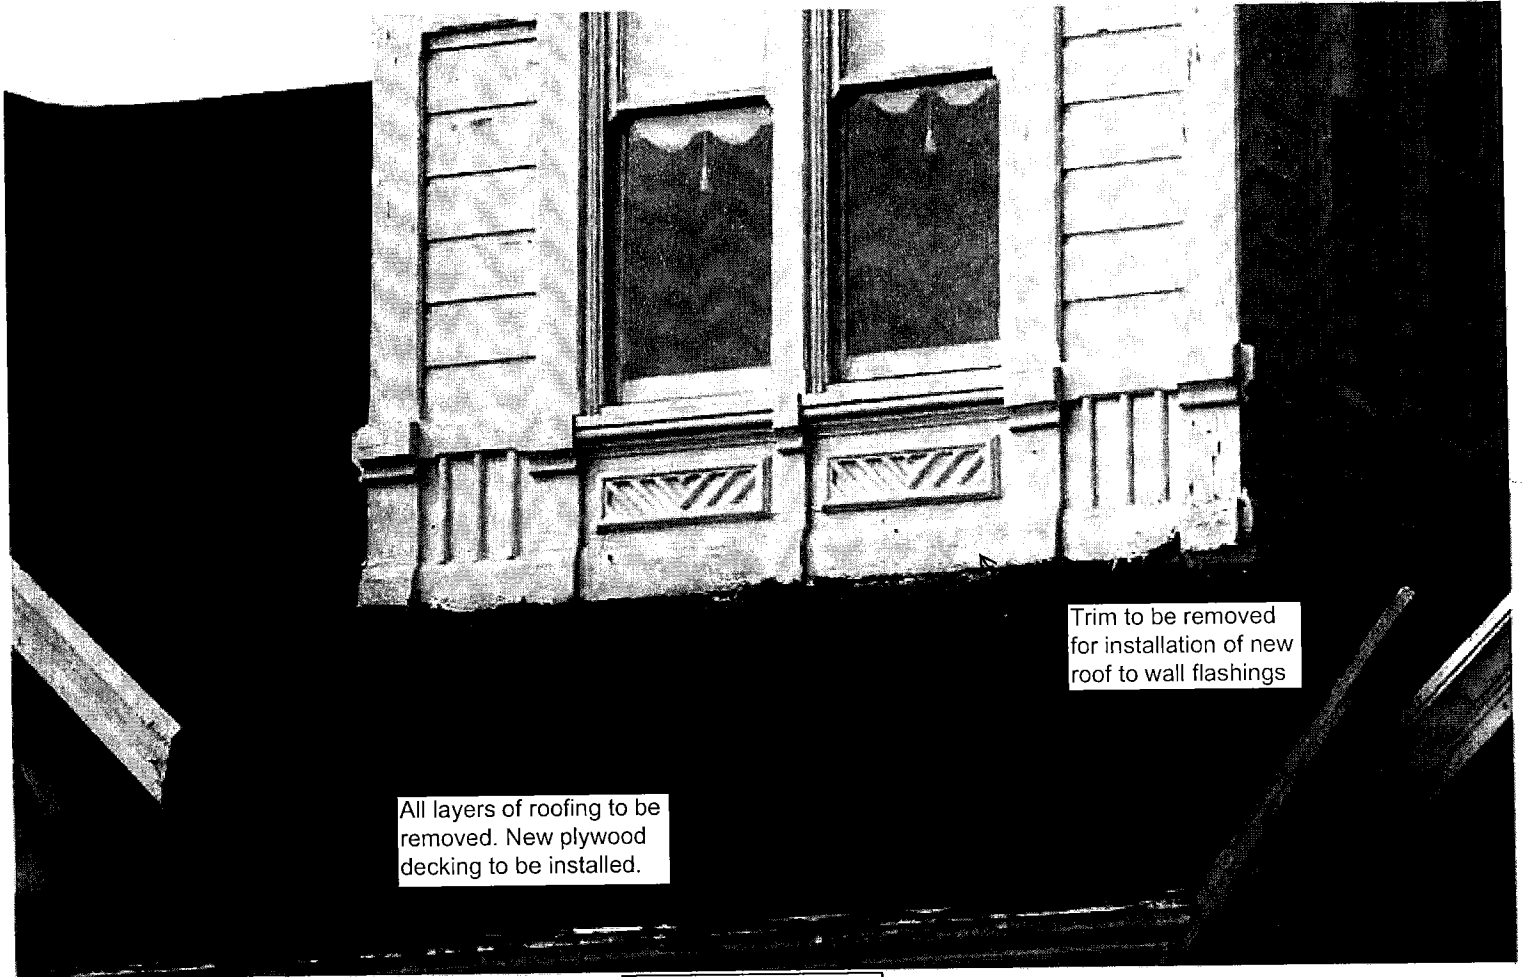
Tower Base (east face)

Trim to be removed  
for installation of new  
roof to wall flashings

All layers of roofing to be  
removed. New plywood  
decking to be installed.

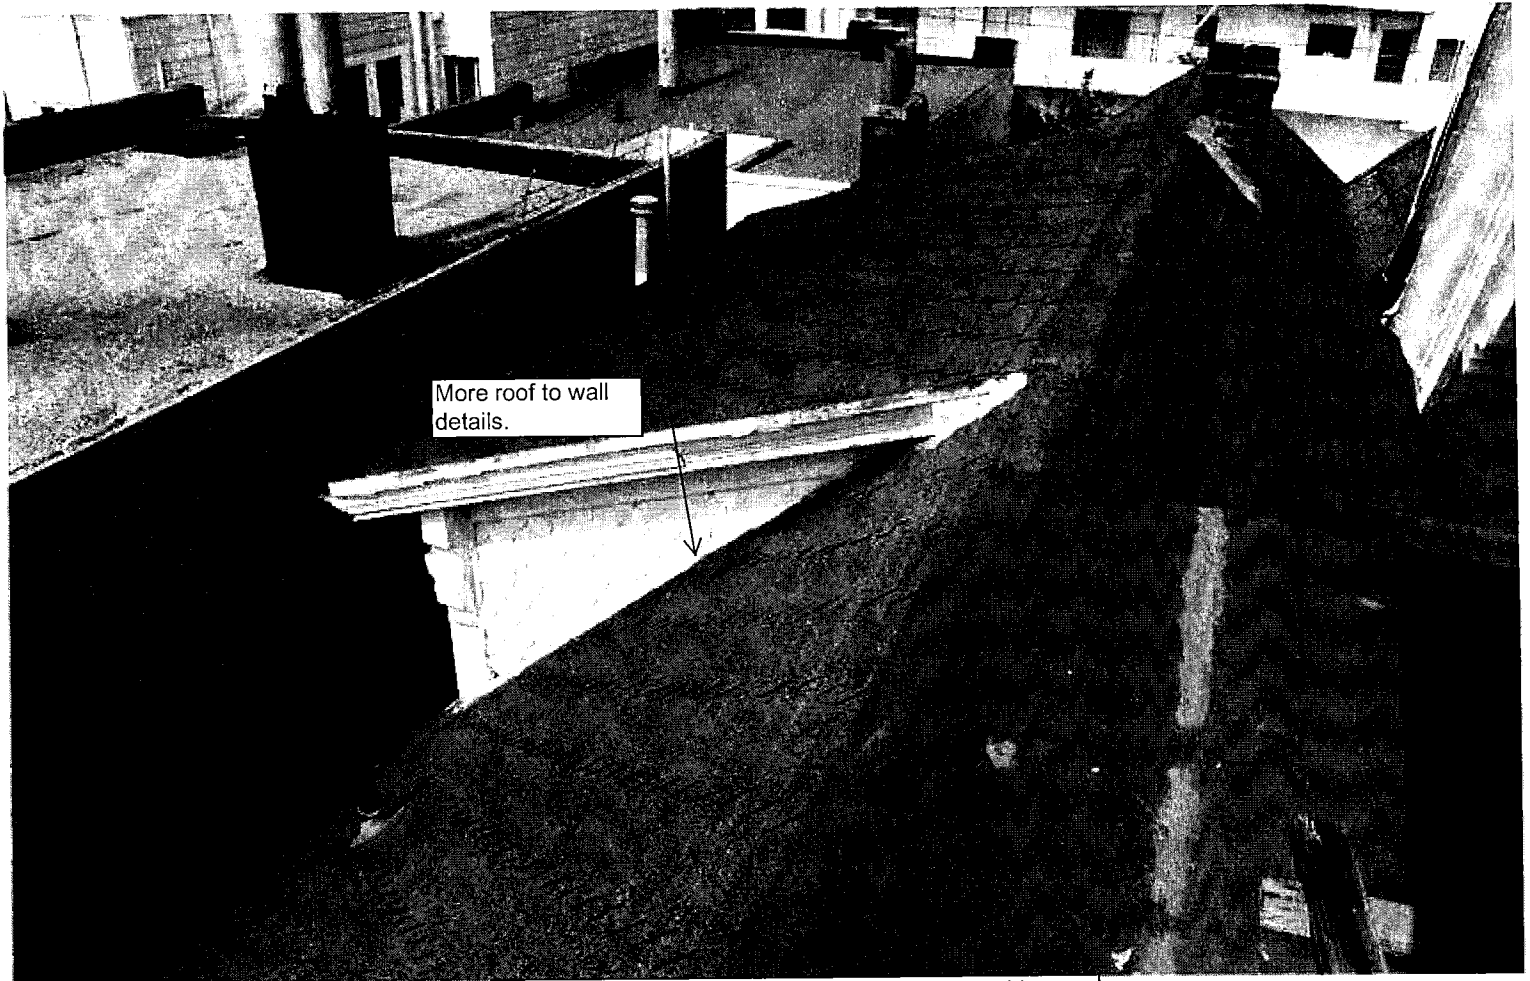
Western shed dormer, dining room and kitchen chimneys

More roof to wall details.

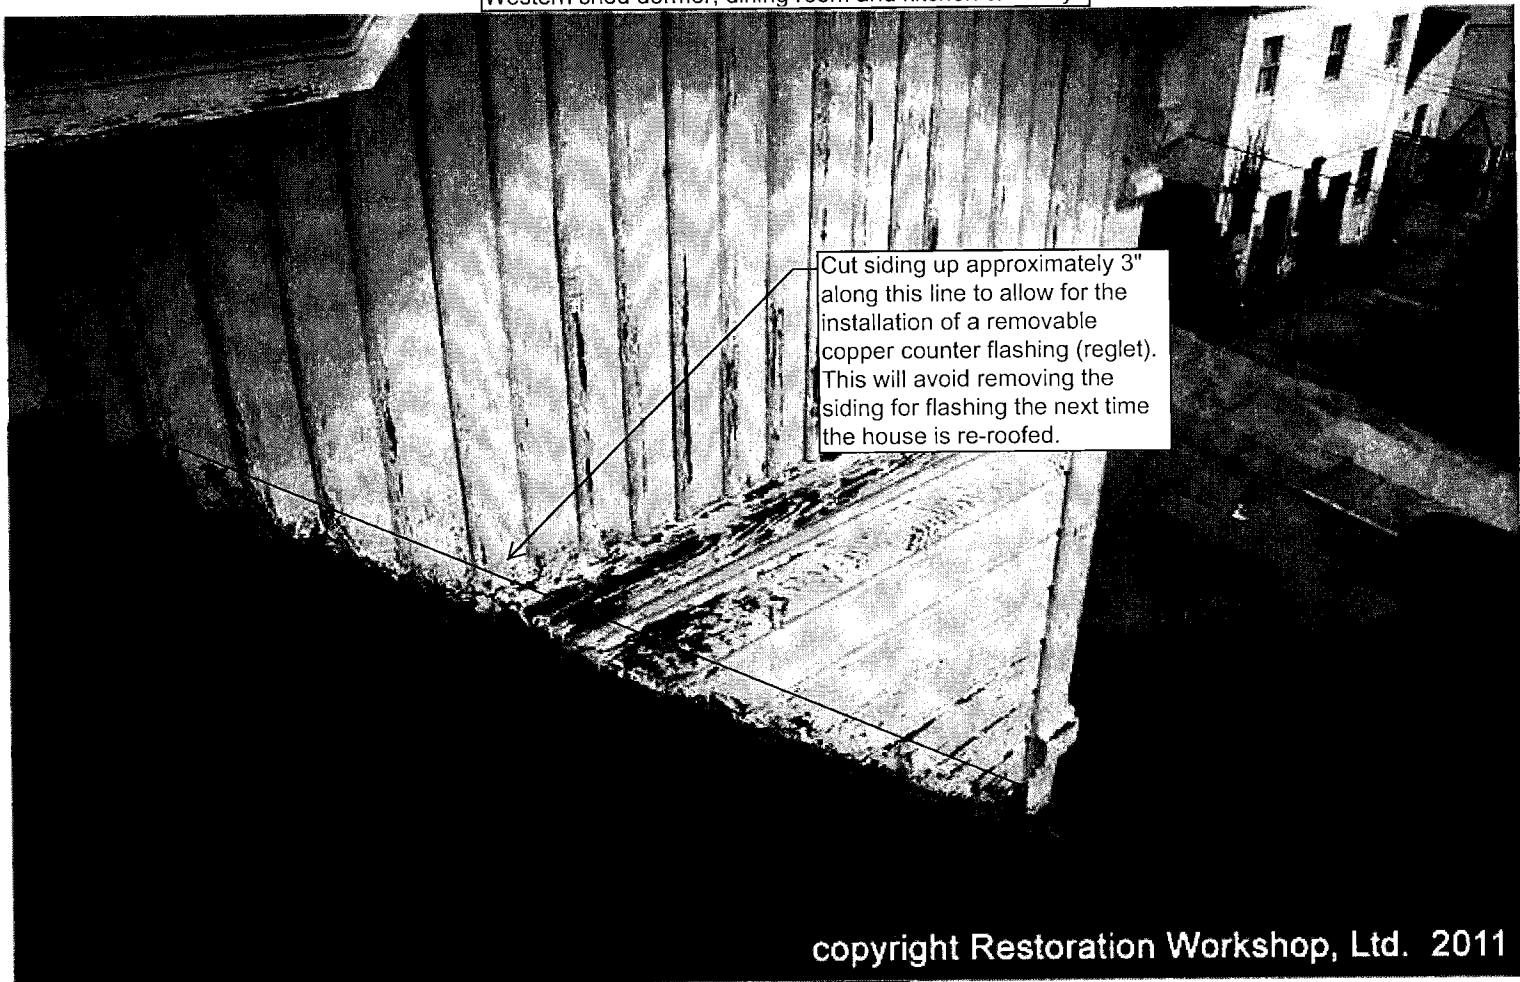
South Face of tower

Cut siding up approximately 3" along this line to allow for the installation of a removable copper counter flashing (reglet). This will avoid removing the siding for flashing the next time the house is re-roofed.

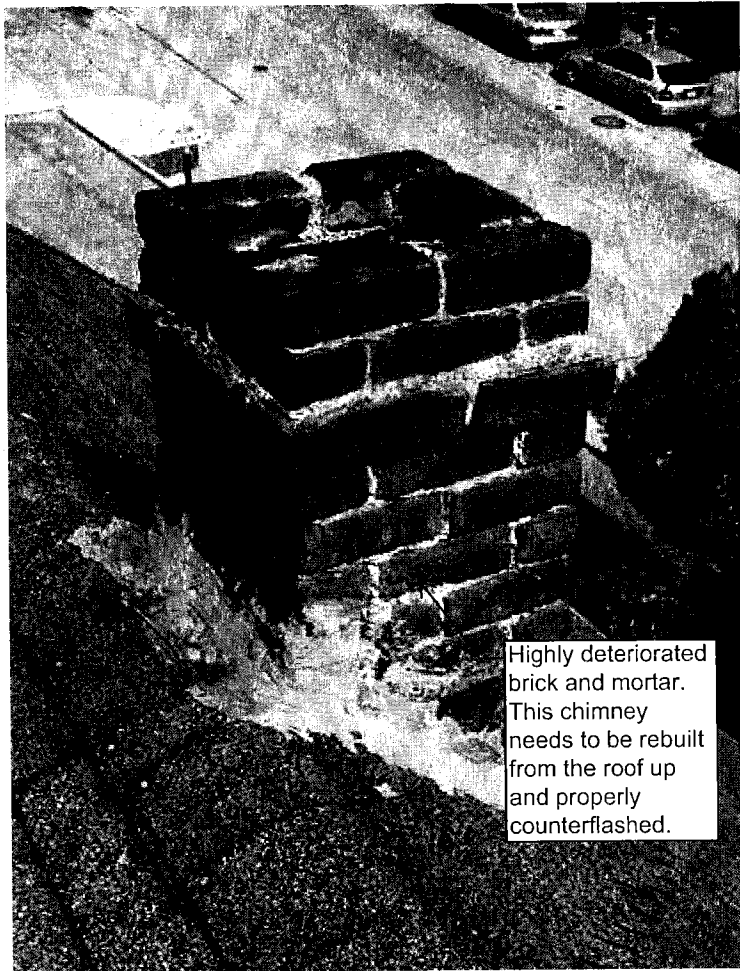
Dining room Chimney

Highly deteriorated brick and mortar. This chimney needs to be rebuilt from the roof up and properly counterflashed.

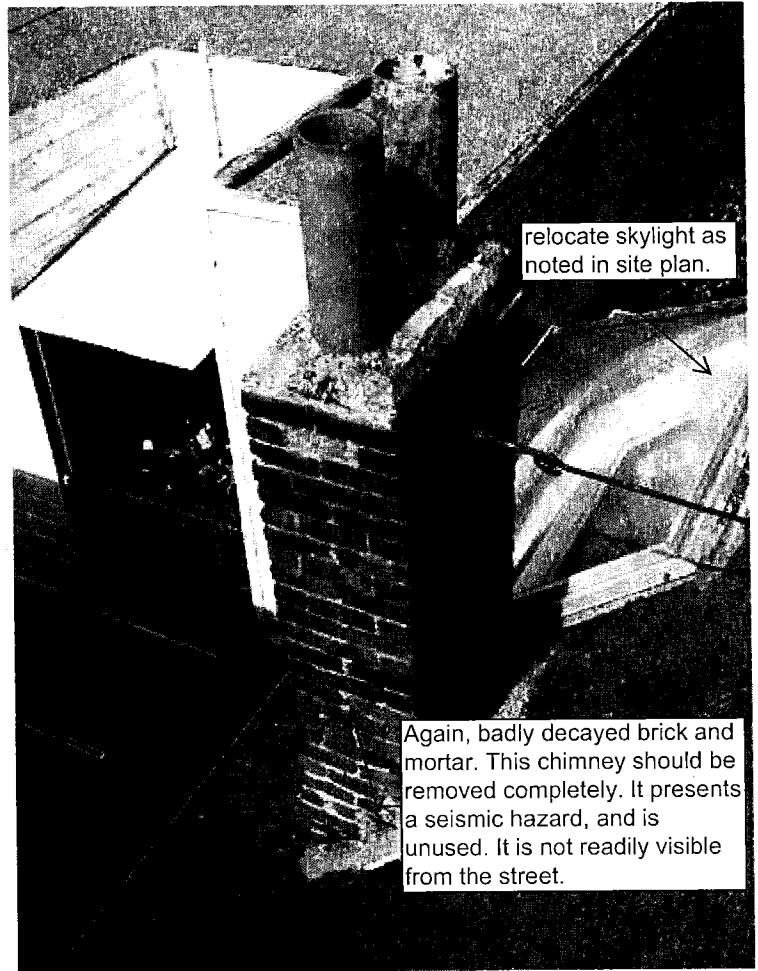
Kitchen Chimney

relocate skylight as noted in site plan.

Again, badly decayed brick and mortar. This chimney should be removed completely. It presents a seismic hazard, and is unused. It is not readily visible from the street.

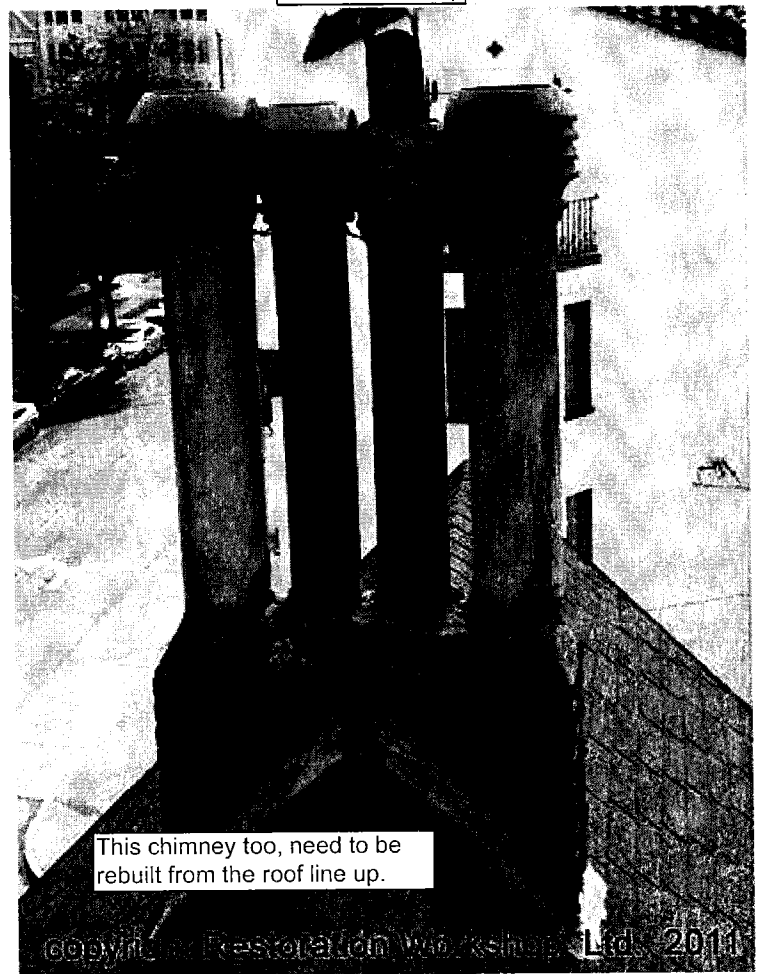
Parlor chimneys

This chimney too, need to be rebuilt from the roof line up.

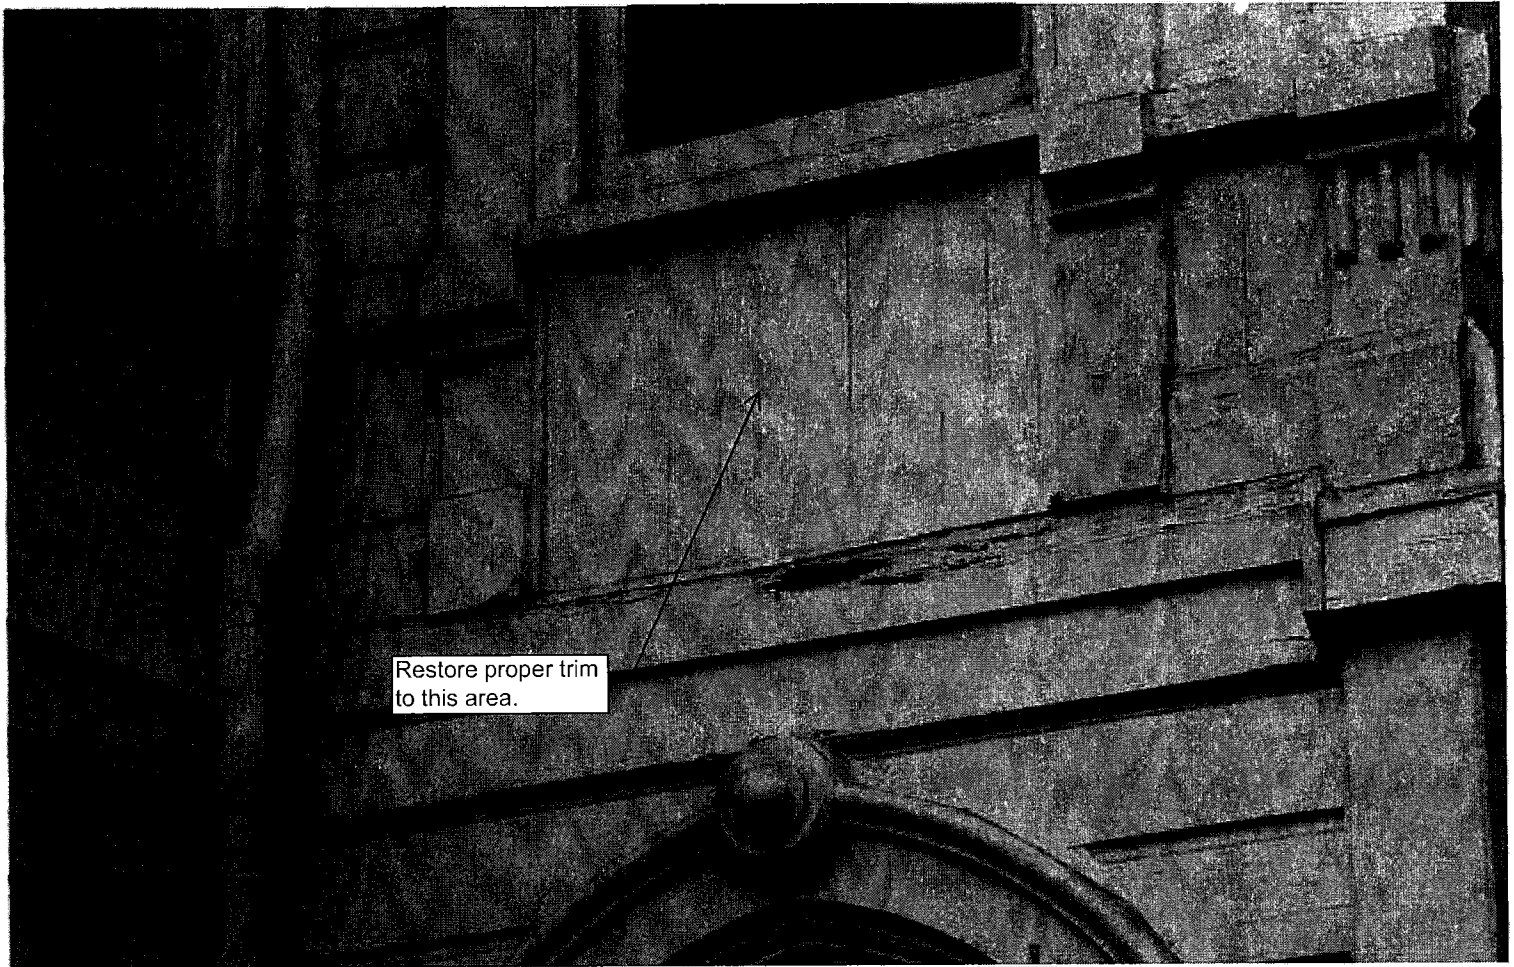
[Former Balcony location at eastern end of sun room.]

Restore proper trim  
to this area.

Balconies at southeast & southwest corners of sunroom, South Elevation (Visible in 1921 DPW photograph. Separate building permit)	Recreate missing balconies by reverse engineering from the photograph. Emphasis will be on closely matching the appearance of the originals while greatly improving the engineering and waterproofing by marrying traditional craft with modern materials and techniques. Plans subject to departmental review before issuance of building permit	45,000
Jib doors opening from parlors to the balconies (separate building permit)	Recreate the jib doors that opened from the parlors to the balconies. Both of the south facing parlor windows which opened upon the balconies where originally jib doors. They have false head jambs which allow the inner sash to recede upwards into the wall cavity. They both have the apron area below the sash completely rebuilt with incorrect later materials, and the historic photograph shows additional evidence that these were jib doors in which the apron portion below the sash was actually a part of the sash, and raised with it creating, in effect a hidden door. These were not uncommon in the period for use to access an exterior porch when, for reasons of symmetry, a window was preferred to that having an actual door.	TBD

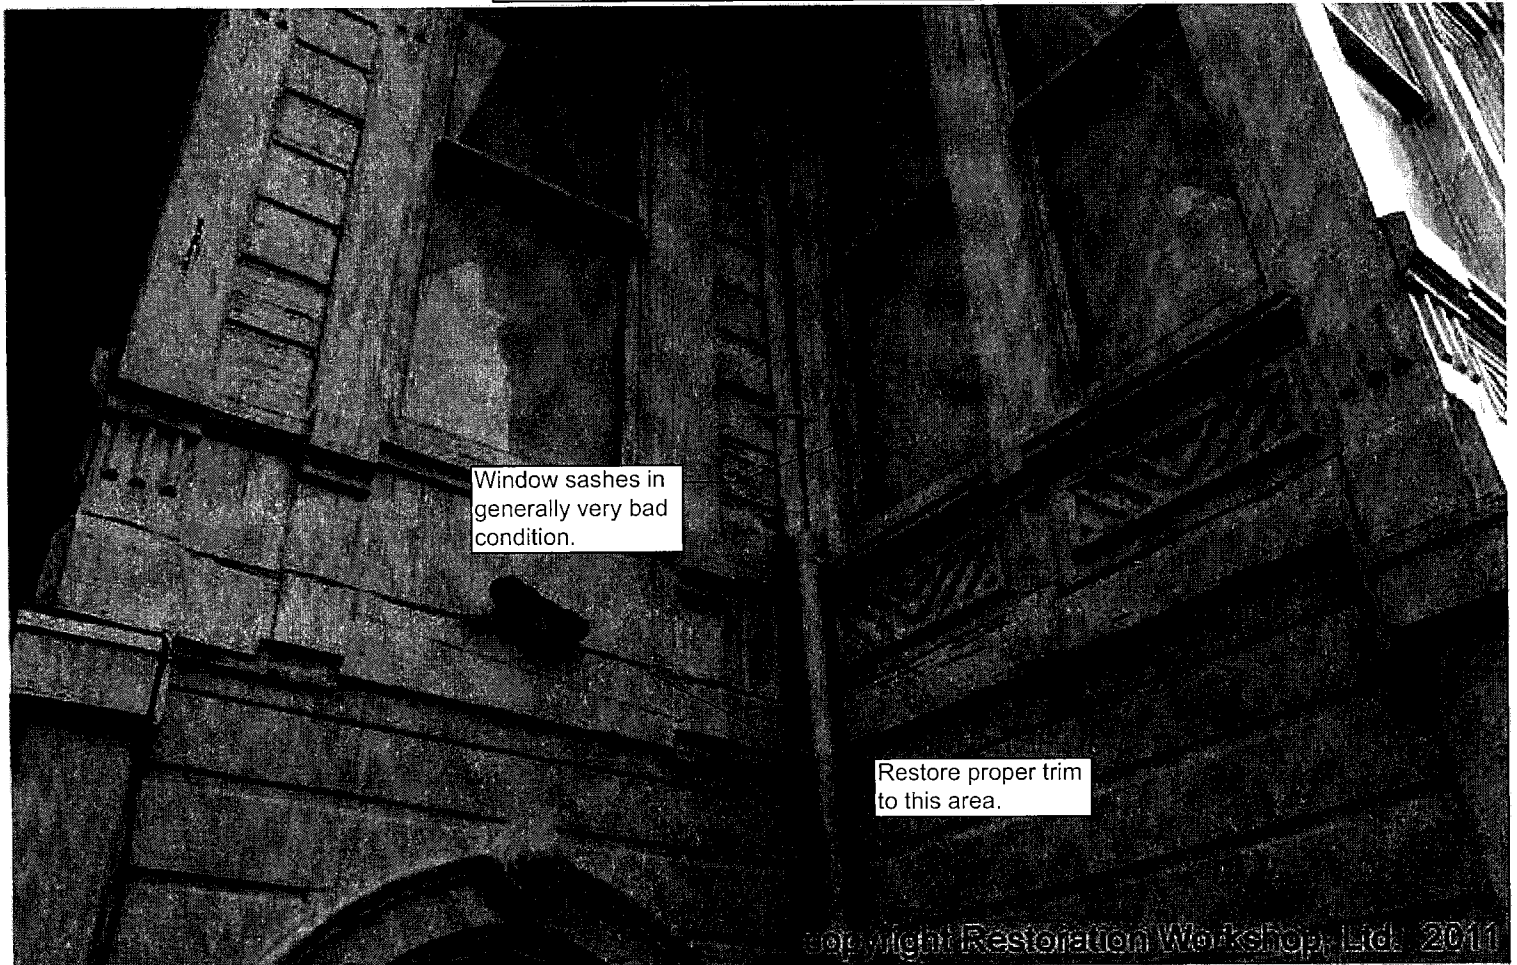
[Former balcony location at west side of sun room.]

Window sashes in  
generally very bad  
condition.

Restore proper trim  
to this area.
