# SAN FRANCISCO PLANNING DEPARTMENT

**Re: Transmittal of Planning Department Case Number 2013.0575U  
Mills Act Historical Property Contract Application  
1772 Vallejo St. (Landmark No. 31, Burr Mansion)**

**APPENDIX 1: HISTORIC MAPS AND PHOTOGRAPHS**

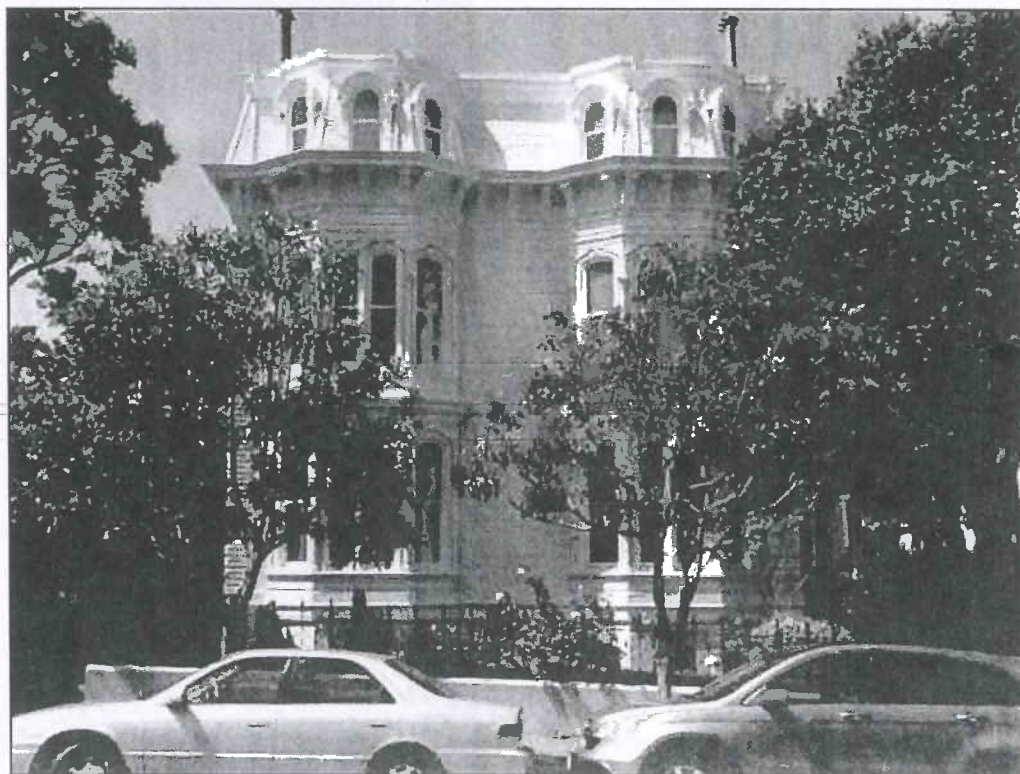
**Photo 1.** Burr House, 1772 Vallejo Street, 94123. Site, view north. Before tree-trimming. Note mature trees encroaching on the house and garden setting.

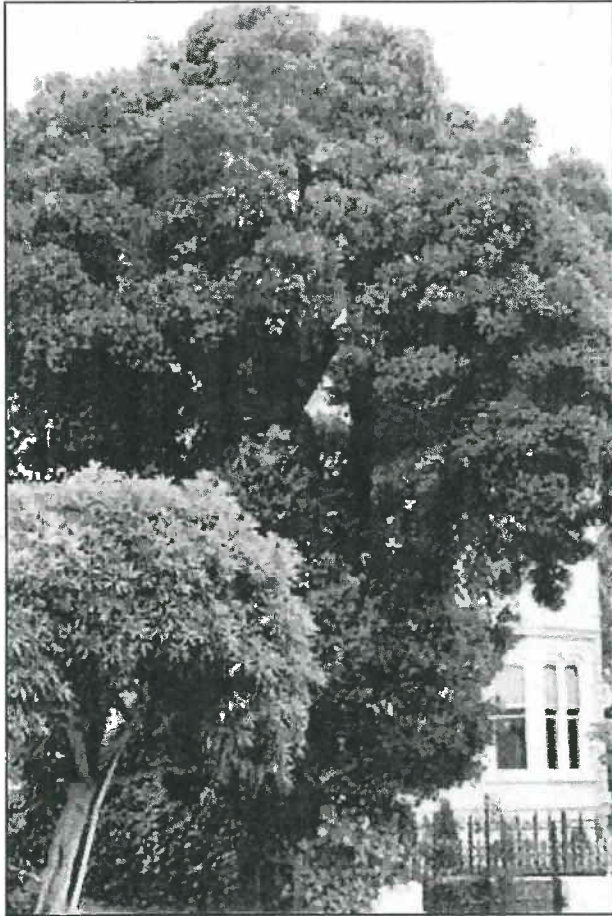
**Photo 2.** Burr House, 1772 Vallejo Street, 94123. Site, view northwest. After tree trimming. Note that trees are no longer encroaching on house or garden setting.

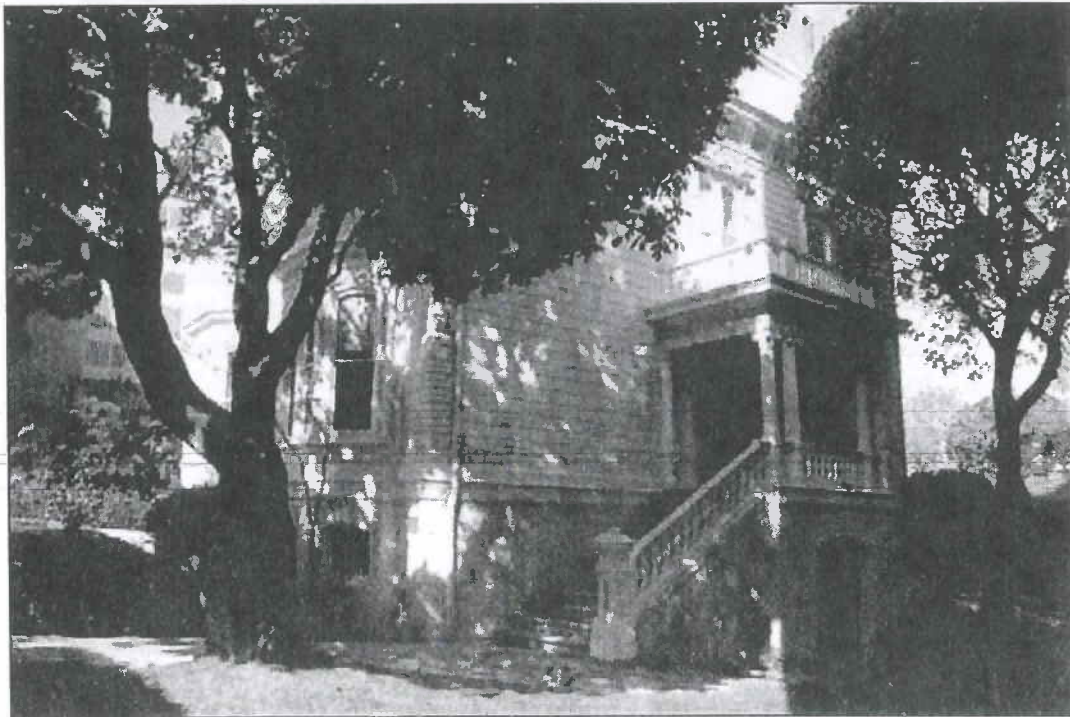
**Photo 7.** Burr House, 1772 Vallejo Street, 94123. Site, view northwest. Note mature trees planted adjacent to porch foundation and tree limbs encroaching on house

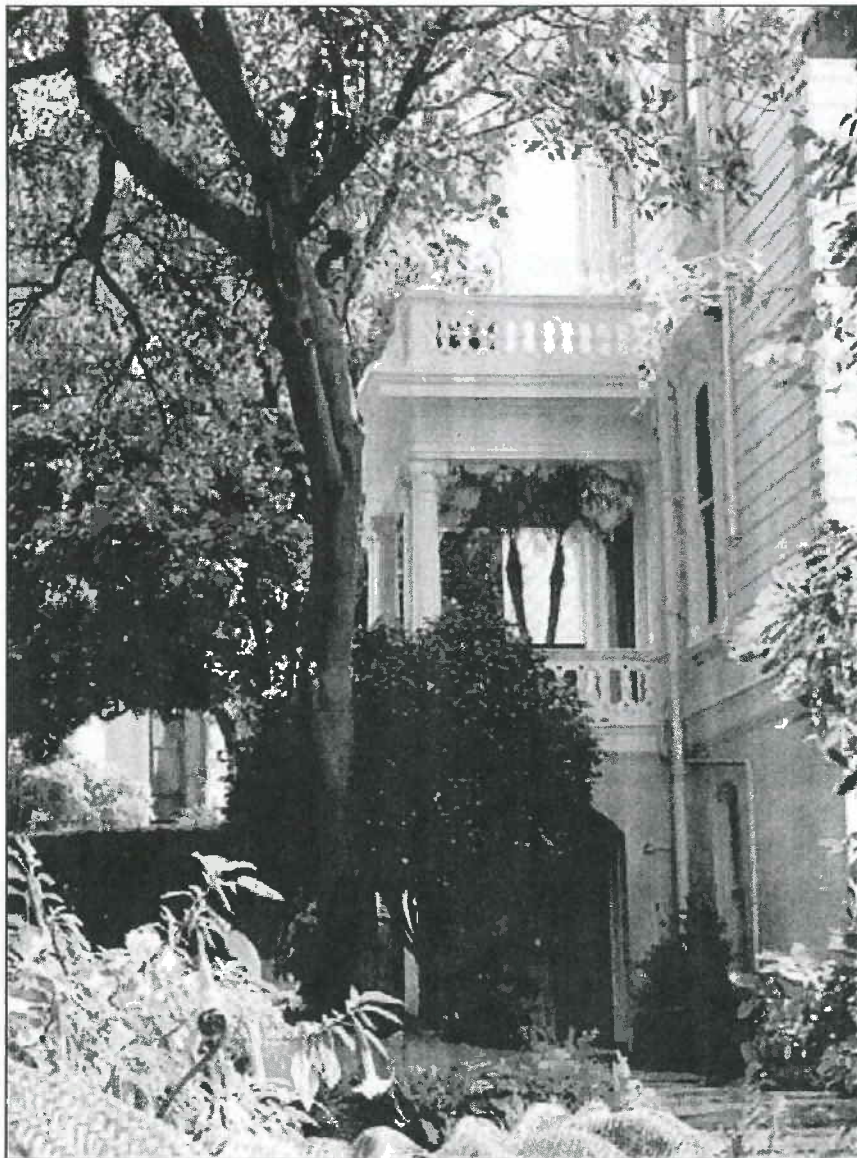
**Photo 8.** Burr House, 1772 Vallejo Street, 94123. Site, view south. Note mature trees planted adjacent to porch foundation and tree limbs encroaching on house

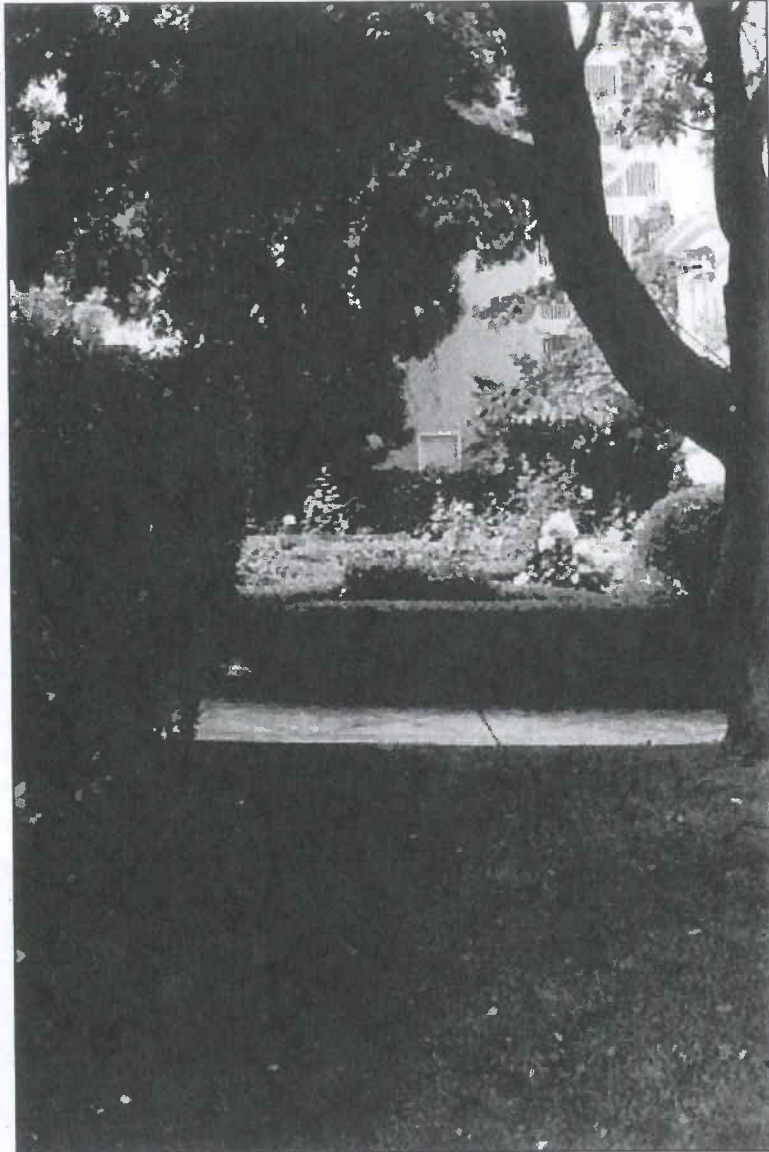
**Photo 9.** Burr House, 1772 Vallejo Street, 94123. Site, view west. Note area with box hedges, site of unreinforced masonry retaining wall.

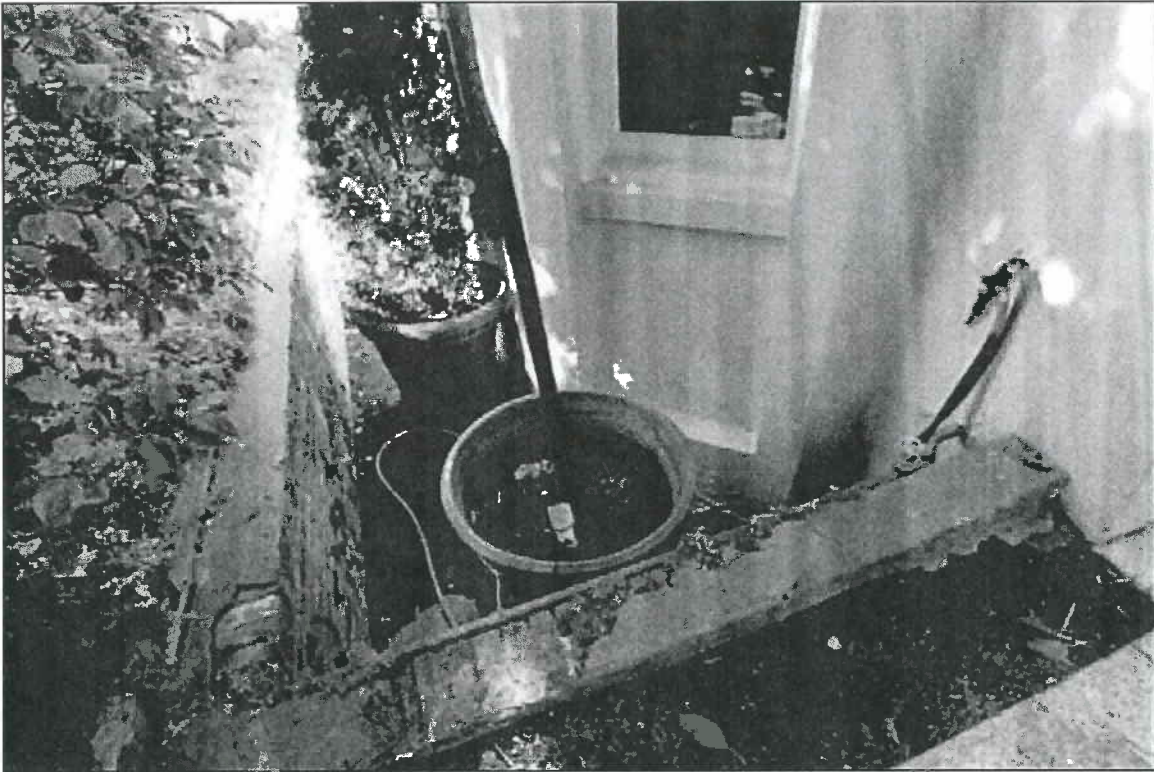
**Photo 10.** Burr House, 1772 Vallejo Street, 94123. Detail of unreinforced masonry retaining wall adjacent to south facade. Note cracking and mortar deterioration.

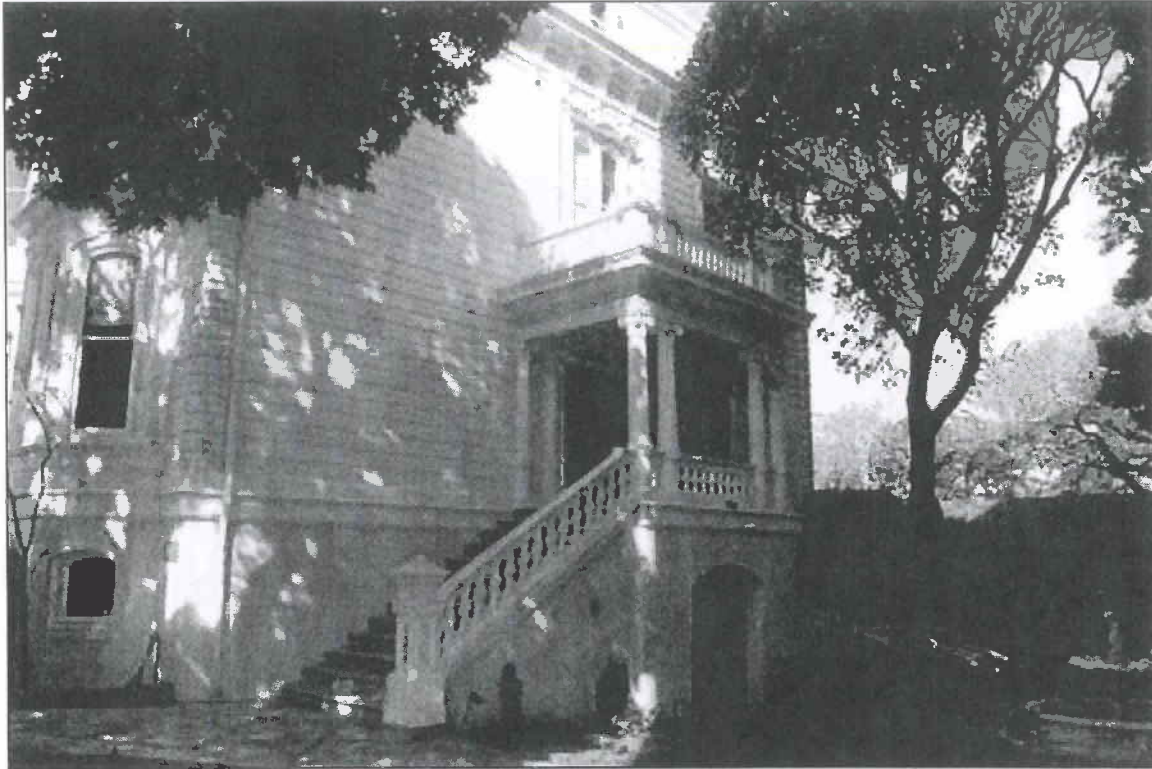
**Photo 15.** Burr House, 1772 Vallejo Street, 94123. East elevation, view northwest. Note mature trees encroaching on porch and house.

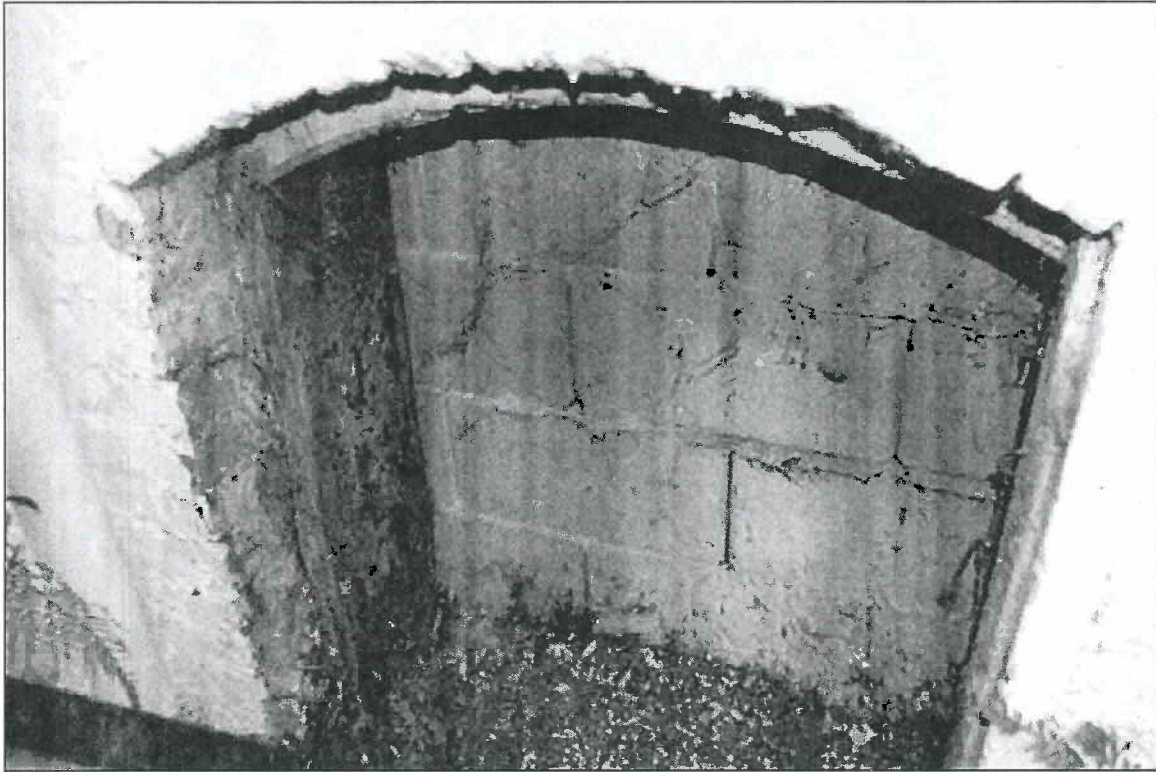
**Photo 19.** Burr House, 1772 Vallejo Street, 94123. Detail of concrete CMU shear wall at west elevation basement.

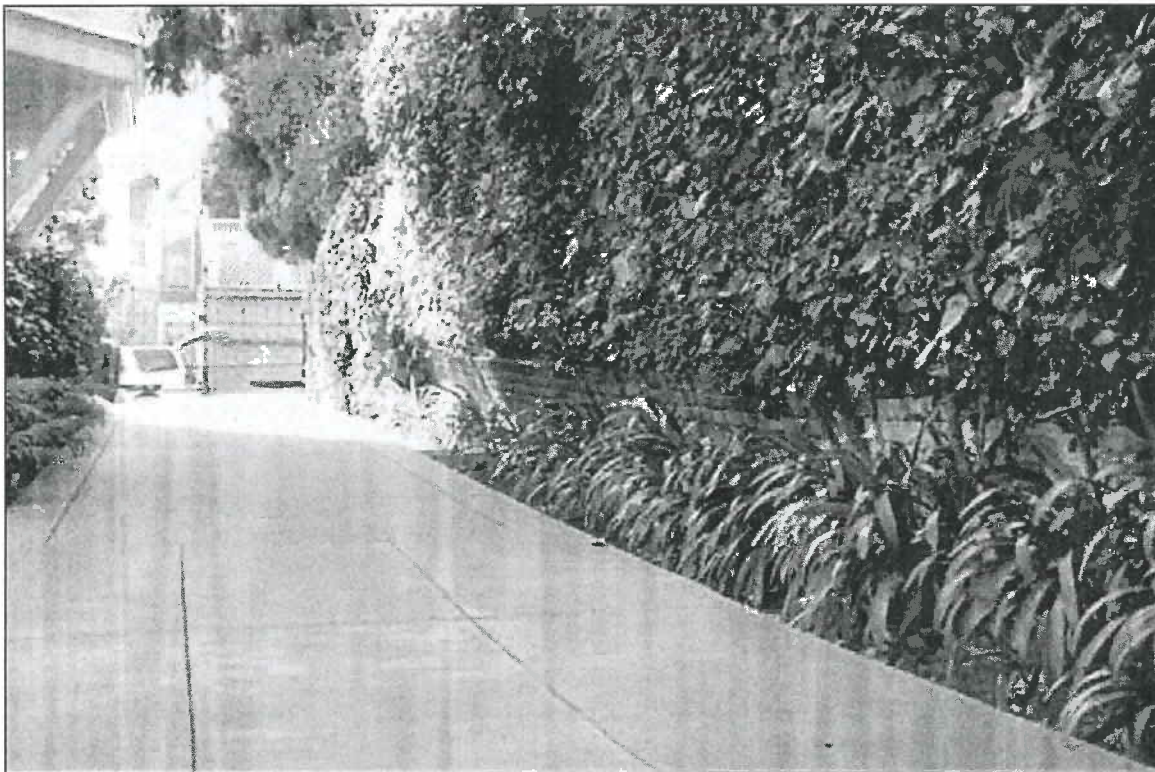
**Photo 22.** Burr House, 1772 Vallejo Street, 94123. Out of plane URM brick wall west of driveway.

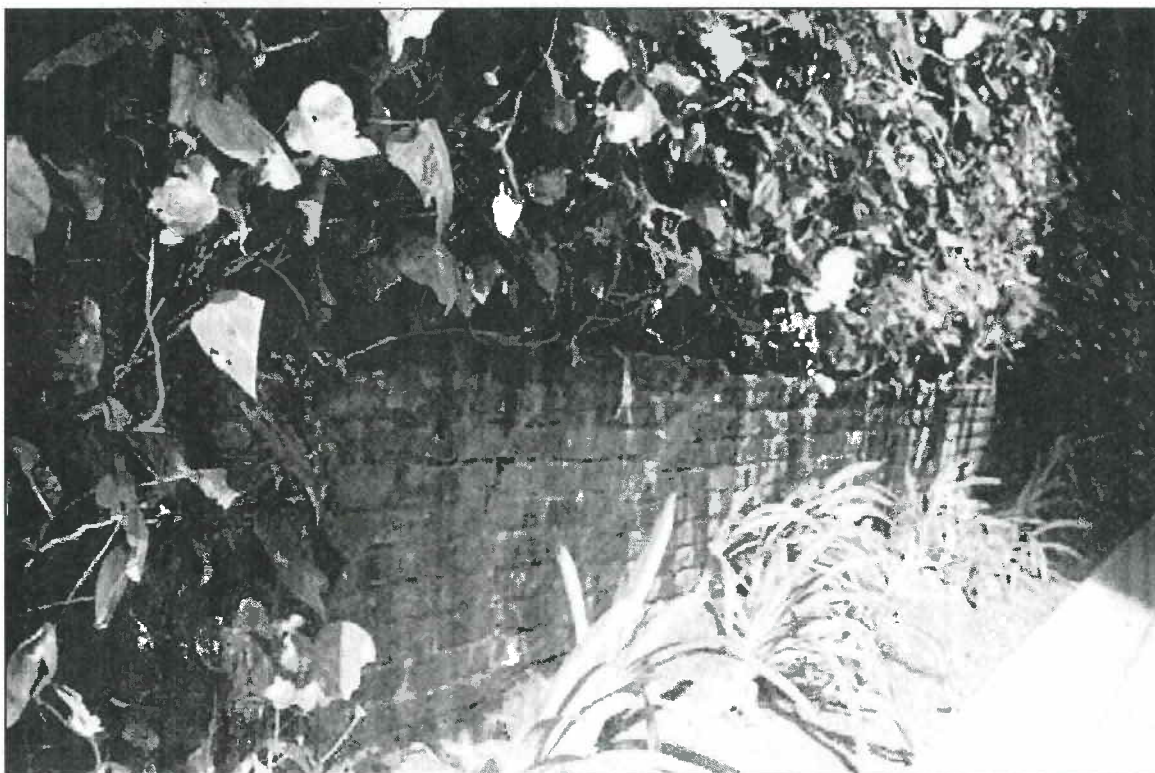
**Photo 23.** Burr House, 1772 Vallejo Street, 94123. Out of plane URM brick wall west of driveway.

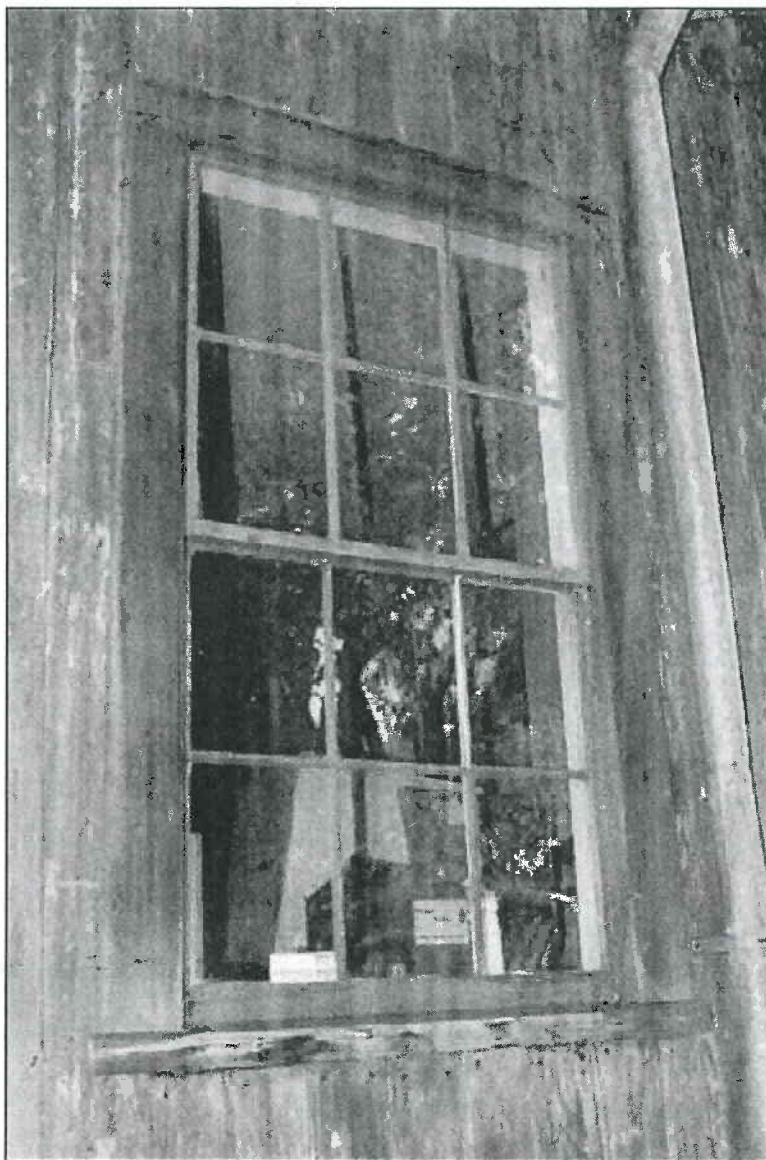
**Photo 33.** Burr House, 1772 Vallejo Street, 94123.  
Cottage, detail of typical double-hung, wood-sash window.

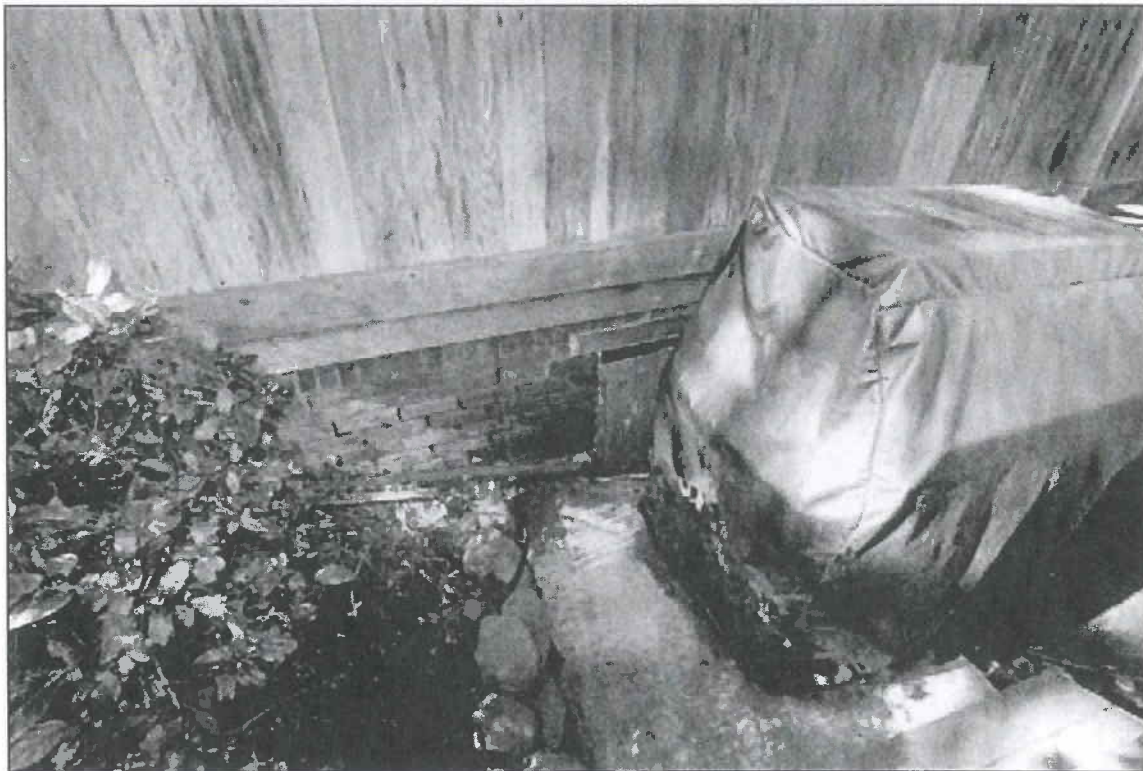
Photo 34. Burr House, 1772 Vallejo Street, 94123. Cottage, detail of URM foundation.
