File No. 171101

COMMITTEE/BOARD OF SUPERVISORS

AGENDA PACKET CONTENTS LIST

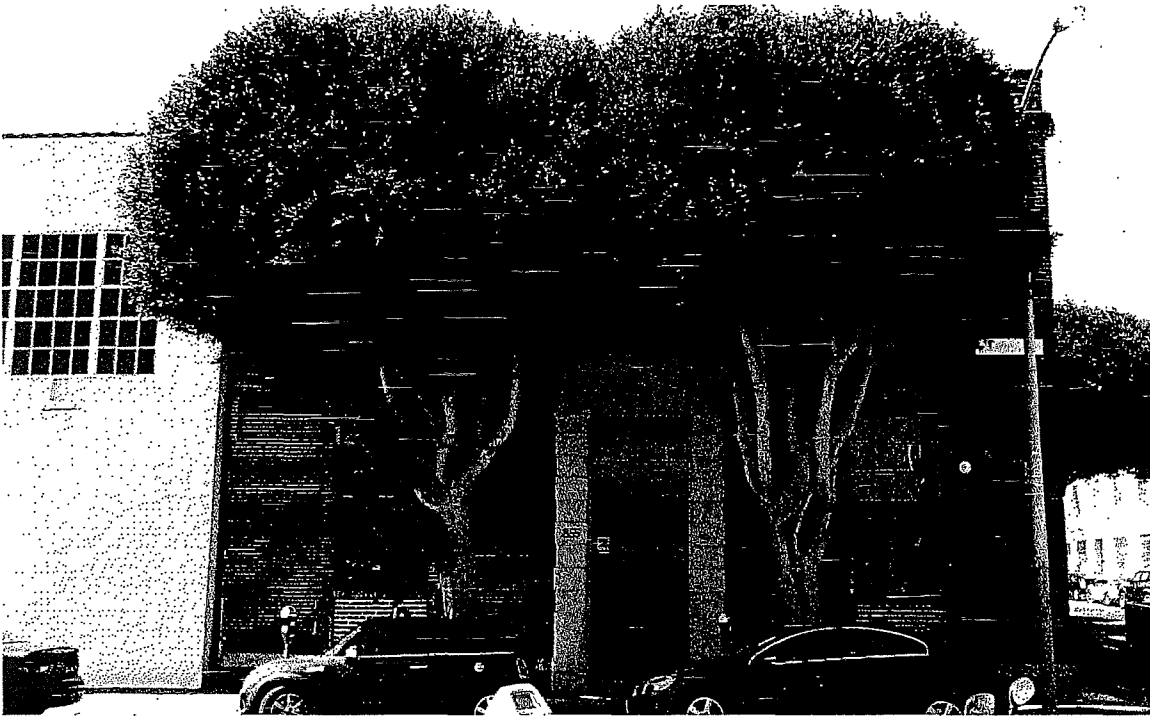
101 Vallejo Street's primary façade faces east along Front Street and is a surviving structure from the Gold Rush era. Daniel Gibb began construction of the building in about 1855 along with 901-921 Front Street, another identical building built by Gibb. The building is designed in the 19th century Commercial style and has sparse ornamentation and Italianate detail. A stone foundation that is likely a fieldstone from Telegraph Hill provides the base of the building. The exterior of the building is brick that was likely obtained locally (as brick manufacturing had been established at this point in the Bay Area). While the majority of the façade was laid in a simple running bond, intricate brick corbeling marks the bottom of the parapet. The central bay includes what was the main entrance from Front Street, though this entrance is currently not in use. The entrance features a large pair of cast iron doors with a glass transom flanked by two sandstone pilasters. The pilasters have alternating recessed and protruding stone units and the entrance is surmounted with a classical entablature. On either side of the entrance portal are two rectangular multi-lite steel windows with a blind arch detail above, constructed of brick. The second story has three windows aligned with the openings below. The central window has a concrete sill, unlike the brick sills of the first floor windows. The northern and southern upper story windows were bricked in as early as 1961, but the infill has since been removed and replacement steel windows installed. This façade has marble insert located roughly at the second floor level with the street name, "Front St." A watertable projects slightly from the façade and is detailed with quarter-round brick above. 101 Vallejo Street was significantly damaged in the Earthquake and Fire of 1906, but was reconstructed within a year. Pictures from before the earthquake and fire show a cornice with modillion blocks or dentils, however, these features were not reconstructed.

Figure 3 855 Front Street (photography taken on 03/30/2017).

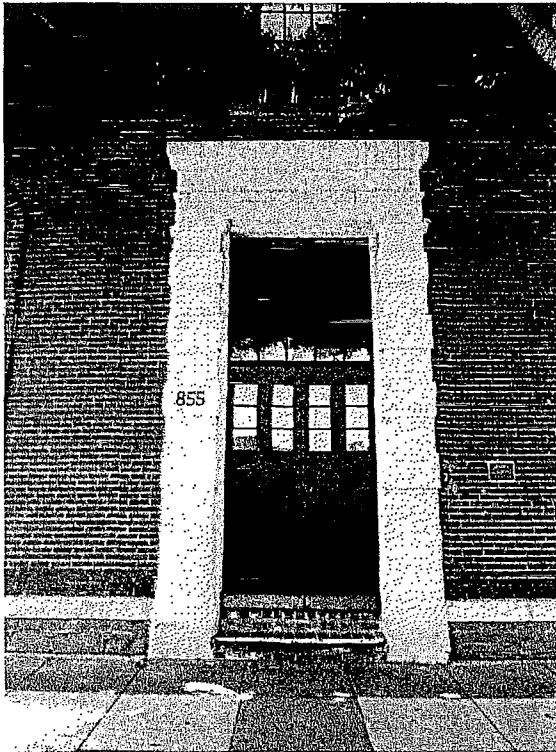
Figure 7 Entry door, 855 Front Street (photograph taken on 03/30/2017).

The door surround is of natural sandstone and is painted off-white. Blocks are arranged in an alternating recessed and protruding pattern and form the classical pilasters surrounding the door. The natural stone of the door surround is in fair condition. Very small, localized cracking occurs. Severe deterioration at the capitals has eroded features beyond recognition and the capitals need to be repaired with a stone Dutchman repair to reconstruct the profile of the capitals. Old anchor points from previous signage are still present. These should be removed and patched accordingly. The base of the door surround has a thick layer of parging cement over the existing stone substrate. While the parging mixture used in the door pilasters is not original, it appears to be in fair condition. The parging coat should be examined and repaired where it has debonded. Repair cracks and patch where the sandstone is separated from the brick stoop.

The brick stoop exhibits biological growth. Remove biological growth.

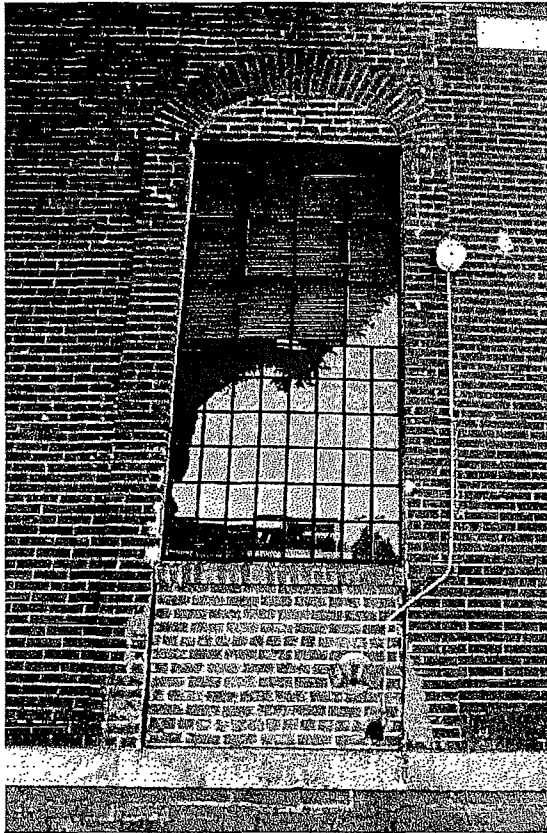
All of the sills have had parging coat repairs made to them on the interior. Seven of the sills (including both Front and Vallejo streets) show cracking of the stone, parging, or concrete/cement on the interior. All of the steel lintels show signs of corrosion and should be treated.

Figure 10 Detail of window opening along Front Street (photography taken on 03/30/2017).

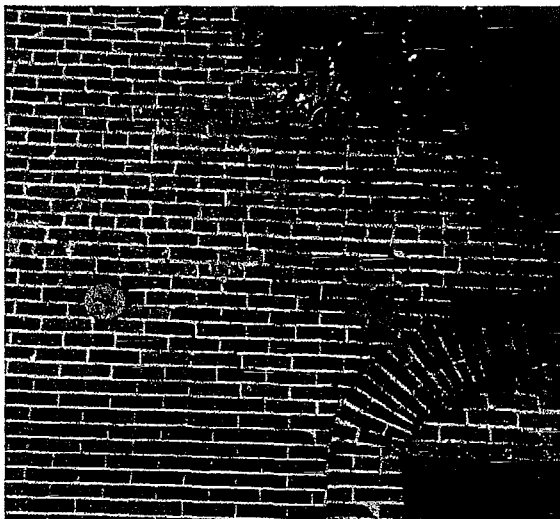
Figure 13 Detail of brick along Front Street (photography taken on 03/30/2017).

The three courses of brick just above the watertable are proud of the brick façade and have a quarter-round detail. Heavy biological growth is exhibited in this area. Clean the lower three courses with a biocide to remove biological growth.

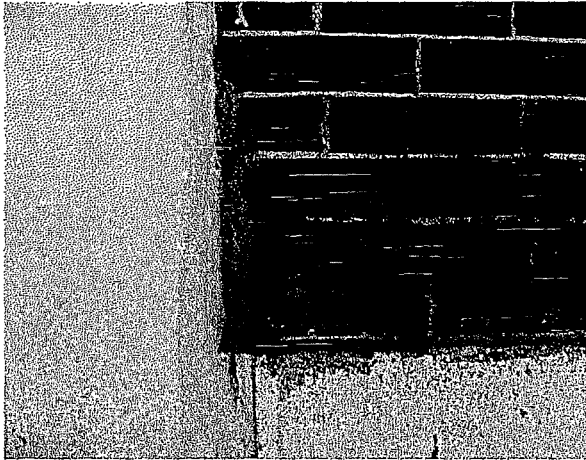
The water table along the Front Street elevation is made of granite that is original and has previously been painted. The granite is in good condition though the paint is flaking and failing. There are, however, a few areas of Portland cement infill. These should be ground out and patched with a compatible patching material. There are three areas where the bond between previous repair patches and the host granite has failed. One granite unit is cracked and fragmented into two pieces. These areas should be ground out and filled-in with an appropriate patching material.

Figure 15 Detail of water table, door surround, and brick facade intersection. Note remaining paint on the watertable granite (photography taken on 03/31/2017).

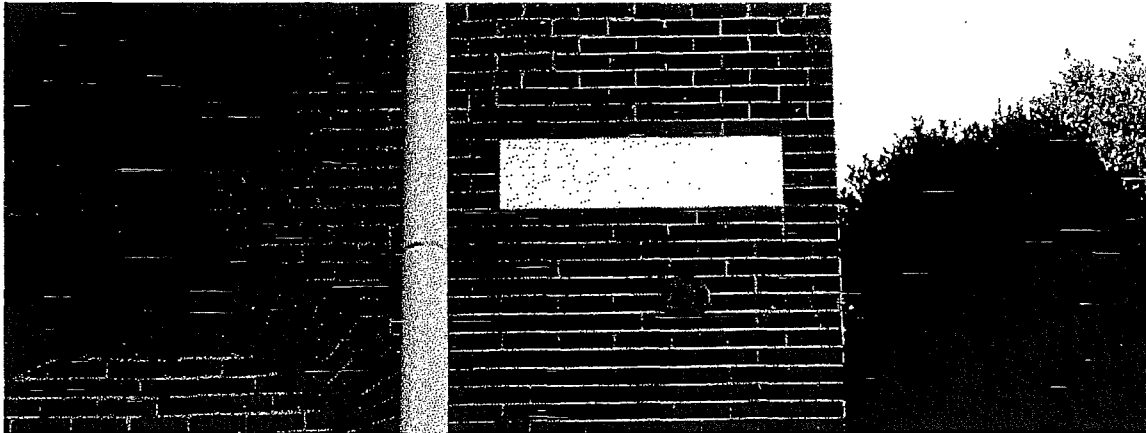
Each elevation includes an original marble insert with the street name incised in the marble. They are in good condition, and do not need rehabilitation.

Figure 17 Detail of street signage on the Front Street elevation (photography taken on 03/30/2017).

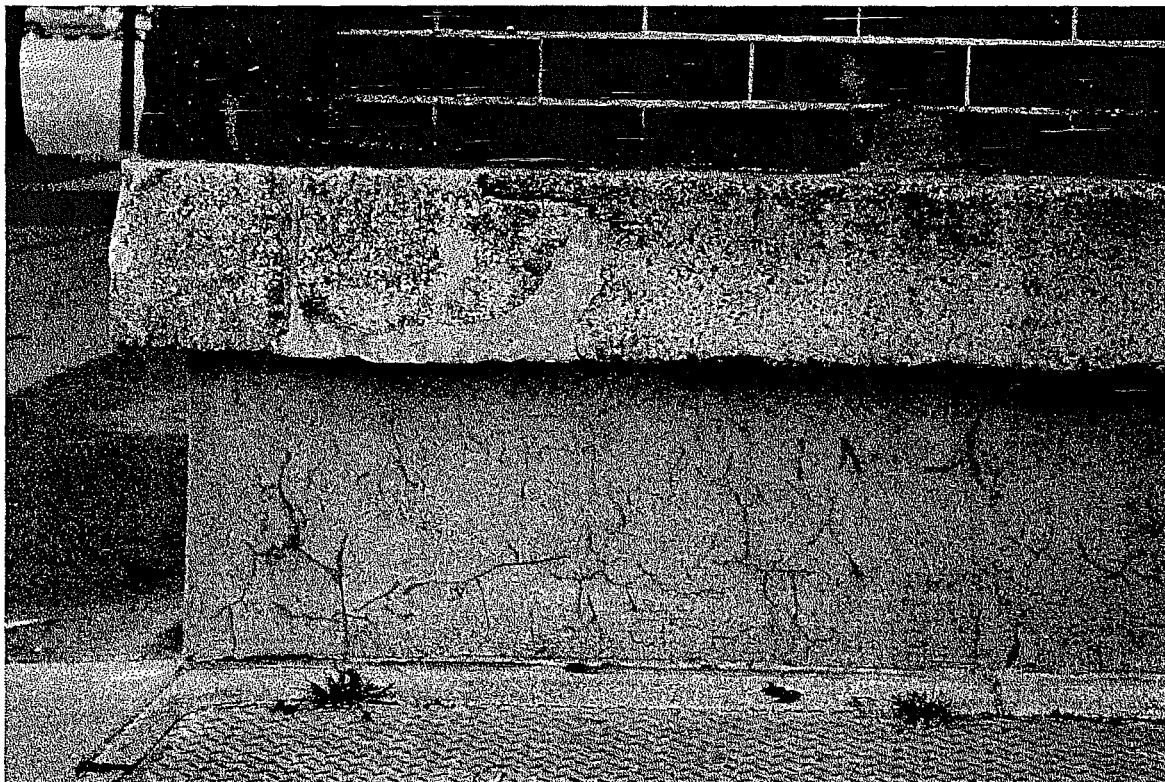
Figure 18 Detail of parging mixture used in the foundation of the Vallejo Street elevation. Note hairline cracking of parging mixture (photography taken on 04/04/2017).

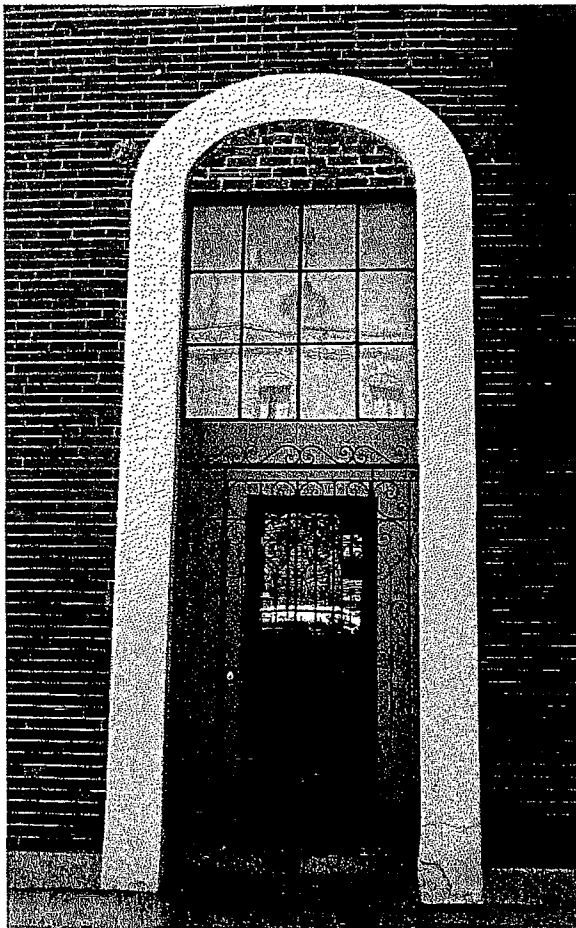
Figure 19 Photograph of easternmost entrance on Vallejo Street (photography taken on 03/30/2017).

The metal doors appear to be in fair to good condition. Remove rust, prepare, prime and paint.

The concrete landing at the center entry should be removed and replaced with a compatible landing.

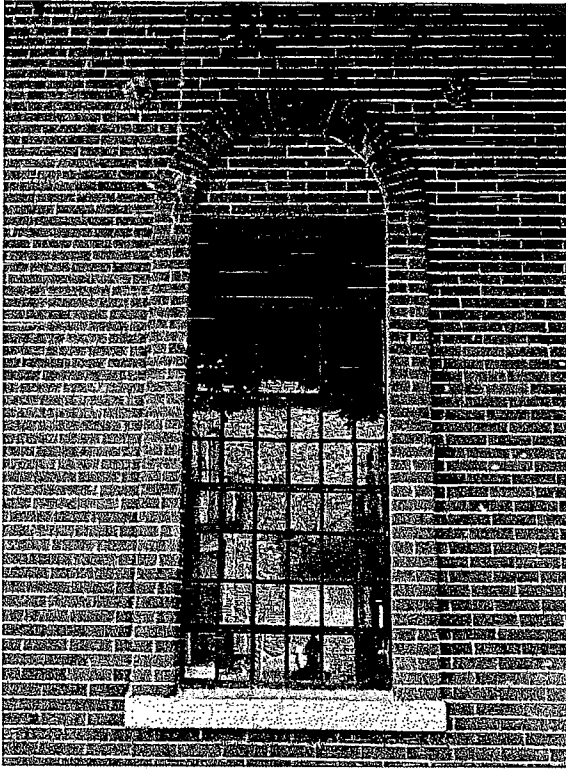
Figure 24 Historic ground level window type. Note transom glass, metal frame, brick surround, and granite sill (photography taken on 03/31/2017).

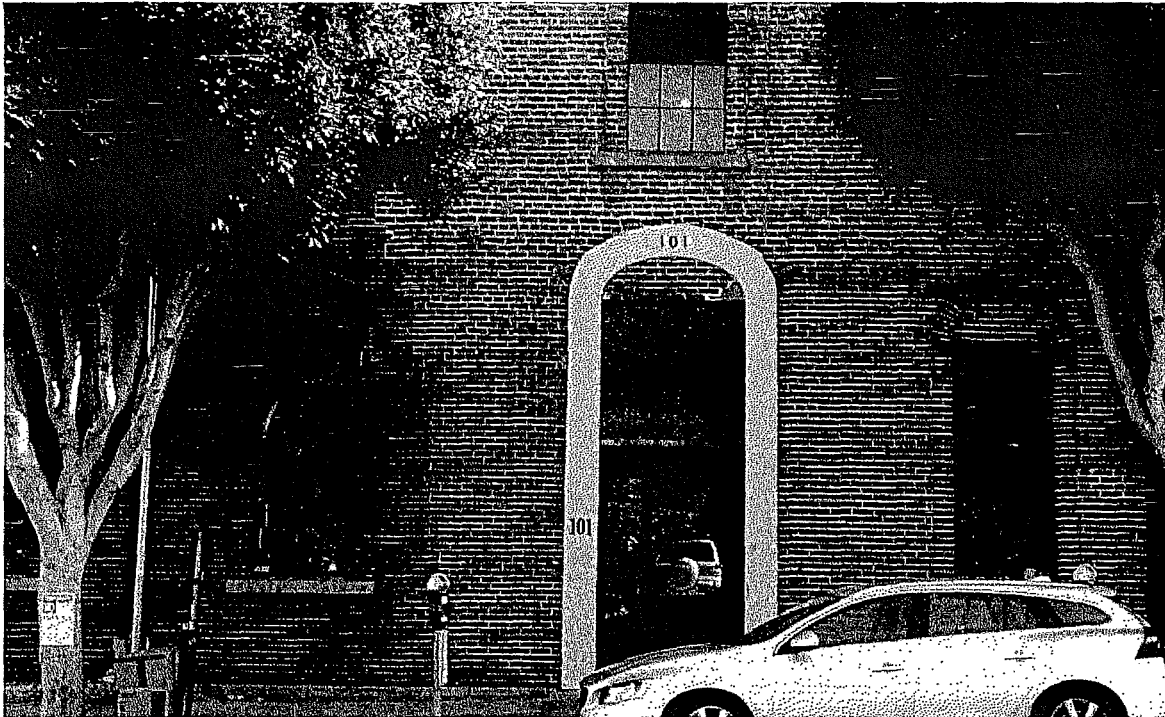
Figure 27 Photograph of 101 Vallejo Street. Note visual seam between historic brick (left) and the brick used in a later restoration campaign (right). Photography was taken on 03/30/2017.

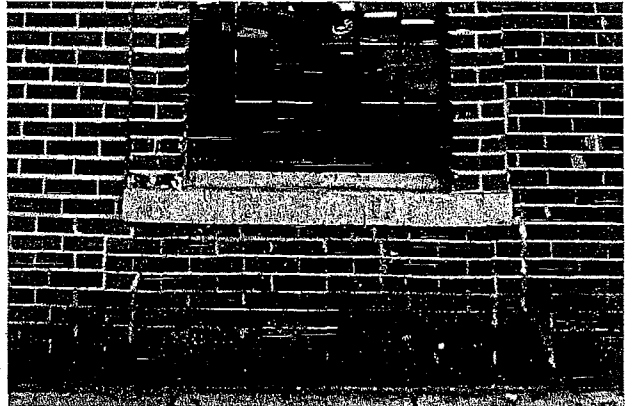
Figure 29 Detail of biological colonization at the bottom courses along Vallejo Street (photography taken on 03/31/2017).

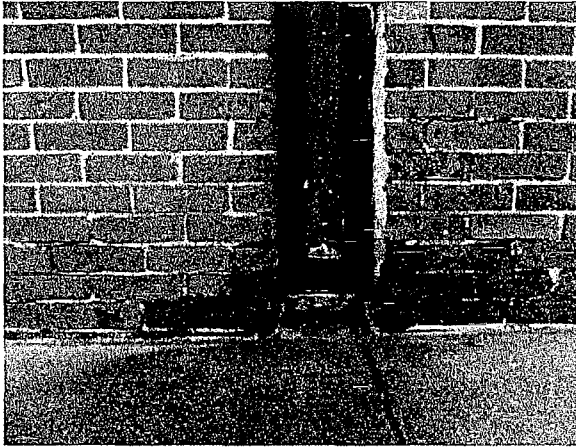
Figure 34 Non-functioning downspout along Vallejo Street. The inability to direct water away from the facade and foundation have resulted in heavy areas of bio-colonization. This will, in turn, accelerate the deterioration of the brick and mortar (photography taken on 03/31/2017).

Figure 35 Non-functioning downspout along Vallejo Street. The inability to direct water away from the facade and foundation have resulted in heavy areas of bio-colonization. This will, in turn, accelerate the deterioration of the brick and mortar (photography taken on 03/31/2017).

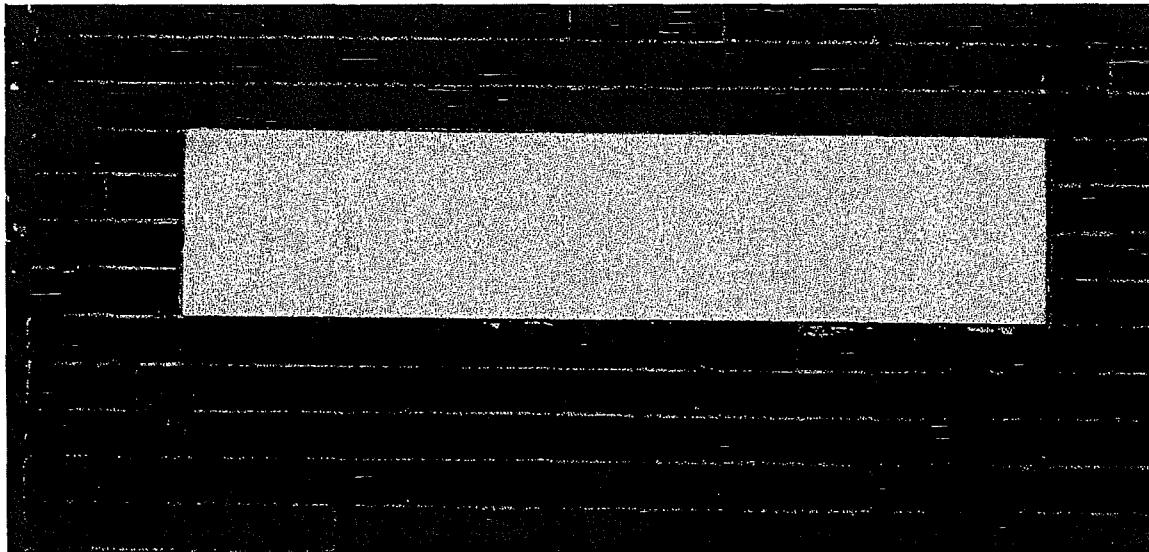
Figure 36 Detail of street signage on the Front Street elevation (photography taken on 03/31/2017).

Each elevation includes a marble insert which indicates the street name. These are historic and date to the initial construction of the building. They are in good condition, and do not need rehabilitation. Clean and repair as needed.

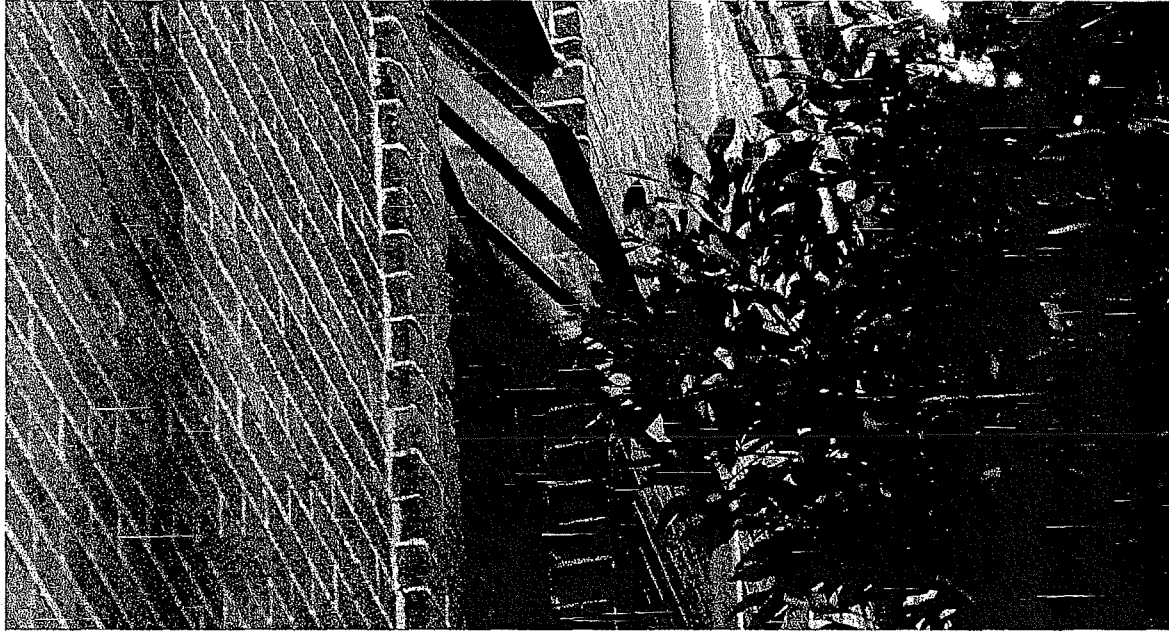
Figure 37 Street-side tree condition along Vallejo (photography taken on 03/31/2017).

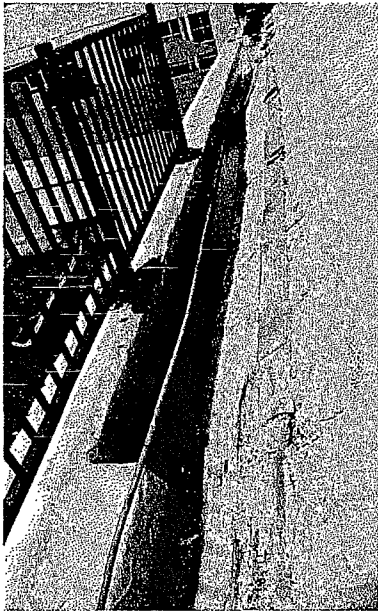
Figure 39 Detail photo of drainage condition along the south parapet. Note standing water (photography taken on 04/05/2017).

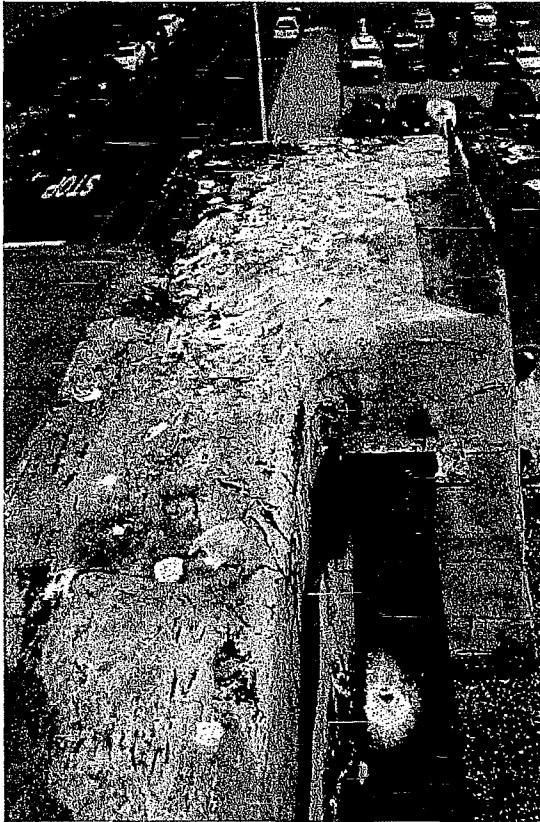
Figure 51 Photograph of the northeast corner and horizontal surface on parapet. Note biological colonization, corrosion, atmospheric pollution, and animal deposits (photography taken on 04/04/2017).

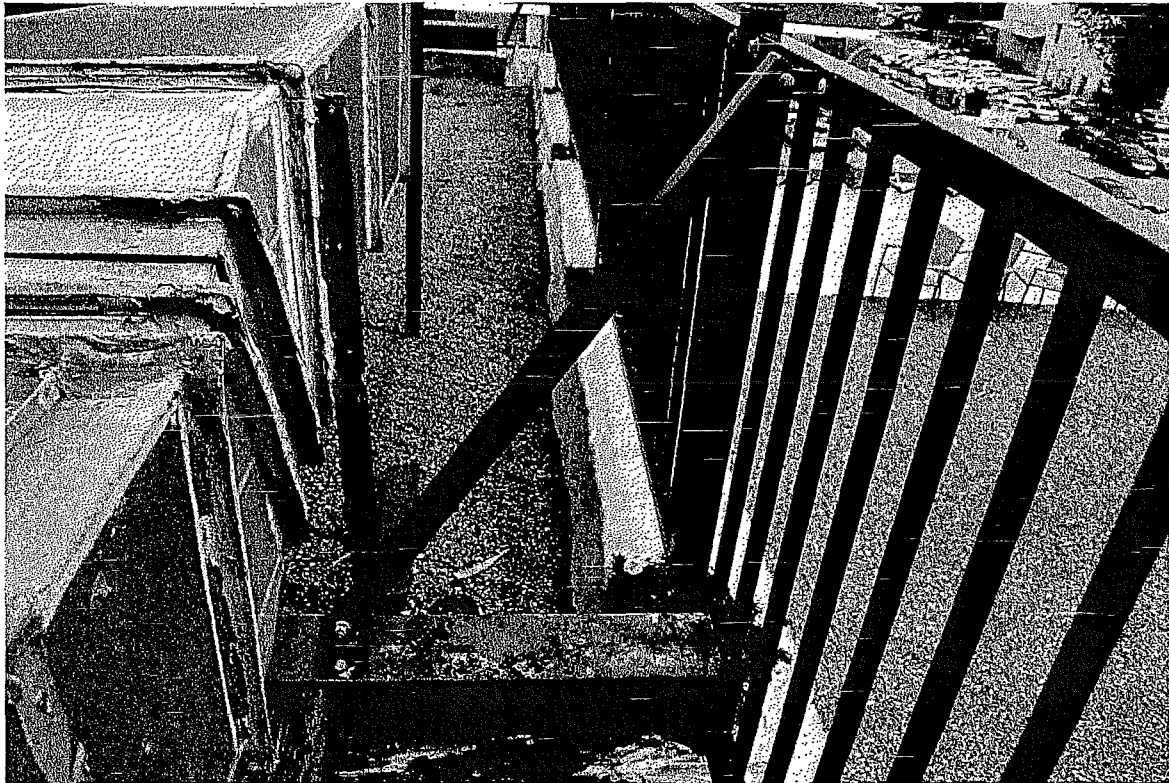
Figure 55 Photograph of non-historic railing and construction (photography taken on 04/04/2017).

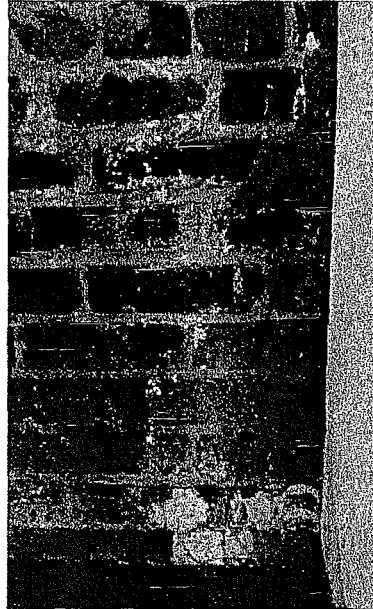
Figure 63 Detail of Portland cement patch and subsequent crack as a result (photography taken on 04/10/2017).

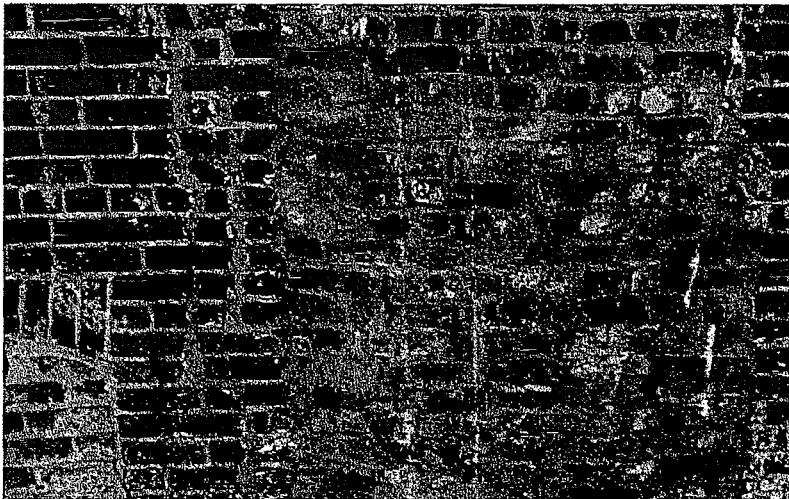
Figure 65 Detail photograph of historic window filled-in with brick on the east wall. There are 4 similar conditions on this elevation (photography taken on 04/10/2017).

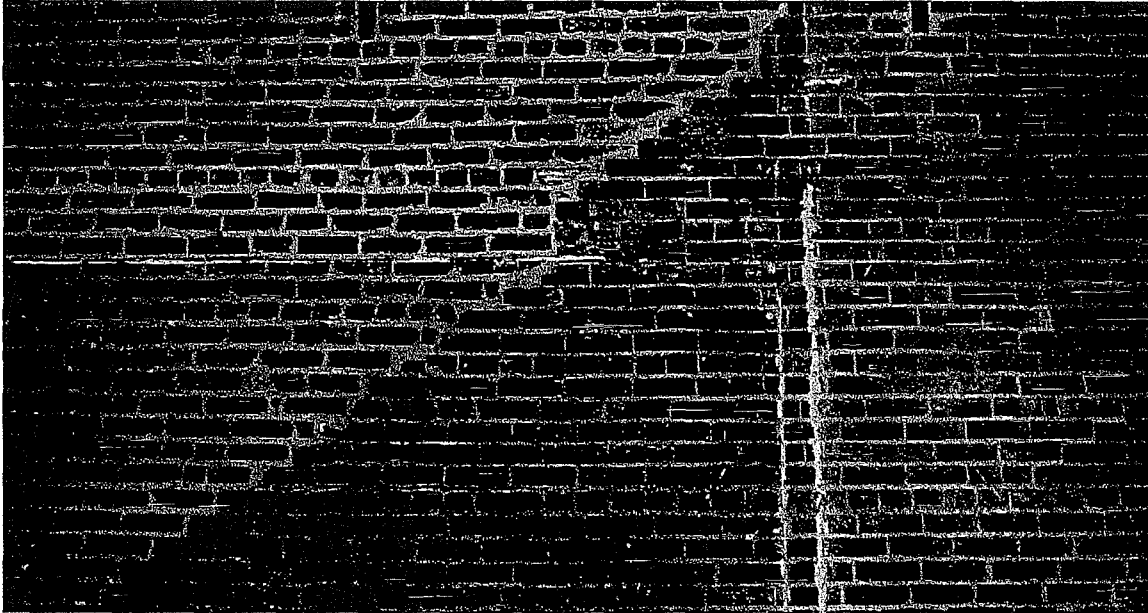
Figure 67 Photograph of south wall at the ground level. Note distinctively different eras of brick and mortar (photography taken on 04/04/2017).

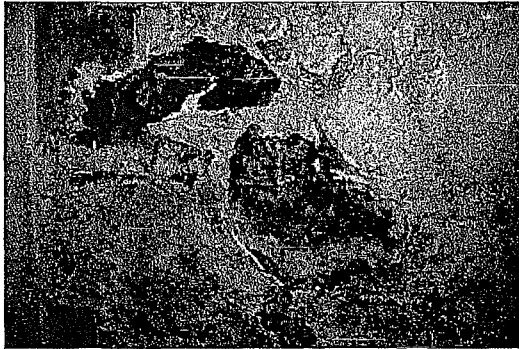
Figure 75 Detail photograph of north foundation condition. Note lost finish, exposed stone, and extensive efflorescence (photography taken on 04/04/2017).

The historic foundation at 101 Vallejo Street was constructed using irregularly-cut masonry fieldstone. Alterations to the building can be seen in the foundation with the use of regularly laid masonry units at some elevations and cement reinforcement throughout. The foundation walls are currently painted white. While the foundation walls are generally in good condition, some localized areas of paint failure have been observed in the walls constructed of fieldstone. Paint failure at the foundation correlates strongly to areas of high efflorescence and/or disaggregated and spalling stone. The walls should be examined to identify the source of water infiltration at areas of paint failure.

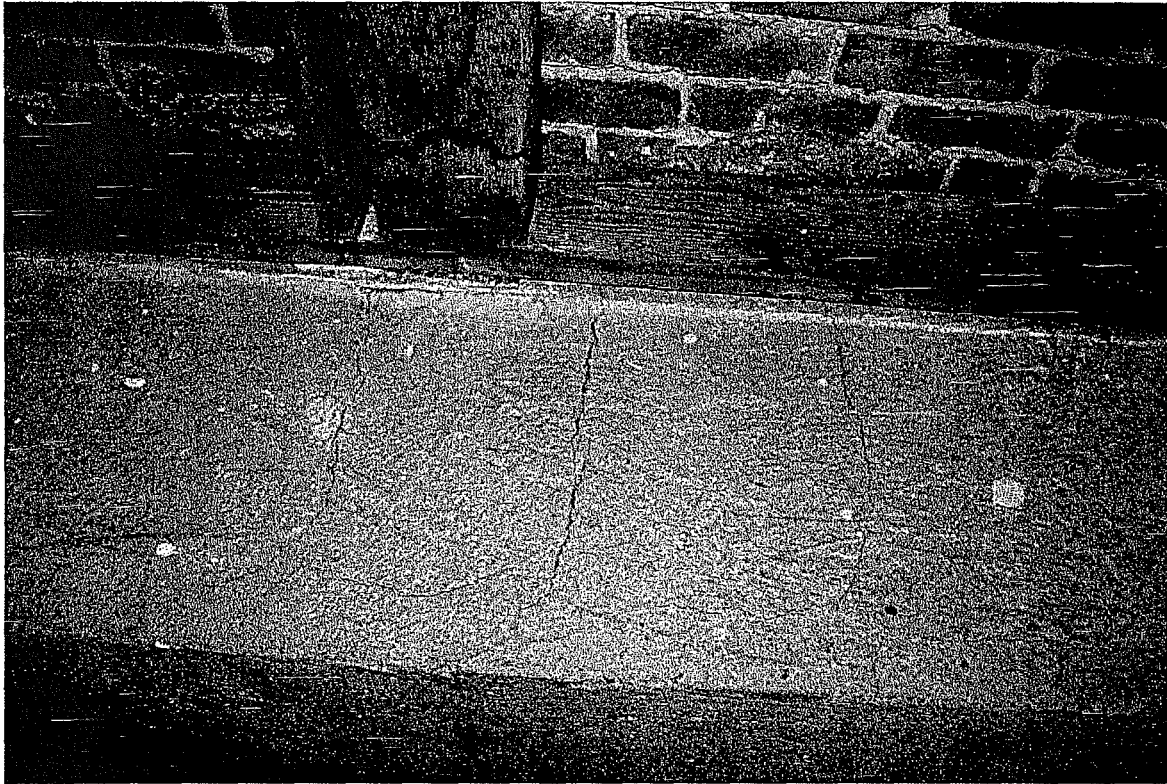
Figure 80 Detail of modern lateral stabilization system (concrete beams). Note severe through-cracking of the cement matrix (photography taken on 04/04/2017).

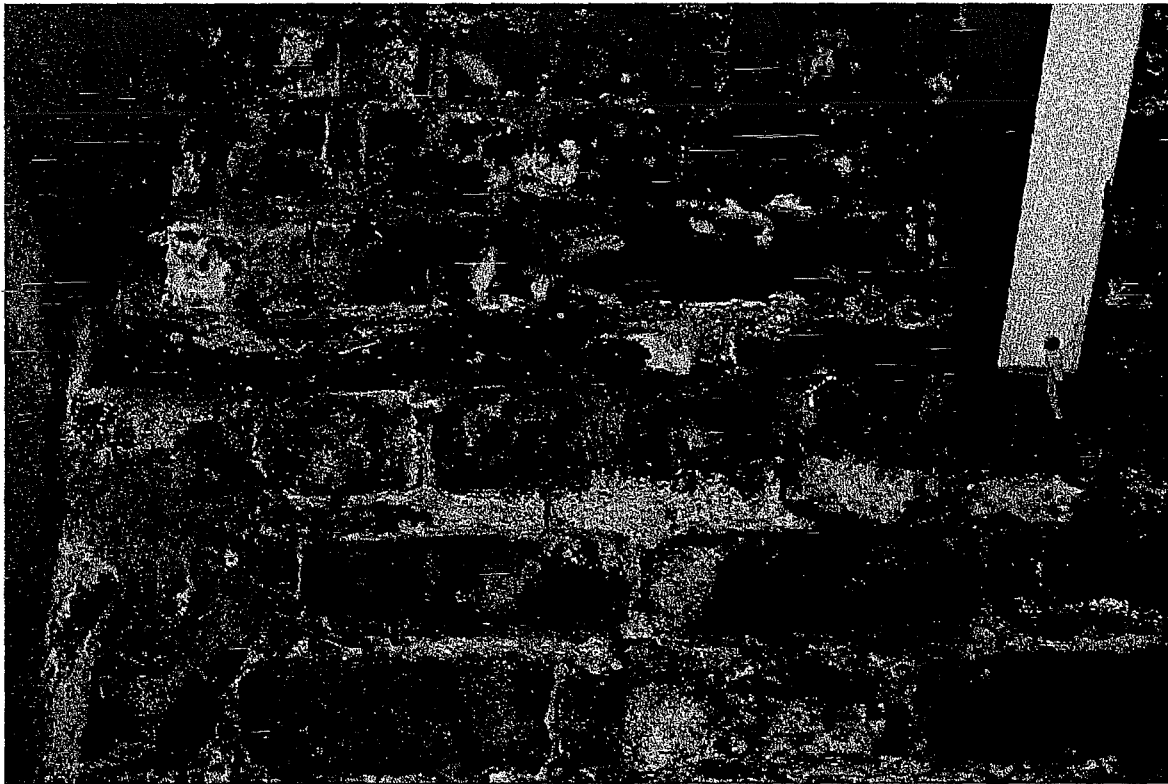
Figure 83 Detail photograph of interior upper brick courses, just below roofline. Note extensive efflorescence and discoloration. The corrosion colored staining is a leaching of ferruginous mineral inclusions innate in the brick and/or mortar (photography taken on 04/04/2017).

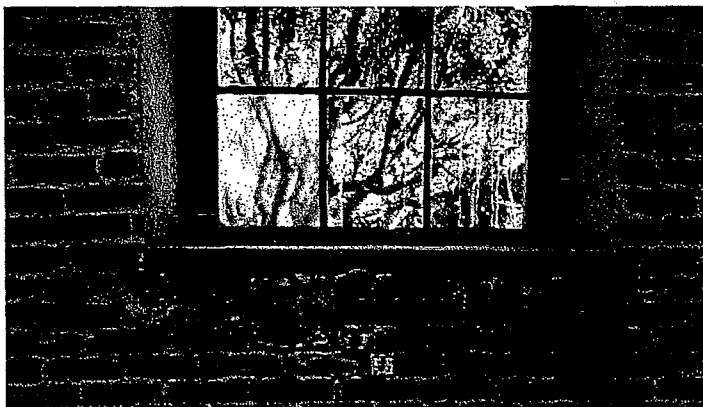
Figure 85 Detail photograph of southernmost window on the east wall. Note occurrence of efflorescence and eroded mortar (photography taken on 04/04/2017).

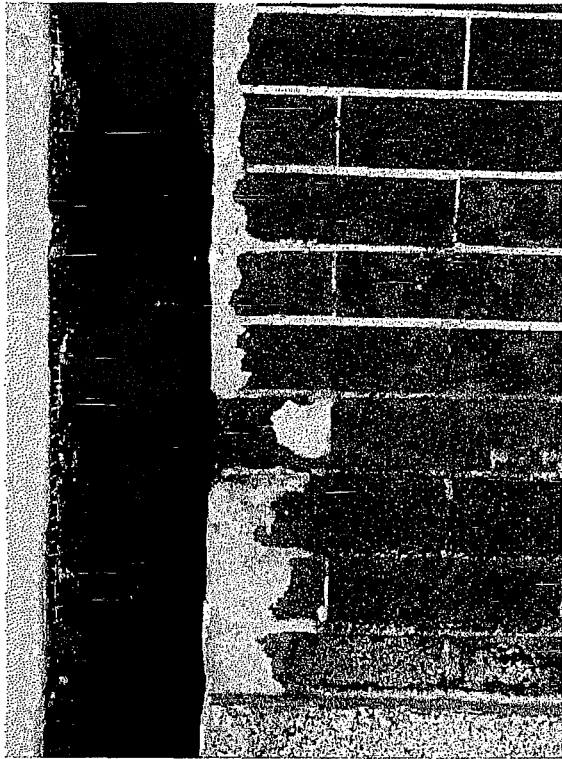
Figure 91 Detail view of incompatible repair along Front Street. Note dissimilarities between brick and repair, and note bio-colonization plaguing the joints (photograph taken on 03/31/2017).

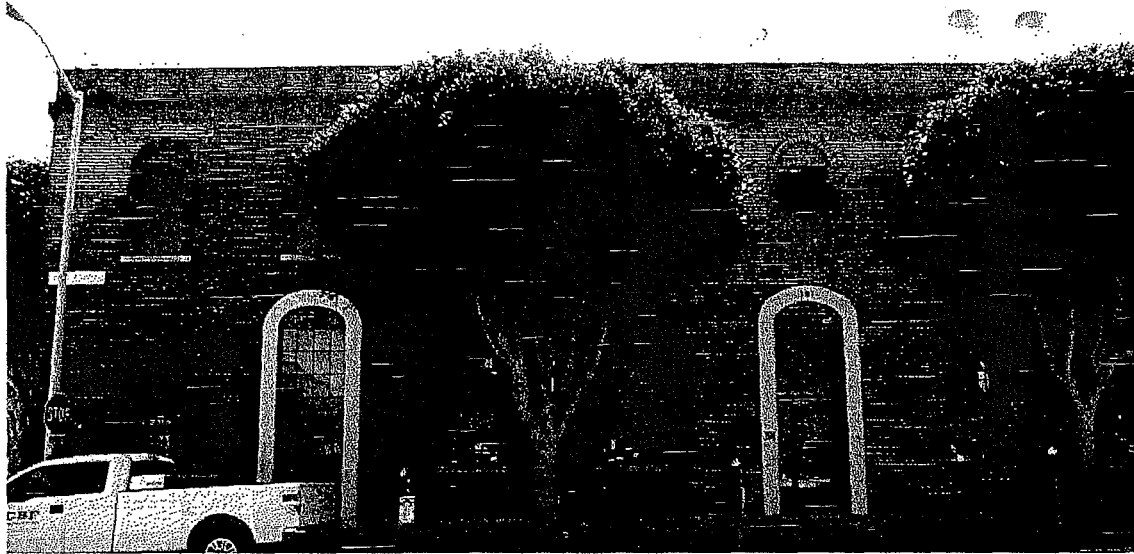
Figure 95 Photography of Vallejo Street elevation. Note characteristic differences between brick of different eras (photograph taken on 03/30/2017).

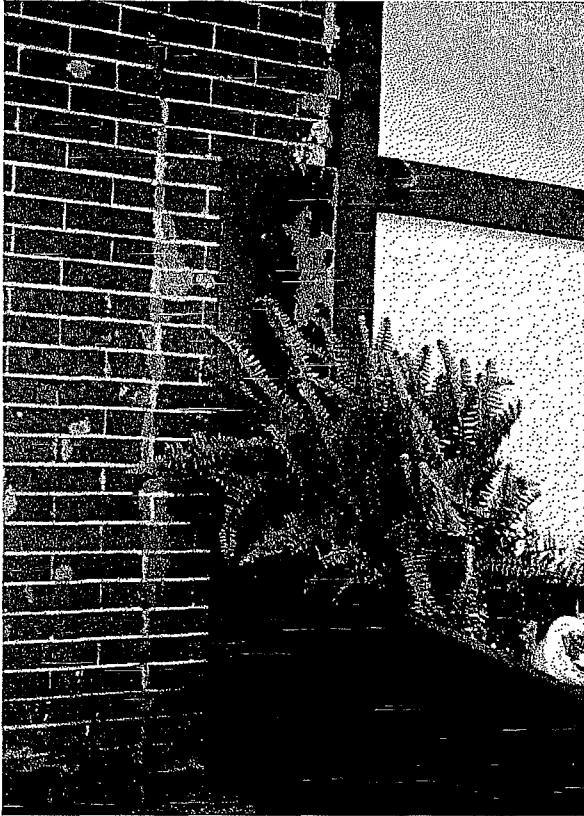
Figure 100 Photograph of steel reinforcement on the northwestern corner of the building (photograph taken on 04/04/2017).

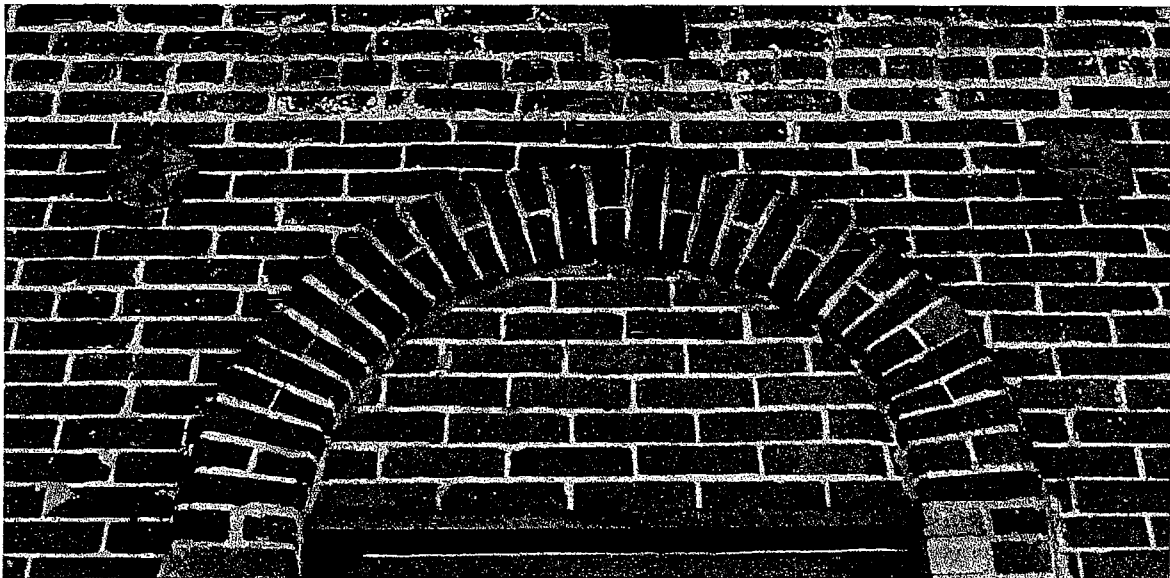
Figure 102 Detail view of pin holes left in brick tympanum over westernmost door along Vallejo Street (photograph taken on 03/30/2017).

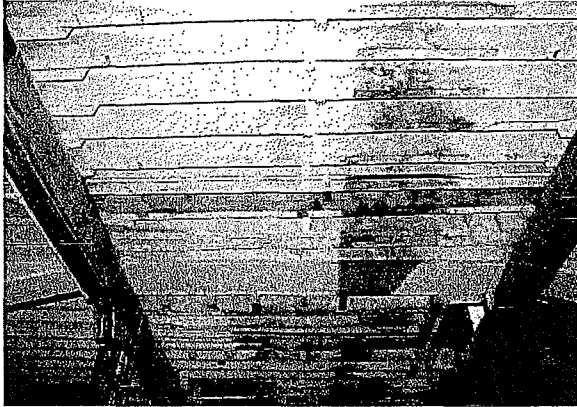
Figure 103 Photograph of ground floor ceiling joists. Note ghosts from old HVAC and water staining (photograph taken on 04/04/2017).

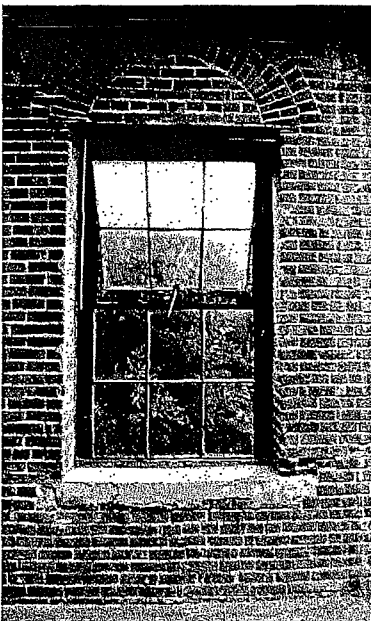
Figure 125 Interior photograph of typical deterioration around window opening (photograph taken on 04/04/2017).

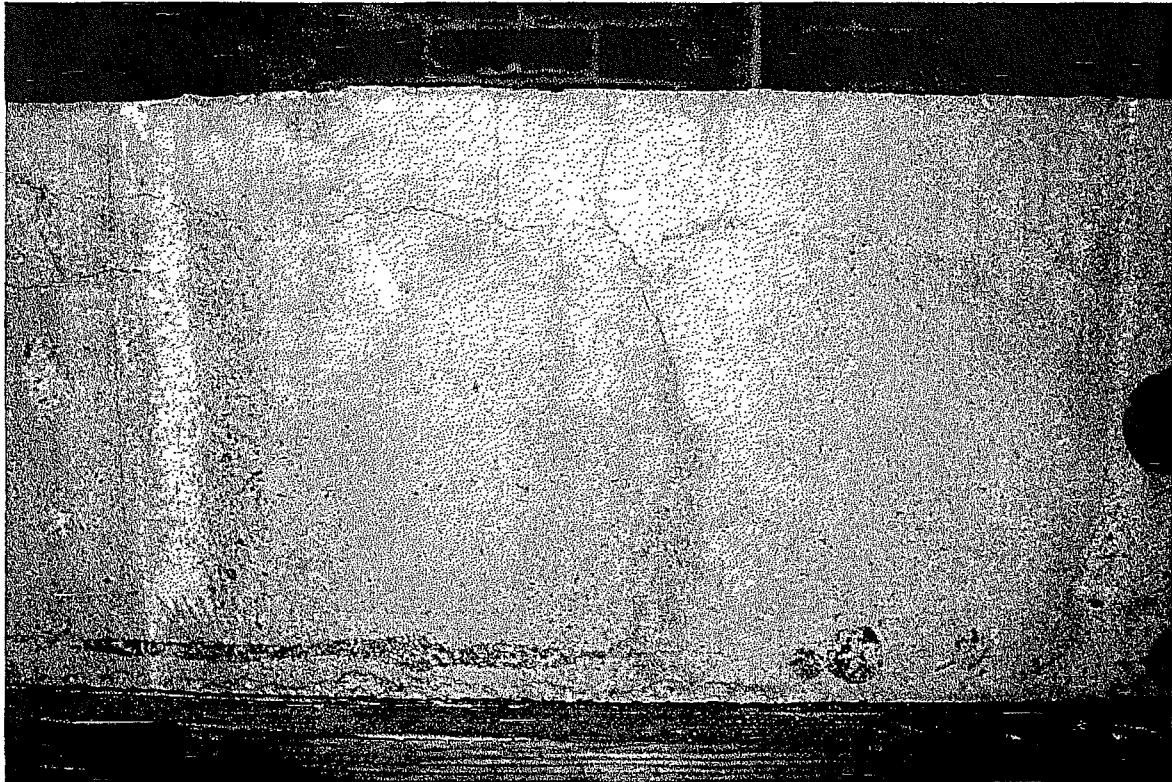
Figure 131 Detail view of cracking pattern found in the reinforced concrete member on the upper story. Note through-cracking: the crack runs the height of the beam and run perpendicular to its width all the way to the exterior brick wall. Stabilization of these structural member has been attempted with thin wooden planks. Also note bolt (right) from steel tie-back, which anchors the exterior walls to the reinforced concrete members (photograph taken on 04/05/2017).

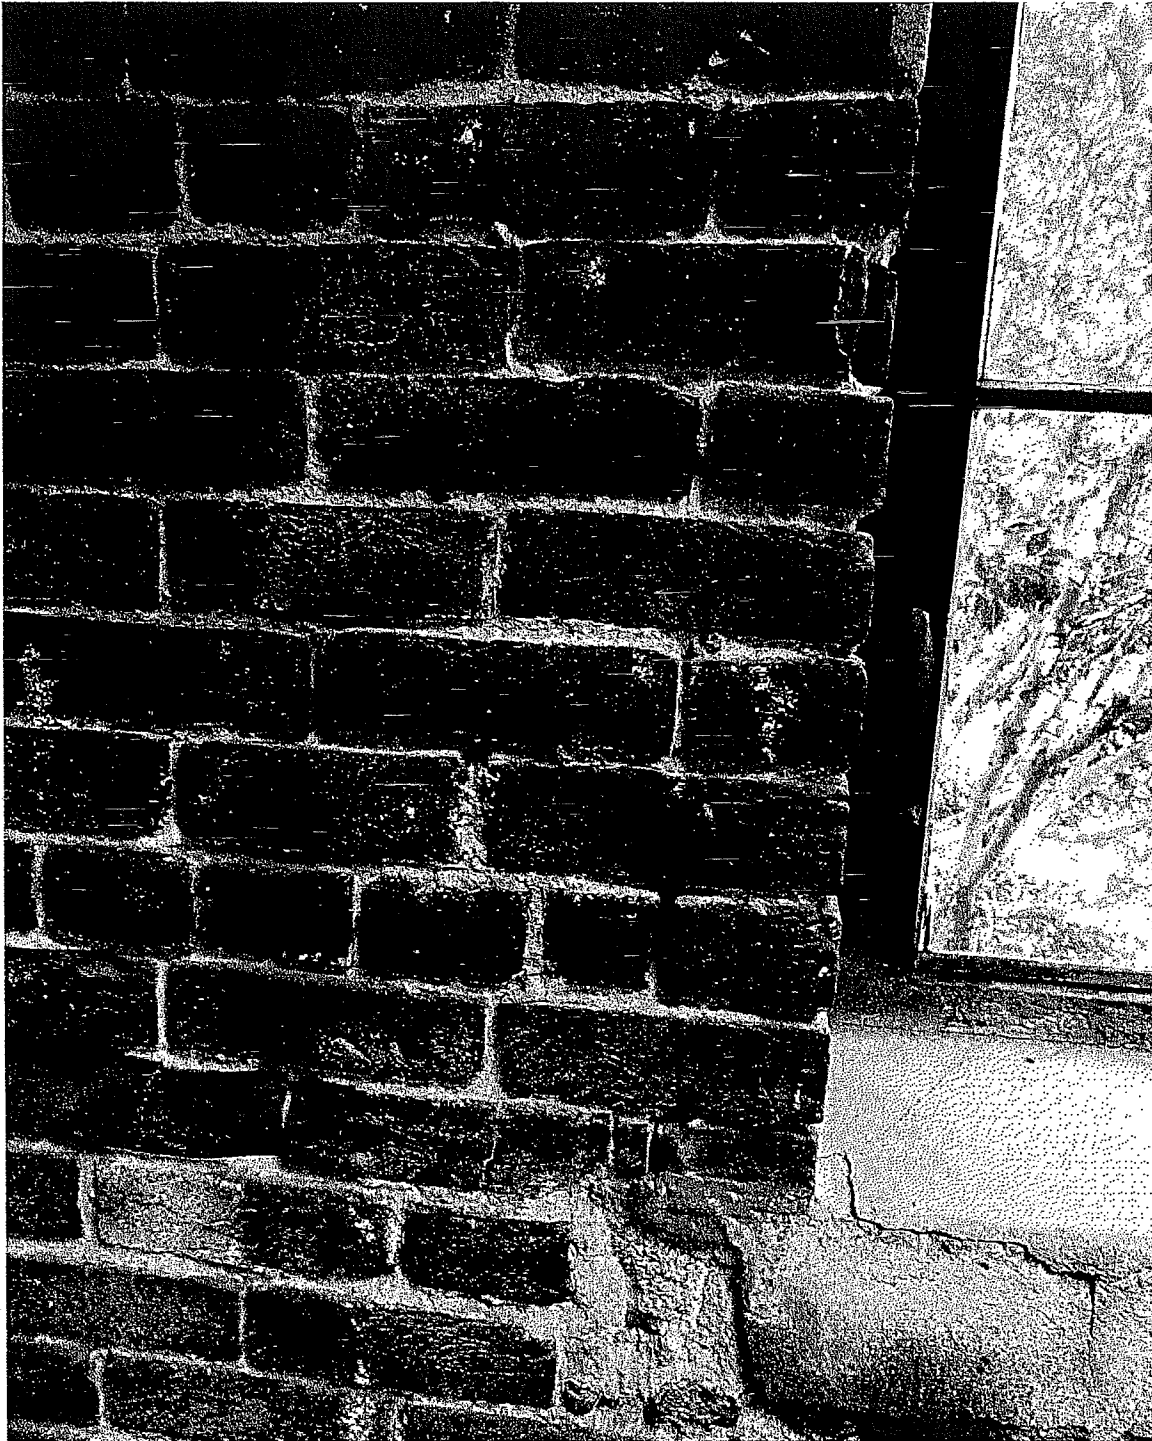
Figure 133 Typical condition of cracked bricks around window openings (photograph taken on 04/10/2017).

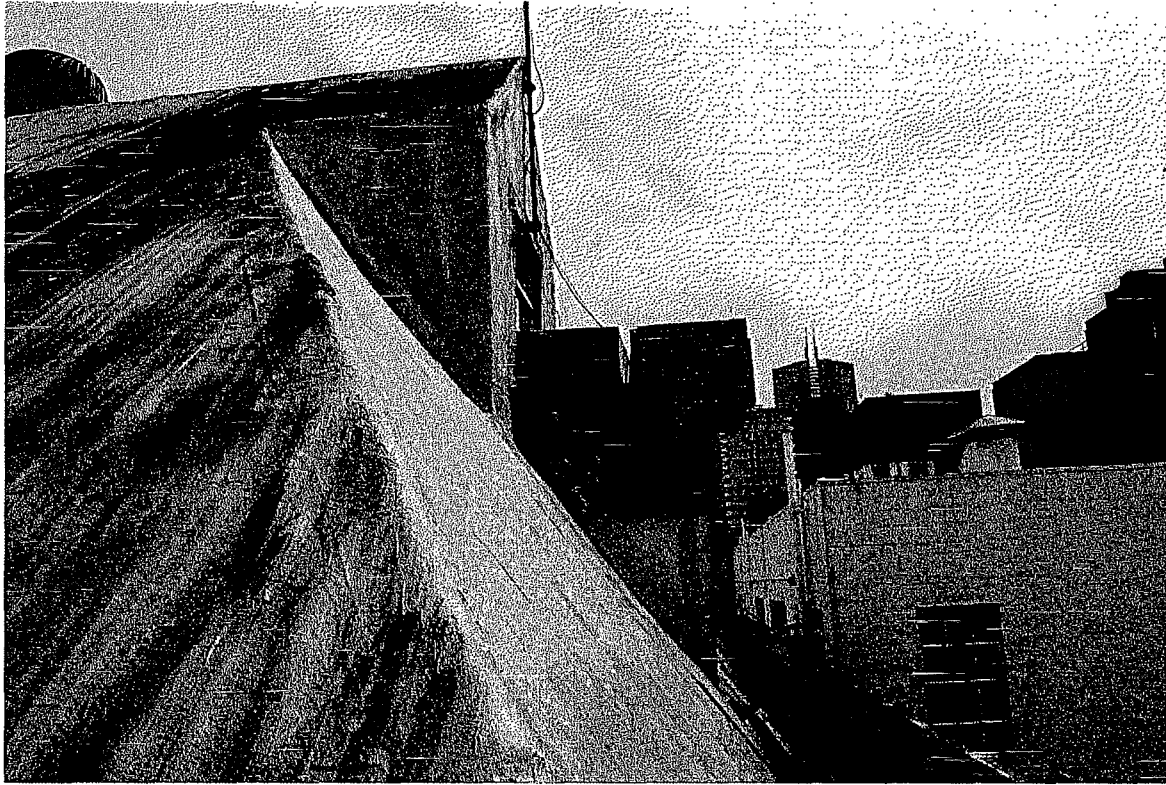
Figure 134 Photograph of western side of roof. Note mechanical equipment ran through the window opening (photograph taken on 04/05/2017).

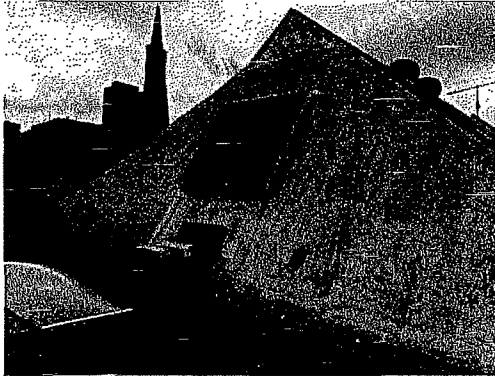
Photo 1: Overview of steep slope roof.

There are two (2) different roofing systems on the building. On the West half of the building, there is a steep slope roof that appears to have a modified bitumen sheet that is set in asphaltic adhesive and coated with an aluminum roof coating (Photo 1). The substrate for the steep slope appears to be a variety of layers and has been added on and modified throughout the years (Photos 2 – 5). Some of the substrate appears to be wood sheathing over corrugated sheet metal, and some of the substrate appears to be wood sheathing with no corrugated sheet metal. MCA observed what appeared to be roofing tar or adhesive leaking through the joints in the sheathing (Photo 6). On some portions of the steep sloped roof, MCA observed moderate to severe decay in the wood framing (Photos 7 – 8). MCA also observed moderate to severe deterioration of the brick and mortar joints along the perimeter of the steep slope roof on the interior of the building (Photo 9).

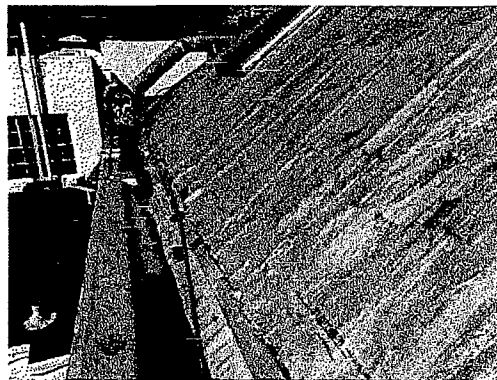
Photo 4: Steep slope roof with aluminum roofing coating.

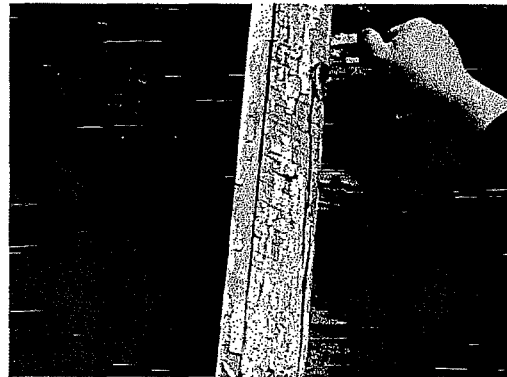
Photo 8: Severe decay in roof framing members.

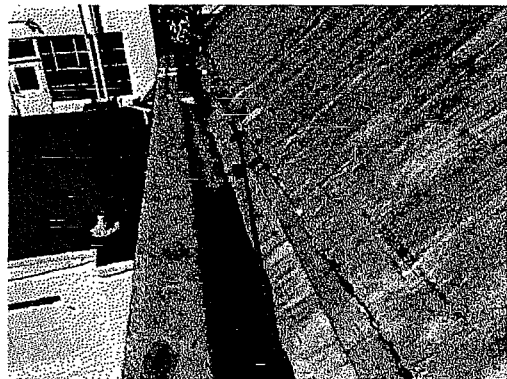
The steep slope roof ends in a perimeter drainage trough that runs along the roof side of the brick parapet (Photo 10). There is a sheet metal base flashing at the bottom of the steep slope roof (Photo 11). This sheet metal flashing was also observed on the interior of the building and did not appear to be set in sealant. MCA also observed that some of the sheathing is exposed and decaying at the base of the steep slope roof. The concrete columns that were used to seismically retrofit the building extend up the parapet and have blocked off drainage, and have created ponding within the perimeter drainage trough in several locations (Photo 12). Several leaks to the interior were observed around the perimeter of the steep slope roof.

Photo 10: Perimeter drainage trough at base of steep slope.
