File No. 171101

COMMITTEE/BOARD OF SUPERVISORS

AGENDA PACKET CONTENTS LIST

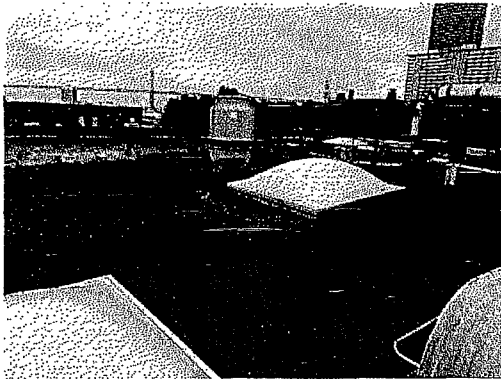
Photo 19: Several pieces of equipment and skylights on low slope roof.

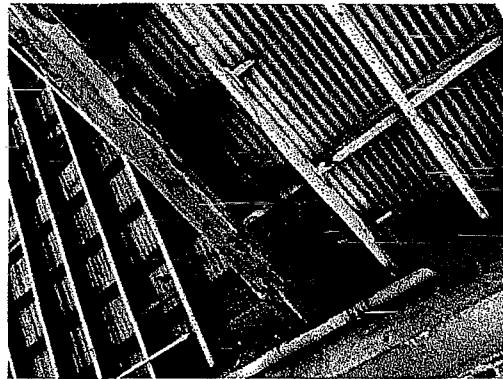
On the East side of the building is a low slope roof with built-up roofing (BUR) and gravel topping (Photo 17). The roofing sheet extends up and over the top of the parapet (Photo 18). This sheet was coated with an aluminum roof coating. There are several HVAC equipment, mechanical equipment, and skylights on this low slope roof (Photo 19). Only one (1) leak was noted at this low slope roof, and it is located at the junction of the steep roof Northeast corner and the Northwest corner of the low slope BUR (Photo 20).

Photo 20: Leak at Northeast corner of low slope roof where it intersects with steep slope roof.

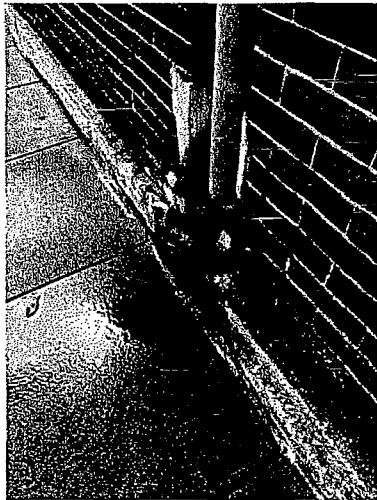
The roof drains to two (2) through-wall scuppers with downspouts on the North side of the building (Photo 21 – 23). The base of the downspouts free flow to the sidewalk below and do not have a splash guard. The slope on low slope roof was measured to be 5/8 inch in 12 inches (Photo 24). The slope on the steep slope roofs measured to be 8-7/8 inches in 12 inches on two (2) sides and 18-1/4 inches in 12 inches on two (2) sides (Photos 25 – 26).

Photo 23: Outlet of downspout at sidewalk.

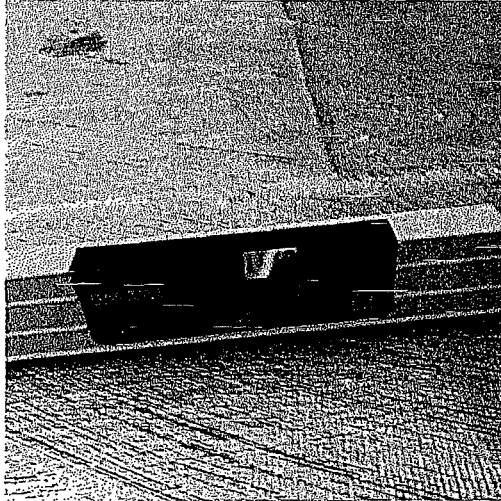
Photo 25: Slope on steep slope.
