SAN FRANCISCO PLANNING DEPARTMENT

Mills Act Contracts Case Report

Hearing Date: October 7, 2015

722 Steiner Street San Francisco, CA Historic Structure Report

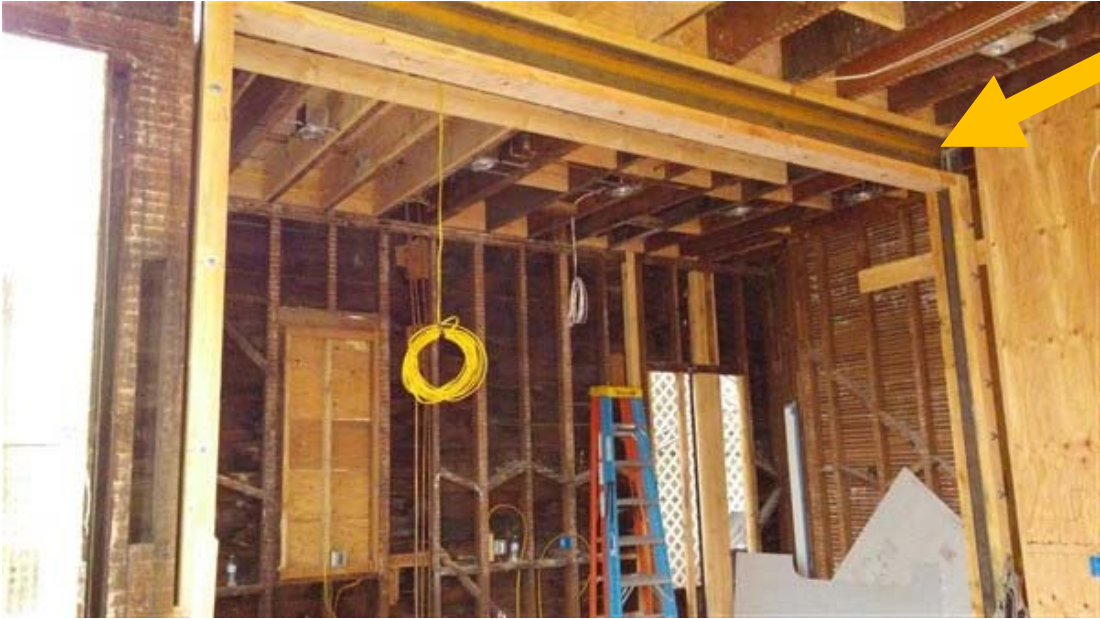
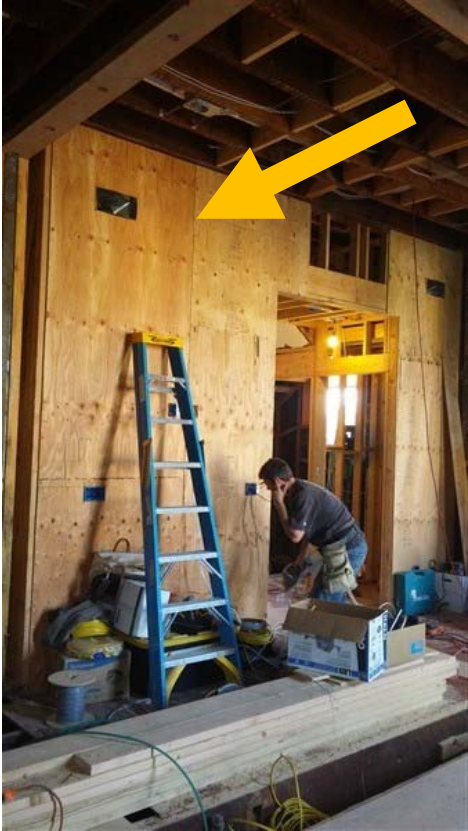
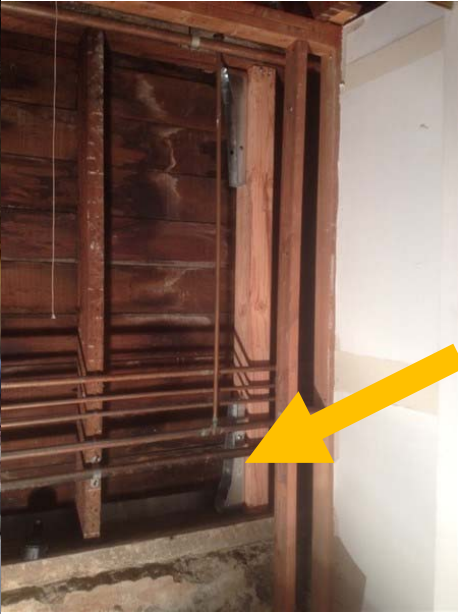
Scope #1:

SCOPE #1	BUILDING FEATURE: STRUCTURAL
Rehab/Restoration <input checked="" type="checkbox"/> Completed <input checked="" type="checkbox"/>	
Contract Year Work Completion: 2015	
Total Cost (rounded to the nearest dollar): \$100,000	
Description of Work	
<p>Seismic Upgrades.</p> <p>A steel moment frame was added to the kitchen/family room area on the second floor ceiling with posts anchored into newly poured footings on the first floor. Shear walls were added north/south and east/west in various locations of the second and third floors with hold downs at the first floor foundation. Framing was rebuilt and reinforced on the second and third floors.</p> <p>The repairs were designed to avoid altering, removing or obscuring character-defining features of the property and to reinforce the structural integrity of the house.</p> <p>Work was done in accordance with the National Park Service’s Preservation Brief #47: <i>Maintaining the Exterior of Small and Medium Size Historic Buildings</i>.</p>

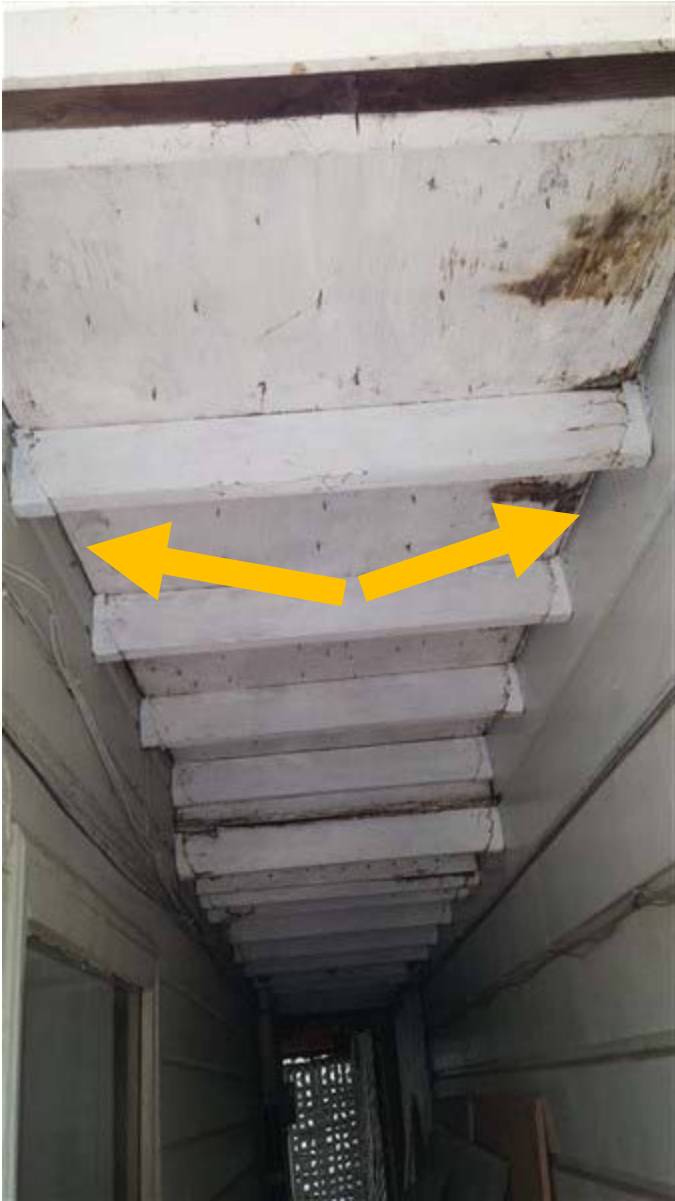
Scope #2:

SCOPE #2	BUILDING FEATURE: WOOD SIDING
Rehab/Restoration <input checked="" type="checkbox"/> Proposed <input checked="" type="checkbox"/>	
Contract Year Work Completion: 2016	
Total Cost (rounded to the nearest dollar): \$3,500	
Description of Work	
<p>Removal of planter deck/abutment above walkway and connected to 720 Steiner house.</p> <p>A planter deck extension was previously installed above the walkway between 722 and 720 Steiner and is currently attached to 720 Steiner which is not permitted and shows signs of deterioration. The structure will be removed, wood siding repaired and repainted.</p> <p>The needed repairs will avoid altering, removing or obscuring character- defining features of the building. Any siding replacements will be made in kind with new wood elements to match the historic building material.</p> <p>Work will be done in accordance with the National Park Service’s <i>Preservation Brief #10: Exterior Paint Problems on Historic Woodwork</i> and <i>Preservation Brief #47: Maintaining the Exterior of Small and Medium Size Historic Buildings</i>.</p>

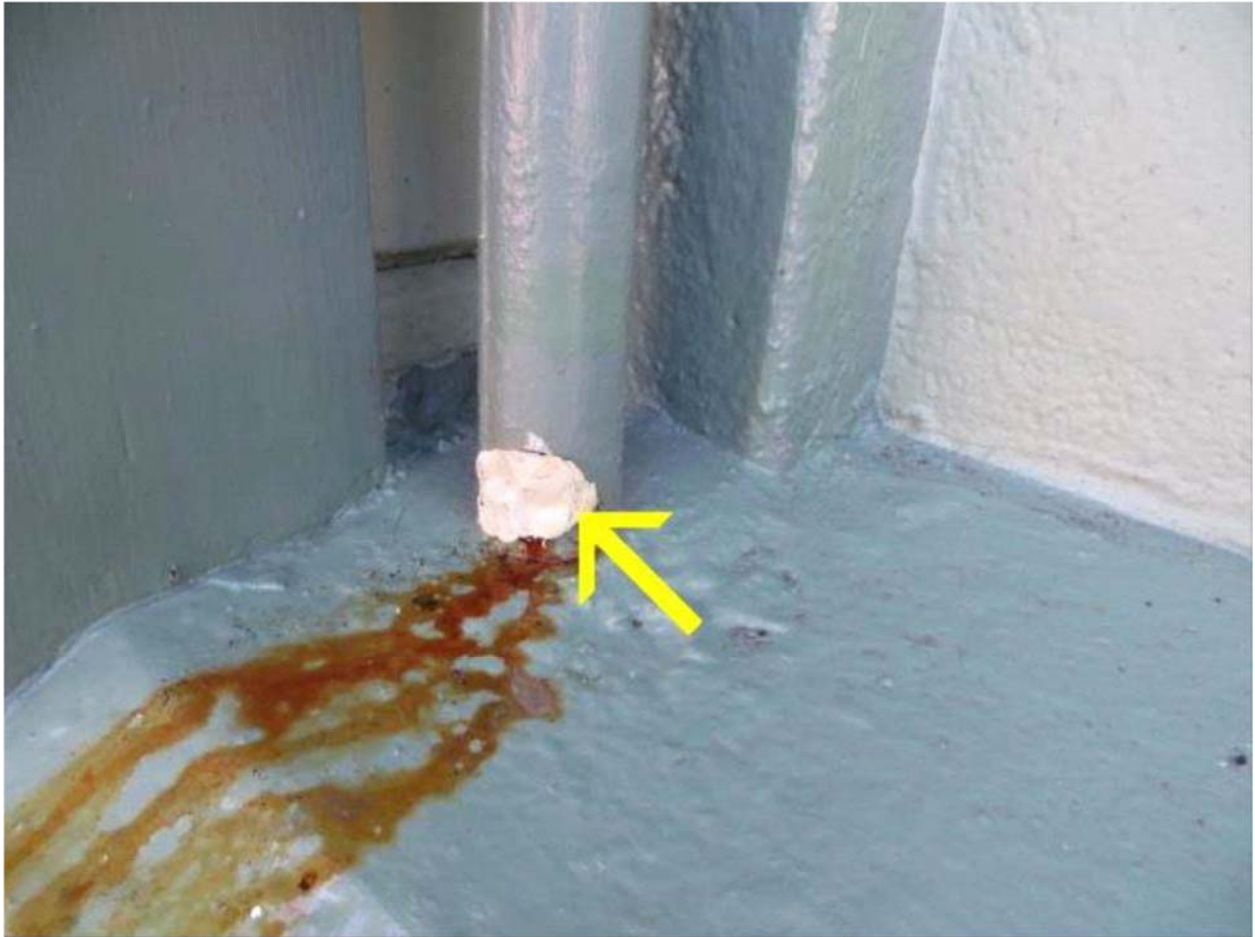
Scope #3:

Corroded downspout

SCOPE #3	BUILDING FEATURE: DOWNSPOUT
Rehab/Restoration <input checked="" type="checkbox"/> Proposed <input checked="" type="checkbox"/>	
Contract Year Work Completion: 2016	
Total Cost (rounded to the nearest dollar): \$1,500	
Description of Work	
<p>Repair to downspout.</p> <p>The downspout at the north west corner of the house facing Grove St is corroded and damaged. It will be repaired to prevent damage to the Grove St. façade and water leakage on the sidewalk. The repair will be designed to avoid altering, removing or obscuring character-defining features of the property.</p> <p>Work will be done in accordance with the National Park Service's Preservation Brief #47: <i>Maintaining the Exterior of Small and Medium Size Historic Buildings.</i></p>

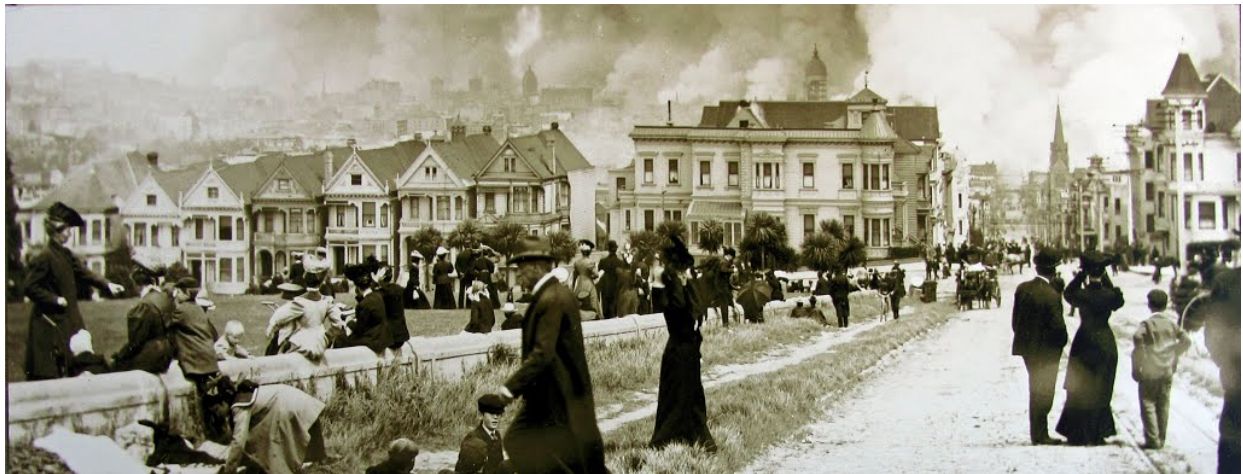
Figure 4. Alamo Square, view to the east and Steiner Street: This photo was taken on April 19, 1906, as the post-earthquake fires devastated the city. 722 Steiner is visible at the far left edge of the photo.

The area was saved from destruction in the 1906 earthquake and fires, as it was just outside of the "burned district." A photograph taken the day after the earthquake shows 722 Steiner Street in the background as San Franciscans flee from the conflagrations that consumed downtown (see Figure 4). The area became much busier than it was before the earthquake, as Fillmore Street became the temporary commercial district. By the 1920s through World War II, many of the residents of Alamo Square were German-Americans, Italians, or Jewish families.³

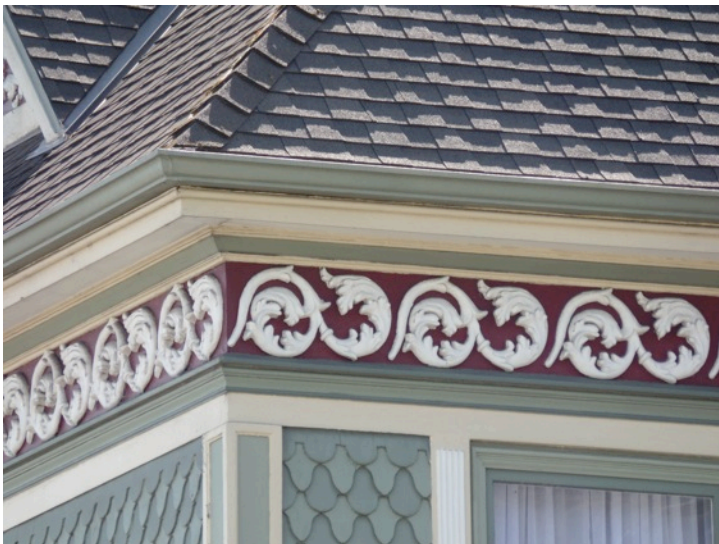
The wood siding along the first floor is horizontal clapboard siding. The second floor features imbricated (fish scale) shingles. The entire exterior, including the concrete foundation, is painted a pale moss green, with burgundy, cream, and gold accents. Immediately under the roof, the fascia around the perimeter of the building features a vine motif, and is topped by profiled projecting eaves. Profiled wood fascias painted cream delineate each floor level, with a simple band between the basement and first floor and more ornate projecting banding between the first and second floors (see Figure 7).

Figure 7. Detail of northwest corner of house at second floor: Note the fishscale shingles and fascia featuring vine motif and articulated eaves. (Photograph by Garavaglia Architecture, Inc., April 2015.)

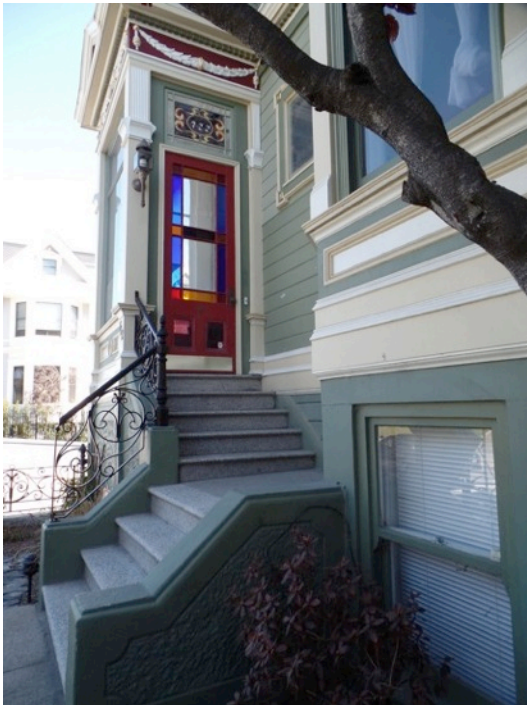
Figure 9. Detail of main entry along Steiner Street, with detail of steps and entrance portico. (Photograph by Garavaglia Architecture, Inc., April 2015.)

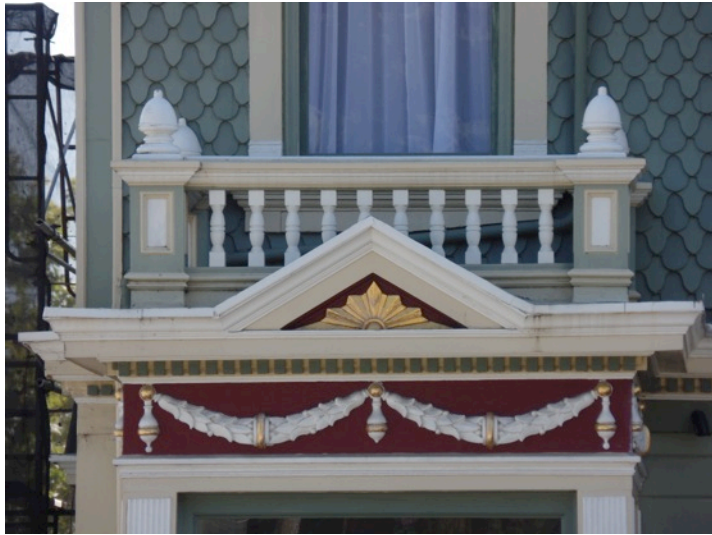
Figure 10. Detail of balustrade over entrance portico. (Photograph by Garavaglia Architecture, Inc., April 2015.)

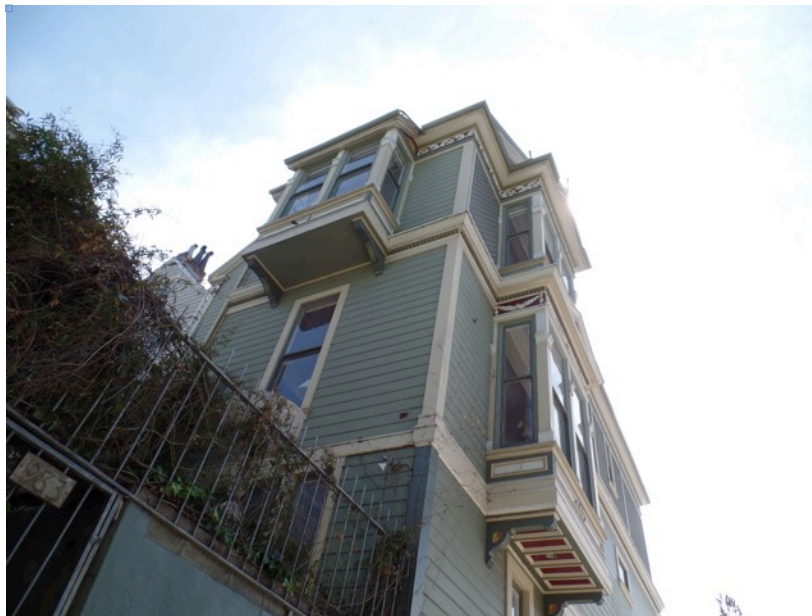
Figure 13. Partial view of the east (rear) elevation. (Photograph by Garavaglia Architecture, Inc., May 2015.)

This facade features a squared bay at the second floor, which is supported by carved wood brackets. The windows in the squared bay are framed by cream-colored wood colonnettes on

The east elevation is fronted by the rear yard, which is accessible via a non-historic entrance gate at the northeast corner of the lot (see Figure 12). The entry leads up a flight of non-historic concrete stairs to the rear yard. The east elevation is also accessible via a pathway between 722 and 720 Steiner Street. The basement, first, and second floors along this elevation are clad with horizontal wood siding (see Figure 13).

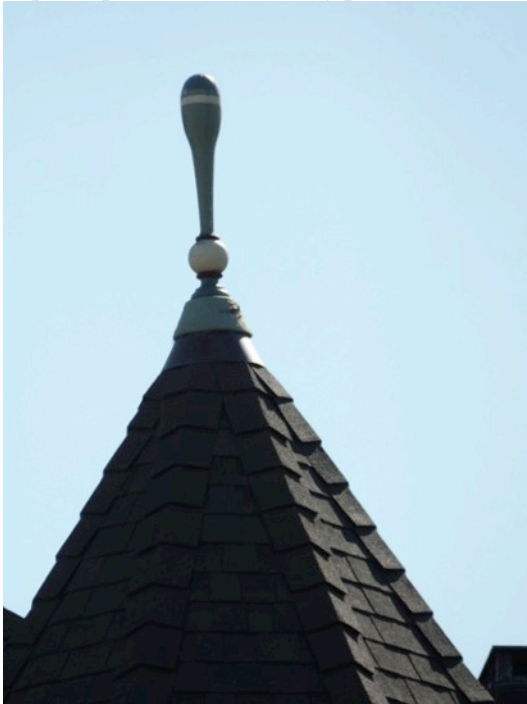
The roof is a complex gable/hip/turret design, which is typical of Queen Anne architecture. The entire roof is clad with dark gray asphalt-composite shingles, which were installed in 2006. The turret roof at Steiner Street and the two gabled dormers at the Grove Street elevation are topped with wood spindles (see Figure 14). Two brick chimneys, featuring profiled sheet metal caps, top the south-facing portion of the roof (see Figure 15).

Figure 14. Detail of turret roof and spindle. (Photograph by Garavaglia Architecture, Inc., April 2015.)

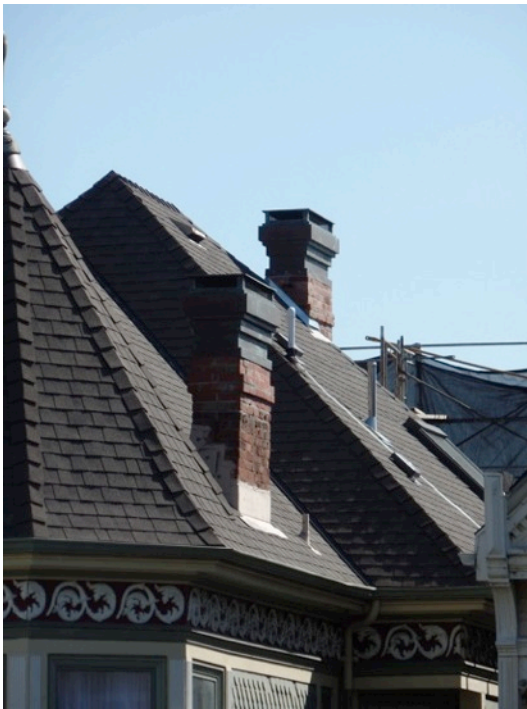
Figure 15. Detail of chimneys at south end of roof. (Photograph by Garavaglia Architecture, Inc., April 2015.)

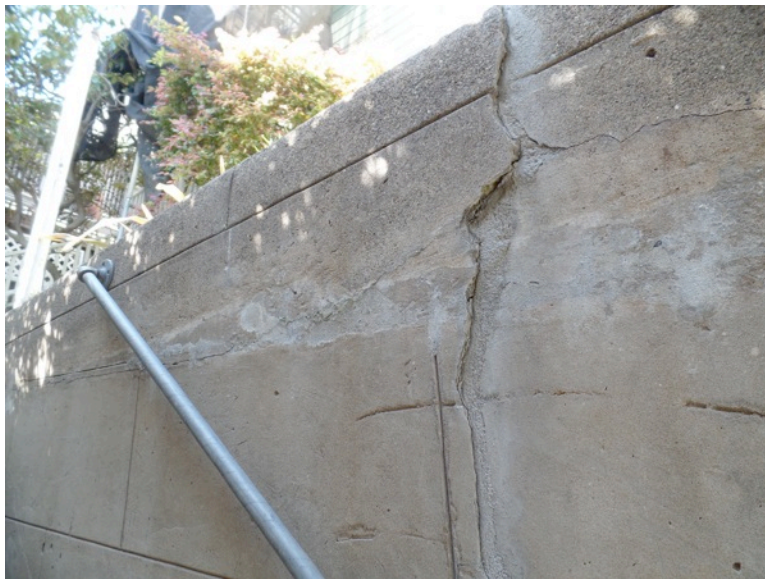
The rear retaining wall exhibits significant cracking and displacement (see Figure 16). The riser heights/tread depths on the concrete stairs are inconsistent in height and variance. The safety handrail does not extend the full length of the stairway (see Figure 17).

Figure 16. Cracked retaining wall along east property line. (Photograph by Garavaglia Architecture, Inc., April 2015.)

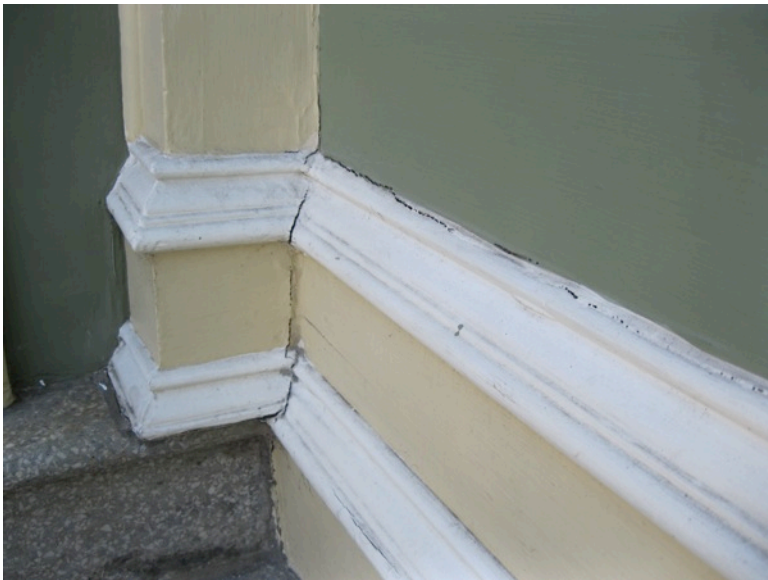
Figure 20. Peeling paint and splitting wood at west elevation. (Photograph by Garavaglia Architecture, Inc., April 2015.)

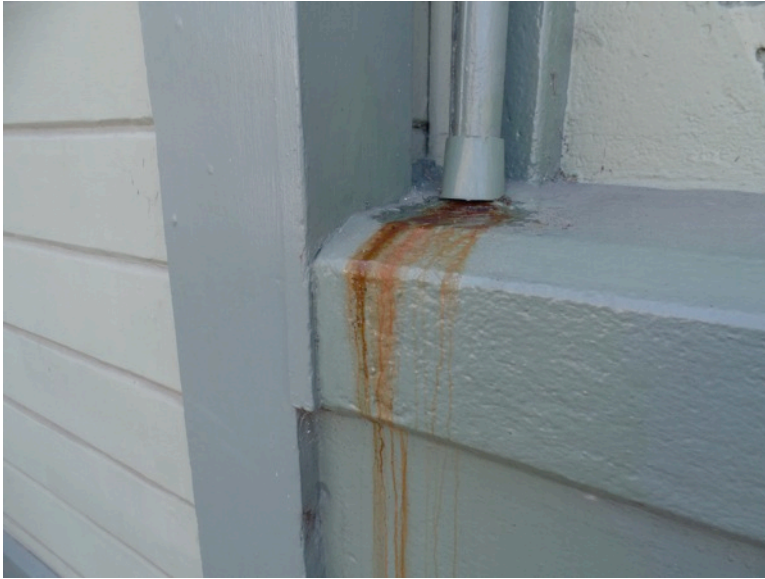
The downspout at the northwest corner of the house (facing Grove Street) is corroded and damaged (see Figure 22).

Figure 22. Corroded downspout along north elevation. (Photograph by Garavaglia Architecture, Inc., April 2015.)
