File No. 161097

1 [Mills Act Historical Property Contract - 1338 Filbert Street]

Re: Transmittal of Planning Department Case Number: 2016-006229MLS  
Mills Act Historical Property Contract Application for the following address:  
1338 Filbert Street (San Francisco Landmark No. 232, 1338 Filbert Cottages)  
BOS File No: \_\_\_\_\_ (pending)  
Historic Preservation Commission Recommendation: Approval

**1338 FILBERT STREET COTTAGES**  
San Francisco, California

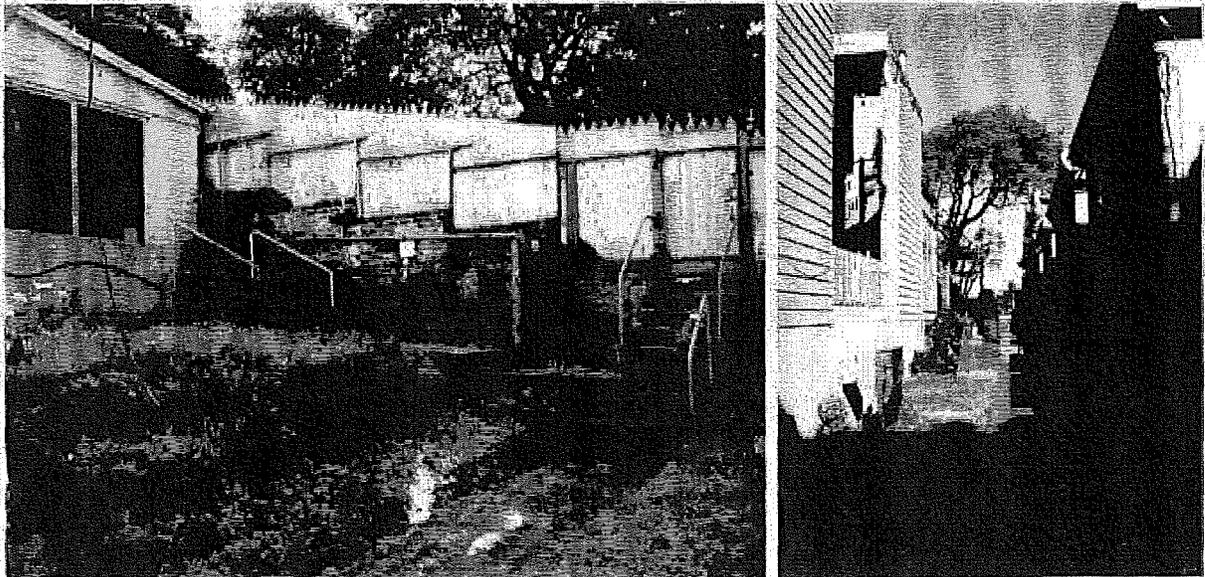
*Figure 2 (right): Site facing north, cottages at right side of path.*

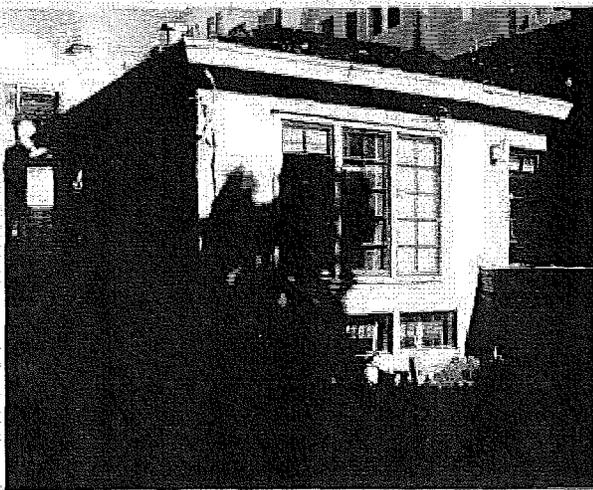
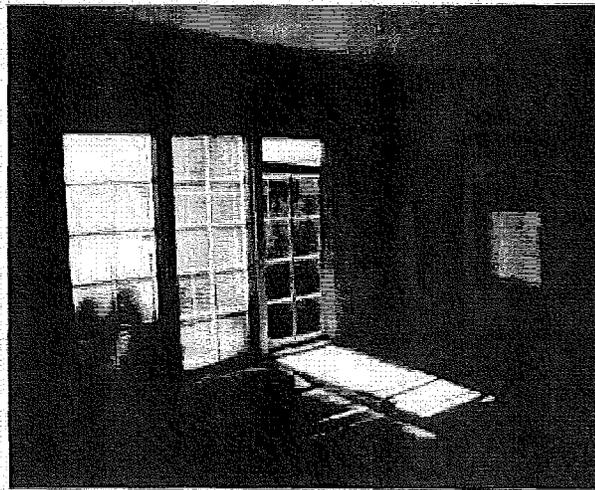
*Figure 5 (right): interior of Cottage A, main room, facing southwest.*

The lower studio unit is roughly half the size of the upper unit with expressed battered and stepped foundation walls and crawlspace access. The unit is composed of a living room, small bathroom and kitchen, and large closet and built-in casework. Some important features of the lower unit are the wood casement windows at the west wall, fixed wood basement/clerestory windows at the south wall, and the utilitarian kitchen with counter dining space. Finishes include press board, wood veneer tile flooring, red concrete bathroom floor, and simple wood trim at openings.

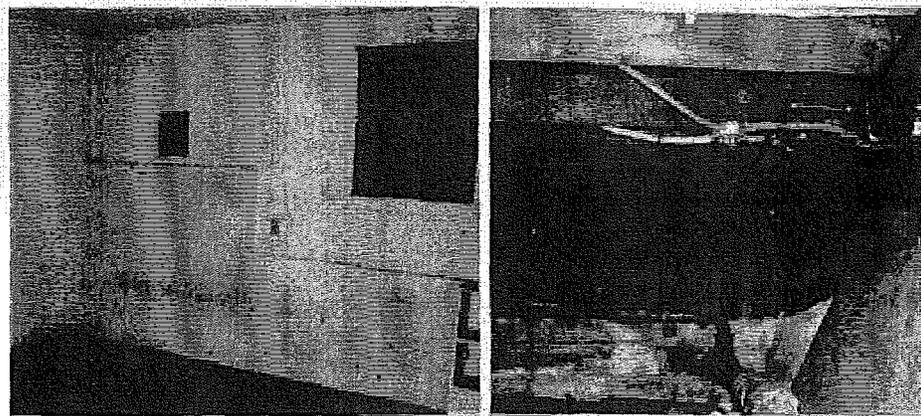
**Figure 17 (right):**  
Wood framing members,  
view from crawlspace  
below upper unit.

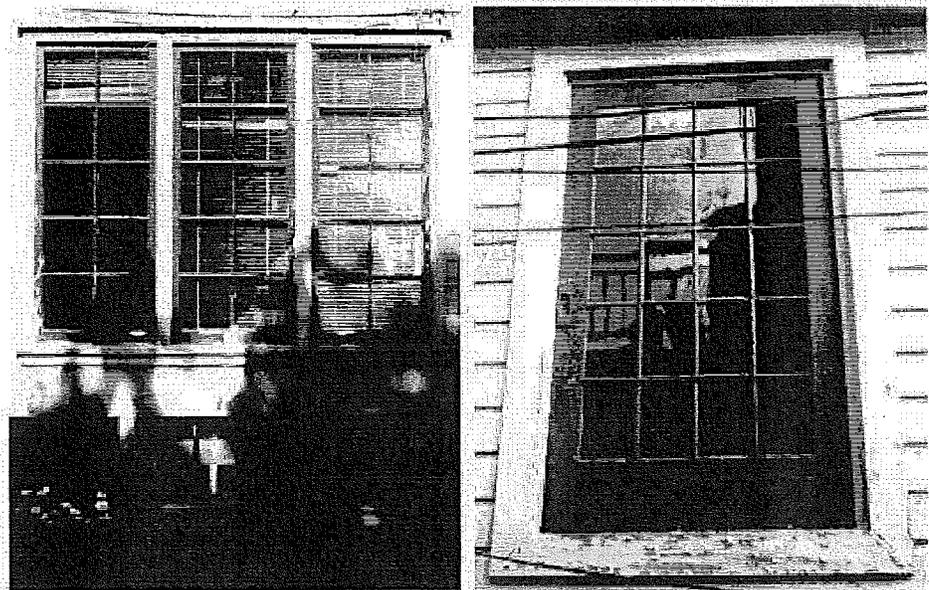
During the mid-century alterations salvaged glazed sliding doors, fixed in place, were installed in upper unit west facades of Cottages B and C. These are wood frame multi-lite doors with their original handle hardware. They provide near floor-to-ceiling glazing. Exterior trim at these doors consist of simple 6" plus wood surrounds with either mitered or butt joints and no sills. These doors appear to be in fair condition exhibiting some signs of weather deterioration and diminishing paint. Glazing is intact.

*Figure 22 (right):  
Fixed divided lite, over  
basement clerestory.*

*Figure 23 (right):  
Salvaged door installed  
fixed at upper unit.*

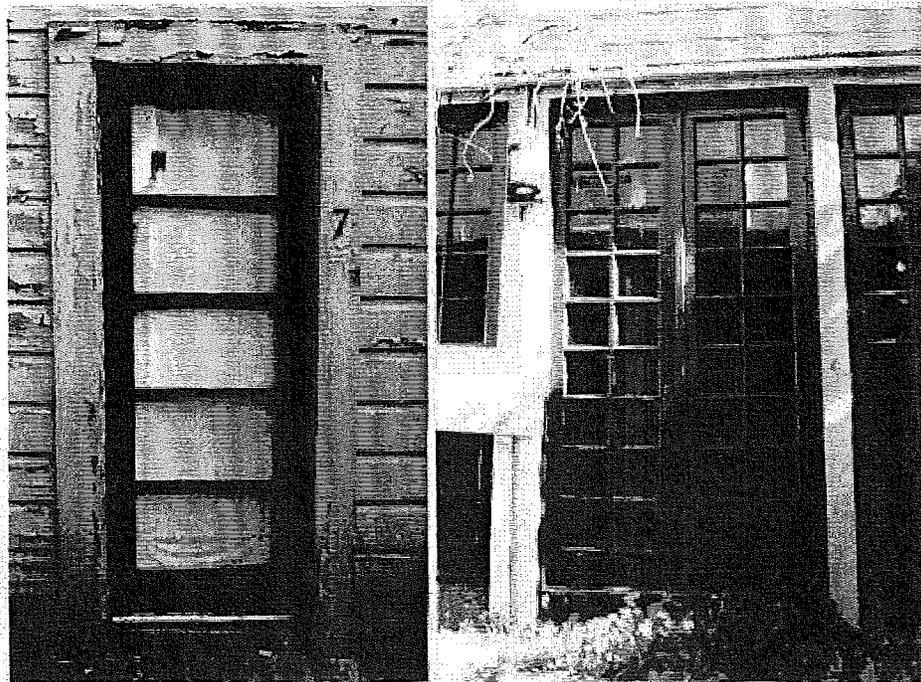
**Figure 25 (right):**  
Series of tall, narrow french doors set in a row at the Studio west facade.

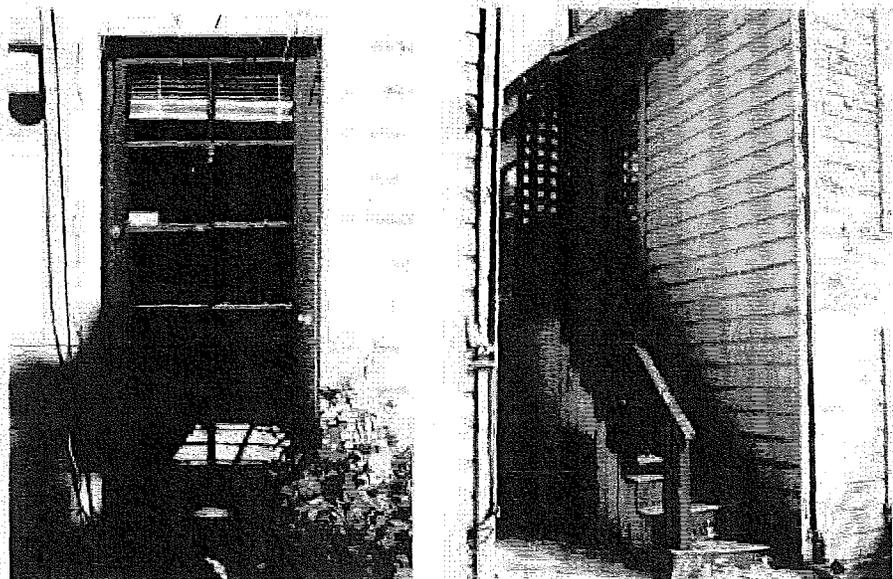
Only two of the cottages retain early wood stair configurations and covered entry porches. Wood risers and treads ascend from brick landings at the north facades of Cottages B and C. The porches at the upper unit entry doors consist of wood landings and wood posts supporting small shed roofs. They also feature simple wood railings with square balusters. Wood skirts enclose the area under each stairway. The stair at Cottage C appears of earlier construction than Cottage B, exhibiting less replacement material. This stair is potentially a contributing element. The stair, landing floor, and skirting at Cottage C are in critical condition having suffered much abuse over the years. The railings and roof appear in fair condition with a few missing balusters. A majority of the stair at Cottage B has been reconstructed after the period of significance and is therefore non-contributing.

**Figure 26 (left):**  
*Single divided-lite door.*

**Figure 27 (right):**  
*Covered wood entry porch and stair at Cottage C.*

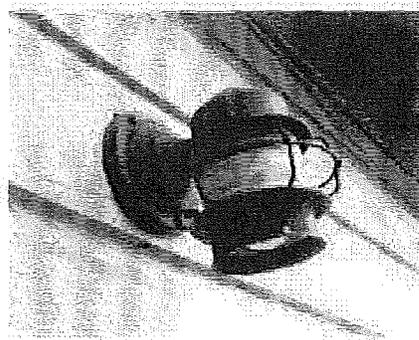
**Figure 28:**  
Wall mounted industrial  
entry porch light.

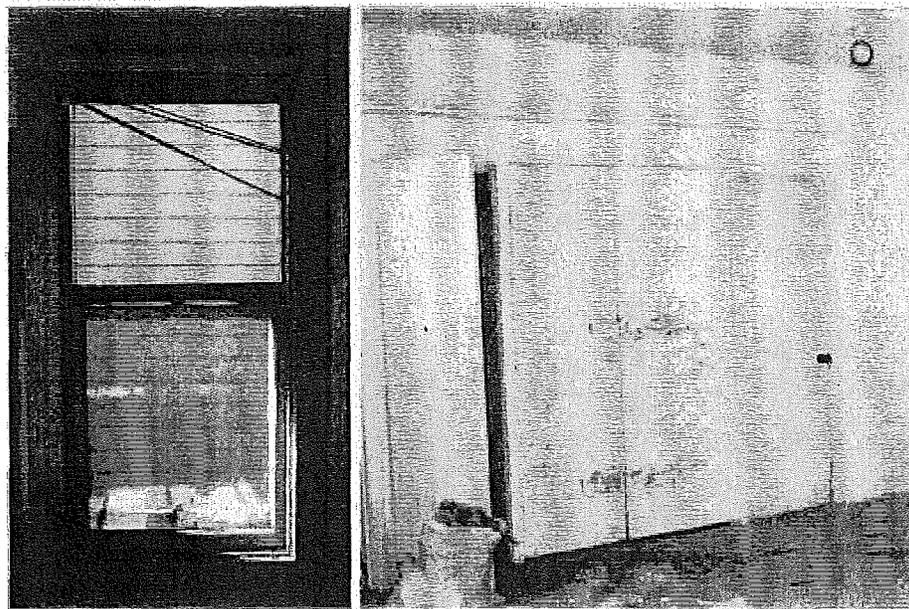
Interior wood trim around doors at the perimeter walls are contributing if four inches or more in width with simple profile. However most interior door trim appears to be of the narrow modern variety and considered non-contributing elements. Trim, in general, is in fair condition.

**Figure 31 (left):**  
*Interior window trim around double-hung window, west wall of Cottage A.*

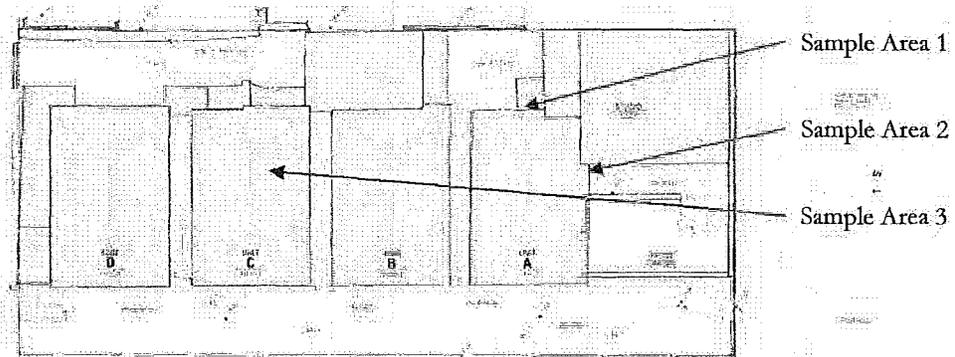
Figure 1. Filbert Cottages existing site plan (Buttrick Wong Architects, 2008).

Samples of the roofing materials were taken in three areas: (1) back of Cottage A; (2) joint of Cottage A and Studio; and (3) ridge of Cottage C (Figures 1-2, 7-8). The following observations were noted at each location:

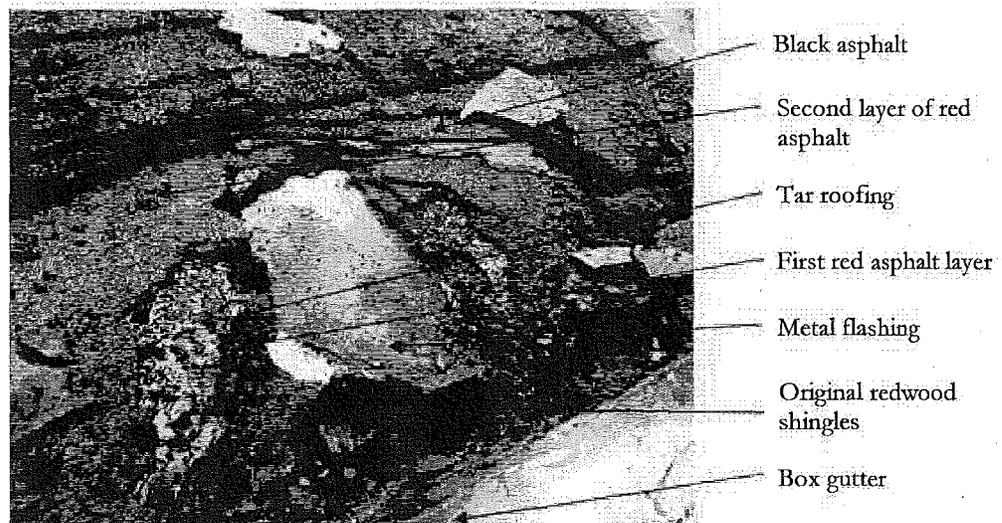
Asphalt shingles on Cottages B and D appear to have been recently installed and are in fair condition, and thus no investigative demolition was undertaken at these roofs (**Figure 2**). Asphalt shingles on Cottages A and C are in poor condition with many shingles broken and missing, exposing the different layers of roofing material.

Figure 2. Detail of layers of roofing material at Sample Area 1. Note wood shingles on bottom, followed by metal flashing, red asphalt, tar, another layer of red asphalt and finally black asphalt.

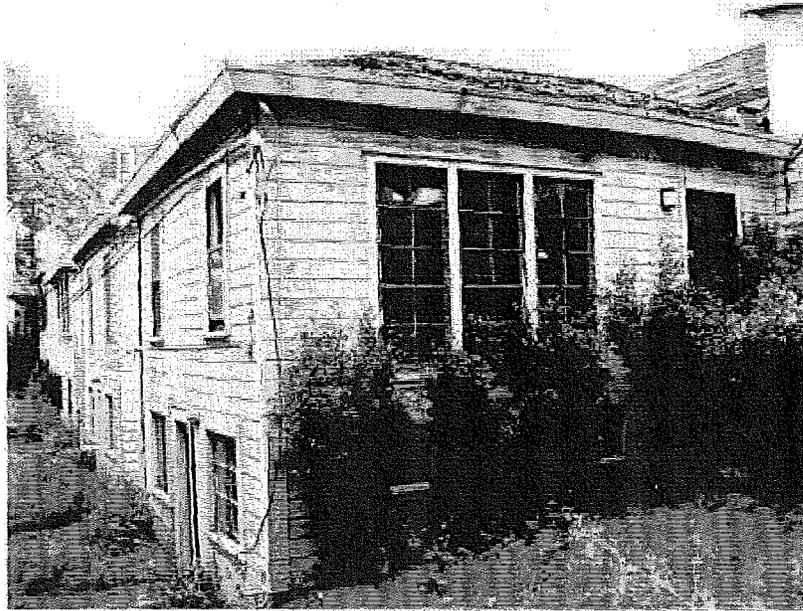
Figure 3: View of the primary (west) facades of the cottages and south façade of Cottage A. Note boxed eaves.

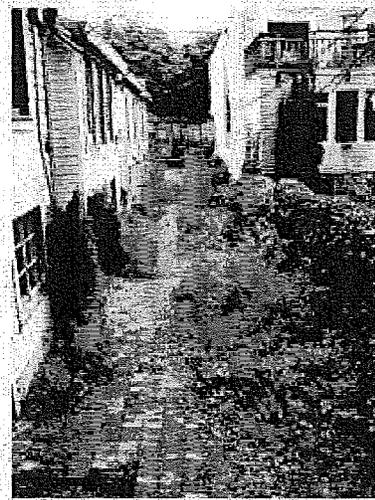
Figure 1: View looking south of the brick path and 1907 cottages, at left.

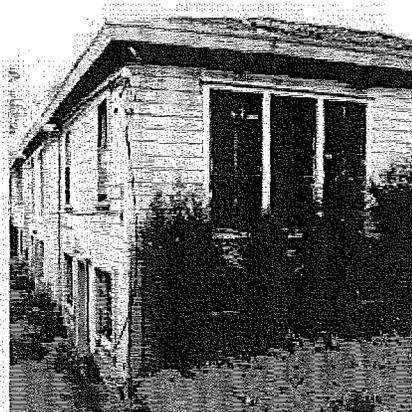
Figure 5: Garden in between of Cottage A and Studio (lower right). The garden will be reconfigured, and the adjacent steps and walkway will most likely have to be removed and reinstalled.

Page & Turnbull recommends preserving the pavement in place where possible using the protective measures outlined above. In areas directly affected by the garage construction, the bricks should be removed and reinstalled. To accomplish this, comprehensive documentation of the brick pavement throughout the site is necessary. The following section outlines procedures for preliminary vegetation removal (necessary for accurate documentation), documentation, brick removal mock-ups, proper storage, and brick reinstallation.

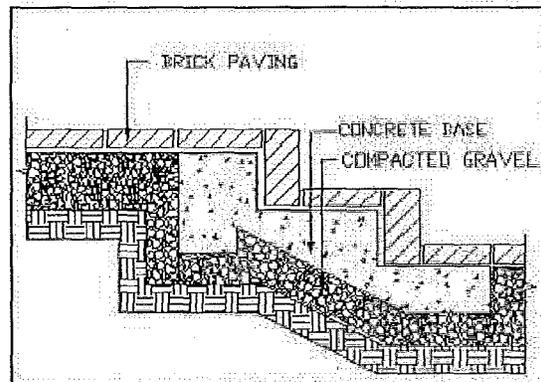
Figure 6: Typical construction of brick stairs, showing concrete base and aggregate base layer

Brick steps should be supported by a concrete base. Deflections or settlement of the support must be minimized to avoid cracking in the brickwork. Figure 5 shows a typical concrete support system for steps. Brick should be adequately bonded to the support or restrained around its perimeter to avoid loosening of units. Mortar is usually used to bond the brick to the concrete. This paving system is very effective when proper materials and installation are used. Dowels or ties into the mortar joints are not necessary since the mortar provides adequate bond. Since the paving assembly is supported on its own footing, an isolation joint should be used between the pavement and steps.
