1 [Planning Code - Landmark District Designation - Alert Alley Early Residential Historic District]

Alert Alley Early Residential District

ALERT ALLEY EARLY RESIDENTIAL DISTRICT

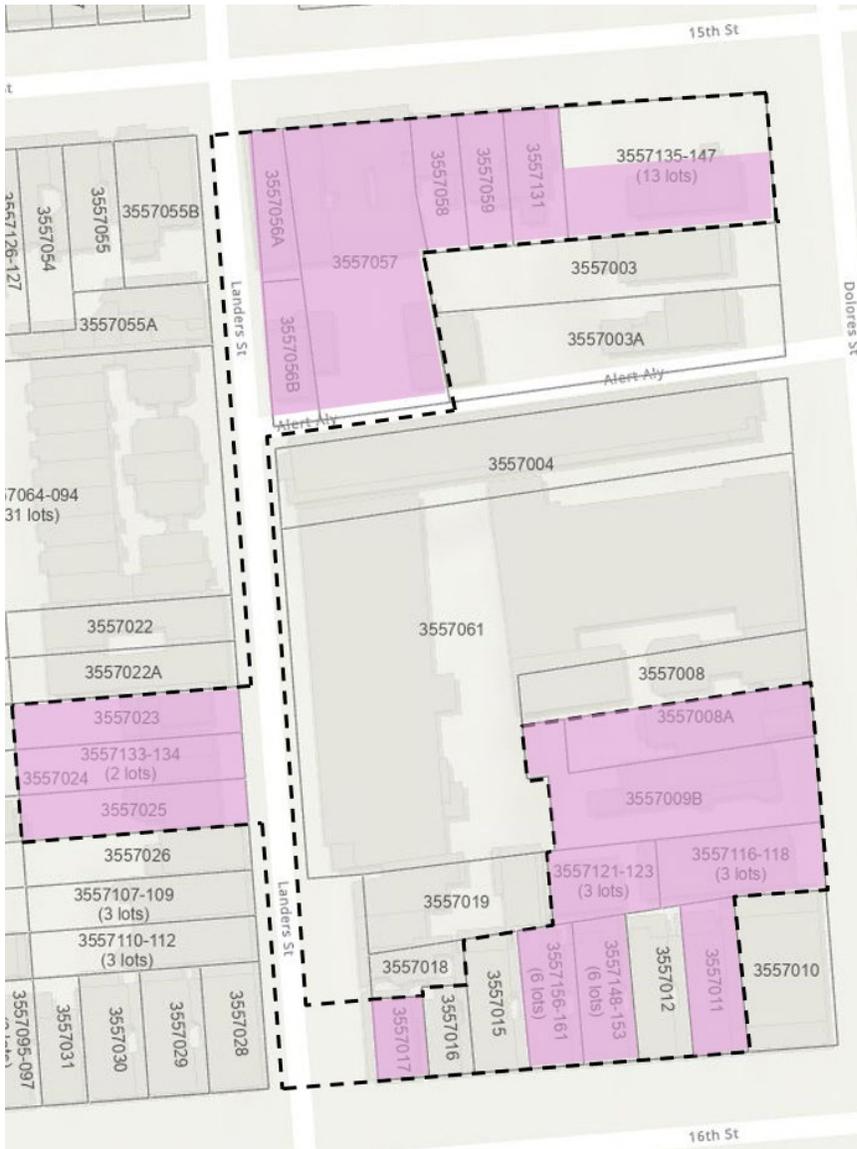
The boundaries of Alert Alley Early Residential District are outlined.

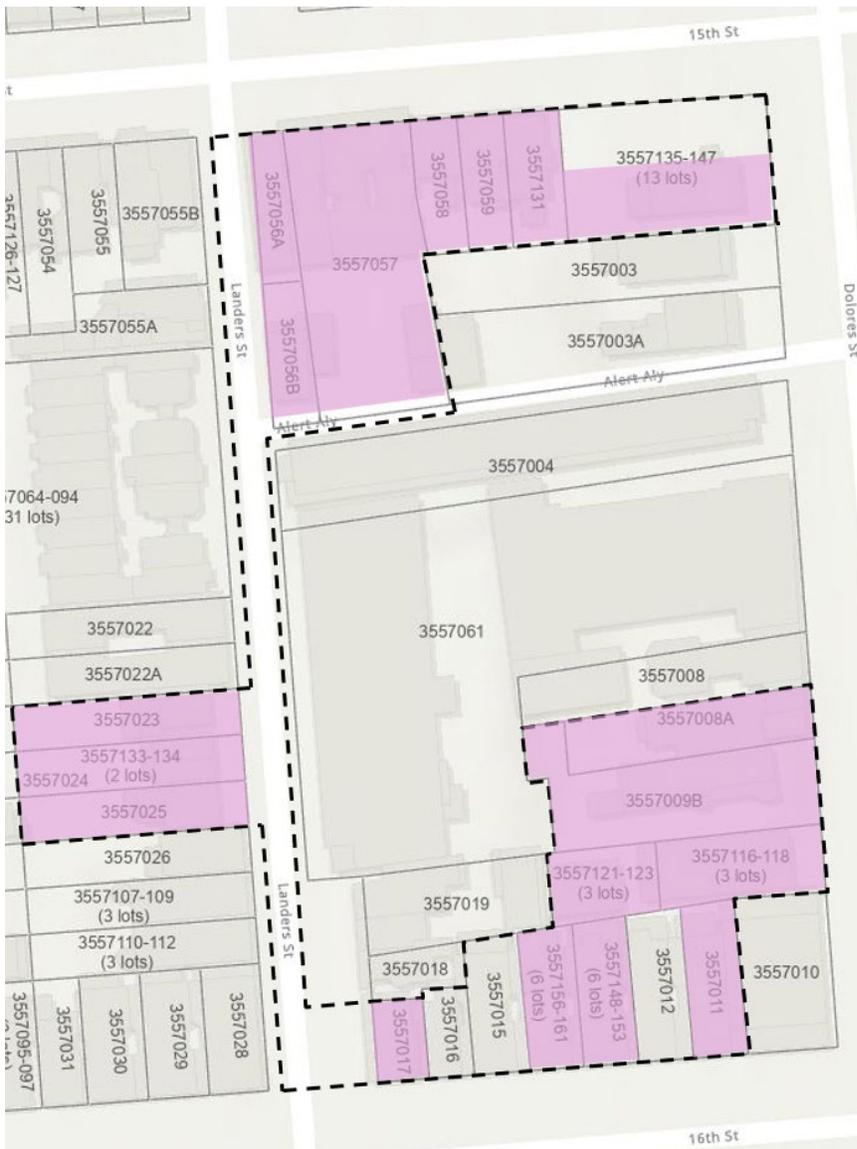
19 The boundaries of Alert Alley Early Residential District are outlined.

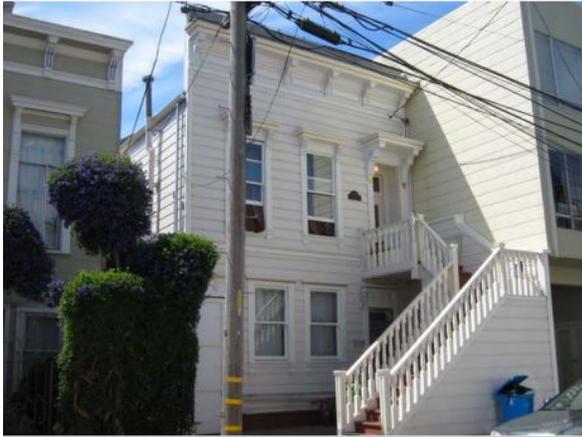
156 Landers Street

- Architectural ornament including brackets, applied columns, window and/or door hoods, and other façade ornamentation indicative of the Italianate style
- Front setback or location on lot in reference to street
- Central or offset primary entrance stair

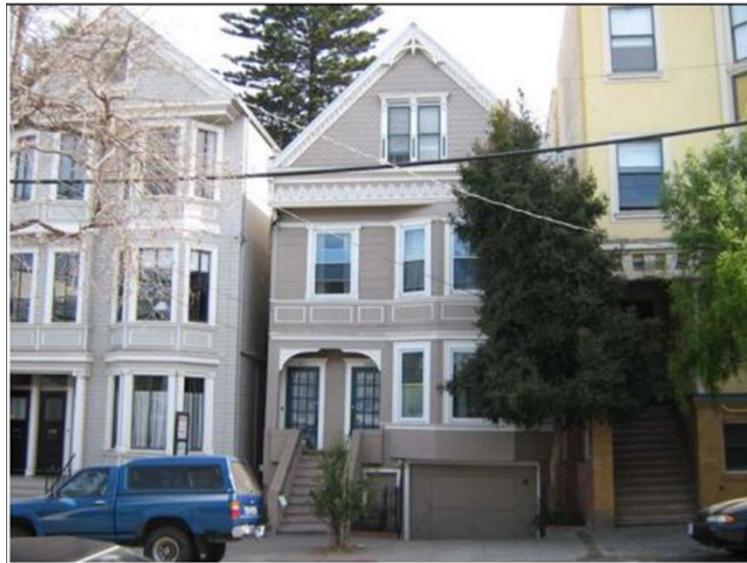
1919-1923 (left) and 1931-1933 15th Street (center)

The district's larger flats buildings, facing onto the wider, primary streets, are typically Classical Revival style, including all the district's Romeo Flats buildings. Buildings in the district in this style feature wide angled or round bay windows, flat roofs, bulky projecting cornices with modillions or dentils, raised panel spandrels, scroll keystones, broken entablatures, and pedimented and columned porch or portico entries.

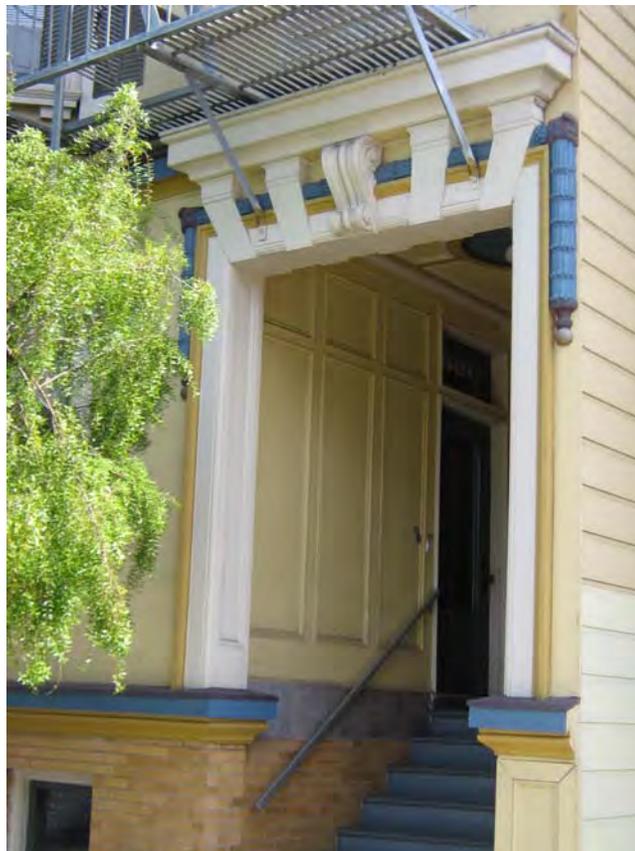
Entry porch detail

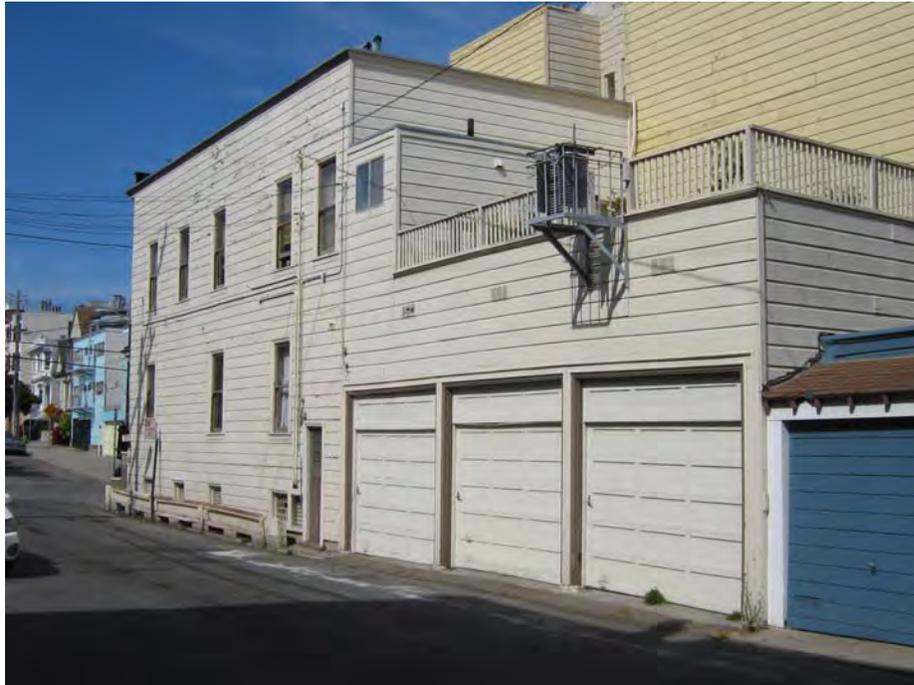
Landers Street elevation

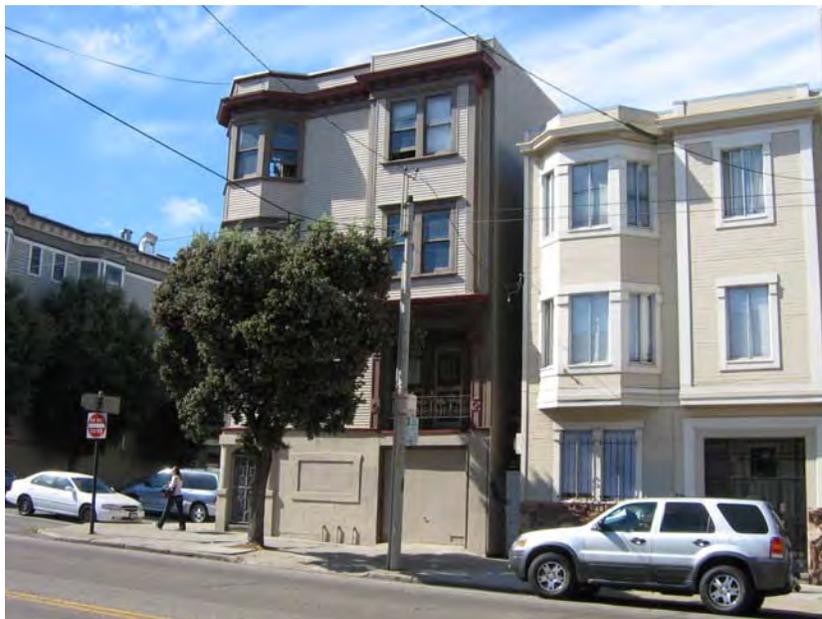
window in the left bay. The right bay windows have pilasters with floral drops and dentil cornices. The Landers Street elevation has four garage entries on the ground floor. The upper stories have paired and single windows with pilaster surrounds and dentil cornices. The right bay of the second and third stories has a semi-hexagonal bay window. All windows have undivided, double-hung wood sash. Both elevations terminate in a deeply projecting cornice with dentils and a plain parapet. The rear elevation has wood egress porches. The building appears to have been lifted to allow for the insertion of garages underneath. The building appears to be in good condition.

16th Street (south) elevation

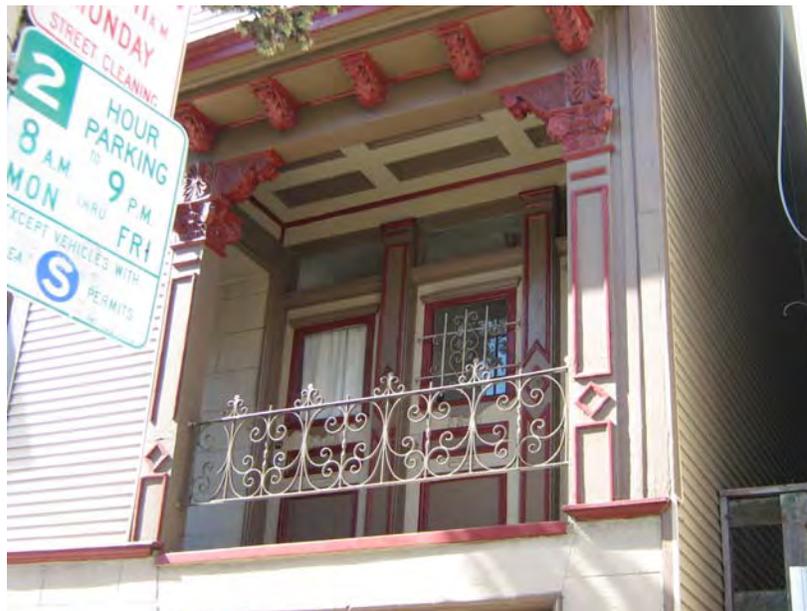
Detail, entry

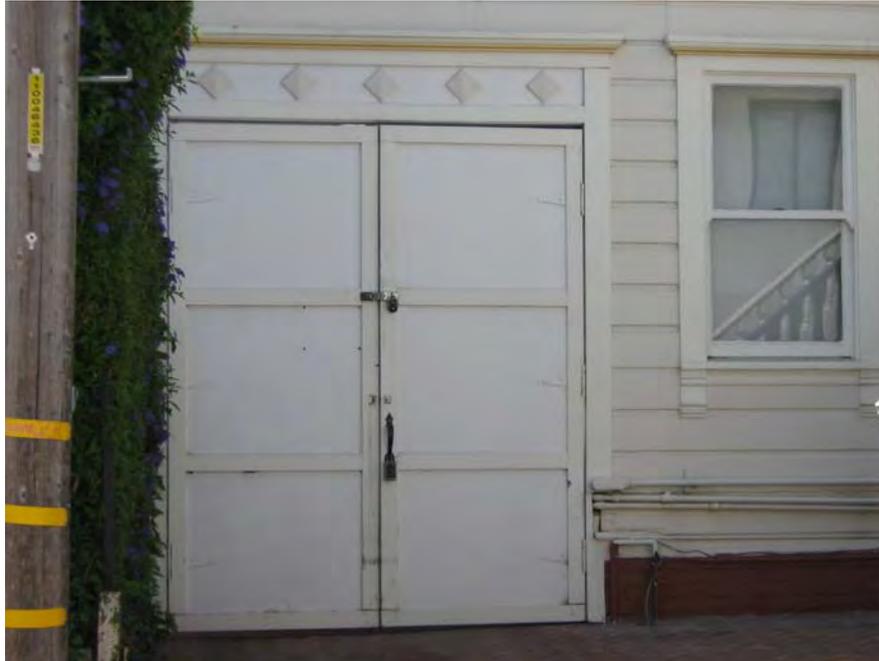
Left bay of the first floor at 156 Landers Street.

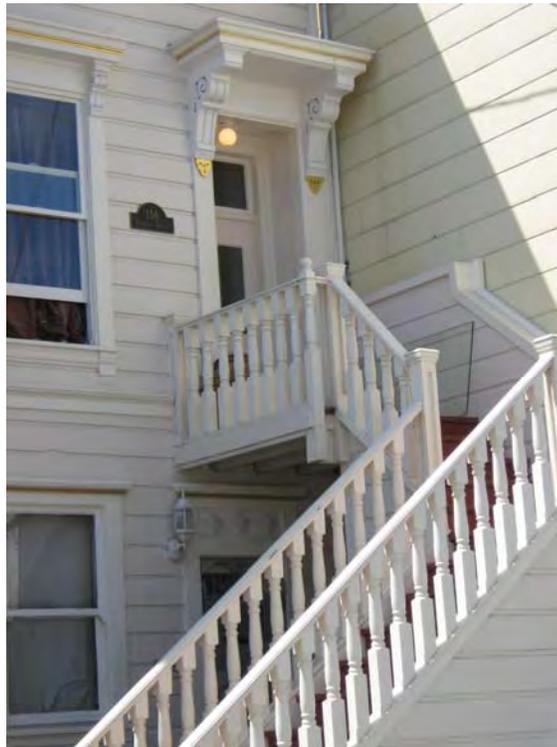
Second-floor entrance at 156 Landers Street.
