Record Number: 2020-004811MLS
 1315 Waller Street
 Mills Act Historical Property Contract

ADOPTING FINDINGS RECOMMENDING TO THE BOARD OF SUPERVISORS APPROVAL OF THE DRAFT MILLS ACT HISTORICAL PROPERTY CONTRACT, REHABILITATION PROGRAM, AND MAINTENANCE PLAN FOR 1315 WALLER STREET.

This Focused Historic Structure Report has been prepared to accompany a Mills Act Historical Property Contract for the John A. Whelan House at 1315 Waller Street (APN 1255/080) in San Francisco’s Haight-Ashbury neighborhood. The house was originally constructed in 1896 by shipwright and speculative real estate developer John A. Whelan as part of a row of four similarly designed houses, later known collectively as the Four Seasons Houses. The house at 1315 Waller Street is the easternmost building within the group and is identified as “Winter” for the applied snowflake centerpiece relief on its front façade. Whelan used the house as his personal family home.

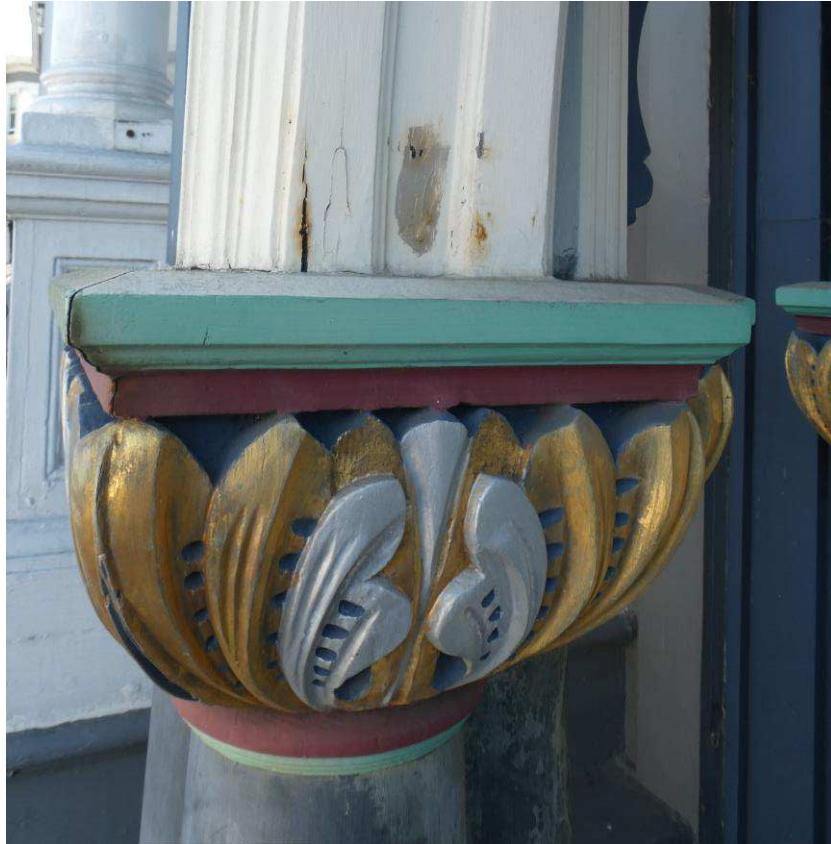
Figure 25: Detail of wood deterioration and checking/splitting at the main entry.

It appears the façade was last repainted sometime before 2008. Assess and inspect the facade for wood damage or deterioration, and repair as needed, including patching holes and sealing gaps at the garage scone escutcheons. Any needed repairs will avoid altering, removing or obscuring character-defining features of the building. and elements determined to be damaged or deteriorated beyond repair will be replaced in-kind (e.g., wood for wood). Prepare, prime, and paint with appropriate paint, including windows - (see Rehabilitation/Restoration Item 5 for detail at windows and Item 6 for detail at doors). Install new sealants every paint cycle at flashings and where occurs as needed. All work will comply with the National Park Service's Preservation Brief #10: Exterior Paint Problems on Historic Woodwork. All work will conform to the Secretary of the Interior's Standards for Treatment of Historic Properties.

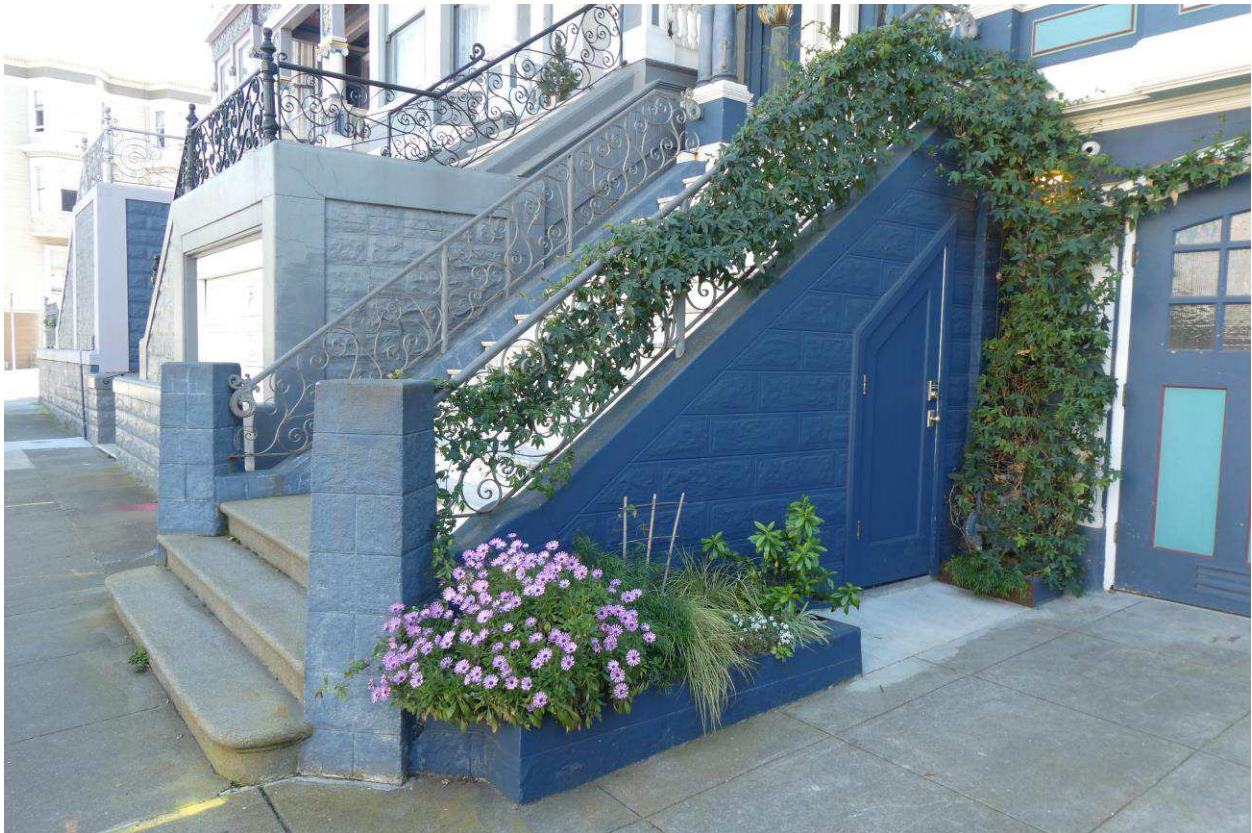
Figure 28: Overall view of entry stairs with concrete lower steps, side wall and newels. Note the flowering plant growing at the juncture of the garage and main stairs.

Clean staining, soiling, biological growth, and discoloration at marble entry stair and concrete base landing/steps. Repair stone, including wear, chips, and cracks as needed. All work will comply with the National Park Service's Preservation Brief #1: Cleaning and Water-Repellent Treatments for Historic Masonry Buildings. All work will conform to the Secretary of the Interior's Standards for Treatment of Historic Properties.

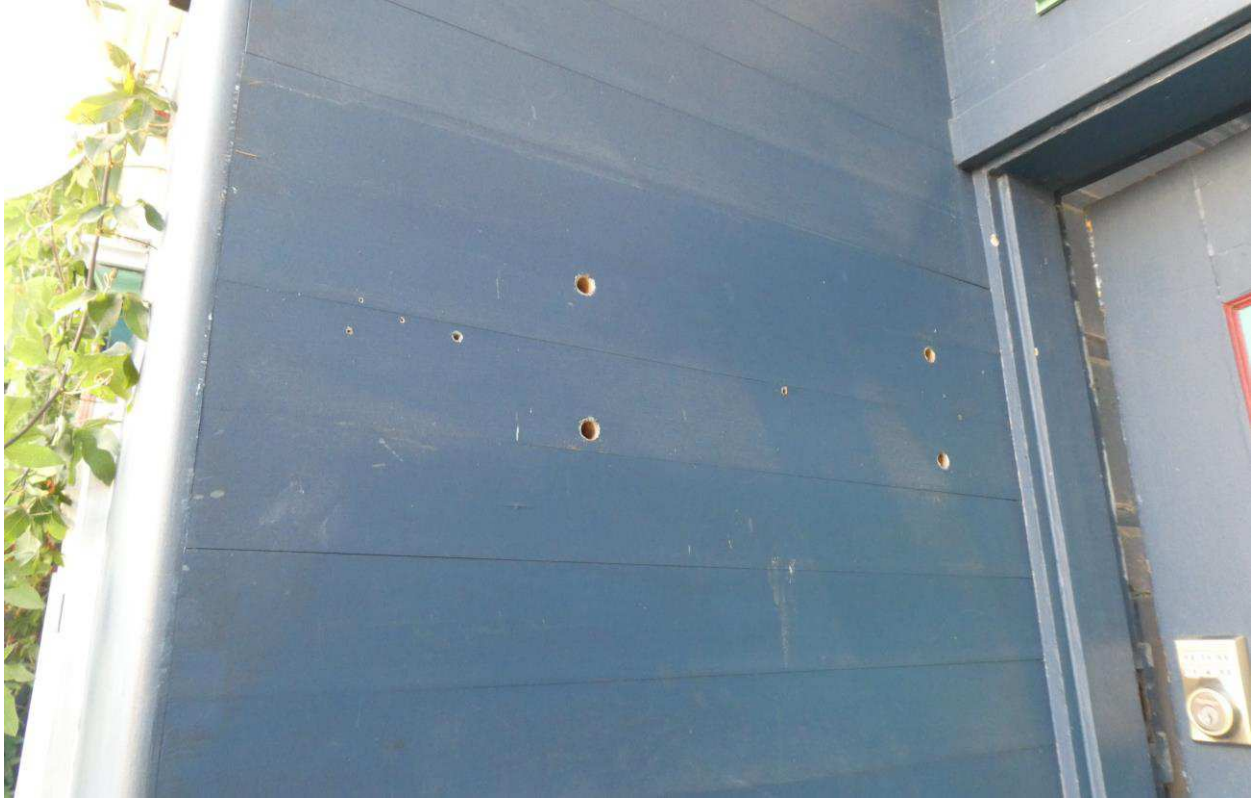
Figure 29: Detail showing holes at the ground level siding.

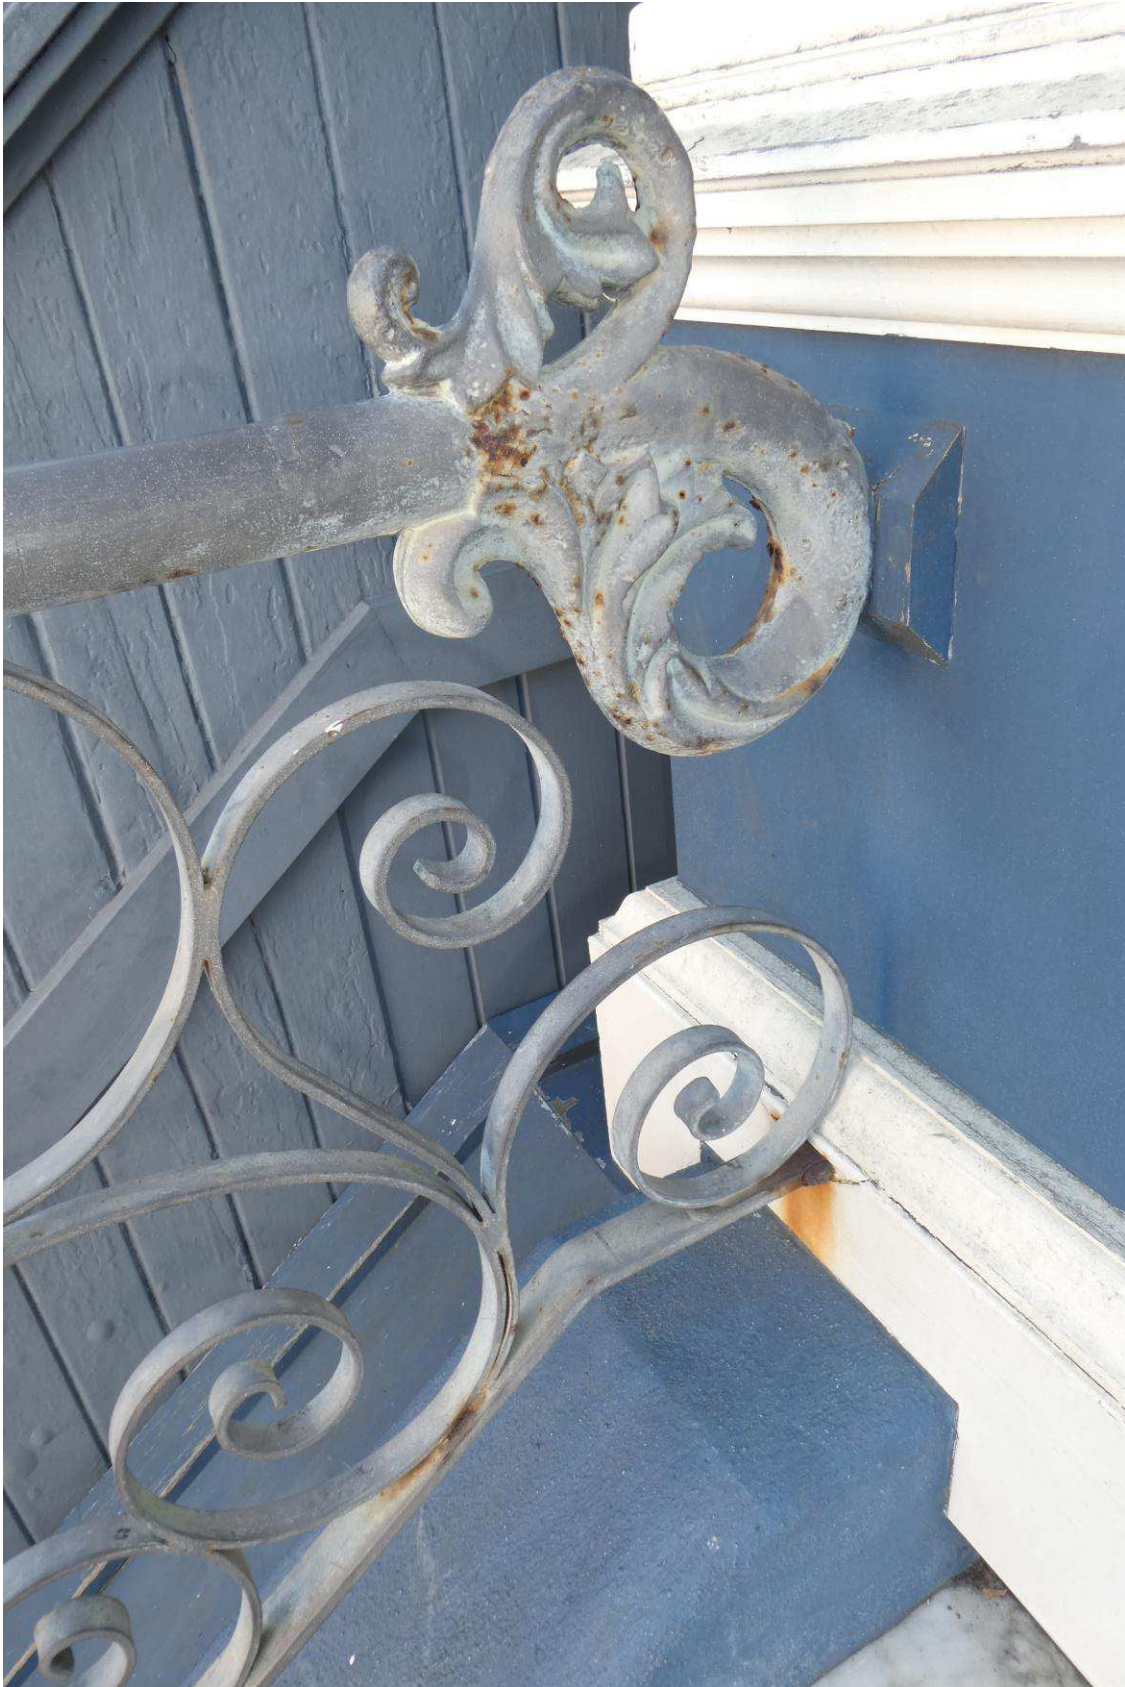
Figure 33: Detail of typical corrosion at the wrought and cast iron stair rail.

Treat corrosion at handrails and prepare, prime, and paint with appropriate rust inhibitive metal paint. At the concrete base of the rail/side walls, remove paint and clean concrete substrate (taking care not to use acidic cleaners near the marble steps) or prepare, prime, and repaint with appropriate breathable masonry paint. Work will comply with the National Park Service's Preservation Brief #27: The Maintenance and Repair of Architectural Cast Iron and Preservation Brief #15: Preservation of Historic Concrete. Work will conform to the Secretary of the Interior's Standards for Treatment of Historic Properties.

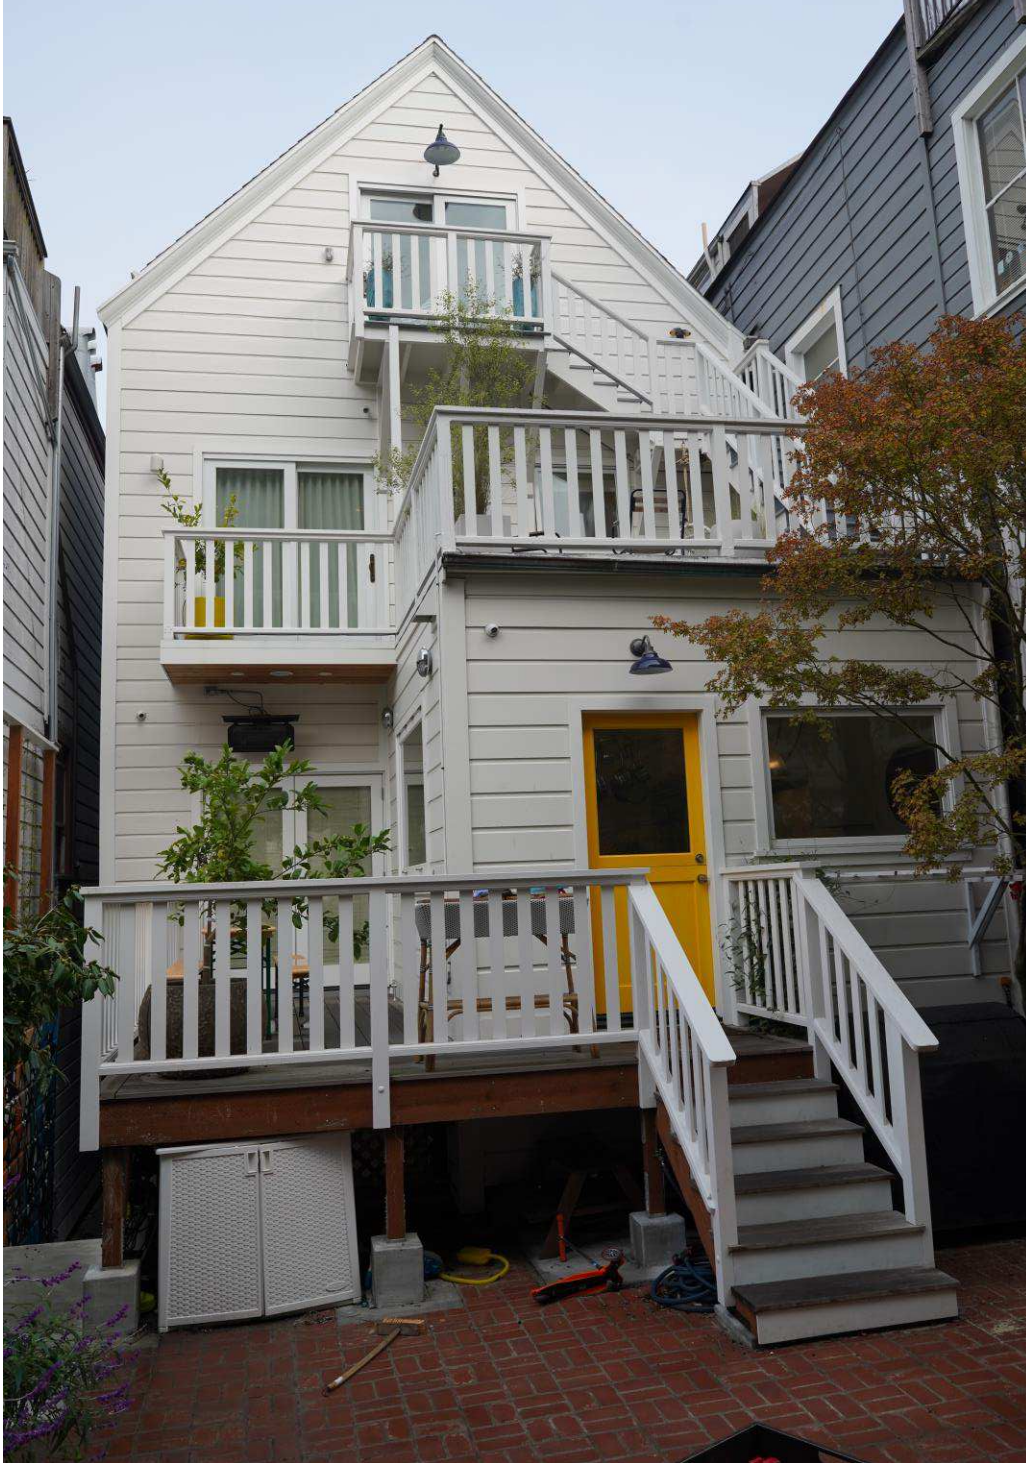
The rear façade is generally in fair condition with a few localized areas in fair-to-poor condition. The painted wood siding is in relatively good condition, however bulging and splitting of the wood siding was noted at the southwest kitchen wall adjacent to the window and at the top of the southeast kitchen wall and at the adjacent eave/soffit boards.

Figure41. Overall view of the rear, southeast facade, view northwest.

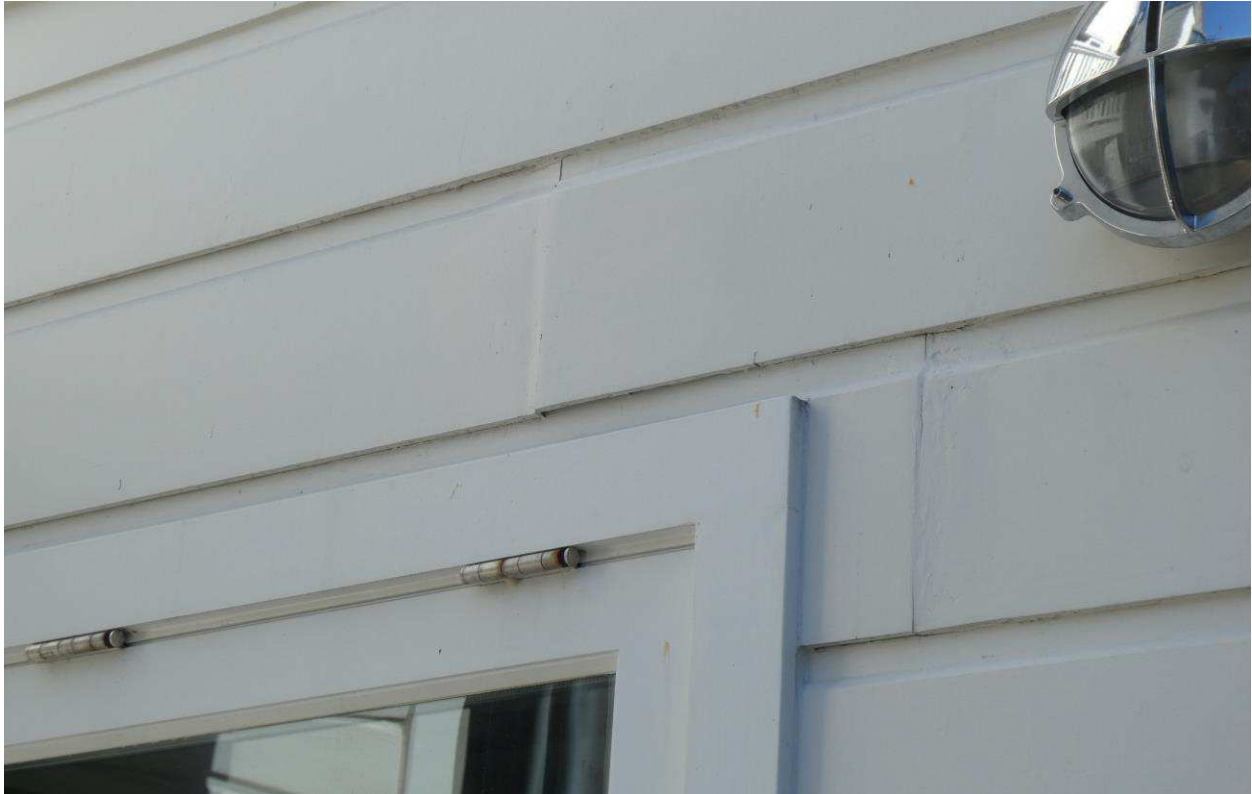
Figure 44: Detail of bulging siding at the upper corner of the window, southwest side of the first floor kitchen. Note bulging at the lower corner in (Figure 45).

Investigate bulged/split siding at the west kitchen window and bulged siding and split eave board at the top of the south kitchen wall. Correct deficiencies and ensure weather-tightness as needed. Repair or replace siding to match existing as needed. Prepare, prime, and paint with appropriate paint. All work will comply with the National Park Service's Preservation Brief #47: Maintaining the Exterior of Small and Medium Size Historic Buildings and National Park Service's Preservation Brief #10: Exterior Paint Problems on Historic Woodwork. All work will conform to the Secretary of the Interior's Standards for Treatment of Historic Properties.

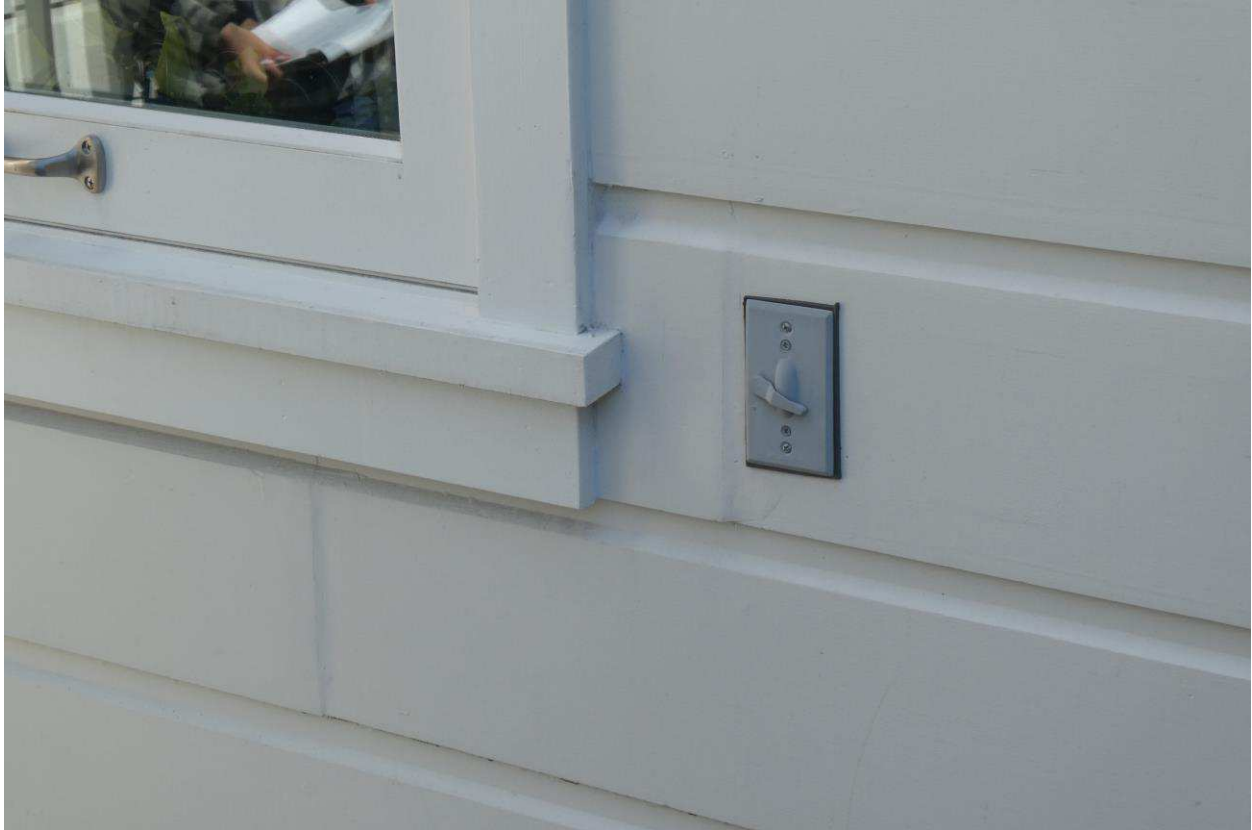
Figure 45: Detail of bulging siding at the lower corner of the window, southwest side of the first floor kitchen.

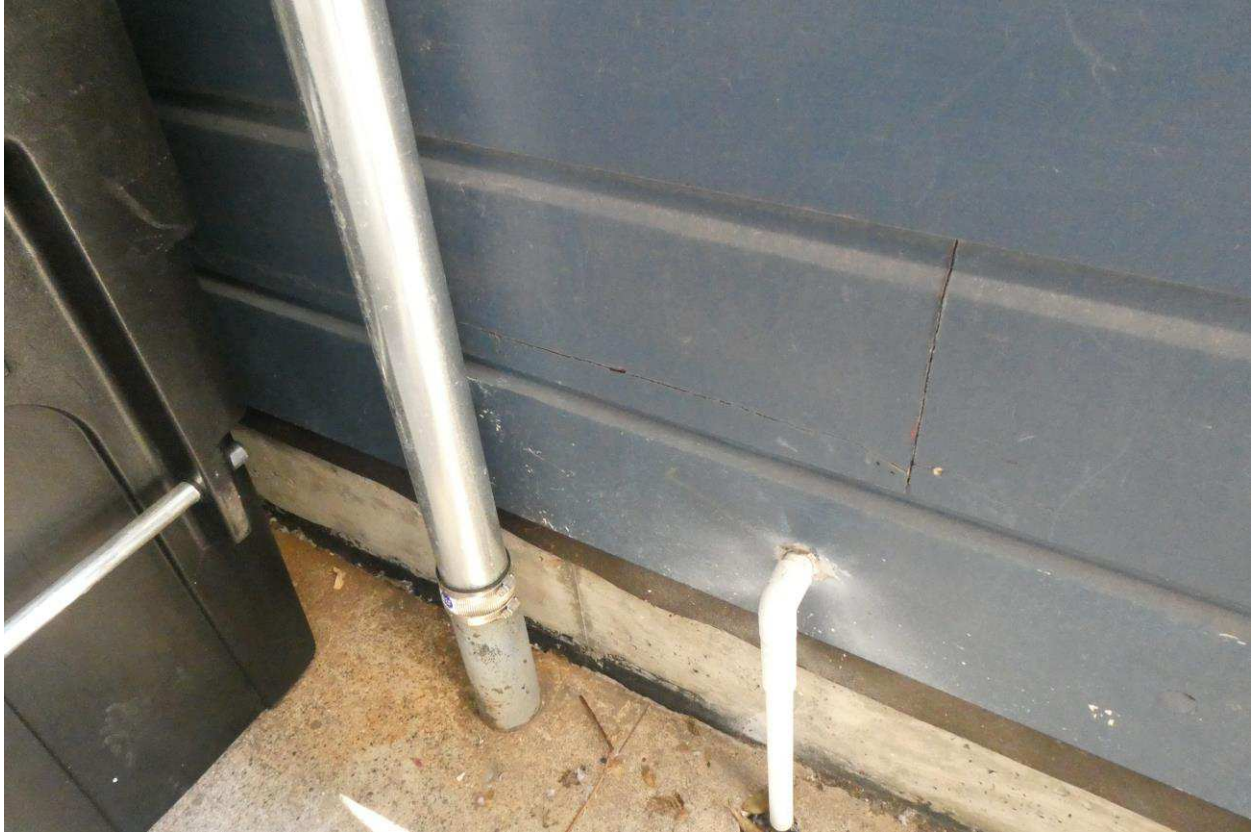
The side façades all appear to be in good to fair condition. The painted wood siding is in relatively good condition. At the southwest façade, minor localized splitting at the wood siding was noted. The double hung bathroom window at the second story is in good condition; it does not have weather stripping. At the northeast façade, the non-historic casement windows at both levels are in fair condition; they have Plexiglas instead of glass, and exhibit failure/deterioration of glazing sealant at the exterior. They also do not have weather stripping.

Figure 47: Detail of checked/splitting at siding on the southwest elevation.

Assess and inspect the facades for wood damage or deterioration, and repair as needed. Repair checked/split wood siding. Patch holes at abandoned mechanical conduits/ducts as needed. Prepare, prime, and paint with appropriate paint, including windows - (see Rehabilitation/Restoration Item 5 for detail at windows). Install new sealants every paint cycle at flashings and where occurs as needed. All work will comply with the National Park Service's Preservation Brief #10: Exterior Paint Problems on Historic Woodwork. All work will conform to the Secretary of the Interior's Standards for Treatment of Historic Properties.

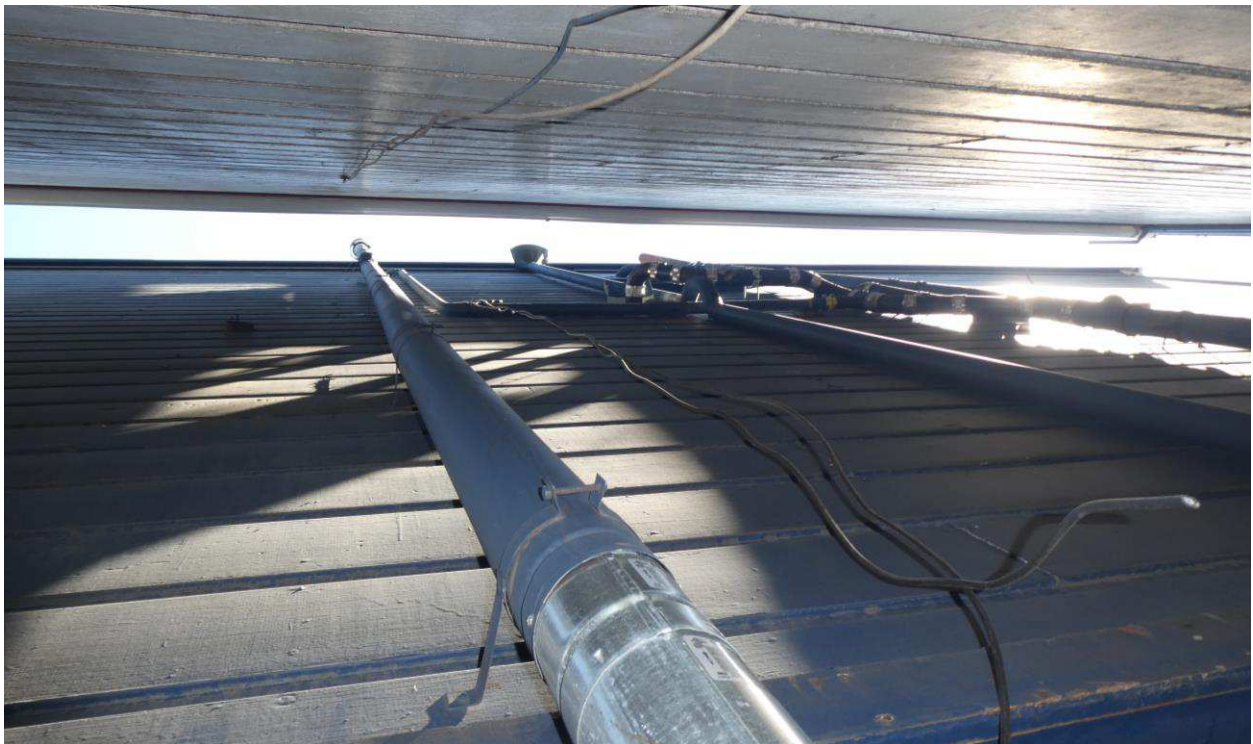
Figure 48: Detail showing the mechanical and plumbing flues/piping/conduits at the upper southwest wall.

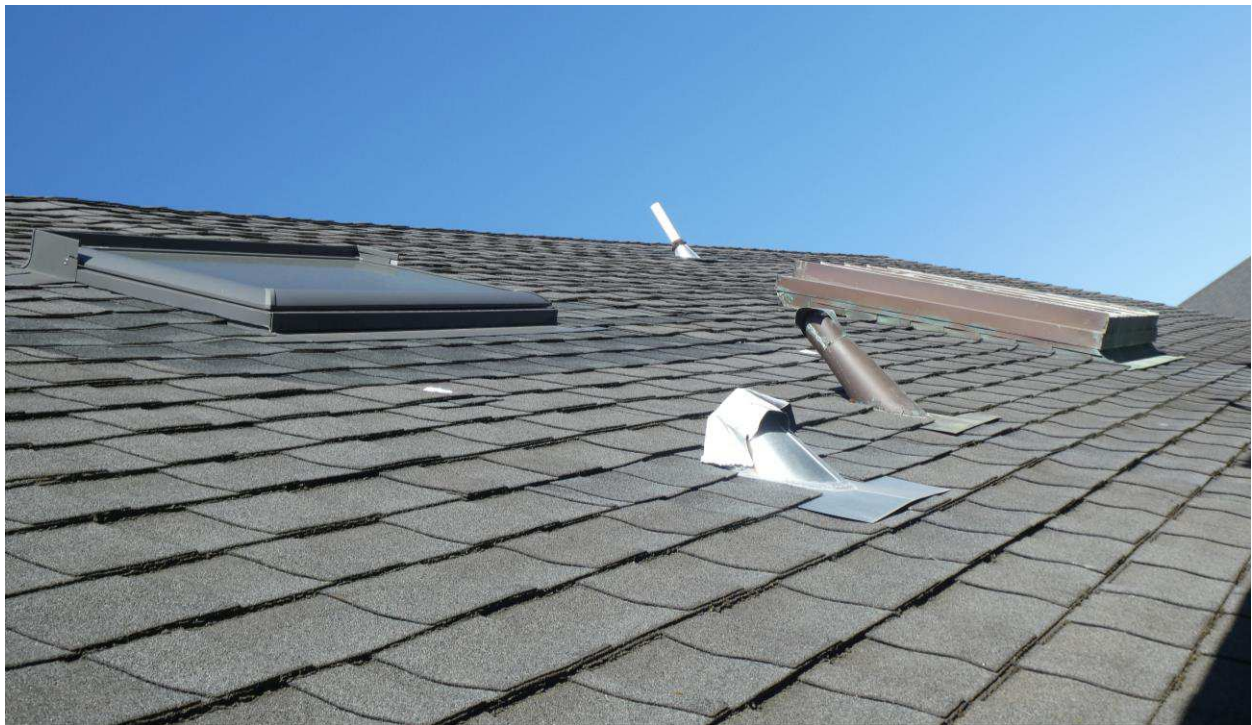
The asphalt shingle roofing at the main roof is nearing the end of its useful life. No issues were noted with the skylights or copper gutters. The asphaltic kitchen roof has also reached the end of its useful life, as it has been previously patched.

Figure 53: Detail of the asphalt shingle roofing on the main roof and two skylights. The original copper skylight over the interior stair is to the right in the photo.

The roofing at the main roof appears to have been replaced in 1993. Inspect main roof and replace existing shingle roofing with new shingle roofing. Repair or replace related flashing, waterproofing, and gutters as needed. Inspect gutters and downspouts, including copper gutters, and repair or replace as needed in conjunction with roofing work. Work shall be done in accordance with the National Park Service's Preservation Brief #4: Roofing for Historic Buildings and Preservation Brief #47: Maintaining the Exterior of Small and Medium Size Historic Buildings. All work will conform to the Secretary of the Interior's Standards for Treatment of Historic Properties.

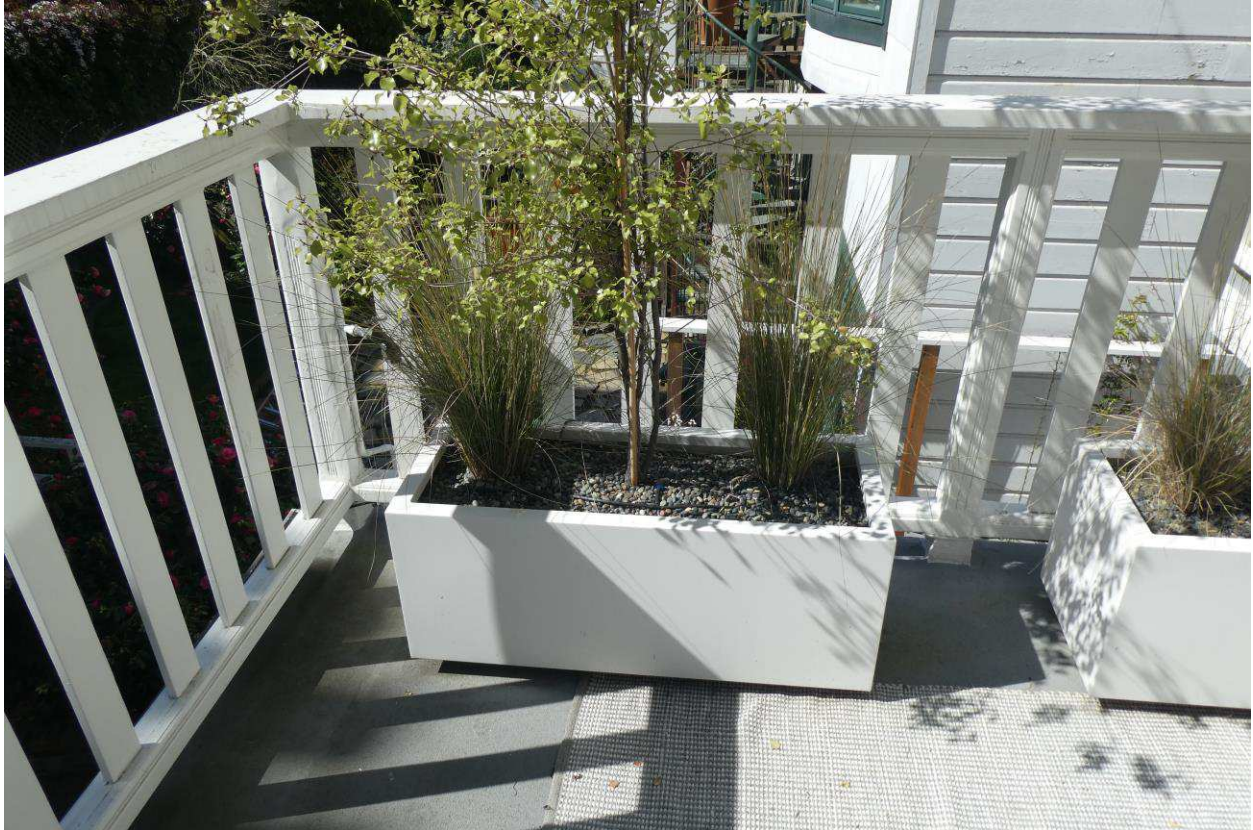
Figure 54: Detail showing the asphaltic roof at the decking above the first floor kitchen.

Figure 55: Detail showing the asphaltic roof at the decking above the first floor kitchen.

Inspect roofing, and replace roofing at deck area over kitchen. Ensure waterproofing at guard rail penetrations/anchorage including repairing wood guardrail as needed. Ensure roof is sloped to drain properly to adjacent gutter. Inspect gutters and downspouts, including copper gutters, and repair or replace as needed in conjunction with roofing work. Work shall be done in accordance with the National Park Service's Preservation Brief #4: Roofing for Historic Buildings and Preservation Brief #47: Maintaining the Exterior of Small and Medium Size Historic Buildings. All work will conform to the Secretary of the Interior's Standards for Treatment of Historic Properties.
