File No. 251126

Committee: Government Audit and Oversight

## EXISTING CONDITIONS ASSESSMENT

# 530 Jackson Street

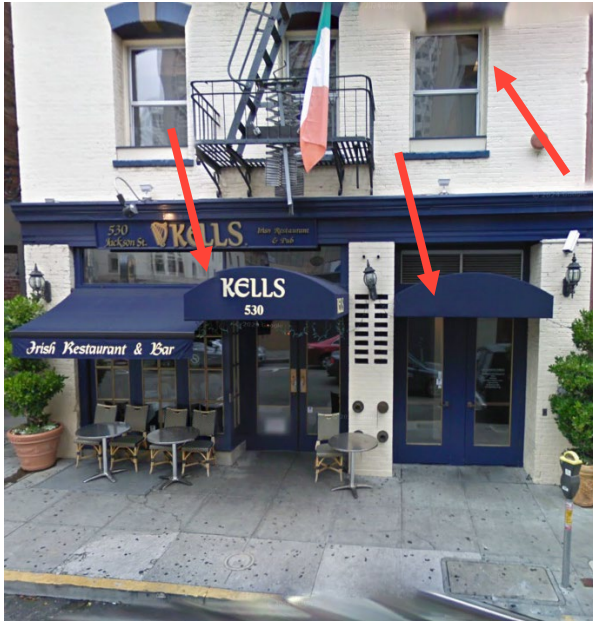
Figure 9: 530 Jackson Street, 1998. The storefront has been demolished and is being reconstructed. Note the original windows at the upper floors are still extant, at the red arrow. Source: San Francisco Public Library, Assessors Office Photograph Collection. Edited by Page & Turnbull.

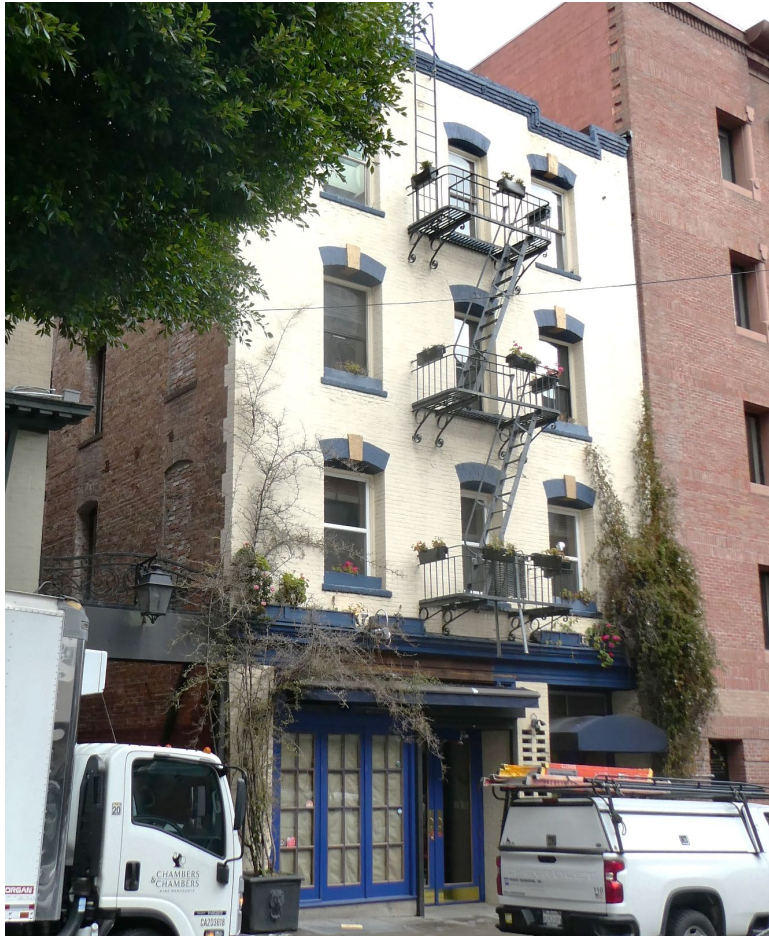
530 Jackson Street is a rectangular five-story over basement, steel reinforced brick masonry and timber frame commercial building built in 1907 (**Figure 12**). The south façade facing Jackson Street is fronted by a wide concrete sidewalk, the east façade of the building is mostly concealed by a modern five-story building, while the west and north façades are bordered by a pedestrian alleyway at the south end of the west façade and a rear courtyard at the north end of the west façade and north facade. All exterior walls of the building consist of brick masonry on the first through third stories and at the south end of the fourth story, while an addition at the north portion of the fourth and all of the fifth story are clad in stucco. Typical windows consist of replacement wood and vinyl double-hung windows inserted into the original wood frames at the historic masonry elevations, while the newer stucco portions of the fourth floor and all of the fifth floor feature a variety of steel and vinyl windows of varying sizes, styles, and operability. A few original wood sash remain in their wood frames at the first floor of the west façade and second floor of the north façade. The fifth story stucco addition is set back from the lower Jackson Street historic brick facade, creating a fourth story balcony (roof deck) with canted metal railings to preserve sight lines. The building has a flat roof with a parapet and is covered in composition roofing material, with several skylights on both the fourth story balcony and the fifth story roof. The fourth-story features a brick cornice with a simple projecting stepped coursing that has two shallow crenellations.

Figure 12. Oblique view 530 Jackson Street. Looking northeast.

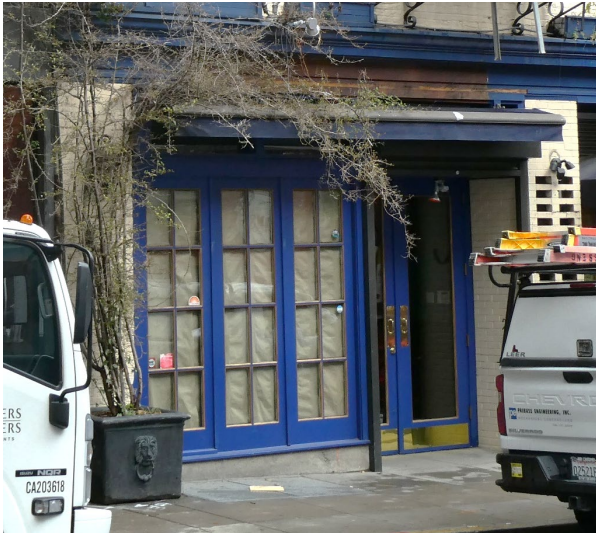
Figure 13: Oblique view of storefront at first story of 530 Jackson Street. Looking northeast.

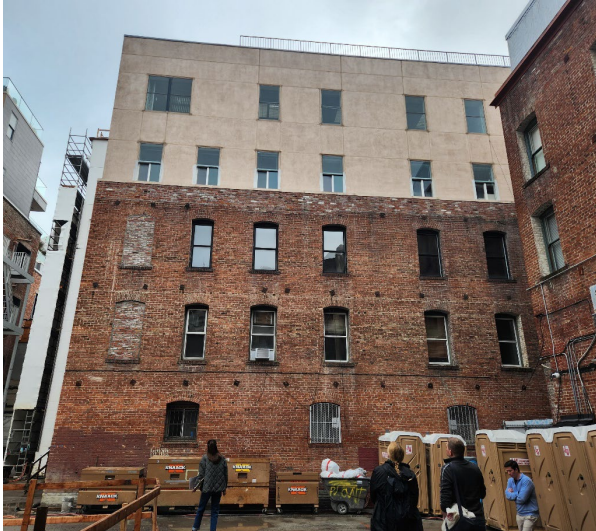
The west façade faces a pedestrian alleyway. At the first story are four arched brick windows covered in metal bars or screens; the three to the south (right) appear to be original wood-frame windows with their original sash, while the north (left) window appears to be an original wood-frame window with a replacement metal sliding window inserted into the original frame (**Figure 17** and **Figure 18**). The second, third, and part of the fourth story feature original wood window frames with replacement metal, wood, and vinyl double-hung windows inserted into the original wood frames. The windows are set in original arched brick openings, and the openings at the far north

Figure 17: West façade of 530 Jackson Street. Looking east.

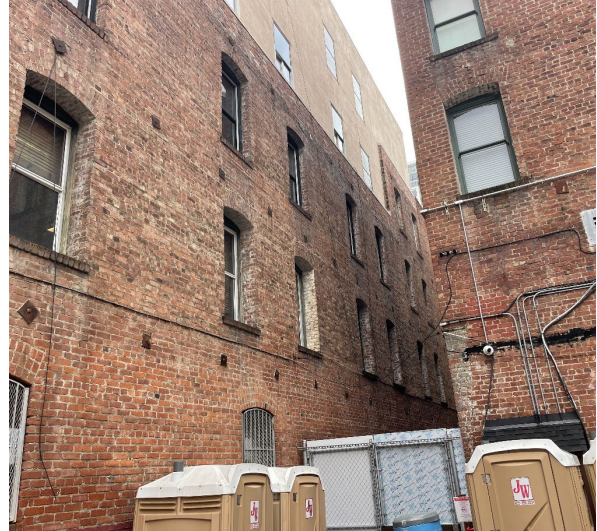
Figure 18: Oblique view of the west façade of 530 Jackson Street. Looking southeast..

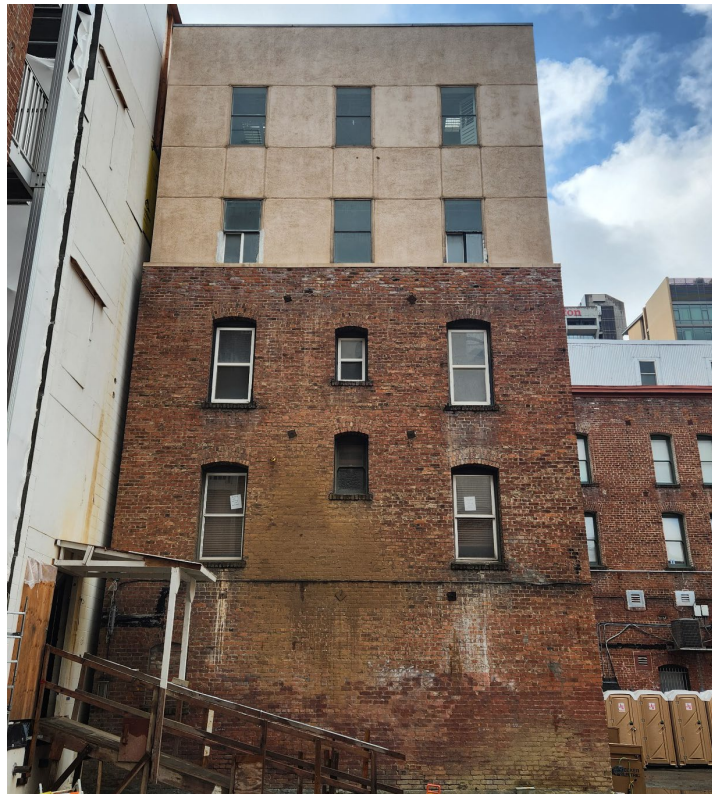
The north façade faces a pedestrian courtyard. It features no openings at the first story (**Figure 19**). The second story features an original wood double-hung window flanked by replacement aluminum and vinyl double-hung windows inserted into original wood frames. The third story features a small vinyl double-hung window inserted into original wood frames, flanked by vinyl double-hung windows inserted into original wood frames. The fourth story features a two-lite metal fixed window flanked by metal windows with fixed upper sash and sliding lower sash. The fifth story features three two-lite metal fixed windows.

Figure 19: North façade of 530 Jackson Street. Looking south.

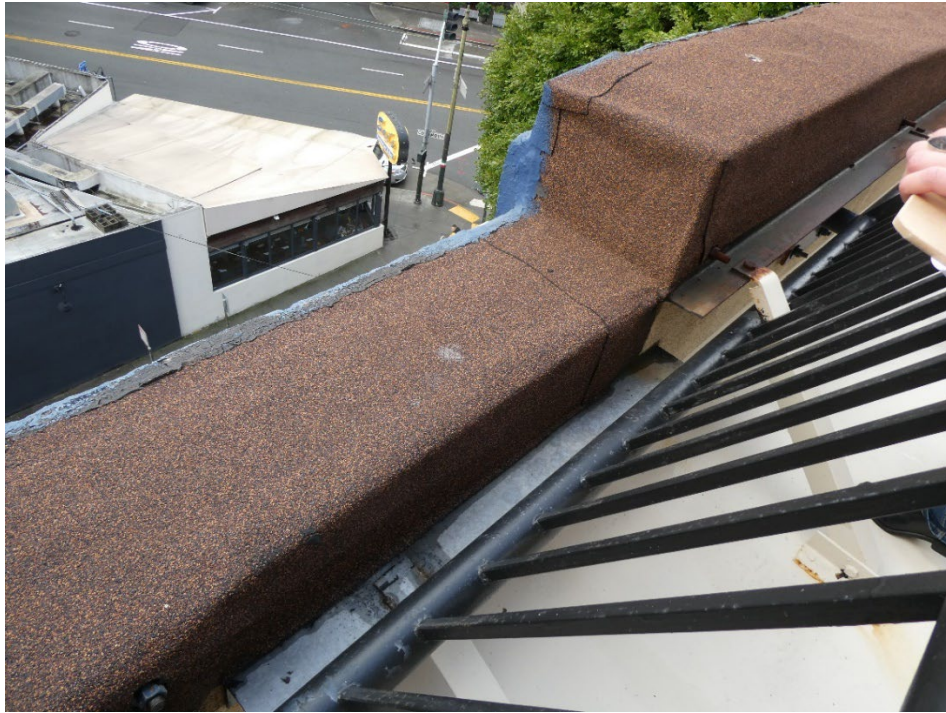
Figure 42: Some deterioration of the seams at the asphaltic coping at the south parapet wall, fifth floor balcony.

| <p>Description of work:</p> <p>Inspect the balcony roofing and ensure there is no water intrusion into the interior. Recoat and patch the membrane roofing at the balcony. Remove the asphaltic coping at the south and west parapet walls and replace with G90 heavy galvanized or non-corroding metal coping and paint with a rust inhibitive paint. Install drain covers at the two roof drains at the north corners. Remove the corrosion from the seismic parapet bracing and metal parapet coping at the expansion joint cover (the expansion joint cover extends along the full east wall at the fifth floor balcony and the upper roof). Paint both with a rust-inhibitive paint to protect from future corrosion.</p> | |

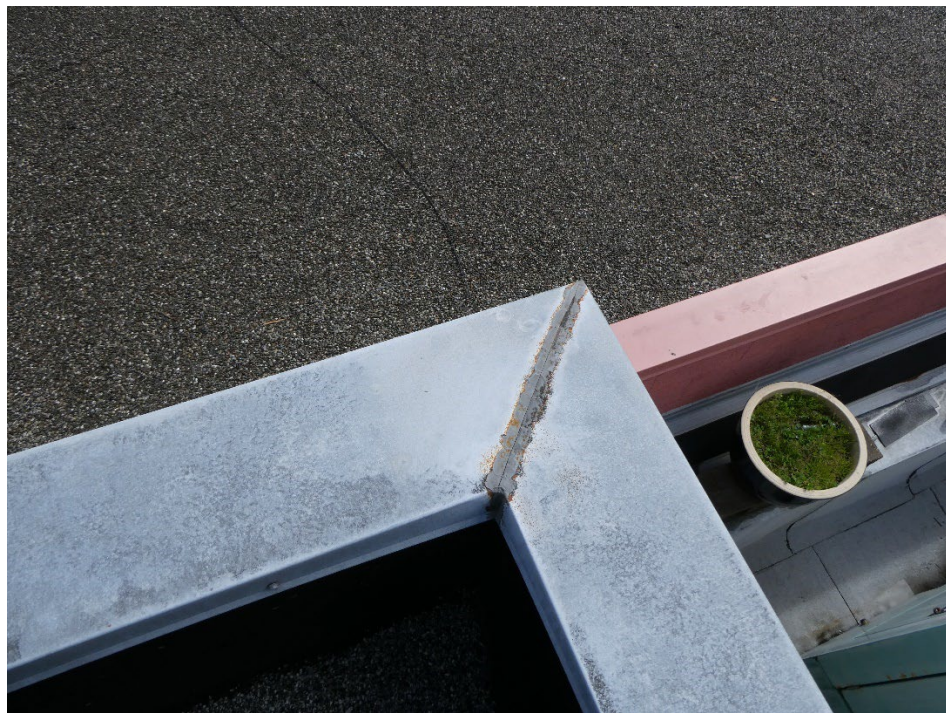
The penthouse stucco is in good condition. The stucco has been painted grey at one end, exhibiting two different paint campaigns. The hollow metal frame and door into the exhibits some surface corrosion but is in fair condition. The rubber threshold should be replaced. The ladder to the penthouse roof has paint loss and moderate superficial corrosion. Rusted fasteners were noted at the connection point between the ladder and the metal coping (**Figure 51**). The penthouse roof is covered with liquid applied asphaltic roofing and gravel that appears to be in fair condition. The exposed asphalt at upturns is cracking and alligatoring (**Figure 52**). No water intrusion was noted at the interior of the penthouse. The metal coping at the perimeter of the penthouse parapet appears to be in fair condition with minor corrosion and separation at some of the soldered seams (**Figure 53**).

Figure 53: Deterioration of the joints at the roof coping, penthouse roof.

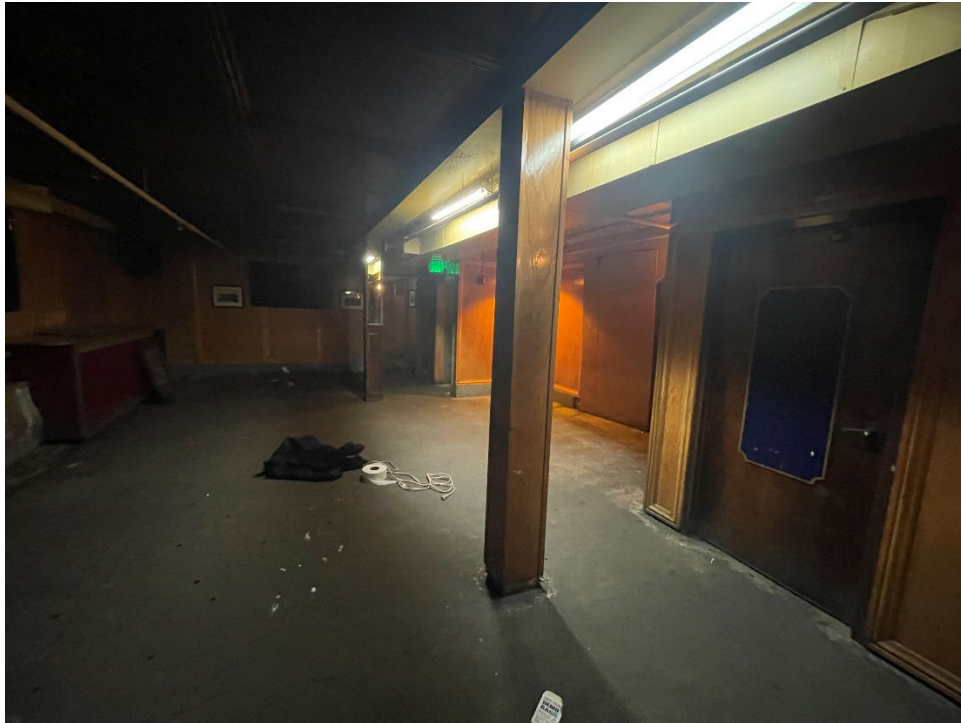
Figure 54: Overall view of the north end of the basement, looking north.

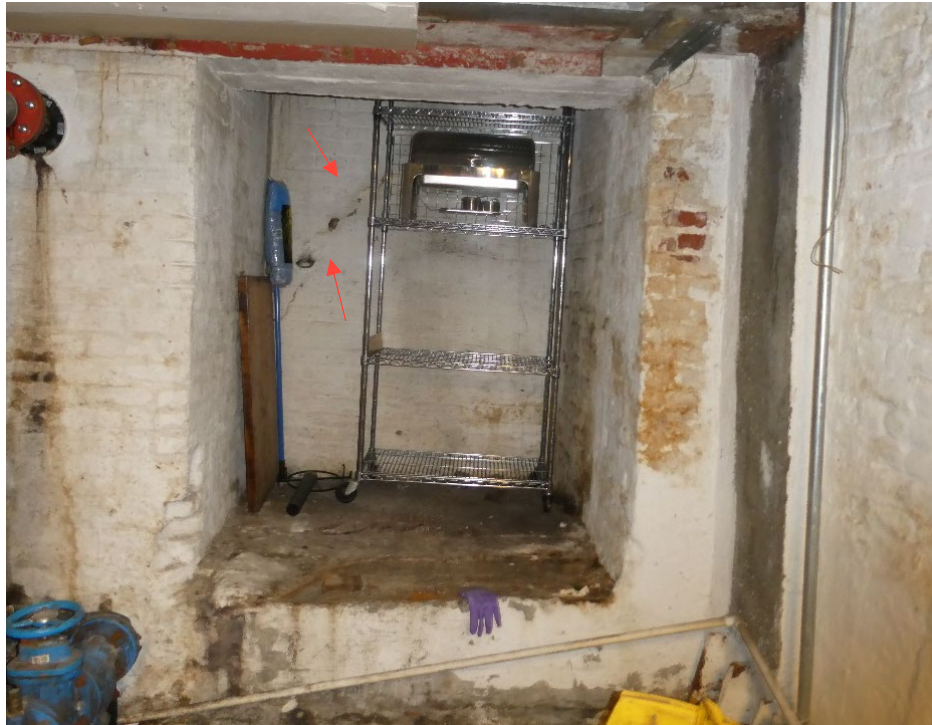
Figure 58: Diagonal crack in the south basement wall under the sidewalk hatch.

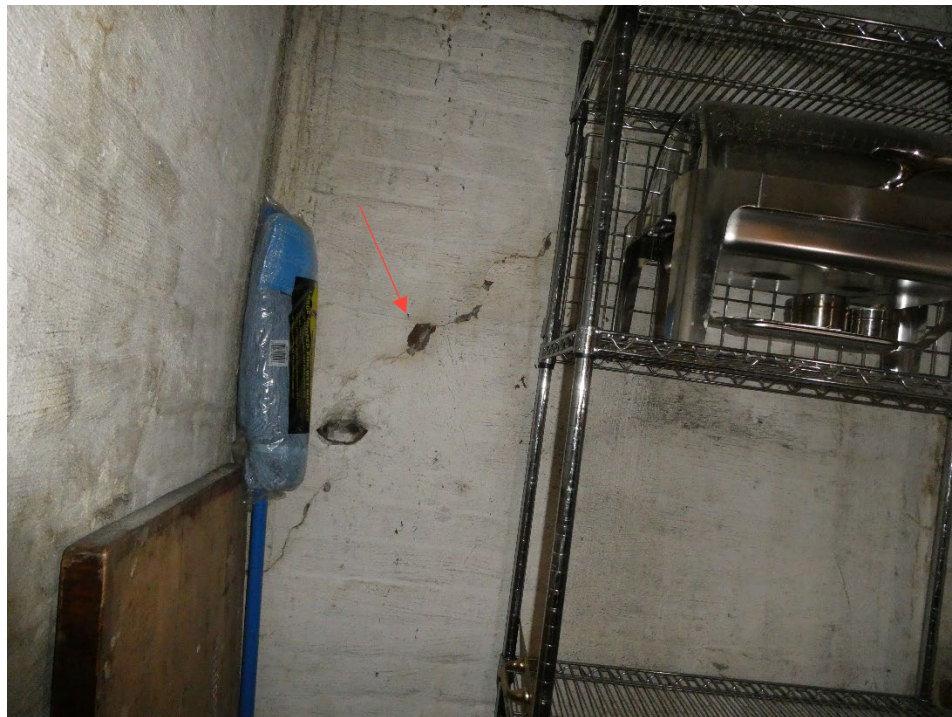
Figure 59: Detail view of the diagonal crack, south basement wall.

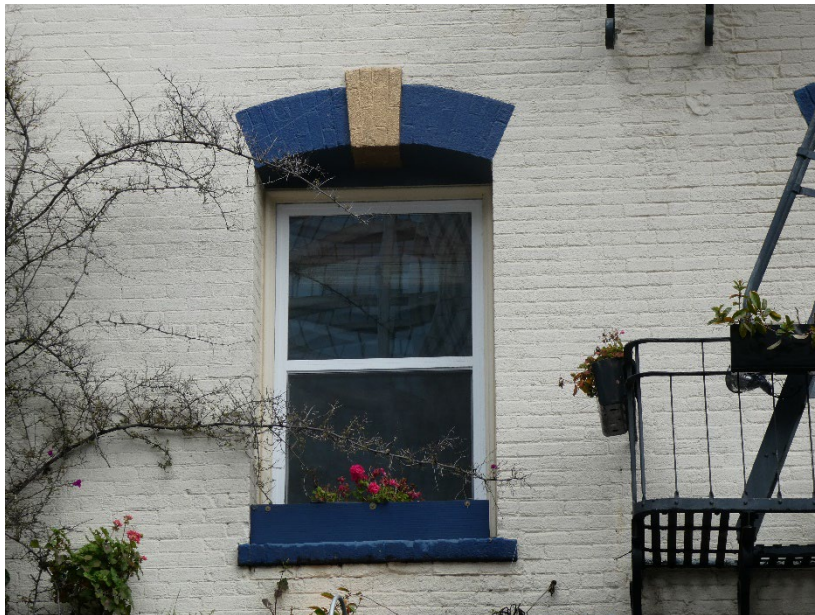
Image 12: Primary façade, typical vinyl replacement window in original masonry opening. (Photo taken by P&T 03/14/2025)

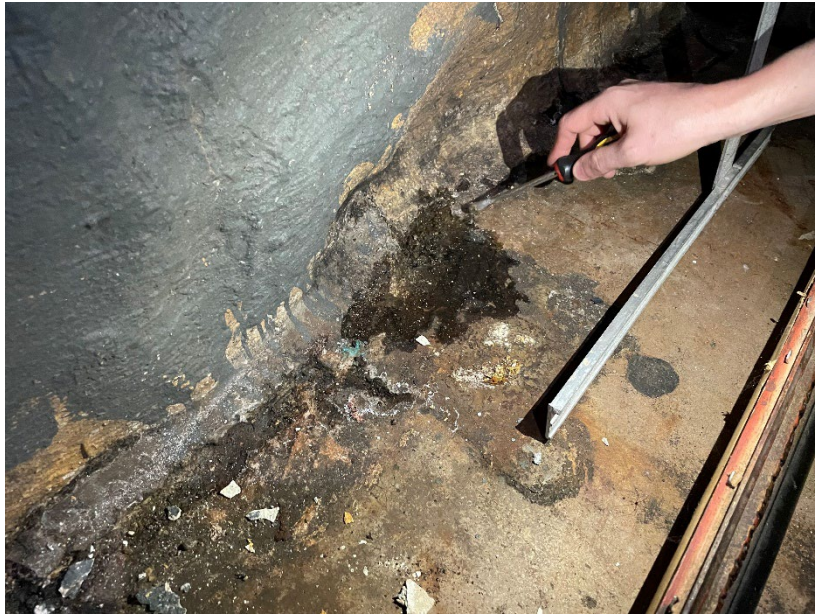
Image 27: View of typical area of water intrusion at west foundation wall, basement floor. (Photo taken by P&T 03/14/2025)

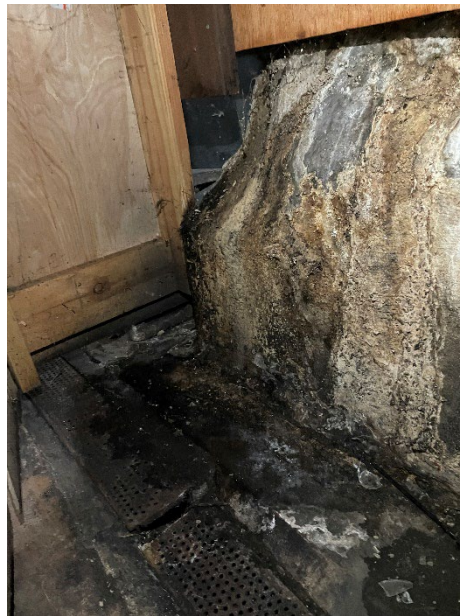
Image 28: View of typical area of water intrusion at west foundation wall, basement floor. (Photo taken by P&T 03/14/2025)

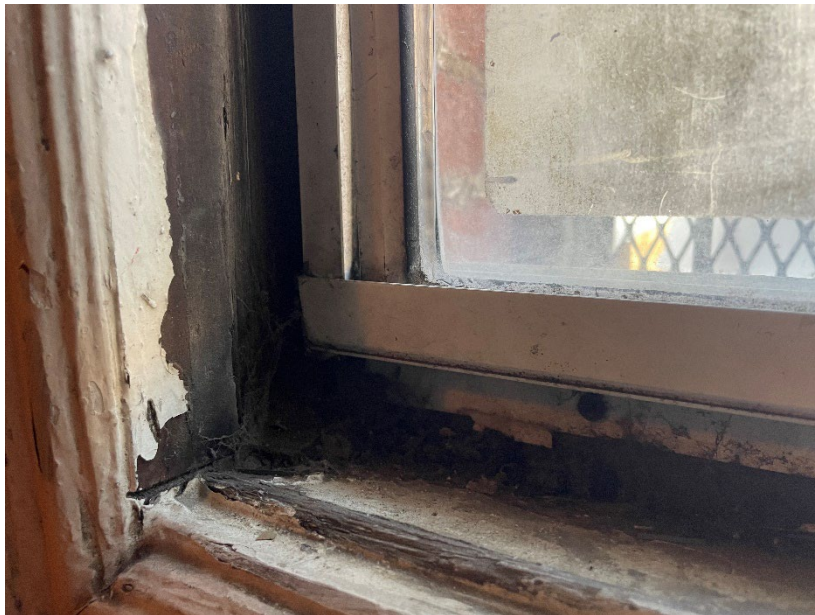
Image 34: View of wood frame deterioration at first floor, west wall. (Photo taken by P&T 03/14/2025)

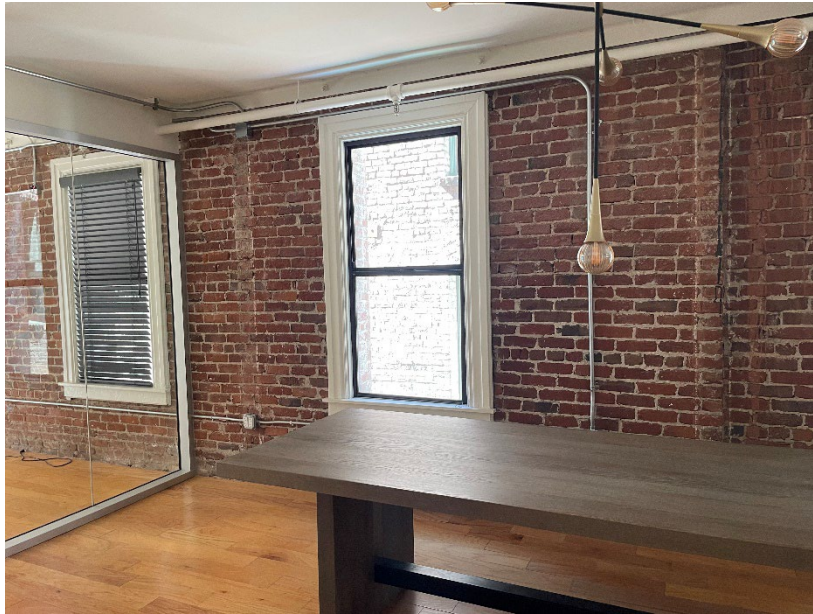
Image 37: Representative wall and window condition at third floor. (Photo taken by P&T 03/14/2025)

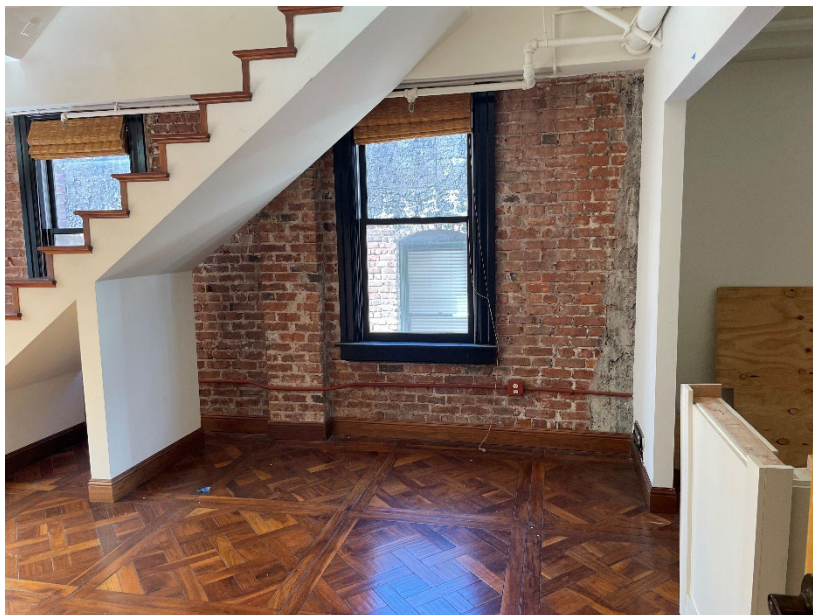
Image 38: Representative wall and window condition at fourth floor, historic area of building. (Photo taken by P&T 03/14/2025)
